Use of an Acoustic Camera to Evaluate the Performance of Tickler Chains and Draghead Deflectors for Sea Turtle Protection during Hopper Dredging in the United States of America

Final report

Under Project No. 468436, "Dredging Operations and Environmental Research Program"

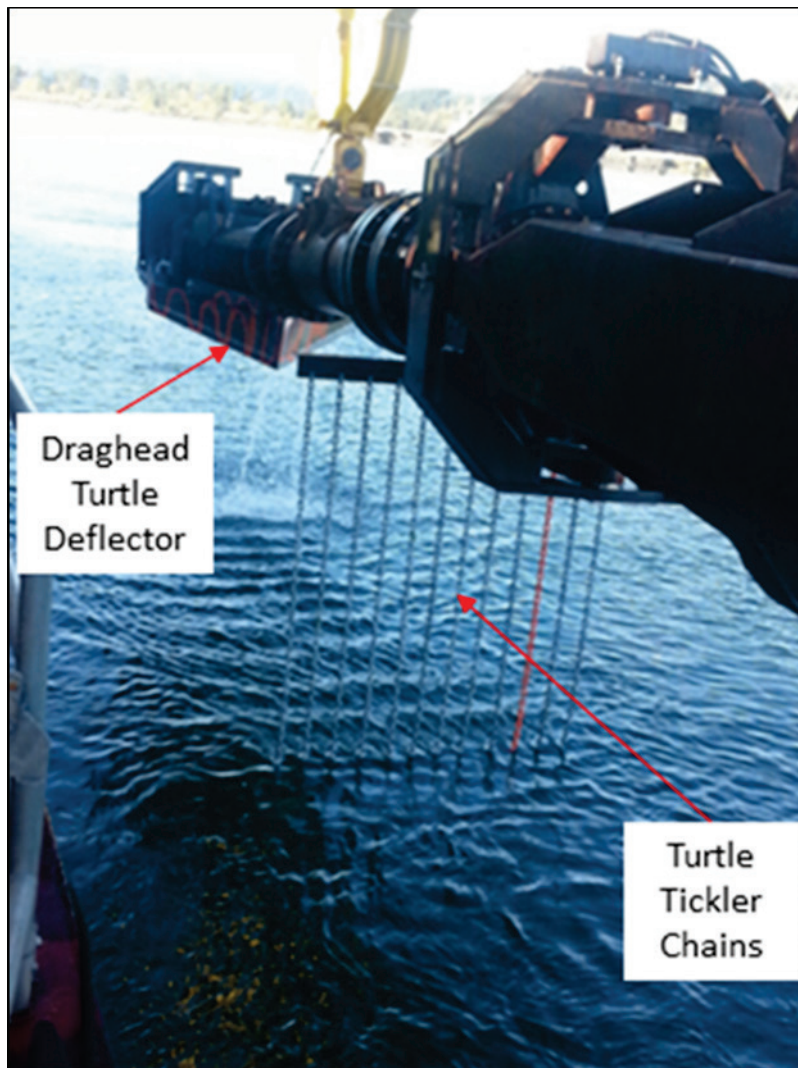
Figure 1. Rigid design draghead turtle deflector and TTC on the Essayons port dragarm (looking aft).

Prior to arrival in Hawaii, the USACE POH support team and *Essayons* crew fabricated a rigid design draghead turtle deflector for the California-style draghead and TTC for both the port and starboard dragarms. Figure 1 shows the port dragarm chain array and turtle deflector. The chain array consisted of twelve 3-meter (m) (10-feet [ft]) long sections of 1.3 cm (0.50 in.) transport chains shackled to an L-shaped angle bar of mild steel that was bolted perpendicular to the dragarm approximately 7.6 m (25 ft) forward of the draghead turtle deflector.

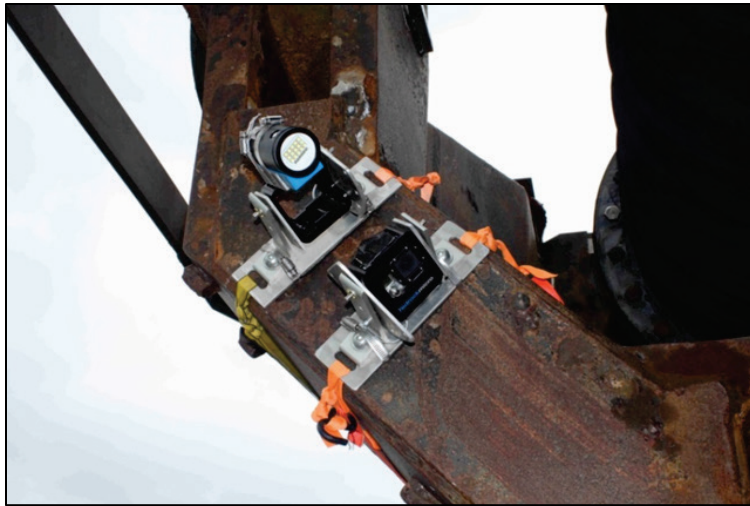
Figure 2. GoPro camera in underwater housing and 700-lumen light source mounted on outboard gimbal frame of the dragarm.

- two GoPro cameras with underwater housings along with a 700-lumen light emitting diode (LED) dive light source (Figures 2 and 3) that are self-recording and require activation before going

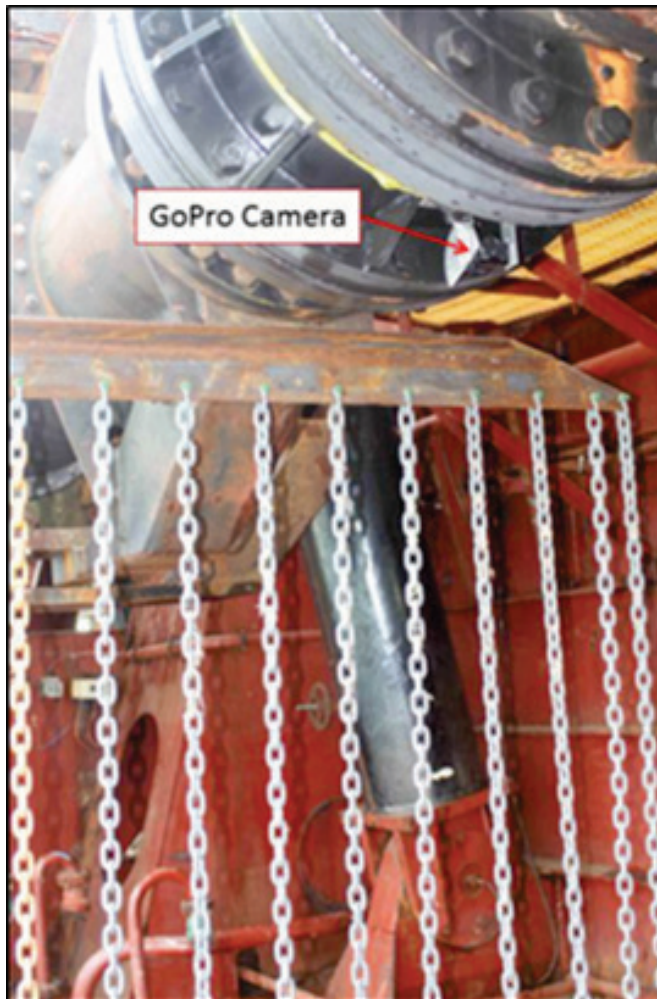
Figure 3. GoPro camera (red arrow) mounted on the dragarm above the chain array.

These camera systems were mounted on the *Essayons* port dragarm while the vessel was in drydock at Mare Island, CA. One of the GoPro cameras was mounted forward of the TTC, and the second one was mounted aft and directly above the TTC with tie-down straps. Figure 2 shows the forward GoPro camera mounted on the outboard gimbal frame of the dragarm along with a 700-lumen LED dive light source on a separate mount. Figure 3 shows the second GoPro camera mounted under the turning gland of the dragarm just aft and directly over the TTC. A special frame was constructed and bolted to the aft flange of the dragarm turning gland to mount the high-definition video system lens and light as well as acoustic camera (Figure 4). The pan and tilt rotator assembly for the acoustic camera, in conjunction with the mount location on the dragarm, allowed this camera to be remotely operated and to view either the TTC or the draghead. The power and communications cables of the high-definition video system and acoustic camera were attached to the dragarm pipe and frame and run into a deck space below (i.e., the boatswain locker) where they were connected to the video monitoring and data recording computers (Figure 5). Two-way radios were used to maintain communication with the ship's bridge and the dragtender during all video monitoring of the tickler chains and deflector with the camera.

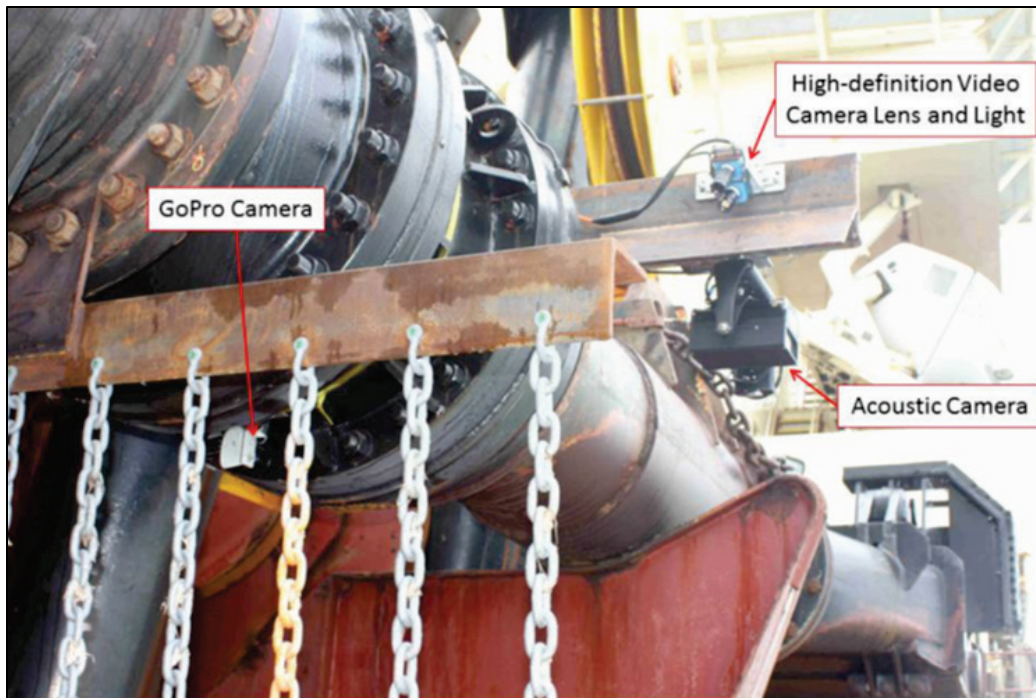
Figure 4. High-definition video camera lens with light and acoustic camera mount.

- into the water, deactivation after coming out of the water, and provide video subsequently downloaded for viewing
- a high-definition underwater video system consisting of an underwater color camera lens and 2,150-lumen (adjustable) light source connected via a single power/communications cable to a monitoring station on deck (manufactured by Outland Technology) that allowed real-time viewing and recording (Figure 4)
 - a 3.0 megahertz (MHz) high-resolution/high-definition imaging sonar acoustic system (ARIS 3000 acoustic camera manufactured by Sound Metrics) mounted on a pan/tilt rotator assembly with 2 degrees of viewing freedom (Figure 4).

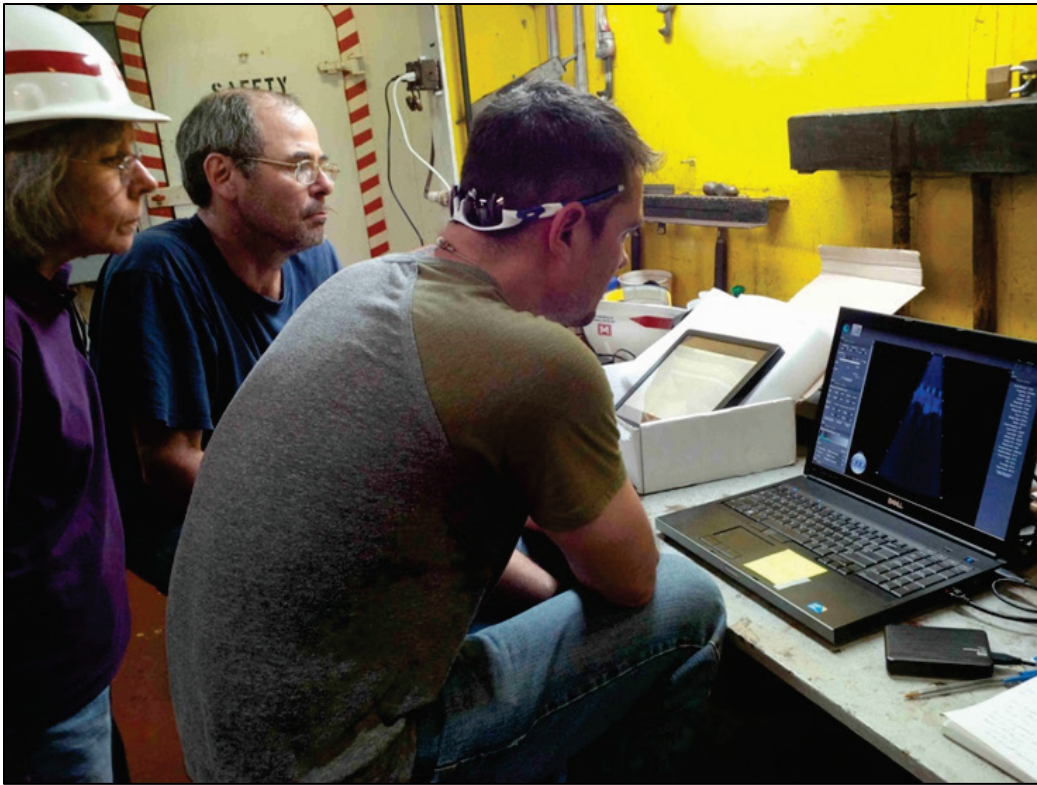
Figure 5. Underwater video and acoustic camera systems viewing and recording station in the boatswain locker.

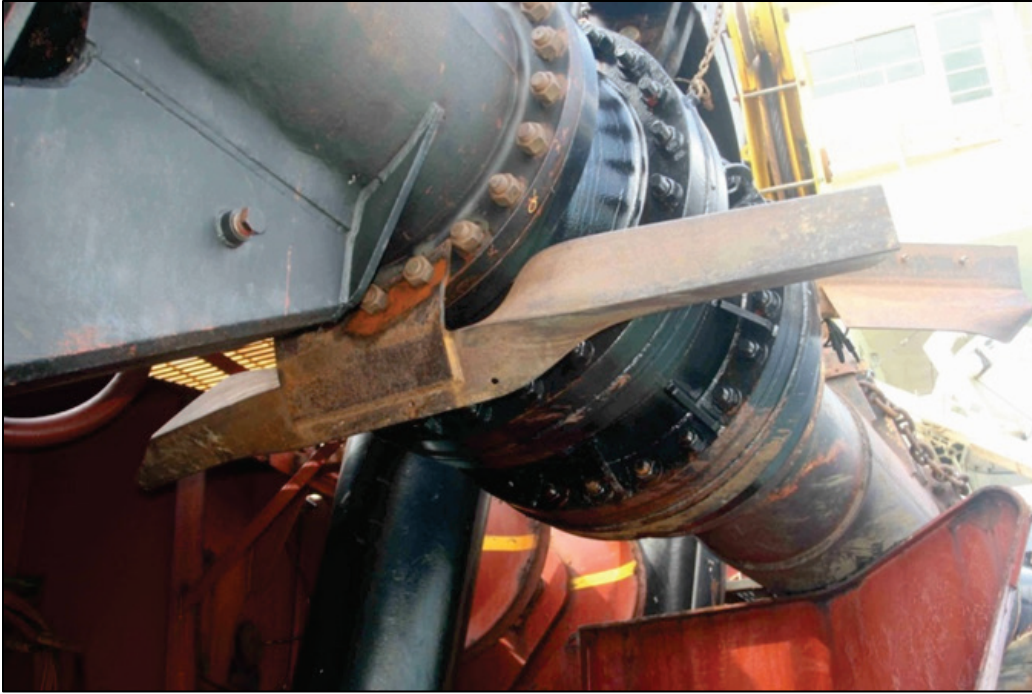
Figure 6. Damage to portside chain bracket and acoustic camera mount.

Although the dredge *Essayons* began dredging in Hawaii at Nawiliwili on 14 March 2016, the TTC could not be used because of unexpected equipment and logistical issues, and therefore underwater camera monitoring could not begin until 24 March 2016 when the dredge reached Kalaehoa Barber's Point, Oahu. The TTC and cameras were removed during dredging at Nawiliwili, but the steel angle mounting brackets were left on the dragarm. During the dredging at Nawiliwili, the brackets installed in Mare Island to hold the TTC as well as the acoustic camera mount sustained substantial damage (Figure 6).

The port TTC bracket had to be replaced before the chains could be attached, and only the acoustic camera could be attached to the bent camera mount. Because the high-definition video camera lens and light could no longer be bolted to the bent mount without significant repair effort and lost dredging time, a GoPro camera mount was modified and used to mount the high-definition camera and light on the aft frame of the dragarm gimbal (Figure 7). Figure 8 provides a different perspective of the mounted positions for the GoPro camera and high-definition camera systems relative to the chain array and draghead, which were deployed during the Kalaeloa Barber's Point testing.

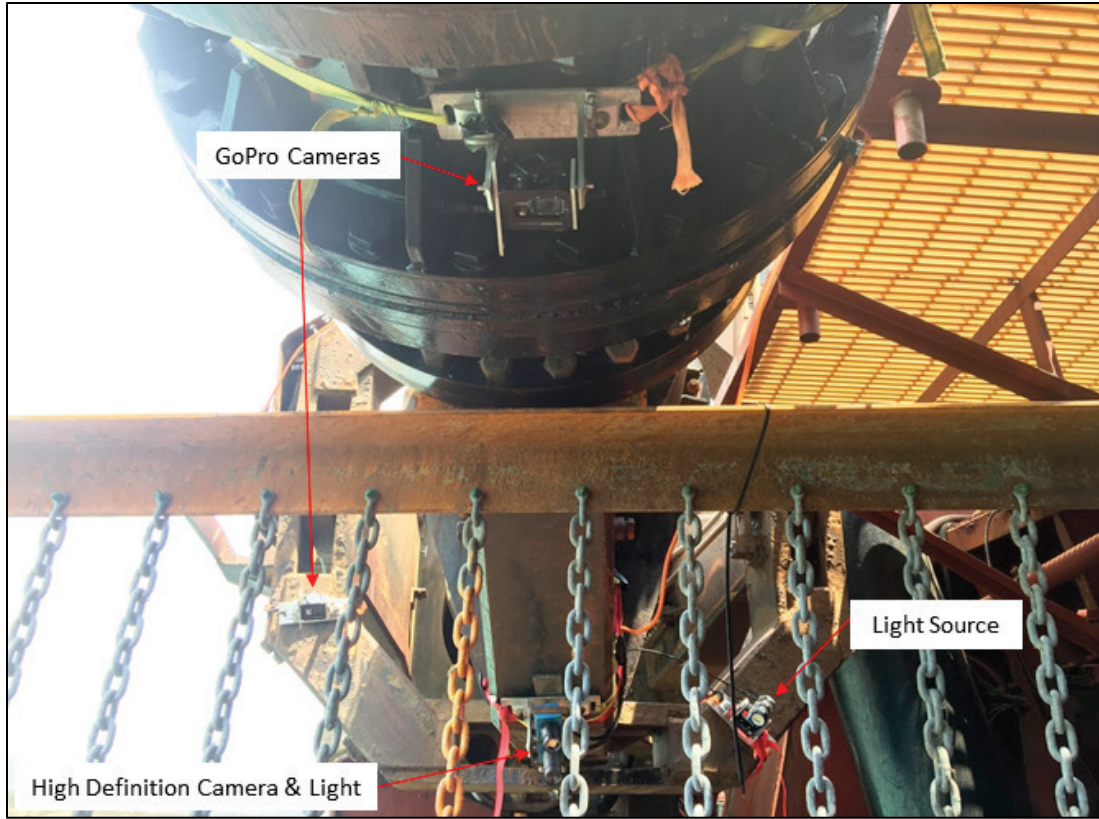
Figure 7. Revised camera and light mount configuration (aft looking forward) for Barbers Point, HI.

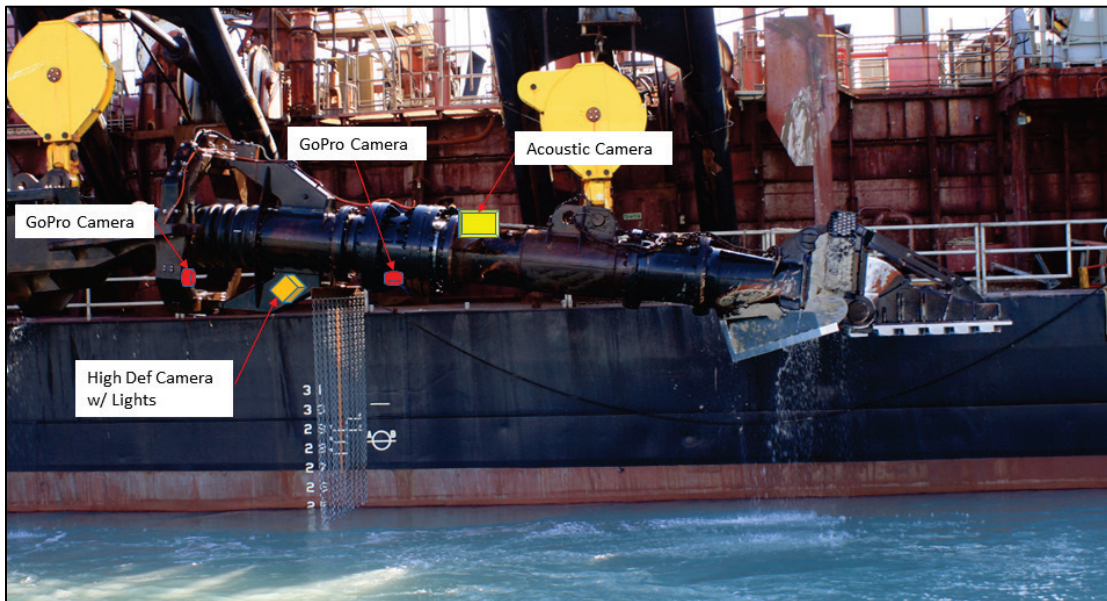
Figure 8. Profile view of revised positions for the three camera systems relative to TTC and draghead (Kalaeloa Barbers Point, HI).

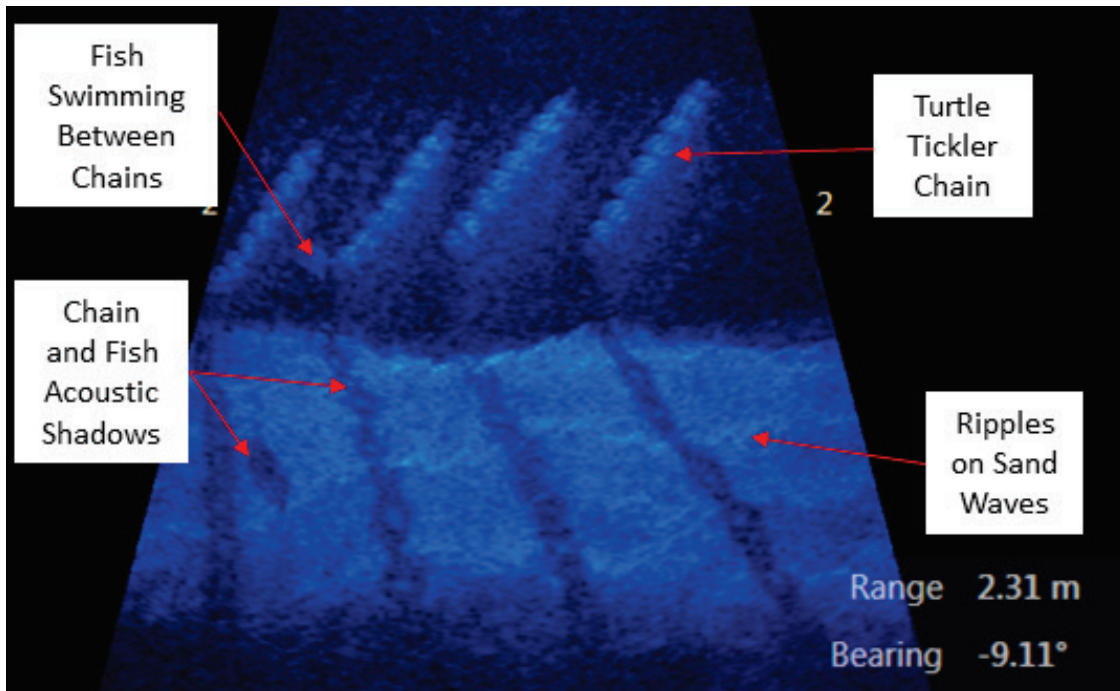
Figure 9. Acoustic camera image of TTC free-streaming in water column over sand waves.

The acoustic camera image in Figure 9 demonstrates this system's resolution by being able to discriminate individual 1.3 cm (0.50 in.) diameter links in the chain sections and by detecting a fish of unknown species swimming between two of the chain sections. However, due to the acoustic camera's grazing angle and distance to the chains, it was not possible to view the entire 3 m (10 ft) lengths of all the chains at the same time. The rotator assembly had to be used to tilt the transducer array to scan from the top of the chain mount down to the chain ends. Use of the rotator assembly's panning capability allowed the camera to be *swung around aft* to view the draghead and turtle deflector. Figure 11 shows an acoustic image of the draghead and turtle deflector in sandy bottom material (this image was not mathematically rotated). These preliminary tests provided valuable information and experience to optimize operation of the camera systems for the main testing during the dredging in Hawaii.

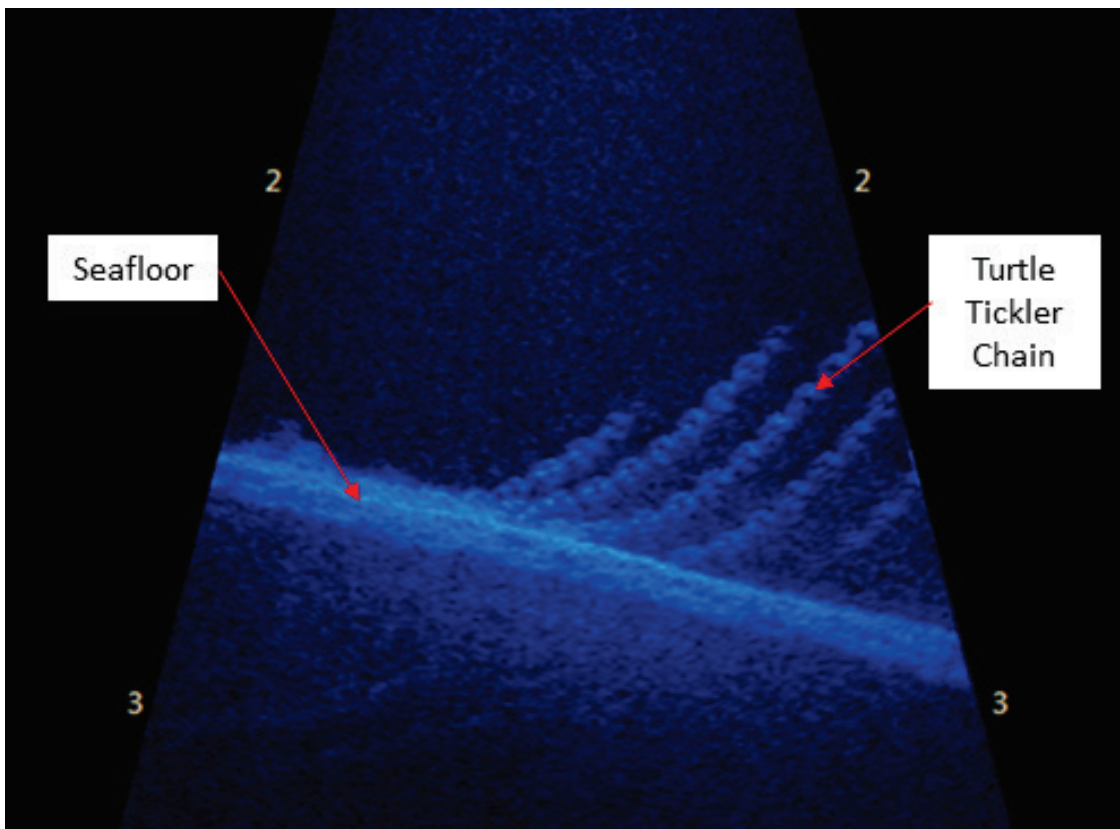
Figure 10. Acoustic camera image of tickler chains dragging over sand bottom.

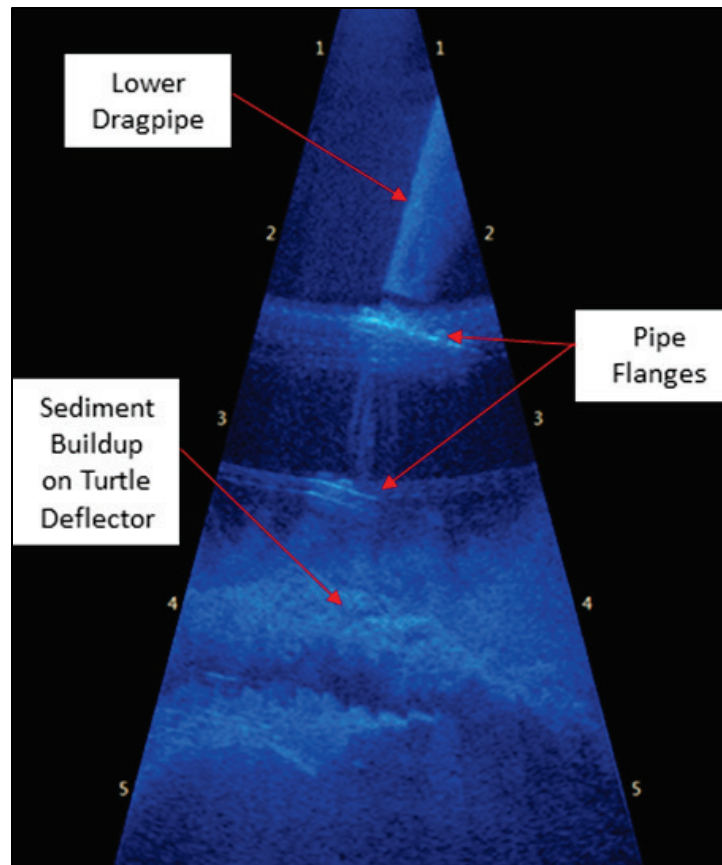
Figure 11. Acoustic camera image of the draghead interacting with sand wave crest.

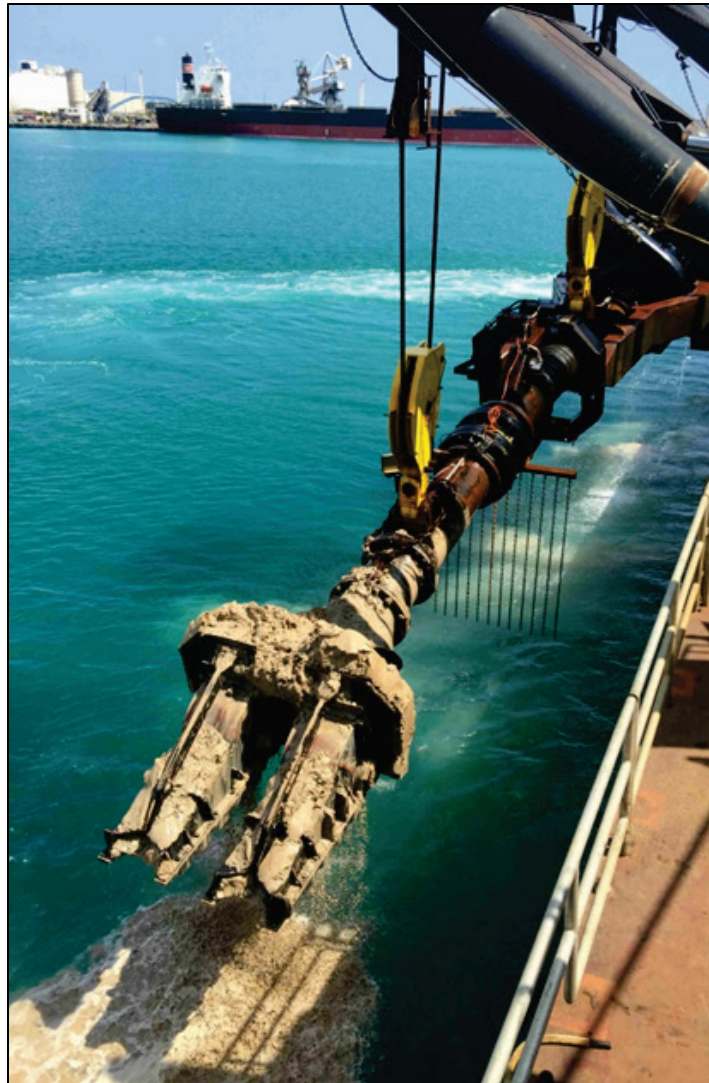
Figure 13. The *Essayons* draghead and lower dragpipe covered in sediment.

The real-time camera output allowed the operator to identify when the camera lens was immersed in the bottom sediment. The unconsolidated shoal material consisted of fine sand (composited samples ranging from 27% to 8%), tan clay (50% to 5%), and silt (30% to 1%) and provided such a low bearing strength that the draghead could easily penetrate down into the sediment. During one of the initial test runs, the sea bottom could be observed as it got closer to both the high-definition and the acoustic camera lens before both screens blacked out. When this occurred, the camera operator notified the dragtender via radio to immediately bring the dragarm up and out of the water to minimize risk of damaging the cameras and to check the camera for damage (no damage was observed). Figure 13 shows the dragarm as it looked when brought to the surface and illustrates how the draghead and lower dragarm could be immersed into the unconsolidated bottom sediment and potentially be damaged.

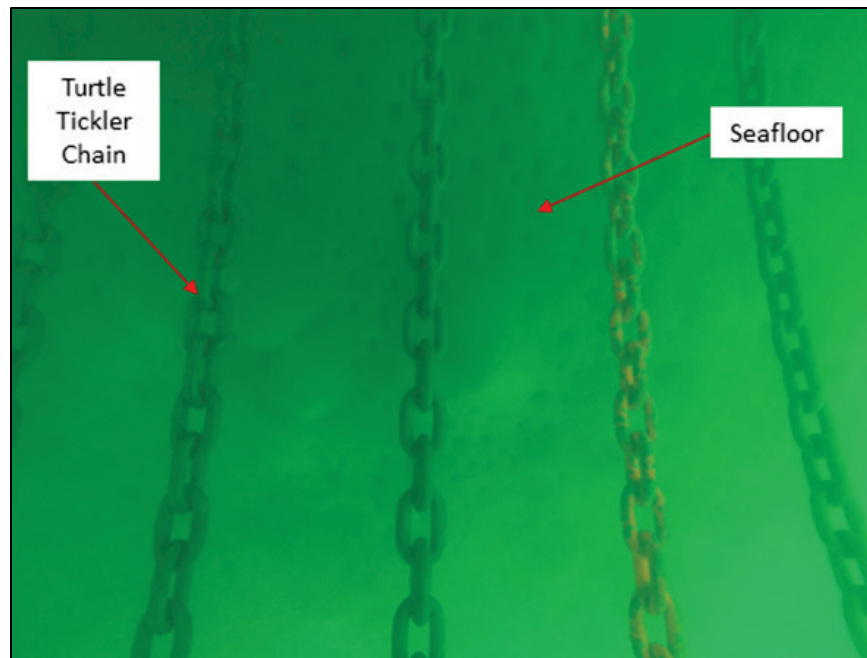
Figure 14. Image of the chain array from the GoPro camera on the bottom of the dragarm turning gland.

Video from the GoPro cameras, similar to the high-definition camera, suffered from the limited water visibility and fixed field-of-vision orientation relative to the chains. The GoPro camera mounted on the dragarm gimbal yielded limited viewable images due to its distance from the chains and less-than-optimum positioning while the GoPro camera attached to the bottom of the turning gland produced the best video when the top of the chains was closest to the top of sediment (Figure 14).

The acoustic camera images were also able to provide detailed representation of the sea bottom texture. Figure 18 shows an image of the sea bottom from the acoustic camera, which has the same *mottled* pattern seen of the sea bottom from the high-definition and GoPro cameras (Figures 12 and 14, respectively).

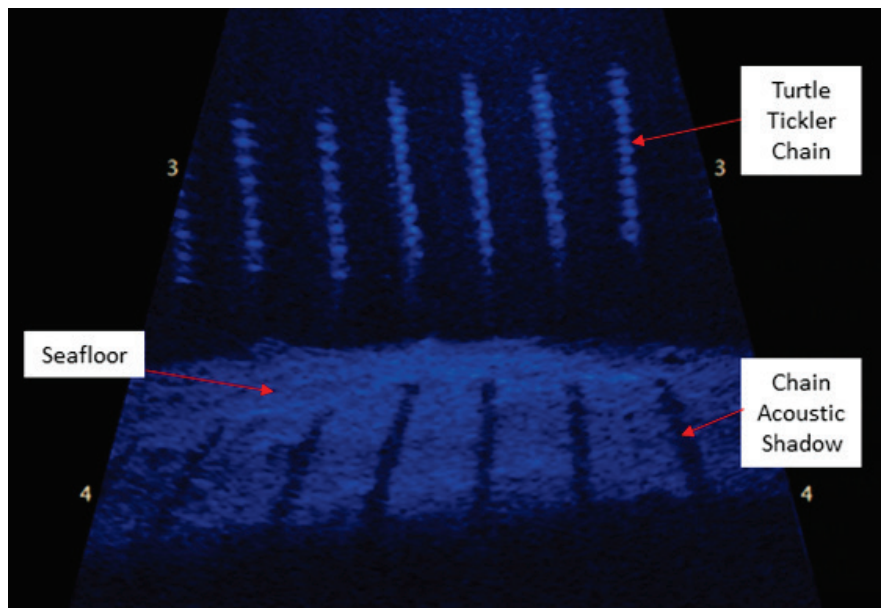
Figure 15. Acoustic camera image of chains free-streaming in water column above the harbor bottom.

When the TTC were suspended in the water column as the dredge moved, the acoustic camera images clearly showed the individual chains hanging down from the dragarm and not becoming entangled. Figure 15 shows the TTC immediately suspended off the harbor bottom. Due to the acoustic camera's grazing angle and distance to the chains, it was not possible to view the entire 10 ft lengths of all the chains simultaneously. The rotator assembly was required to tilt the acoustic camera to scan from the top of the chain mount down to the chain ends. When the draghead was on bottom, the TTC maintained contact with the seafloor, did not entangle, and maintained a relatively constant separation distance between individual chain lengths (Figure 16). While the chains maintained a relatively constant separation distance from each other when dragging in the seafloor (Figure 16), it was noted that range of horizontal and vertical motion was larger in

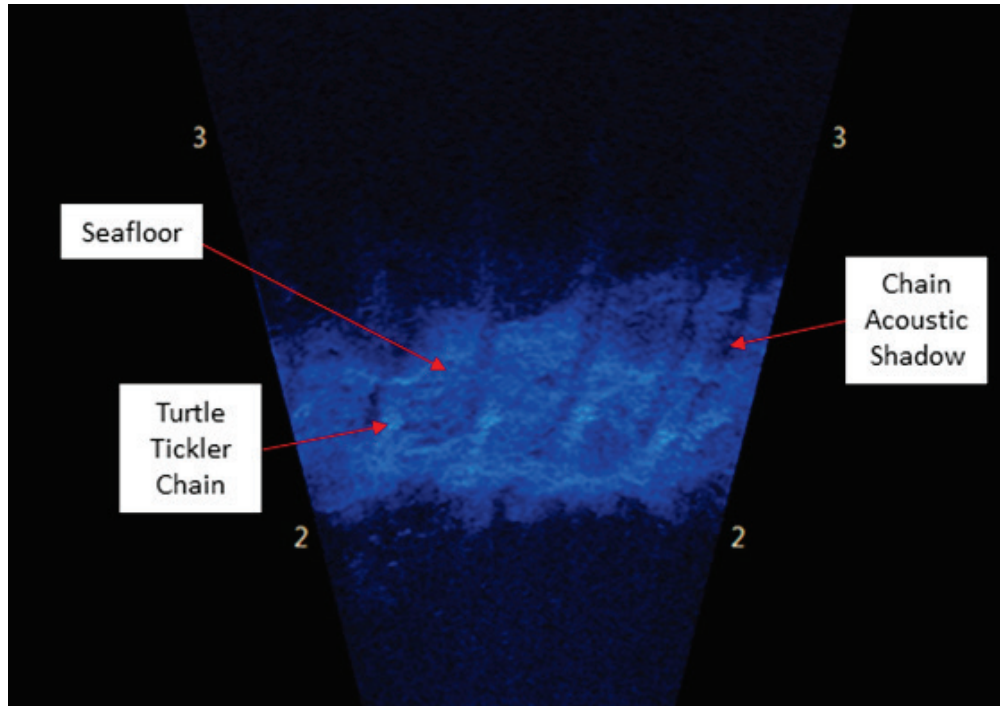
Figure 16. Acoustic camera image of chains dragging on harbor bottom.

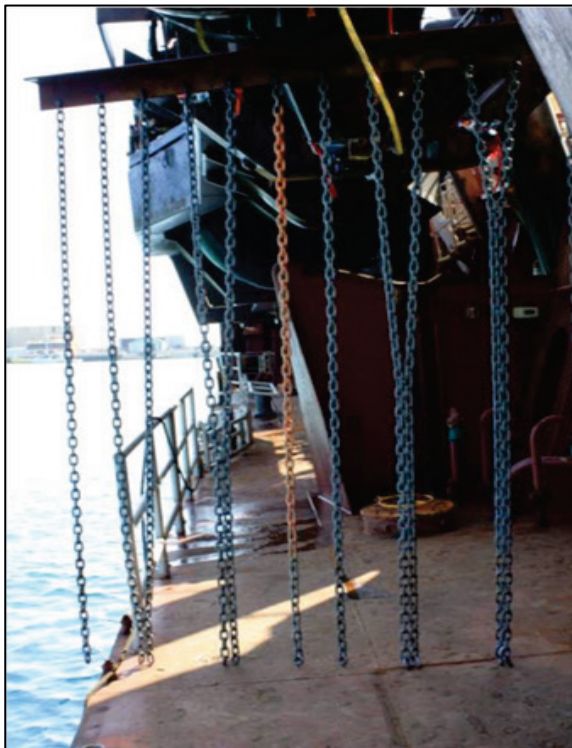
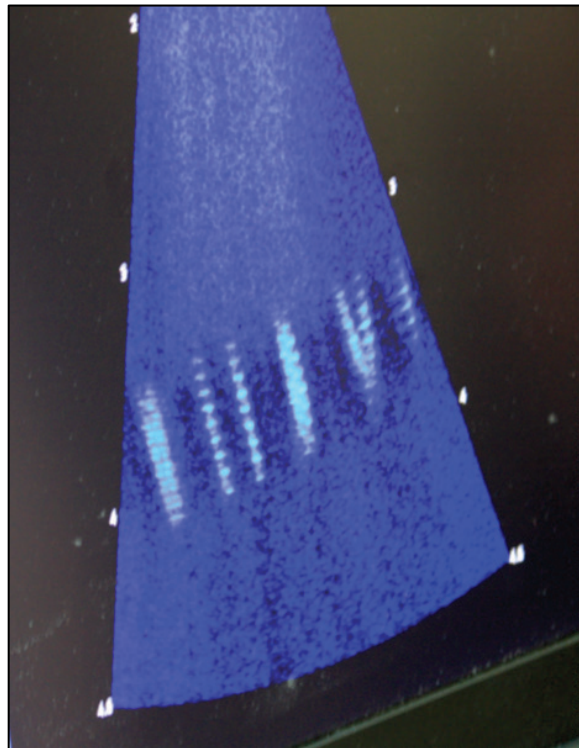
Figure 17. Photograph (left) of the bound chain array out of the water compared to the acoustic camera image (right) of chains free-streaming in the water column.

When the tickler chains were bound with electrical wire ties to evaluate the acoustic camera's ability to discriminate a potential chain entanglement that could pose a drowning risk to turtles, these tie points could be clearly and easily identified in the acoustic camera images. Figure 17 shows a comparison of a photograph of the bound chain array out of water with the acoustic camera image of the bound chain array free-streaming in the water column.

The chain binding locations could be identified in the acoustic image by observing where the chains were angled and no longer parallel and the image formed a notably large signal return. It was observed that the motion behavior of the bound chains was slightly different than that of the unbound chains.

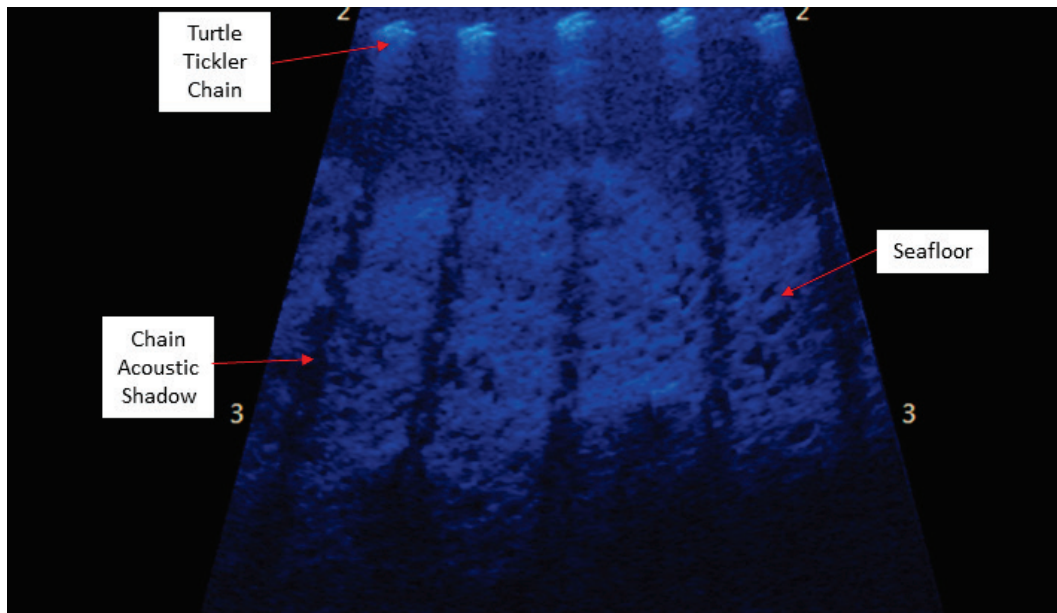
Figure 18. Acoustic camera image of the sea bottom.

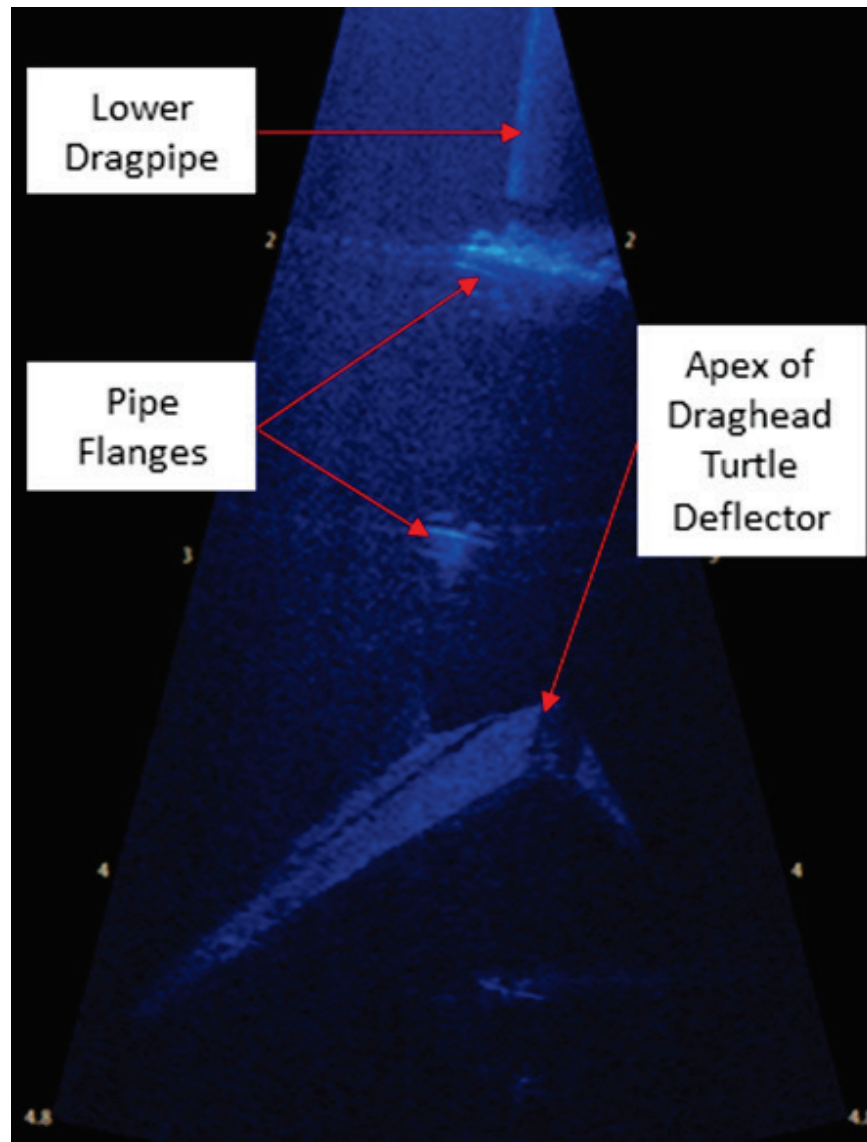
Figure 19. Acoustic camera image of the draghead with turtle deflector in water column.

were unable to view the deflector due to turbidity and the position of the cameras. The acoustic camera was able to clearly confirm that the draghead deflector was positioned correctly to create the needed sediment wave forward of the draghead to potentially move sea turtles away.

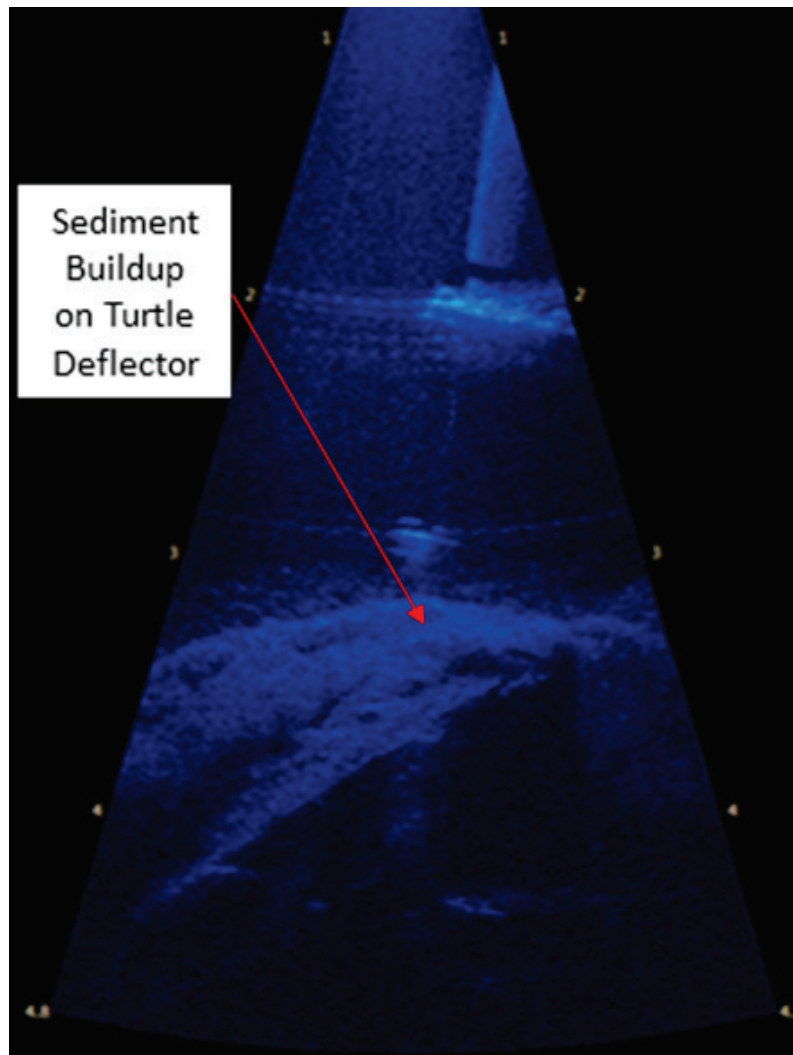
Figure 20. Acoustic camera image of the draghead in mud with a sediment wave building up on turtle deflector.

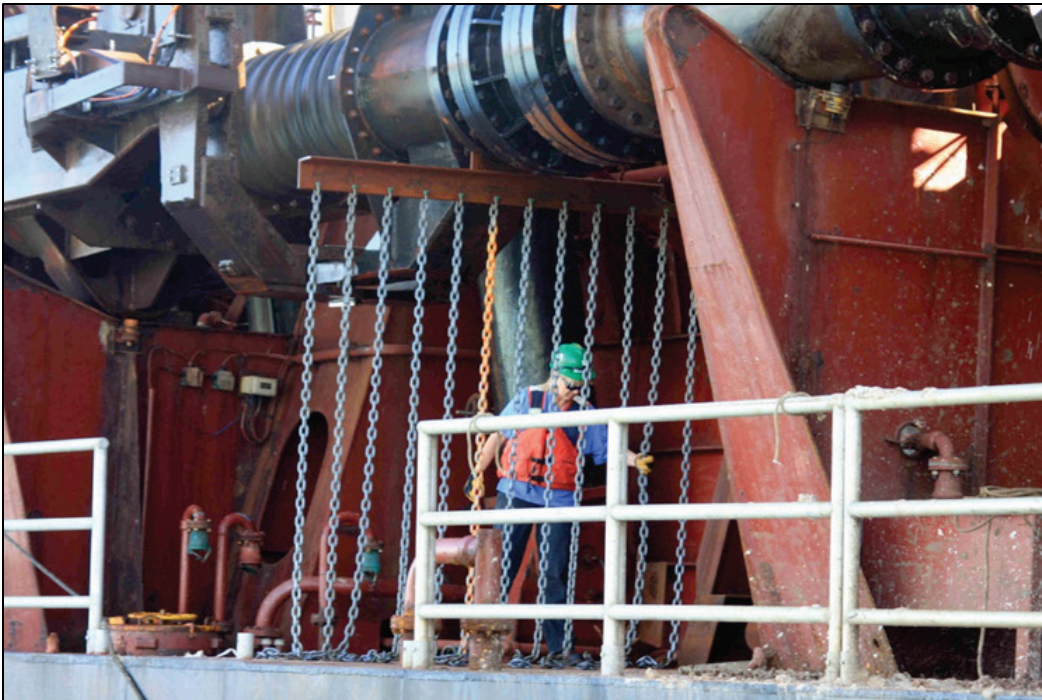
Figure 21. Endangered species observer inspecting condition of TTC after dredging a load on the *Essayons*.

The period of performance for the cameras mounted on the dragarm was only intended to be for the short duration of this study. Due to the vulnerability of the camera mounts and cameras being damaged or lost, particularly the acoustic camera, all camera systems were removed at the end of the monitoring period on 24 March 2016. The cameras were not used for monitoring during the remainder of the dredging project. As requested by NMFS-PIR in the Biological Opinion, the TTC were left attached to the dragarms and were to remain for the duration of the project unless there was evidence of damage to the chain structure or a change in its performance. For the remainder of the dredging project, the endangered species observers inspected the chain arrays for damage after each dredge load (Figure 21).
