**CREEP OF HI-NICALON™ S CERAMIC FIBER TOWS AT 700°C IN AIR AND
IN SILICIC ACID-SATURATED STEAM**

THESIS

Matthew W. Piper, Captain, USAF

AIR FORCE INSTITUTE OF TECHNOLOGY

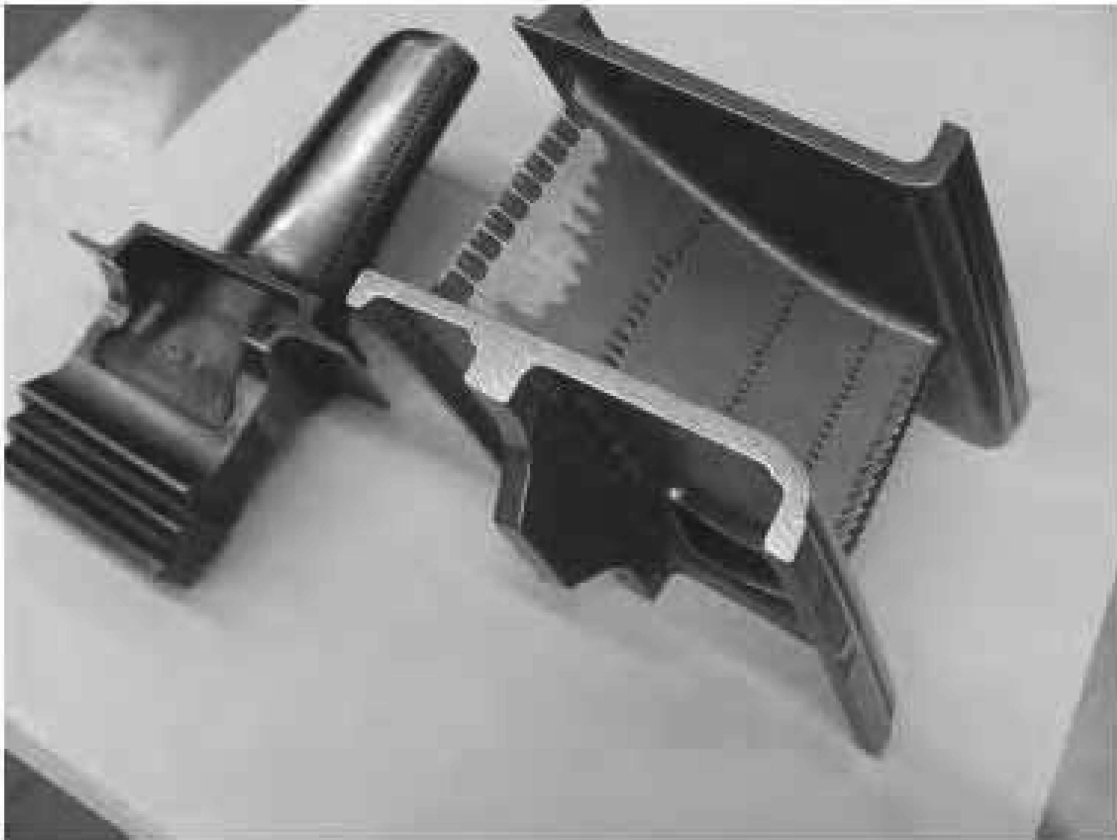
Figure 1: Turbine blade built from super-alloy with vanes for cooling, reproduced from Shillig [10]

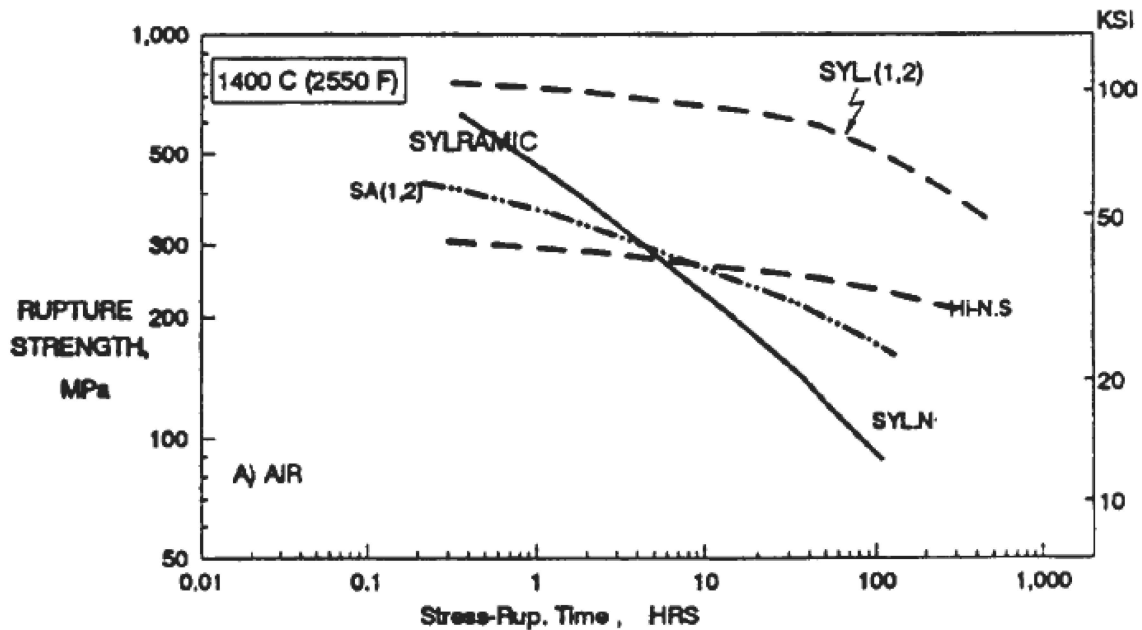
Figure 8. Rupture strengths of SiC fibers at 1400°C in air. Reproduced from Yun and DiCarlo [28]

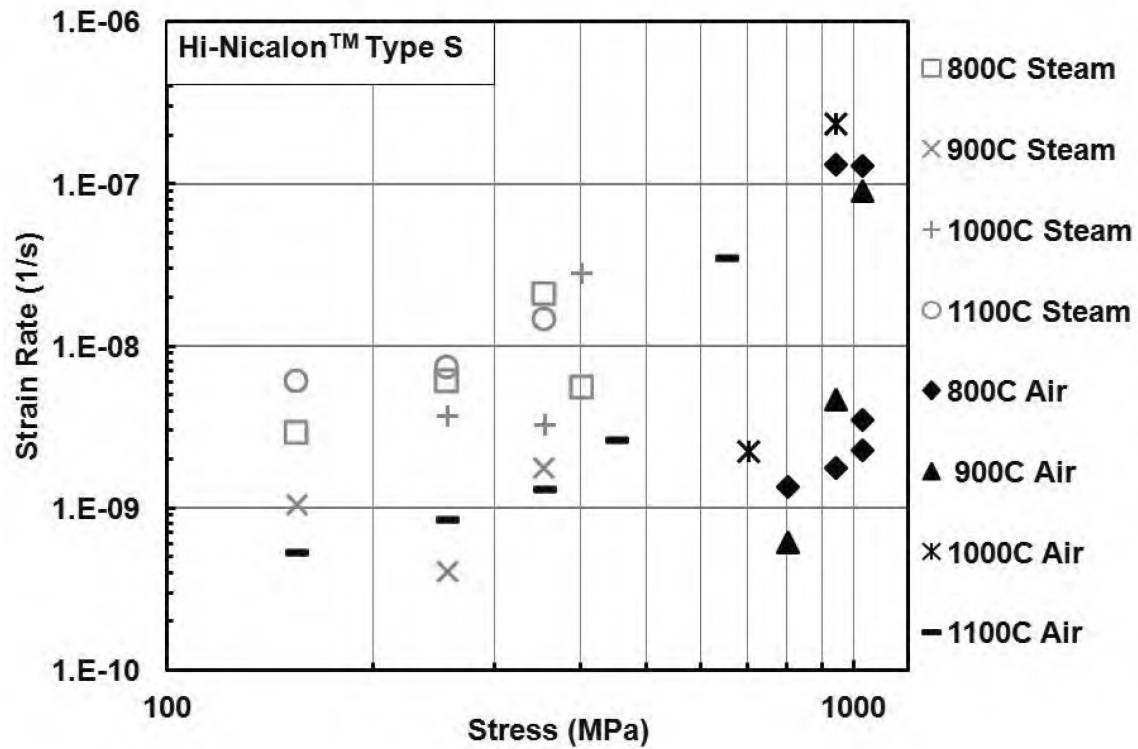
Figure 11. Steady-state creep rate vs applied stress for Hi-Nicalon™ S fiber tows at 800°C, 900°C, 1000°C, and 1100°C in air and in steam. Reproduced from Shillig [10].

steam but was unable to do so because of the considerable scatter in the data, as shown in **Figure 11**. Creep rupture data is shown in **Figure 12**.

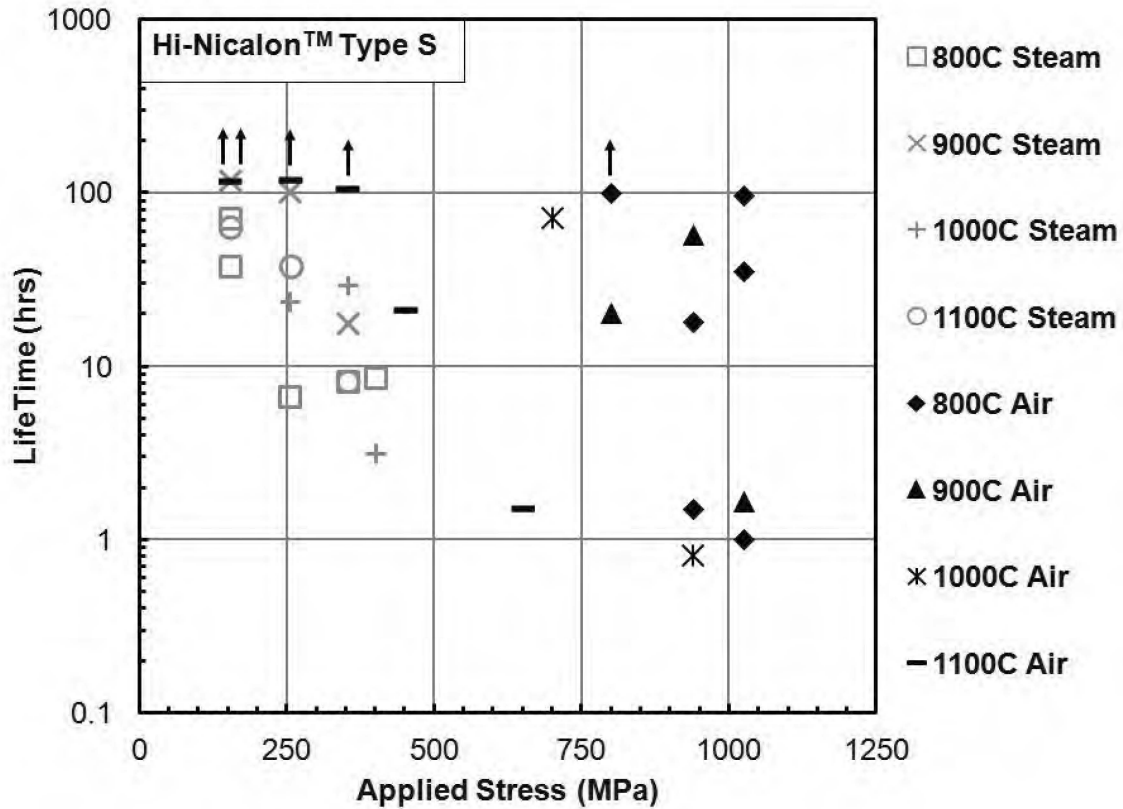
Figure 12. Stress Rupture data for Hi-Nicalon™ S fiber tows tested at 800°C, 900°C, 1000°C, and 1100°C in air and in steam. Reproduced from Shillig [10].

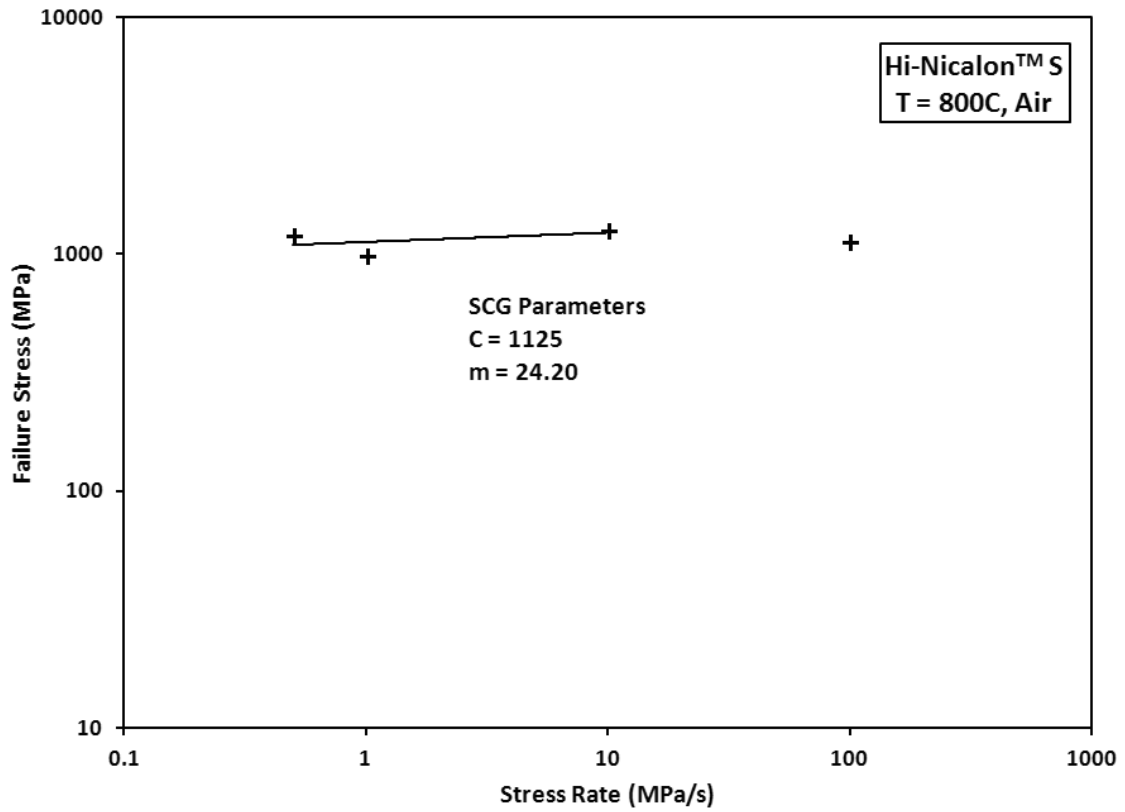
Figure 13. Failure stress of Hi-Nicalon™ S fibers at 800°C in air as a function of stress rate. Note the lack of stress rate dependence. Reproduced from Robertson [13]

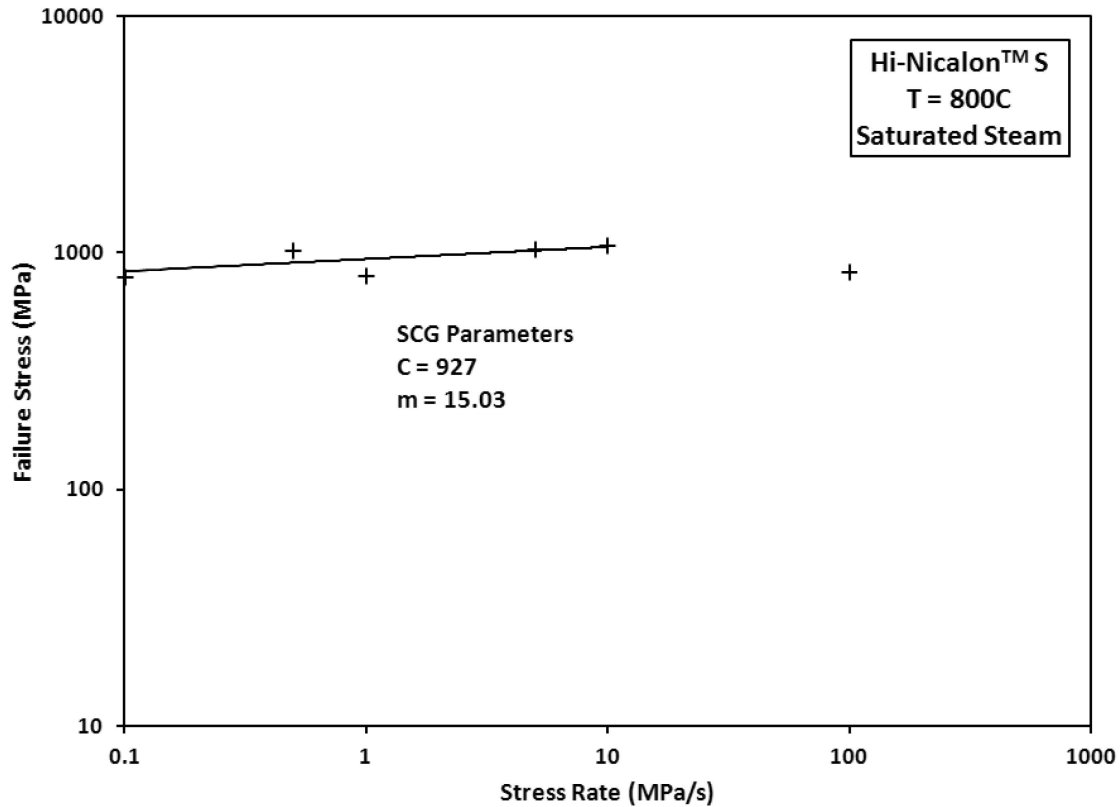
Figure 14. Failure stress of Hi-Nicalon™ S fibers at 800 °C in silicic acid-saturated steam as a function of stress rate. Note the lack of stress rate dependence. Reproduced from Robertson [13]

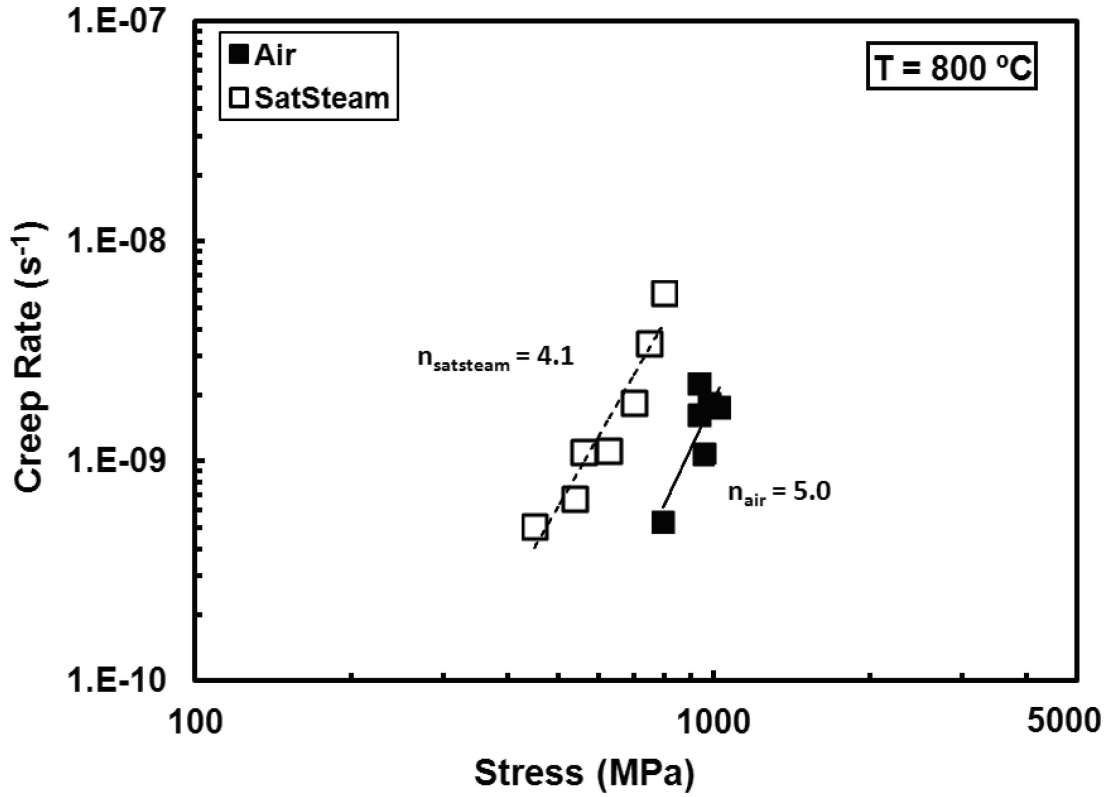
Figure 15. Creep strain rate vs. applied stress of Hi-Nicalon™ S fibers at 800 °C in air and in silicic acid-saturated steam. Reproduced from Robertson [13]

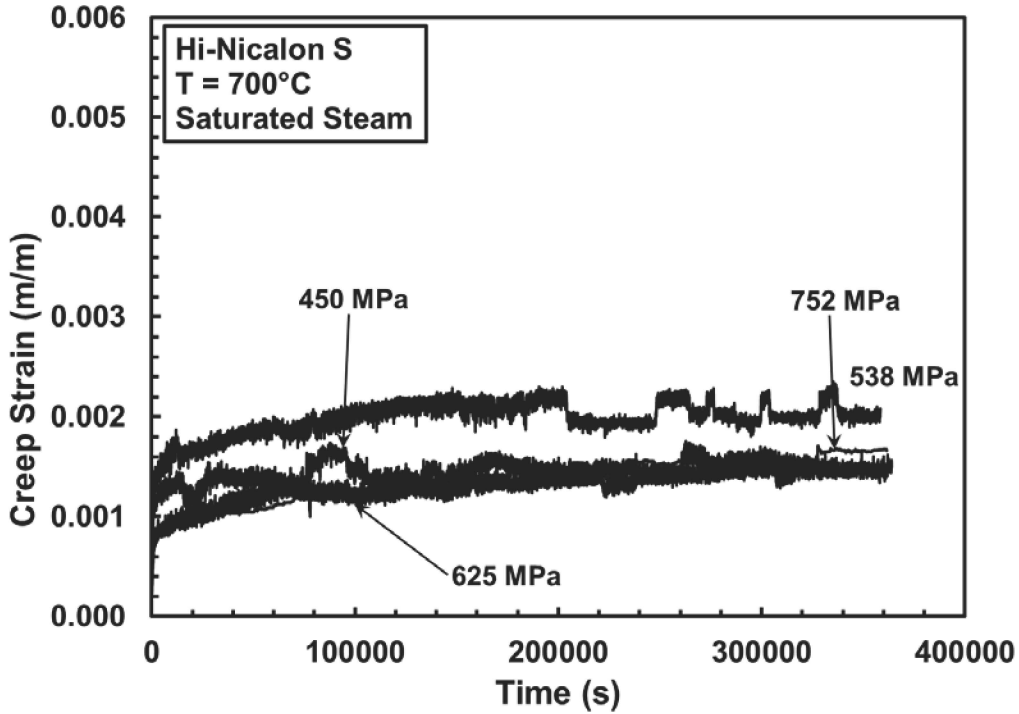
Figure 24. Representative creep curves for Hi-Nicalon™ S fibers at 700°C in silicic acid-saturated steam

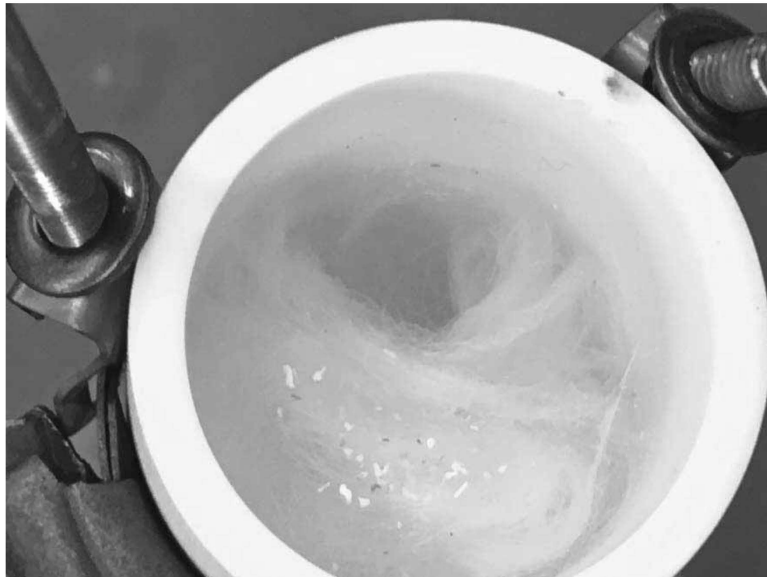
Figure 42. Silica wool inserted into the tube

Figure 42 shows the aft end of the alumina tube after the silica wool has been inserted and the opening for steam flow has been made. Silica wool should be replaced every 100 running hours.

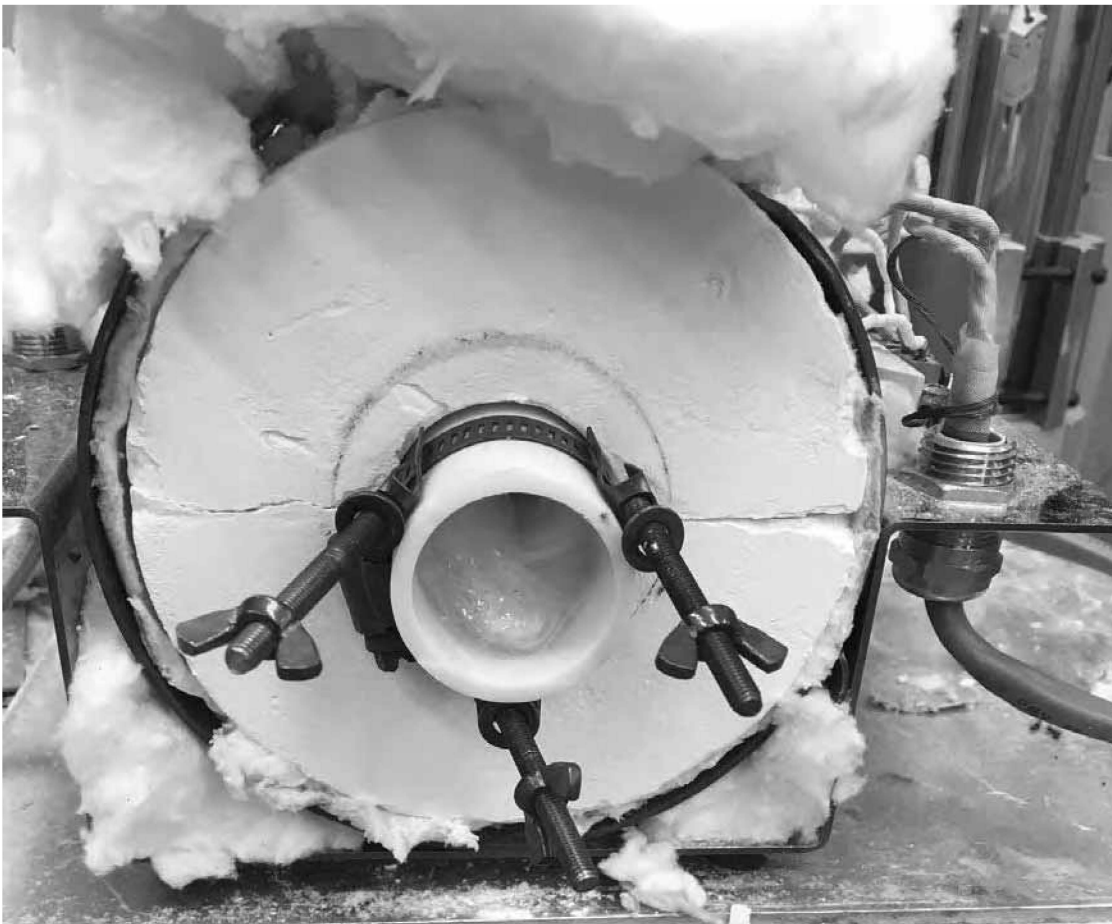
Figure 43. Alumina tube filled with silica wool and inserted into the preheaters

After the alumina tube has been filled with silica wool, insert it gently into the cylindrical opening in the preheaters as shown in **Figure 43**. The tube should slide through the preheaters, and the nose should rest inside the smaller diameter alumina tube on the test chamber side of the preheaters. The tube should not be fully inserted; approximately 5 cm (2 in) of the tube, including the metal collar, should extend from the preheater.

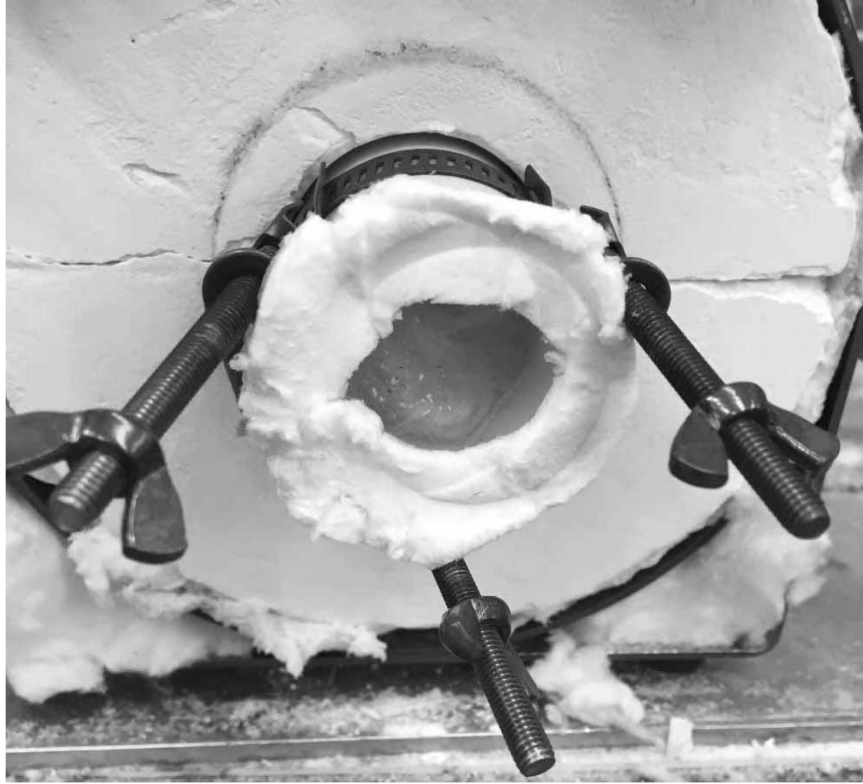
Figure 44. Cut, round piece of sheet insulation in place prior to attachment of steam generator to alumina tube.

Place the circular piece of sheet insulation on the aft end of the silica tube, as shown in **Figure 44**. (Note: if needed, cut a new piece of insulation from the sheet. The outer diameter should be larger than the alumina tube, and the inner diameter should be large enough not to obstruct steam flow. Three slots should be cut in the insulation to allow the bolts to pass through.) Gently slide the steam generator into position directly behind the preheater. Rotate the alumina tube until the three bolts attached to the tube align with the three slots cut into the plate on the nose of the steam generator. Slide the bolts through the slots ensuring that the washers are on the steam generator side. Tighten the wingnuts to secure the steam generator to the tube. Check that the nose of the alumina tube is still in place on the other end of the preheaters; adjust alignment if necessary. **Figure 45** shows the nose of the steam generator and the alumina tube after they have been attached.

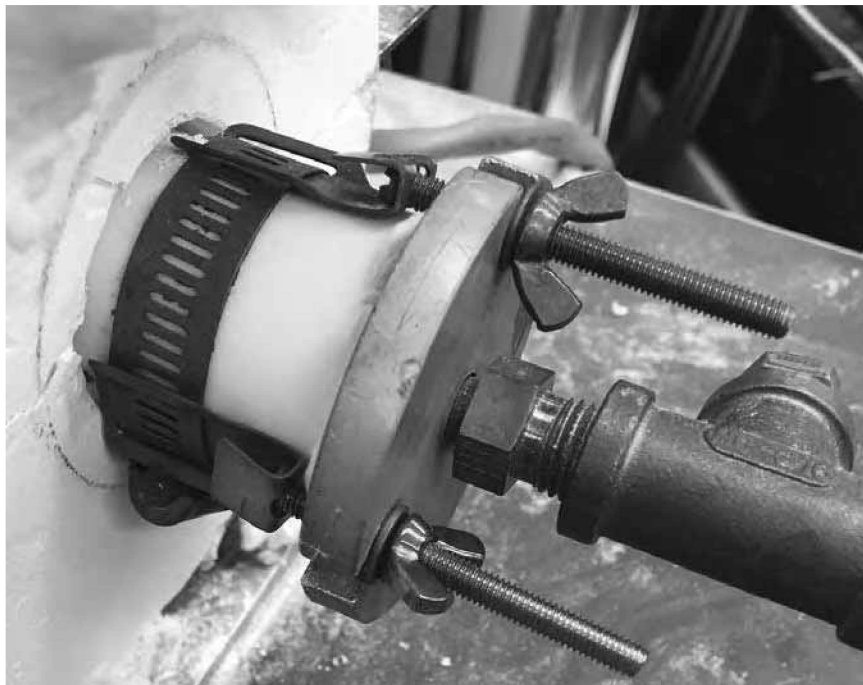
Figure 45. Nose of steam generator (right) secured to alumina tube which is inserted into preheaters (left).

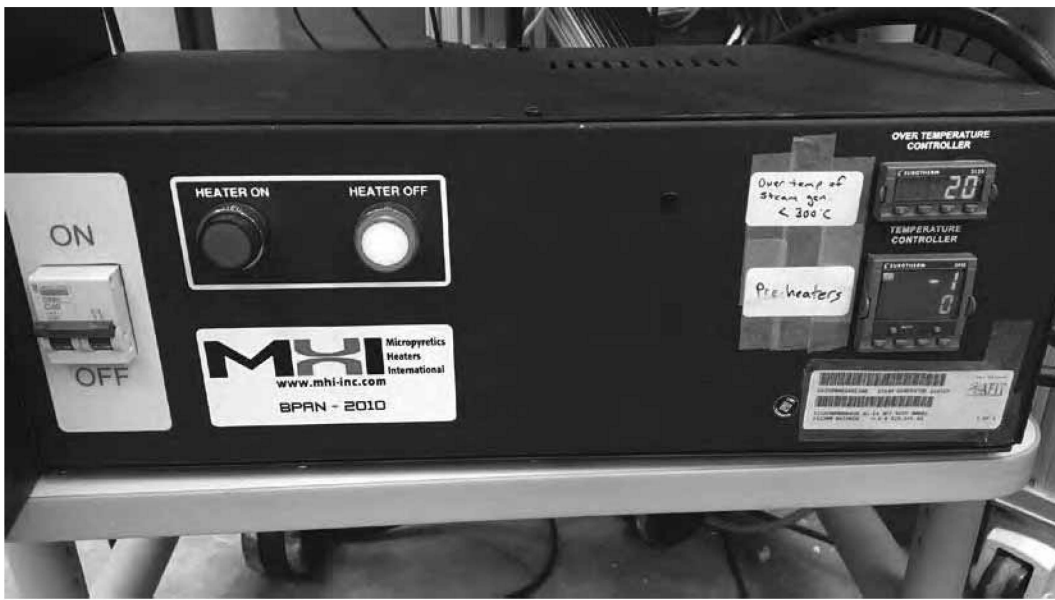
Figure 47. MHI BPAN-2010 control box. The switch on the left must be in the ON position and the HEATER ON light must be on in order for current to flow to the preheaters. As pictured, the switch is ON and the HEATER OFF light is on.

Flip the switch on the left side of the BPAN-2010 to turn the system on. (Note: this switch can be left on between tests if not making adjustments to the preheaters.) Press the green button labeled “HEATER ON” to activate the preheaters. Use the Manual Command 40 Controller computer terminal to input the desired preheater temperature. Preheaters take several hours to heat up and can generally be left at temperature between tests unless adjustments to the equipment are required. The BPAN-2010 controller is shown in **Figure 47**. Turn on the steam generator power by flipping the switch on the voltage controller, shown in **Figure 48**, to ON. Adjust the voltage as necessary by turning the knob on the top of the voltage controller in order to regulate voltage between 0% and 100%.

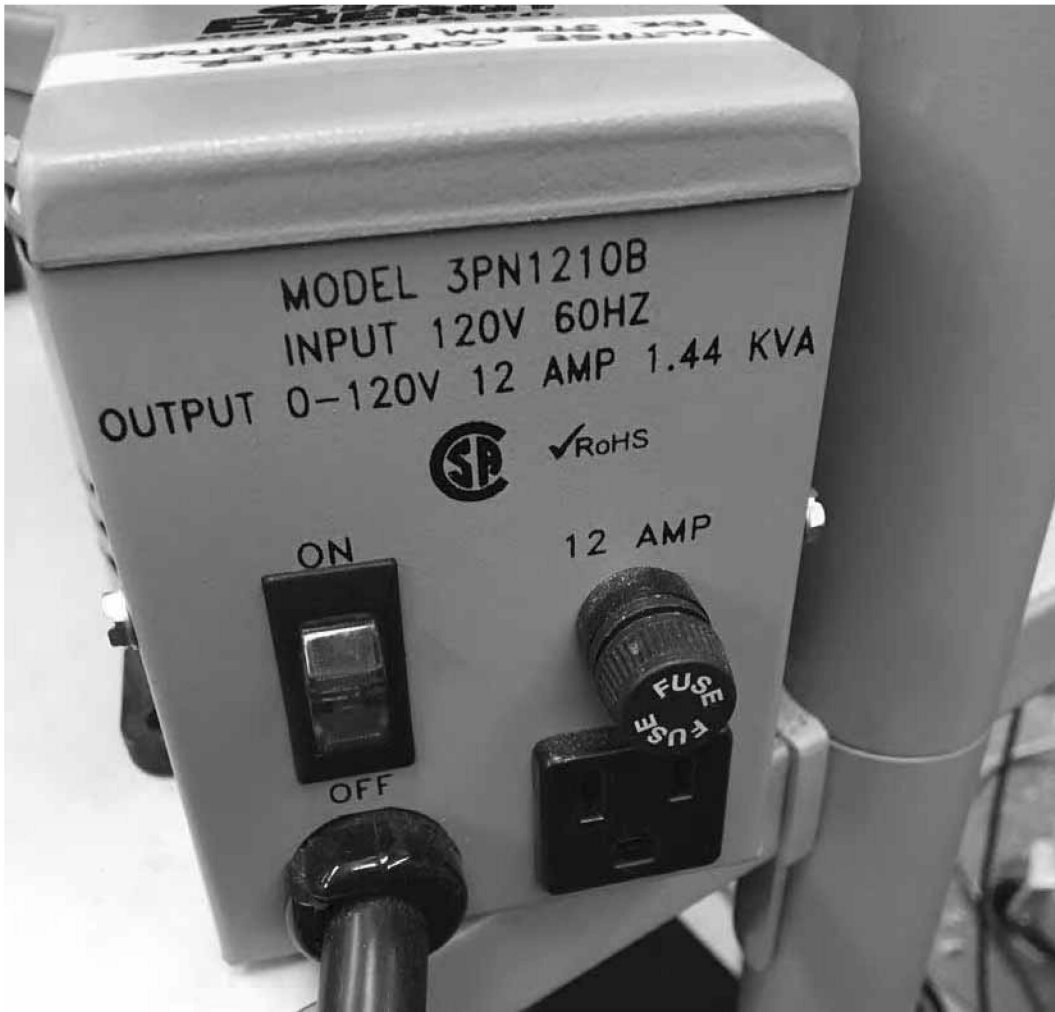
Figure 48. Voltage controller for steam generator. Steam generator power is controlled using the switch on the left side

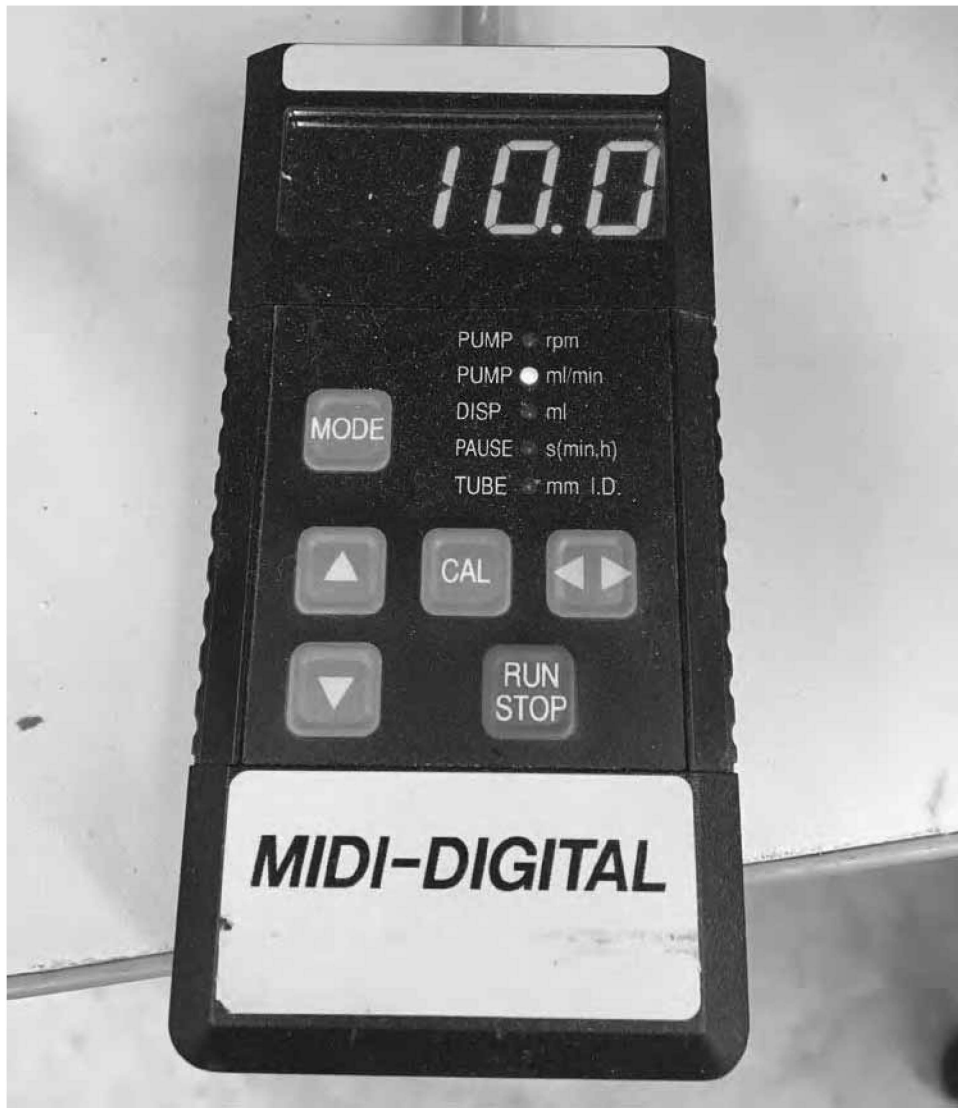
Figure 49. Flow rate controller. The red “RUN STOP” button is used to stop and start the flow of distilled water. Flow rate is adjusted using the vertical blue arrow buttons

On the flow rate controller, pictured in **Figure 49**, press the red button labeled “RUN STOP.” The same button is used to stop the water flow. As pictured, the flow rate is set to 10.0 mL/min. This flow rate can be adjusted using the vertical arrows on the left side of the controller. Steam should be produced within five minutes of turning on the steam generator and activating the distilled water pump.
