**ACTIONABLE STITCHED IMAGES FROM AN UNMANNED AERIAL
SYSTEM**

THESIS

AFIT-ENV-MS-17-M-168

March 2017

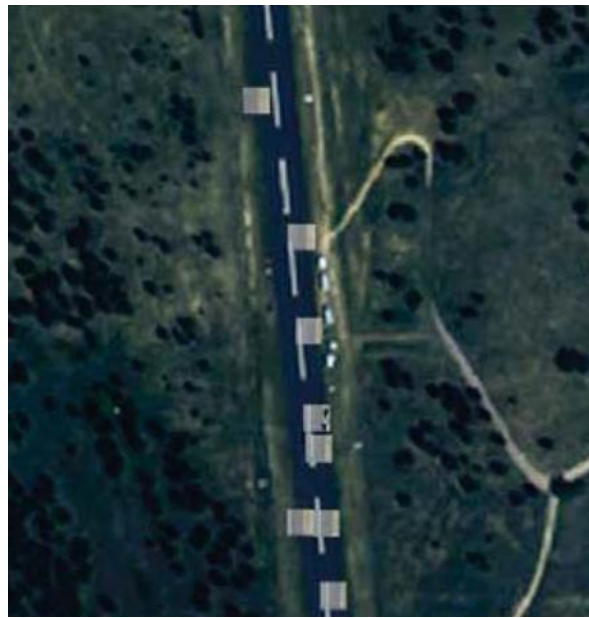
Figure 3 shows some of the challenges of integrating detailed images of areas of interest onto a runway. The satellite image below is of a portion of the 2,000 ft by 75 ft runway at the U.S. Air Force Academy. Eight individual pictures were taken by a UAV.

Figure 3: Runway Analysis Overlaid on Satellite Image (Anderson, Pasque, Lane, Pond, 2017)

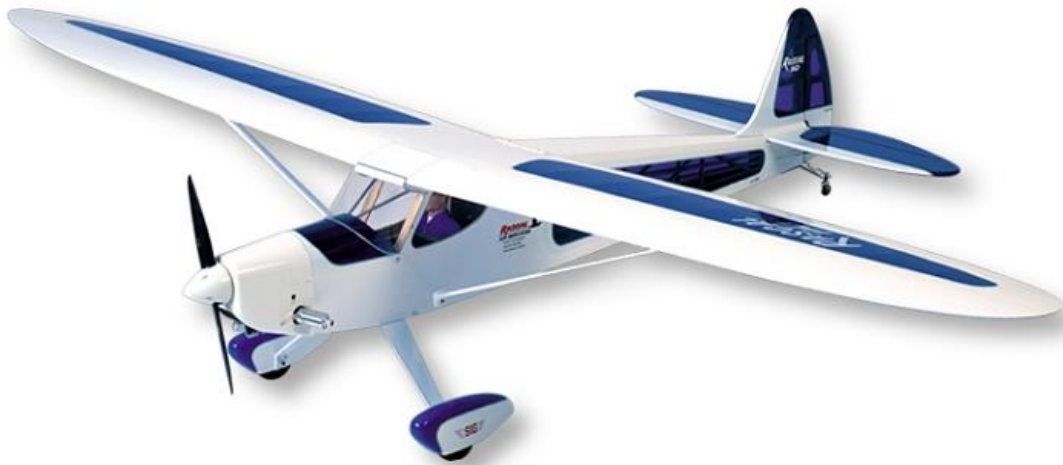
The UAV chosen for this research was the 110” wingspan electric Sig Rascal shown in Figure 4. The model had an electric motor which produces less vibration to affect the payload, as opposed to the gas motor model shown in Figure 4. The manufacturer refers to this model as a “versatile workhorse” that is being used by universities and government agencies for capturing aerial pictures and video.

Figure 4: Sig Rascal 110 (SIGPlanes, n.d.)

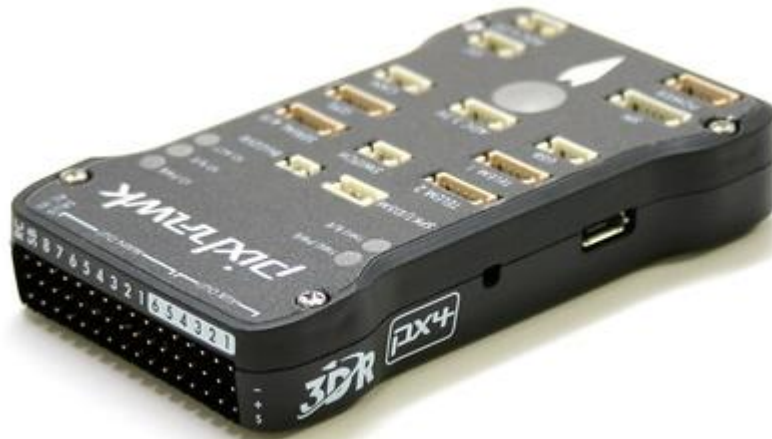
Control of the Sig Rascal once in the air was provided by a Pixhawk autopilot, shown in Figure 5, which is one of the leaders in UAV flight controllers. The Pixhawk receives the waypoints from the ground control station and works to position the UAV to meet those points. Vehicle control is done by the autopilot adjusting the throttle, ailerons, elevator, and rudder. The UAV’s response to those signals are verified through the GPS.

Figure 5: Pixhawk Autopilot (3D Robotics, n.d.)

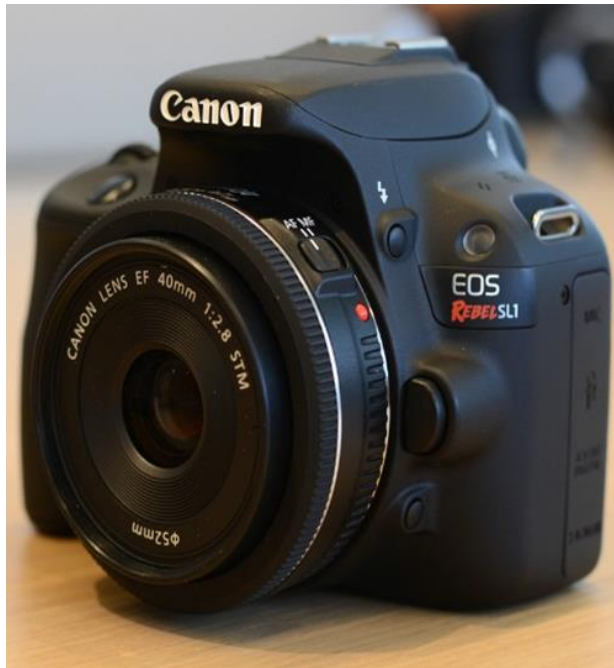
The camera body selected was the Canon SL1 illustrated in Figure 7. The SL1 is one of the smallest and lightest DSLR cameras available. Both metrics are important when mounting to a UAV. The 24mm pancake lens was used as it provided both the best combination of ground clearance and field of view. The Canon GP-E2 GPS receiver was utilized as it writes altitude, latitude, and longitude directly to each image file. Figure 8 shows the receiver in its typical mounting position on the top of the camera in the “hot shoe” circled in red.

Figure 7: Canon SL1 with pancake lens (Canon, n.d.)

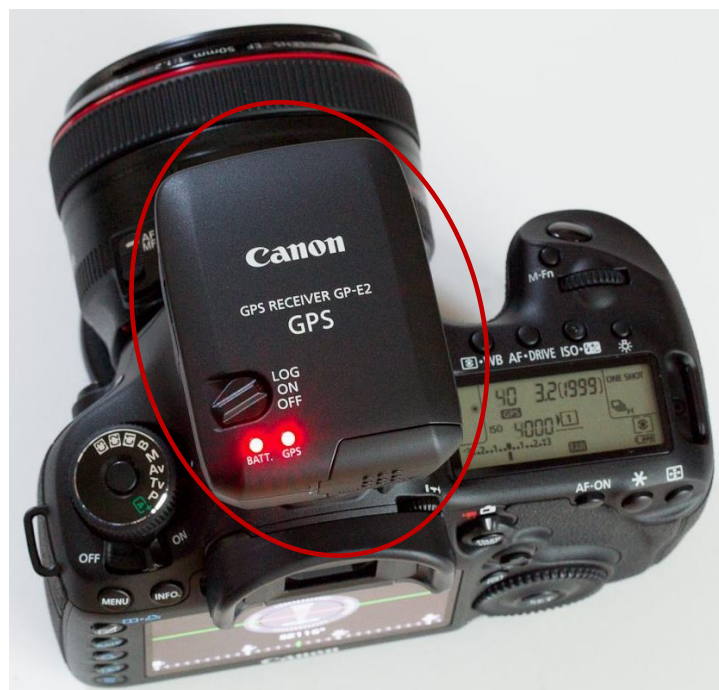
Figure 8: Canon GP-E2 GPS Receiver (Canon, n.d.)

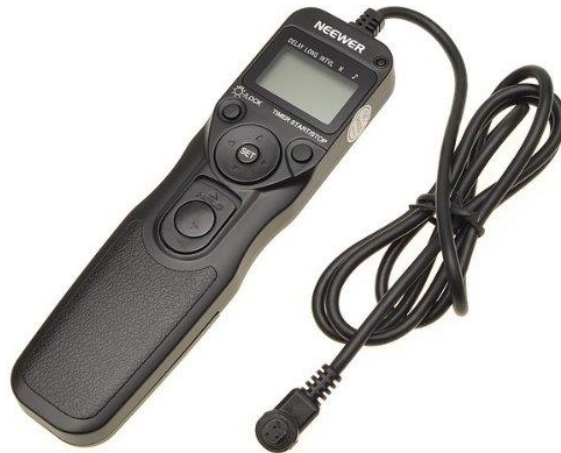
The camera shutter was controlled by both a cable from the Pixhawk autopilot and an intervalometer. Both plug into the 2.5 mm remote jack in the camera body and complete the circuit between the camera shutter and ground electrically. The Pixhawk sends a signal when the UAV reached the prescribed waypoint. The intervalometer is based upon time alone with options including time between shots, the length of time the shutter is opened, delay between shots, and total shots possible. Figure 9 shows an intervalometer similar to the one used for the research.

Figure 9: Intervalometer (Neewer, n.d.)

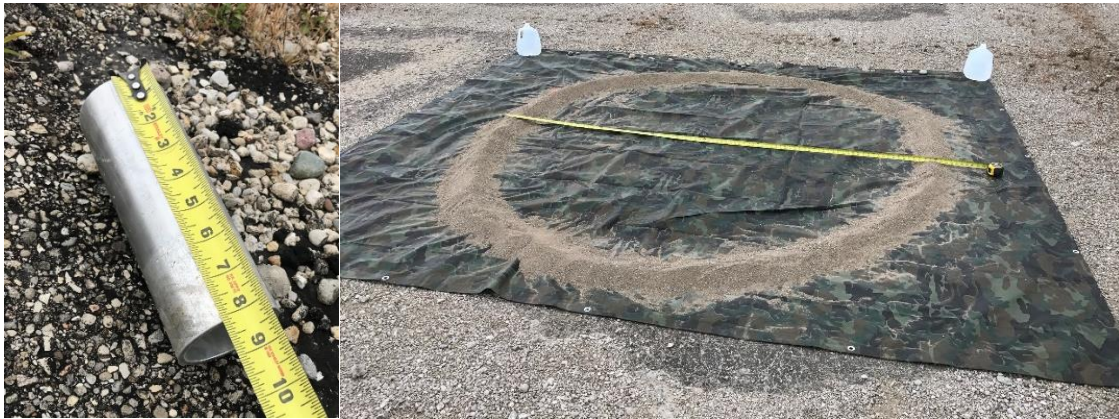
The AFIT model shop was able to obtain most of the pipe sections. To replicate explosive damage, a tarp and three 50-pound bags of sand were used to form a ring. This combination produced a circular 2-inch mound, 96 inches in diameter, that was placed in the area of interest. Figure 10 provides ground level images of both types of test articles used.

Figure 10: 3"x8" pipe section left, 96" dirt ring right

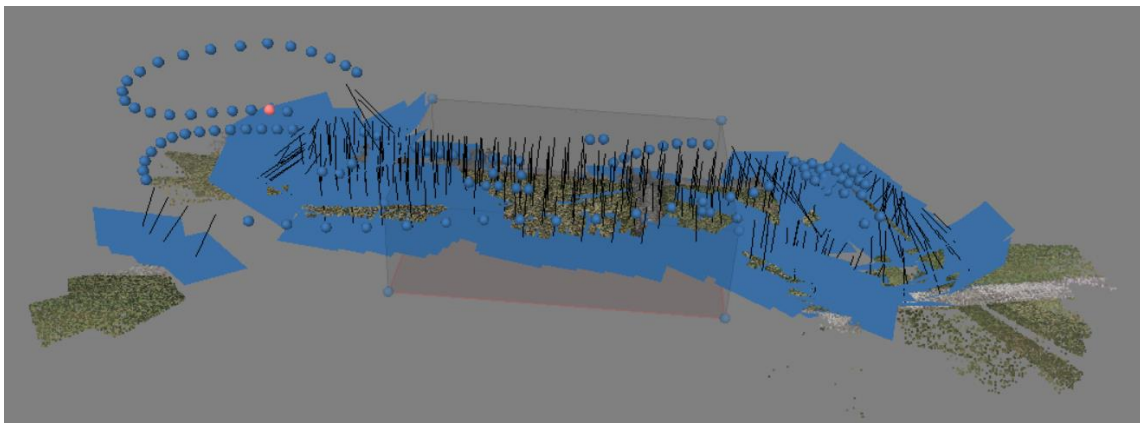
Step three is when the software builds a digital elevation model (DEM) by assigning depth information to the 2-dimensional image. Resolution can be maximized and processing time reduced by adjusting a bounding box to focus on the area of interest as shown in Figure 16. Care should be taken to ensure that the red rectangle that forms the base of the bounding box is below the point cloud to ensure all of the image is captured.

Figure 16: Flight 3B bounding box to focus on area of interest

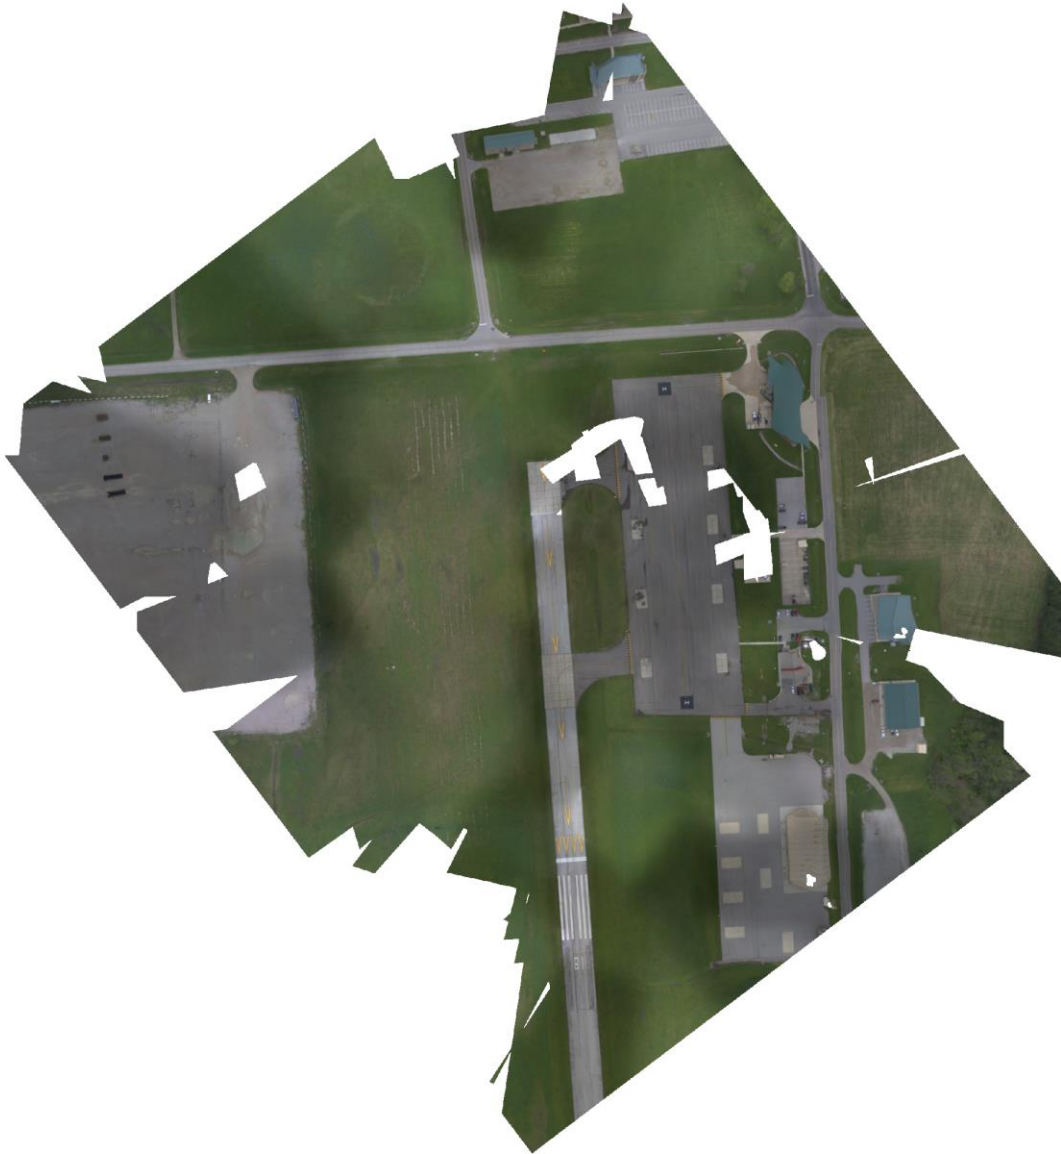
waypoint shown in Figure 19. The orthomosaic diamond shape can be recognized within the flight path illustrated in Figure 20.

Figure 21: Flight 1A Orthomosaic

The gaps in the orthomosaic are somewhat understandable on the perimeter of the flight pattern. The interior gaps are likely due to not having the recommended overlap

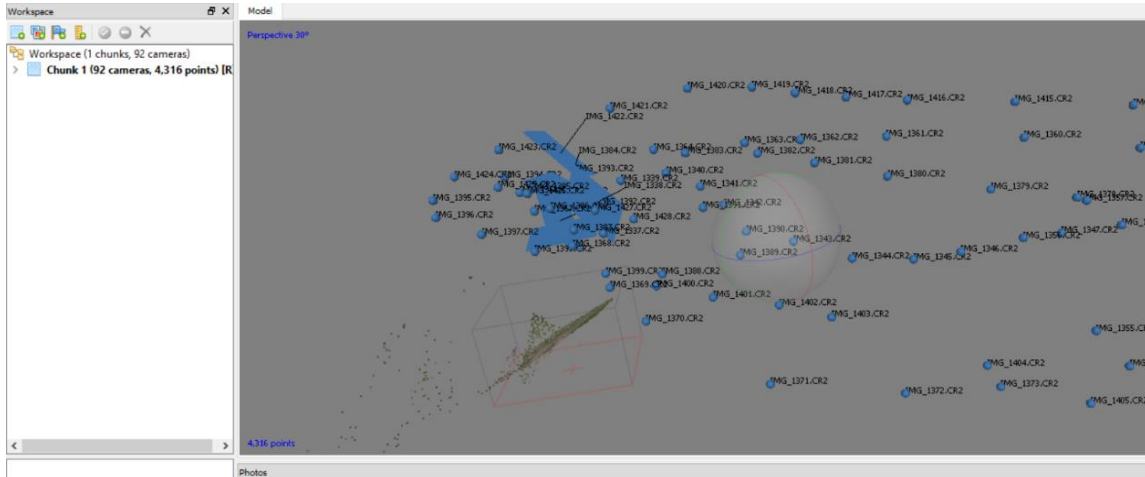
Upon further review, 152 image files had the same GPS coordinates. The cause for this is unknown as the remaining 92 images had unique locations as illustrated in Figure 23 by the multiple blue spheres. Multiple attempts were made to eliminate the alignment error to include removing the image files with identical GPS coordinates. Figure 24 shows that this offered only minimal improvement and no orthomosaic was generated from Flight 1B images.

Figure 24: Flight 1B Alignment Difficulty with 92 Images

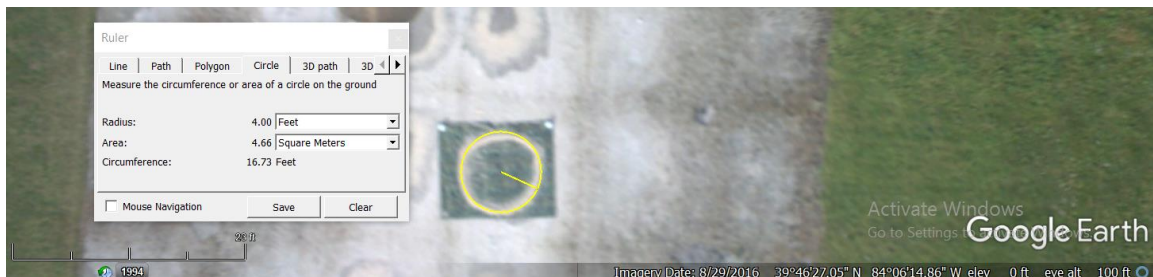
One of the measurements from the Flight 2B was the radius/diameter of the test ring in the orthomosaic. After merging dozens of photos together, would a 96” diameter circle still be represented as a 96” diameter circle? The radius value measured within Google Earth was 48” as shown in Figure 29. Figure 30 shows the test ring measured with a physical tape measure.

Figure 29: Flight 2B 8’ Dirt Ring Verification

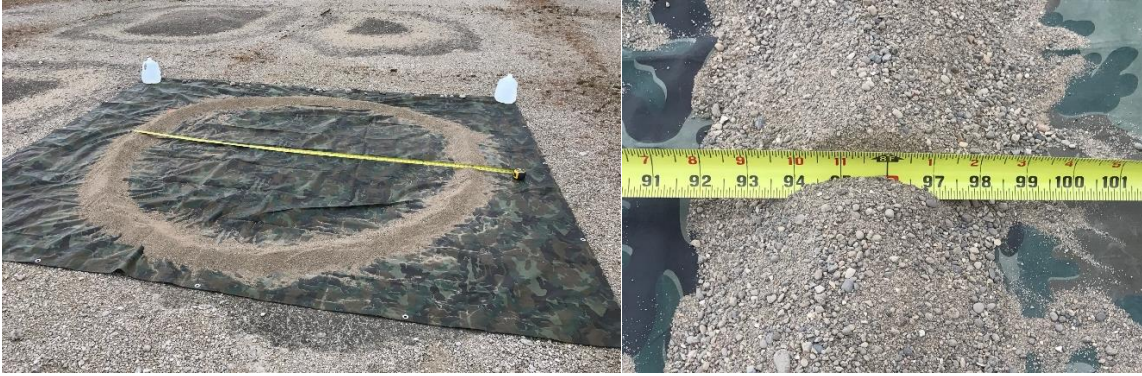
Figure 30: Test Ring Measured Diameter Approximately 96” with Tape Measure

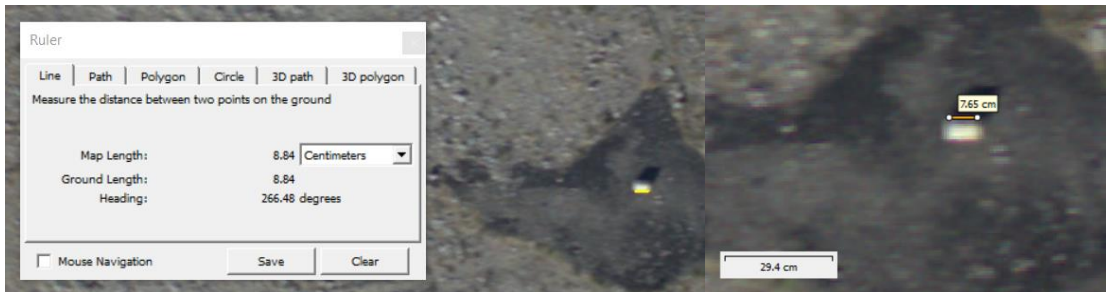
The 2” x 3” pipe section was also measured from the orthomosaic. Figure 31 shows the measured length values in both Google Earth (GE) and Photoscan. The units default to metric, but the conversion of the 8.84 cm length in GE is equal to 3.48 in and the 7.65 cm via Photoscan is equal to 3.01 in.

Figure 31: Flight 3B Measured Length of 2” x 3” Test Article GE left, Photoscan right

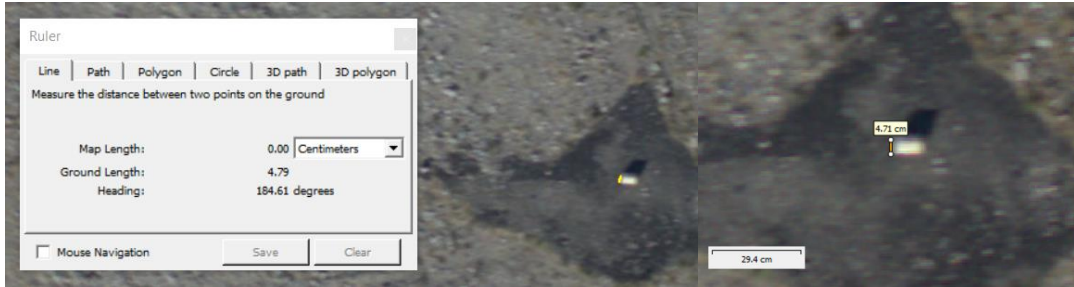
Figure 32 shows the test article diameter which was found to be 4.79 cm in GE which converts to 1.89 in and the Photoscan measurement of 4.71 cm or 1.85 in.

Figure 32: Flight 3B Measured Diameter of 2” x 3” Test Article GE left, Photoscan right

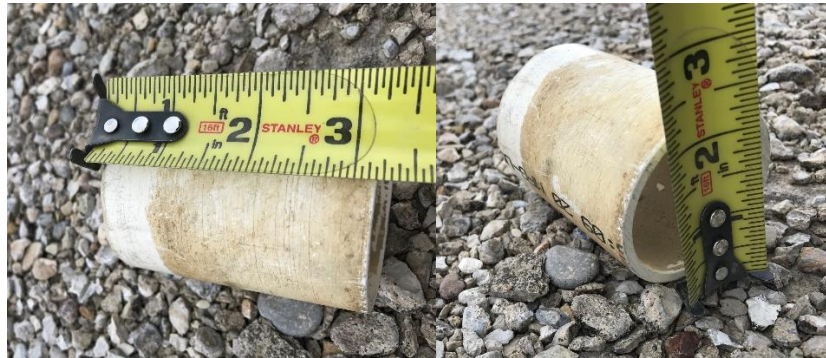
The ground truth of the 2” x 3” test article is shown in Figure 33.

Figure 33: 2” by 3” Pipe Section Length and Diameter Measured with Tape Measure

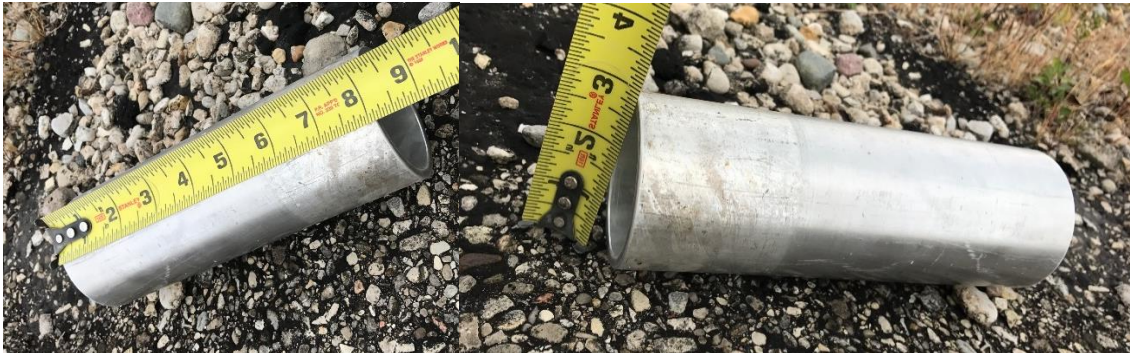
The ground truth of the 3” x 8” test article is shown in Figure 36 and all values are listed in Table 9.

Figure 36: 3” by 8” pipe section length and diameter measured with tape measure

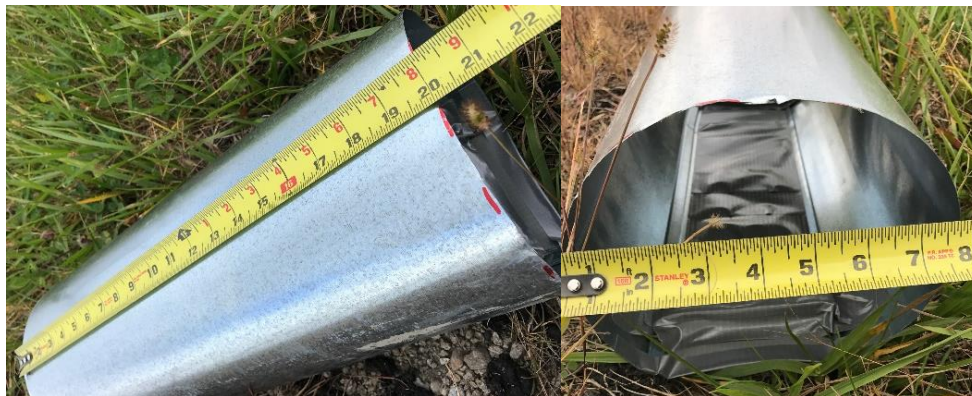
The ground truth of the 8" x 20" test article is shown in Figure 39 and all values are listed in Table 10.

Figure 39: 8" by 20" Pipe Section Length and Diameter Measured with Tape Measure

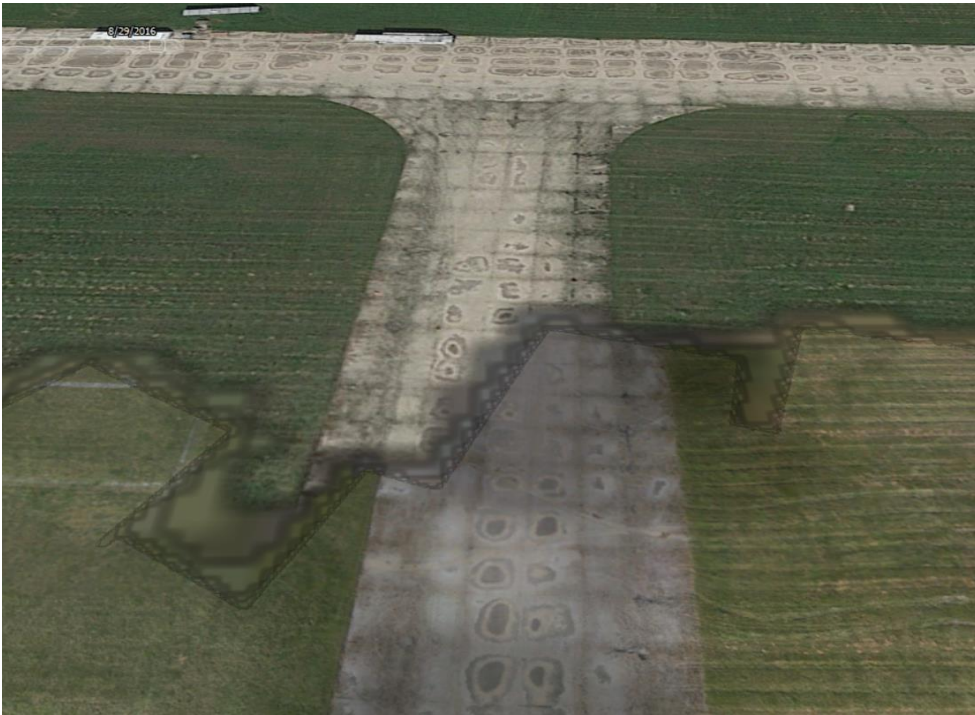
Figure 46: Error Between Flight 3B Orthomosaic and 2016 Google Earth Satellite

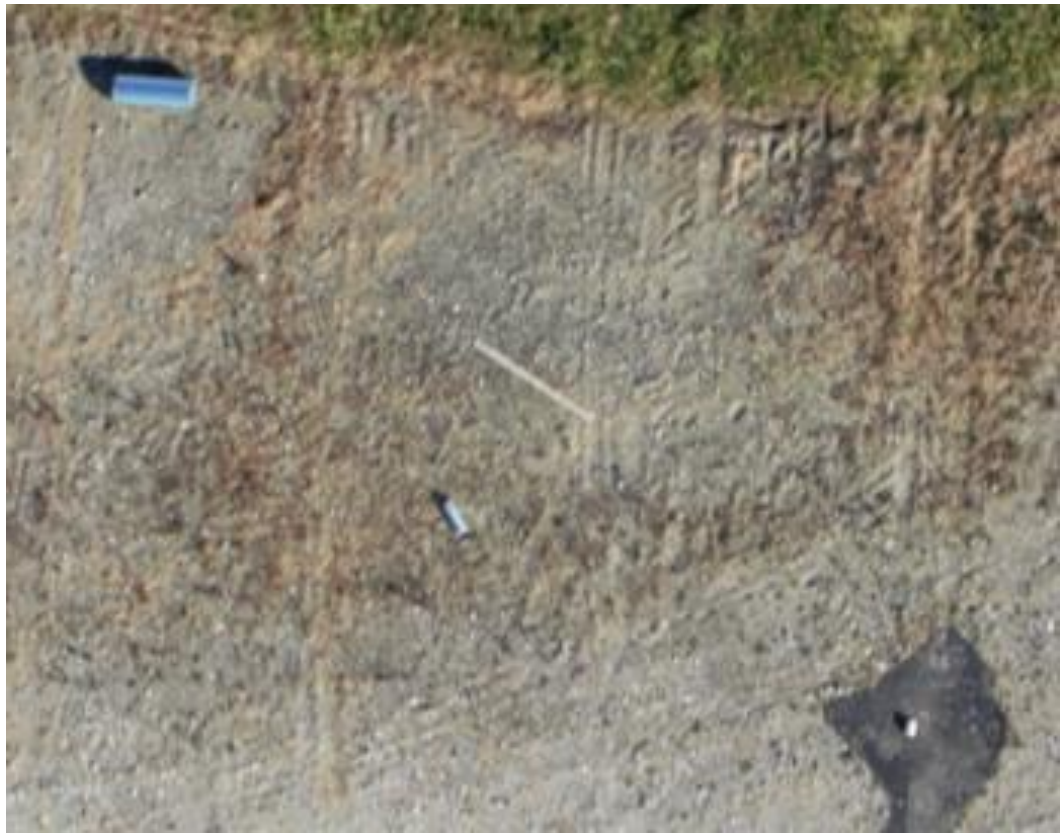
Figure 48: Ground Level Image of Test Articles top, Flight 3B Orthomosaic of Test Articles (32m altitude) bottom
