STRESSED OXIDATION OF HAFNIUM DIBORIDE IN AIR AT 1500°C

THESIS

Thomas A. Bowen, Captain, USAF
AFIT-ENY-MS-17-M-243

AIR FORCE INSTITUTE OF TECHNOLOGY

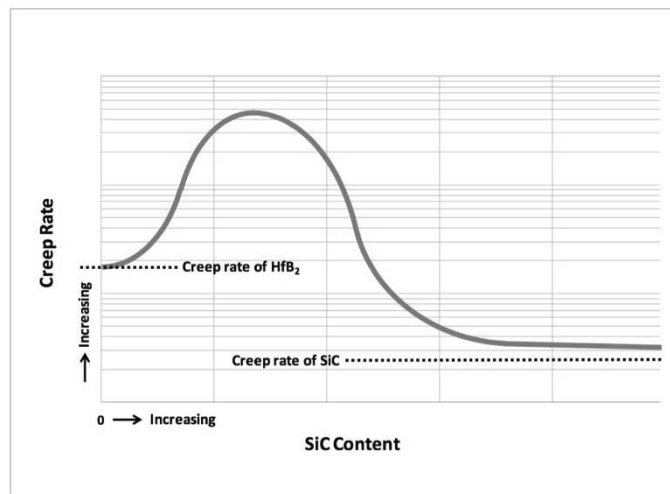
Figure 3. Creep Rate vs. SiC Content, reproduced from [17].

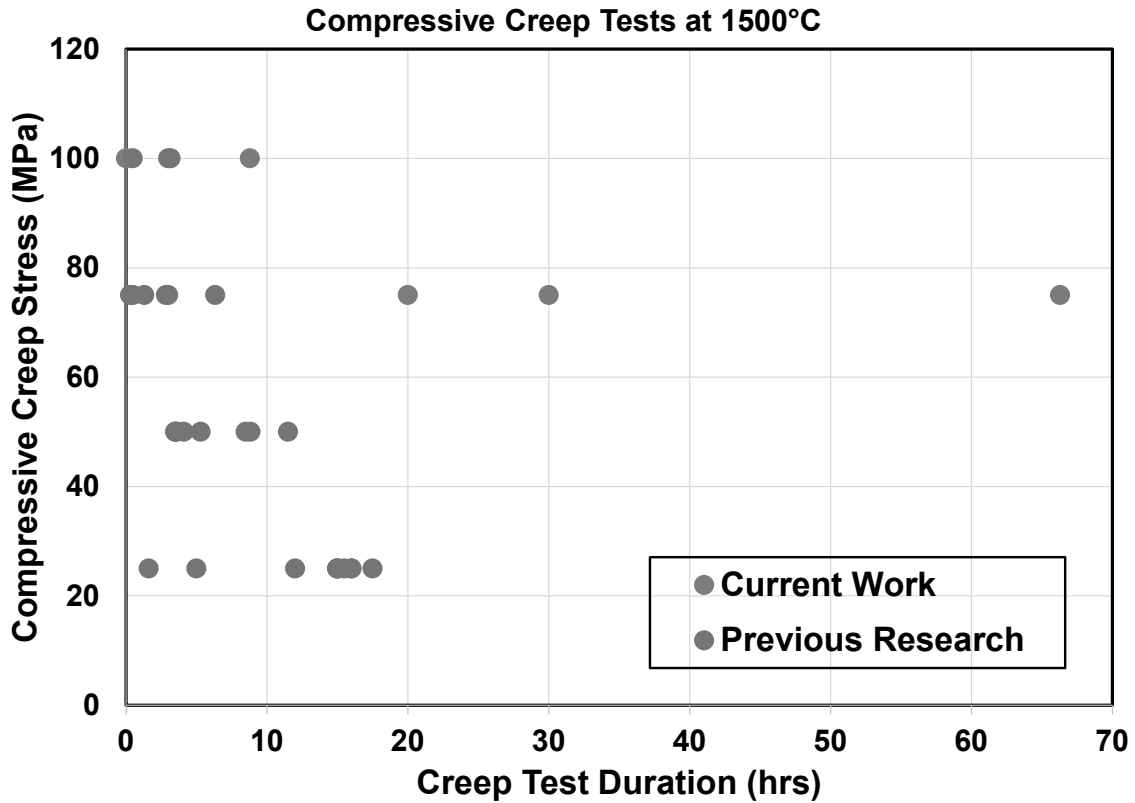
Figure 18. Summary of Compressive Creep Tests Performed at 1500°C in Air: Creep Stress vs. Test Duration

As mentioned in Section 2.5, DeGregoria [17] was unable to achieve compressive loads higher than 50 MPa for any significant duration due to the failure of alumina spacers. Hence this research focused on the replacement of alumina spacers with sapphire spacers. With that goal in mind, the first test using sapphire spacers was performed at a compressive creep stress of 75 MPa. All test results are summarized in Figure 18 along with previous test data from Winder [12] and DeGregoria [17].

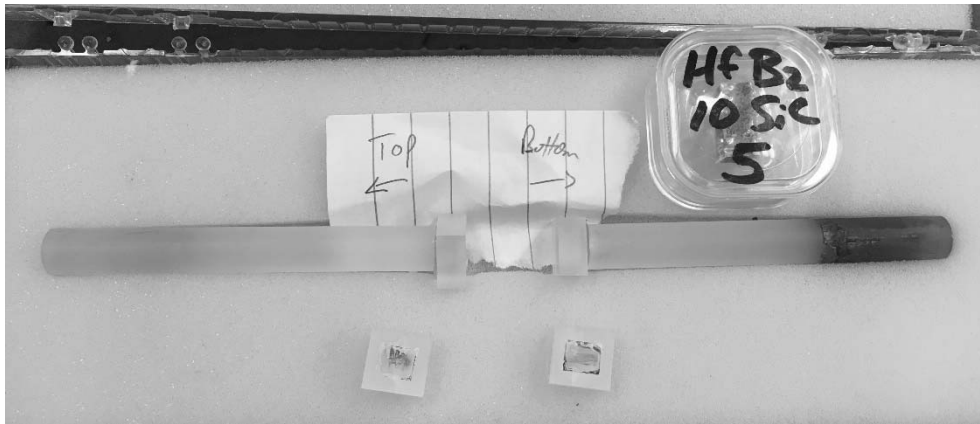
Figure 19. YAG Rods and Sapphire Spacers used in the 75 MPa compression creep test of 66-h duration. Note depressions in the sapphire spacers indicative of substantial superplastic deformation.

Prior to this effort, the longest compression creep test duration achieved at 75MPa at 1500°C in air at AFIT was 6.3 hours. Recall that those tests had to be terminated due to failure of alumina spacers included in the load train [12, 17]. In this work, a successful 75 MPa compression creep test lasted 66.3 h. Furthermore, failure of test specimen, sapphire spacers or the YAG pushrods did not occur when this test was terminated. While this test indicates that sapphire spacers facilitate longer test durations at higher compressive loads. All four sapphire spacers exhibited multiple cracks with the bottom two spacers showing more damage than the upper two. Additionally, there were visible depressions in the spacers where the test specimen was in contact with the spacer (see Figure 19). Post-test

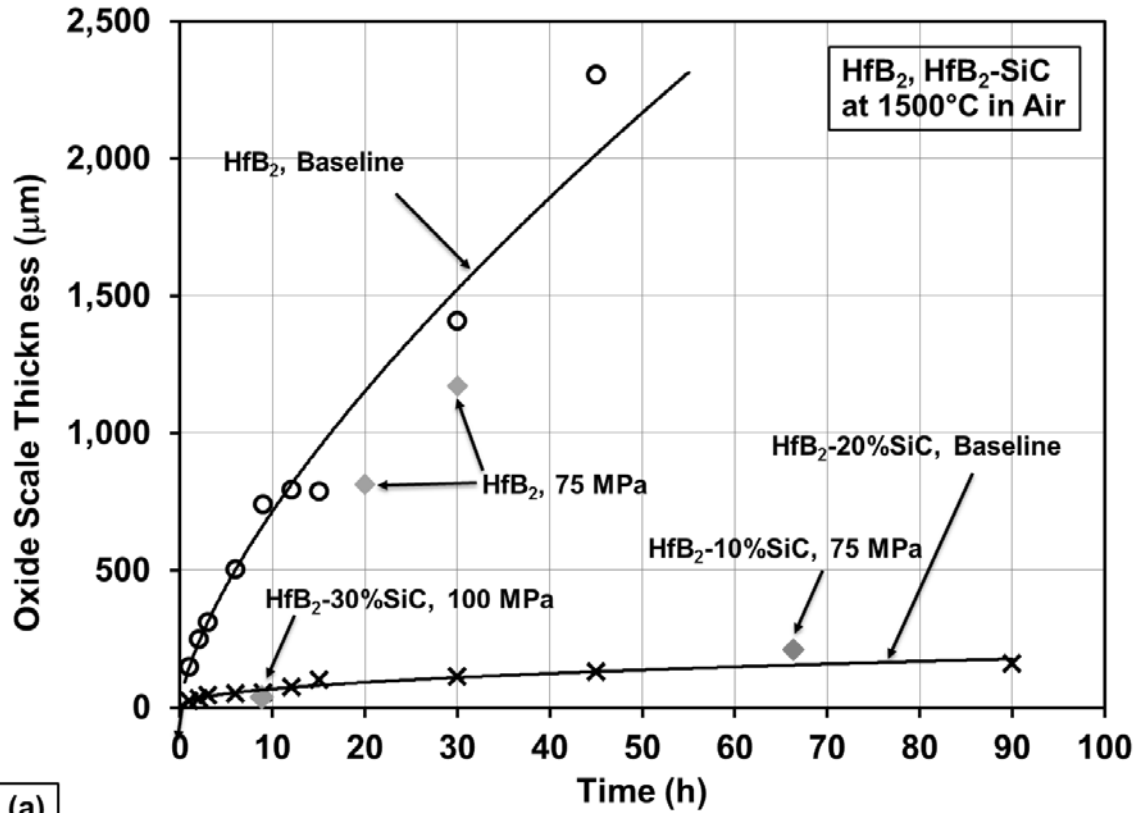
(a)

The average oxide thickness was plotted along with DeGregoria's [17] baseline oxidation results and Parthasarathy model [26, 27] as shown in Figure 30.

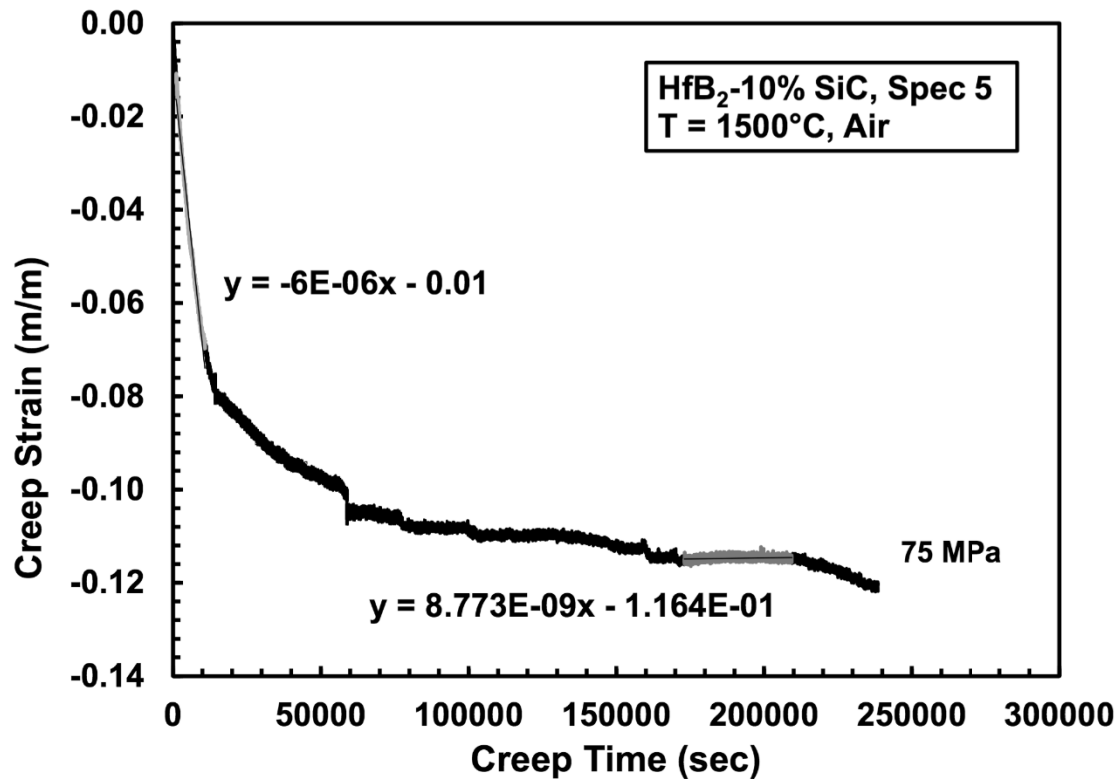
Figure 39. Creep Curve from HfB₂-10% SiC specimen subjected to 75 MPa compressive load for 66.3 h at 1500°C in air.

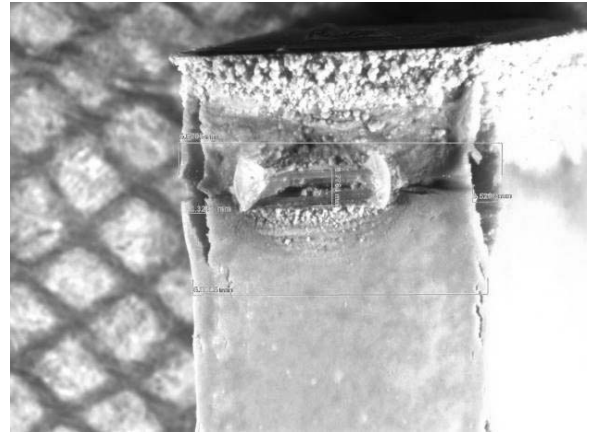
Figure A-152. Optical micrograph of the HfB₂ specimen subjected to 30 h of compression creep at 75 MPa at 1500°C. Note the scale buildup and discoloration near ends. Depression at extensometer groove includes two broken pieces of sapphire extensometer rod.

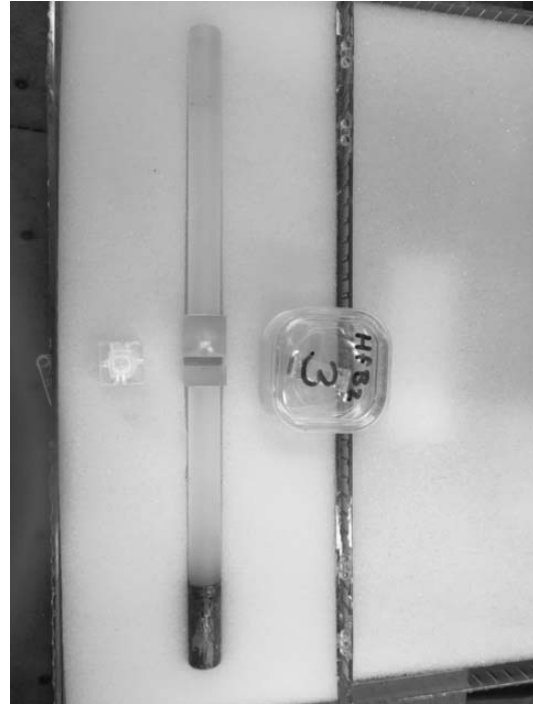
Figure A-207. Load train subjected compression creep of HfB_2 specimen at 75 MPa for 30 h with four random orientation spacers.
