**TENSILE PROPERTIES AND FATIGUE BEHAVIOR OF GEOPOLYMER
MATRIX COMPOSITES WITH CARBON FIBER REINFORCEMENT AT
ELEVATED TEMPERATURE**

THESIS

AIR FORCE INSTITUTE OF TECHNOLOGY

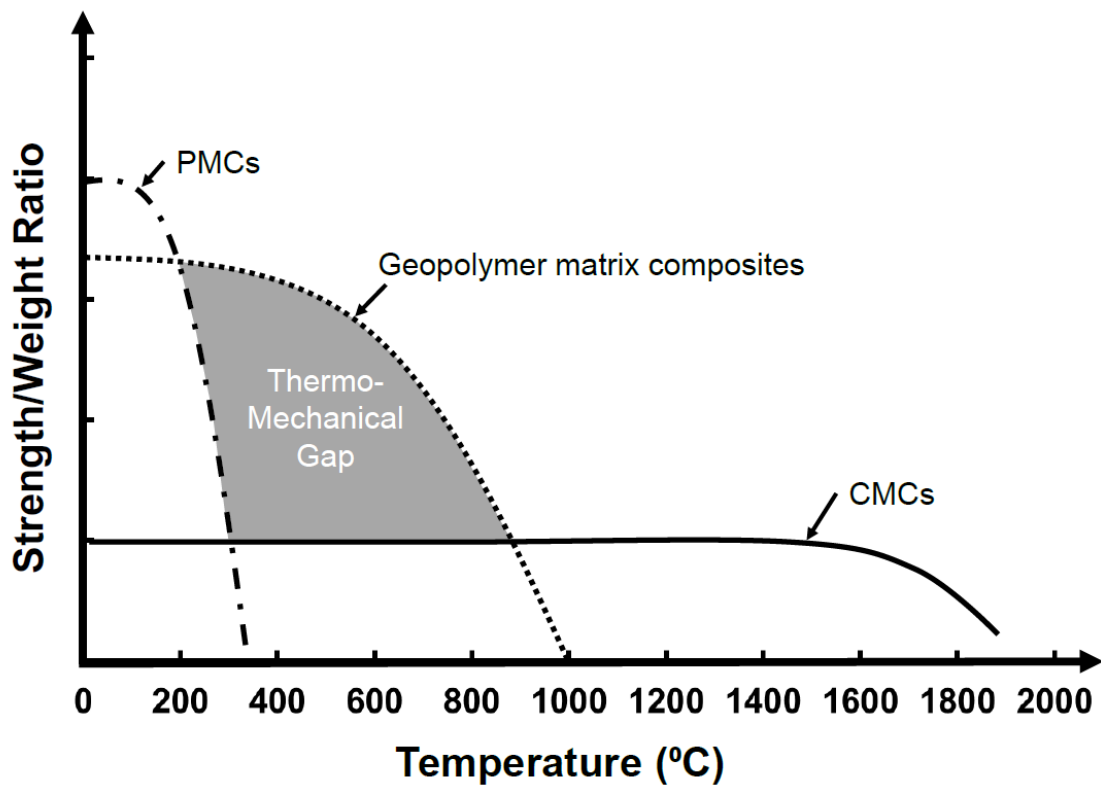
Figure 3. Schematic of retained Strength/Weight Ratio at Temperature, adapted from [15]

We define a large difference between the strength-temperature characteristics of the PMCs and CMCs as the thermo-mechanical gap (see the shaded region in Figure 3). To fill this thermo-mechanical gap, we need a composite with the right combination of reinforcing fiber and inorganic matrix. Geopolymer matrix composites may be able to bridge this gap.

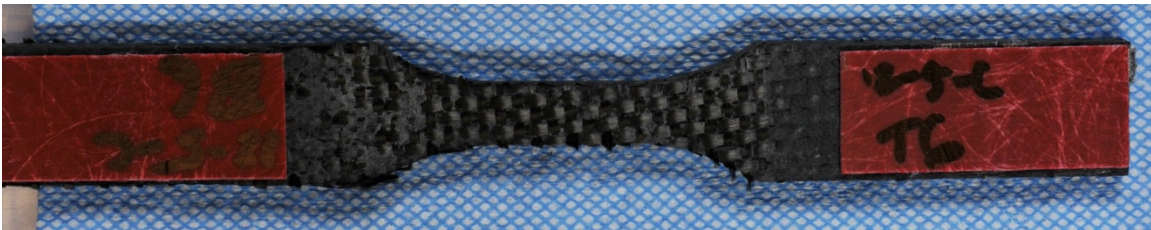
Figure 9. Test specimen with fiberglass tabs, from panel 12-5-C.

In preparation for testing, 38-45 mm x 16.5 mm x 0.9 mm fiberglass tabs were bonded to the gripping sections of the test specimens using M-Bond 200 adhesive. Fiberglass tabs protect the specimen from damage due to gripping and help distribute the gripping pressure. A test specimen with fiberglass tabs is shown in Figure 9.

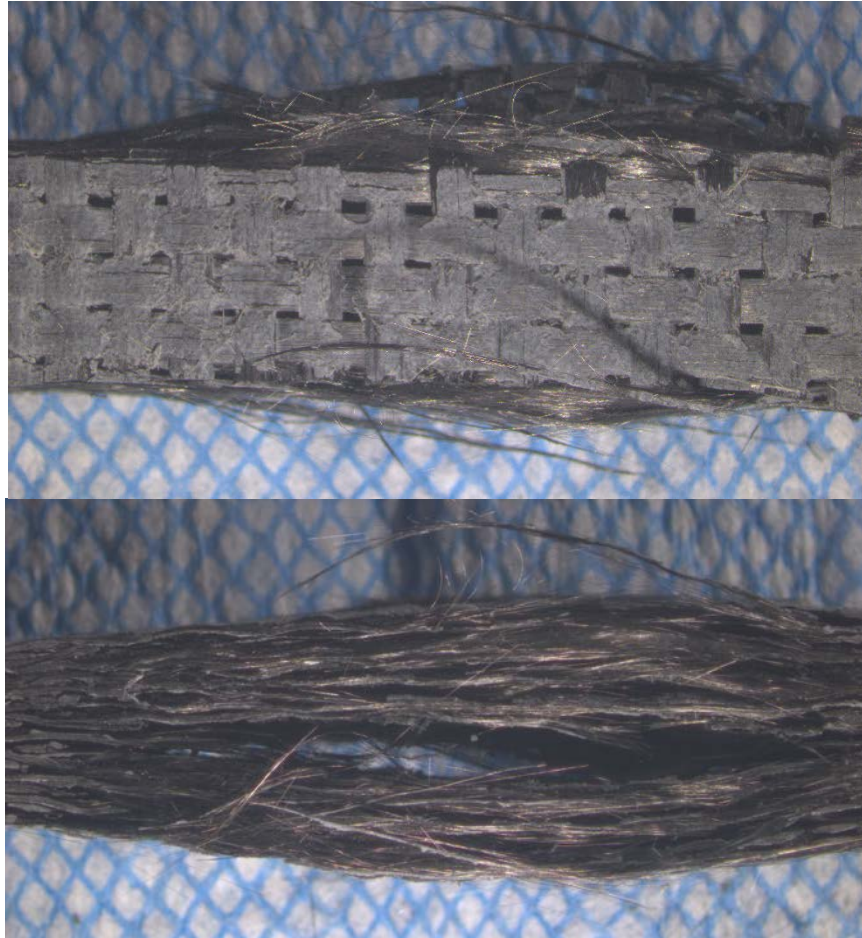
Figure 22. Specimen 5-7-C-1-3, failed in tension test at 23°C.

Specimen failure in tension tests (manifested by the loss of load-carrying capacity) occurs much earlier than the separation of the specimen into two parts. Figure 22 shows considerable swelling and delamination in the specimen gage section. The geopolymer matrix cracks and fails to hold the composite together, causing the plies to delaminate and fail. As the displacement continues to increase, the specimen eventually separates into two parts. Careful examination of the failed specimens reveals no indication of a strong bond between the geopolymer matrix and the carbon fiber, with the matrix undergoing flaking off of the failed carbon fiber sections. A stronger, less fragile matrix or stronger fiber-matrix bond would likely yield a different failure mode and might also improve composite performance. A stronger matrix might also improve

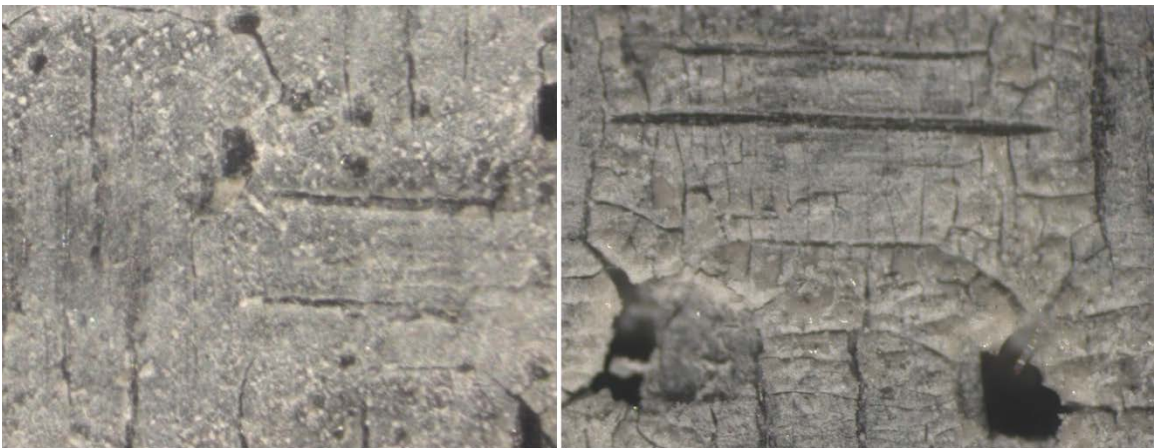
Figure 27. Microcracking of matrix on surface of 5-7-C-14 Type 2 geopolymer matrix specimen before thermal exposure (left) and after (right).

To achieve a better understanding of the material response to thermal exposure, specimens were first examined with an optical microscope, then subjected to temperature increase to 300°C followed by a 45-min dwell at 300°C (the first thermal exposure), and finally cooled down to room temperature and once again examined with an optical microscope. The strain measurements obtained during this process were analyzed as discussed before. The effect of thermal exposure on composite microstructure can be clearly seen in the micrographs, with Figure 26 showing a severe case of matrix cracking and thickness swelling due to thermal exposure. For Type 1b and Type 2 geopolymer matrix materials this behavior was less pronounced and harder to detect on the thickness view, but looking at the specimen surface there are still signs of dehydration and microcracking of the matrix (Figure 27).

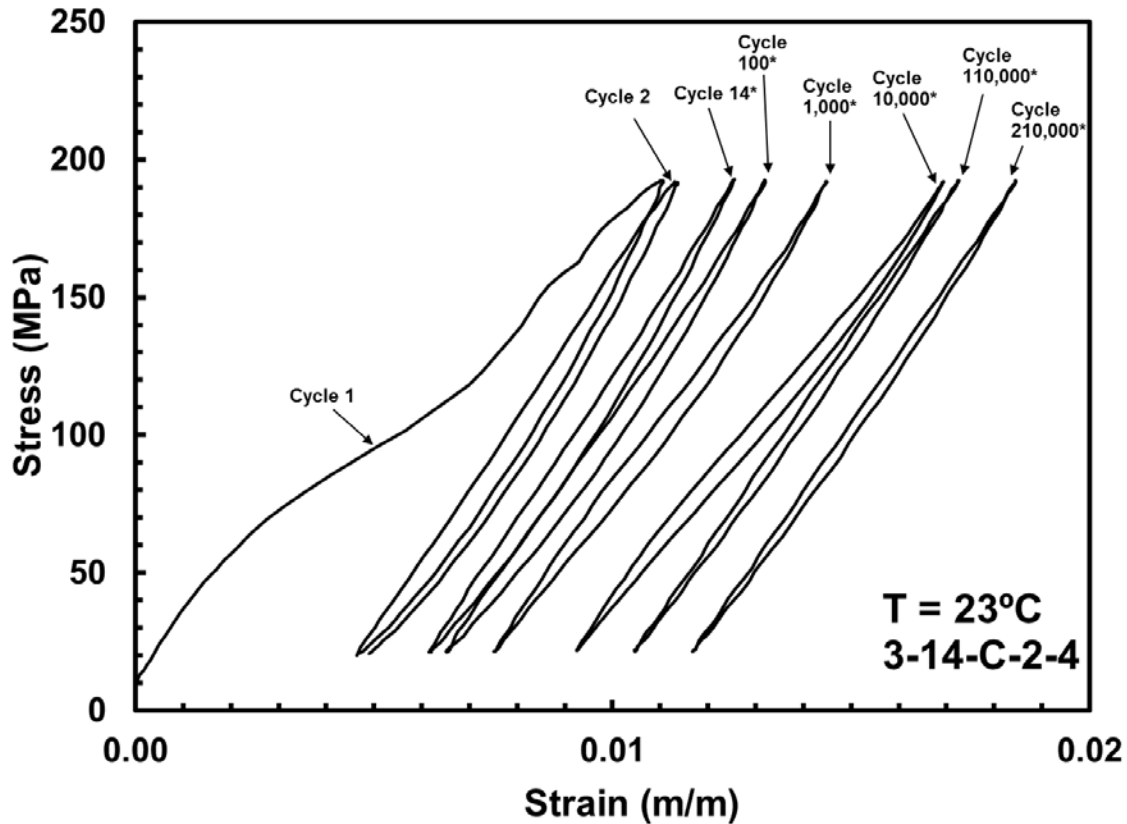
Figure 37. Stress-strain hysteresis response of composite specimen 3-14-C-2-4 with Type 1 geopolymer matrix in a tension-tension fatigue test performed at 23°C. Due to extensometer slippage, the cycles with an asterisk (*) are separated arbitrarily to show hysteresis curve evolution.

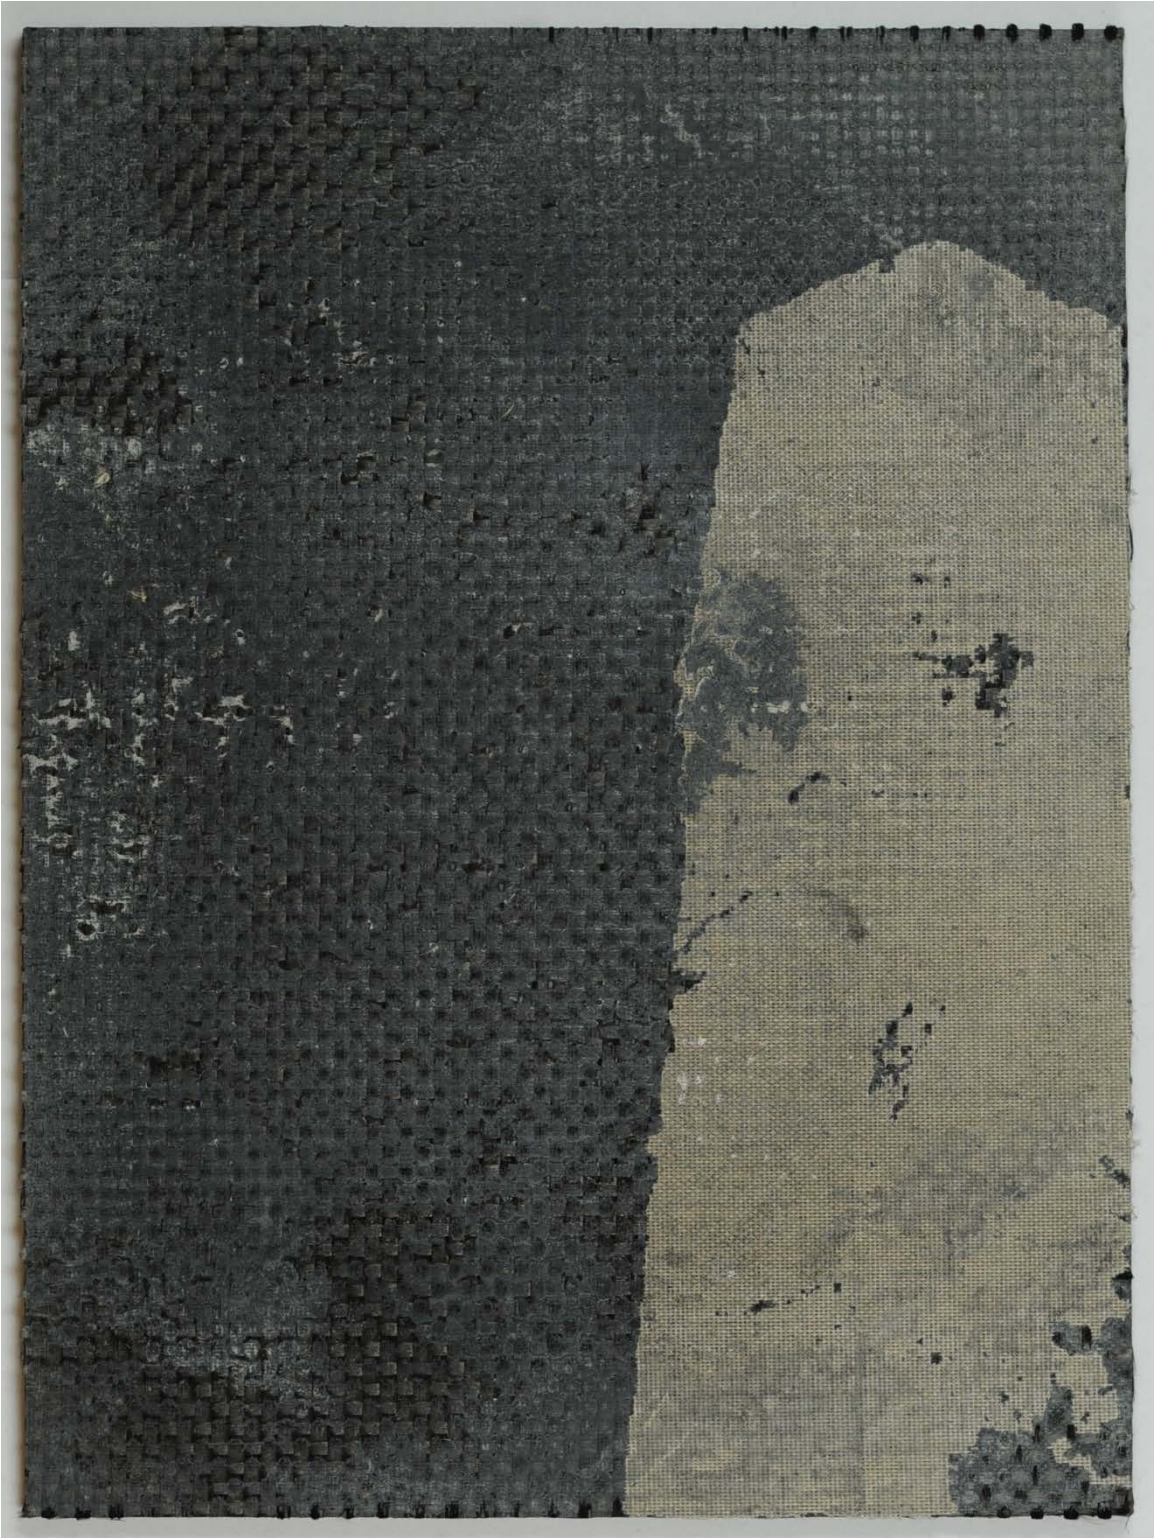
Figure 57. "Back" side of panel 5-7-C-1.
