Report No. CG-D-05-18

Joint Maritime Test Facility (JMTF) Summary Burn Report for FY17

JMTF Summary Burn Report for FY17

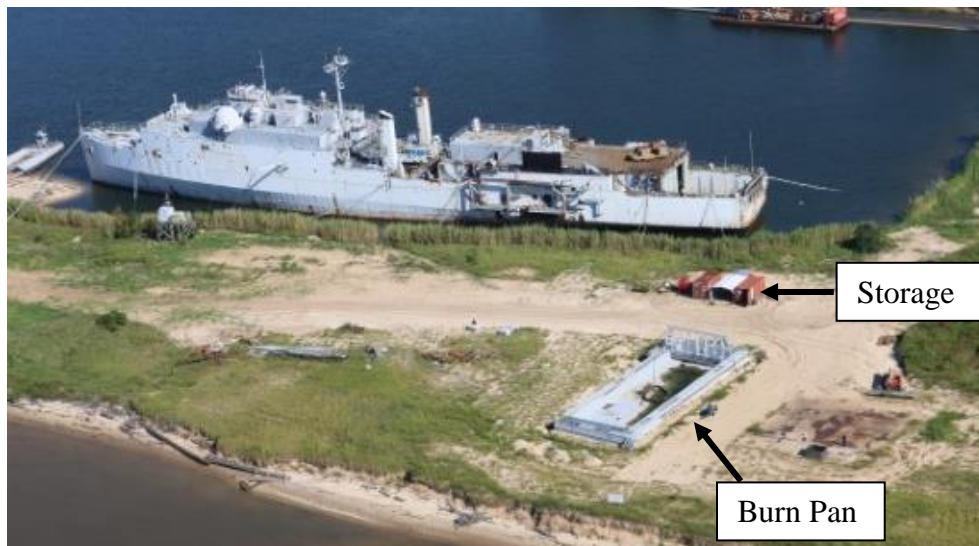
Figure 1. View of Little Sand Island in October 2016.

The burn pan was fabricated out of steel on Little Sand Island (LSI) in 1998. The outer burn pan is approximately 33.0 meters (108 feet) long, 11.6 m (38 ft) wide and 1.5 m (5 ft) deep. The inner test area is 100 feet by 30 feet. The 1.02 m (4 ft) wide trough separates the inner burn wall from the outer wall, and is designed to be filled with water to act as a protective heat-sink. The top of the trough is covered with deck grating and serves as a walkway around the top of the burn pan. A safety railing was added in 2016. About

4.9 m (16 ft) of the north end of the burn pan is occupied by the wave generator that features a hydraulic cylinder connected to a wave paddle suspended 4.9 m (16 feet) above the tank floor.

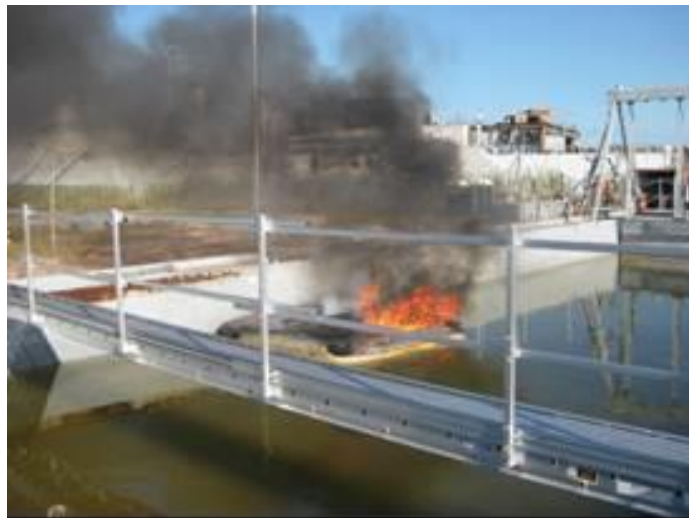
Figure 2. Aggregate and oil burning.

and south sides. Two heat-flux gauges were mounted on the east and west side of the boomed area. Video cameras were mounted on poles attached on the outside wall of the burn pan trough. The tests consisted of placing crude oil within the boomed area, distributing the aggregator, waiting for about 10 minutes and then igniting the combined oil/aggregator. A small propane burn igniter was used to start the burn. A total of seven burns were conducted with burn times of only 2-3 minutes (Figure 2). Some smoke that was blown towards the west and north dispersed before reaching the water. In some of the tests, leftover aggregator was left unburned on top of the oil (Figure 3). It was not clear how successful the burn was and the aggregator appeared to suppress some of the burning. A sample of the data collection using the NRL Data Acquisition System (DAQ) shows the temperatures and heat flux measured for the baseline study that included oil without any aggregator (Figure 4). PNNL took samples of the leftover residue to assess burn efficiency. The project report has not been completed but will eventually be loaded on the BSEE Internet site at: <https://www.bsee.gov/research-record/osrr-1071-multifunctional-herding-sorbent-agents-use-icy-water>

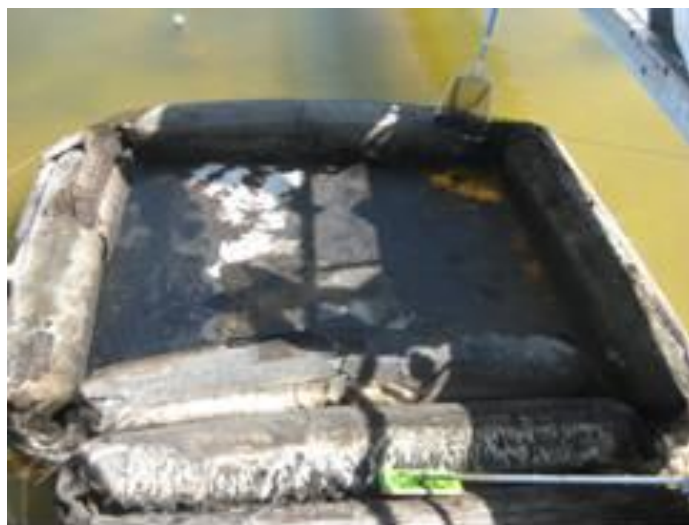
Figure 3. View of test area after burn.

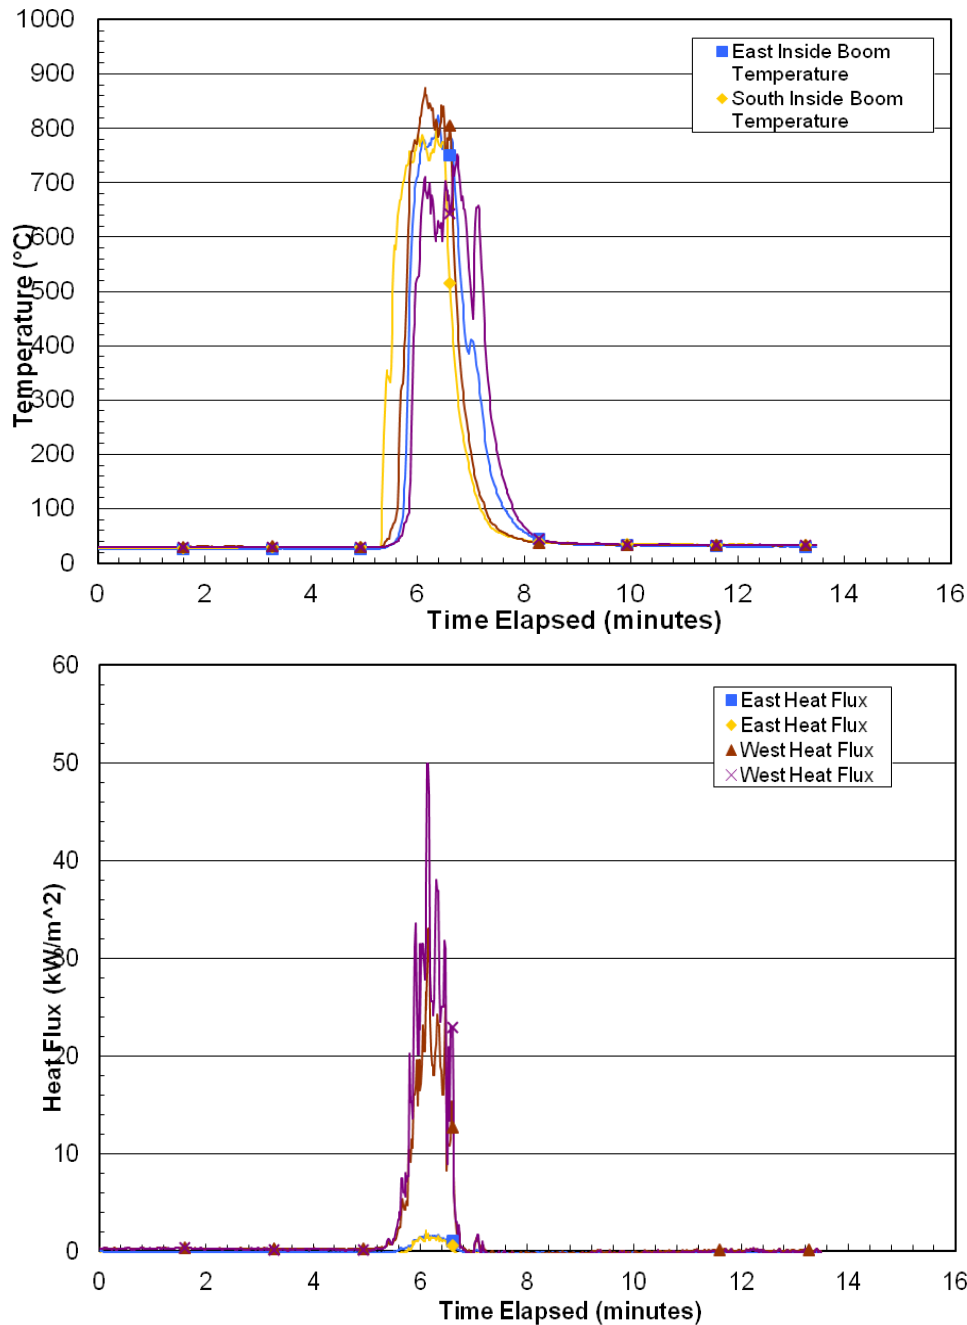
Figure 4. Examples of temperatures (top) and heat flux (bottom) for baseline test.

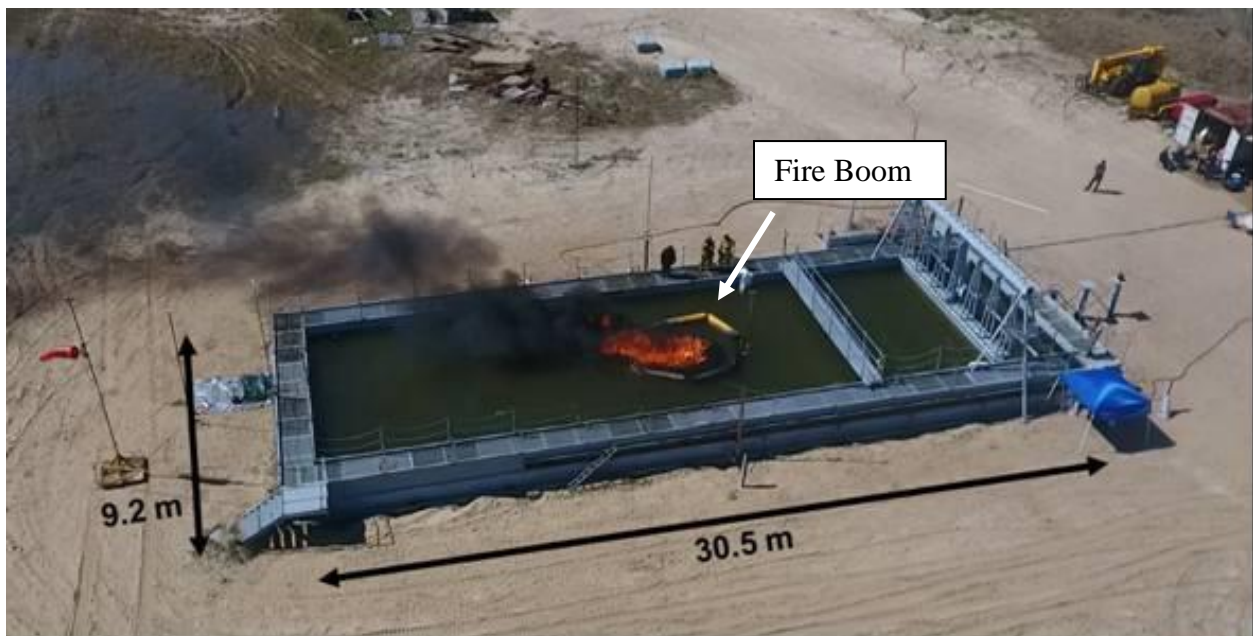
Figure 6. Overhead view of a burn with fire-resistant boom in place.

can be seen in Figure 5b. RDC placed a fire-resistant boom around the ring to keep any burning oil from spreading out and potentially damaging sensor wiring or other data gathering components (Figure 6). Besides collecting temperature, heat flux and other data, WPI also captured smoke from the plume to analyze. The Outdoor Gas Emission Sampling System (OGES) was used to sample and analyze the gas concentrations of O_2 , CO_2 , and CO (see Figure 7) and can also be seen on the left side of Figure 6.

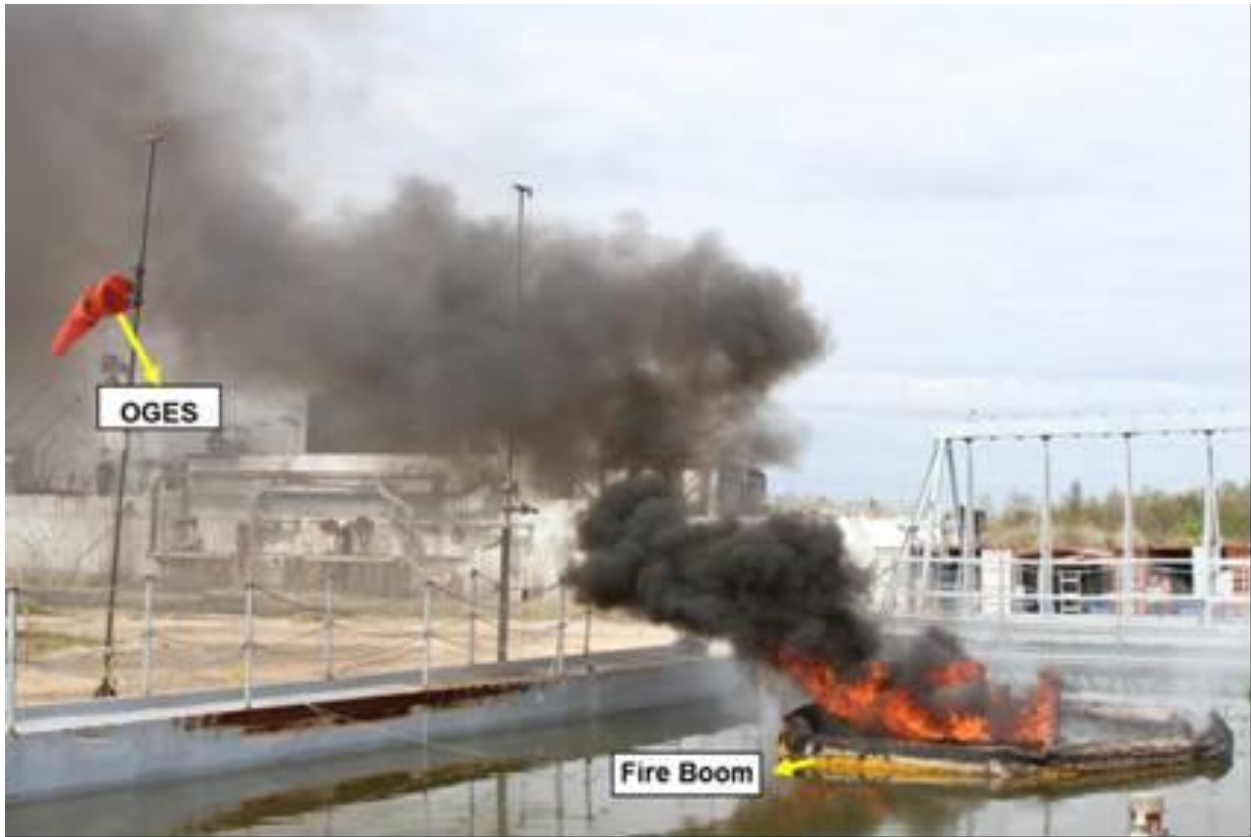
Figure 7. Outdoor Gas Emission Sampling System (OGES) in place.

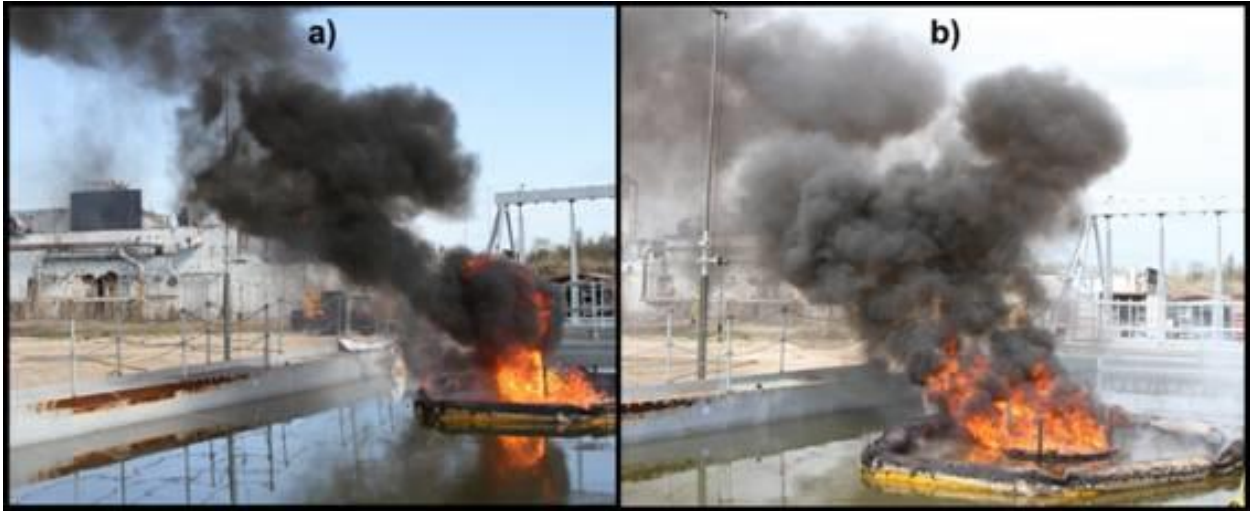
Figure 8. Picture of the smoke plume a) baseline, b) blanket with 48 coils (VH).

Five tests were done with the general results showing in Table 1. The baseline burn was without any blanket or coils, then for subsequent tests the mesh and coils were added. Figure 8 clearly shows that the color of the smoke plume is much lighter for the blanket with 48 coils case (VH). The light color smoke indicates reduction in small black particles of carbon and more complete combustion. In general, the use of the mesh and coils appears to increase the efficiency of the burn.

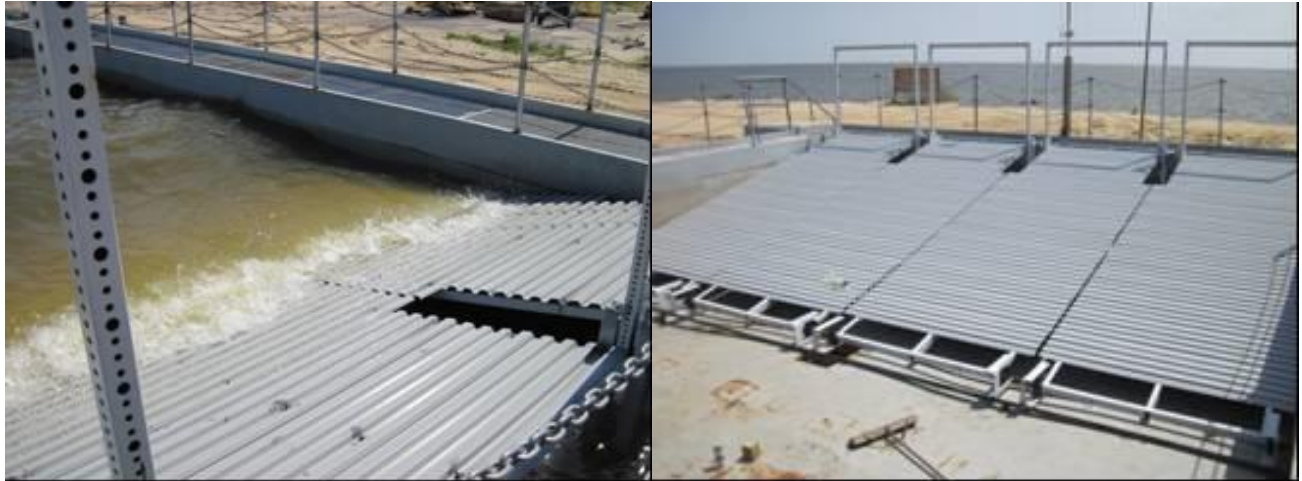
Figure 9. View of energy dissipation beach with (left) and without water (right).

In 2016, RDC awarded a contract to Chant Engineering to design, build, and install a system that would use the existing wave paddle to create the wave required by standard ASTM F2152. A wave-dissipation beach, a new hydraulic cylinder and a hydraulic power unit were installed beginning in May (Figures 9 through 12). The system was installed and tested, but the resulting waves damaged the beach where sections of the corrugated steel pulled through or broke off the mounting studs that were welded to the frame. The repairs were completed in July, and a final user manual and the system were accepted in August. The system is able to make wave heights up to 12 inches with a 2-second period, which exceeds the required ASTM standard.

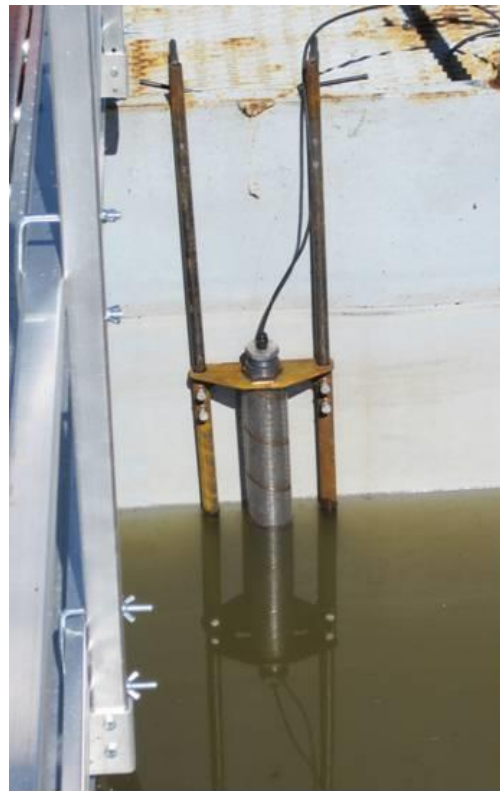
Figure 10. Wave height measurement device.

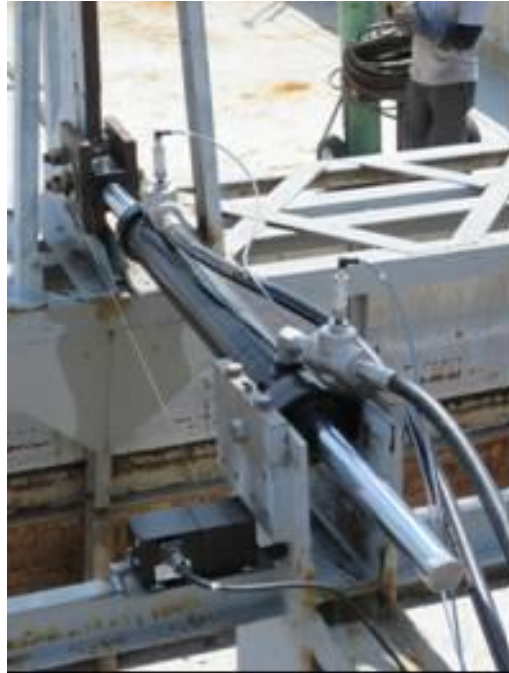
Figure 11. Close up of hydraulic cylinder.

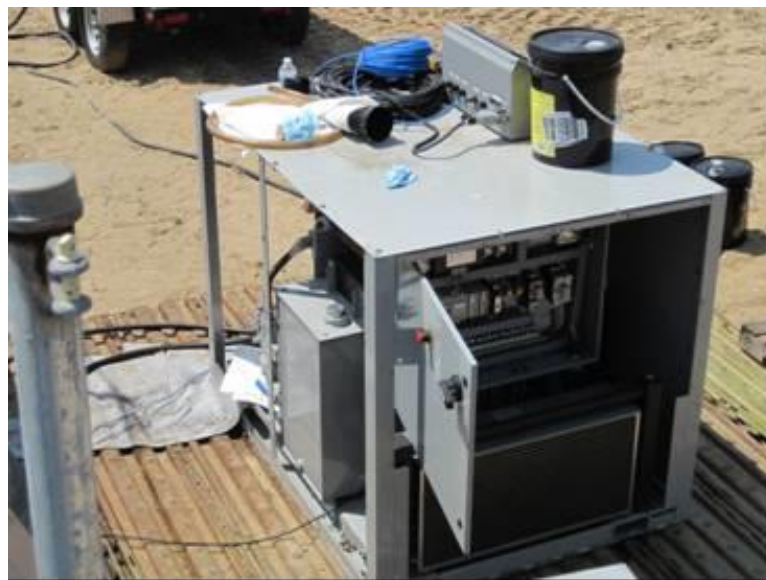
Figure 12. View of Hydraulic Power Unit (HPU).

While the system was operated with power from the diesel generator on LSI, the size of the waves and operation was limited by this generator's capacity. Any attempt to exceed these current parameters either by increasing the wave height or shortening the period will cause the generator to trip the circuit breaker. In addition, the tests performed for the minimum requirements were accomplished with the beach in the full-up position. Additional calibration tests are needed to see how the wave conditions change with different beach slopes and when the beach is submerged. This last condition usually will create a more confused surface causing waves to break within the tank, a condition needed for more sophisticated burning or dispersant tests.
