Evaluation of 90 Degree Gearbox Design

GVR-BOT Technical Report

Tyrus Valascho, Robert Sosin
8-15-2013

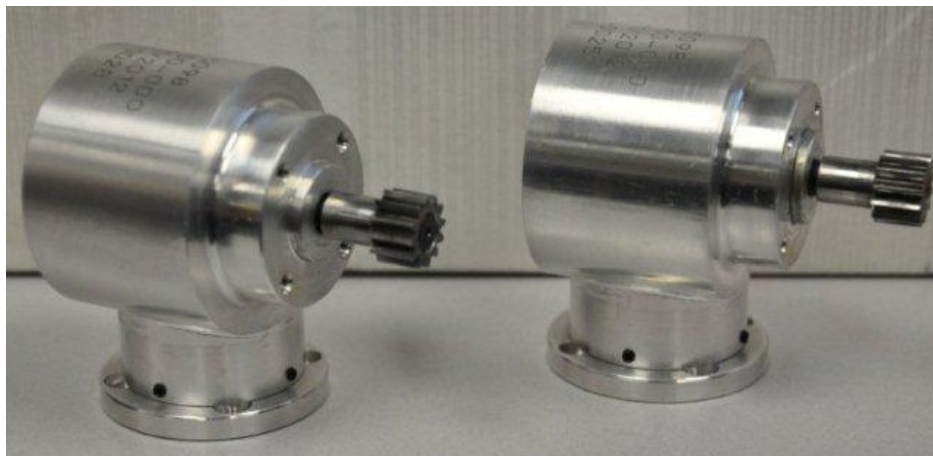
Figure 1 - Two Prototype 90 Degree Gearboxes

For the testing, two prototype gearboxes were produced and PackBot 500 gearheads attached for mounting inside a Standardized PackBot / GVR-BOT. An image of the two completed parts – separated from the motors – is provided in Figure 1.

The serial numbers of the two parts used in testing are 12-0028 and 12-0025.

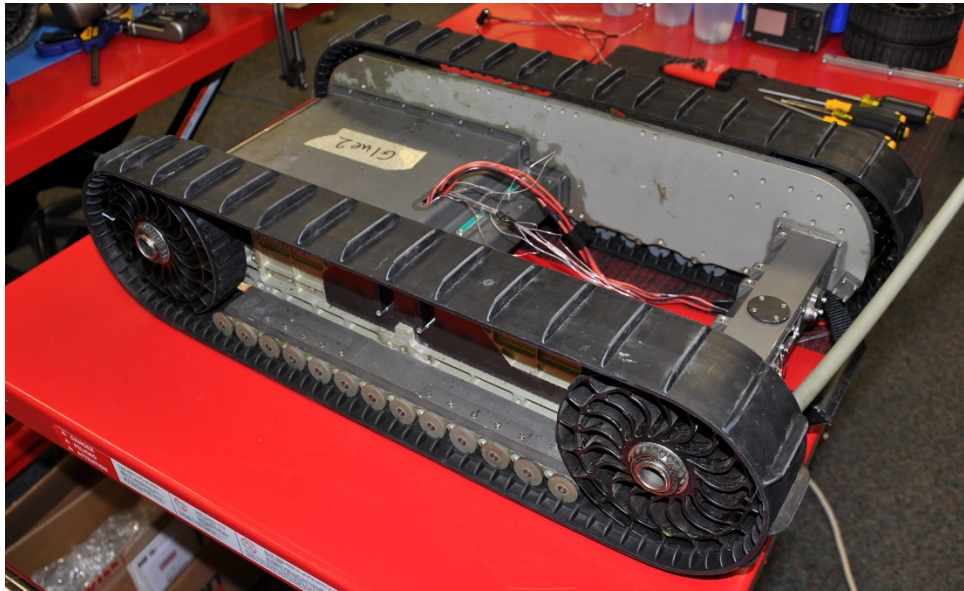
Figure 2 - Standardized PackBot with Instrumentation Installed

For testing of the Standardized PackBot, the motors, gearboxes, and motor controllers were instrumented with thermocouples. An image of the instrumented vehicle, including power and thermocouple wiring, is provided in Figure 2.

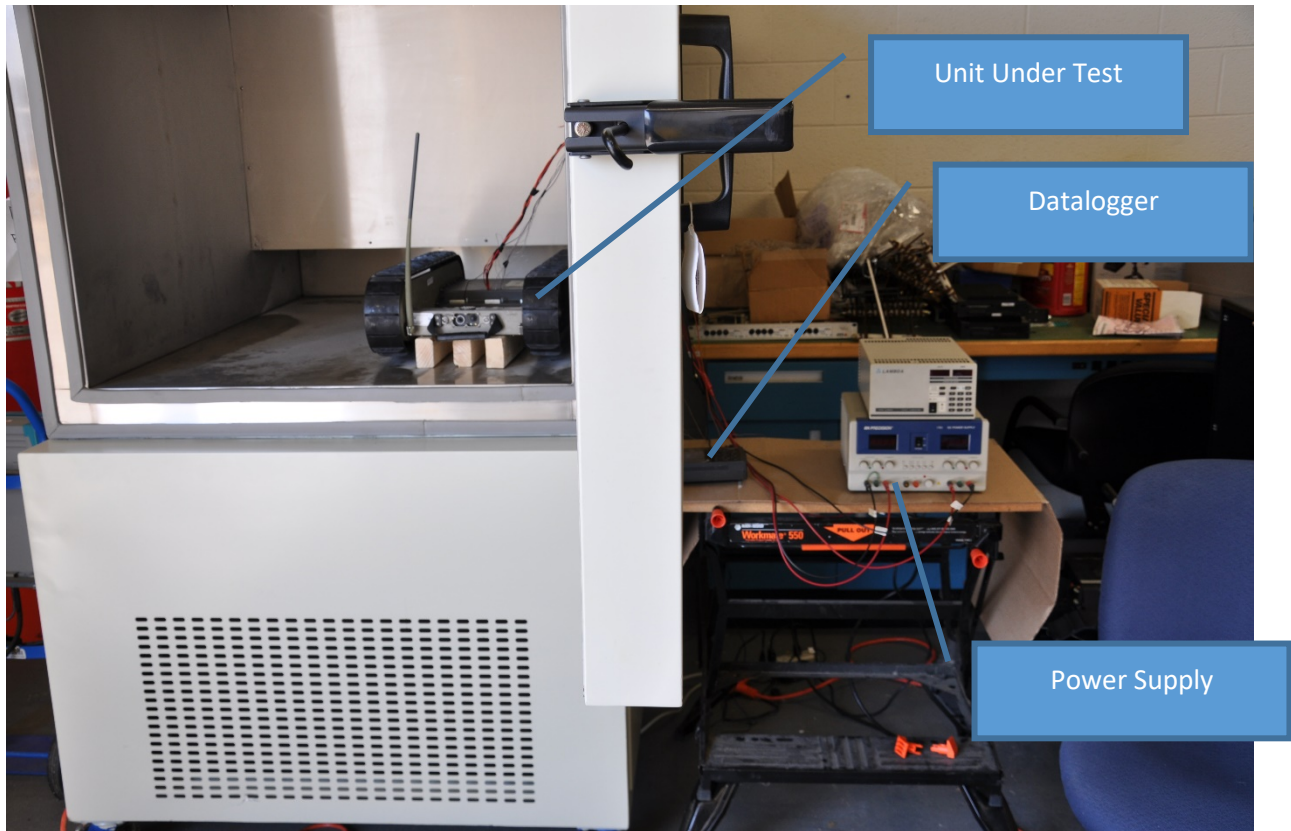
Figure 3 - Test1 Configuration without Dynamometer

The test was run with all components installed in a prototype Standardized PackBot chassis and installed in the small robot dynamometer and the complete assembly placed in the temperature chamber. Figure 3 provides an image of the pre-test configuration, before the robot was placed in the dynamometer.

Power was provided externally by a power supply - not the robot batteries - so the tests could continue without stopping the test, opening the temperature chamber, and replacing batteries. Thermocouples were installed as indicated in Table 4.

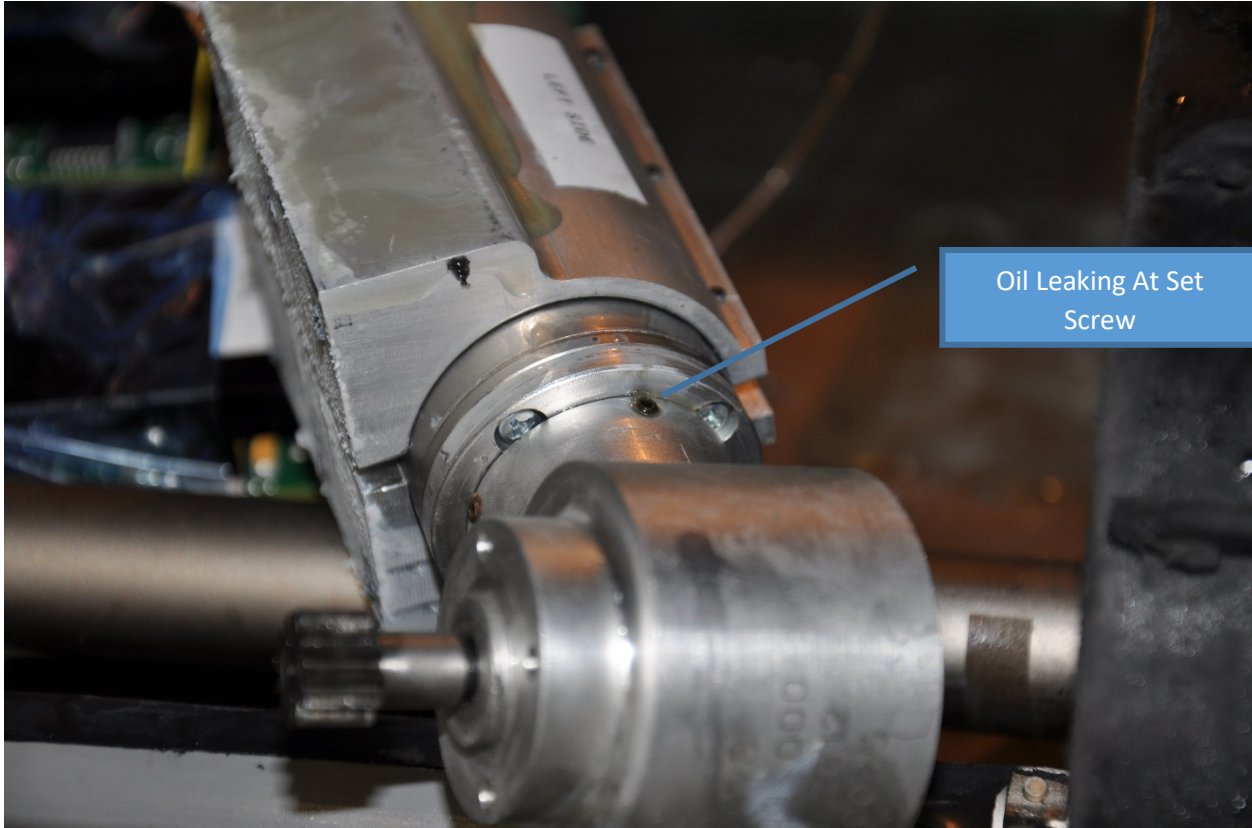
Figure 4 - Oil Leak Observed in Left Side Gearbox

In addition, one of the gearboxes was observed to leak oil during the 50 C ambient testing. The leaking is documented in Figure 4.

Based on these results, the manufacturer requested that the gearboxes be returned so they could investigate the issues observed by the TARDEC testing team.

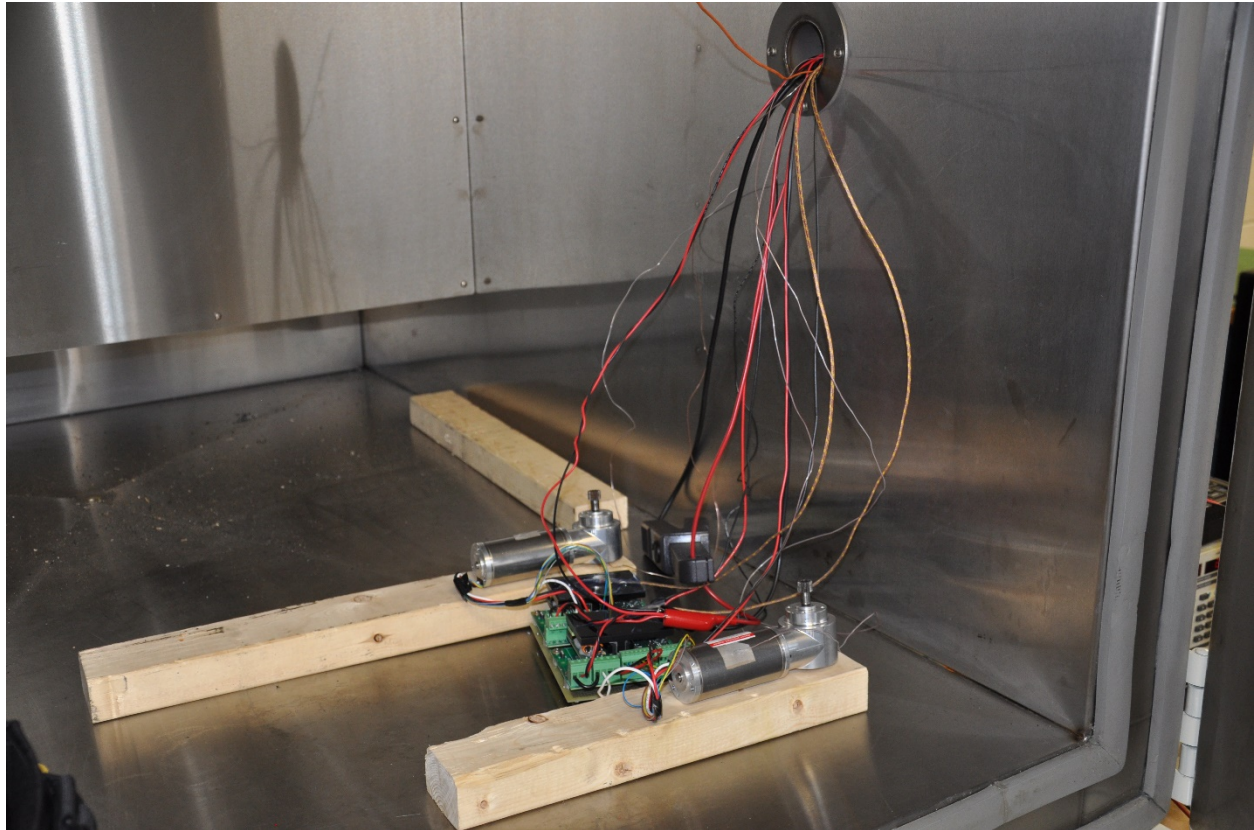
Figure 5 - Test with Components in Chamber

The test was run with all components placed directly in the test chamber, as can be seen in Figure 5.

Power was provided externally by a power supply. Thermocouples were again installed as indicated in Table 4 - Location of Standardized PackBot Thermocouples, even though the components were now removed from the electrical housing of the robot.

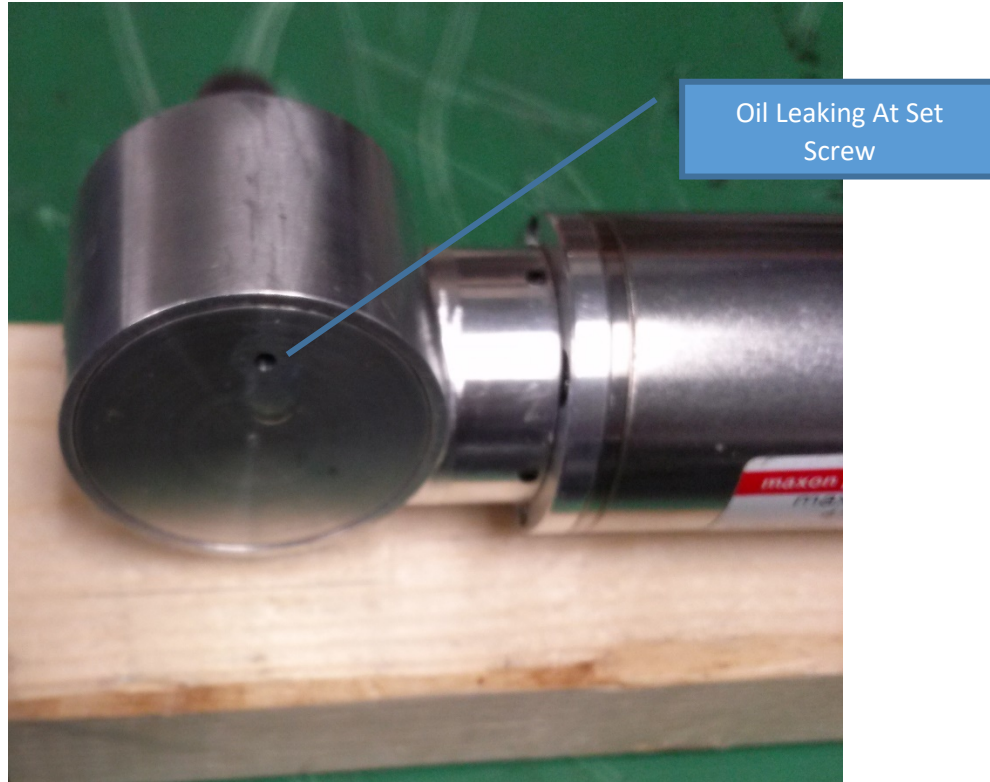
Figure 6 - Oil Leak Observed at Back of Gearbox

In addition, another oil leak was found. This time the leak occurred at the back of the gearbox, as can be seen in Figure 6.

After receiving the results, the manufacturer again requested that both units be returned for analysis and repair.

The gearboxes were returned to TARDEC after modifications to correct the leaking. Once received, another test was initiated to verify operations.
