**NAVAL
POSTGRADUATE
SCHOOL**

THESIS

**SEDIMENT TRANSPORT ASSOCIATED WITH
EPHEMERAL RIVER BREACHING AND CLOSING
EVENTS**

June 2018

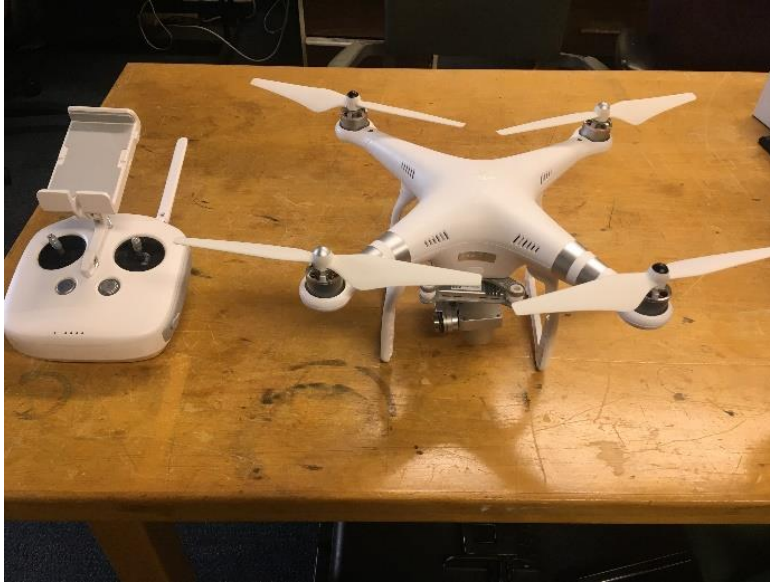
Figure 4. DJI Phantom 3 Advanced

The UAV surveys were conducted using a DJI Phantom III Advanced quadcopter (Figure 4), which has a twelve megapixels resolution camera with a 1/2.3" sensor and f/2.8 prime lens. The UAV flights were flown at an altitude of 60 m at medium drone speed (5m/s) with a camera angle of 80 degrees (10 degrees off nadir) and fast mode triggering. The mapping software used was Pix4DCapture. A single grid survey pattern with 80% along track and 70% side overlap of imagery that is recommended for analyzing the data with Agisoft Photoscan software for SfM was used. The single grid pattern was then offset from the first flight by 90 degrees in order to mimic a double grid pattern for each survey. Three UAV surveys were conducted. The flights were not conducted using double grid mode owing to a consistent software glitch for flights requiring multiple batteries. A pre-breach survey was conducted on December 06, 2017, a breached beach survey on January 11, 2018, and a closed breach survey on January 23, 2018.

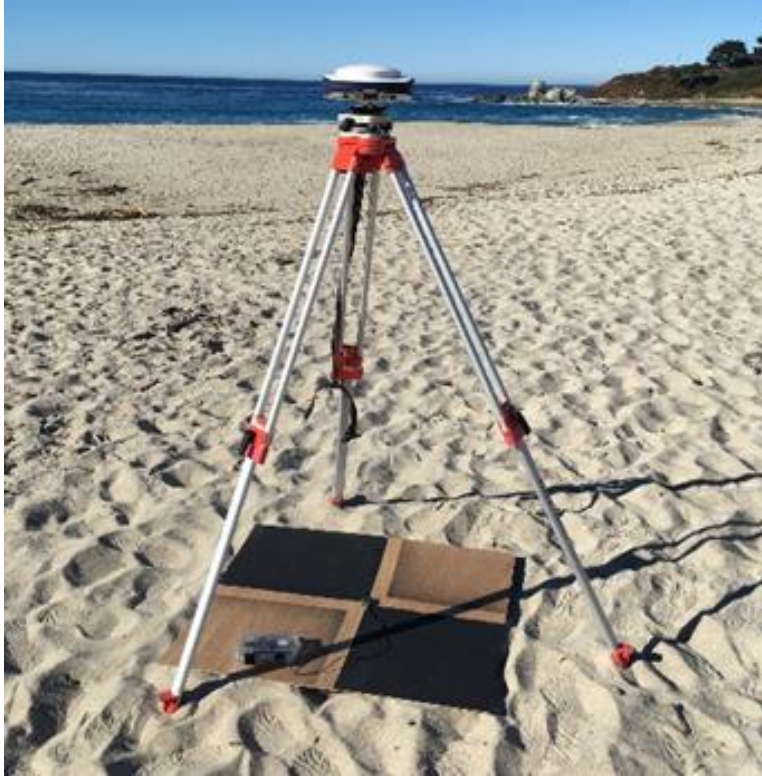
Figure 5. Ground Control Point with GPS Positioning

To significantly improve the aerial survey accuracy from meters to centimeters, GPS-surveyed ground control points (GCP) were used. The GCPs were 2.5'x 2.5' quarter-inch plyboards painted into quad panels of black and natural squares to give color contrast and precise center points for improved detectability in the imagery and positioning. The control points were surveyed in using an Ashtech ProMark GPS receiver on each point for a minimum of 5 minutes (Figure 5). The GPS accuracy was within +/- 0.5 cm and analysis of the positioning revealed a vertical and horizontal precision on the order +/- 5 cm (Figure 6). For the first two UAV surveys, six GCP and the final survey twelve GCP were deployed. The reason for the increase in the number of GCP placed for the final survey was to see if accuracy of digital elevation model produced from the data could be improved, and if the improvement would be worth the additional time to deploy and position each point.

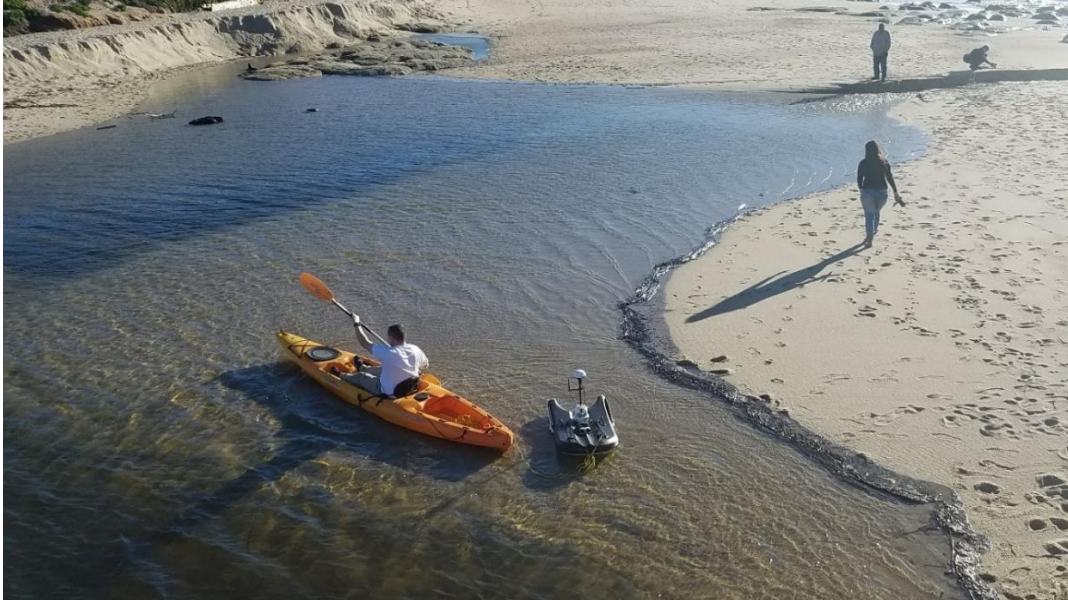
Figure 8. Conducting Bathymetry Survey Using RiverSurveyor and Kayak

Bathymetric surveys of the lagoon were conducted to determine changes in the bathymetry caused by sediment transport. A SonTek RiverSurveyor M9 was used along with a GPS base station to get Realtime Kinematic (RTK) GPS accuracy in positioning. The RiverSurveyor is a nine transducer multibeam array system with 1% depth accuracy and 1mm depth resolution. A single person kayak was used to pull the RiverSurveyor in

the lagoon (Figure 8). The hydrographic surveys were conducted on November 27, 2017 and January 11, 2018.

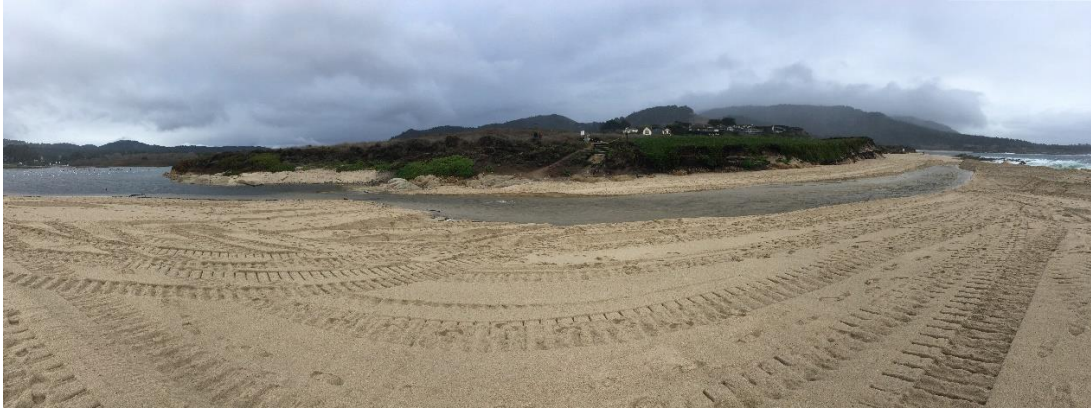
Figure 9. Excavated Breach of the Beach (View from the North)

The Monterey Peninsula Water Management District (MPWMD) monitors the Lagoon water levels with a surveyed water level gauge which was monitored to observe changes in lagoon depth to determine when breaching and/or closure of the beach might occur. The gauge accuracy is ± 0.015 m in comparison to a staff gage (James 2005). Reviewed data from 2014–2017, a breach typically occurs when the lagoon reaches an elevation of approximately 4 m, as likely constrained by beach elevation. All of December, 2017 and until January 8, 2018 there was little precipitation, and lagoon levels remained at 3.7 – 3.8 m. On January 8–9 water levels increased to 4 m with continued precipitation. However, in response to growing concerns of flooding to local residences in Carmel along with lagoon and river, the Resource Management Agency of Monterey County dredged a small breach of the south end of Carmel River State Beach in the early hours of January 9 (Figure 9 and 10), resulting in a rapid outflow and elevation drop of lagoon waters (Figure 11). According to the county workers, approximately 230 m³ of sand was displaced to create a man-made breach.

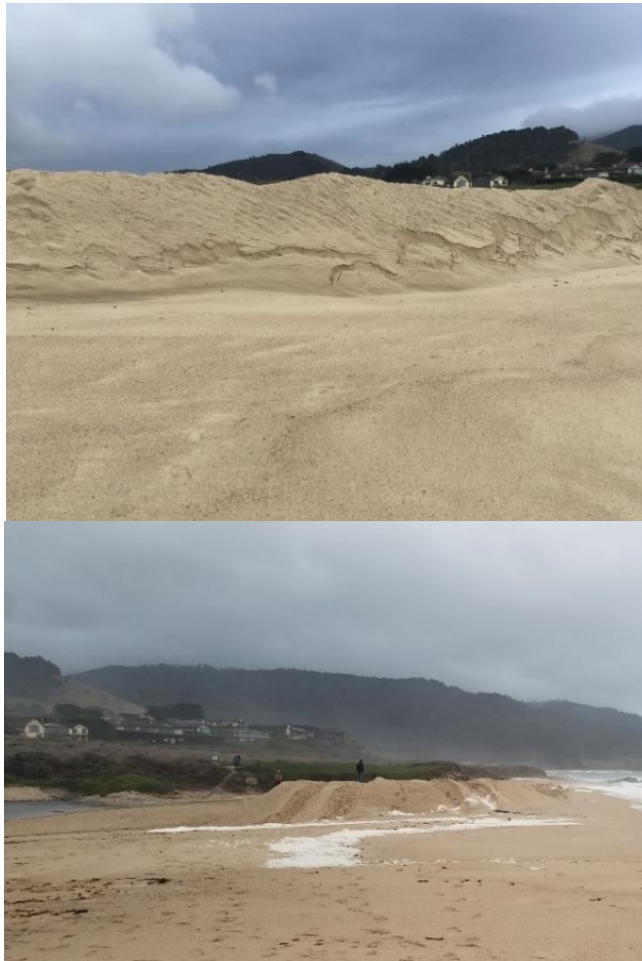
Figure 10. Sand Berm Resulting from Excavation of the Breach.

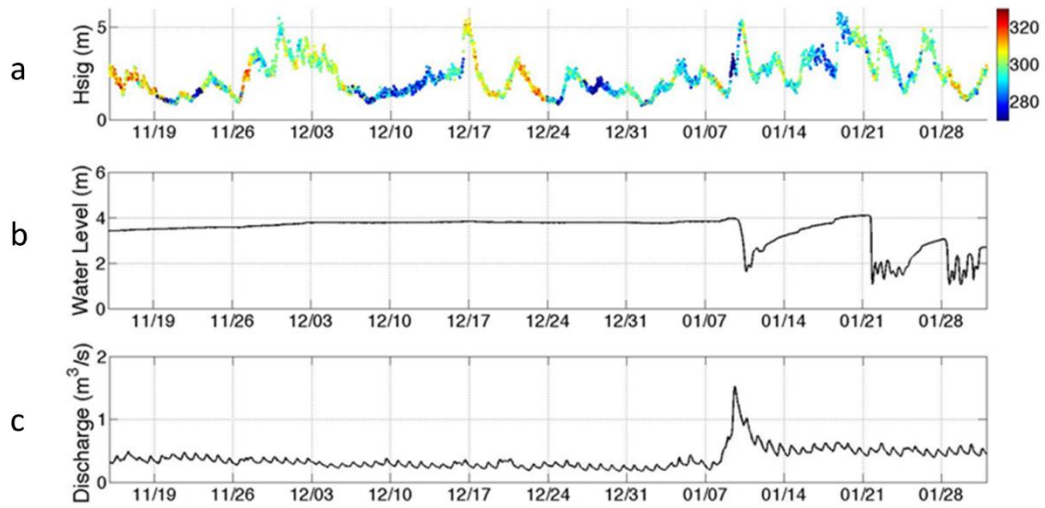
Figure 11. (a) Carmel River State Beach significant wave height and direction, (b) lagoon water levels (NAVD88), and (c) river discharge.

occurred on January 22. Analysis of the water levels demonstrate that the breach closed within 48 hours and water levels began to rise (Figure 11b), indicating that the mechanical breach was ineffective in maintaining the breach, but the natural breach that followed on January 22 maintained a pattern of shallow sand deposition that allowed the system to maintain a pattern of opening and closing throughout the observation period (Figure 11). Furthermore, the mechanical breach resulted in looser sand compaction at the breach site which resulted in a more rapid breaching directly across the beach on second major breach and increased out flow as indicated by the steeper decline in lagoon water levels. This rapid outflow may result in the transfer of biologicals from the lagoon into the ocean. The day of the mechanical breach, the lagoon water levels were within a meter from height of the crest of the southern portion of beach where the breach was created, and had the breach been allowed to occur naturally, the sediment transport would have occurred more slowly and reduced the rate of outflow.

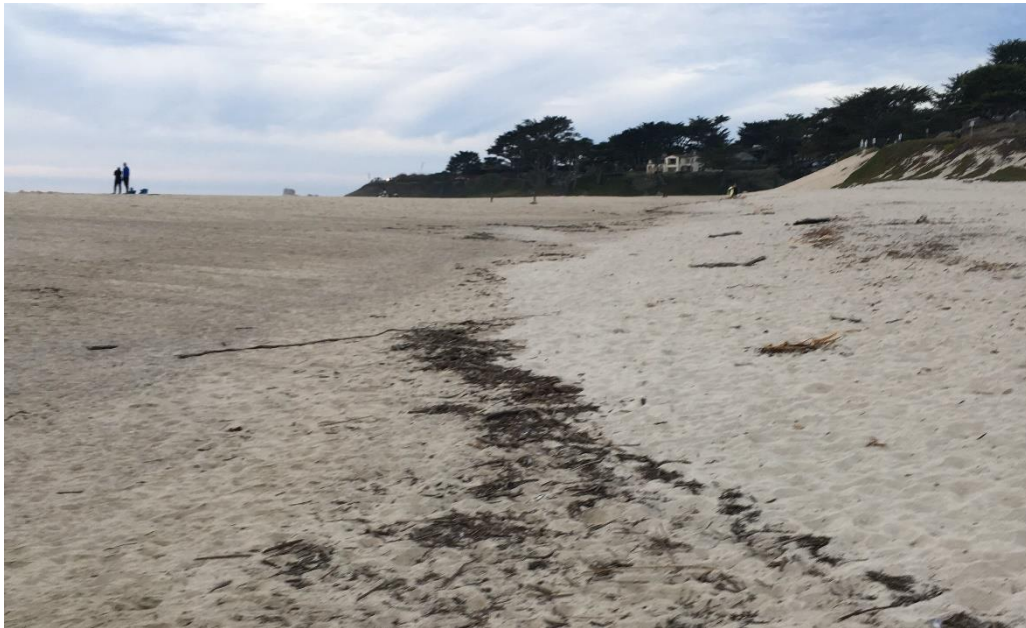
Figure 16. Northern crest of beach from 2017 breach of the Carmel River
(Viewed from lagoon looking seaward)

The area of the beach that was not dredged showed a net gain of sediment of approximately 5190 m³ (Figure 15). The pattern of sand deposit shows that the northern edge of buildup was along a pre-existing crest that was the reminisce of a berm created from the breaching of the beach in the 2017 winter season (Figure 16) and bound to the west by the crest of the beach oriented along its northwest to southeast axis. The majority of the sediment gain was along the lagoon water edge.

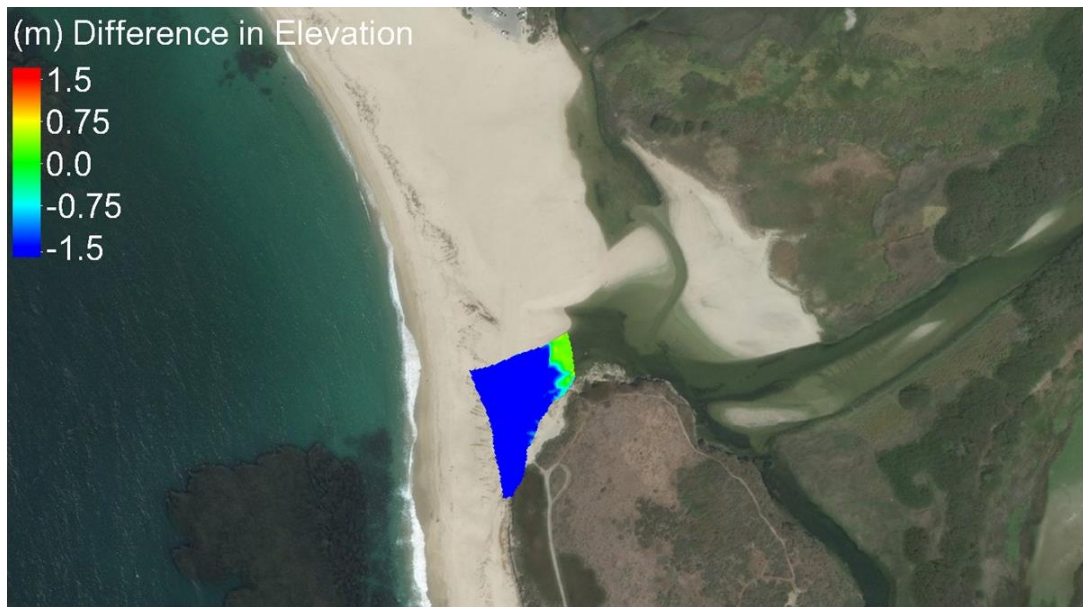
Figure 17. Change in sediment elevation in area of the breach from December 06 to January 23.

The area that was dredged on January 9, 2018 widened significantly over the two weeks until the final survey on January 23 which was restricted to a northern migration

because of rock outcrops and step sand berms and cliffs on the southern side of the breach, and the breach went through a series of openings and closings primarily driven by river discharge filling the lagoon and wave action once the lagoon water elevations dropped below 2 meters. There was a net loss of sediment of approximately 7400 m³ (Figure 17).

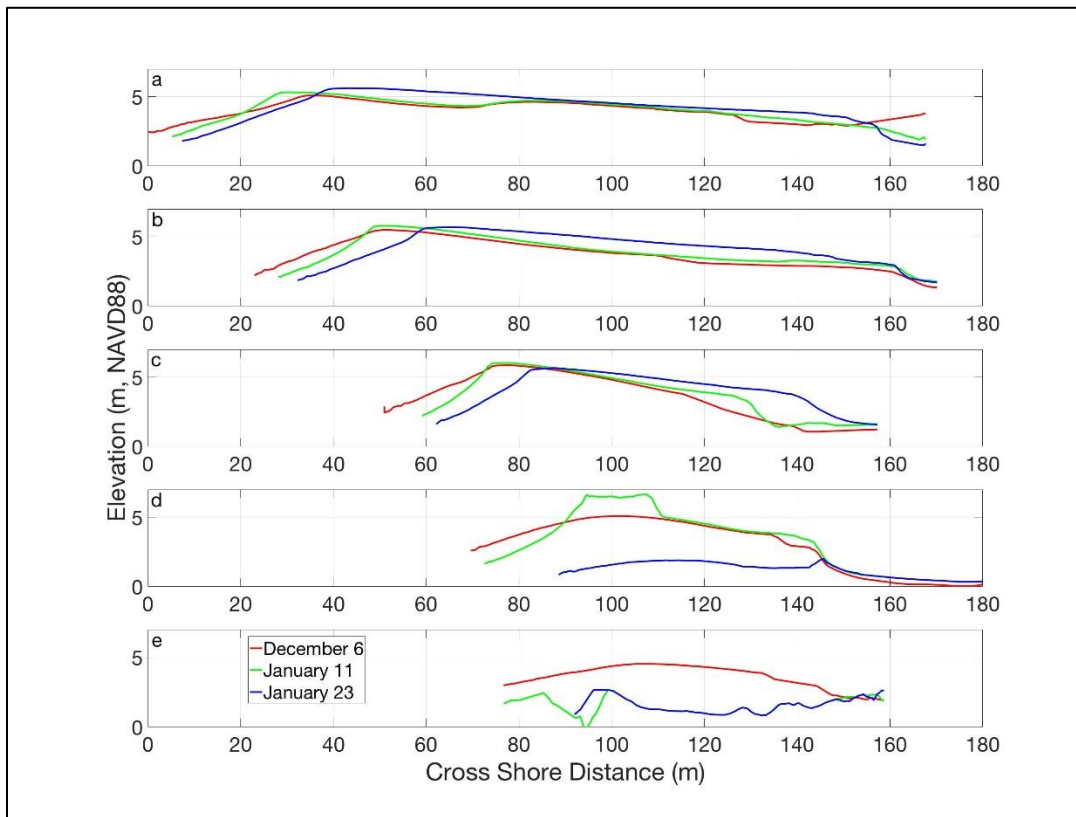
Figure 20. Cross shore elevation changes of the three DEMs.

The majority of influx of sediment in the system (14,000 m³) was found on the inshore slope of the beach and along the lagoon water edge where a steep sand berm formed from both the decrease in water elevation (>2 m) and deposition of sand over a period of a month (Figure 19 and 20). The pattern of the sediment transport onto the beach was consistent with that expected of a beach with a crest closer to the shoreline with steepening foreshore and mild to gentle sloping backshore (Jimenez, J., A.H.Sallenger, and L. Fauver 2007). From December throughout January, a steady increase in significant wave heights to a maximum of over 5 m on January 19 just prior to the final survey and cross-shore direction from 290 to 310 occurred. These wave conditions allowed for increased wave-induced sediment transport caused by beach overwashing, an established feature of Carmel River State Beach (Laudier et al. 2001; Scooler 2017), in which significant amounts of seaside shoreline is eroded into the surf zone, approximately 8500 m³ in this case, and then redeposited beyond the crest onto the backshore as the wave is unable to return back to sea but instead slowly flows down the backshore slope into the lagoon and rapid downslope flow depositing sediment into the back barrier watershed in the event of significant overflow (Baldock et al. 2007), approximately 13,700 m³ of sand on Carmel River State Beach.

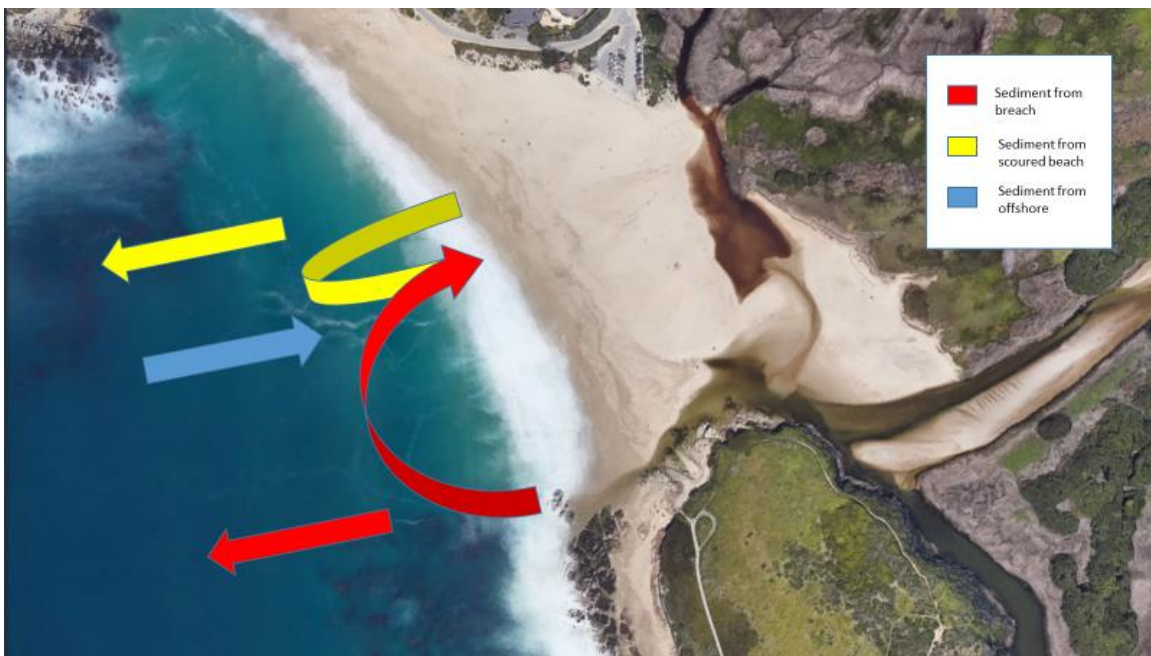
Figure 21. Scheme of sediment transport in the littoral system.

The difference in the amount of sediment eroded away from the beach versus the amount deposited can also be explained by a rapid outflow of sediment from the breach, net total of 7500 m³, that occurred on January 9 after the initial mechanical breach, and again on January 22 just prior to the final survey (Figure 11). Based on established littoral sediment transport processes, the sediment from the breach would have primarily moved into the surf zone for weak jets, or offshore if the jet from the river penetrated the surfzone and wave action was insufficient to contain the offshore flow (Hicks, D.M and Inman, D.L. 1987). Furthermore, because the surfzone is uncondusive to accurate elevation estimates from SfM (or walking surveys), that portion of the DEMs was removed, but scouring in that region may have also attributed to the total amount transported from the surf zone on the backshore (Figure 21).
