# **SYSTEMS APPROACH TO IMPROVED FACILITY ENERGY PERFORMANCE**

**ESTCP Project # EW-201150  
Energy and Water Projects**

**James P. Miller, P.E.  
U.S. Army ERDC-CERL**

**October 2017**

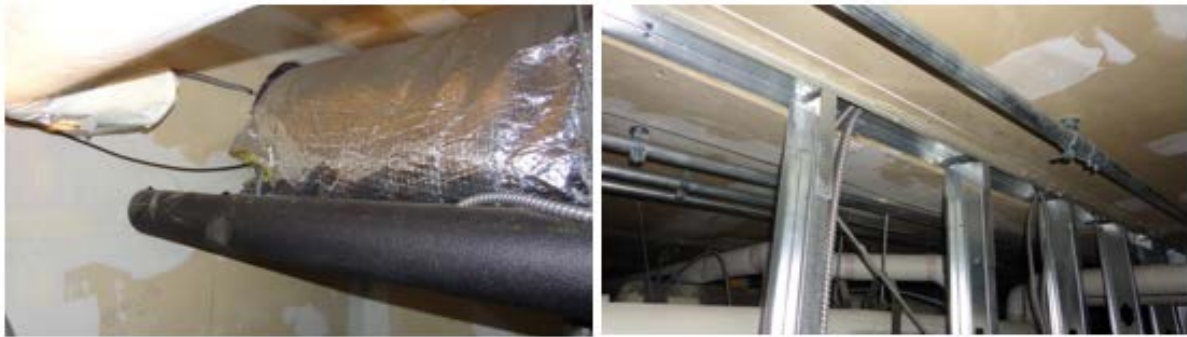
**Figure 3-1. Leakage sources at pipe penetrations and at framing systems.**

spray foam, gypsum board, and other materials. Figures 3-1 through 3-5 show examples of envelope sealing measures.

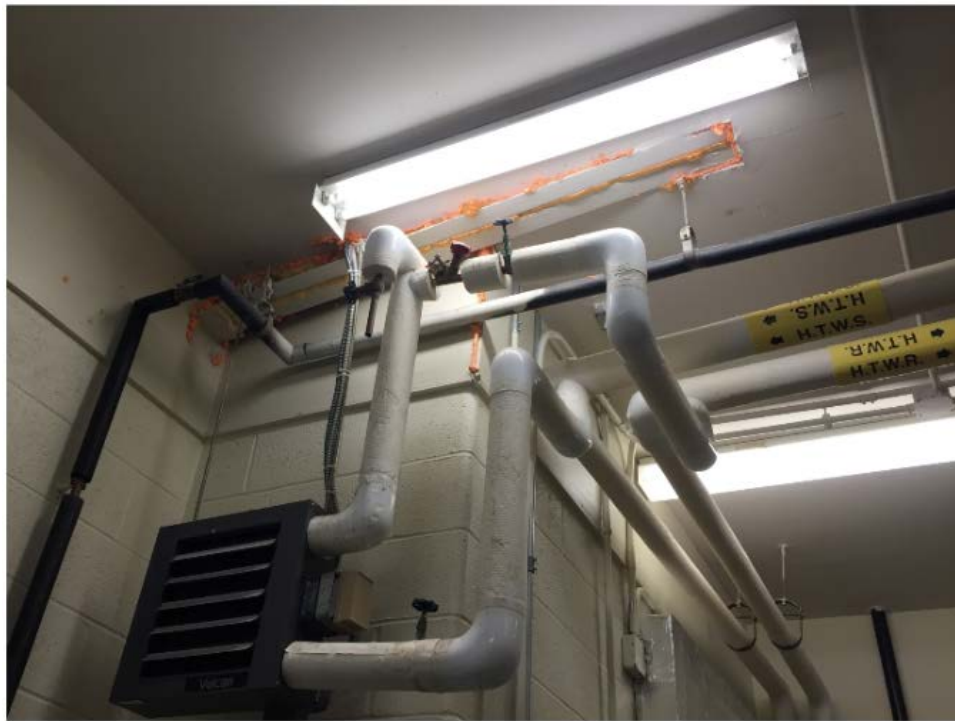
**Figure 3-2. Leaks sealed at pipe hangers in “heated-only” portion of Bldg 1540A.**

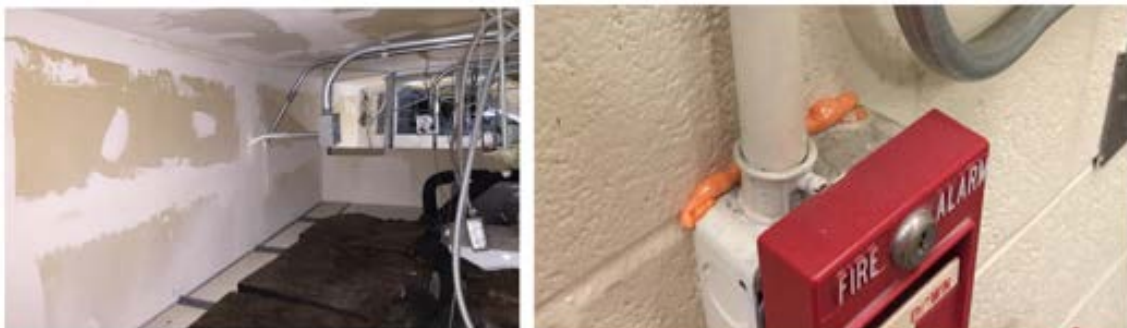
**Figure 3-3. Sealing of conduit penetrations in cavity space above the suspended ceiling of Bldg 1540A (left) and at the mounting location of a 4x4 conduit box (right).**

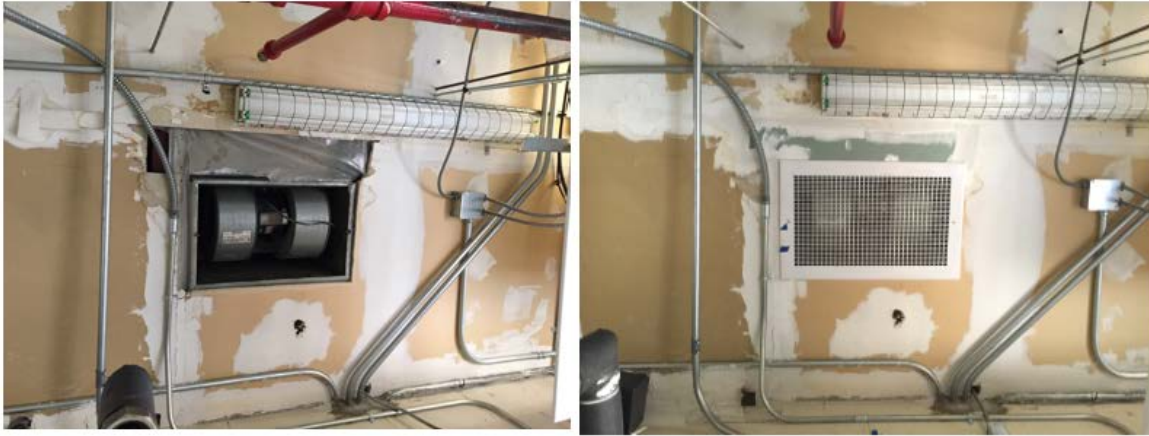
**Figure 3-4. Sealing of leaks around an exhaust fan in the mechanical room.**

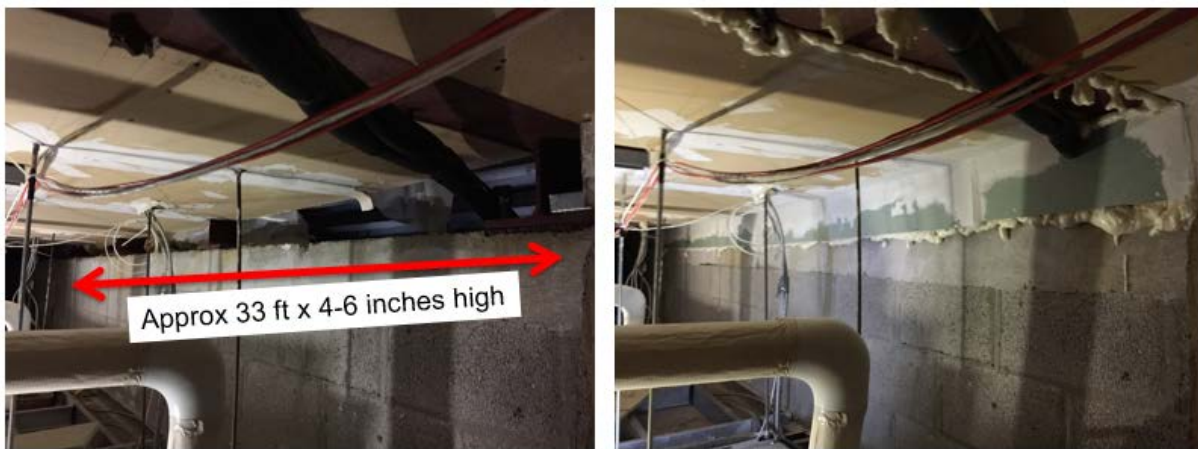
**Figure 3-5. Sealing of a major opening above the hard ceiling above the Men's Latrine.**

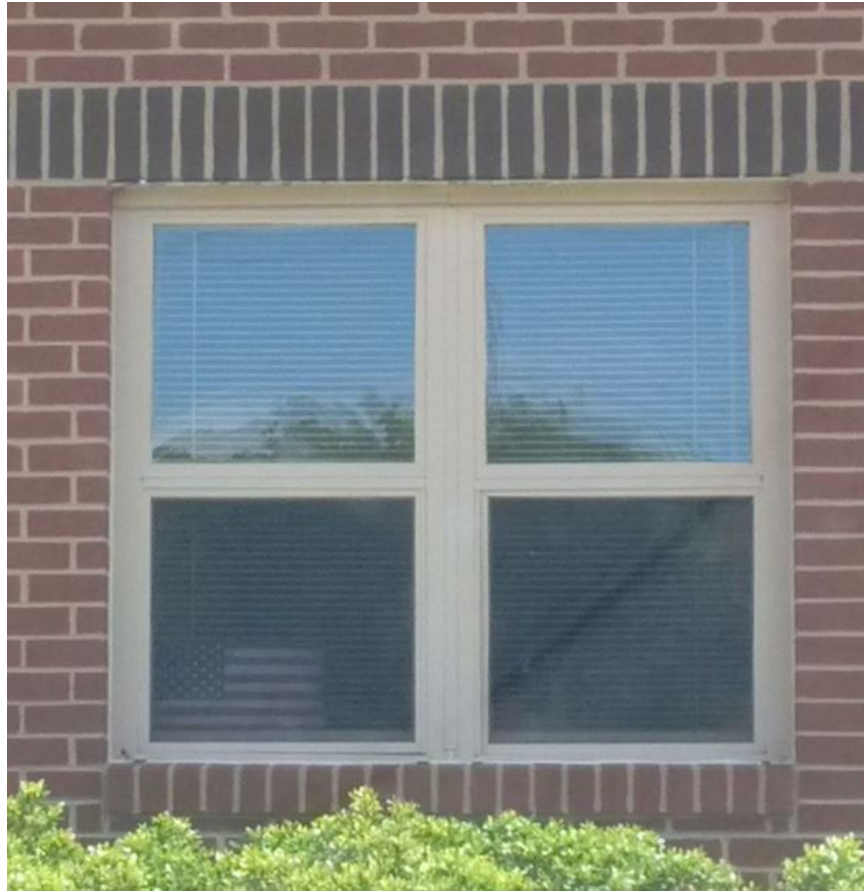
**Figure 3-6. Single hung window (4x4-ft) in Bldg 1540A (typical of 10).**

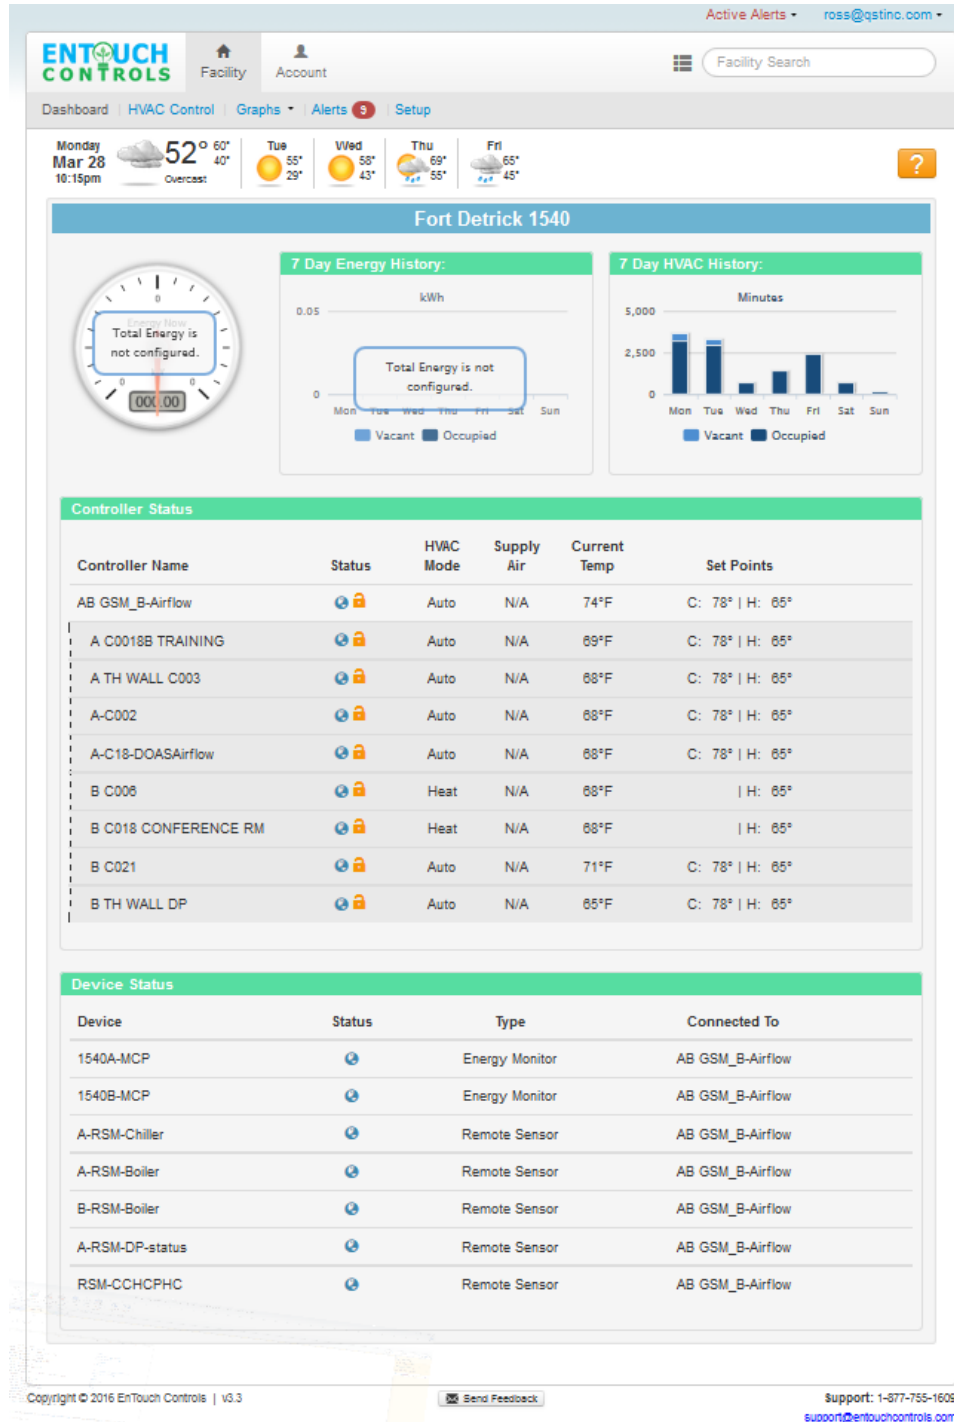
**Figure 4-4. Screen capture of the online EnTouch energy management system platform for Bldg 1540.**

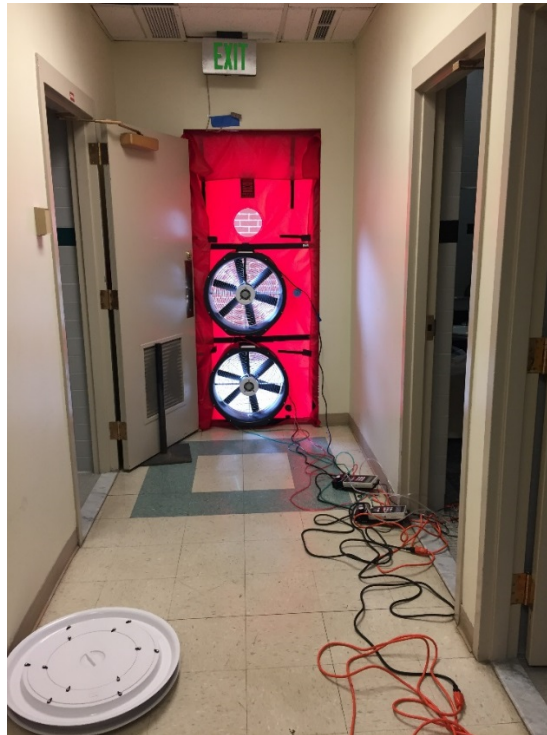
**Figure 5-1. Air barrier testing apparatus.**

- **Data Collection Equipment.** The air barrier testing apparatus (Figure 5-1) consisted of a calibrated blower door system that was installed in the doorway of the facility being tested. The system accurately measured the air being blown into/drawn out of the building while simultaneously measuring the pressure differential ( $\Delta P$ ) across the building envelope. By measuring a number of paired volume/ $\Delta P$  data points, it was possible to calculate the leakage rate per unit of envelope surface area at a reference differential pressure of 75 Pa. Small, inexpensive temperature and RH dataloggers (Figures 5-2 to 5-4) were easily deployed where needed. Existing utility gas and electric meters (Figures 5-5 and 5-6) were used to measure energy consumption.

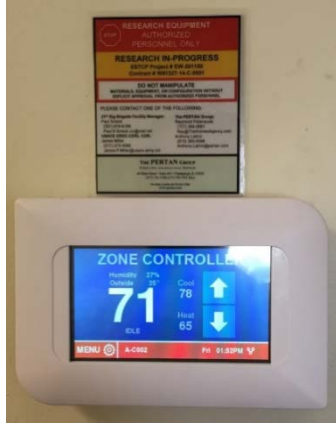
**Figure 5-2. Typical EnTouch EMS zone thermostat and temperature/humidity logger.**

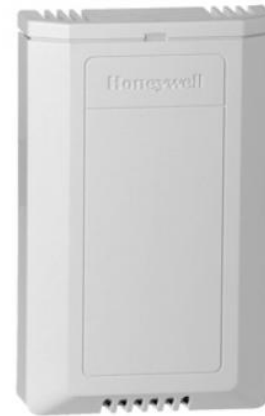
**Figure 5-3. Typical temperature and RH dataloggers.**

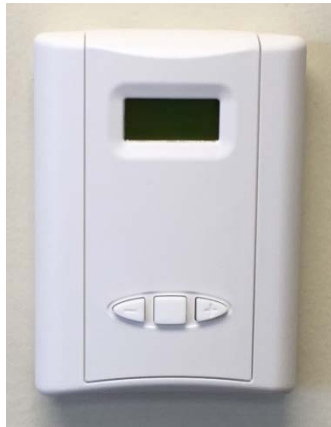
**Figure 5-4. Typical room thermostat and RH sensor.**

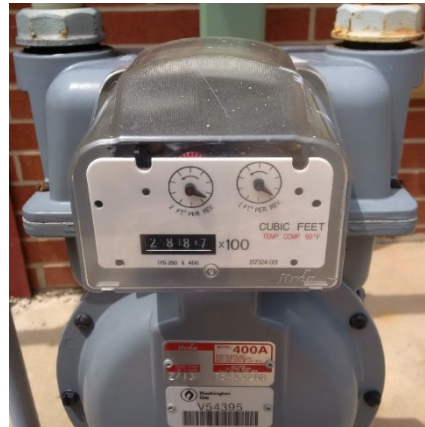
**Figure 5-5. Existing utility gas meter for Bldg 1540A.**

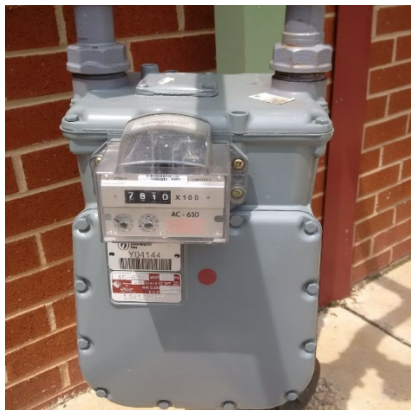
**Figure 5-6. Existing utility gas meter for Bldg 1540B.**

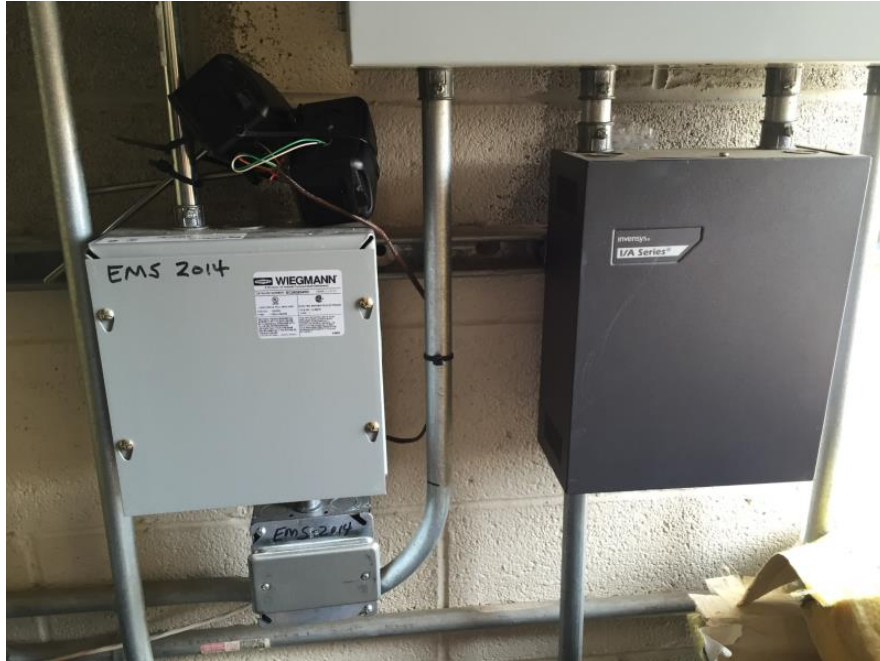
**Figure 5-13. EMS panel with monitoring devices installed.**

The installation of the project's EMS within Bldg 1540A began in Nov 2014 and was substantially completed by Jan 2015. Figures 5-13 to 5-17 show some components of the installed EMS system.

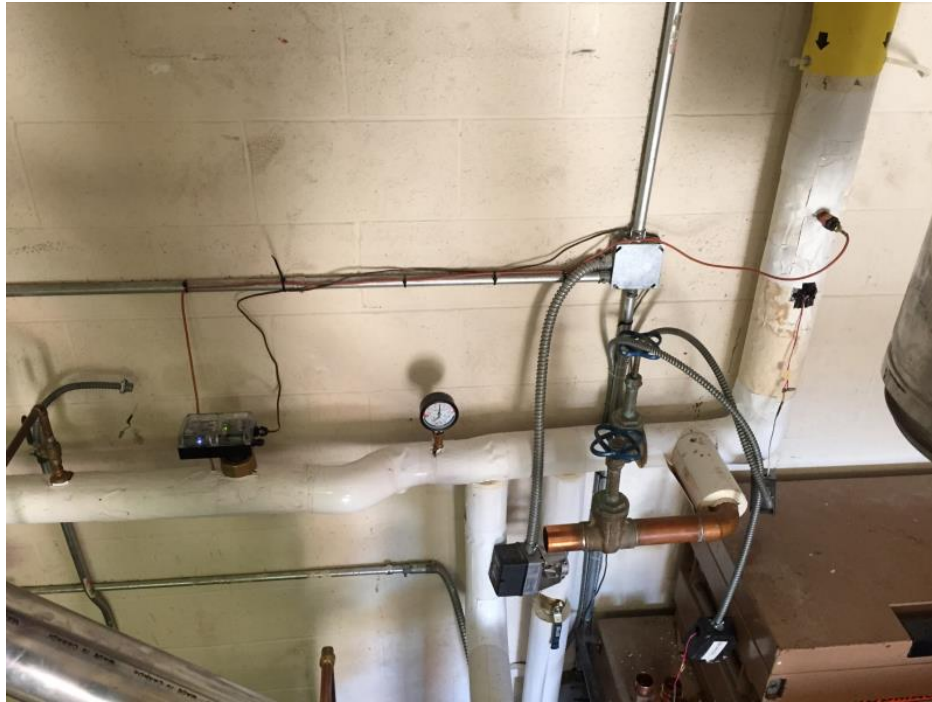
**Figure 5-15. Boiler BTU Meter as installed.**

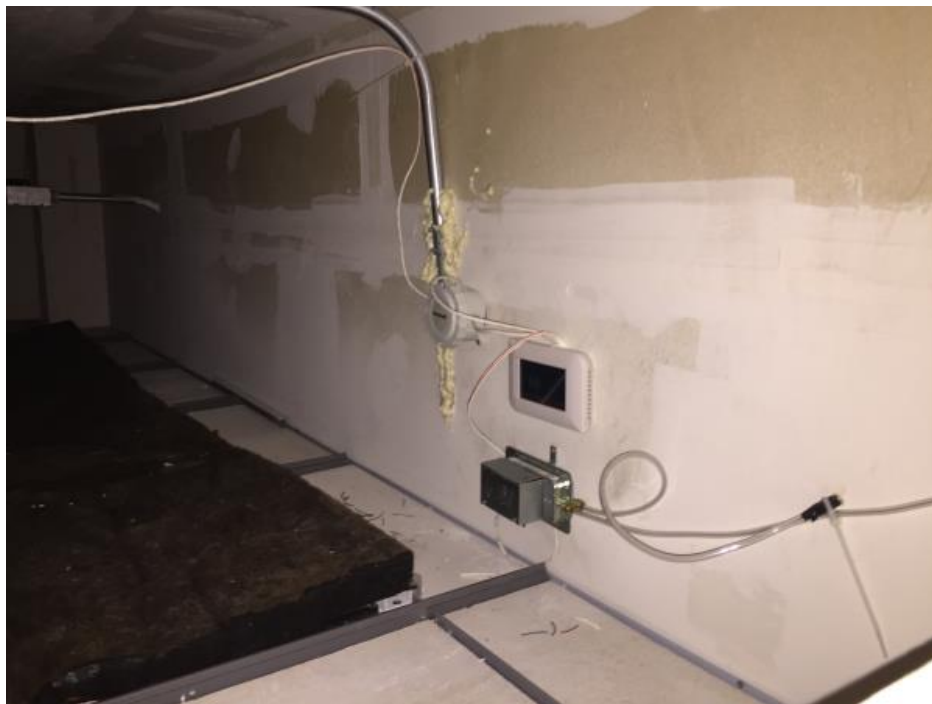
**Figure 5-16. Building envelope DP sensor and wall temperature/RH sensors installed above office C003.**

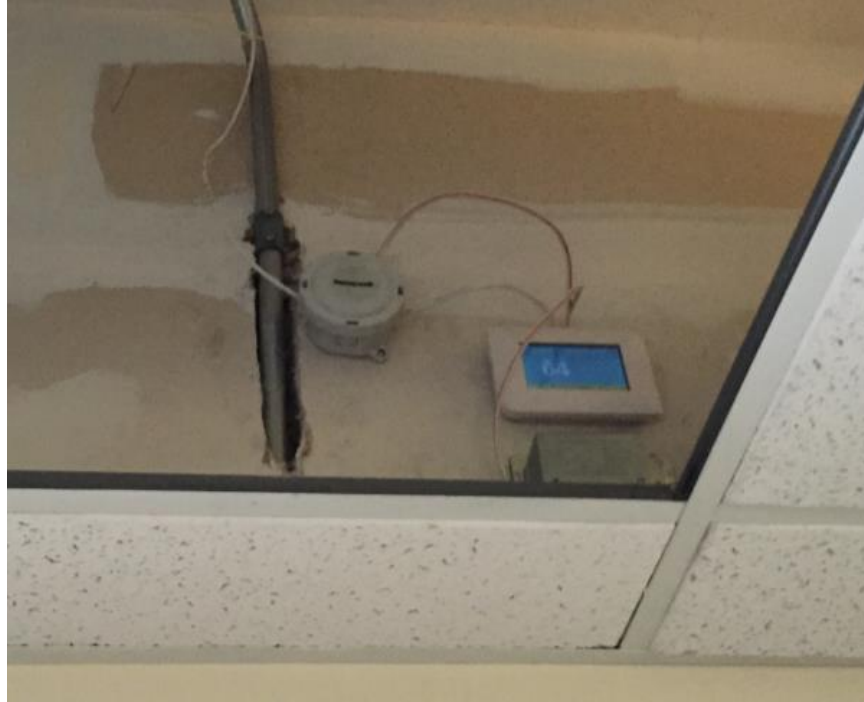
**Figure 5-17. Building Envelope DP Sensor (high side inside room, low side outside building) and Wall temperature/RH sensor installed above office C003.**

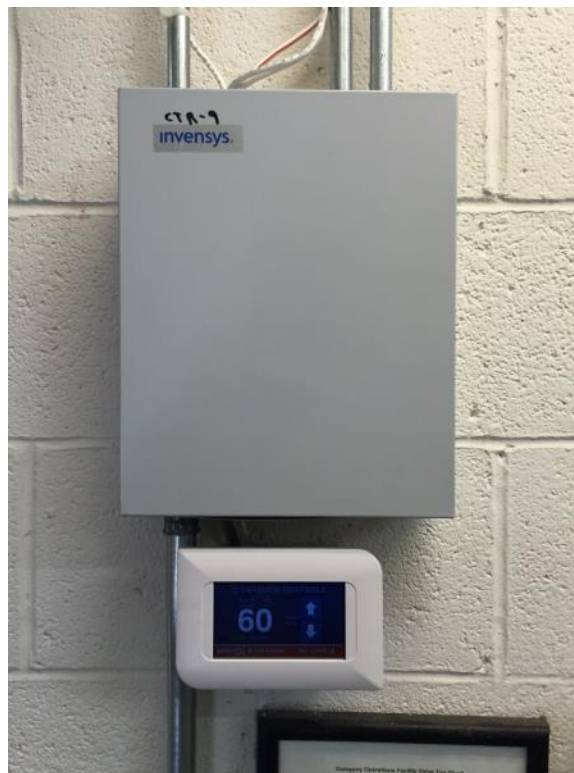
**Figure 5-18. EMS master monitoring device with Global System for Mobile Communications (GSM) communication device.**

The installation of the project's EMS within Bldg 1540B began Nov 2014, and was substantially completed by Jan 2015. Figures 5-18 to 5-24 show some components of the EMS installation.

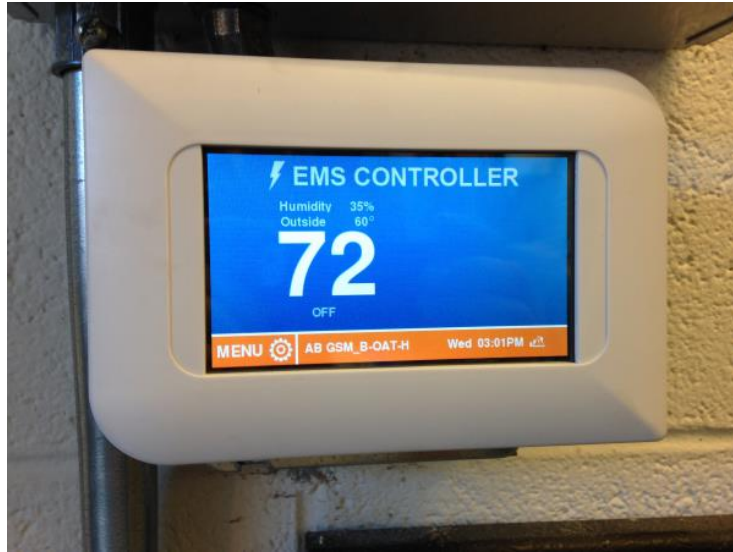
**Figure 5-19. EMS Controller.**

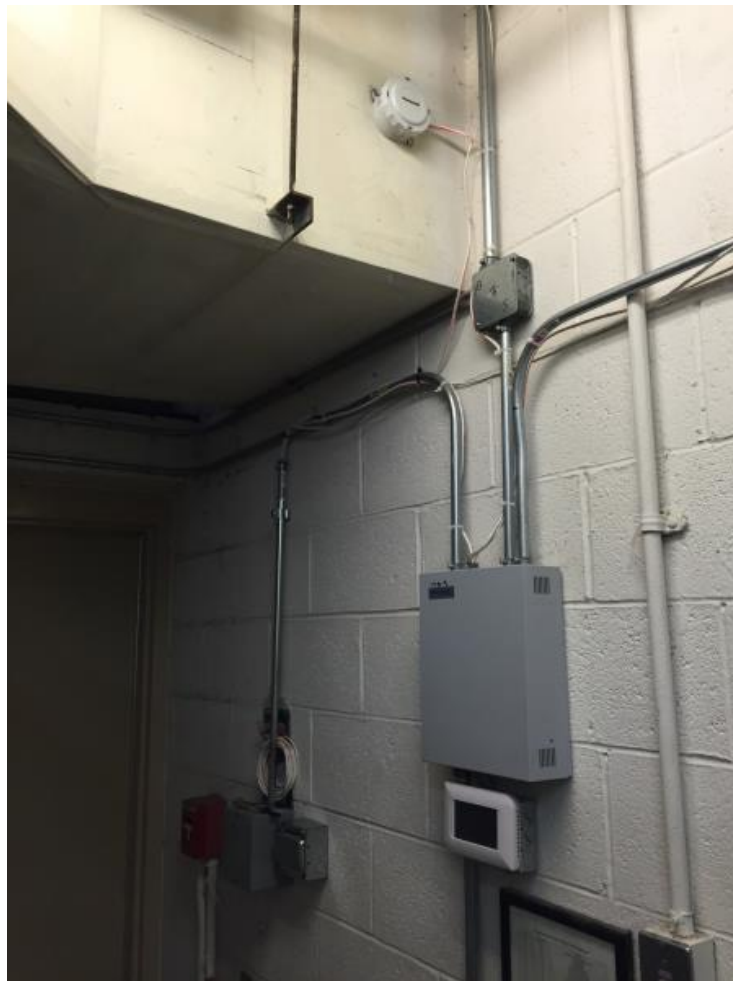
**Figure 5-20. EMS installation within Bldg 1540B Mechanical Room, showing EMS controller and outside air (OA) temperature sensor.**

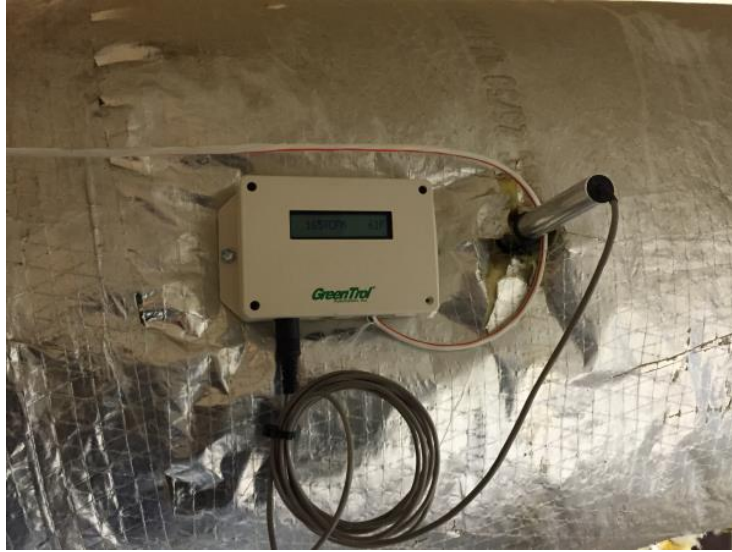
**Figure 5-21. Air flow sensor located in AHU-4 supply air.**

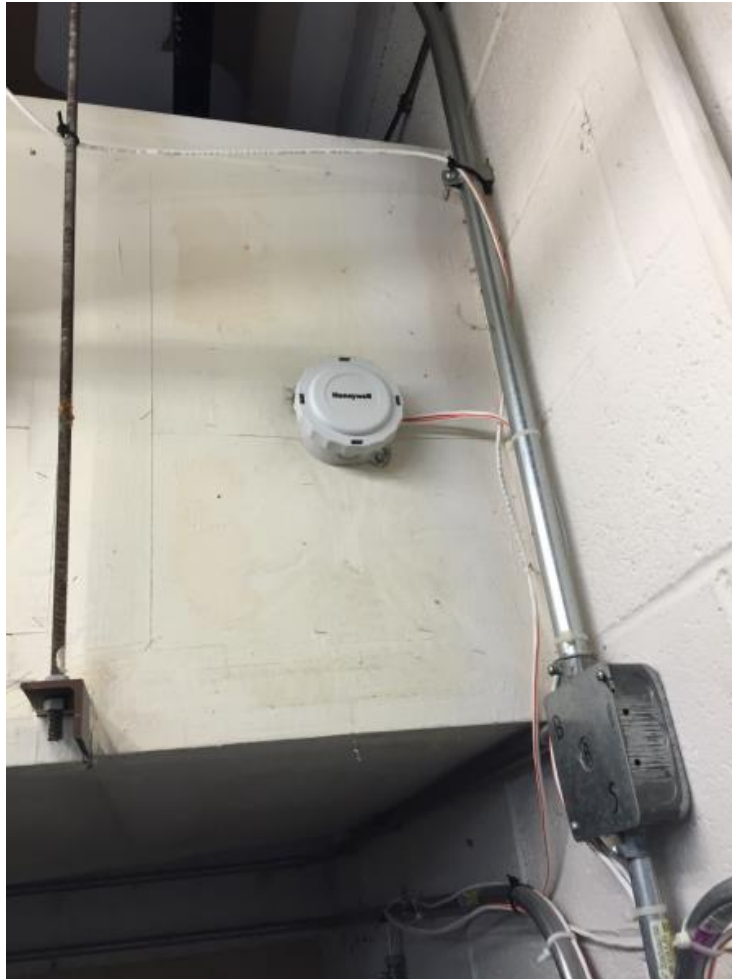
**Figure 5-22. Outside air temperature sensor.**

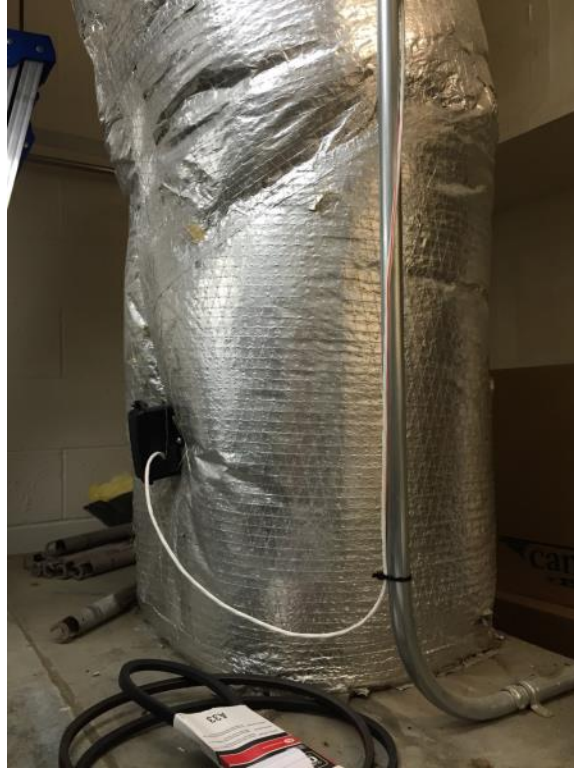
**Figure 5-23. Supply air temperature AHU-4 duct sensor.**
