## **Building Envelope Assessment Using Thermal Infrared and Lidar Scanning**

Palmer Station, Antarctica

Final Report

Under Engineering for Polar Operations, Logistics, and Research (EPOLAR)  
EP-ANT-15-31, "Building Envelope Assessment Using Thermal Infrared and  
Lidar Scanning"

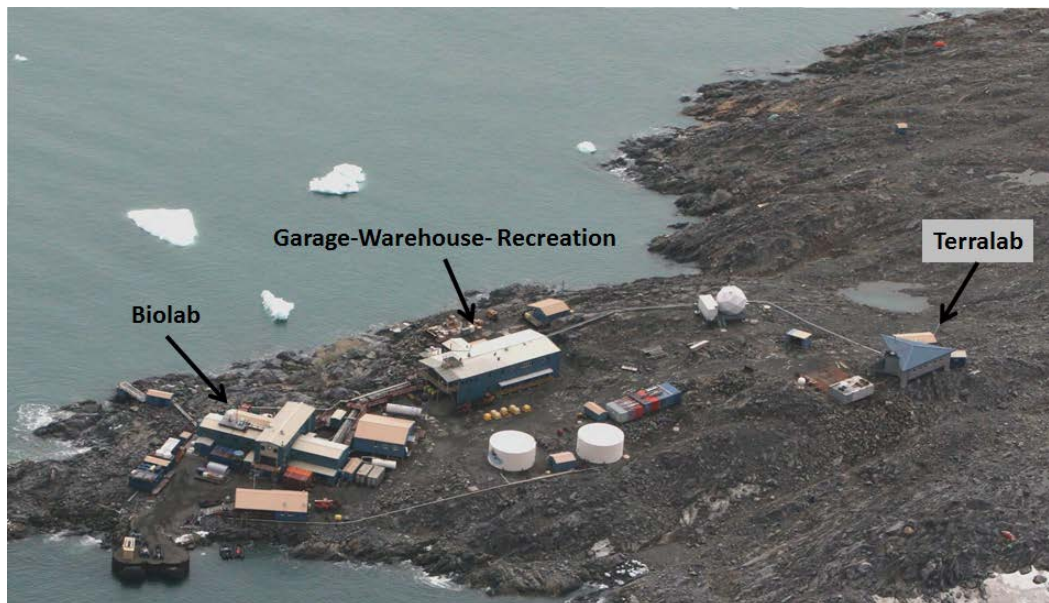
Figure 1. Site layout for Palmer Station, Antarctica, with the three surveyed buildings (Biolab, Garage-Warehouse-Recreation, and Terralab) identified. Photo provided by the National Science Foundation.

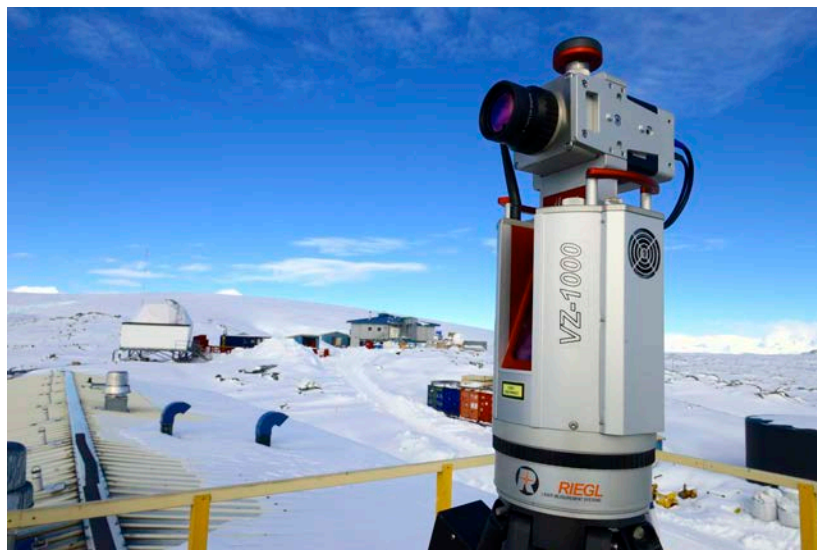
Figure 2. CRREL's lidar/TIR system in use on the GWR rooftop platform, October 2015. The InfraTec VarioCAM HD camera is mounted to a Riegl VZ-1000 terrestrial laser scanner.

The lidar sensor is a Riegl VZ-1000 terrestrial laser scanner (TLS). This is a full-waveform sensor capable of capturing multiple returns per laser pulse. In addition to collecting lidar data, the scanner also provided the mounting platform and power for operating the TIR sensor. It uses a 1550 nm eye-safe pulsed laser to measure range and surface reflectance values over a 360° horizontal by 100° vertical field of view. The scanner is capable of measuring at ranges up to 1400 m, has a maximum pulse rate of 300 kHz, and has an accuracy/precision of 8 mm/5 mm. Additional information about the VZ-1000 terrestrial scanner may be found at <http://www.riegl.com/>.

The TIR sensor used is an InfraTec VarioCAM HD 880 sensor. The sensor uses an uncooled microbolometer focal-plane array, has a spectral range of 7.5–14  $\mu\text{m}$ , and outputs a 1024  $\times$  768 pixel image. The sensor has a measurement range of  $-40^{\circ}\text{C}$  to  $1200^{\circ}\text{C}$ , a measurement accuracy of  $\pm 1.5\%$  when surface temperatures are below  $0^{\circ}\text{C}$ , and a thermal resolution better than 0.05 K at  $30^{\circ}\text{C}$ . This sensor was well within its operating range of  $-25^{\circ}\text{C}$  to  $50^{\circ}\text{C}$  throughout the Palmer Station Survey with observed air temperatures ranging from  $-5.1^{\circ}\text{C}$  to  $24^{\circ}\text{C}$ . A wide angle (field of view:  $60^{\circ} \times 47^{\circ}$ ) 15 mm lens was used to best match the field of view of the laser scanner. When mounted to the laser scanner, the camera is in portrait configuration with the  $60^{\circ}$  field-of-view edge of the image aligned vertically.

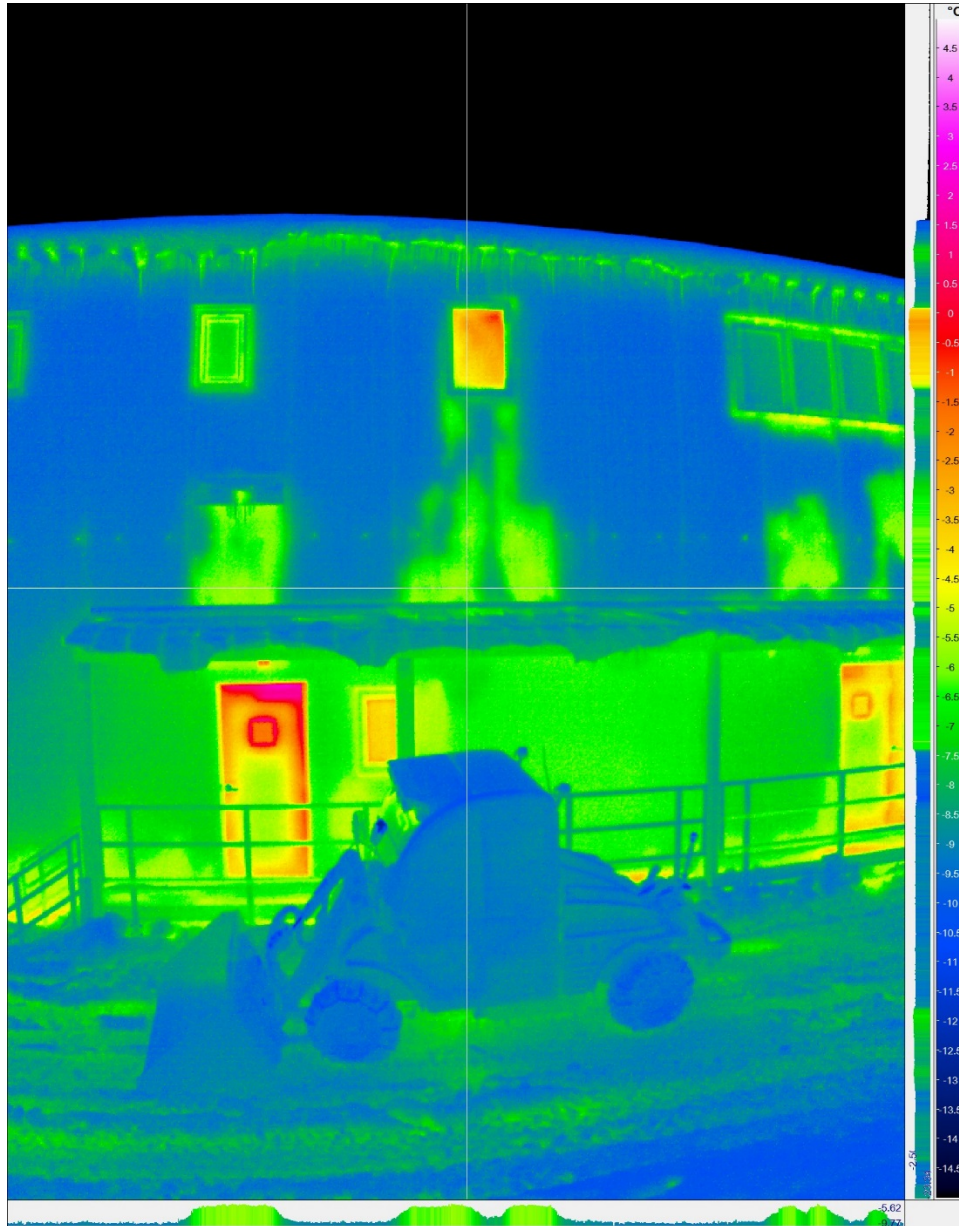
Figure 3. Sample TIR image captured by the VarioCAM sensor. The color scale is  $-15^{\circ}\text{C}$  to  $5^{\circ}\text{C}$ . Temperature profiles (vertical and horizontal) are displayed on the *bottom* and *right* of the image for the pixels intersecting with the cross hairs. The horizontal profile clearly captures insulation deficiencies below windows.

The TIR sensor outputs a proprietary-format image file for each image captured. This file type, .irb, is then ingested into InfraTec's IRBIS 3 software package for both analysis and processing. The image preserves scalar radiometric values for each pixel, which can be converted or displayed as temperature values in IRBIS 3 and assigned to each pixel and exported in a variety of file formats (Figure 3).

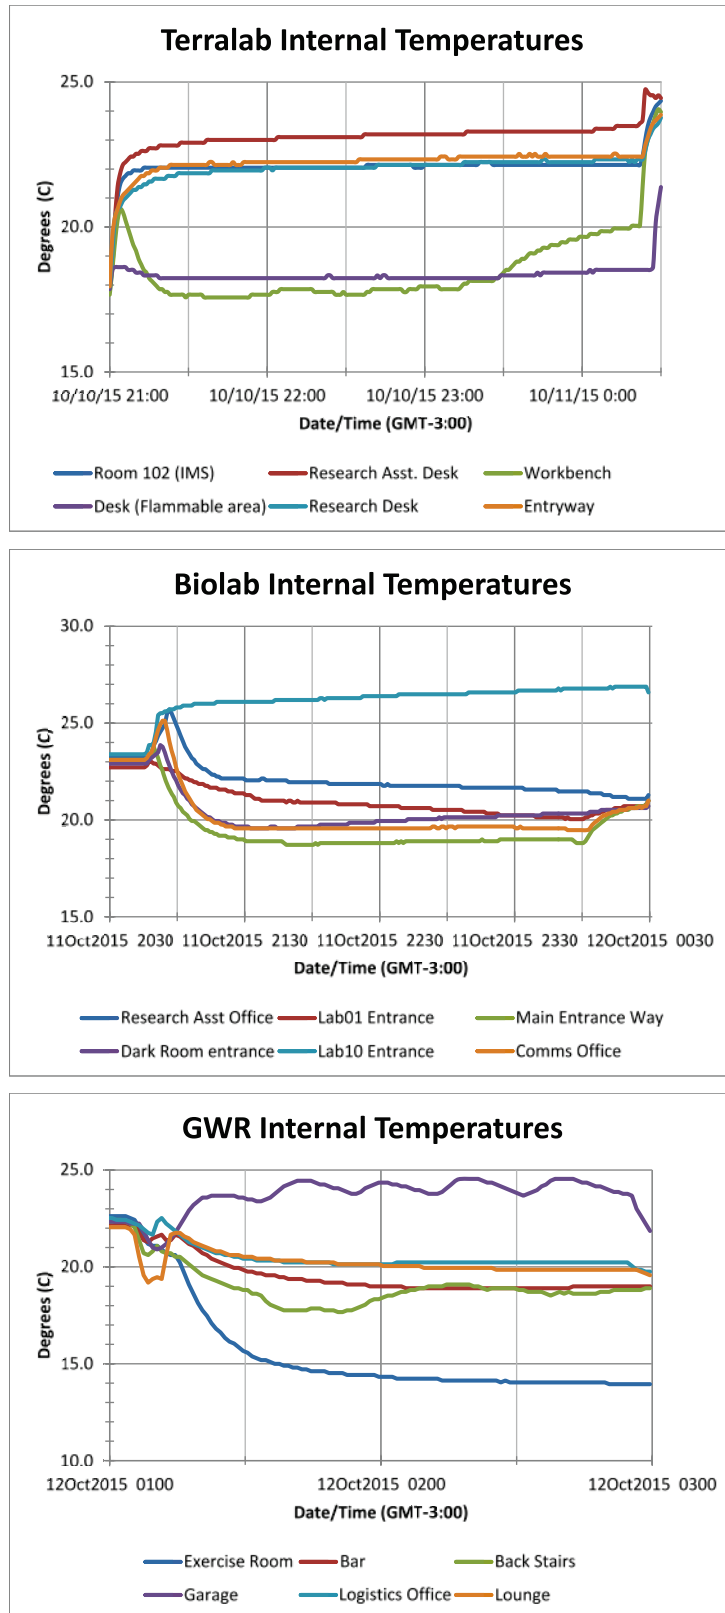
Figure 4. Internal building temperatures from various locations within each of the three buildings at the time of external lidar and thermal scanning.

The data loggers were deployed in each of the assessed buildings, and the time interval for data acquisition was set to 10 seconds to monitor any internal temperature fluctuations that occurred during the external lidar and thermal scanning. For each scanning period, Figure 4 shows the set of internal building temperatures for various locations throughout each of the three buildings (Terralab, Biolab, and GWR). Temperature fluctuations at the beginning of the record are due to establishing equilibrium once data loggers were in place, and fluctuations at the end of the record are a result of the data loggers being retrieved from their stationary locations. Fluctuations throughout the record may be a result of heating systems cycling on/off, drafty conditions, or external doors opening and closing near the data loggers.

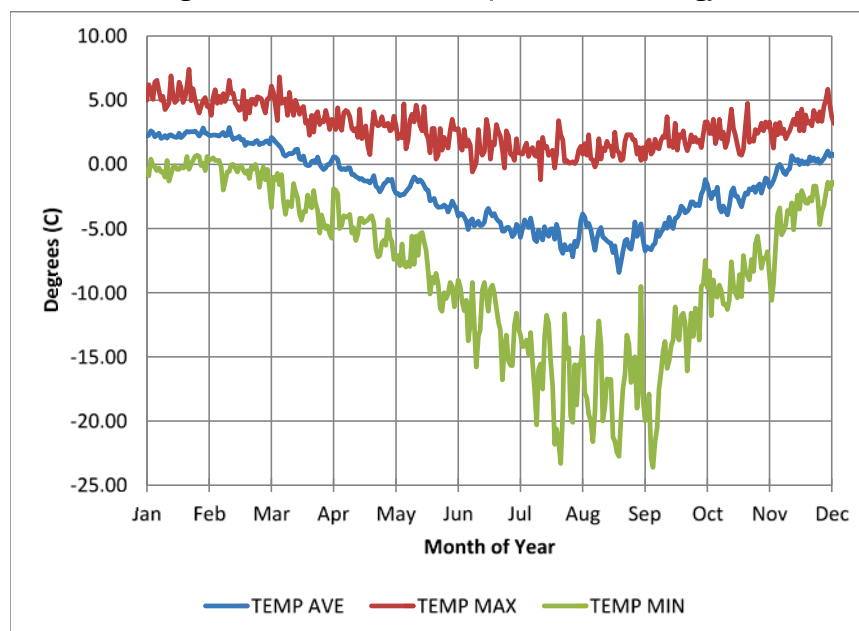
Figure 5. Palmer Station temperature climatology.

Figure 5 includes the historical temperature time series processed into a daily climatology of minimum, maximum, and average temperature over the period of record (1986 to 2016). In general, for the month of October, temperatures do increase; however, the average daily temperatures are typically below freezing (approximately  $-2.5^{\circ}\text{C}$ ). Table 1 highlights the lidar and thermal scan times for the three Palmer Station buildings, and Figure 6 shows the historical daily temperatures along with the actual daily temperature from the climate station during deployment. For the purpose of this assessment and through a general comparison of the internal and external temperatures (Figures 4 and 5, respectively), there is a significant temperature gradient (greater than  $15^{\circ}\text{C}$ ) between the indoor and outdoor temperatures, allowing for a meaningful assessment of the thermal building envelope through the external lidar and thermal scanning activities.

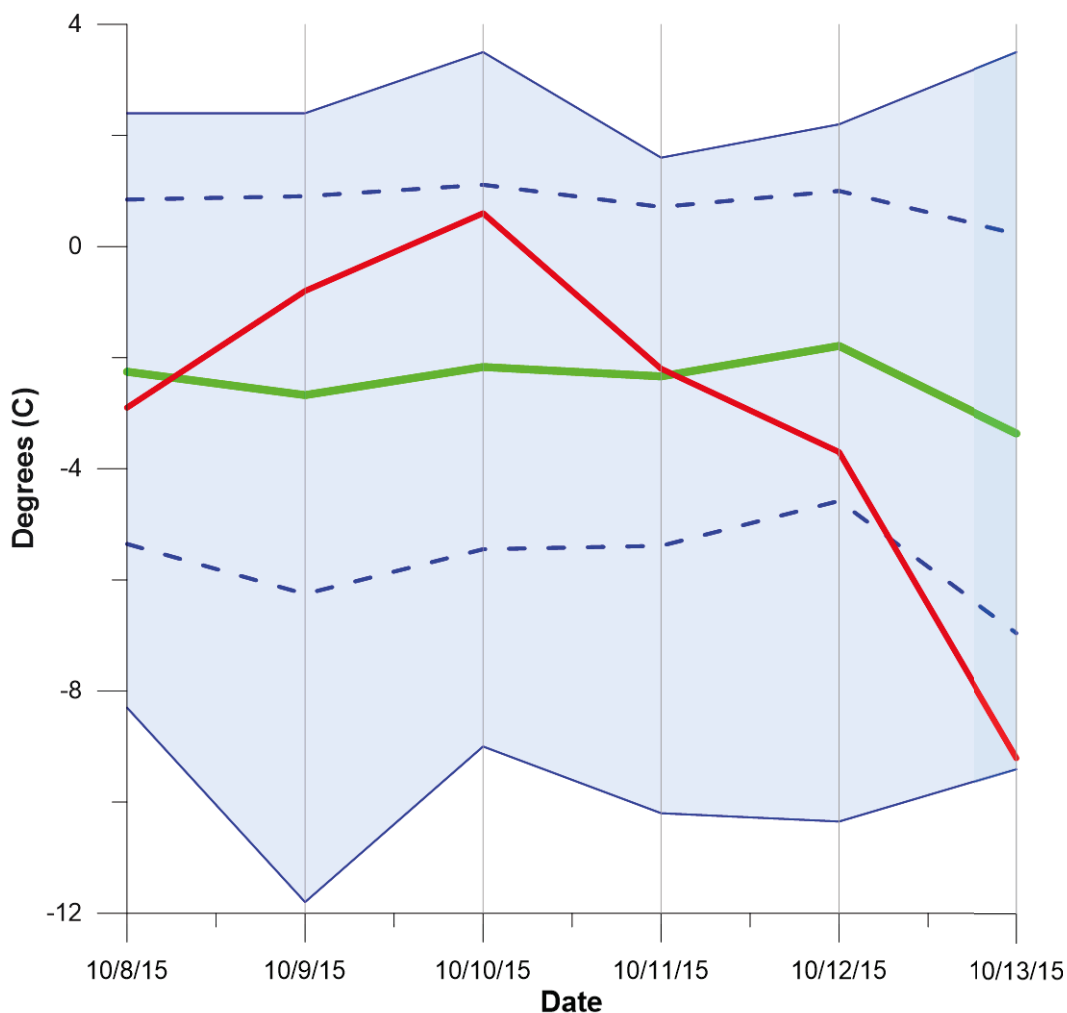
Figure 6. For the dates of deployment, Palmer Station daily temperature (*red*) and temperature climatology (*green* = historical mean; *solid blue* = historical minimum and maximum; *dashed blue* =  $\pm 1$  standard deviation from the mean).

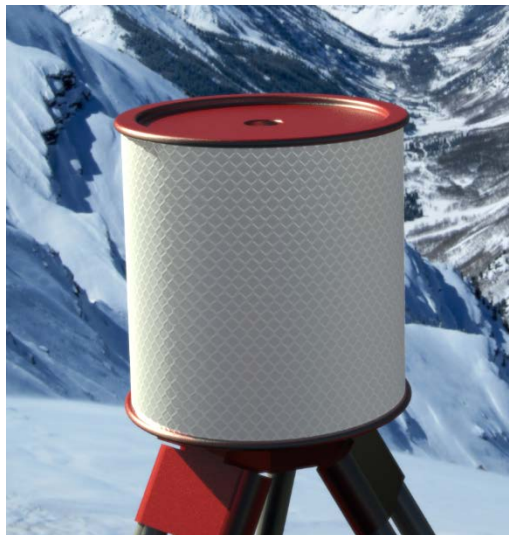
**Figure 7. Example image of a 10 cm reflector cylinder with a reflective tape face used in georeferencing lidar point clouds.**

Two RTK surveys were conducted at Palmer Station: the first on 10 October 2015 and the second on 12 October 2015. For each RTK survey, three 10 cm reflector cylinders were set up throughout the survey area (Figure 7). These reflectors were visible from multiple scan positions. The reflector has a reflective tape face 10 cm in height  $\times$  10 cm in diameter that is highly visible in the point cloud, allowing the precise shape and location of the cylinder to be recorded and identified. Each reflector was surveyed, and a height offset from the GNSS antenna was applied to measure the centroid of each reflector cylinder. Table 2 is a list of all recorded values from the two RTK surveys. Resulting measurements from both RTK surveys yielded an average horizontal precision of 0.005 m and vertical precision of 0.011 m.

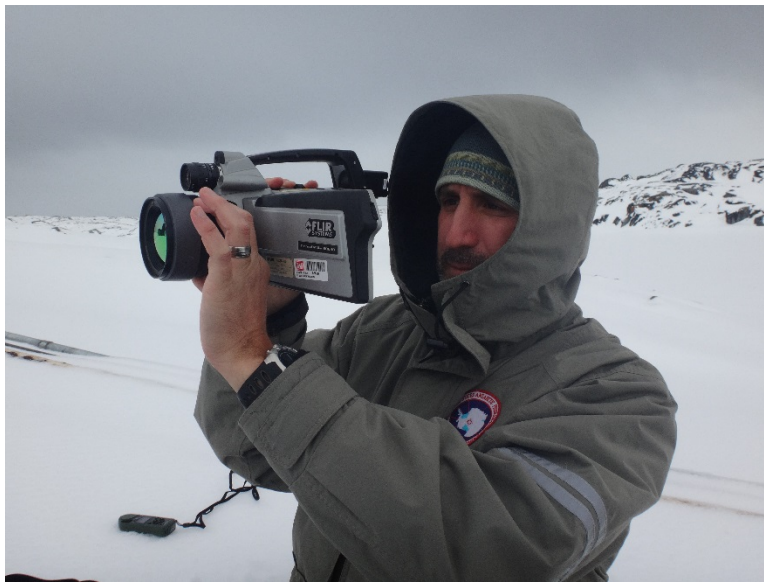
In addition to the lidar/TIR system, a FLIR SC640 handheld TIR camera was used for the collection of areas either not covered by the lidar/TIR system's field of view or areas that demanded higher detail. The SC640 has similar technical specifications to the VarioCAM HD 880 sensor, with the following main differences: spectral range of 7.5–13  $\mu\text{m}$ , 640  $\times$  480 pixel image, measurement range of  $-40^{\circ}\text{C}$  to  $1500^{\circ}\text{C}$ , measurement accuracy of  $\pm 2^{\circ}\text{C}$  or  $\pm 2\%$  of the reading, and operating temperature range of  $-15^{\circ}\text{C}$  to  $50^{\circ}\text{C}$ . Like the VarioCAM sensor, the SC640 fell within its operating temperature range while at Palmer Station. Figure 8 is an image of the SC640 in use at Palmer Station.

Figure 8. CRREL's Dr. Elias Deeb operating the FLIR SC640 during daytime for comparison to nighttime image collections.

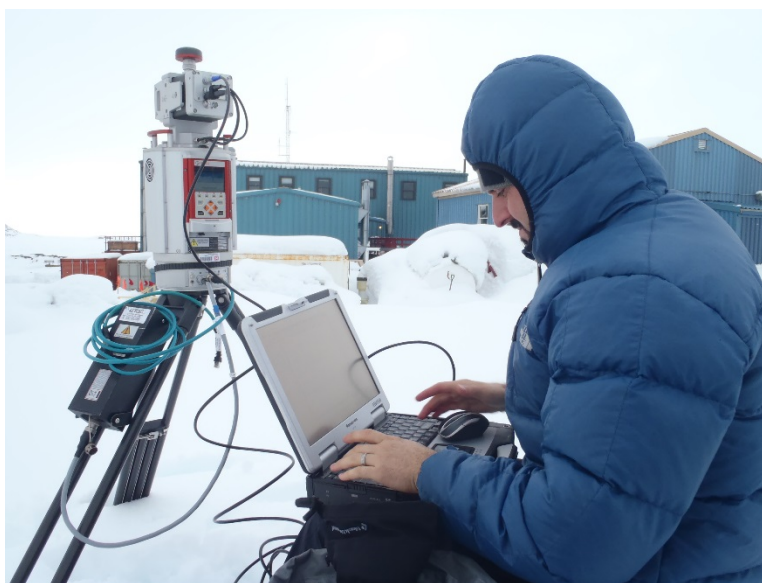
Lidar scans and TIR imagery were acquired from multiple system setups throughout Palmer Station. The combined lidar/TIR system is composed of the VZ-1000 laser scanner with the VarioCAM HD sensor mounted externally to the top of the scanner. An external battery pack supplied power to the scanner, which in turn provided power to the camera. Both sensors were controlled via Ethernet cable using a ruggedized PC (Figure 9). The system was attached to a survey tripod, which was set up temporarily at each scan position. For scan positions on deep, unconsolidated snowpack, sections of snow were cleared; and each tripod foot was driven into the snow manually. It is important to be aware of potential settlement of the

Figure 9. CRREL's Adam LeWinter collecting data at Palmer Station using the lidar/TIR System.

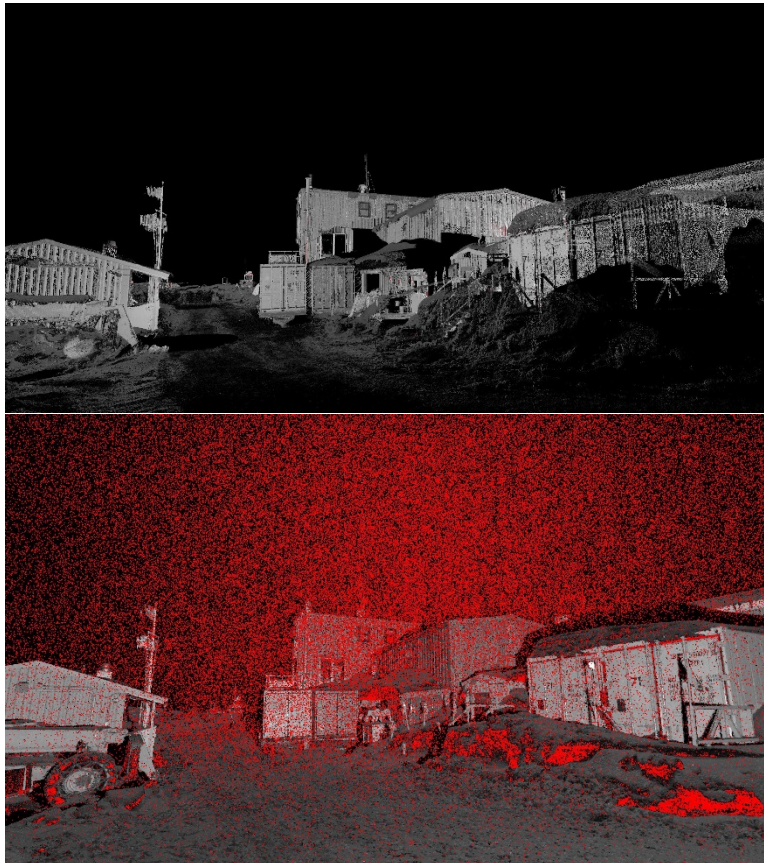
Figure 10. Comparison of lidar data collected without snow precipitation (*top*) and with significant falling and blowing snow, highlighted by reflectance, in *red* (*bottom*). While the lidar system is capable of measuring the building surface through snowfall, the building surface resolution is reduced, and the thermal values are skewed.

While the lidar scanner, which uses online-waveform processing to capture multiple returns per pulse, is capable of successfully capturing focus surfaces through snowfall, the TIR sensor does not perform well. Figure 10 provides a comparison between TIR images captured during both atmospheric conditions. Therefore, it was necessary to wait for optimal weather conditions devoid of snowfall and blowing snow. The first two surveys, conducted on 9 and 10 October 2015, were terminated early due to heavy blowing snow. A full survey of the Biolab was conducted on 10 October 2015 but was deemed suboptimal as it was conducted in full daylight. Optimal weather conditions occurred on 11 to 12 October 2015 where all exterior scans for Biolab and GWR (11 October 2015) and Terralab (12 October 2015) were collected under little to no precipitation during the night.

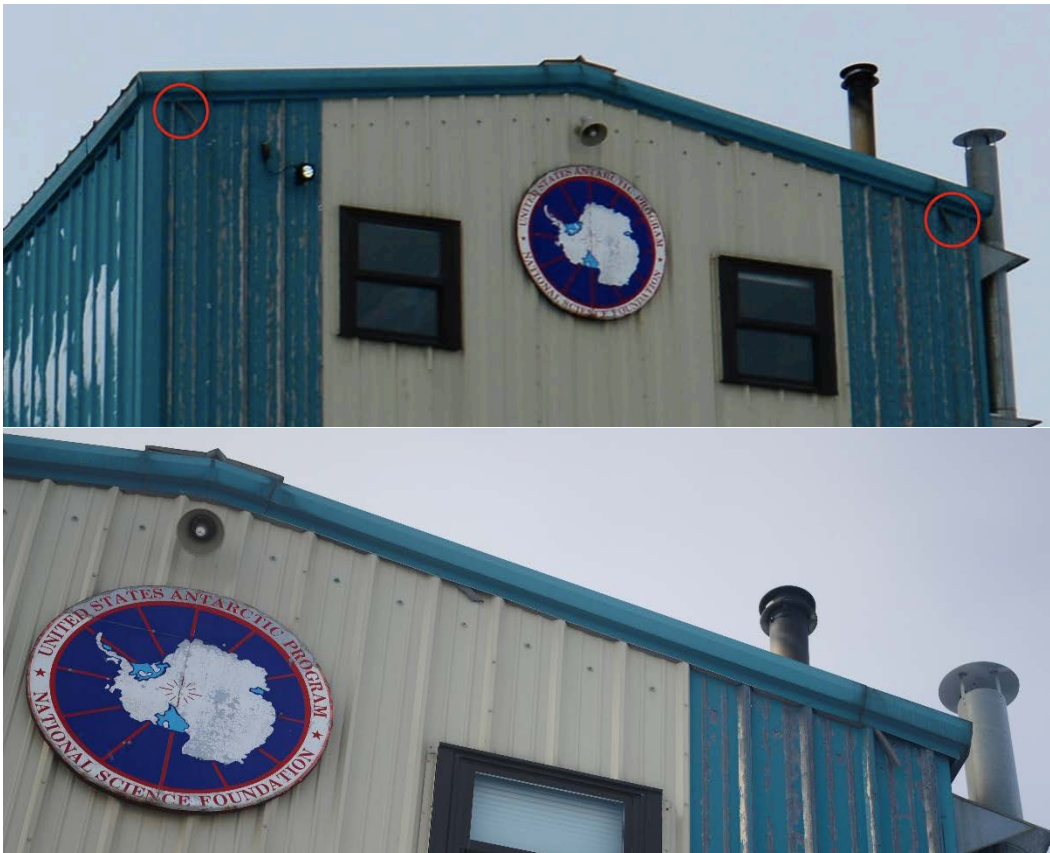
There were significant areas of temperature anomalies observed on the exterior of the Biolab. The roofline soffits, which had varying levels of gap-filling insulation material with large sections missing, displayed significant heat loss (Figure 11). Additionally, apparent degradation of insulation directly below windows indicates damage caused by leaking or insufficient insulation. This was observed in both the Biolab and GWR buildings. Unlike GWR, all windows in the Biolab appear to be of the same make and style throughout the building. As expected, doorways also displayed heat loss. Sections along the exterior surfaces adjacent to the ceiling/floor interfaces between floor levels displayed slight temperature differences, particularly along the southeast wall. Figures 12–15 provide a sample of observed deficiencies. These images are taken of the point cloud colored by temperature, with color scale bars provided.

Figure 11. Detail of damaged or unseated insulation along southwest roofline soffits on the Biolab. Multiple areas were completely devoid of this insulation material.

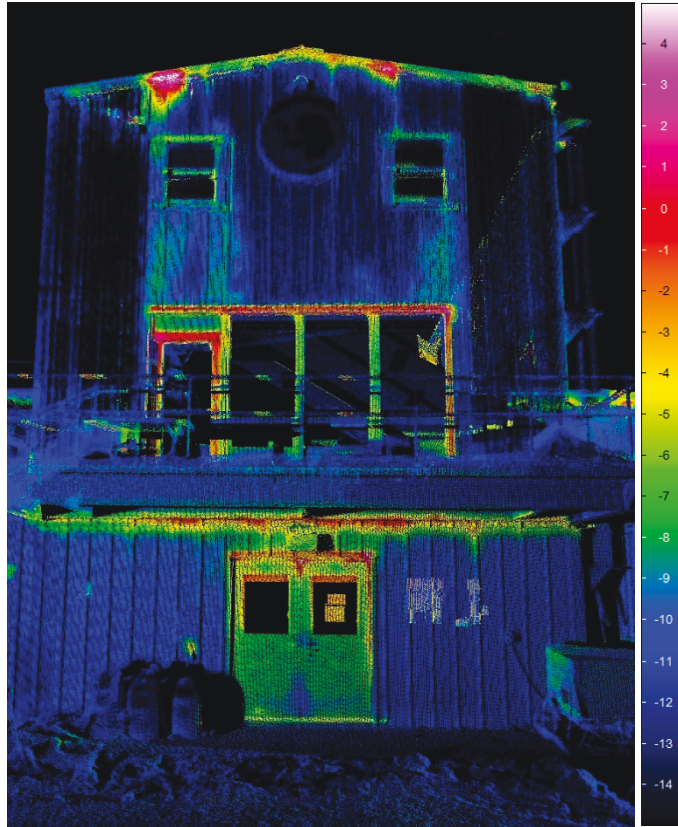
Figure 12. Southwest face of Biolab. Significant venting of heat was observed at the ground-level doorway, along the lower connection of the cafeteria deck, at the cafeteria deck exit, and along the roofline soffit. In addition, degradation of insulation is evident below the upper-level windows. Temperature scale:  $-15^{\circ}\text{C}$  to  $5^{\circ}\text{C}$ .

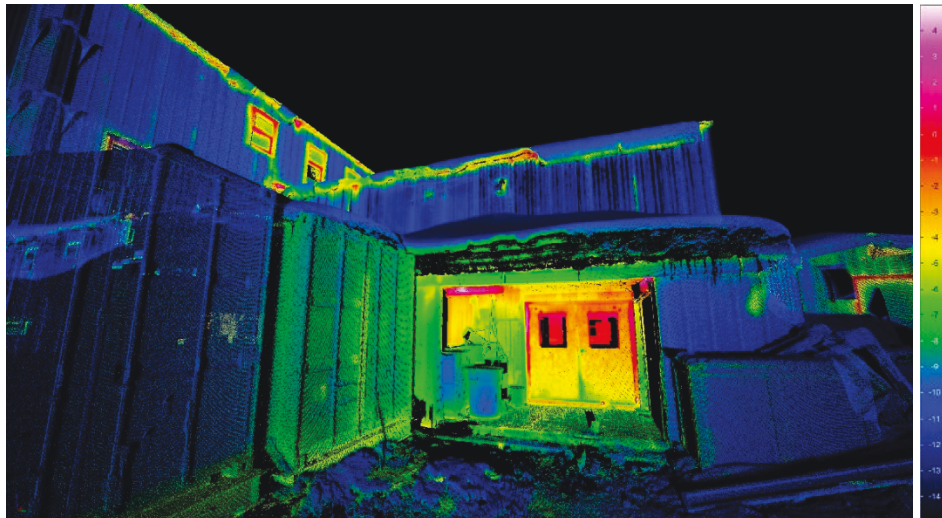
Figure 13. Ground-level entrance and vestibule on the south-southwest section of Biolab. Higher surface temperatures were measured at the entrance and within the vestibule. The second- and third-level soffits show heat loss. Some heat loss was observed along exterior metal sheeting overlaps. Temperature scale:  $-15^{\circ}\text{C}$  to  $5^{\circ}\text{C}$ .

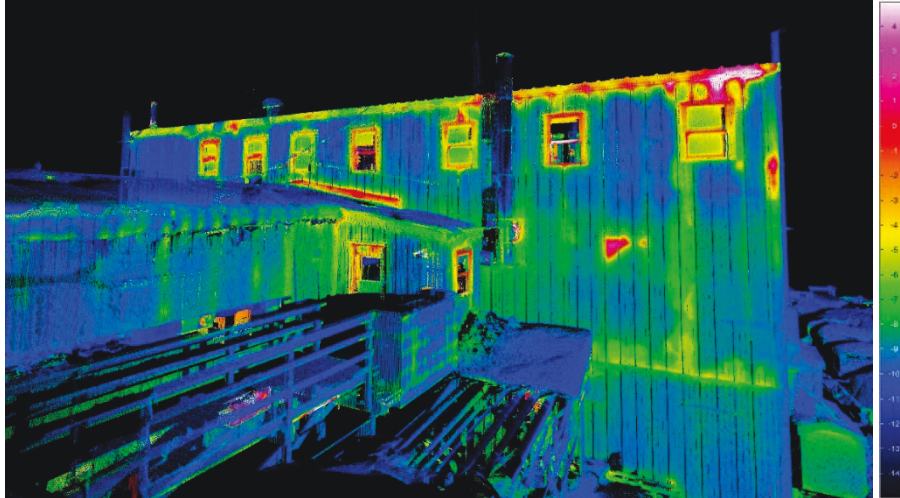
Figure 14. Southeast face of Biolab, including the walkway and entrance into the kitchen/cafeteria. Significant heat loss was observed along the top soffit with the highest temperature values measured on far right side of the image. Windows display varying levels of heat loss. There is degradation of insulation below the upper windows, possibly from water leaking. The ceiling level of the ground level/floor of second level has heat loss along the exterior. Temperature scale:  $-15^{\circ}\text{C}$  to  $5^{\circ}\text{C}$ .

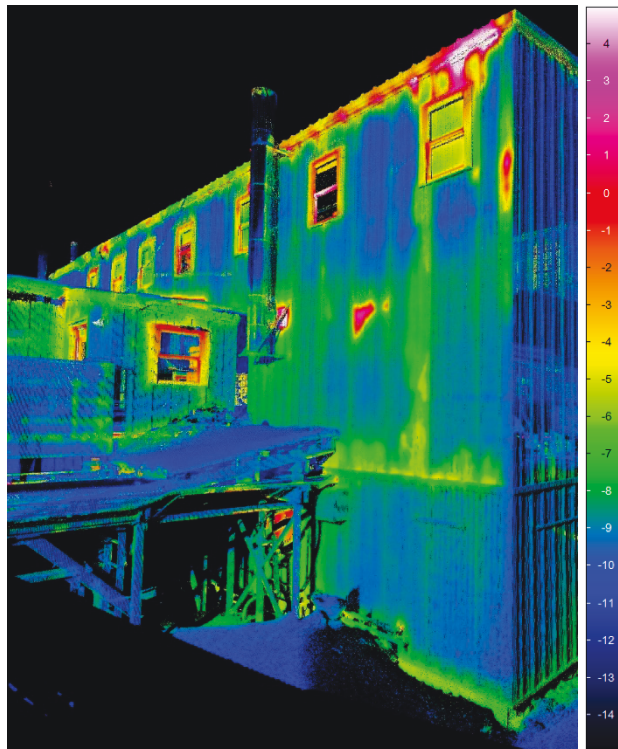
Figure 15. Southeast face of Biolab. The far right of the roofline shows significant heat loss along the roofline soffit. There is degradation of insulation below upper windows, possibly due to water leaking. The ceiling of the ground level and floor of the second level has heat loss along the exterior. A hot spot is visible to the right of the kitchen exhaust vent. Temperature scale:  $-15^{\circ}\text{C}$  to  $5^{\circ}\text{C}$ .

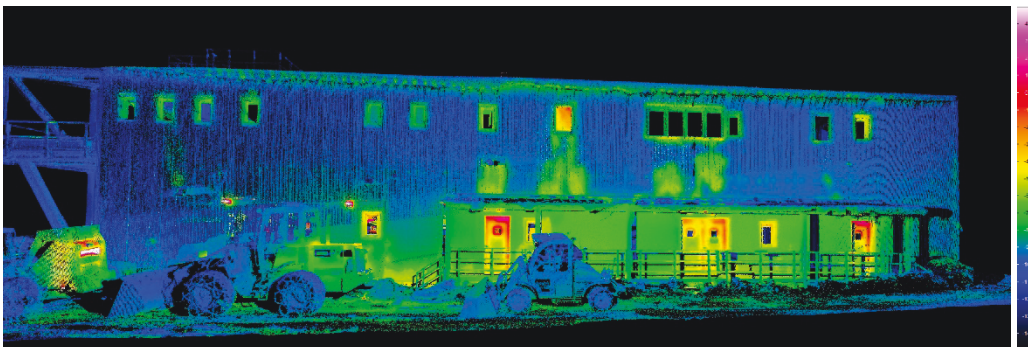
While there were sections of expected heat loss on the exterior of the GWR building (e.g., generator exhaust, garage doors, and doorways), significant heat loss was measured below many of the windows (Figures 16–19). Specifically, two window types were present: smaller black-trim windows in recessed frames and larger white-trim windows mounted essentially flush with the exterior metal panels. While the black-trim windows displayed little to no heat loss below their frames, all white-trim windows had large temperature anomalies. This appears visually in the temperature-colored point cloud as a “leak” below each window. This is likely due to either leaking then subsequent damage to insulation or insufficient seals between the window frame and exterior panels/insulation. Figure 20 also shows an example scan of the interior of the garage bay in the GWR building where an increasing temperature gradient is evident from the floor to the ceiling as well as areas of cold ingress and heat loss around the garage door and entry doorway.

Conversely, the seams between individual metal panels facing the exterior displayed very little heat loss, indicating quality construction and seal. This is apparent by the uniform surface temperatures along the exterior, not including the above-mentioned window leaks.

Figure 16. South face of GWR. There is significant degradation below white-trim windows (see Fig. 17 for the electro-optical image). Smaller, black-trim windows display no leaking of heat below the frames, indicating a better seal. Heat loss is observed along the roofline soffit, though not as large of a temperature difference compared to observations of the Biolab soffits. Lower portions of the building were obstructed by heavy equipment parked by the building, a necessity for charging and heating purposes. Temperature scale:  $-15^{\circ}\text{C}$  to  $5^{\circ}\text{C}$ .

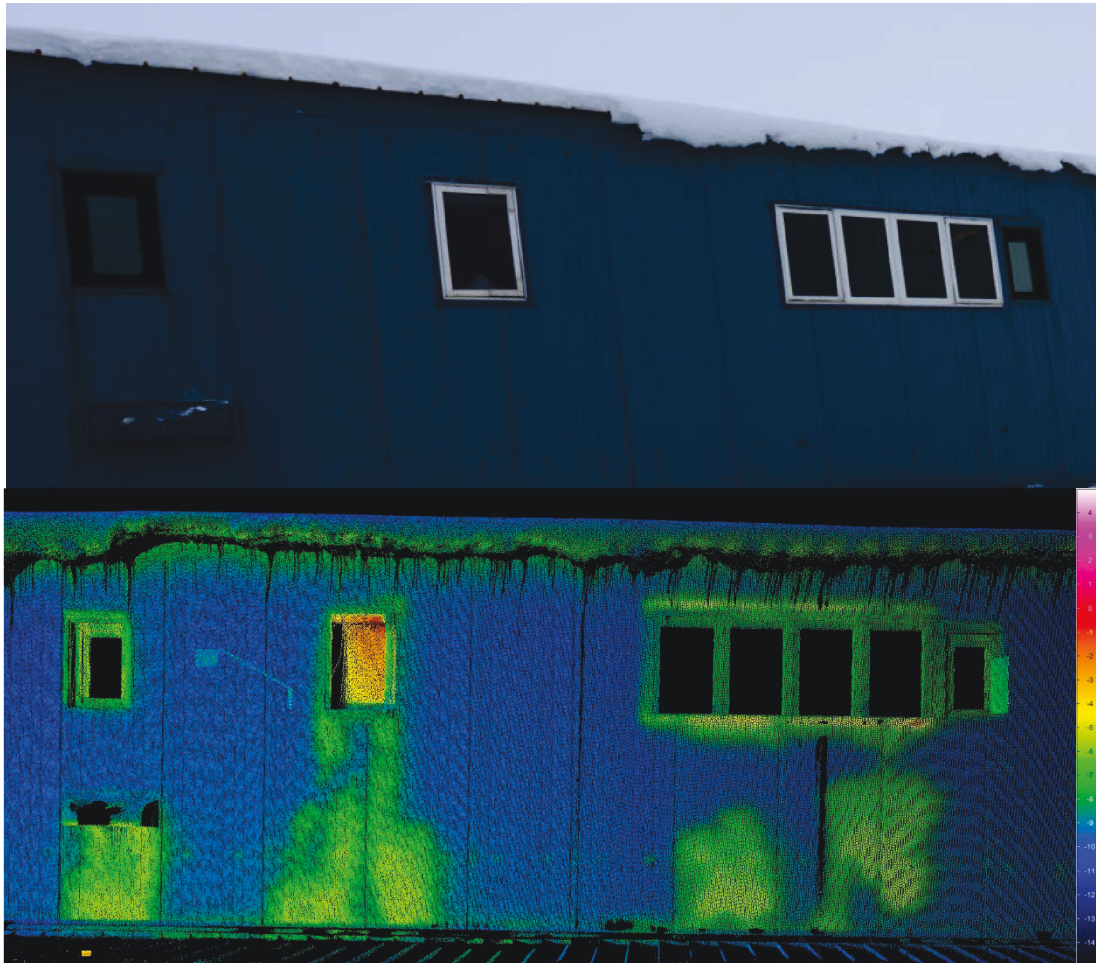
Figure 17. Detail images from the south face of GWR. The *top* image, captured with the handheld DSLR camera, demonstrates the two main types of windows in use in GWR: black-trim and white-trim. The white-trim windows clearly show significant heat loss below while no temperature differences were measured below the smaller black-trim windows. Temperature scale for the bottom image:  $-15^{\circ}\text{C}$  to  $5^{\circ}\text{C}$ .

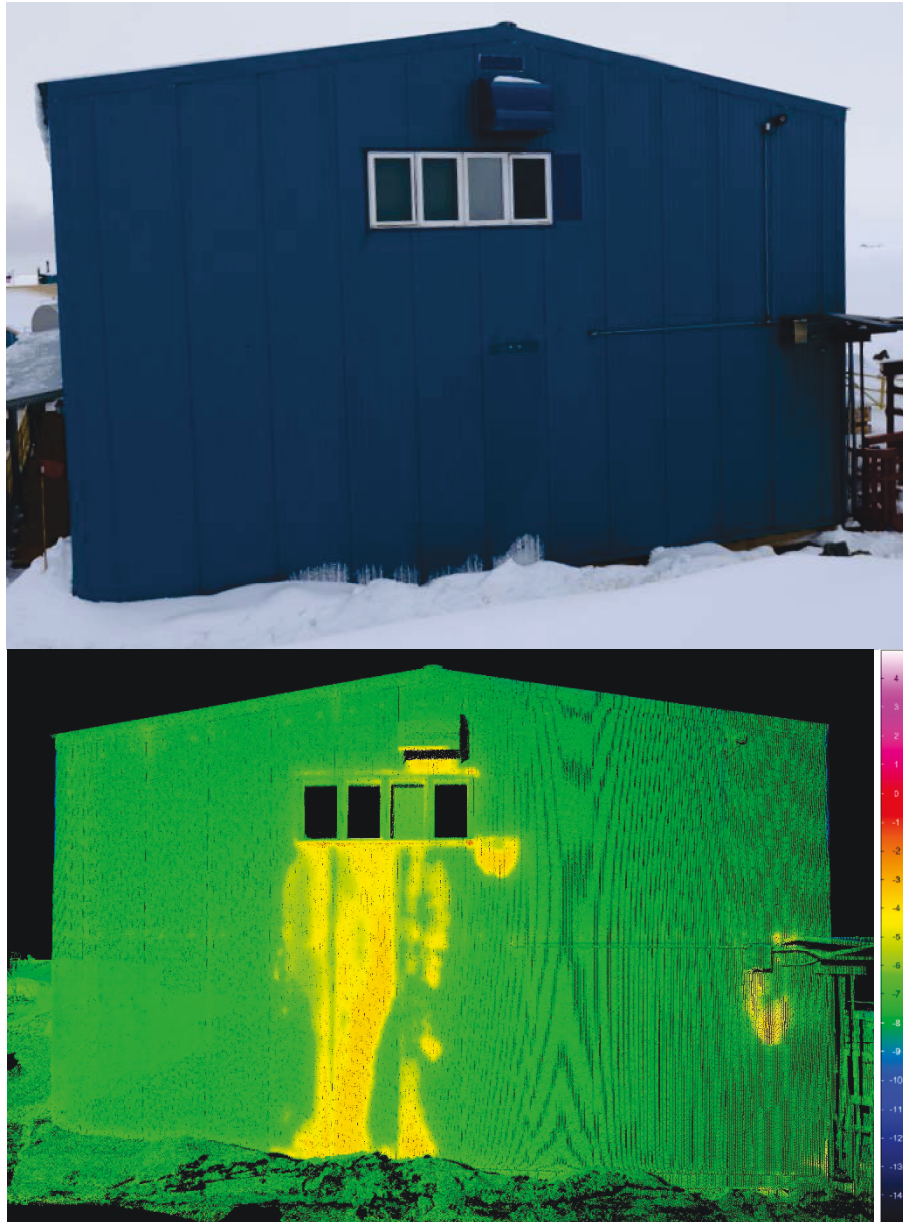
Figure 18. East face of GWR, displaying significant heat loss and insulation damage below white-trim windows. The damage to insulation continues from the top-floor windows fully down to ground level. A patched panel to the right of the windows also displays heat loss below. No significant heat loss was measured along the roofline or exterior panel seams. Temperature scale for the bottom image:  $-15^{\circ}\text{C}$  to  $5^{\circ}\text{C}$ .

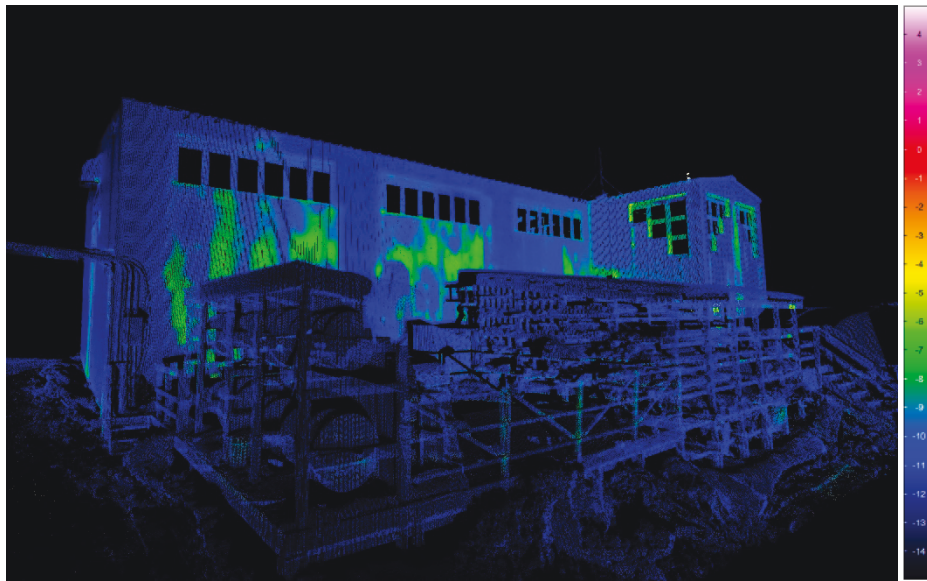
Figure 19. Significant heat loss below all windows along the GWR north side. All windows are white-trim style. Temperature scale:  $-15^{\circ}\text{C}$  to  $5^{\circ}\text{C}$ .

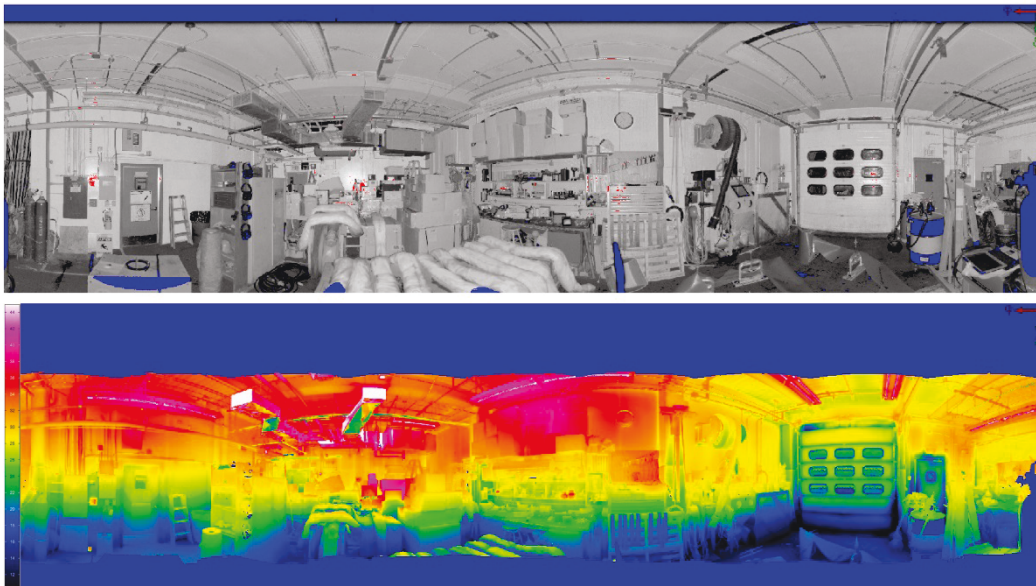
Figure 20. Interior scan of the garage bay in GWR. The *top* image is a two-dimensional view of the point cloud colored by surface reflectance in the lidar laser wavelength (dark-to-light equals low-to-high surface reflectance). The bottom image is the same view colored by temperature. An even gradient from the floor up in temperature is visible along with areas of cold ingress and heat loss around the garage door and entry doorway. Temperature scale for the bottom image:  $10^{\circ}\text{C}$  to  $45^{\circ}\text{C}$ .

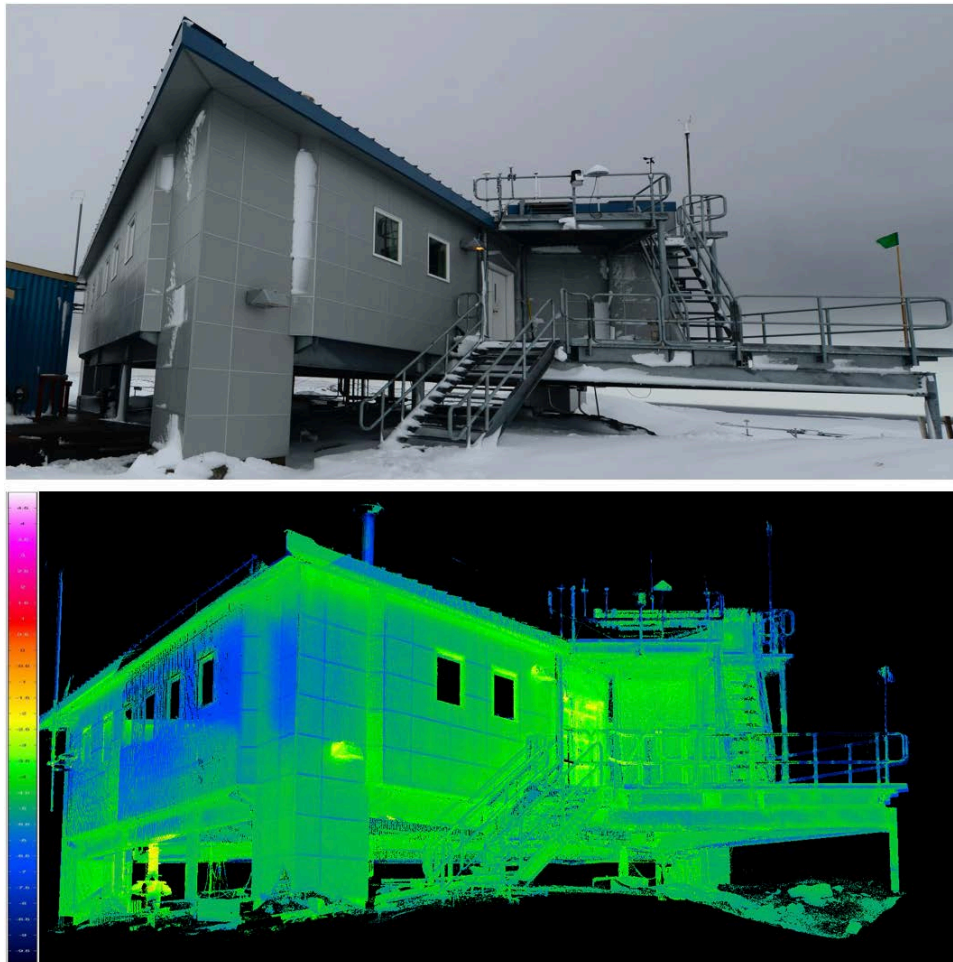
model. No significant heat loss was observed along wall seams, exterior panels, windows, or soffits or on the exposed bottom of the building. The most significant temperature gradients were observed on the entryway doors and a vent on the northwest corner of the building (both indicated below in Figure 21). While there are slight temperature differences along the exterior panel seams (light colored grid), this does not seem to be attributed to heat loss but due to heat absorption of differing colors of materials (Figures 21–22). Again, an example of an interior scan of the Terralab (Figure 23) shows interesting features of thermal bridging between studs and rafters and, in contrast to the Biolab and GWR buildings, minimal cool air ingress along all of the windows, indicating better insulating performance.

Figure 21. Visible image (*top*) and lidar/TIR image (*bottom*) of Terralab. Small temperature gradients along the exterior panel seams are visible. The most significant heat loss occurs at the entryway doors and a vent halfway up the image foreground support post. Overall, this building appears sufficiently insulated. Temperature scale for the bottom image:  $-10^{\circ}\text{C}$  to  $5^{\circ}\text{C}$ .

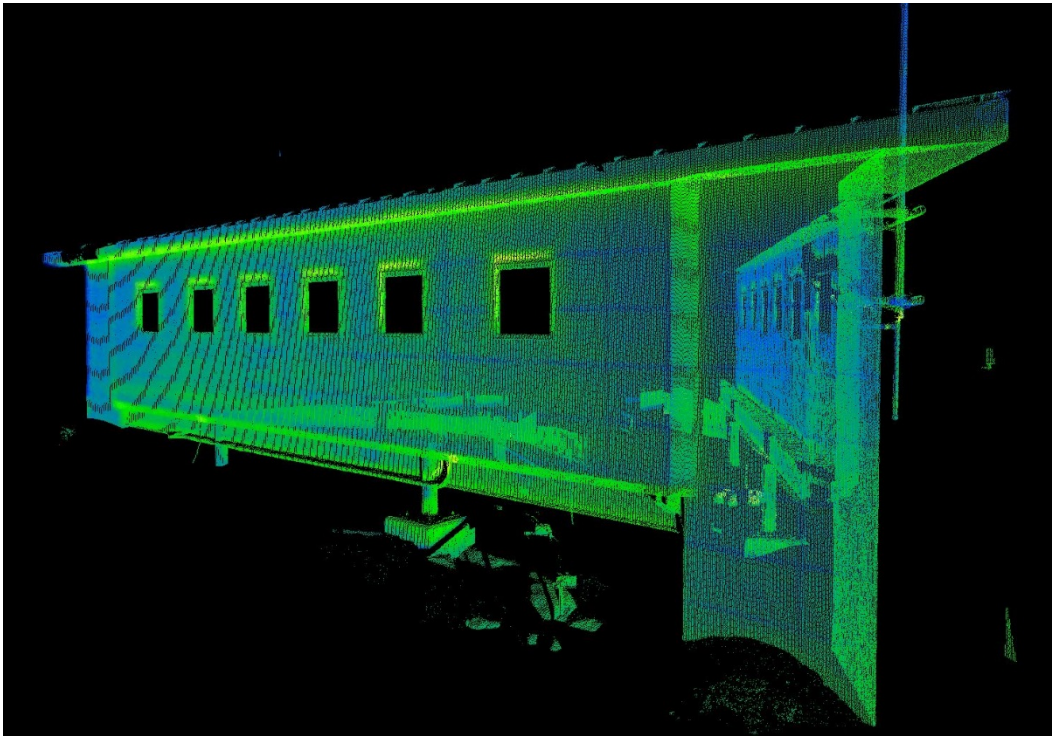
Figure 22. Temperature-colored point cloud view of the southeast side of Terralab.  
Temperature scale:  $-10^{\circ}\text{C}$  to  $5^{\circ}\text{C}$  (same temperature scale as Fig. 21).

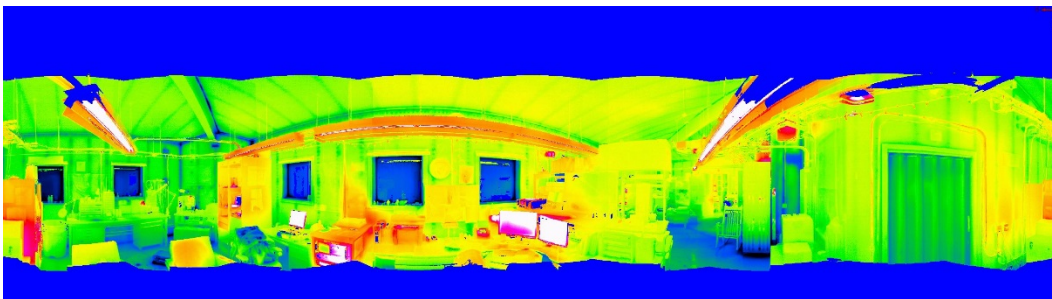
For the interior of Terralab, a temperature gradient was measured from low to high along with cool air ingress and heat loss along wall seams and corners. Studs and rafters are visible within the thermal data. Of note is the minimal cool air ingress surrounding all of the windows, indicating that these windows are performing well in the conditions.

Figure 23. Panorama of the interior of Terralab's south room. Slight cool air ingress is visible along the wall-ceiling interface. Studs and rafters are visible through the drywall. Of note is the minimal cool air ingress along all of the windows, indicating that they are performing very well. Temperature scale:  $17^{\circ}\text{C}$  to  $30^{\circ}\text{C}$ .

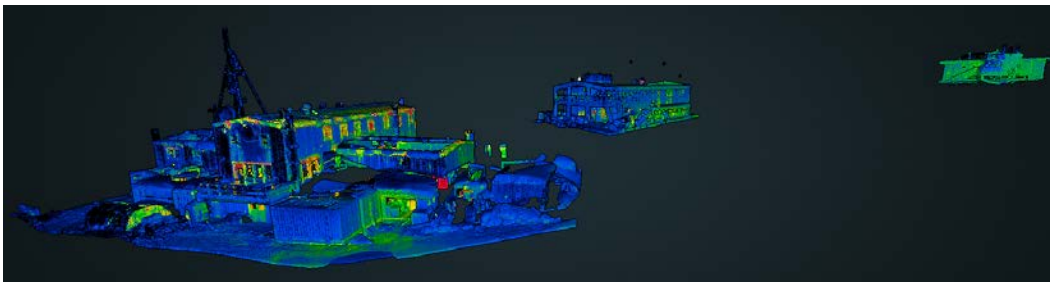
Figure 24. Screen shot of the lidar/TIR survey data for the three major buildings at Palmer Station, Antarctica, in the web-based portal.

Through this effort, a web-based portal for viewing the 3-D thermal models was prototyped, tested, and provided to the National Science Foundation (Figure 24). Please contact the authors for access to the web-based portal.
