U.S. ARMY TANK AUTOMOTIVE RESEARCH, DEVELOPMENT AND ENGINEERING CENTER

Fuel Cell All-Terrain Transport (FCATT) Proton Exchange Membrane (PEM) Fuel Cell Stack Failure Analysis

21-May-2018

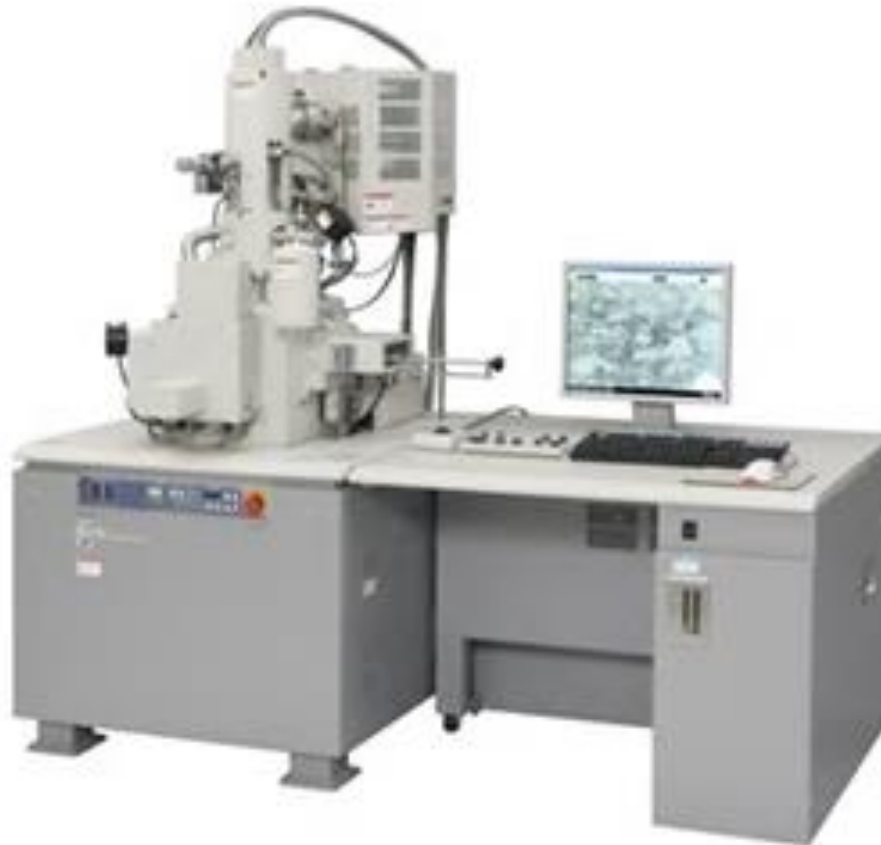
Characterization Technique Analysis

Scanning Electron Microscopy (SEM) & Energy Dispersive Spectroscopy (EDS)

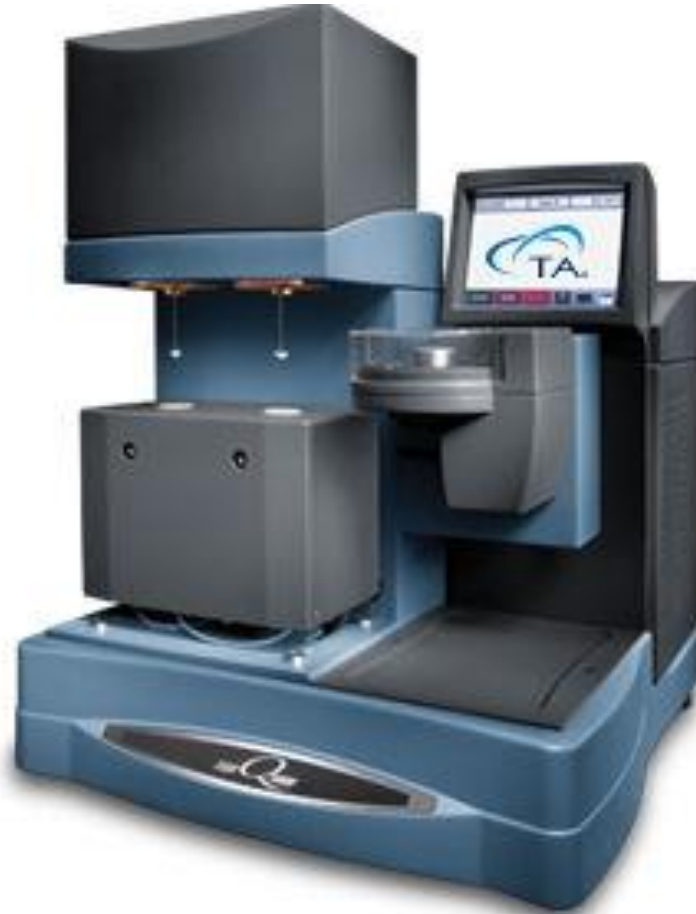
Characterization Technique Analysis

Thermo-Gravimetric Analysis (TGA)

1. At Stack Operating Temperature PEM Mass Degradation Could be Between 1.5 wt.% and 17 wt.%
2. PEM Mass Degradation could be Much Worse if Temperatures are Greater

1. Addition of Quartz Enhanced Thermal Stability Similar to that of Nafion
2. Mass Loss was Reduced from 1.5 wt.% to ~0 wt.% at the Operating Temperature of 65°C, when Compared to PBI from Literature
3. Thermal Stability was Significantly Improved over Previous Material Properties Results, so why did the PEM Material Produce Acetic Acid from Degradation?

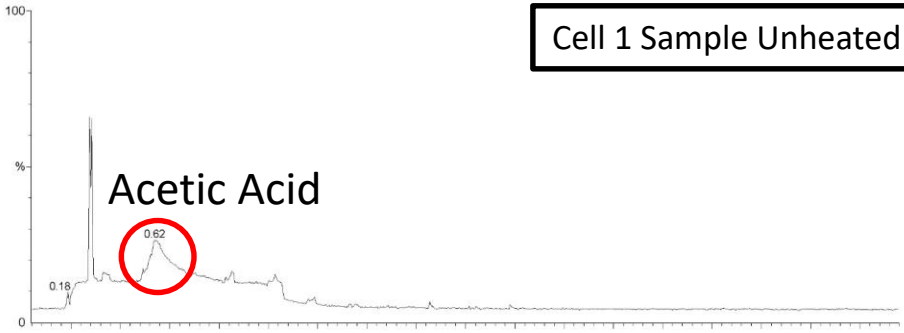
Cell 1 Sample Unheated

PEM Material Produced Additional Acetic Acid under Increased Heating

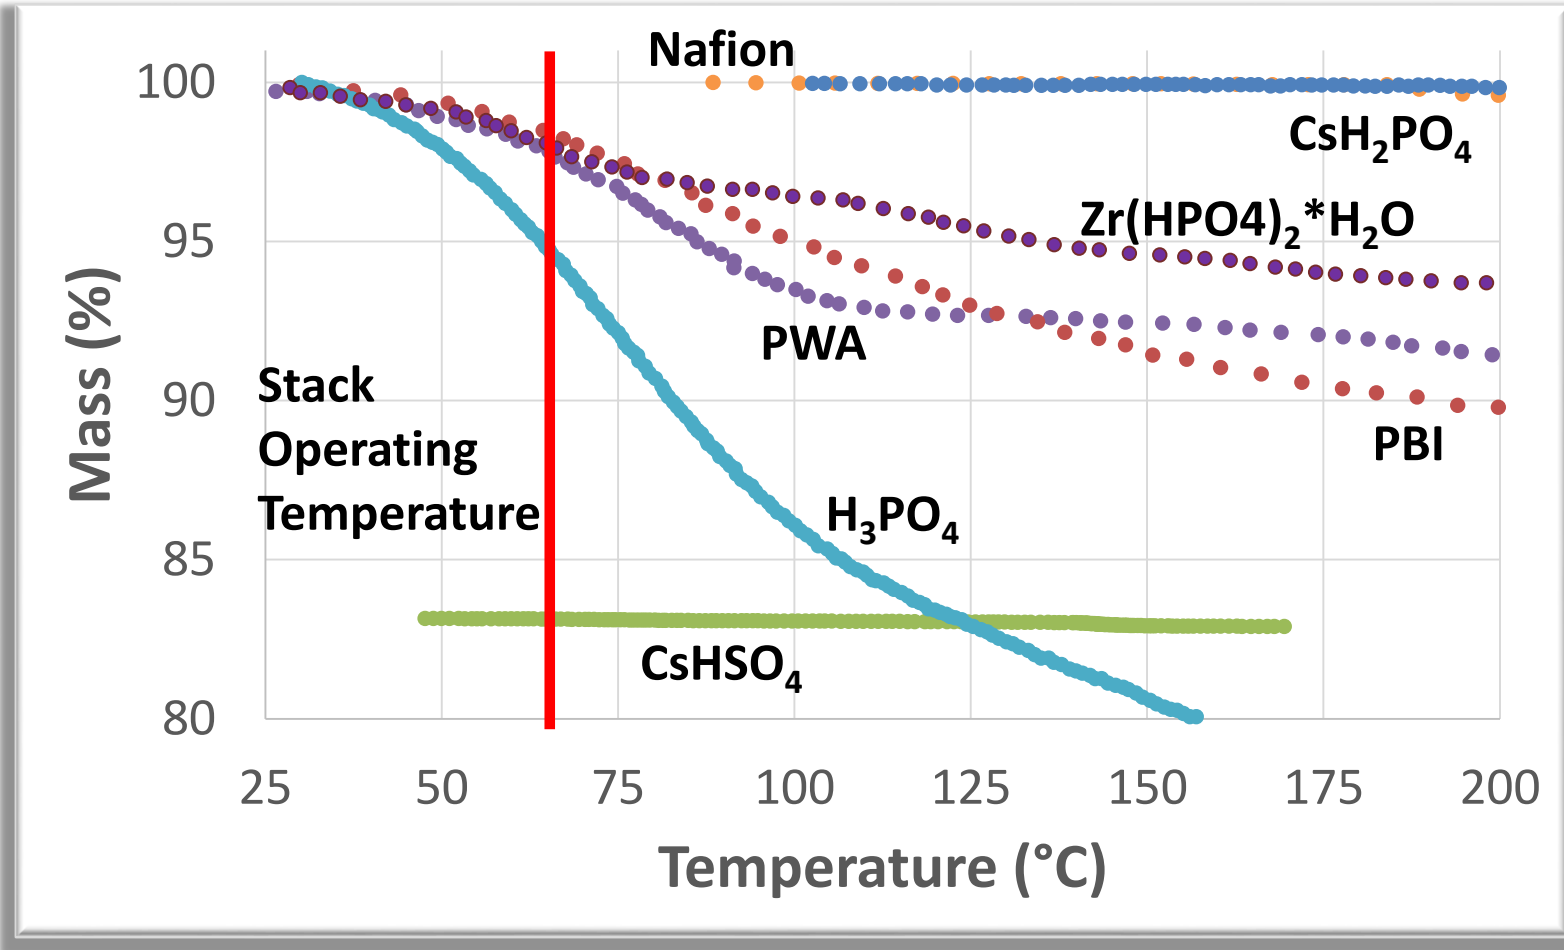
Material Choice and Operating Temperature are Important

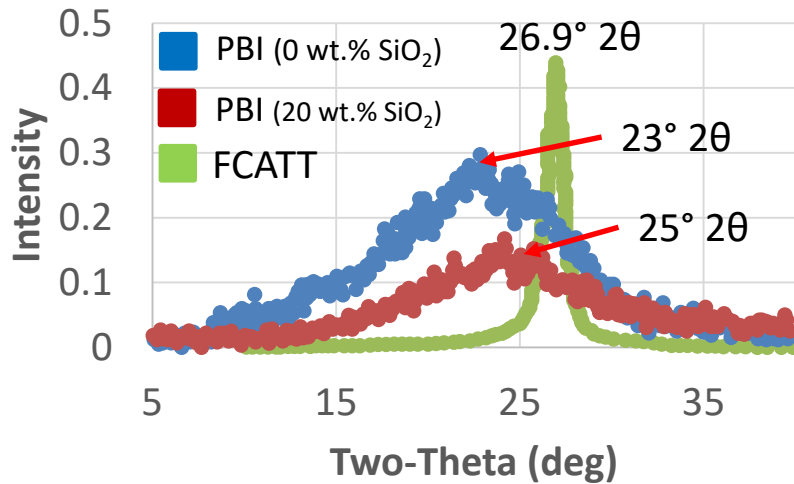
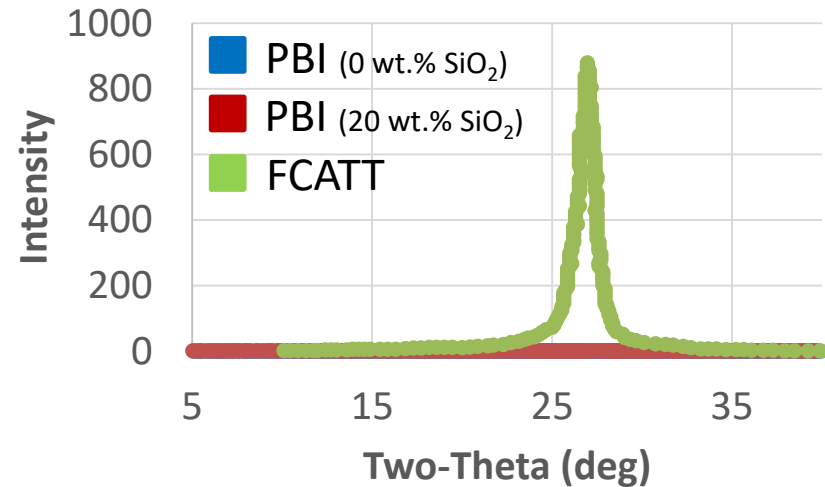
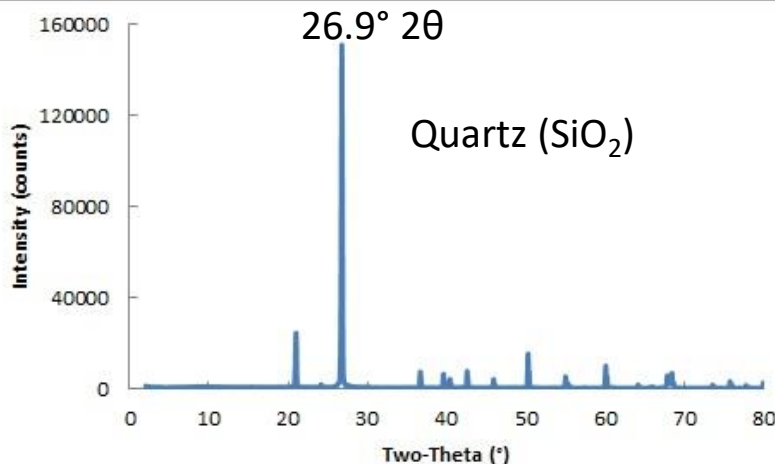
Quartz Doping Shifts Main Peak Location and Increases Crystallinity

1. PEM Material Peak Close to PBI. Addition of SiO₂ Shifts PBI Main Peak in Literature Closer to PEM Material.
2. PEM Material Significantly more Crystalline than PBI Literature Results
3. Quartz XRD Results also Indicted a Very Crystalline Structure, which is SiO₂
4. Quartz XRD Results Indicate Quartz has the same Main Peak Position as PEM Material
5. Literature Reports Addition of SiO₂ Increased Thermal Stability and Mechanical Strength of PEM Material

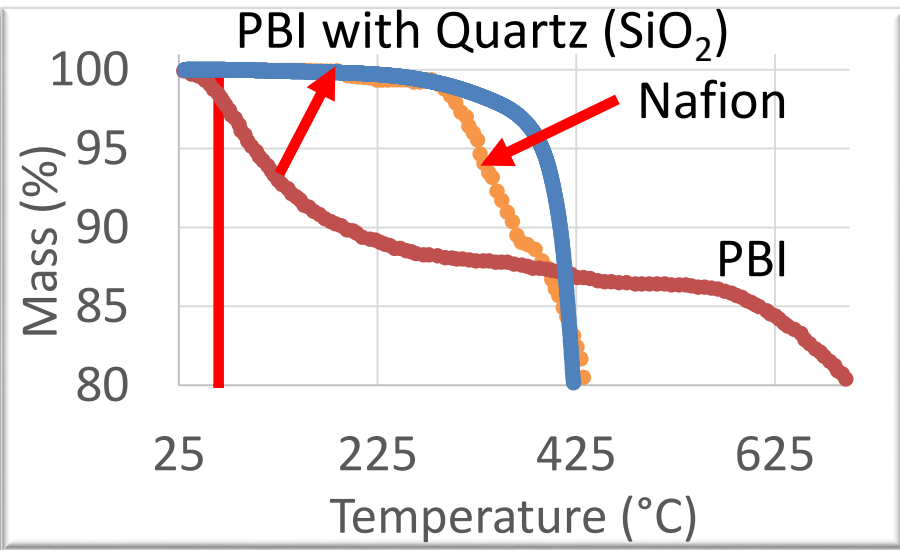
Addition of Quartz Enhanced Thermal Stability Significantly

3. The Addition of Quartz Improved the PEM Material's Thermal Stability and Reduced its Thermal Degradation at Lower Operating Temperatures
4. FCATT PEM Fuel Cell Failure was Found to most likely be the Result of:

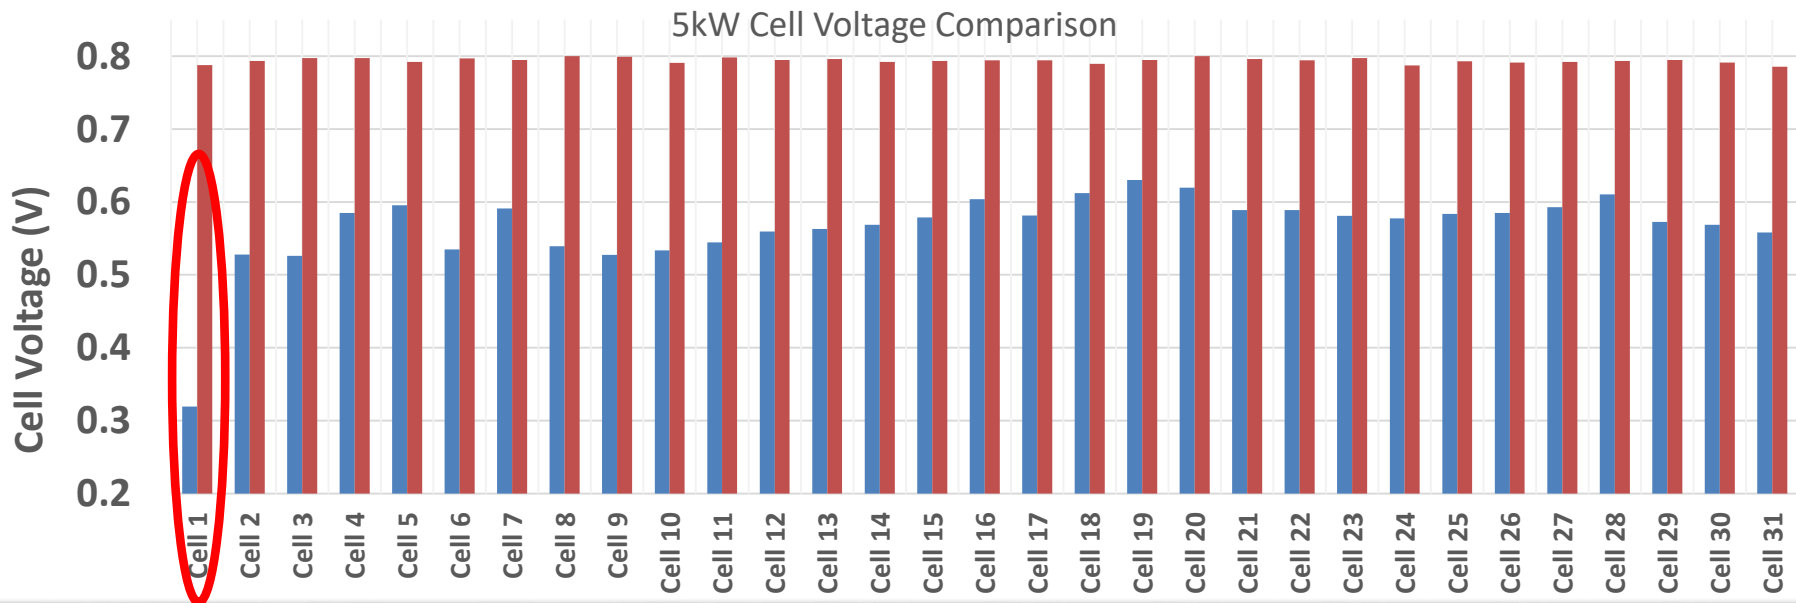
Possible Reasons for the Overall Stack Degradation

- ➔ The Recommended Maximum Manufacturer Operating Temperature was 65°C
 1. PEM stack, at 5 kW, was Operated between 71-75°C
- ➔ There were Times where the FCATT was Operated in Summer Temperatures of 37°C, which put an Additional Heat Load on the Stack
- ➔ The Stack was Thermally Cycled Frequently (Returned Stack from Operating Temperature to Ambient Temperature). Thermal Cycling Degrades Stacks Faster than Continuous Operation.
- ➔ But What About Cell 1??? Largest Contributor of Acetic Acid and 40-50% Lower Cell Voltage

1. Operating the Stack at 5-10° C Above the Manufacturer's Recommended Maximum Temperature and Repeated Thermal Cycling Resulted in Overall Stack Performance Loss

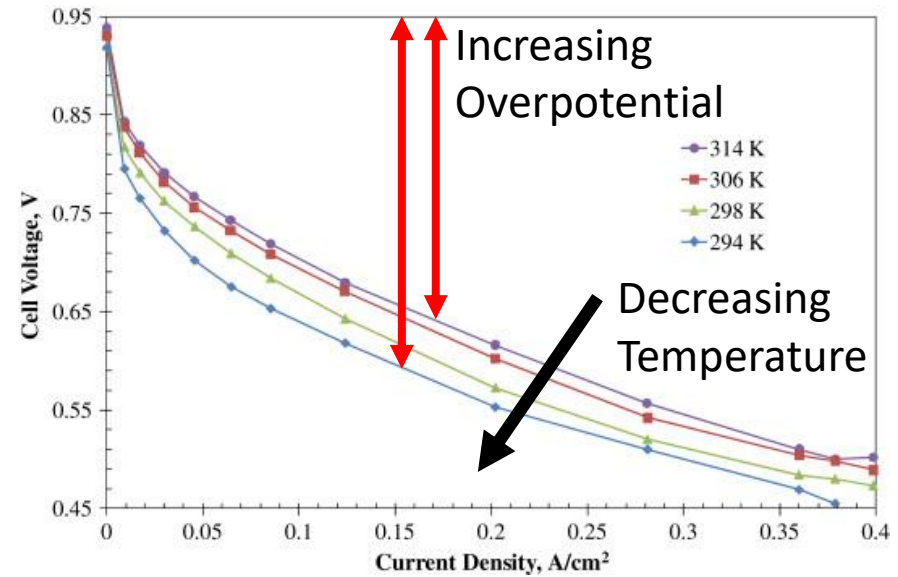
The Manifold is Hypothesized to Lower Cell Voltage in Cell 1

Stack
Manifold

Cell 1

1. The Manifold and other Metal Attachments Cool the Topmost Cell, Cell 1.
2. Operating a Cell at a Lower Temperature Increases its Overpotential (i.e. difference in voltage between actual and thermodynamically derived). Higher overpotential means lower cell voltage efficiency.
3. Higher Overpotential is Caused Primarily due to Increased Ohmic Resistance Losses at Electrode Surfaces and Interfaces.
 1. The Interface between the Manifold and Cell 1
4. The Cell uses More Energy to Overcome those Increased Inefficiencies than Thermodynamically Required. That Additional Energy is Lost to the Cell as Heat, Locally and Degrades the Cell.

2. The Cell Closest to the Stack Manifold was Less Efficient due to being Cooled by Manifold. This Resulted in the Cell being Less Efficient, Increasing Energy Consumption which was Lost as Heat to the PEM Material Interface.

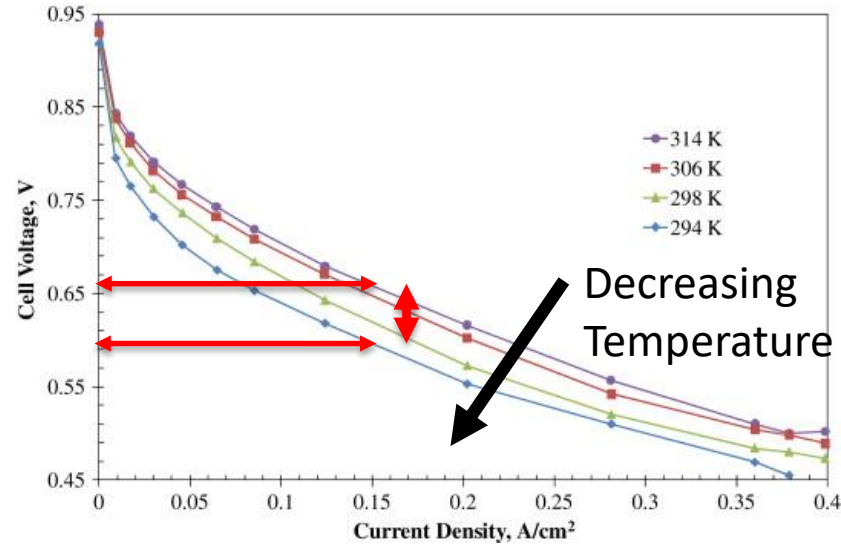
Lower Operating Temperature did not Reduce Cell 1 Voltage

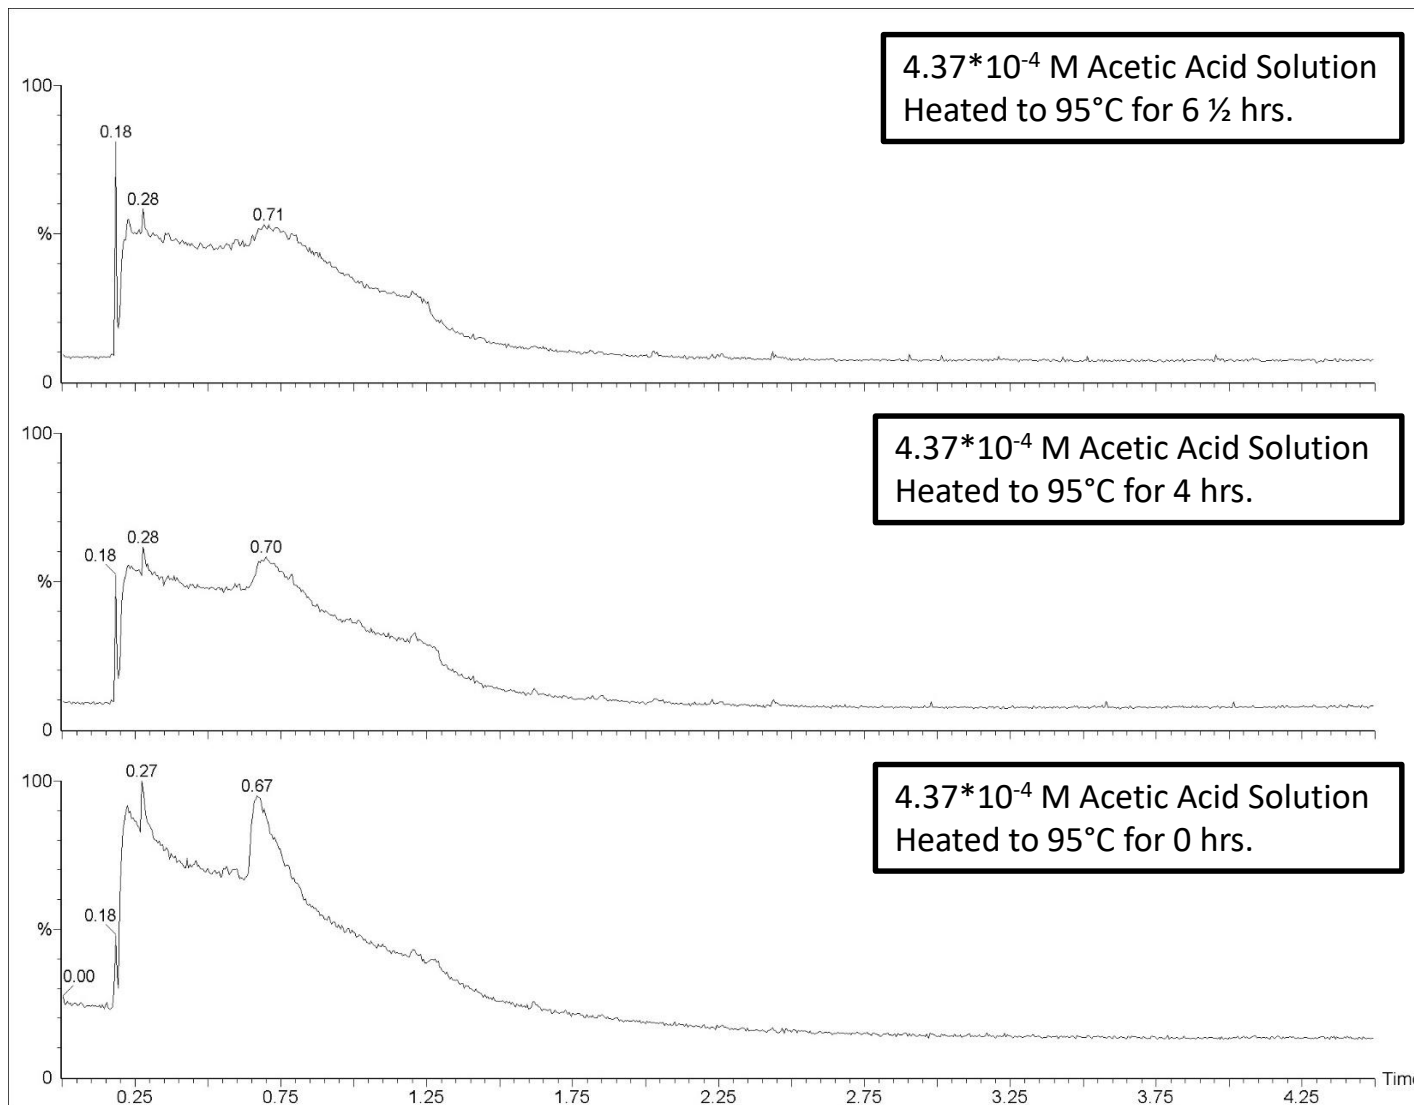
Cell 1 PEM Material Heated to 95°C

Acetic Acid Evaporates Around 100°C
