**NSWCCD-61-TR-2014/35**

**October 2014**

Survivability, Structures, and Materials Department  
Technical Report

## **U.S. Navy Alternative Fuels Program - Metallic Materials Immersion Corrosion Study - Phase 2**

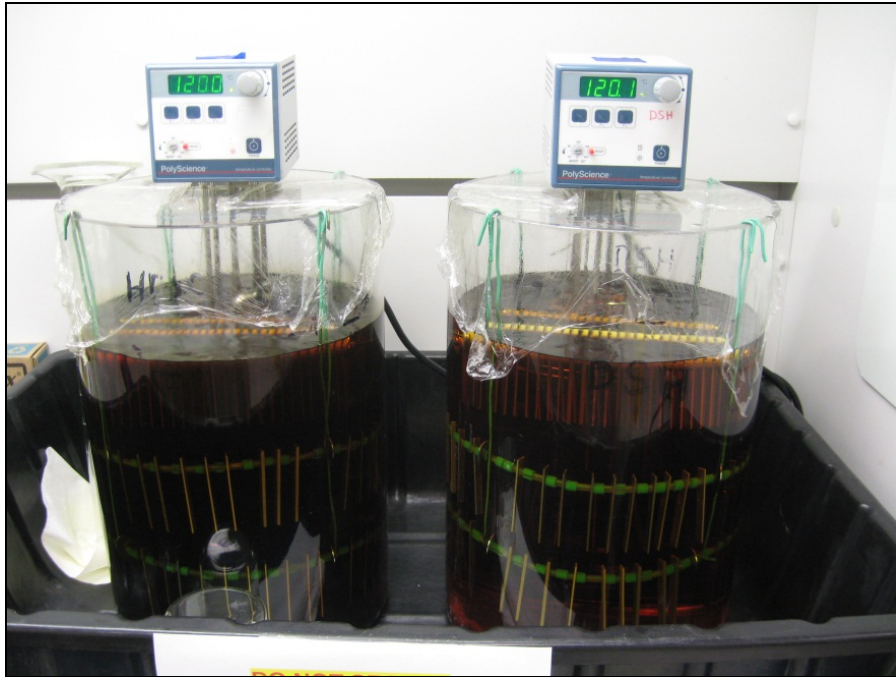
**Figure 4.** Laboratory set-up for flow test. Unit on tank is a combination circulator pump and heating element.

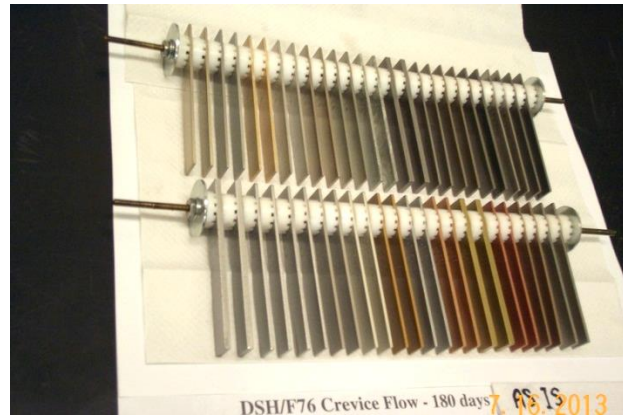
**Figure 5.** Typical coupon mounting for flowing fuel corrosion testing. Left photo shows coupons for determining general corrosion. Right photo is for determining crevice corrosion with each coupon separated by a Teflon® crevice washer.

| | <i>Page</i> |
|---|---|
| <b>Figure 5.</b> Typical coupon mounting for flowing fuel corrosion testing. Left photo shows coupons for determining general corrosion. Right photo is for determining crevice corrosion with each coupon separated by a Teflon® crevice washer..... | 8 |

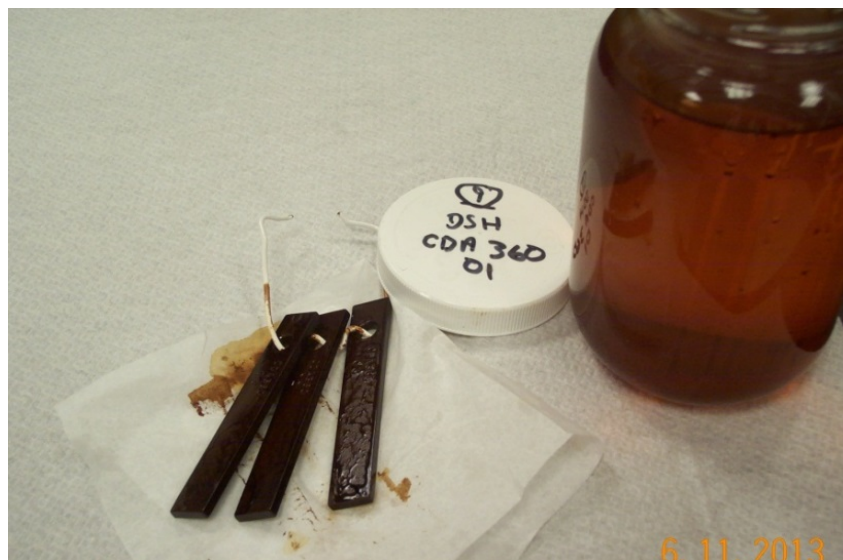
**Figure 7.** 360 leaded brass alloy exposed to DSH for 180 days at 120 °F became coated with a thick, black, tacky material.

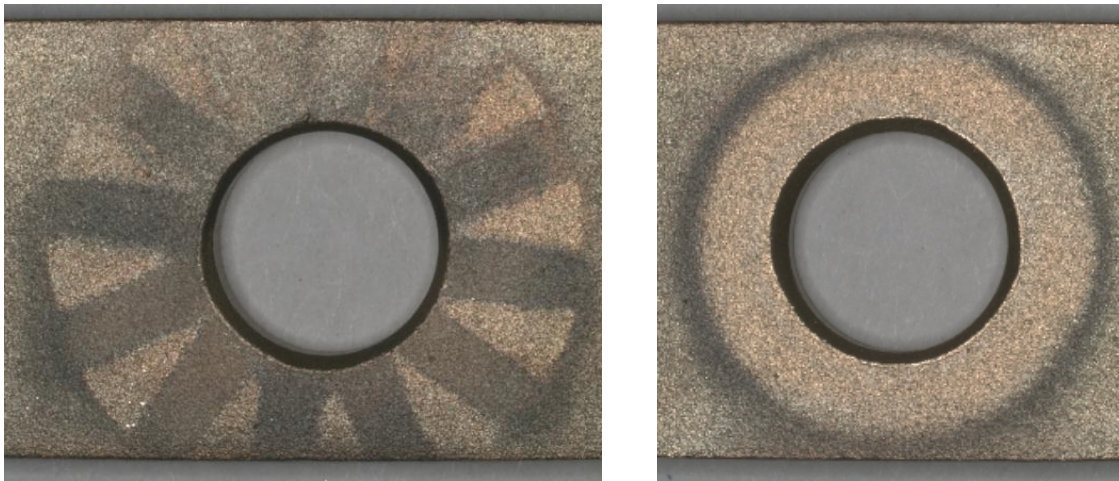
**Figure 12.** Macrophotograph of Cu-Ni alloy CDA 706, after immersion testing in the DSH fuel as a crevice corrosion assembly. Note the stains that developed at the crevice washer (left) and flat washer (right) sites. Mag.: 10X

- Figure 12.** Macrophotograph of Cu-Ni alloy CDA 706, after immersion testing in the DSH fuel as a crevice corrosion assembly. Note the stains that developed at the crevice washer (left) and flat washer (right) sites. Mag.: 10X.....24

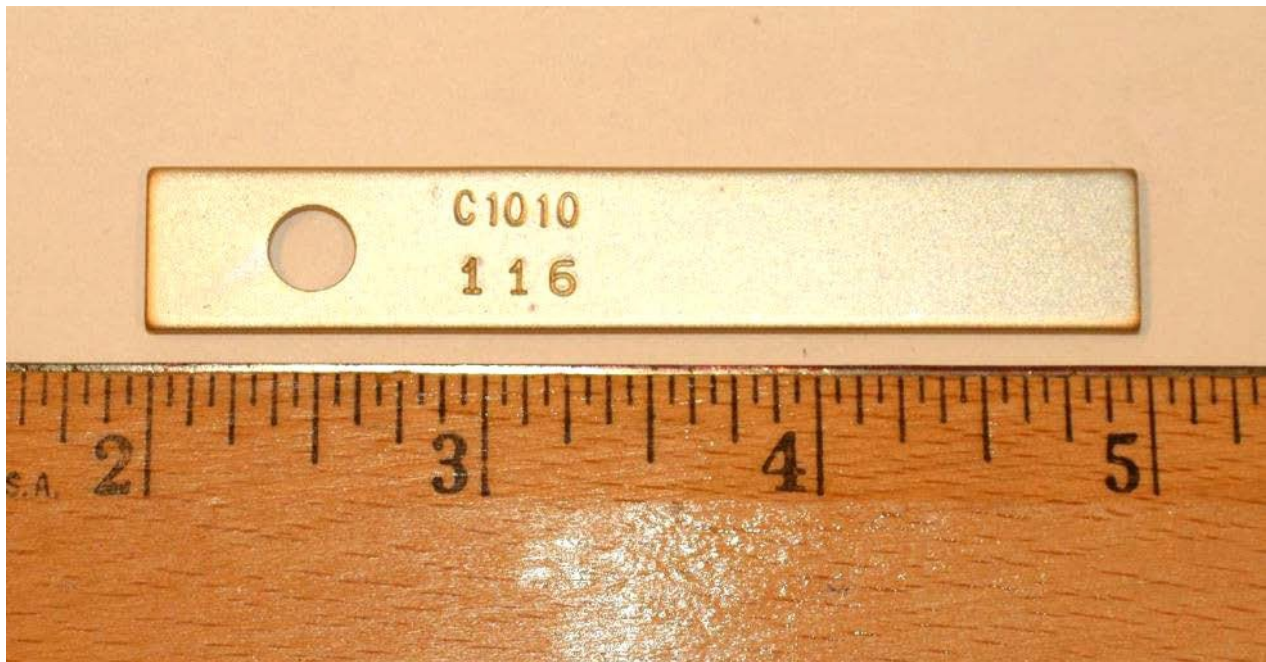
Figure 2. An example of one (1) of the IVD Aluminum Class 3 plated carbon steel coupons, as received.

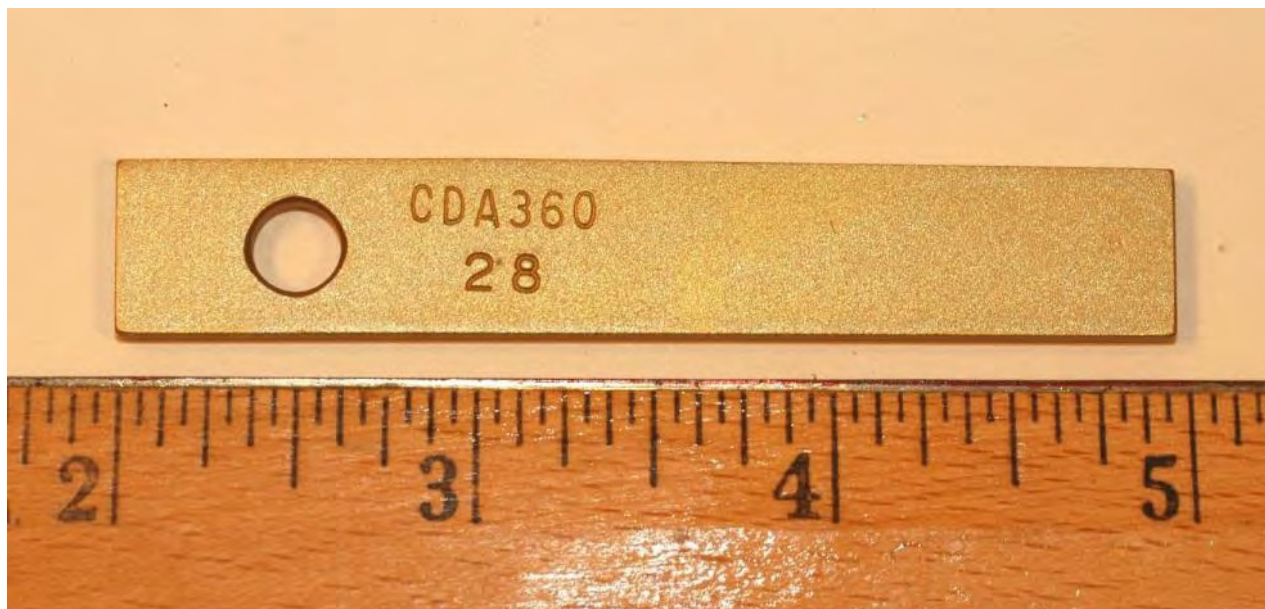
Figure 3. An example of one (1) of the copper alloy coupons, leaded brass alloy CDA360 (UNS C36000), as received.

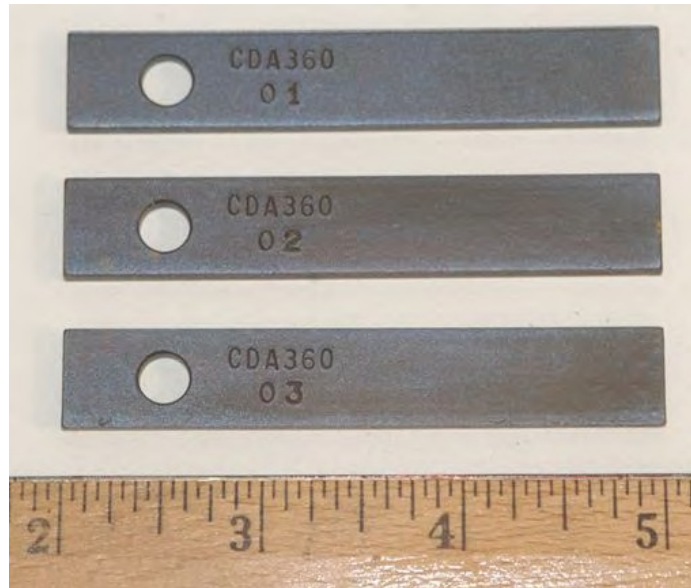
Figure 4. Macro photograph of the leaded brass coupon that were immersion tested in the DSH fuel. Note the dark blue colored appearance.

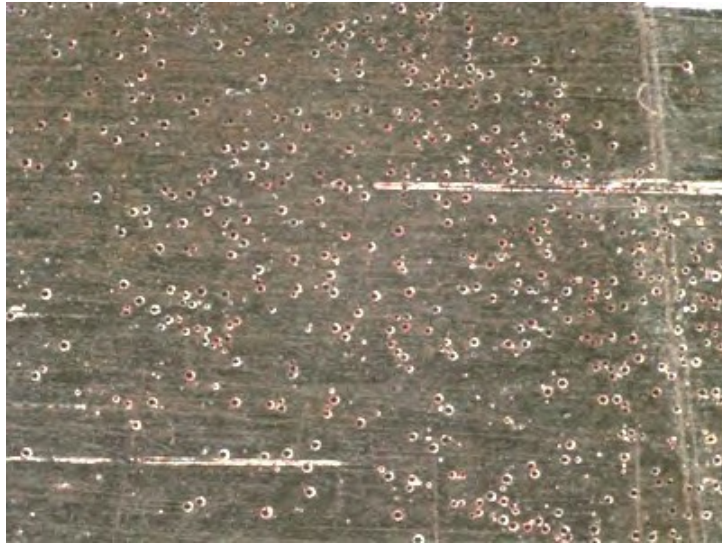
Figure 6. Macro photograph of a carbon steel coupon that had the electrodeposited zinc plating, static immersion tested in the F-76 fuel. Fine pits were observed. Mag.: 50X

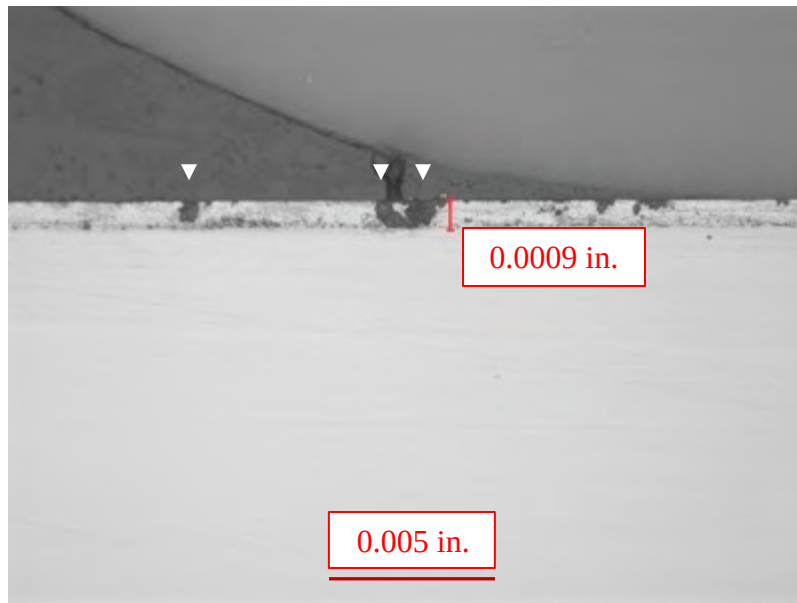
Figure 8. Photomicrograph of a carbon steel coupon that had the electrodeposited zinc plating, static immersion tested in the F-76 fuel. Fine pits, indicated by the white arrows, are evident in the zinc plating, extending to a maximum depth of 0.0009 in. As polished, Mag.: 200X

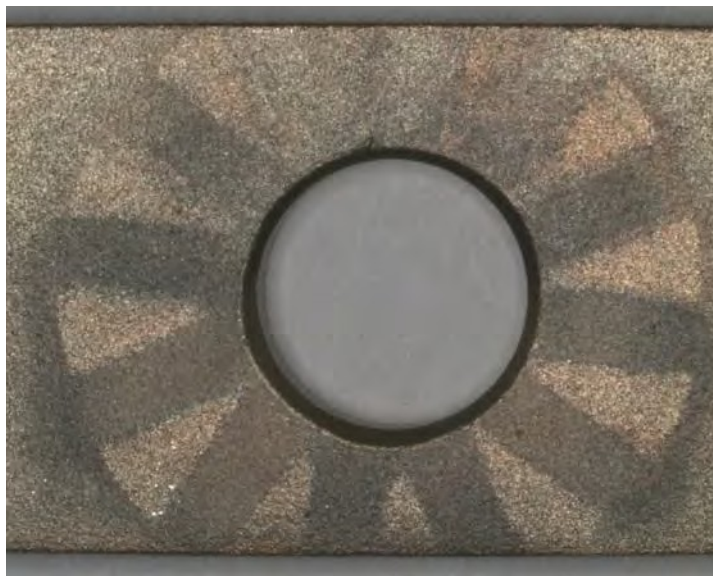
Figure 12. Macro photograph of Cu-Ni alloy CDA 706, after immersion testing in DSH fuel as a crevice corrosion assembly. Note the stains that developed at the crevice washer site. Mag.: 10X

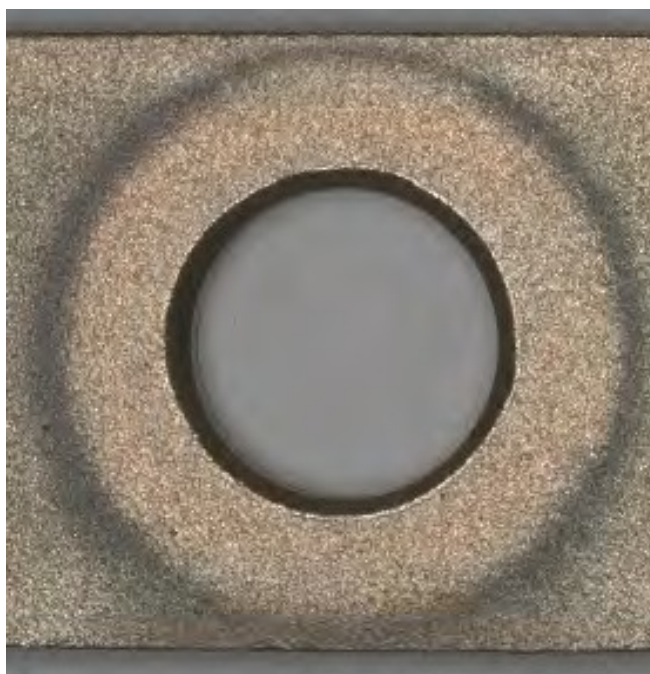
Figure 13. Opposite side of the coupon shown in Figure 12. Macro photograph of Cu-Ni alloy CDA 706, after immersion testing in DSH fuel as a crevice corrosion assembly. Note the stains that are evident on the flat washer side. Mag.: 10X

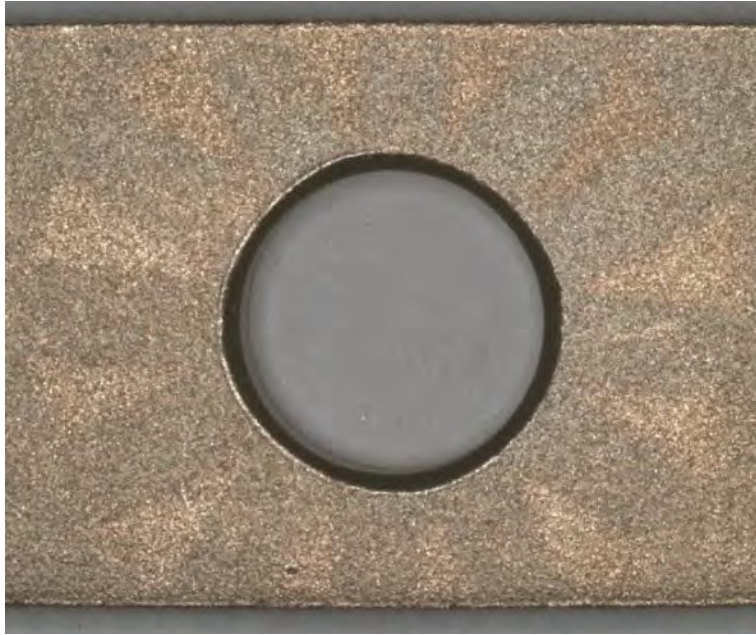
Figure 14. Macrophotograph of Cu-Ni alloy CDA 706, after immersion testing in HDCD-1 fuel as a crevice corrosion assembly. Note the stains that developed at the crevice washer site. Mag.: 10X

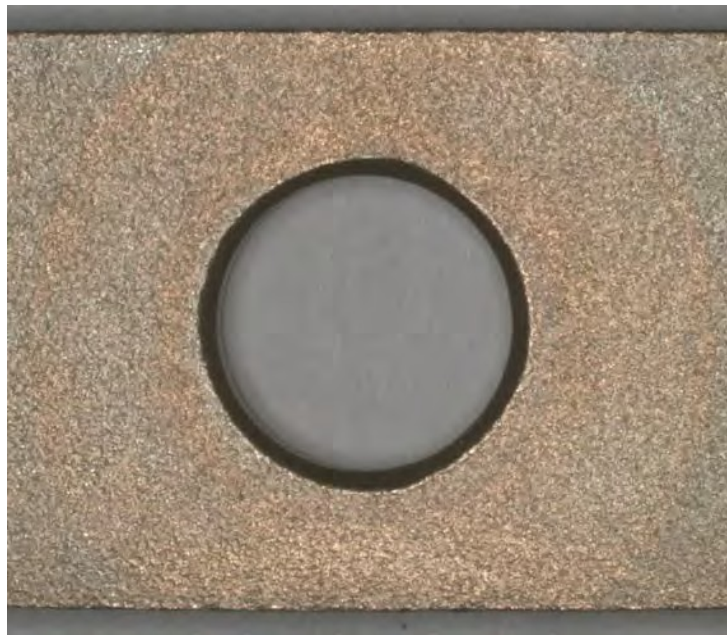
Figure 15. Opposite side of the coupon shown in Figure 14. Macrophotograph of Cu-Ni alloy CDA 706, after immersion testing in HDCD-1 fuel as a crevice corrosion assembly. There was evidence of staining on the flat washer side. Mag.: 10X

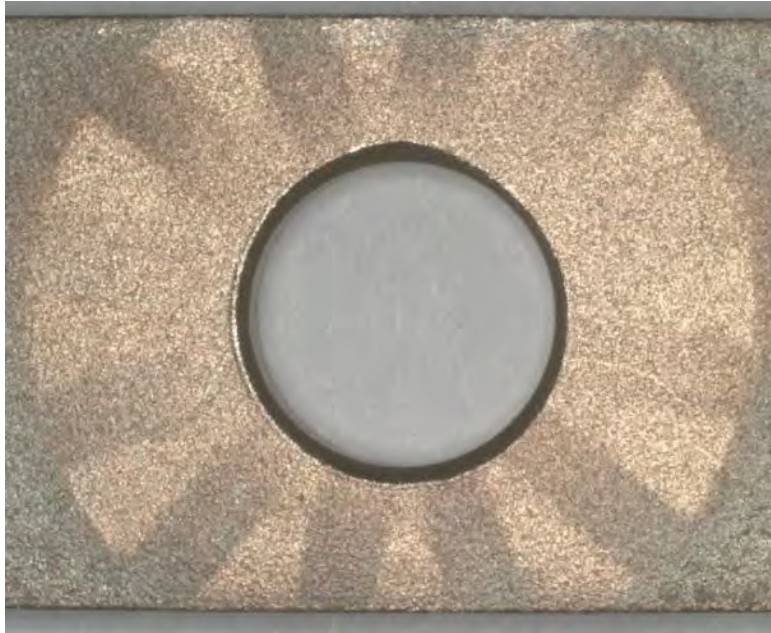
Figure 16. Macro photograph of Cu-Ni alloy CDA 360, after immersion testing in HDCD-2 fuel as a crevice corrosion assembly. Note the stains that developed at the crevice washer site. Mag.: 10X

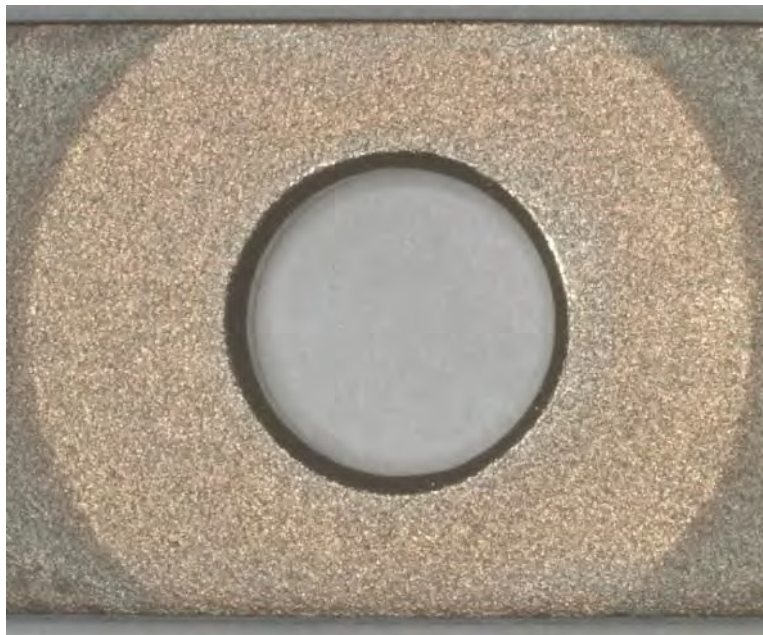
Figure 17. Opposite side of the coupon shown in Figure 16. Macro photograph of Cu-Ni alloy CDA 360, after immersion testing in HDCD-2 fuel as a crevice corrosion assembly. Note the stains that are evident on the flat washer side. Mag.: 10X

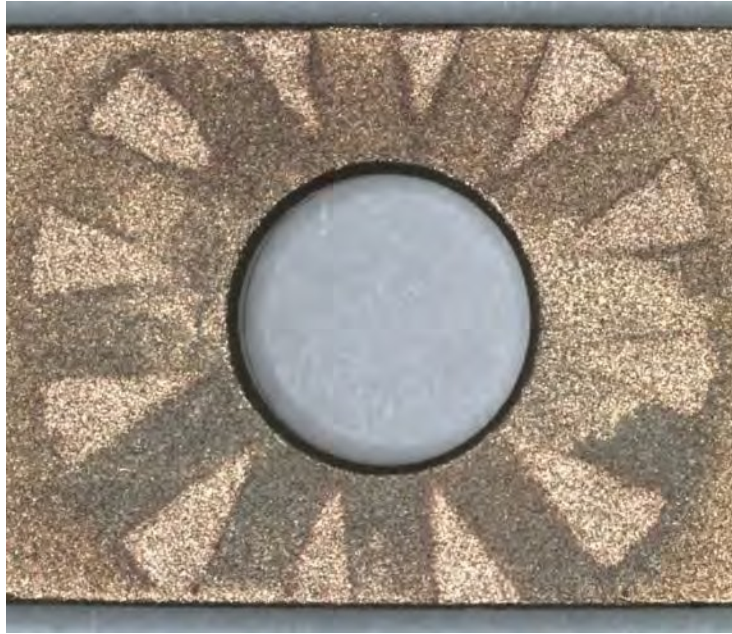
Figure 18. Macrophotograph of Cu-Ni alloy CDA 360, after immersion testing in F-76 fuel as a crevice corrosion assembly. Note the stains that developed at the crevice washer site. Mag.: 10X

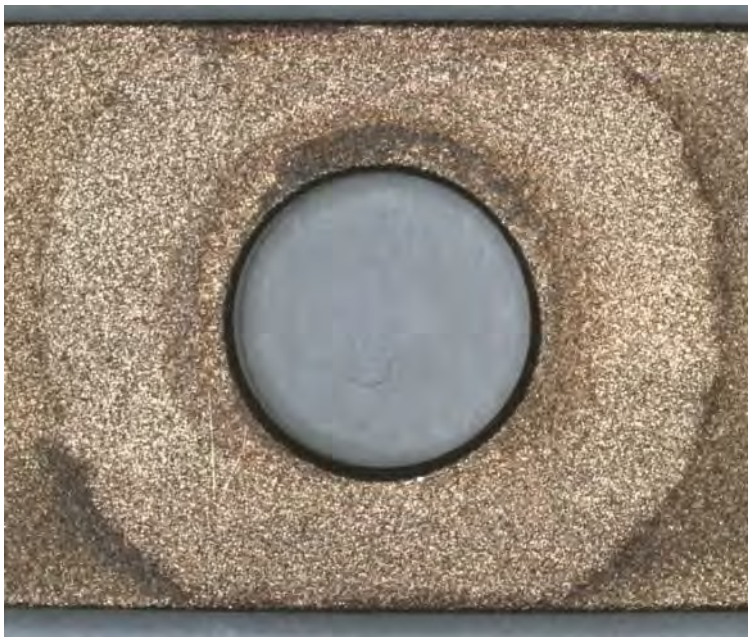
Figure 19. Opposite side of the coupon shown in Figure 18. Macrophotograph of Cu-Ni alloy CDA 360, after immersion testing in F-76 fuel as a crevice corrosion assembly. Note the stains imparted on the flat washer side. Mag.: 10X

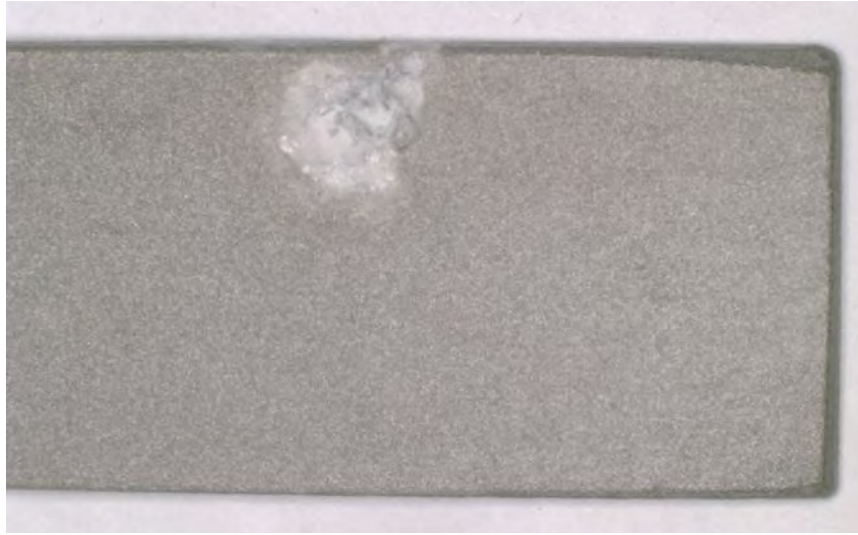
Figure 20. Stereophotograph of one (1) of the aluminum coupons, after immersion testing in the DSH fuel/seawater mixture. Note the pit present in the seawater side of the coupon. Mag.: 8X

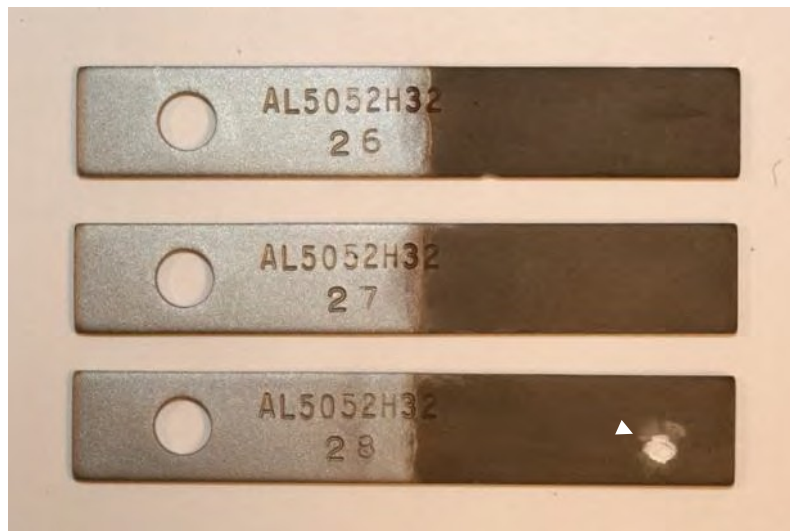
Figure 27. 35mm macrophotograph of the aluminum coupons, after immersion testing in F-76 fuel/seawater mixture. Note the pit present on the bottom coupon that was immersed in the seawater (identified by the white arrow). The portion that was immersed in the fuel was on the left, and the portion immersed in the seawater was on the right. Mag.: 0.5X

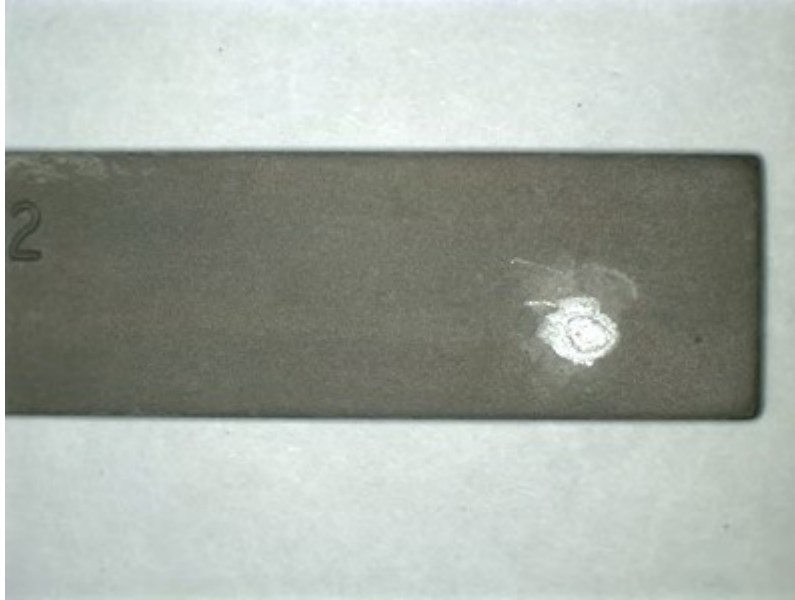
Figure 28. Enlarged view of the bottom coupon shown in Figure 27. The pit is located on the seawater side. Mag.: 4X

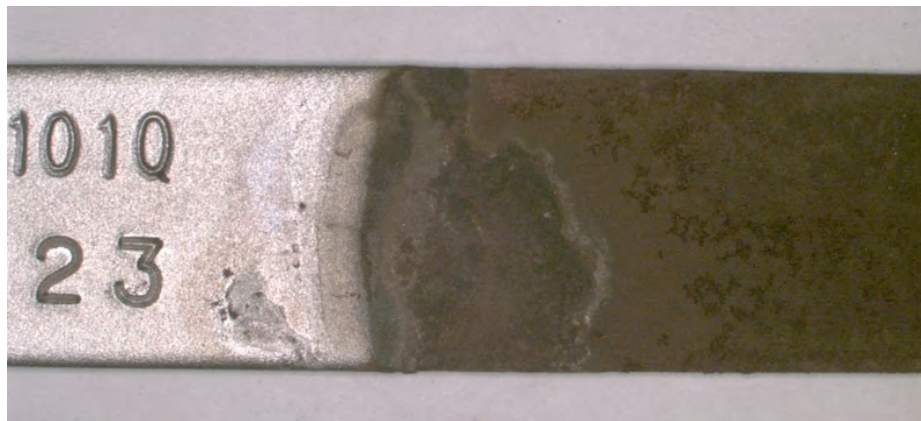
Figure 30. Macrophotograph of a carbon steel coupon, after immersion testing in the DSH fuel/sea water mixture. The portion that was immersed in the DSH fuel was on the left, and the portion immersed in the seawater was on the right. Oxidation, general corrosion, and pitting were evident at the fuel/sea water interface as well as on the portion that was immersed in the seawater. Mag.: 5X

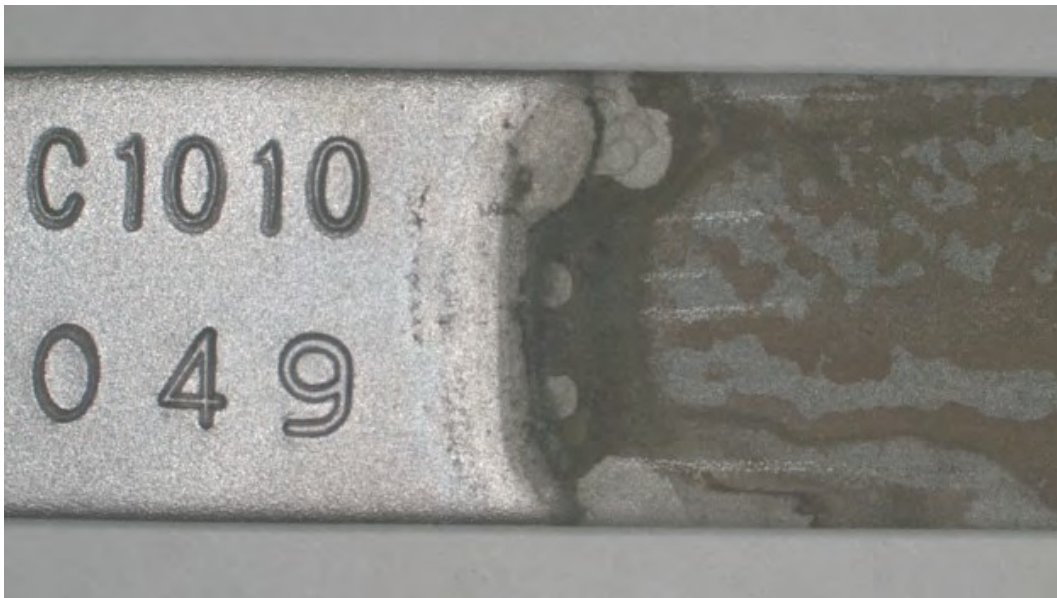
Figure 34. Macro photograph of a carbon steel coupon, after immersion testing in the HDCD-2 fuel/seawater mixture, showing an enlarged view of the fuel/seawater interface. The portion that was immersed in the HDCD-2 fuel was on the left, and the portion immersed in the seawater was on the right. Oxidation, general corrosion and pitting were evident, particularly at the fuel/seawater interface. Mag.: 10X

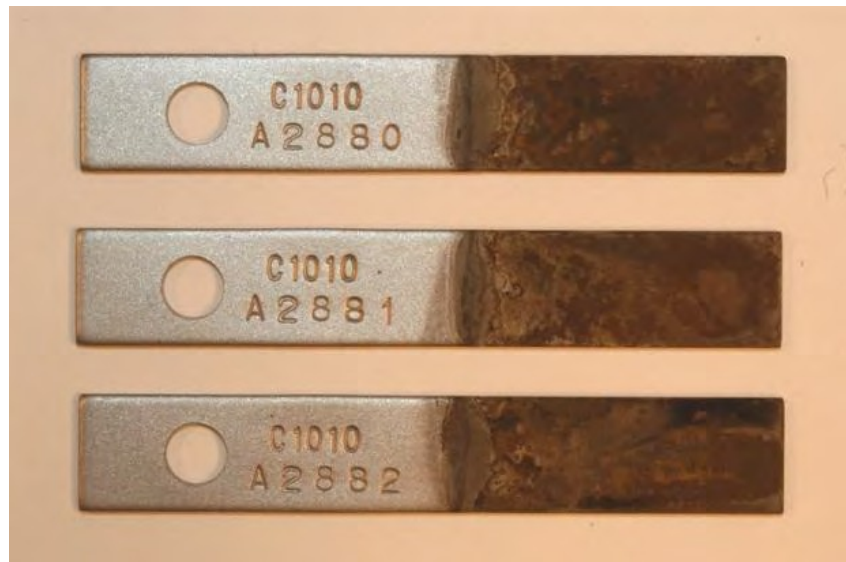
Figure 36. Macro photograph of the carbon steel coupon, after immersion testing in F-76 fuel/seawater mixture. The portion that was immersed in the F-76 fuel was on the left, and the portion immersed in the seawater was on the right. Some oxidation and general corrosion were also evident on the portion that was immersed in the seawater. Mag.: 1.2X

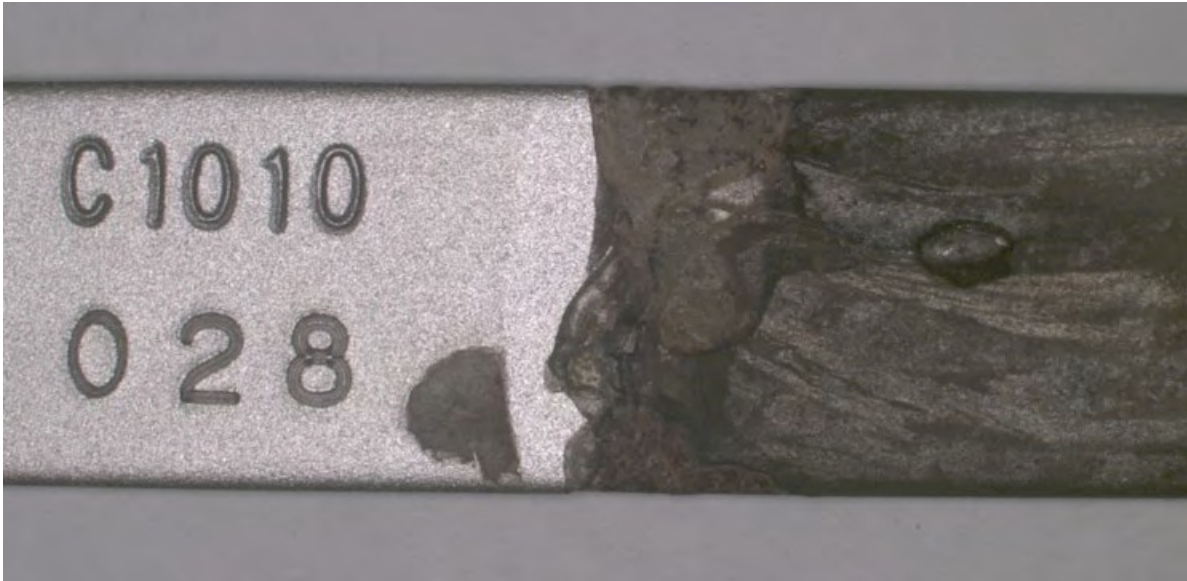
Figure 38. Macrophotograph of a carbon steel coupon, after immersion testing in the DSH fuel/deionized mixture. The portion that was immersed in the DSH fuel is on the left, and the portion immersed in the deionized water is on the right. Oxidation, general corrosion and pitting are evident on the deionized water side. The largest pitting was observed on the fuel side, directly adjacent to the fuel/deionized water interface. Mag.: 5X

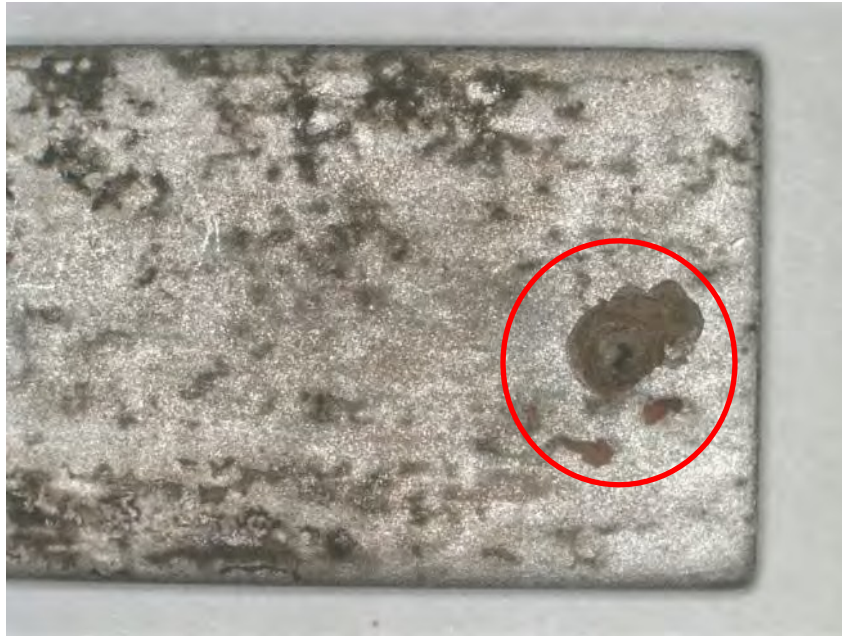
Figure 42. Macro photograph of a carbon steel coupon, after immersion testing in the HDCD-2 fuel/deionized water mixture which shows an enlarged view of one (1) of the coupons that was immersed in the deionized water portion. Oxidation, general corrosion and pitting were evident. A cluster of pits was identified within the red circle. Mag.: 10X

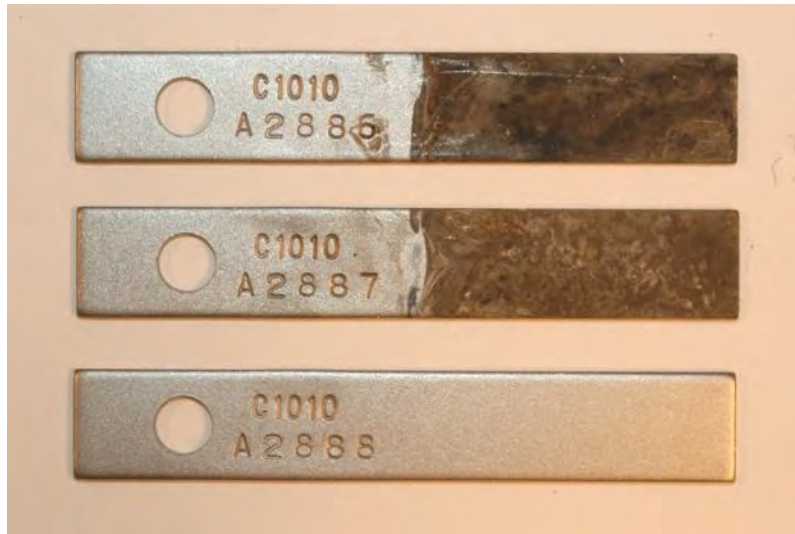
Figure 44. Macrophotograph of the carbon steel coupons, after immersion testing in the F-76 fuel/deionized water mixture. The portion that was immersed in the fuel was on the left, and the portion immersed in the deionized water was on the right. Oxidation and general corrosion were evident on the portion that was immersed in the deionized water on the top two (2) coupons. There was some attack noted in the water side in close proximity to the fuel/deionized water interface. The bottom coupon, for some unknown reason, was not corrosively attacked. SEM/EDS analysis verified that the coupon was carbon steel; the lack of oxidation on the deionized water side cannot be explained. Mag.: 0.5X
