**NSWCCD-61-TR-2011/04** February 2011

Survivability, Structures, and Materials Department  
Technical Report

## **Nondestructive Examination of Aluminum Friction Stir Welds: A Literature Search**

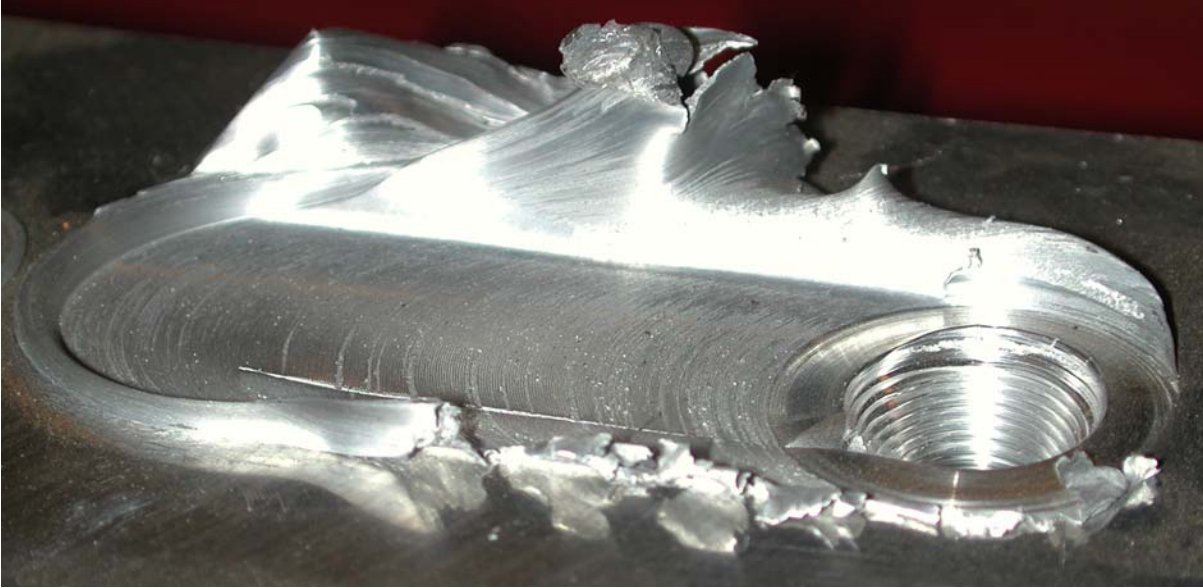
Figure 6. An FS welded aluminum alloy with excessive flash.

Flash is produced by displacement of material from the mating components caused by the pin tool being plunged into the materials. If the insertion depth is too deep, the tool plunges into the weld joint creating excessive flash. This may result in a significantly concave weld, causing local thinning of the welded plates [2]. Figure 6 shows an example of an FS welded aluminum alloy with excessive flash. This condition can be detected visually and through in-process monitoring. The flash can then be machined off to meet surface finish requirements for the part.

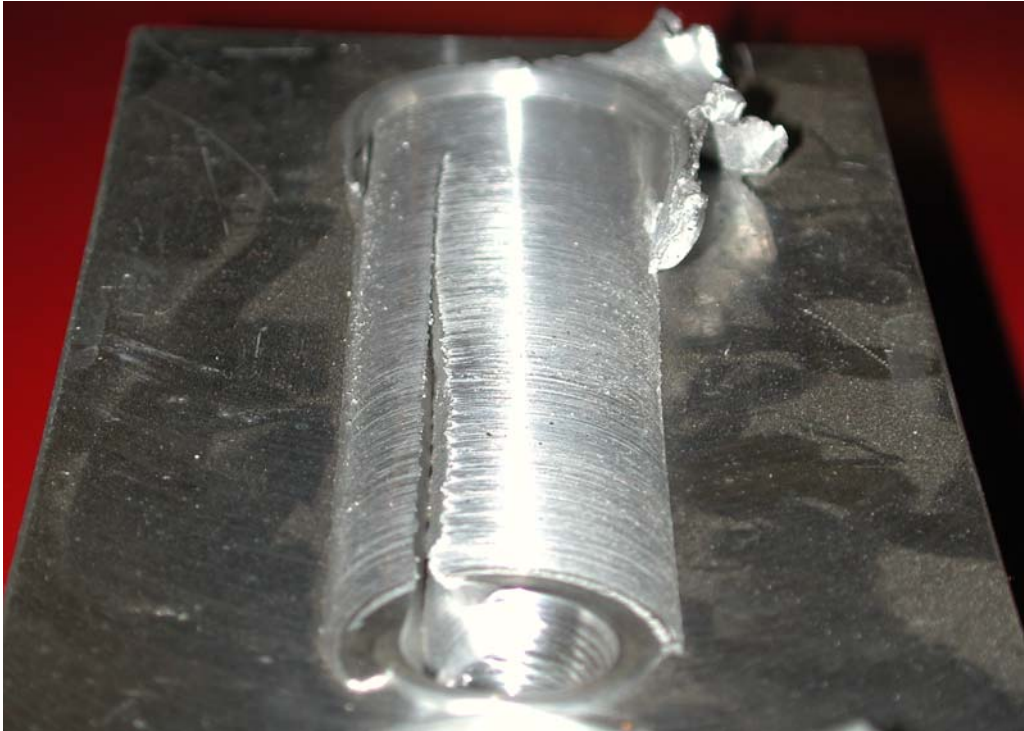
Figure 10. An FS welded aluminum alloy containing a surface-breaking wormhole defect.

Wormholes are single voids extending longitudinally along the weld. Wormholes may be surface breaking or contained entirely within the volume of the weld. Lack of forging defect is a term that is sometimes used to describe an FSW defect, but it is believed to be equivalent to a wormhole defect [14]. Figure 10 shows a wormhole which has opened to the surface.

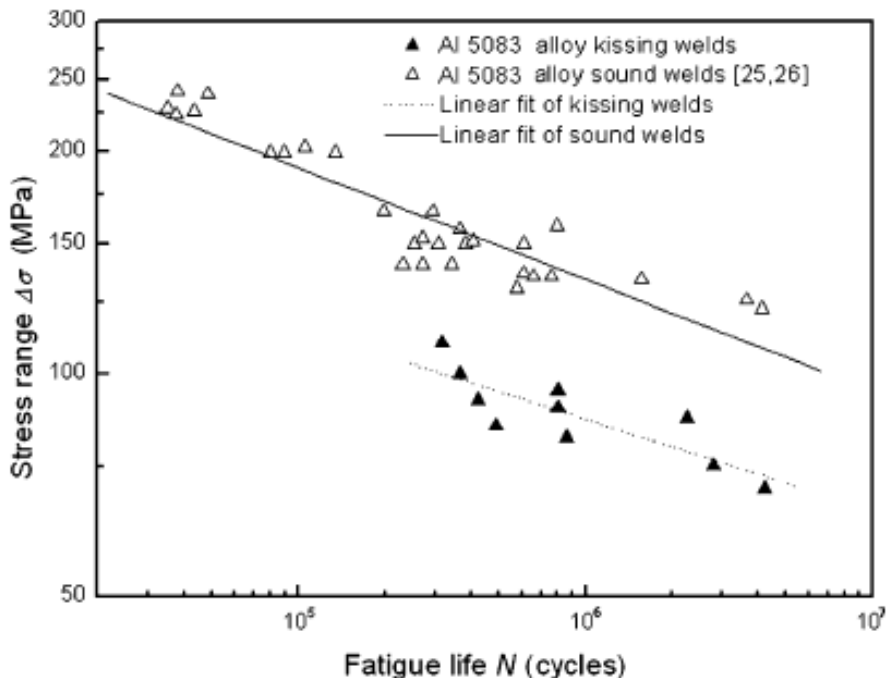
Figure 13. Fatigue data and corresponding S-N curves of AA 5083 kissing bonded and sound welds [18].

Zhou et al. reported that kissing bonds reduce the fatigue life of FS welds in both low-cycle and high-cycle fatigue, but especially in the former [18]. Figure 13 shows fatigue data obtained for AA 5083. The group found the fatigue life of AA 5083 FS welds with kissing bonds, in the form of oxide arrays, to be 20 – 40 times less than the fatigue lives of sound welds, under the stress ratio  $R = 0.1$ . For example, compared to sound FS welds, the fatigue properties of the AA 5083 FS welds with kissing bonds were reduced by 35% at  $2 \times 10^6$  cycles [18].

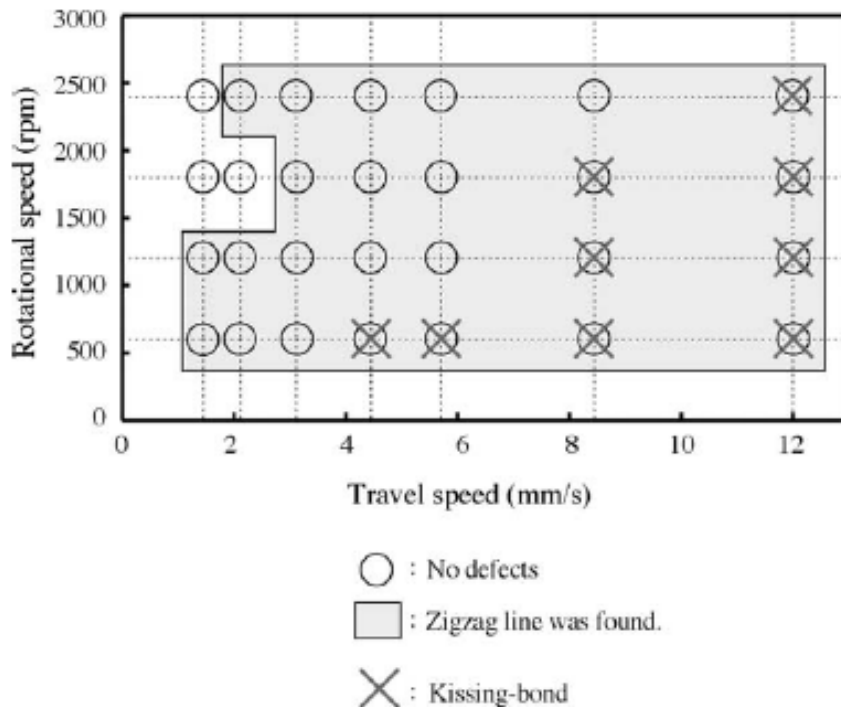
Figure 14. Effect of welding parameters on the formation of a visible zigzag line (upon etching) and kissing bond in an FSW AA 1050 weld [17].

Sato et al. studied the kissing bond in AA 1050 [17]. The study found no defects by either PT or VT in the as-polished cross-section. However, etching in an NaOH aqueous solution, preferentially etched the zigzag oxide-line in the stir zone of all the welds
