## NAVAL MEDICAL RESEARCH UNIT SAN ANTONIO

### CHARACTERIZATION OF THE CLINICAL PERFORMANCE OF A CHAIRSIDE AMALGAM SEPARATOR IN A MILITARY DENTAL TREATMENT FACILITY

**NAMRU-SA REPORT # 2019-14**

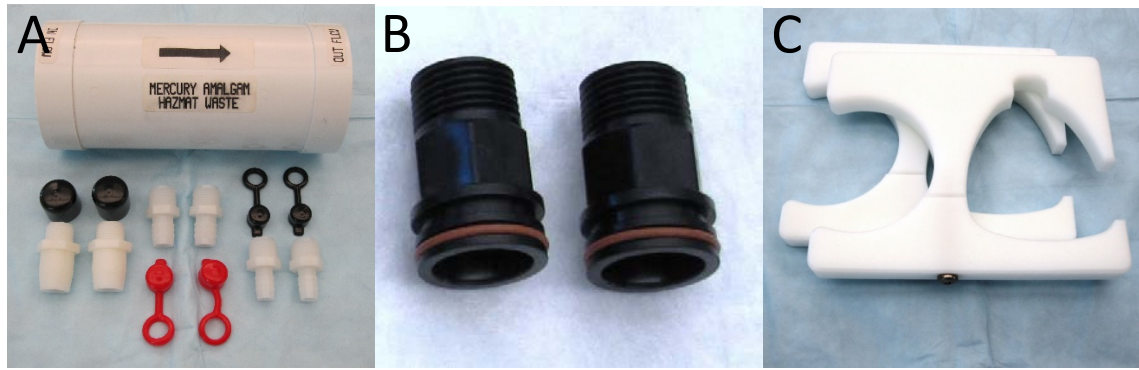
**Figure 1.** The DD2011P chairside amalgam separator with installation parts: **(A)** The DD2011P is packaged with three sets of hose barbs to accommodate different tubing sizes and vinyl caps are furnished to close off the connections when the separator is removed for disposal. **(B)** Quick-disconnect fittings developed by NAMRU-SA and fielded to Navy dental facilities for testing and improved convenience of installation. **(C)** Mounting brackets which anchor the separator to the back of A-dec 500-series chairs.

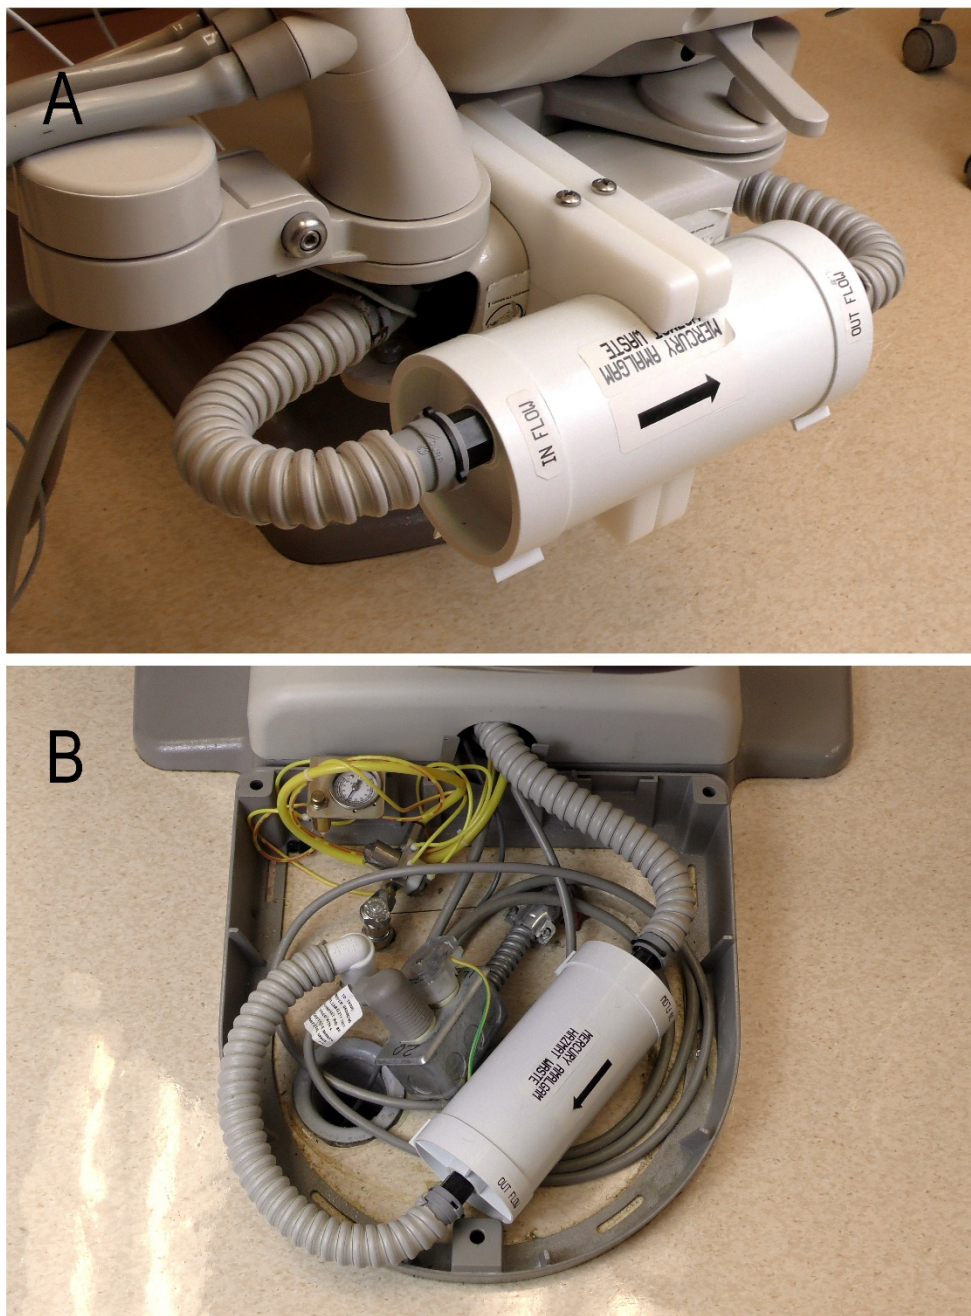
**Figure 2.** A typical installation of the DD2011P chairside amalgam separator (white cylinder) on the rear support link of an A-Dec 500-Series dental chair (**A**). This particular installation makes use of the optional mounting brackets (white clamps with screws). An alternative installation is shown (**B**) in which the separator is contained within the floor box under the chair. Both installations illustrate the use of the quick-disconnect fittings (black).

Greater convenience and ease of use can be achieved in other ways as well. For our test installations, we used the recently developed quick disconnect fitting, which replaces the hose-barb to tubing, friction-fit installation with a male coupling that adapts the separator to connect directly with the A-dec chairs' native quick-disconnect female fittings (**Figures 1 and 2**). We visited the clinic every other week to collect effluent samples, vacuum data, and check the suction on our test chairs. During the year-long course of our investigation, we did not observe any leakage or deterioration of the fittings we installed, and only in two instances did the fittings break: One was due to frequent articulation of the dental chair to accommodate a left-handed dentist which caused repetitive acute flexural strain on the connection, and the other was a stress crack that began in the threads after months of being repeatedly disconnected and reconnected. Under normal use, the lifespan of these fittings could be several years (as they can be removed from spent separators and re-used if desired), and overall, the benefits of their use greatly outweighed the minimal cost: Separator removal and reinstallation was shortened from an approximate 20 minutes to an approximate 3 minutes, required only a Philips-head screw driver, and hoses did not need to be pried or cut from the barbs for disassembly. Cutting the hose just next to the hose barb is faster than prying the hose off the barb, and is a common shortcut employed when changing the separators, however, each time this is done it shortens the hose incrementally, increasing the likelihood of kinks and eventually necessitating hose replacement. Use of the quick disconnects results in separator replacements that are faster and easier than the shortcut and also lack the drawbacks. At the time of this writing, bulk pricing for the quick-disconnect fittings runs about \$5 for a pair. Based on our positive experience, we have recommended these fittings and have distributed them on request at both the Budge Dental Clinic and Navy DTFs around the country. Feedback has been overwhelmingly positive.

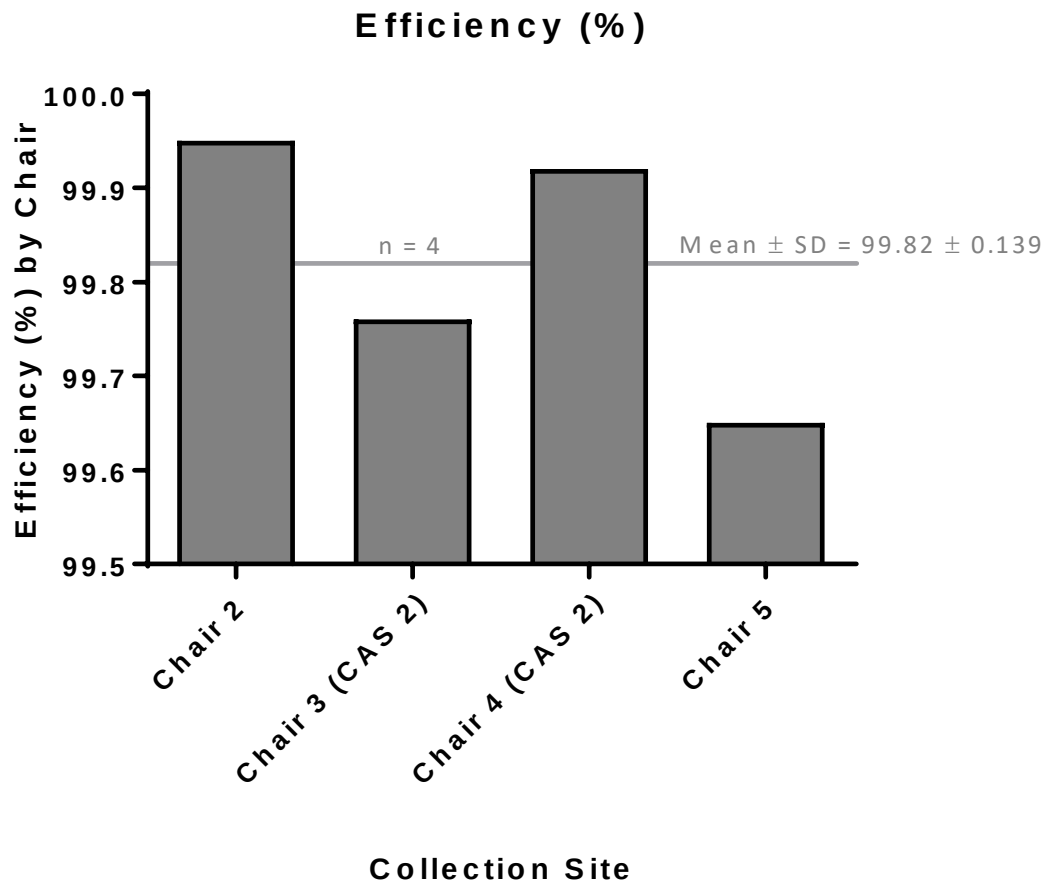
**Figure 3.** Four DD2011P CAS units were recovered from Budge Clinic after their service lives were expended, dried and weighed for total solids analysis, and then re-wetted and subjected to a modified efficiency test based on the ISO 11143:2008 method. A defined mixture of dental amalgam particulate was suspended in filtered water, passed through the spent CAS units, and the mass of dental amalgam exiting the separators weighed to calculate the efficiency. The mean efficiency of four CAS units is represented by the gray line, indicating mean  $\pm$  standard deviation.

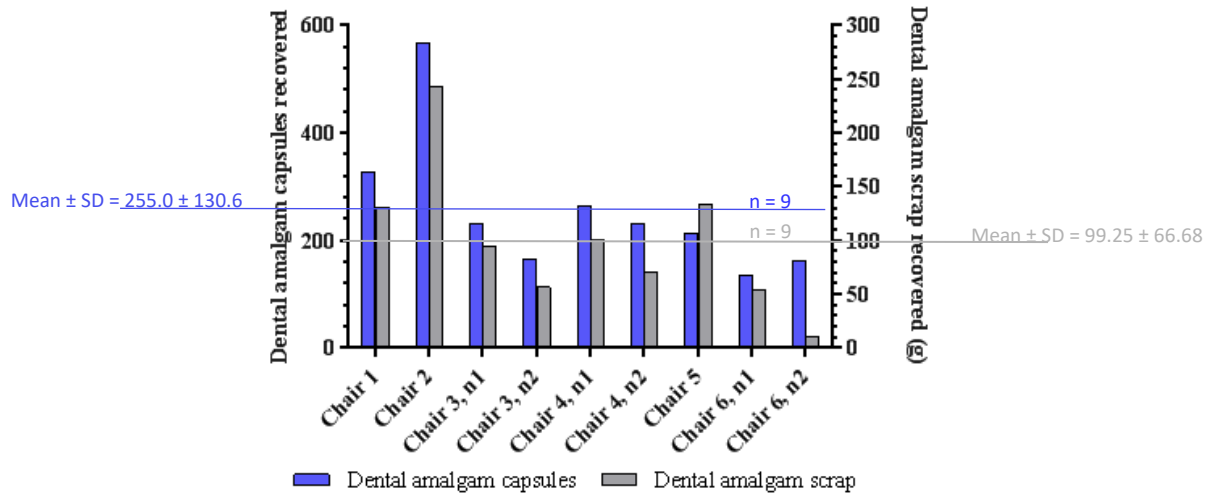
**Figure 4.** Dental amalgam capsules and scrap were recovered at each dental chair for the duration of each separator’s service life. The total numbers of capsules collected during the service lives are displayed in blue, and correspond to the left Y-axis. The total weights in grams (g) of amalgam scrap collected during the service lives are displayed in gray, and correspond to the right Y-axis. The means for nine experimental replicates are represented by the horizontal lines with means  $\pm$  standard deviations.

Total dental amalgam capsules and total dental amalgam scrap were collected at each chair during the full course of each separator's service life and totals were compiled from the bi-weekly collections from the amalgam capsule and scrap collection bins provided at each chair. Amalgam scrap consisted of non-contact scrap that was not used in the restoration, plus excess contact amalgam scrap trimmed from the restoration and recovered from the dental unit evacuation trap. Amalgam scrap was separated from the capsules, composite material, and other contaminants, then weighed. A loose correlation was seen between dental amalgam capsules used and the service life of the CAS, and in general, separators which were in service a short time show fewer amalgam capsules used and less amalgam scrap collected in that time-frame. On average,  $255.0 \pm 130.6$  capsules were used and an average of  $99.25 \pm 66.68$  g of amalgam scrap were collected during a separator's service life (see **Figure 4**).

Examining **Figure 4**, it can be seen that on average, 255 amalgam capsules (each being a 600 mg, two-spill aliquot) were used in a separator's service life, producing 153 g of amalgam ( $600 \text{ mg} \times 255 \text{ capsules} = 153 \text{ g}$ ). Since, on average, 99 g of amalgam scrap were generated during a separator's service life (see **Figure 4**) only 54 g ( $153 \text{ g} - 99 \text{ g} = 54 \text{ g}$ ), on average, would remain to be distributed between dental restorations placed and the separator. Since, on average, 195 g of solids were found in spent separators (see **Table 4**), the contribution of amalgam in new restorations toward total solids accumulated in the separator must therefore be no more than 28% ( $54 \text{ g} / 195 \text{ g} = 0.277$ ), and likely much less, assuming that the majority of non-scrap amalgam is incorporated into the dental restorations placed. When we compare this assessment to the workload characterization provided by the DTF clinical staff (**Table 2**) and the amalgam placement data collected from the clinic database (**Table 1**), it can be seen that amalgam placements were actually much more frequent than could be accounted for by counting spent capsules. This observation perhaps accounts for part of the discrepancy between our capsule-count-based estimate of separator deposit composition (28%) and our observed value (43%), most likely because some capsules were disposed of outside of the specified collection bin, and thus were not available to us for counting. It is possible that amalgam scrap measurements are similarly undervalued. Also, it is worth considering that the difference between our estimated 28% ceiling and the observed 43% must be also partially due to the removal of existing amalgam placements,

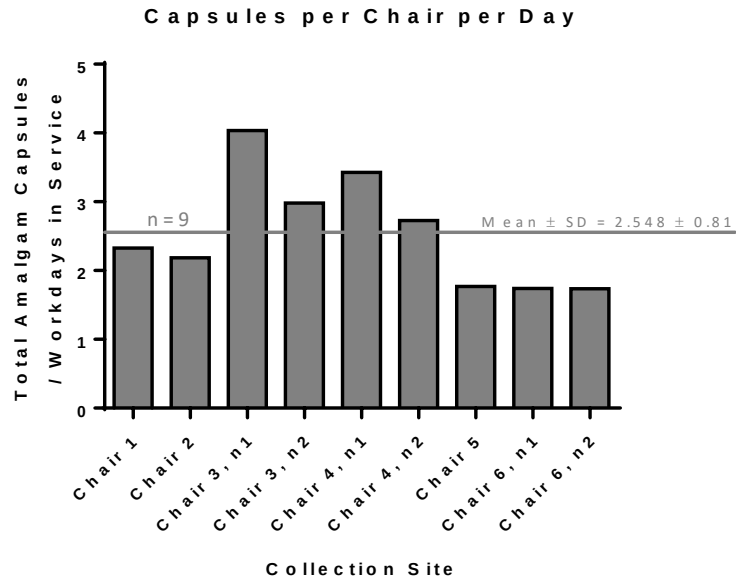
**Figure 5.** The total amalgam capsule count for each separator’s service life (reported in **Figure 4**) was divided by that separator’s total service life in working days (reported in **Table 1**) to calculate the average number of amalgam capsules used per day at each chair. The mean for nine experimental replicates is represented by the horizontal line with mean  $\pm$  standard deviation.

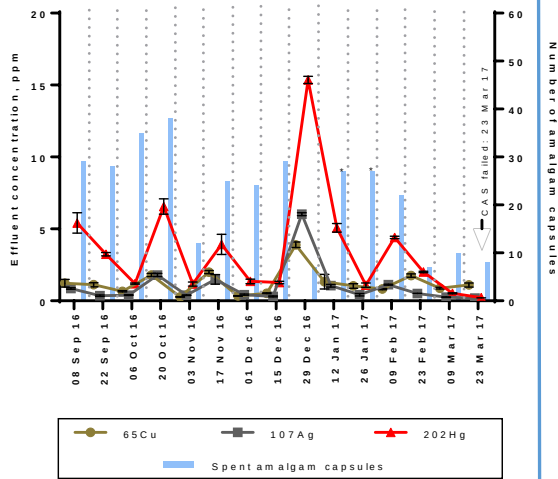
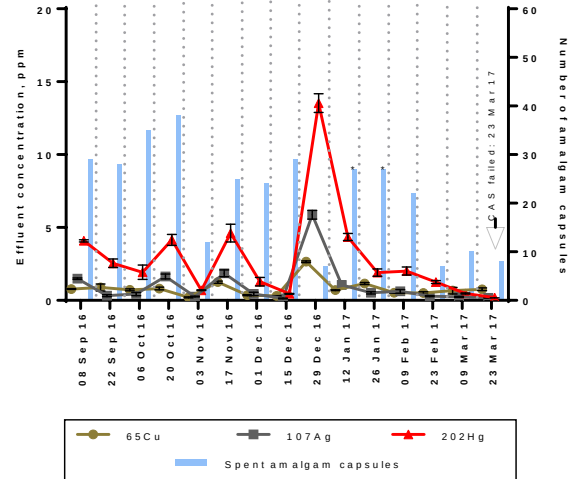
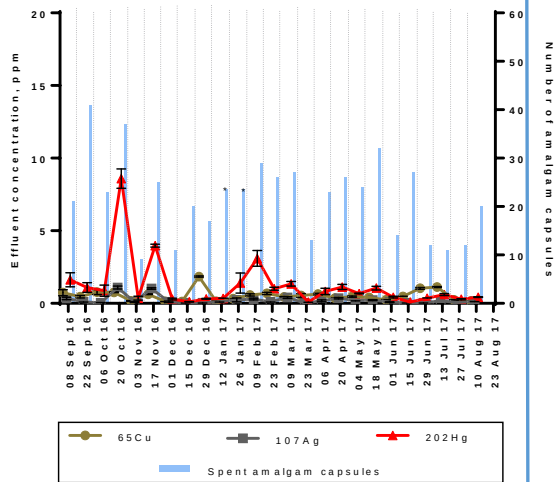
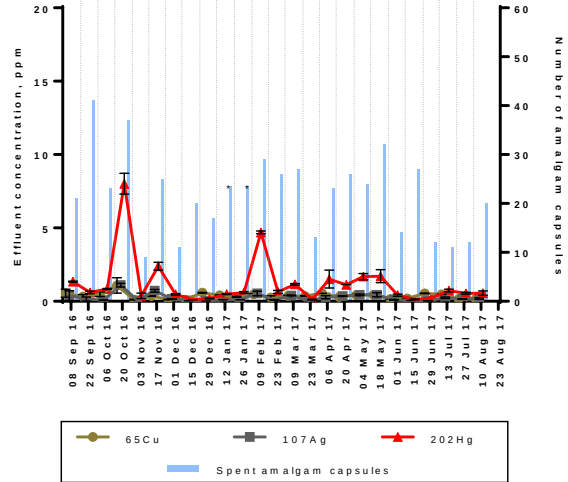
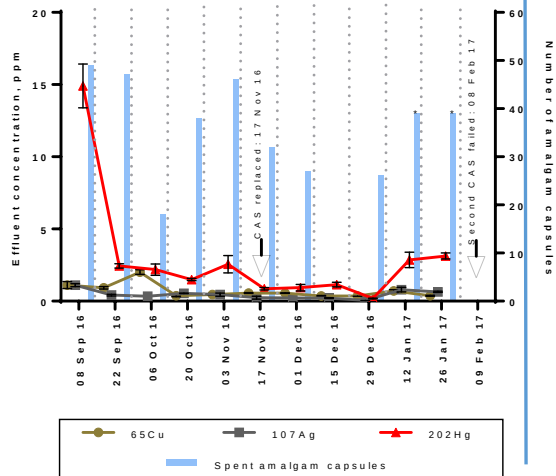
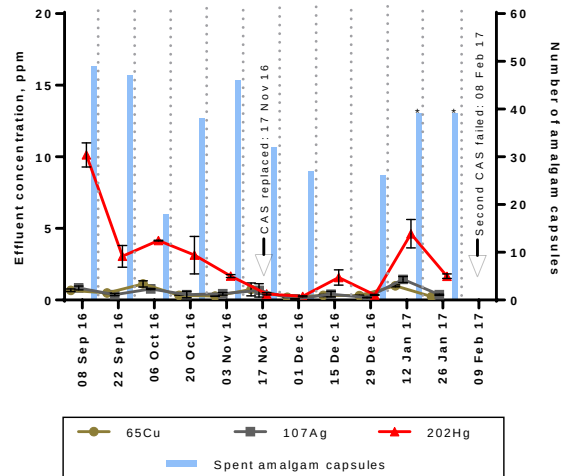
**Figure 6.** Samples of effluent were collected from installed amalgam separators and analyzed for mercury, silver, and copper. Concentrations (ppm) of each metal are shown (reference the left Y-axis), juxtaposed against the number of spent amalgam capsules collected from the corresponding chair during the corresponding period (blue bars, reference the right Y-axis).

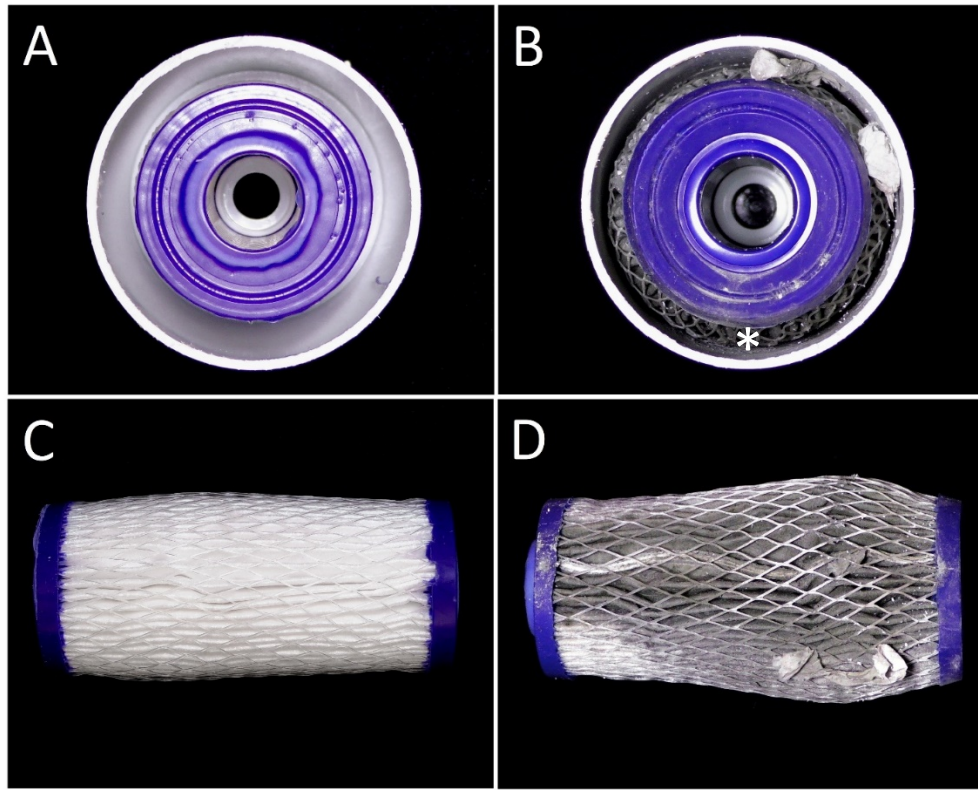
**Figure 7.** Representative cross-sectional and interior views of a DD2011P CAS before installation and at the end of its service life. Panel **(A)**: Cross-sectional view of a DD2011P CAS before installation. Panel **(B)**: Cross sectional view of the CAS at the end of service life. Note the minimal amount of accumulated sediment (white asterick) within the interior space between the filter element and the plastic filter housing. Panel **(C)** shows the interior filter medium removed from a new DD2011P CAS unit. Panel **(D)** shows the same filter medium removed from a CAS at the end of its service life.

All CAS units installed at the DTF consistently failed or reached one year in service with relatively little solid material collected in the fillable space (see **Figure 7**). At the end of their service lives, the six DD2011P CAS units were dried and assayed for total solids accumulated within each separator. For the six CAS units sampled from those expended on the study, total solids in the fillable space were a mean of  $195.4 \pm 63.4$  g (see **Table 4**). We calculated the weight of the fillable volume to be approximately 2,953 g if composed entirely of amalgam particulate, and to be 634 g if composed entirely of lighter, non-metallic materials such as abrasive, tooth, or dental composite. Based on our observation that 43% of the accumulated solids were amalgam (see **Table 5**), the approximate weight of the contents of the fillable space ( $43\% \times 2,953\text{g} + 57\% \times 634\text{g}$ ) is 1,631 g. Therefore, the actual deposits accumulated (195.4 g) are less than 12% of the estimated capacity, supporting the assertion that development of a smaller CAS should be pursued, and is likely possible without impacting service life. However, separator size impacts both the cross-sectional flow area and filter surface area, partially determining performance, and therefore care must be taken in balancing size with efficiency and performance. In turn, if a smaller CAS

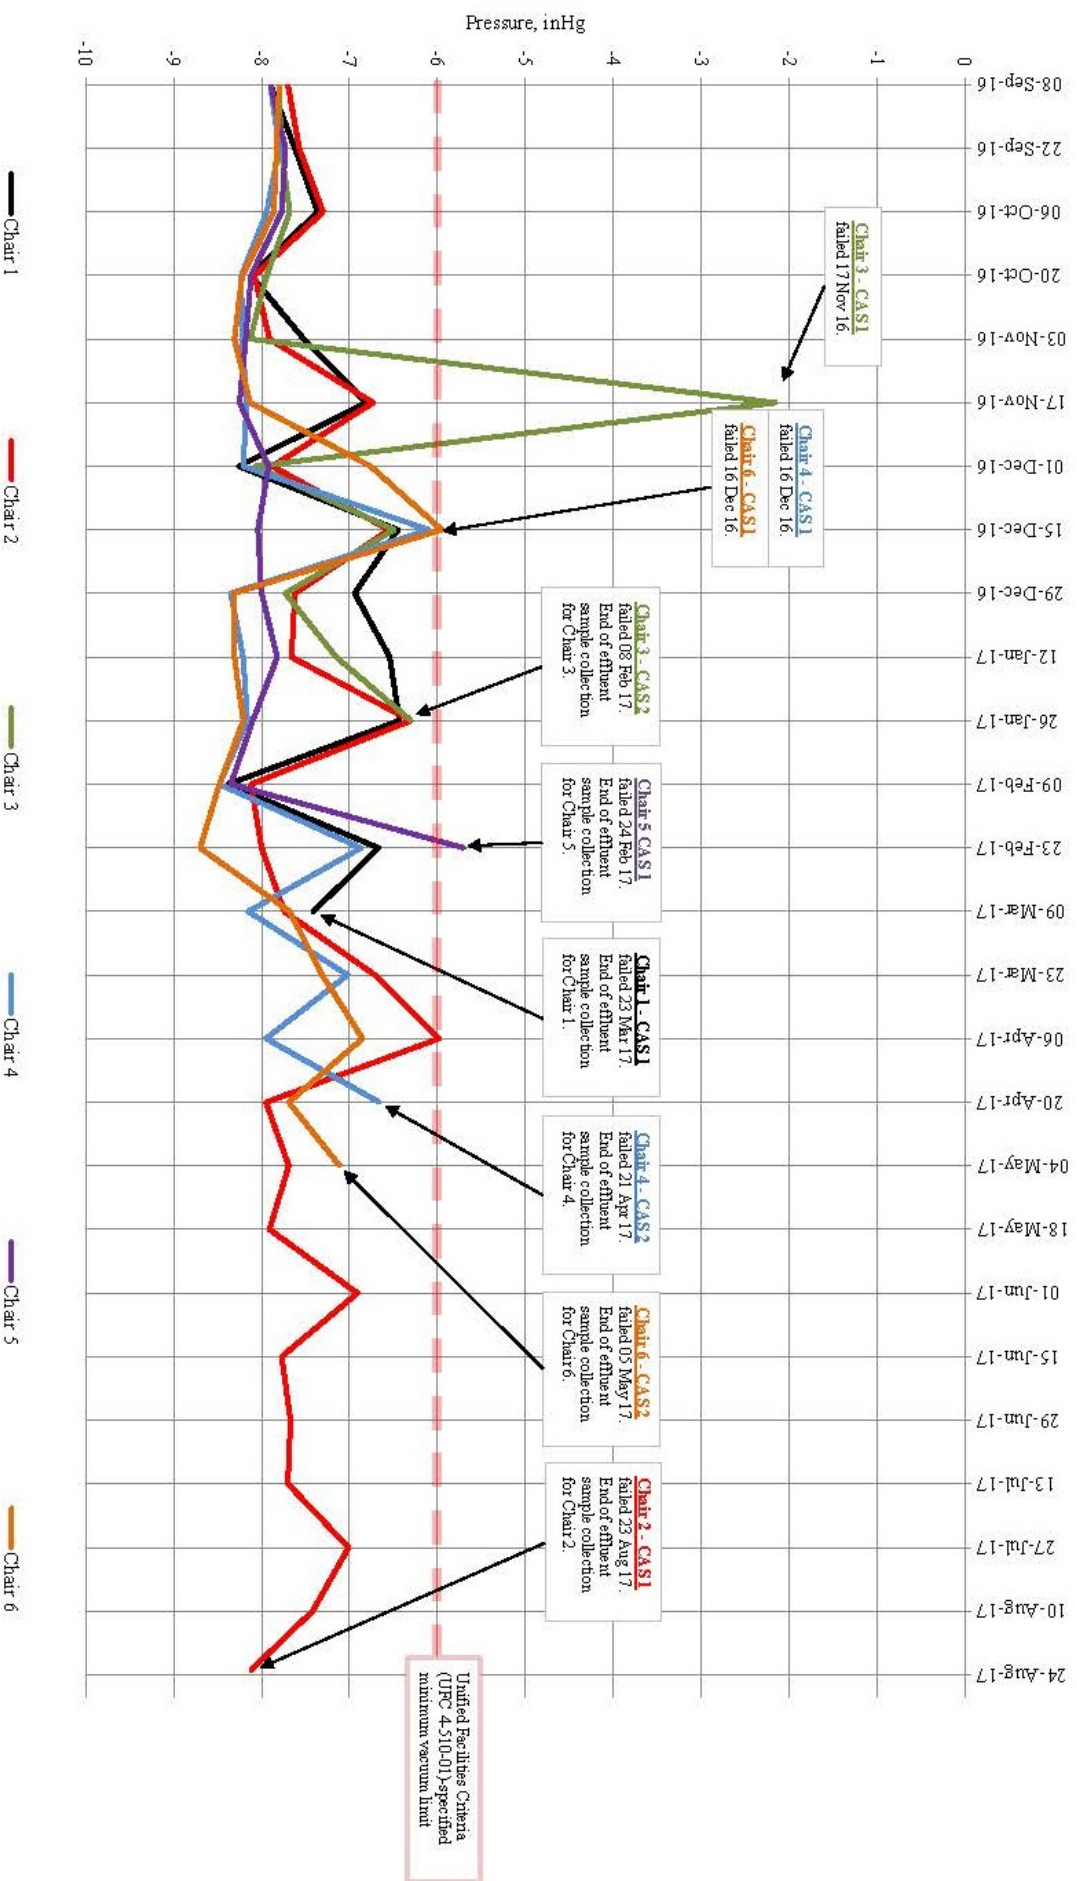
**Figure 8.** Timeline of amalgam separators’ pressure data during their service lives, as recorded during bi-weekly site visits to Budge Dental Clinic. The dates of clinic visits are displayed on the X-axis (top), while pressure readings in inHg, are displayed on the Y-axis. Actual dates of separators’ removals from the study are noted in boxes. Criteria for removal of separators from the study were readings above -6 inHg during our bi-weekly site visits, or complaints from Budge Clinic staff of persistent clogging or poor suction.

As was described in the Results, we noted that on several occasions, dental staff requested CAS unit replacement immediately following effluent collections (see **Figure 8**, Chair 4 - CAS 1 on 16 December 2016, Chair 6 - CAS 1 on 16 December 2016, Chair 1 - CAS 1 on 23 March 2017, Chair 4 – CAS 2 on 21 April 2017, and Chair 6 – CAS 2 on 5 May 2017). While we do not have a definitive answer for why this occurred, we believe that turbulence generated from the fluid bolus applied to the separator to collect our effluent samples redistributed particulate matter across the filter surface, which likely occluded any remaining functional filtration zones.

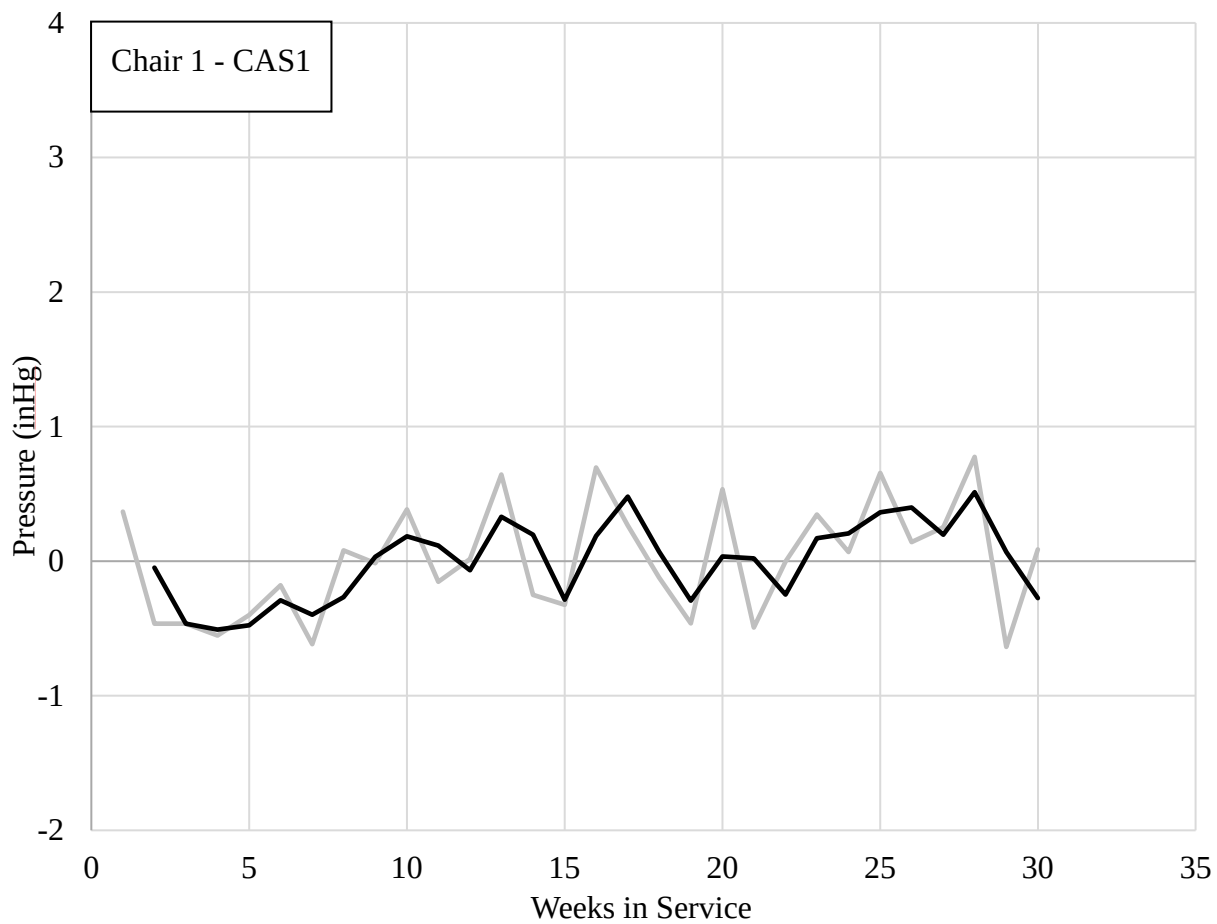
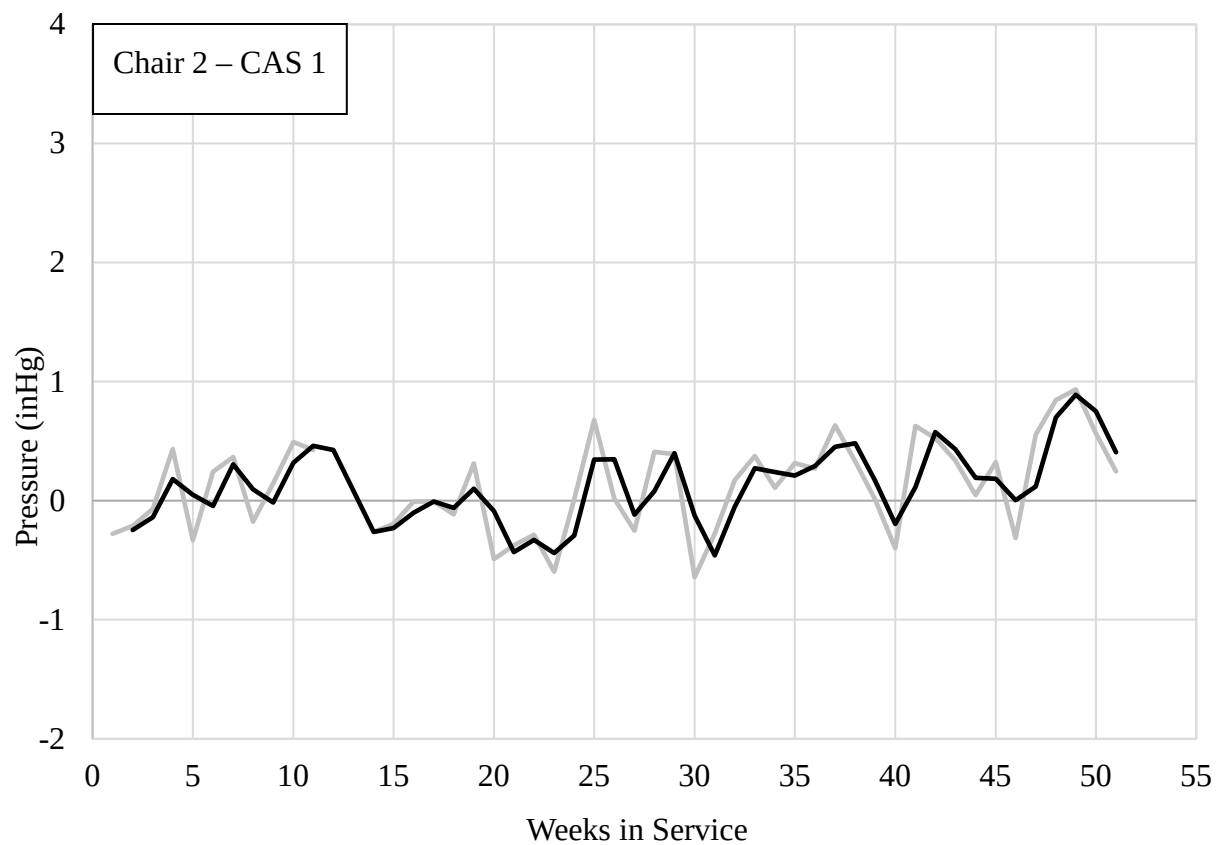
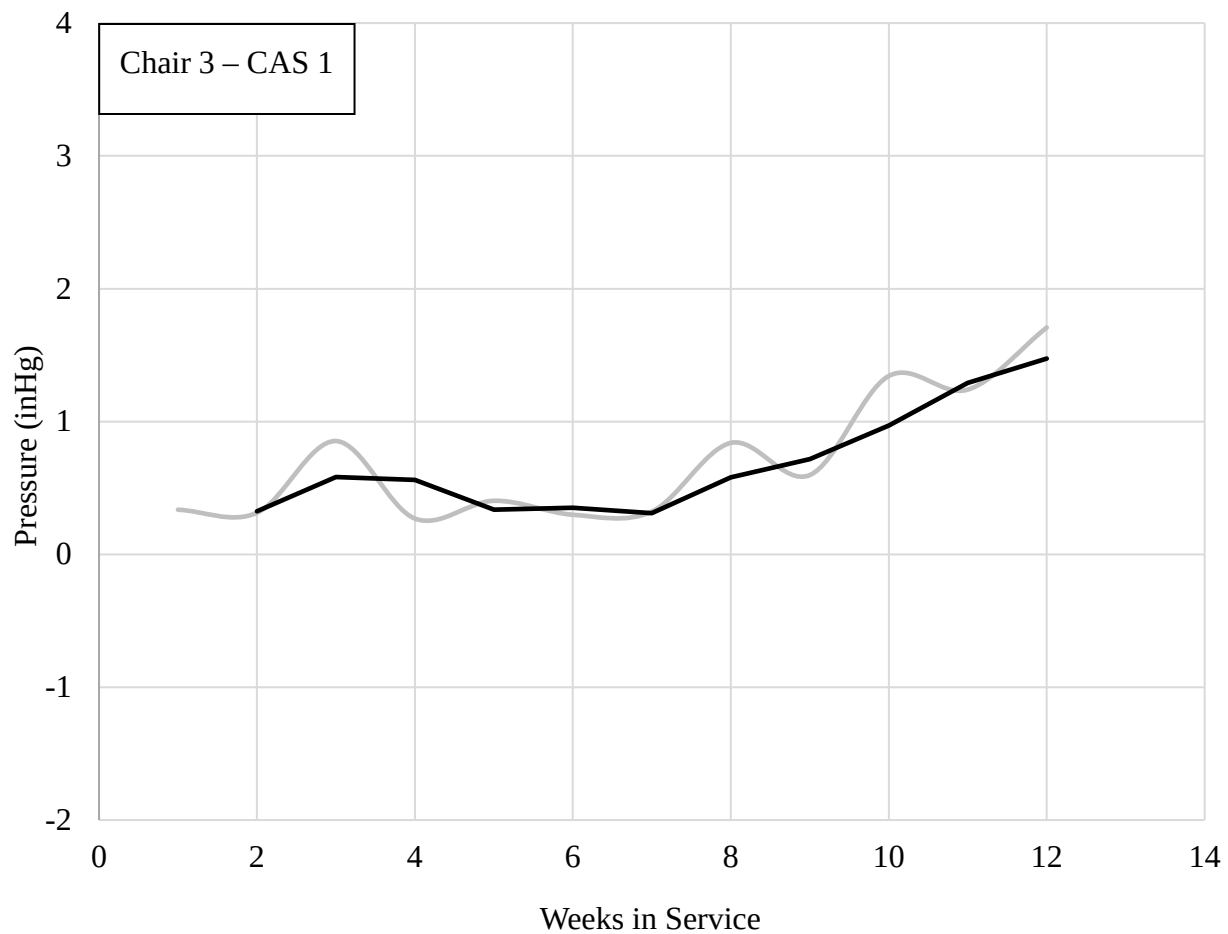
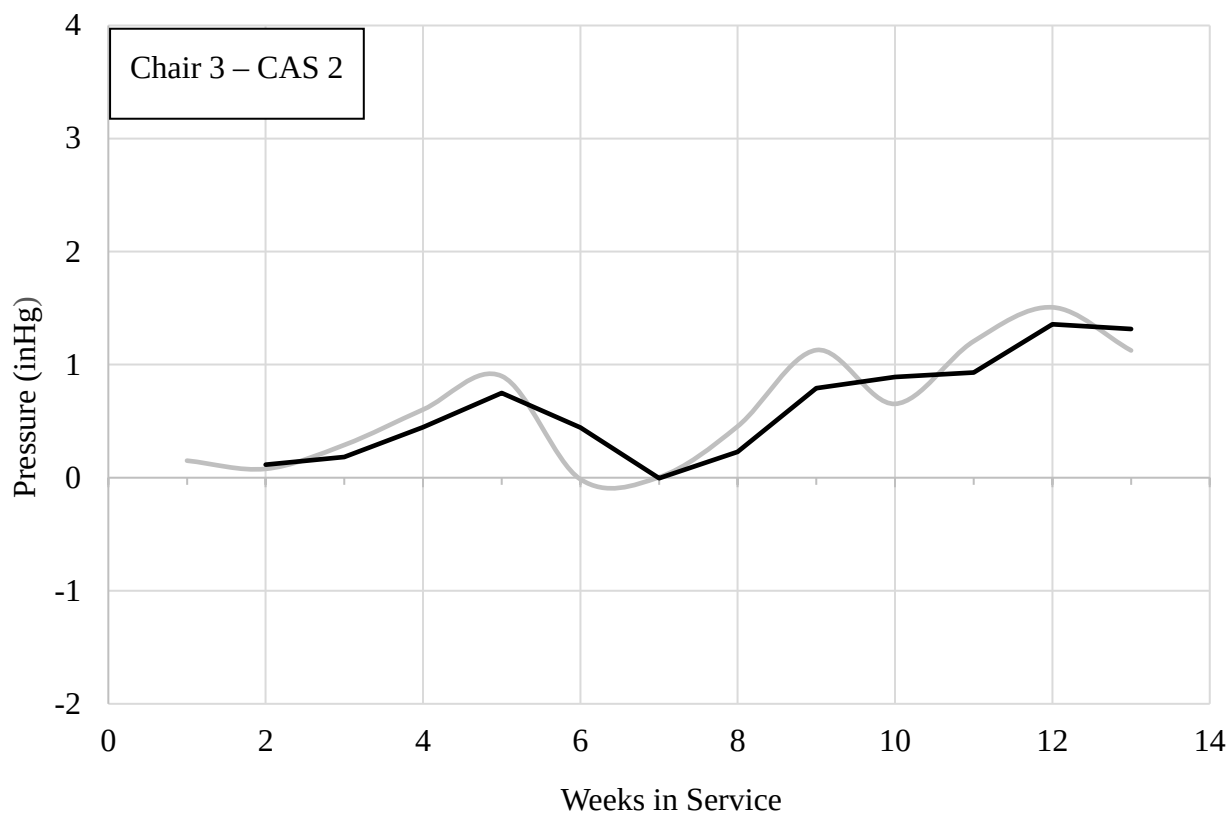
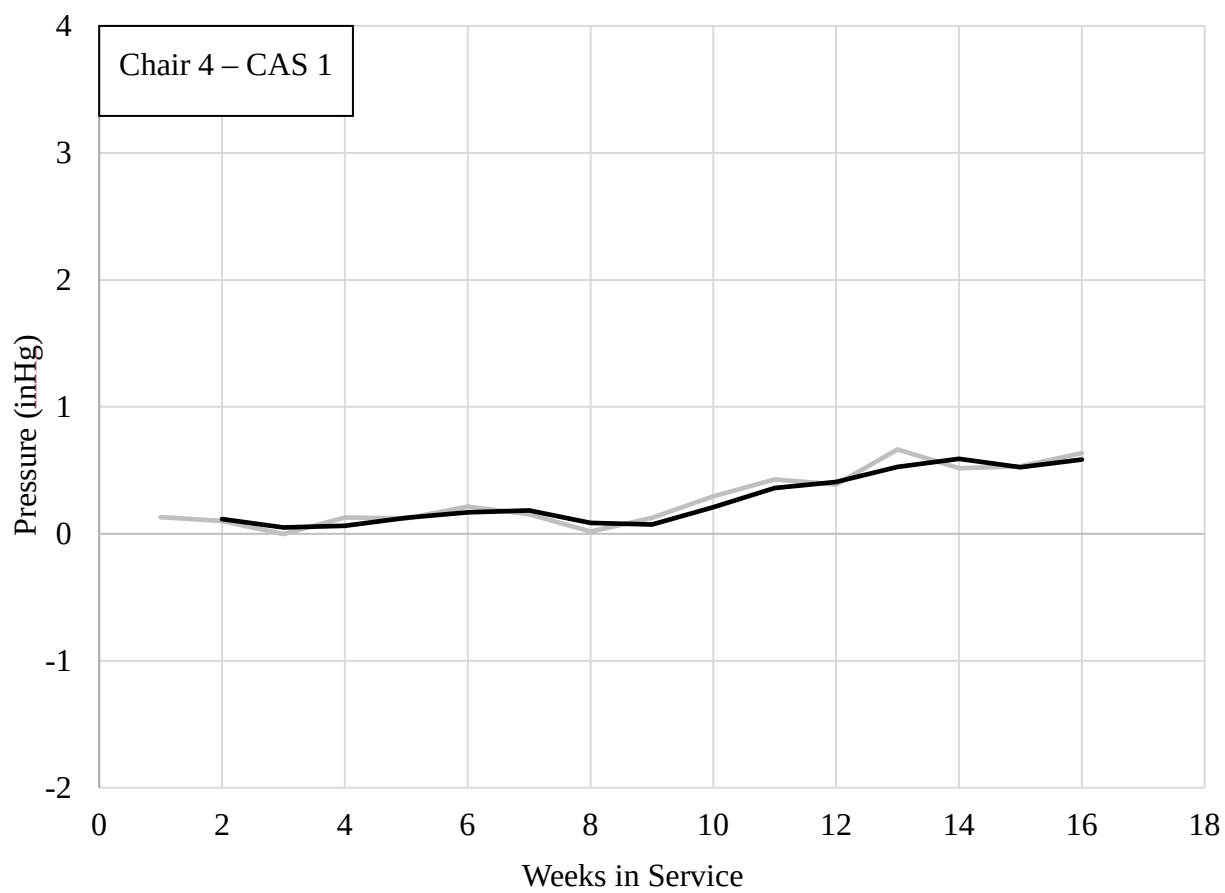
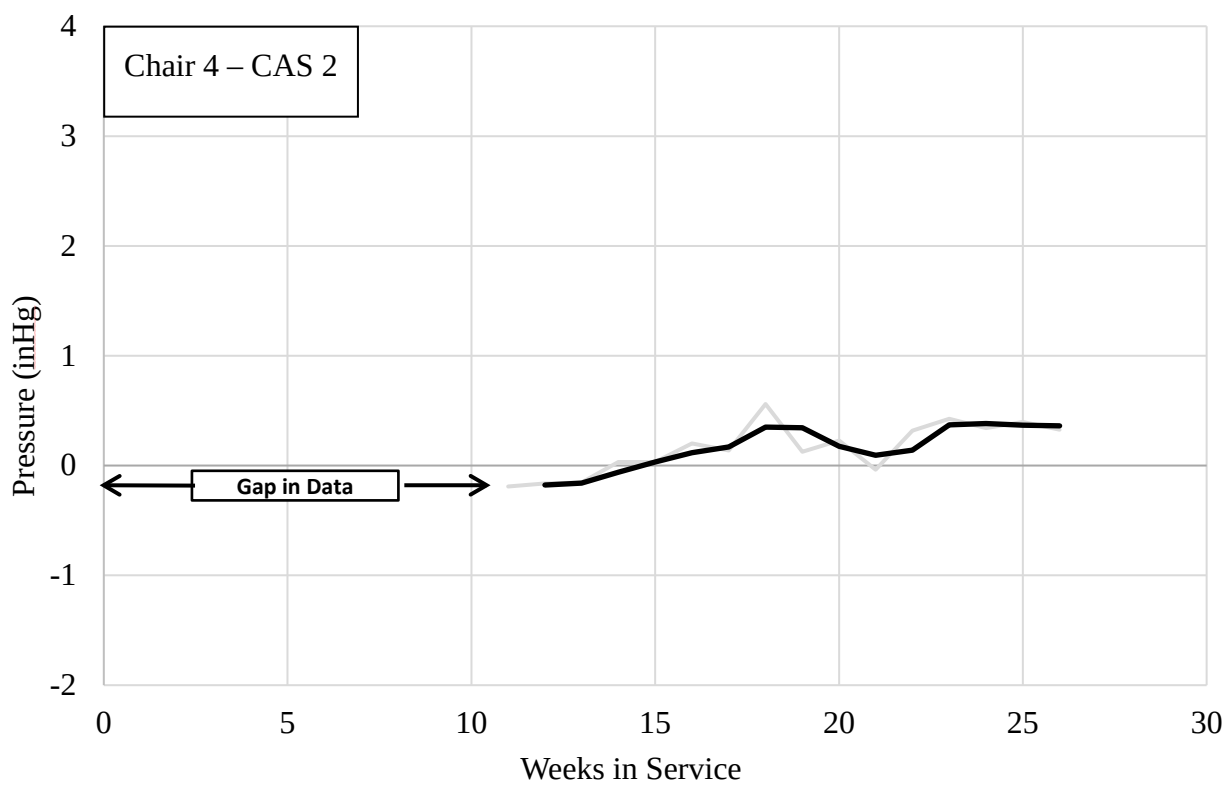
**Figure 9.** Timelines of pressure sensor differential during amalgam separators' service lives. Moving averages were calculated from data collected during working hours. For each chair, the averages of the preceding week's data, analyzed at weekly intervals, are displayed as gray lines. Similarly, the averages of the preceding two weeks' data for each chair, analyzed at weekly intervals, are displayed as black lines. A loose sensor wire caused data drop-out for Chair 4, CAS 2 (4.2) in the 1-10 week period. Chair 6, CAS 2 (6.2) data were corrupted for the last four weeks of the recording. The other seven pressure data timelines run the complete service life from installation to replacement.

averaged. One-week moving averages (gray lines) and two-week moving averages (black lines) of pressure differentials for each chair, calculated at weekly intervals, are shown in **Figure 9**. Across all CASs, using the two-week moving average method, a persistent differential between inlet pressure and outlet pressure is seen to precede failure, although data recorded on Chairs 1 and 4 show a magnitude of pressure drop of approximately half that of the other installations (**Figure 9**, Chair 1 – CAS 1, Chair 4 – CAS 1, Chair 4 – CAS 2).

Scale, on the other hand, would need to be calibrated by other means. A difference in scale can be observed in Chair 4 (**Figure 9**), where the separator failed due to inadequate suction, while the recorded vacuum data showed only half the pressure drop at failure as was observed on other chairs. It may be that this was due to small air leaks between the sensors on chairs 1 and 4, however, the Vac-Check procedure we performed indicated sufficient suction at the HVE tip, which would have been inconsistent with HVE system leaks. More likely, this scaling issue was due to sensor drift, skewing the accuracy of the readings, and thus causing a reduction in the read pressure differential. Since the same observation is true for both Chair 4 data sets (Chair 4 – CAS 1 and Chair 4 – CAS 2), additional weight is added to this supposition. More weight for this
