## **DEMONSTRATION OF ICE PIGGING TECHNOLOGY TO REMOVE BIOFILMS IN WATER DISTRIBUTION SYSTEMS**

**Energy and Water Projects  
EW-201510**

**March 2019**

**Naval Facilities Engineering and Expeditionary Warfare Center**

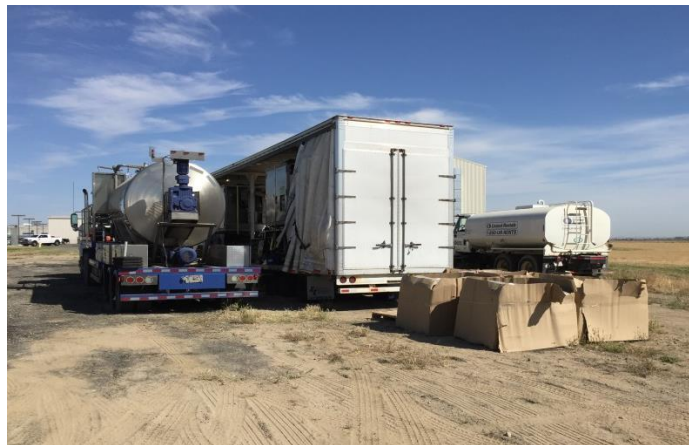
**Figure E-1. Ice Production Setup Showing the Delivery Rig (left) and Ice Machines (right)**

The brine is prepared in a 316 stainless steel delivery tanker with hoses connected to ice machines that are mounted on a separate trailer (Figure E-1). The brine is fed into the ice machines which, in turn freeze the liquid and returns it to the delivery tanker. This cycle continues until the ice slurry is at certain consistency labeled as the ice fraction. Ice fraction measures the amount of ice crystals as a percentage of total volume. Ice fraction is related to the cooling capability of the slurry compared to pure ice (100%); this is known as the Calorimetric Value. Ice Pig operators use a simple French press coffee plunger (Figure E.2) to test the "ice fraction" (or the ice thickness) on site prior to pumping the slurry into the main. Typically, the thickest ice slurry is used on plastic and sound concrete lined pipes as well as asbestos cement pipes (ACP). But when older unlined cast iron pipes are cleaned, a thinner ice slurry is used that does not clean as aggressively to avoid pipe damage. The thinner ice slurry will not disturb the

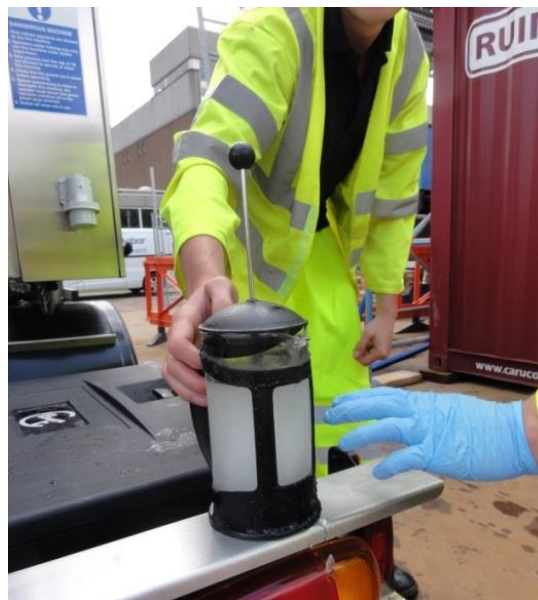
**Figure E-2. French Press Method of Testing the Ice Fraction**

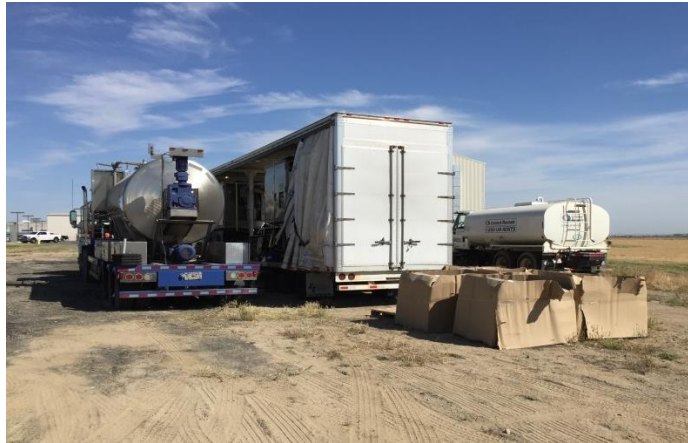
**Figure 1. Ice Production Setup Showing the Delivery Rig (left) and Ice Machines (right)**

The brine is prepared in a 316 stainless steel delivery tanker with hoses connected to ice machines that are mounted on a separate trailer (Figure 1). The brine is fed into the ice machines which, in turn freeze the liquid and returns it to the delivery tanker. This cycle continues until the ice slurry is at thickness known as the ice fraction. Ice fraction measures the amount of ice crystals as a percentage of total volume. Ice fraction is related to the cooling capability of the slurry compared to pure ice (100%); this is known as the Calorimetric Value. Ice Pig operators use a simple French press coffee plunger (Figure 2) to test the "ice fraction" (or the ice thickness) on site prior to pumping the slurry into the main. Typically, the thickest ice slurry is used on plastic and sound concrete lined pipes as well as asbestos cement pipes (ACP). But when older unlined cast iron pipes are cleaned, a thinner ice slurry is used that does not clean as aggressively to avoid pipe damage. The thinner ice slurry will not disturb the buildup of tuberculation which could damage the integrity of an old heavily corroded unlined cast iron pipe.

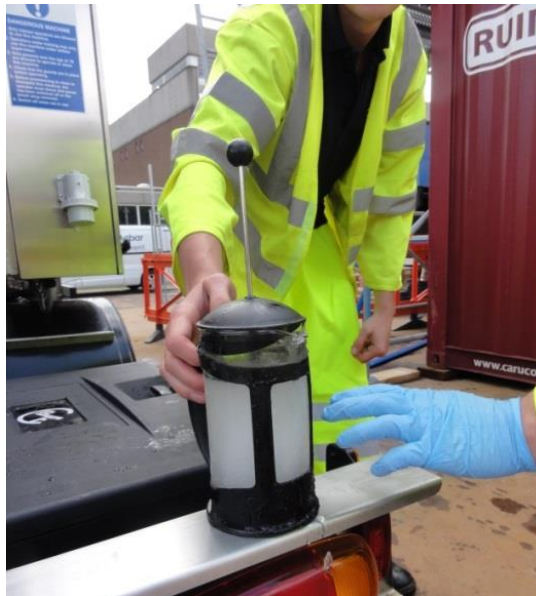
**Figure 2. French Press Method of Testing the Ice Fraction**

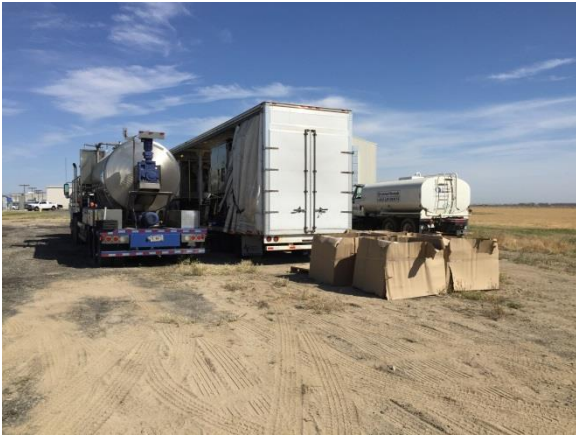
**Figure 6. Making Ice On-Site**

Figure 3 (in Section 2.1) shows a schematic of an overall ice pigging process. Figures 6 through 11 depict the main components of an ice pigging system and an ice pigging operation in action.

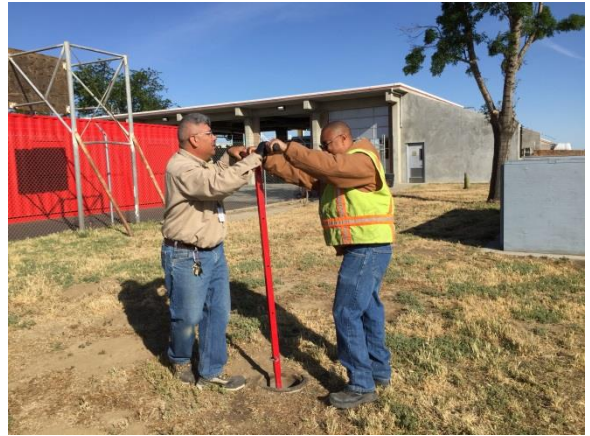
**Figure 7. Isolating Valves Up- and Down-Stream**

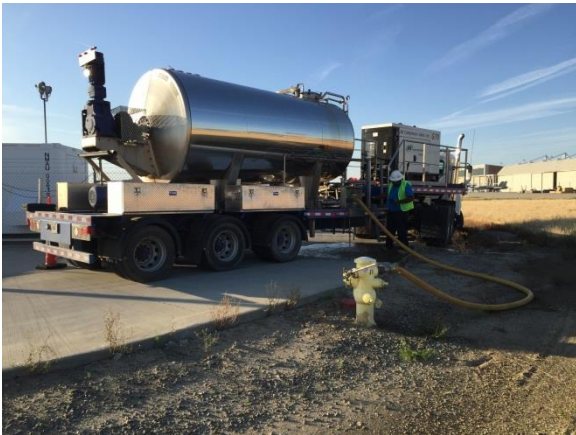
**Figure 9. Inserting Ice Slurry into Upstream Hydrant**

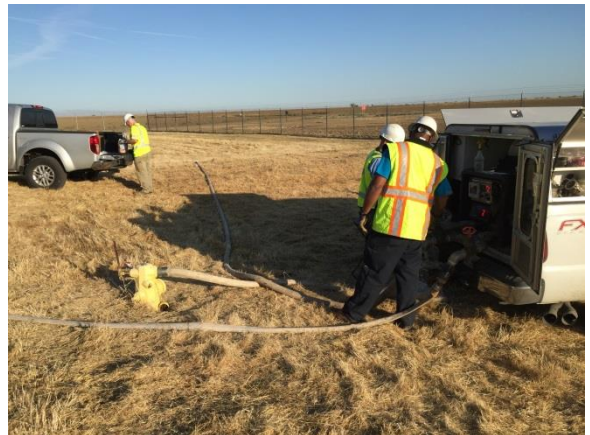
**Figure 8. Extracting Ice at Downstream Hydrant**

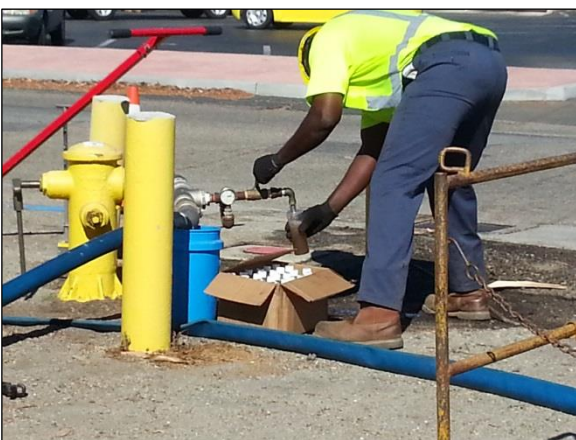
**Figure 10. Collecting Samples during Ice Extraction**

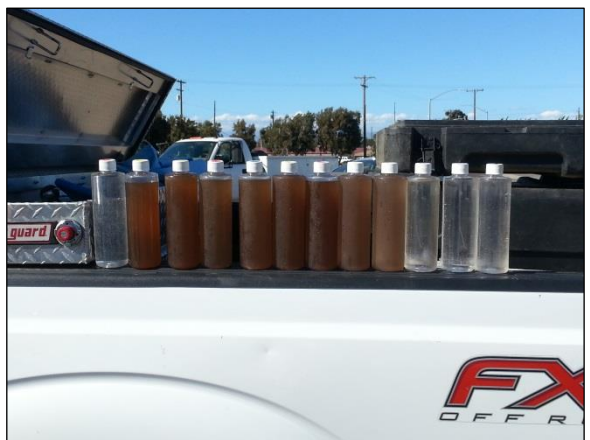
**Figure 11. Samples of Ice Slurry during Ice Extraction**

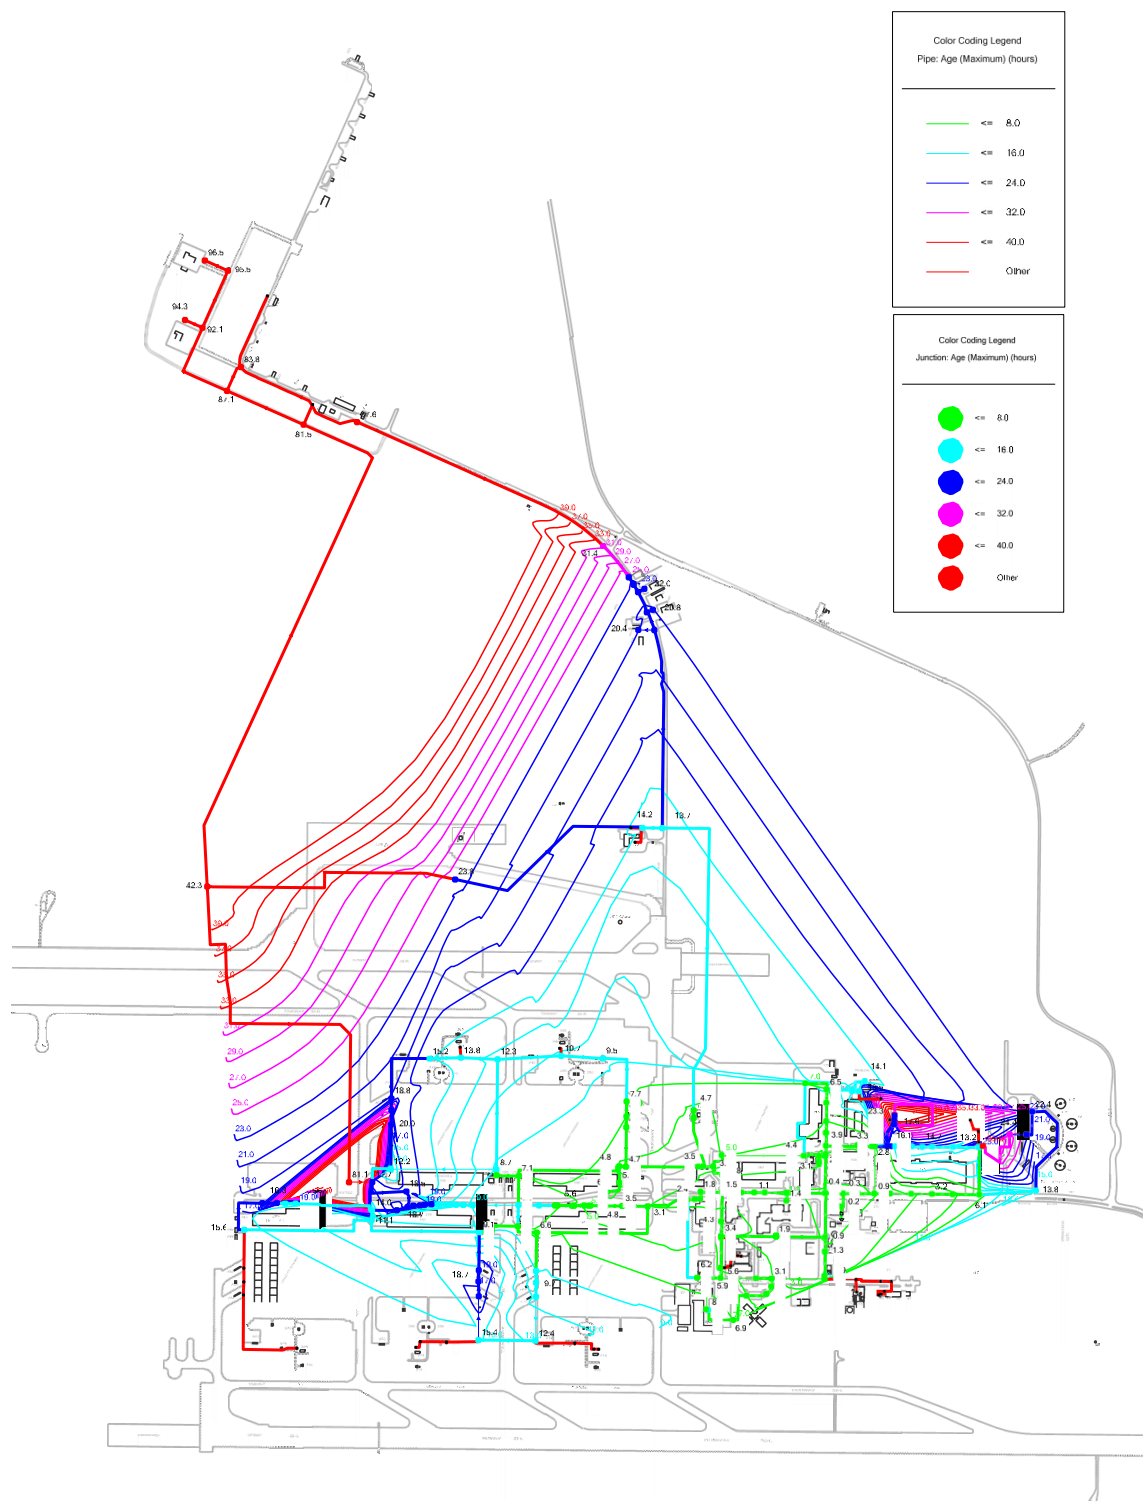
**Figure 12. OPS Area Water Age Analysis**

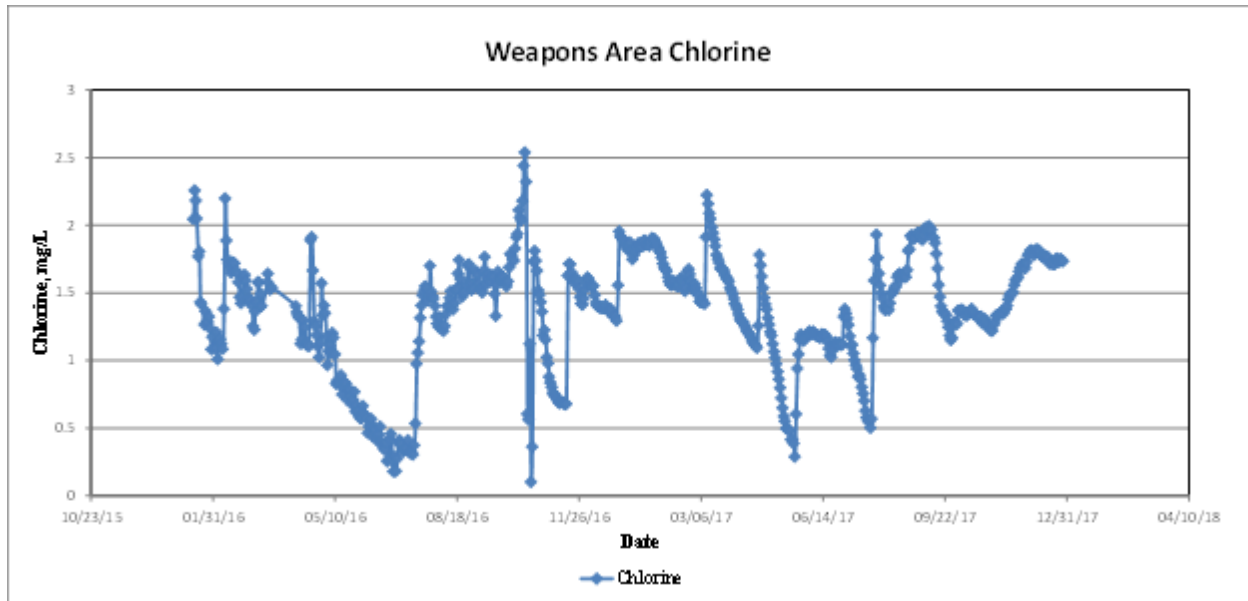
**Figure 24. Daily average of chlorine residual in the Weapons Area.**

Chlorine residual is typically lower in the far end of the distribution system. Chlorine residual by itself is not a good indicator of how well the system performs. Other factors, such as differences in residual between upstream and far end area, and intensity of flushing to maintain adequate residual in the system should be considered. Figures 24 and 25 show that chlorine residual post-ice pigging is not significantly different from the baseline and varies based on the chlorine set point in the incoming water. The average monthly residuals upstream (Building 10) and downstream (Weapons Area Building 440) post-ice pigging are 1.79 and 1.5 mg/L, respectively, which is within 16% difference. The data show that post-ice pigging the residual was adequately maintained with minimum hydrant flushing. The improvement can be attributed to both the recirculation in the dead-end area to reduce water age and ice pigging to clean the pipes.

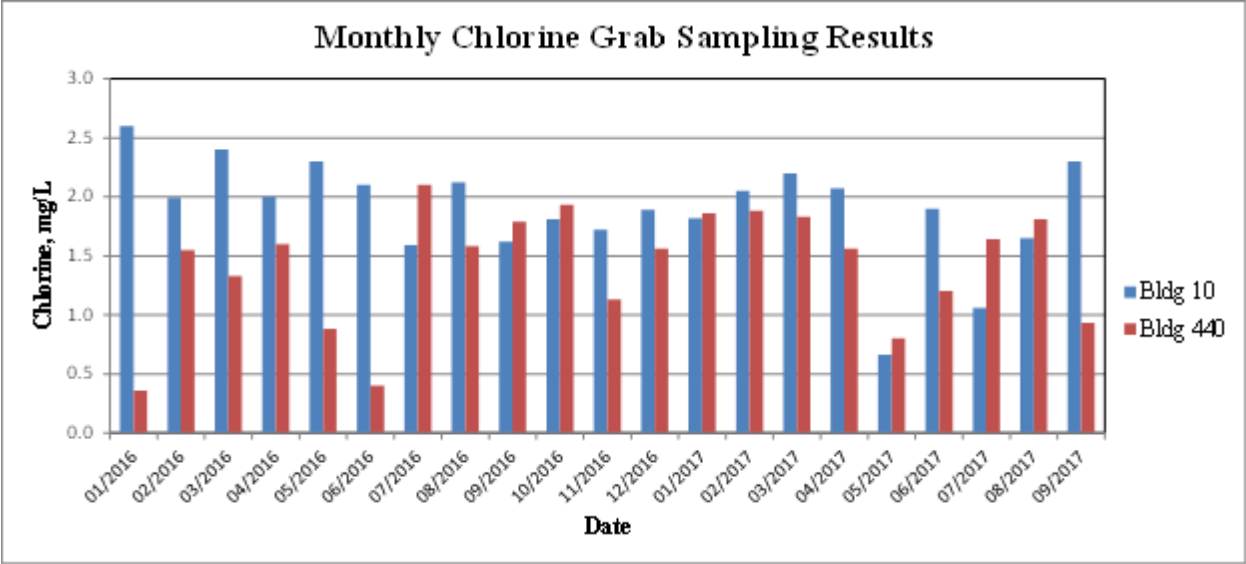
Figure 25. Monthly chlorine grab-sampling results.

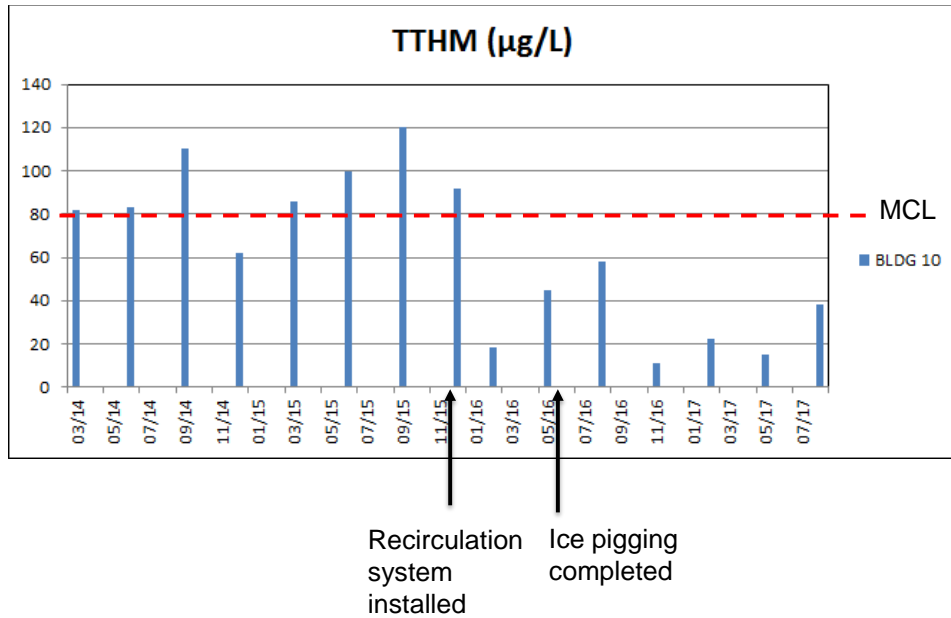
**Figure 26. TTHM Compliance Monitoring Results**

The presence of biofilms and TOC in pipelines results in the reaction of chlorine with these constituents and the production of disinfection byproducts (DBPs) such as TTHM and HAAC (Wang et al, 2013). Thus, the removal of biofilms can increase the chlorine residual levels, and reduce DBP production. Figure 26 shows the results of TTHM compliance monitoring. As shown in the figure, there were multiple MCL exceedances prior to ice pigging. After ice pigging, TTHM concentrations were consistently below 80 µg/L and compliance was achieved post-ice pigging. Ice pigging removed carbonaceous compounds including biofilms deposited on pipe walls that can react with chlorine in water to form TTHM and other DBPs.

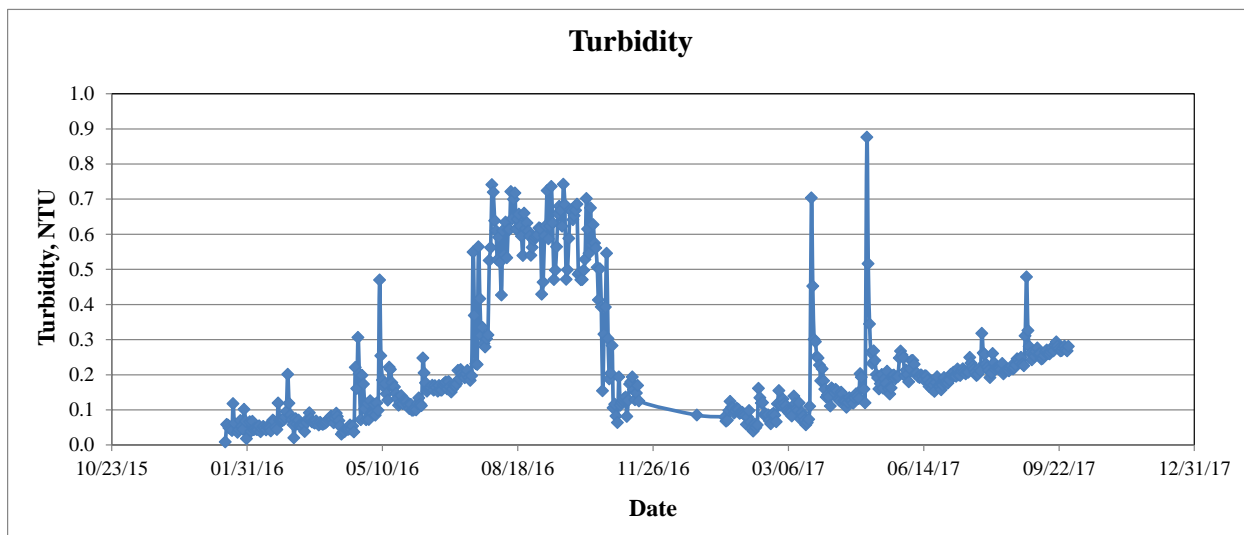
**Figure 27. Turbidity levels in the Weapons Area distribution system**

Turbidity levels in the distribution system is impacted by raw water quality, water treatment process, and by the release of accumulated sediments and biofilms into the water phase. Raw water quality of the surface water source varies to some extent with the seasons, particularly with respect to TOC levels. Since there have been no major changes in the water treatment process at NASL, the main cause of changing turbidity levels in the distribution system is likely due to the release of sediments and biofilms under different flow demand conditions. The data shown in Table 11 indicate that significant amounts of sediments were removed by ice pigging. Moreover, as discussed in Sec. 6.2.3, ice pigging has also resulted in the removal of biofilms. Thus, the turbidity levels can be expected to be lower post ice-pigging in the distribution system. However, turbidity results post-ice pigging were about the same, and not lower than the baseline level, as shown in Figure 27. The changes in turbidity levels are not discernable due to the low turbidity levels pre- and post-ice pigging. In both cases, turbidity changes from ~ 0.1 NTU in Winter to less than 0.3 NTU in Spring. It appears that although sediments and biofilms were present on pipe walls prior to ice pigging, turbidity was low because no suspended solids were released into the water under those flow conditions.
