## **A Snow Runway for Supporting Wheeled Aircraft**

Phoenix Airfield, McMurdo, Antarctica

Final Report

Under Engineering for Polar Operations, Logistics, and Research (EPOLAR)  
EP-ANT-15-01, "CRREL Support to Alpha Site Runway"

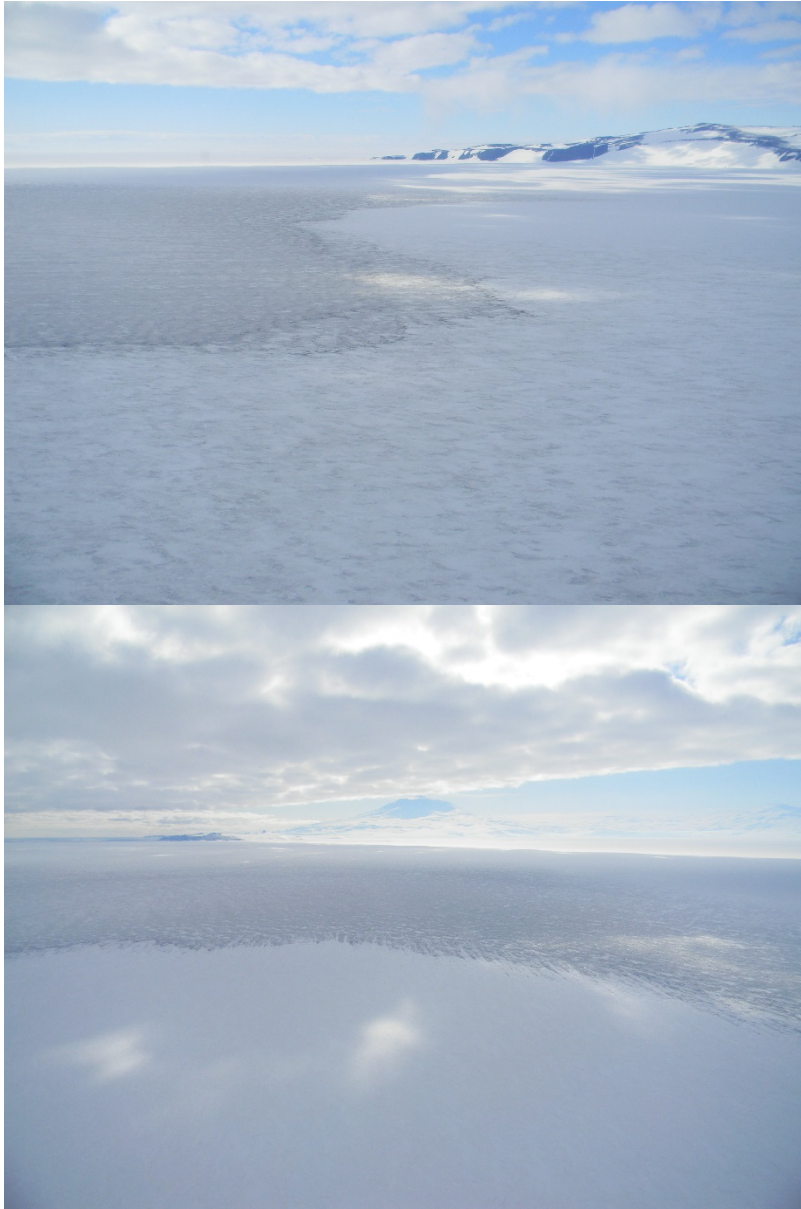
Figure 14. Curvilinear south edge of contaminated area 1a depicted in Fig. 12 and Fig. 13 (*top*: view looking east-southeast toward White Island) and sharpness of the boundary between contaminated and clean snowpack (*bottom*: view looking north towards Mt. Erebus).

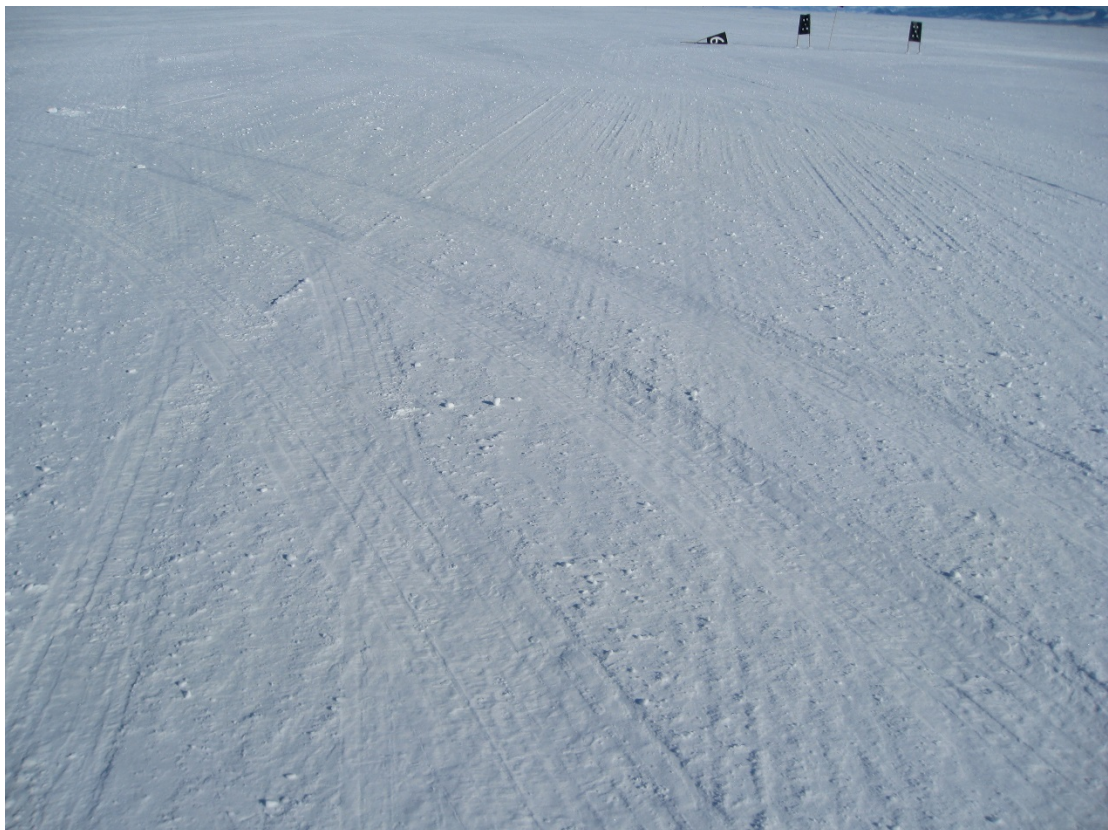
Figure 65. Close-up view of C-17 taxi tracks at the north end of the airstrip.

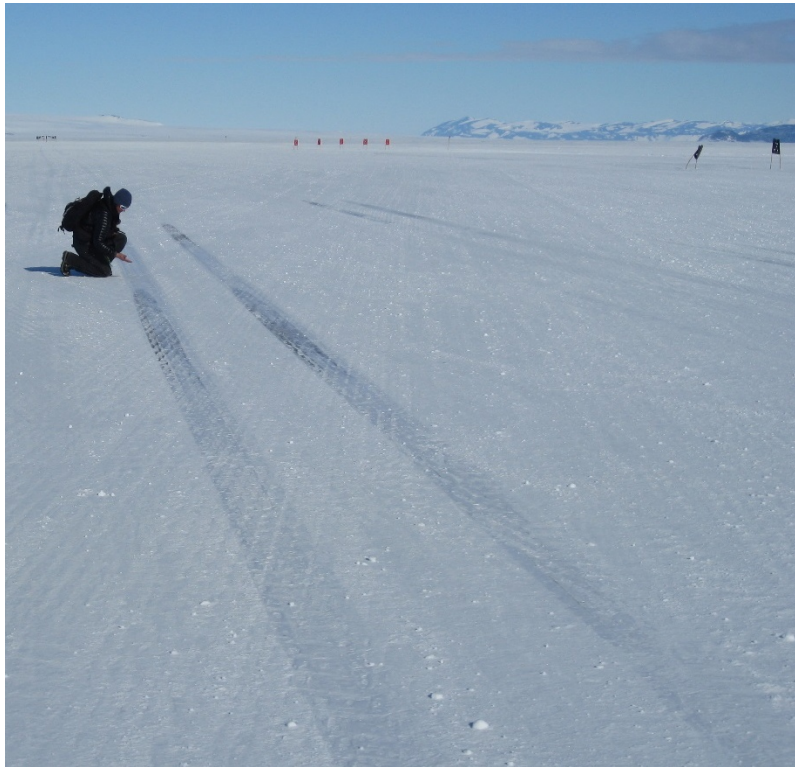
Figure 66. Tracks of eroded rubber from a C-17 landing.

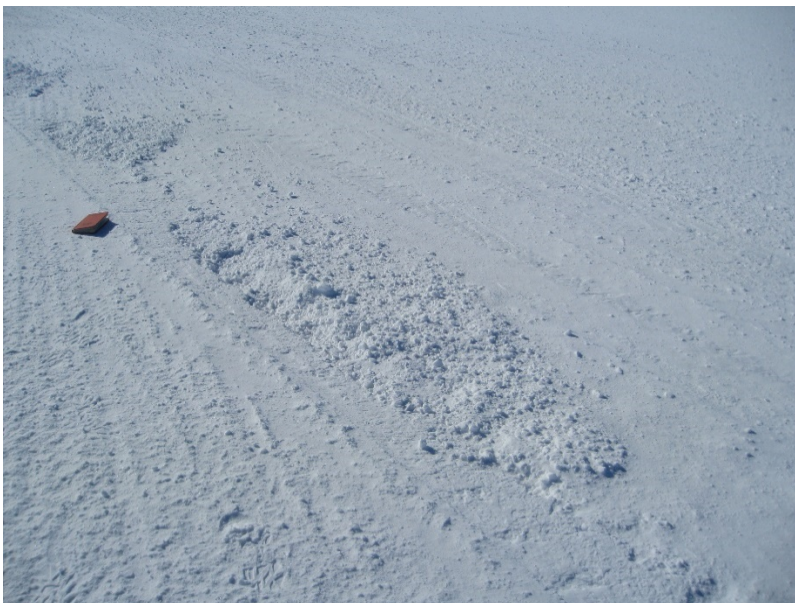
**Figure 68.** One of a handful of areas showing rutting of the runway surface with the passing of aircraft tires.

Secondly, several areas showed some degradation of the pavement surface. These took the form of slight “unravelling” of the surface (Figure 67) to outright rutting (Figure 68). Both types of surface disturbances represented a tiny percentage of the area touched by the aircraft tires, and neither was detectable by the aircrew when they occurred. Nonetheless, these areas were of keen interest to the project team since they represent strength levels that perhaps were on the margin of adequate.

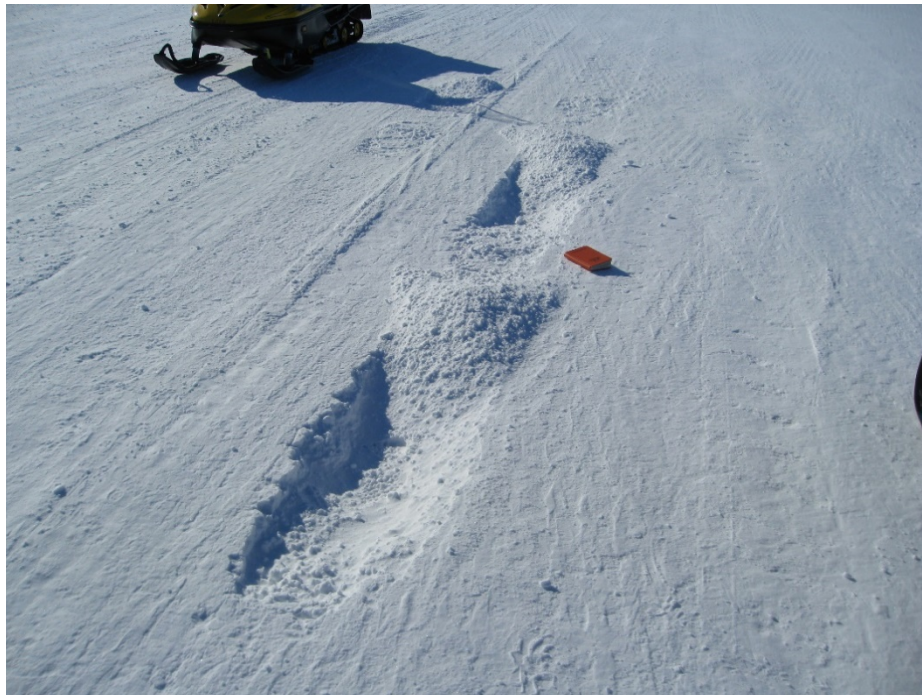
Figure 70. Isolated but deep ruts associated with one tire path of the main landing gear at the point of C-17 rotation at takeoff.

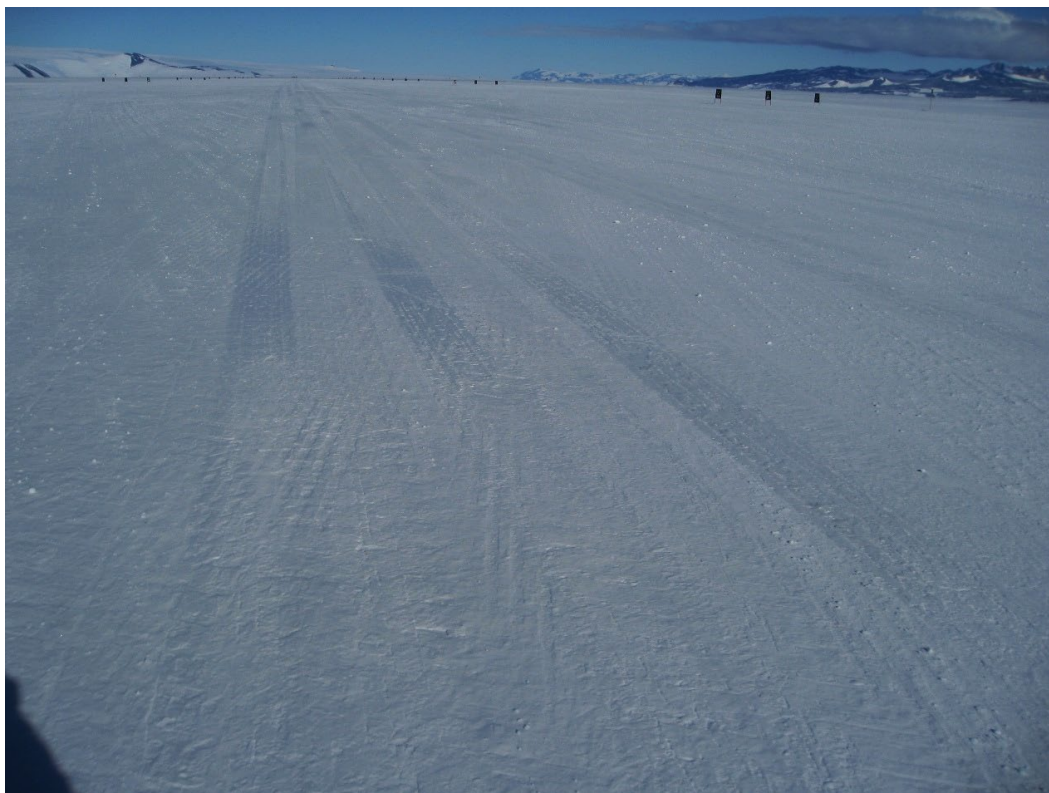
Figure 72. Segments of the main landing-gear tire tracks showing snow-pavement polishing where the main landing gear's antilock braking system created tire slip and segments where tires were rotating without slip in between antilock braking system pulses.

Eroded rubber tracks and both types of frictional melt-refreeze features represent areas of the runway that will be susceptible to accelerated deterioration if left untreated. Maintenance activities to disaggregate and disperse all of the ice and rubber must be completed as soon as possible after each aircraft mission.

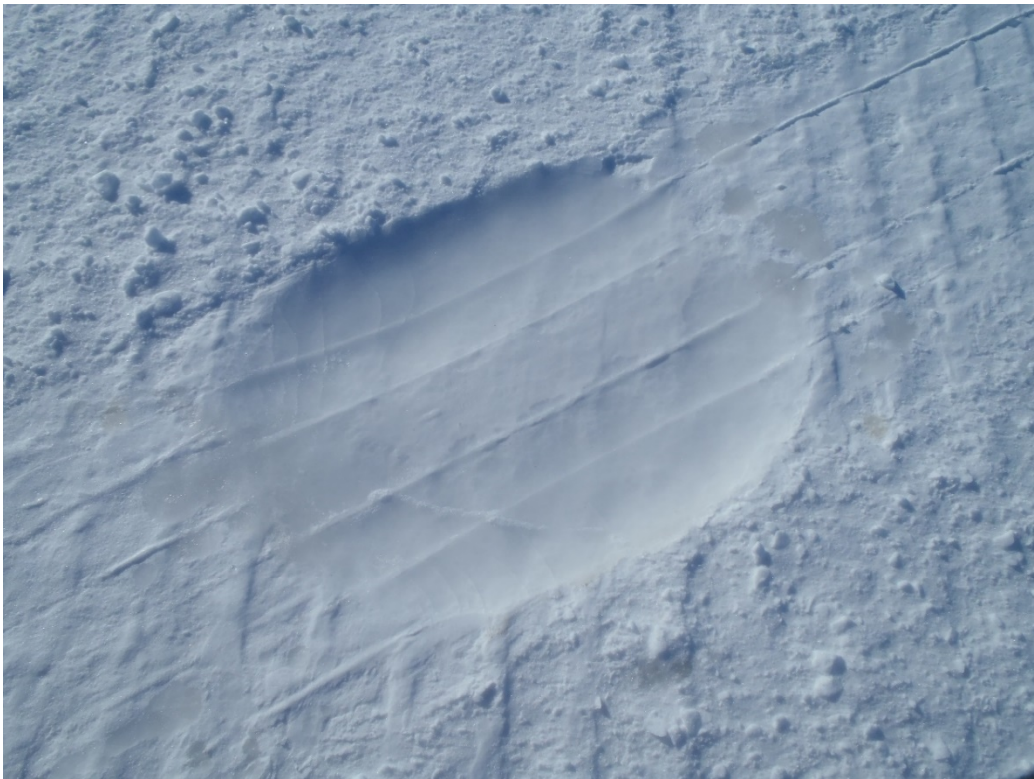
Figure 74. Thin melt-refreeze ice layer at the tire-ice interface of the parking depression.
