**title:** "AIRFIELD PAVEMENT CONDITION SURVEY, USNAS MIRAMAR, CALIFORNIA, by

# AIRFIELD PAVEMENT CONDITION SURVEY, USNAS MIRAMAR, CALIFORNIA

Technical Memorandum M-75-53-2

The results of a condition survey and friction measurements on the runways at the U.S. Naval Air Station, Miramar, California are presented. The survey established statistically-based condition numbers (weighted defect densities) which were direct indicators of the condition of the individual pavement facilities. The runway friction measurements showed the aircraft hydroplaning/skidding potential of the field. The results of the condition survey show an increasing amount of joint seal defects. Continuing repairs have effected a decrease in the number of spalls. Runway friction measurements show that all runways have satisfactory frictional resistance.

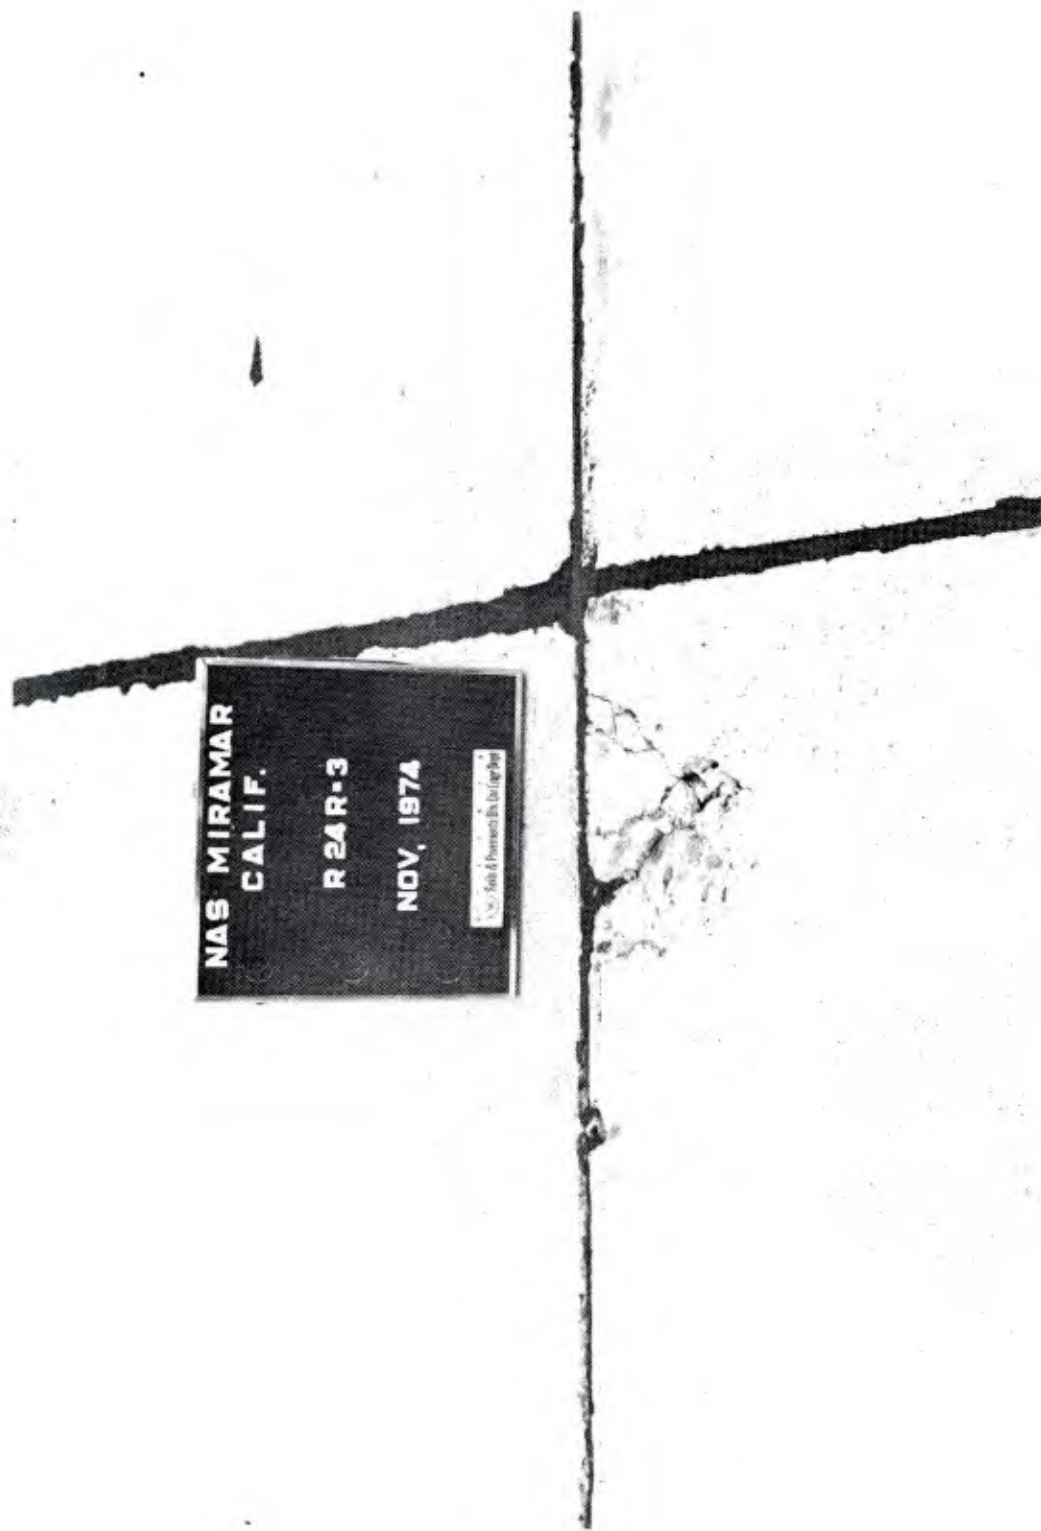
Figure 11. Typical corner spall, Discrete Area R24R-3.

The joint seal was hardened and shriveled. Joint was completely missing from a few joints. Spalls were primarily located on slab corners (see Figure 11).
