# **FINAL REPORT**

## **Electrodeposited Nanocrystalline Co-P Alloy Coatings as a Hard Chrome Alternative**

**ESTCP Project WP-200936**

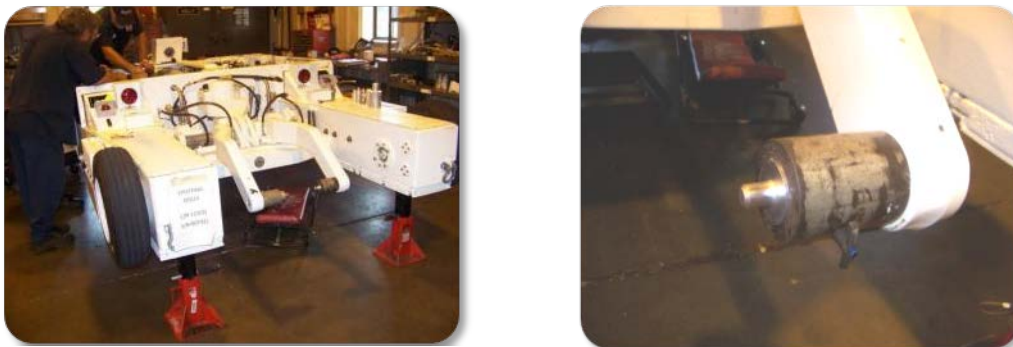
**Figure 4-7. Image of lifting arm pin installed on Spotting Dolly (left) and close-up (right).**

The spotting dolly lifting pin (P/N: 1117AS243-1) has been selected as the component for demonstration/validation of nCoP electroplating. Figure 4-7 illustrates the location identified for application of the nCoP electroplate. This is the primary wear area resulting from aircraft spotting procedures. The Dem/Val component will be electroplated and then installed on a spotting dolly awaiting maintenance at Solomons, MD. This vehicle will then be tracked by NAWC-AD (NAVAIR Lakehurst) during deployment by the vehicle's unique ID. In this manner, its location and service environment shall be known throughout its deployment. Field data will be obtained by regular correspondence with ship's force. Final inspection will compare nCoP performance versus in-service baseline lifting pins.

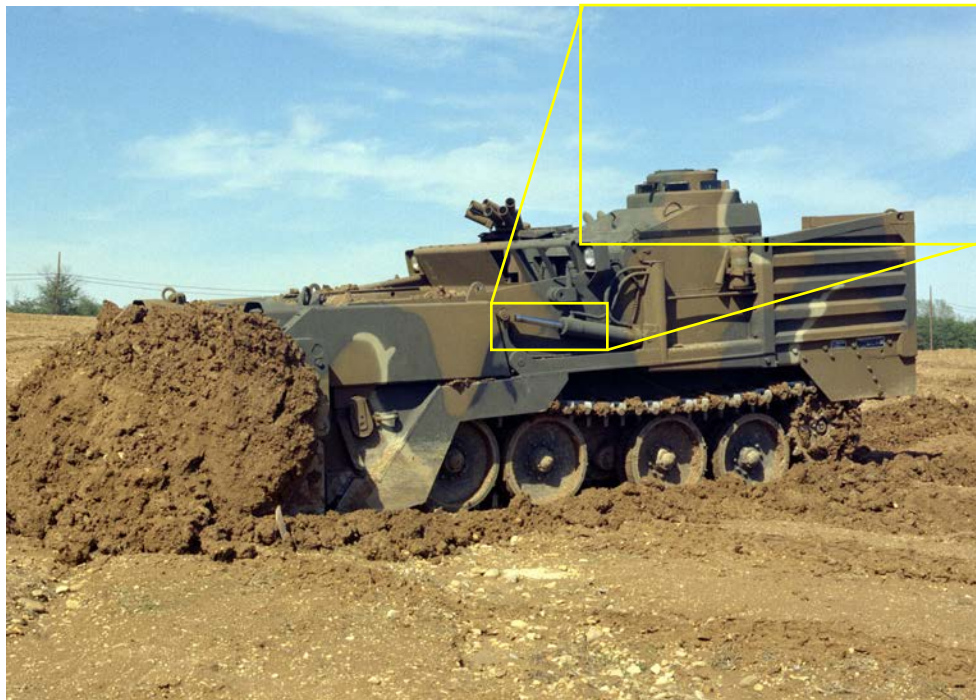
**Figure 4-8. Image of M9 ACE vehicle with an inset image of the hydraulic cylinder coated with EHC plating.**

The M9 Armored Combat Earthmover (ACE) is a fully tracked armored combat engineer vehicle (see Figure 4-8), that provides combat engineering support to front-line Marine forces. Tasks of this vehicle include digging positions for armored vehicles and field artillery systems to increase their survivability. It also breaches berms, prepares anti-tank trenches, barriers, repairs roads, clears obstacles, and prepares riverbanks for vehicle crossing.

In collaboration with NAVSEA (OSD & NESDI leveraged effort), a hydraulic cylinder on the M9 ACE was selected for the demonstration/validation of nCoP. The substrate material is carburized steel. They are currently coated with EHC for corrosion and wear resistance with coating applied to a target thickness of 0.001". NSWC Panama City Division (PCD) procured a M9 ACE apron cylinder assembly that included an EHC cylinder rod. The apron cylinder was sent to NSWCCD for disassembly and then the rod only was shipped to Integran for EHC stripping and plating with nCoP. The nCoP coated rod was then sent back to NSWCCD, where the apron cylinder was reassembled and shipped to the Production Plant Albany (PPA) for 4500 psi pressure testing. Once PPA validated that the cylinder assembly had no internal or external leakage, the Dem/Val prototype cylinder was shipped to NSWC PCD for M9 ACE installation.

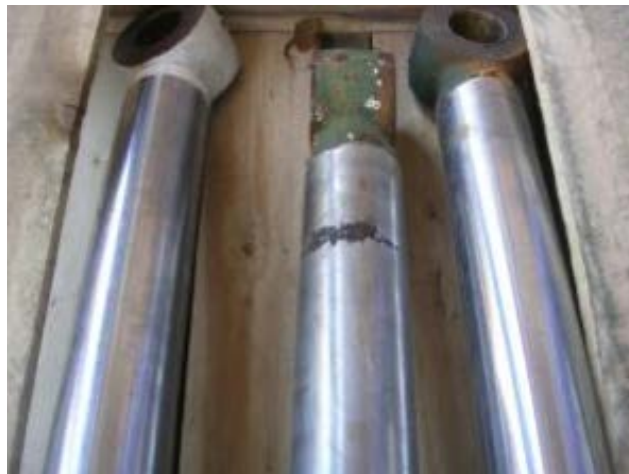
**Figure 4-9. Representative hydraulic cylinder tube casings from MK48 LVS disassembled following service.**

In advance of demonstration testing, an evaluation in a cyclical wear and corrosion environment was conducted. The testing simulates field conditions for a different platform (MK48 LVS) with similar functional requirements. The coated cylinders were exposed for 240 hours in an ASTM B117 salt fog chamber and then inspected for corrosion damage. Test cylinders were then loaded into a piston manifold, operated for 1000 cycles, and then inspected for wear and evidence of seal leakage due to either corrosion or cylinder actuation. Testing was repeated until cylinder failure occurred. Test results for the nCoP coated cylinders were ranked against the currently used EHC coating and other candidate coatings. Figure 4-9 shows disassembled hydraulic tube casings following service.

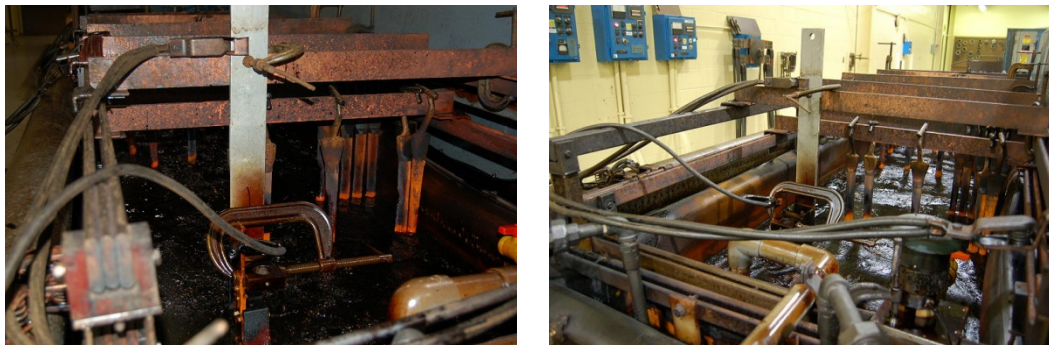
**Figure 4-10. Image of a chrome plating tank currently in use at FRCSE.**

Building 794 at the depot houses all cleaning, plating, plasma and HVOF spray, and other coating operations. The facility includes a closed-loop air circulation system that enables compliance with all EPA air emission regulations. EHC plating is conducted in a number of tanks of size ranging from 200 gallons to 2,000 gallons (see Figure 4-10). These tanks are located in a room separate from other plating operations with additional air exhaust capability to minimize worker exposure to plating chemical fumes. Power supplies are located in a separate rectifier room to ensure they are not exposed to the tank vapors which could induce corrosion of the electronic circuitry. Figure 4-11 and Figure 4-12 show the plating process line and process work flow respectively.

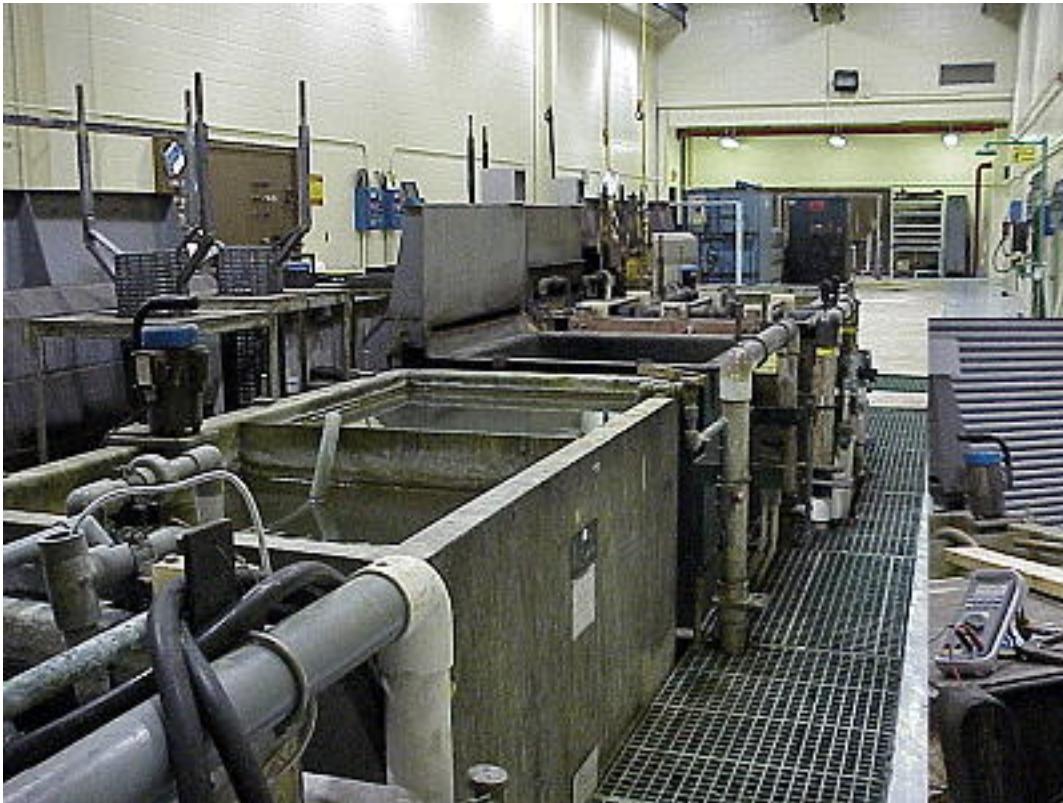
**Figure 5-1. nCoP Dem/Val plating line location in Building 794 at FRCSE.**

Building 794 at FRCSE houses all cleaning, activation, and plating operations which will be performed during this demonstration/validation effort. The facility includes a closed-loop system that enables compliance with all EPA regulations. The chrome plating process tanks are located in a room separate from other plating operations with additional air exhaust capability to minimize worker exposure to plating chemical fumes. Utilizing existing infrastructure within this room a small line was modified for the purpose of the demonstration. The line consists of an activation tank, the nCoP plating tank and associated rinse tanks (Figure 5-1). All prior processing steps, i.e. cleaning, blasting, masking & racking are performed within the general area of plating facility.

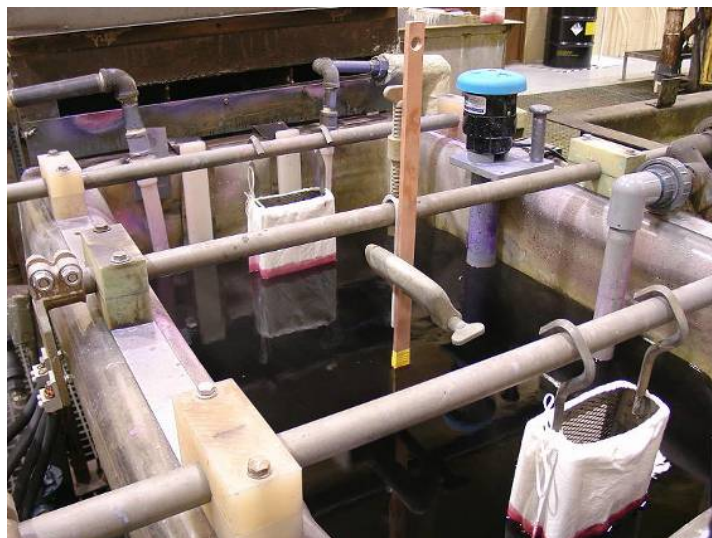
**Figure 5-2. Photograph of 300 gal nCoP plating tank at FRCSE.**

An existing process tank within the chrome plating room at FRCSE, identified as Plating Tank A-11, formerly used for EHC plating, was dedicated to the nCoP process. The tank has a capacity of ~ 300 gallons and was equipped with a drop-in liner made of a modified vinyl based polymer, 0.125" thick. Other installed equipment includes a steam coil, steam line, regulator, in-tank pump and filter using 5  $\mu$ m nominal size polypro cartridges. A sparger equipped with eductors, nickel plated copper buss bars and a level sensor for maintaining the solution level was also installed. Titanium anode mesh baskets with anode bags were also installed to hold the 99.9% pure Cobalt anode pieces. Figure 5-2 shows the installed nCoP process tank at FRCSE. Figure 5-3 shows a schematic of the plating tank design/setup.

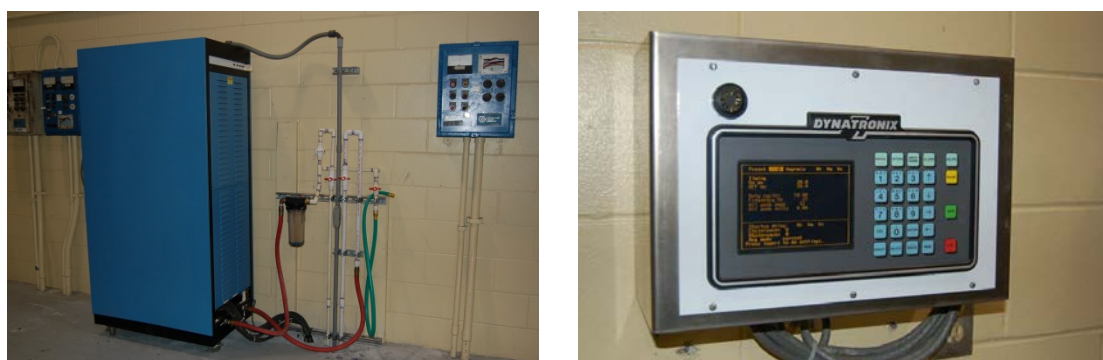
**Figure 5-4. Pulse Rectifier with filtered water system (left) and MicroTouch Remote (right).**

In order to maintain good pulse waveforms, the power supply was located as close to the tank as possible to avoid the inductance/capacitance problems associated with long power cables. Four twisted pairs of 1/0 cable in parallel were installed and terminated at the anode/cathode connections or busbars at the tank. A communications cable between the rectifier and the remote controller (MicroTouch) was also installed on the wall adjacent to the plating tank to control the current to the part.

A photo of the pulse rectifier and MicroTouch remote controller is shown in Figure 5-4.

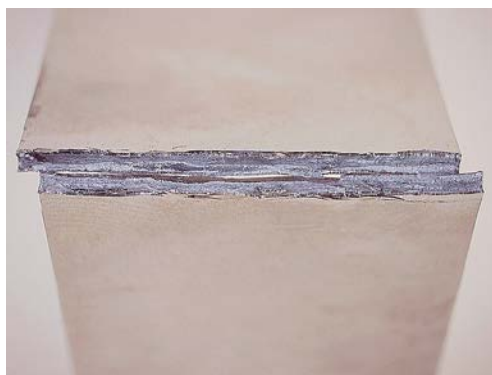
**Figure 6-38. Representative image of nCoP fracture surface following bending.**

Adhesion testing was completed on substrates in order to validate that nCoP could be applied to various alloys applicable to aerospace applications. Samples were subjected to bend tests IAW ASTM B571. Figure 6-37 and Figure 6-38 show representative results of the adhesion testing of nCoP and EHC on 4130 substrates. As demonstrated in the images, both nCoP and EHC were found to be fully adherent to the underlying 4130 substrate with no evidence of flaking, delamination, or peeling of the deposited material.

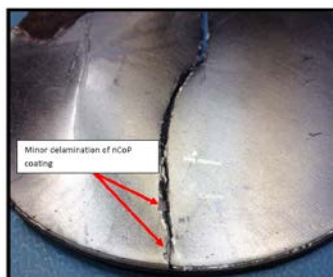
Figure 6-39. Image of Hy-tuff-2 which showed minor delamination.

Table 6-16 summarizes results of the adhesion testing on applicable alloys. The nCoP deposit on all samples of 4130 and 1018 passed bend adhesion testing. The nCoP deposit on selected Hy-tuff samples (Hy-tuff-1, -3) passed bend adhesion testing. There was minor delamination of the nCoP coating on sample Hy-tuff-2 which indicated unsatisfactory adhesion of the coating as depicted in Figure 6-39. Smutting of the surface during surface activation/preparation prior to plating was observed, which is believed to have contributed to the adhesion failure. The nCoP/Ni sulfamate duplex plating on all samples of 4130 exhibited satisfactory adhesion following bend adhesion testing. The nCoP coating on all samples of 15-5PH, Inconel 718, Al 7075 and Aermet100 passed bend adhesion testing. Pitting was observed on some samples as noted. The pitting was found to be originating during surface preparation and not a result of the deposition process.

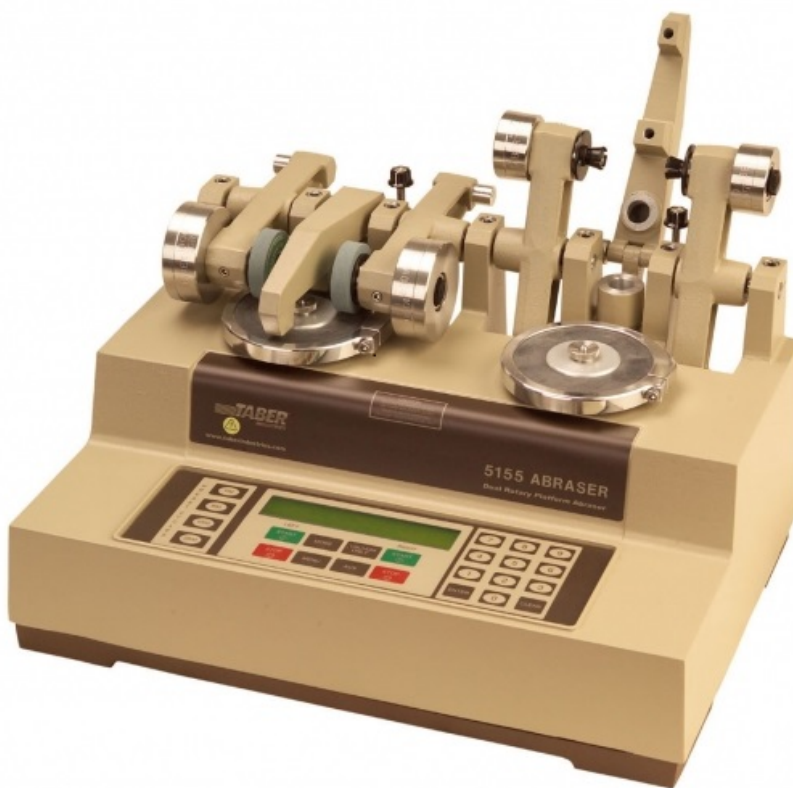
Figure 6-42: Image of Taber 5155 Abraser.

Taber wear testing was performed on EHC and nCoP samples at varying annealing conditions. An increase in microhardness is observed for nCoP samples following heat treatment at 375°F for 24 hrs and 550°F for 5 hrs. A summary of results is presented in Table 6-26 for both coatings tested using CS-17 (ASTM D4060) and H-22 (ASTM F1978) Taber Abraser Calibrade™ wheels (as shown in Figure 6-42). Figure 6-43 and Figure 6-44 summarizes results in TWI (mg/1000 cycles) for nCoP and EHC using CS-17 abrasive wheels. The EHC samples achieve an average TWI=3.3 as compared with nCoP samples which achieve TWI=17.9 (375°F for 24 hrs), TWI=18.0 (550°F for 5 hrs) and TWI=18.5 (as-deposited). Figure 6-45 summarizes results in TWI (mg/2000 cycles) for nCoP and EHC using a more abrasive H-22 wheel. Additional wear testing such as gravelometry was conducted in order to augment understanding of how nCoP performs when subjected to varying wear modes.

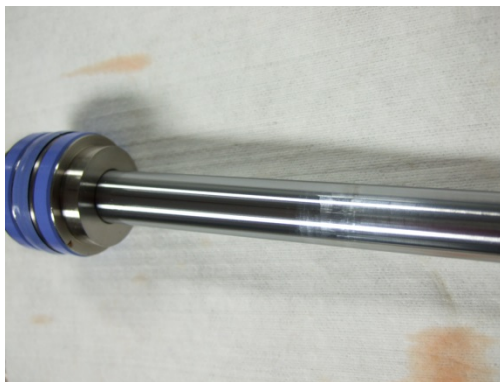
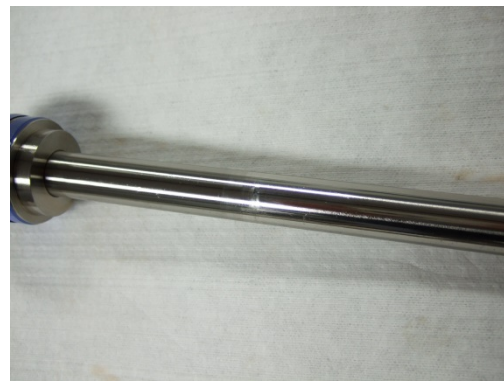
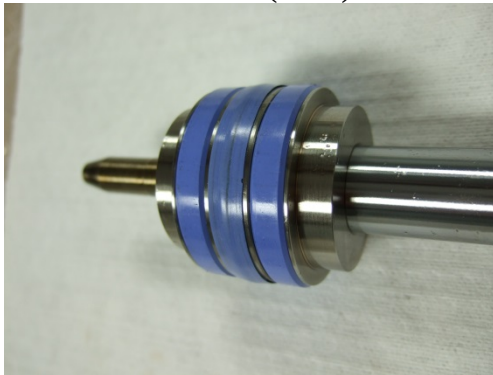
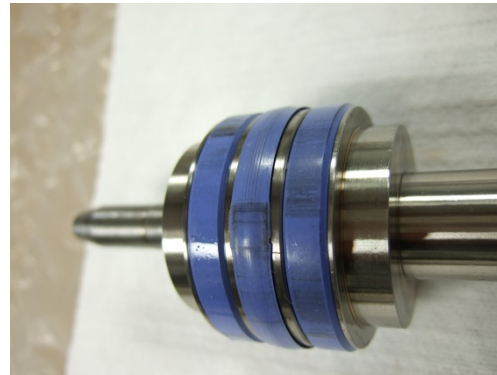
**Rod #11 (EHC)**

**Rod #12 (nCoP)**

**Piston Seal #11 (EHC)**

**Piston Seal #12 (nCoP)**

**Figure 6-54. Images of the rods and piston seals after testing.**

Both nCoP coated and EHC coated articles met the acceptance criteria of less than one drop of hydraulic fluid in 25 cycles and acceptable wear as defined as wear not affecting leakage performance (Table 6-30 and Figure 6-54).

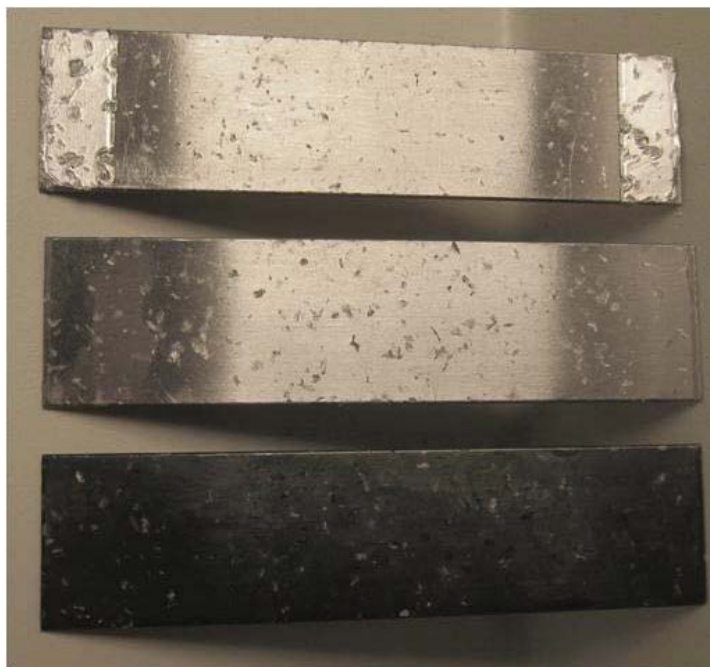
**Figure 6-59. Almen N Test Strips After Gravelometry Testing.**

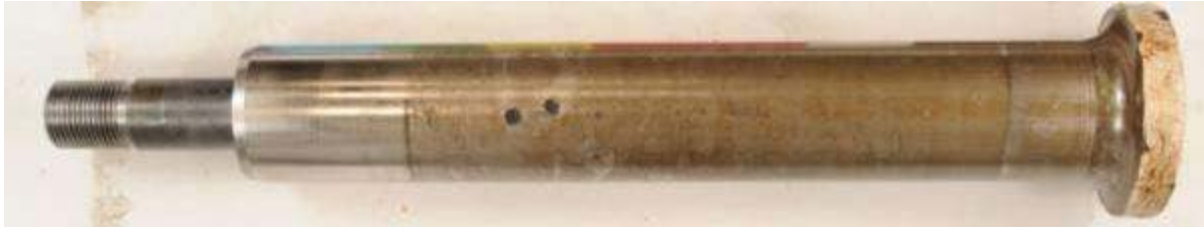
**Figure 6-68. Image of nCoP Sample after hydraulic cycling with corrosion events testing.**

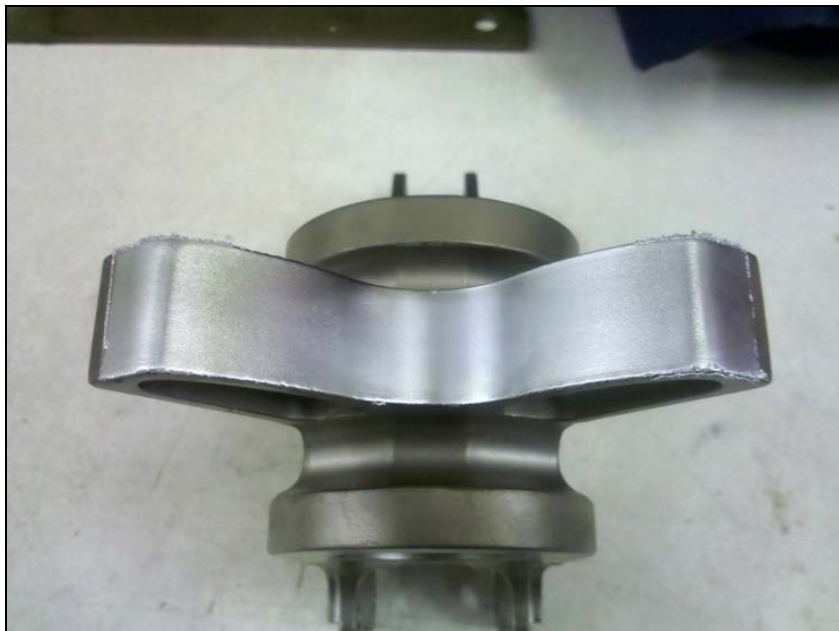
**Figure 6-75. Image of T-45 EHC plated pivot shown in the “as-plated” condition.**

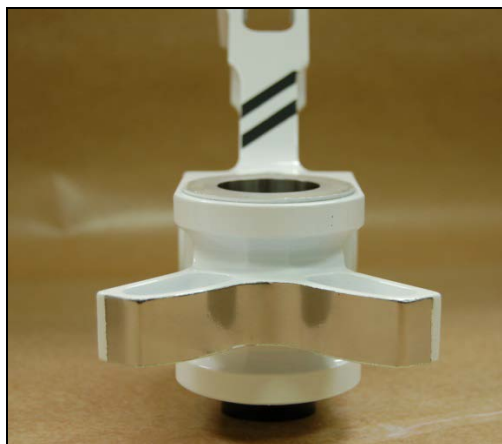
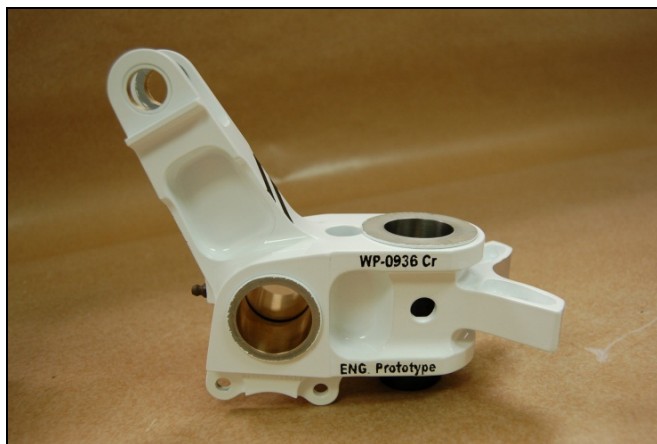
**Figure 6-78. Image of EHC coated Pivot Assembly following painting front view (left) and side view (right). Stenciling of two stripes is used as identifier for field inspection.**

Following the IVD coating process and bushing installation, both the nCoP plated and EHC plated pivots were routed for painting. Each pivot was uniquely identified by painting a series of black stripes along the fitting with the project number and coating type stenciled on side of the pivot body to identify them in the field. The nCoP plated pivot was identified by three black stripes painted on the fitting with the words “WP-0936 nCoP” and “ENG. Prototype” stenciled in black on the side (Figure 6-77). The EHC plated pivot was identified by two black stripes painted on the fitting with the words “WP-0936 Cr” and “ENG. Prototype” on the side (Figure 6-78).

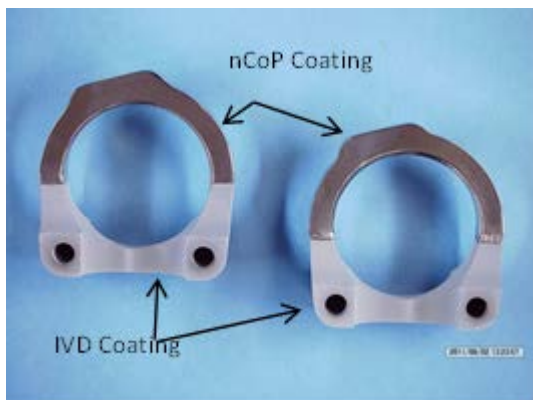
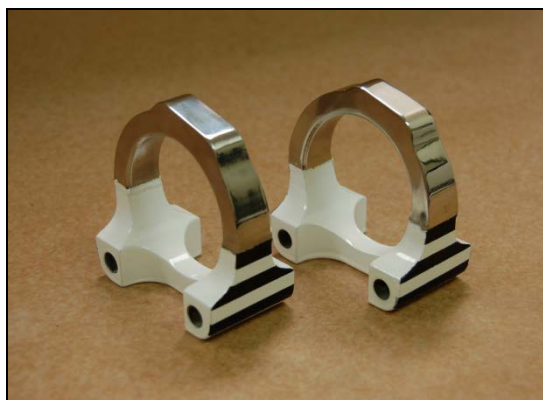
**Figure 6-79. Image of nCoP and IVD Plated Tie down rings (left) and following painting Tie down rings ready for installation (right).**

To provide supplemental field data with the nCoP coating, the pivot assembly tie down rings were also plated. Only half the ring required a wear coating (plated with nCoP) while the remaining surfaces were IVD aluminum coated and painted with similar identification markings for field demonstration purposes (Figure 6-79).

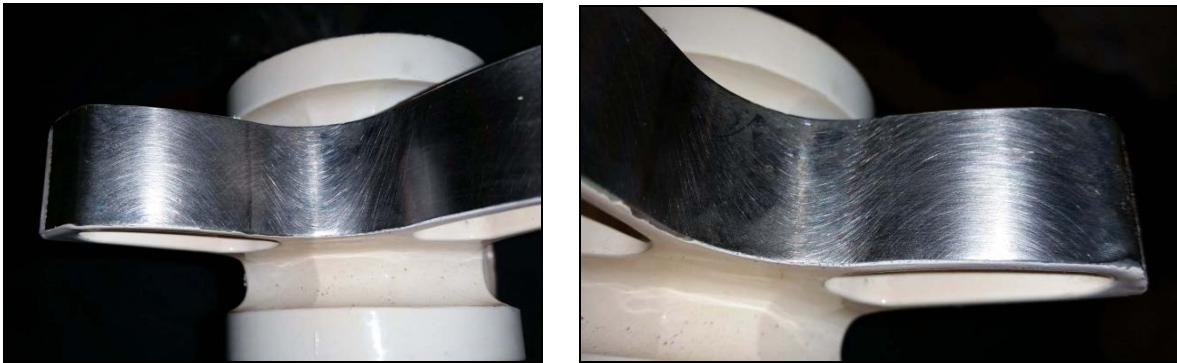
**Figure 6-85. Images of cam surface of nCoP plated pivot following 97 arrestments.**

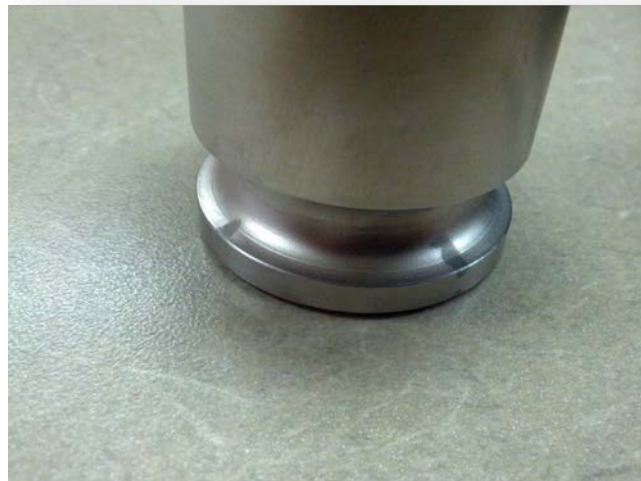
**Figure 6-87. Image of Nanovate R3010 electroplated part. Grey areas are contact points which will be protected by sacrificial coating.**

Electroplating was performed Oct 2012 in accordance with the Nanovate R3010 Process Specification Guide. Custom racking and anodes were designed to ensure uniform electroplating thickness throughout the component. Figure 6-86 illustrates racking and anode design features utilized for electroplating. Following application of nCoP items were returned to the Fleet Readiness Center Southeast for application of IVD-Al. IVD-Al was applied in accordance with Local Process Specification 300 followed by supplemental chromate treatment. IVD-Al was applied to the large diameter areas of the lifting pin for corrosion protection of Spotting Dolly's Lifting Arm. The small diameter and flange face of the lifting pin were fielded without IVD-Al.

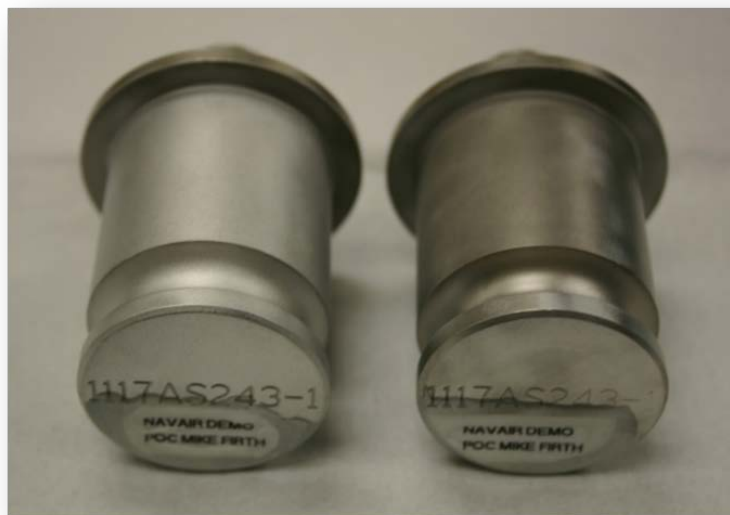
**Figure 6-89. Lifting Pin demonstration components following processing at Integran Technologies and FRCSE.**

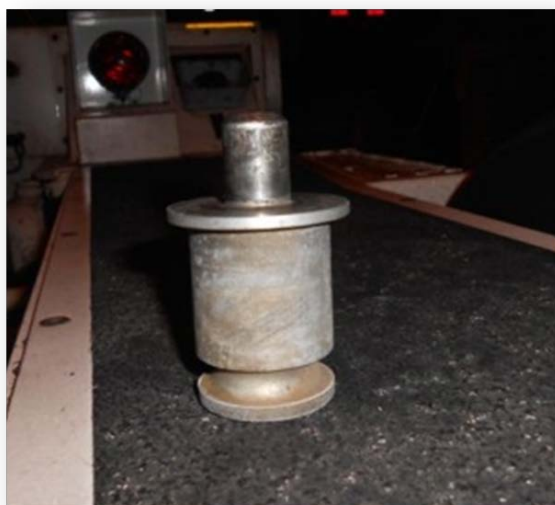
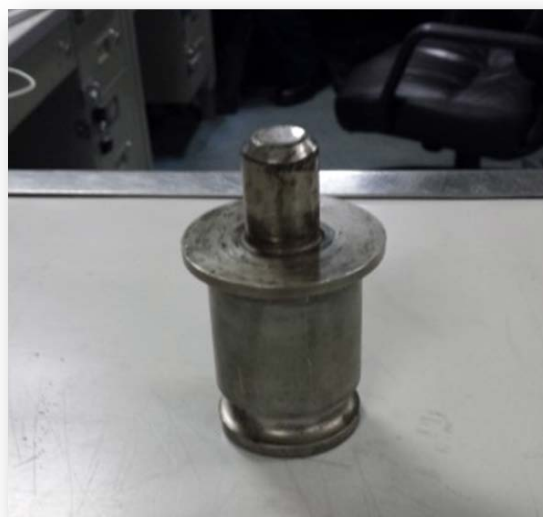
**Figure 6-91. Visual appearance of demonstration component following 91 Day NDI examination aboard CVN-75 Sept 2013 (left) and Jan 2014 (right).**

| <b>Dem/Val Inspection</b> | <b>Date</b> | <b>Criteria</b> | <b>Observation</b> | <b>Conclusion</b> |
|---|---|---|---|---|
| 4 | Mar 2014 | No visual presence of corrosion or cracking | No Defects Observed | PASS |

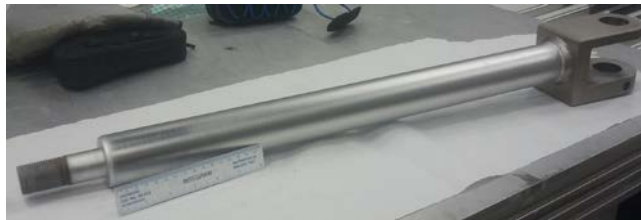
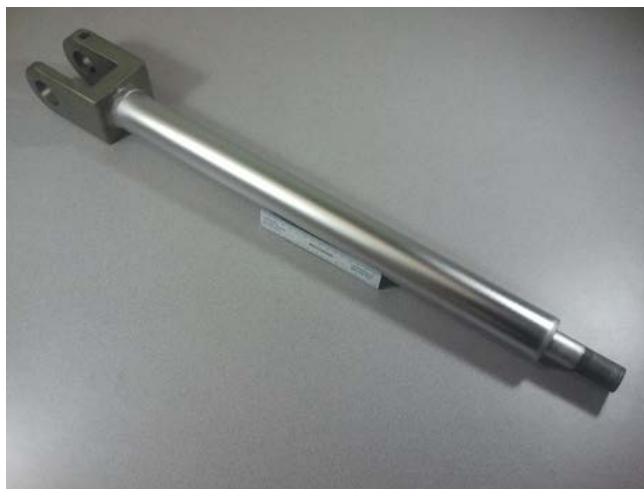
**Figure 6-93. Images of the nCoP coated component at Integran.**

Electroplating was performed at Integran in December 2013 in accordance with the Nanovate R3010 process guide. The component provided by FRCSE was stripped of EHC. Maskant was applied to areas where no coating was desired. Coating was applied to the OD surface selectively as shown in Figure 6-93.

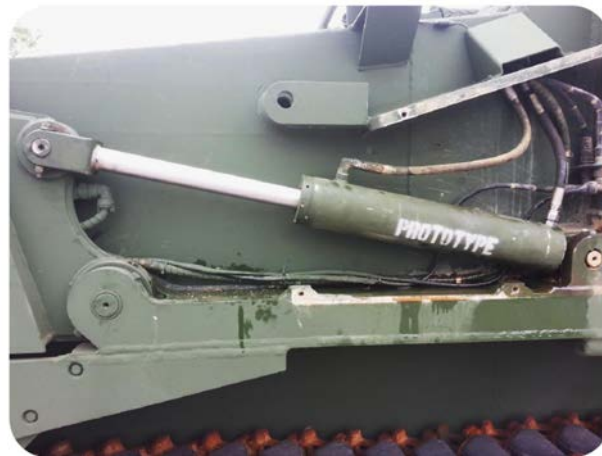
**Figure 6-94. Image of installed prototype nCoP Dem/Val cylinder assembly on the M9 ACE.**

The original test plan for the apron cylinder Dem/Val was a one year exposure on the M9 ACE which included an interim visual inspection at six months and a final evaluation at 12 months. The apron cylinder was installed in March 2014 and was removed from the test vehicle in May 2014, after approximately two months exposure. The M9 ACE vehicle selected for the Dem/Val was NSWCCD's Program Management (PM) vehicle used for local operations, tests and instructional purposes. During the field trial, an operational need for the M9 ACE presented itself and resulted in the prototype Dem/Val cylinder being removed from the vehicle and a production cylinder installed in its place for verified product assurance and operation. The Dem/Val cylinder was then shipped back to NSWCCD for final inspection. Post exposure visual examination of the nCoP coated cylinder showed no indication of any coating degradation or damage. Figure 6-94 shows the prototype Dem/Val nCoP coated apron cylinder after installation on the M9 ACE vehicle, and Figure 6-95 shows the unassembled hydraulic cylinder after the field test exposure on the M9 ACE.
