**title:** "RUNWAY FRICTION MEASUREMENTS AND PAVEMENT CONDITION SURVEY, MCALF CAMP PENDLETON, CALIFORNIA, by"

**sponsor:** NAVAL FACILITIES ENGINEERING COMMAND

Runway Friction Measurements and Pavement Condition Survey,  
MCALF Camp Pendleton, California

Technical Memorandum TM 76-53-2

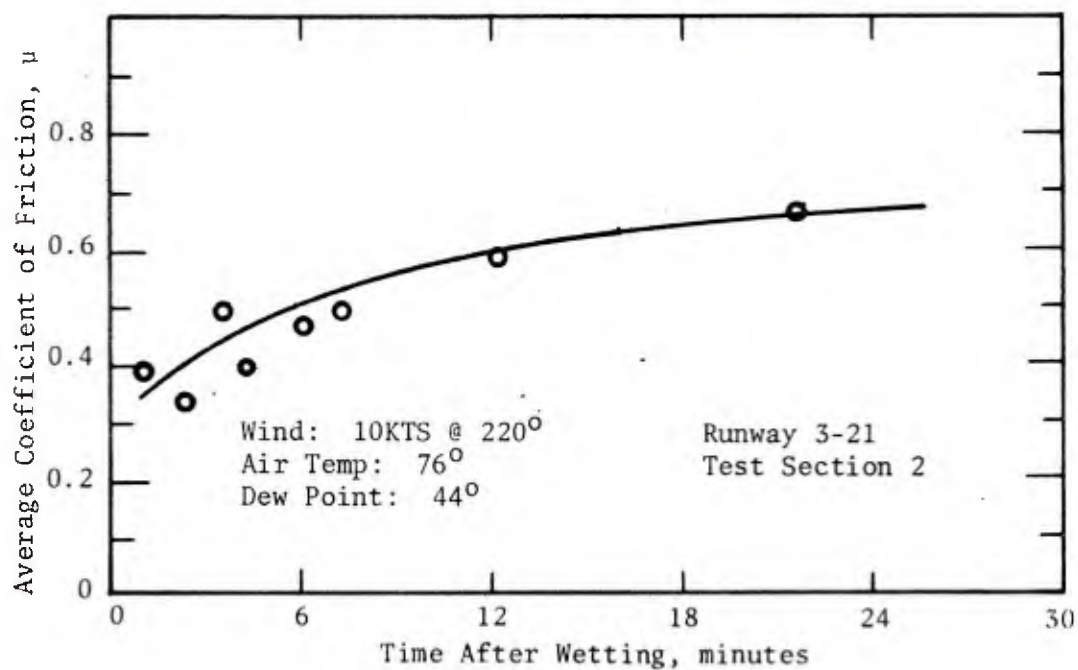
Figure 5. Average Friction Coefficient versus Time, USMCALF Camp Pendleton, CA

Figures 5 and 6 show changes in surface friction coefficient versus time after wetting for each pavement section tested. (Note that the time intervals after wetting at which skid tests were made often differed from one test to another, due to small variations in water truck speed and Mu-Meter adjustments.) These graphs demonstrate the natural drainage characteristics of the runway surface and the time required to return to an essentially dry condition or a consistently high friction coefficient.

Table 4 presents the average skid resistance values for each skid test section. From the curves presented in Figures 5 and 6, values of  $\mu$  were determined for time periods of 3, 15, and 30 minutes after water was applied. The coefficient determined at 3 minutes after water application corresponds to a wet runway condition and the coefficient determined at 15 minutes after water application corresponds to a damp runway condition. At 30 minutes after wetting the friction coefficient can be considered a dry pavement condition. The curves in Figures 5 and 6 were extrapolated, if necessary, to obtain friction coefficients at those time intervals. These data indicate the rate the pavement skid resistance properties were recovered after the test sections were wetted. By comparing the actual values of  $\mu$  shown in Table 4 with the expected aircraft response in the associated rating guide, Table 5, it is possible to evaluate aircraft hydroplaning potential.

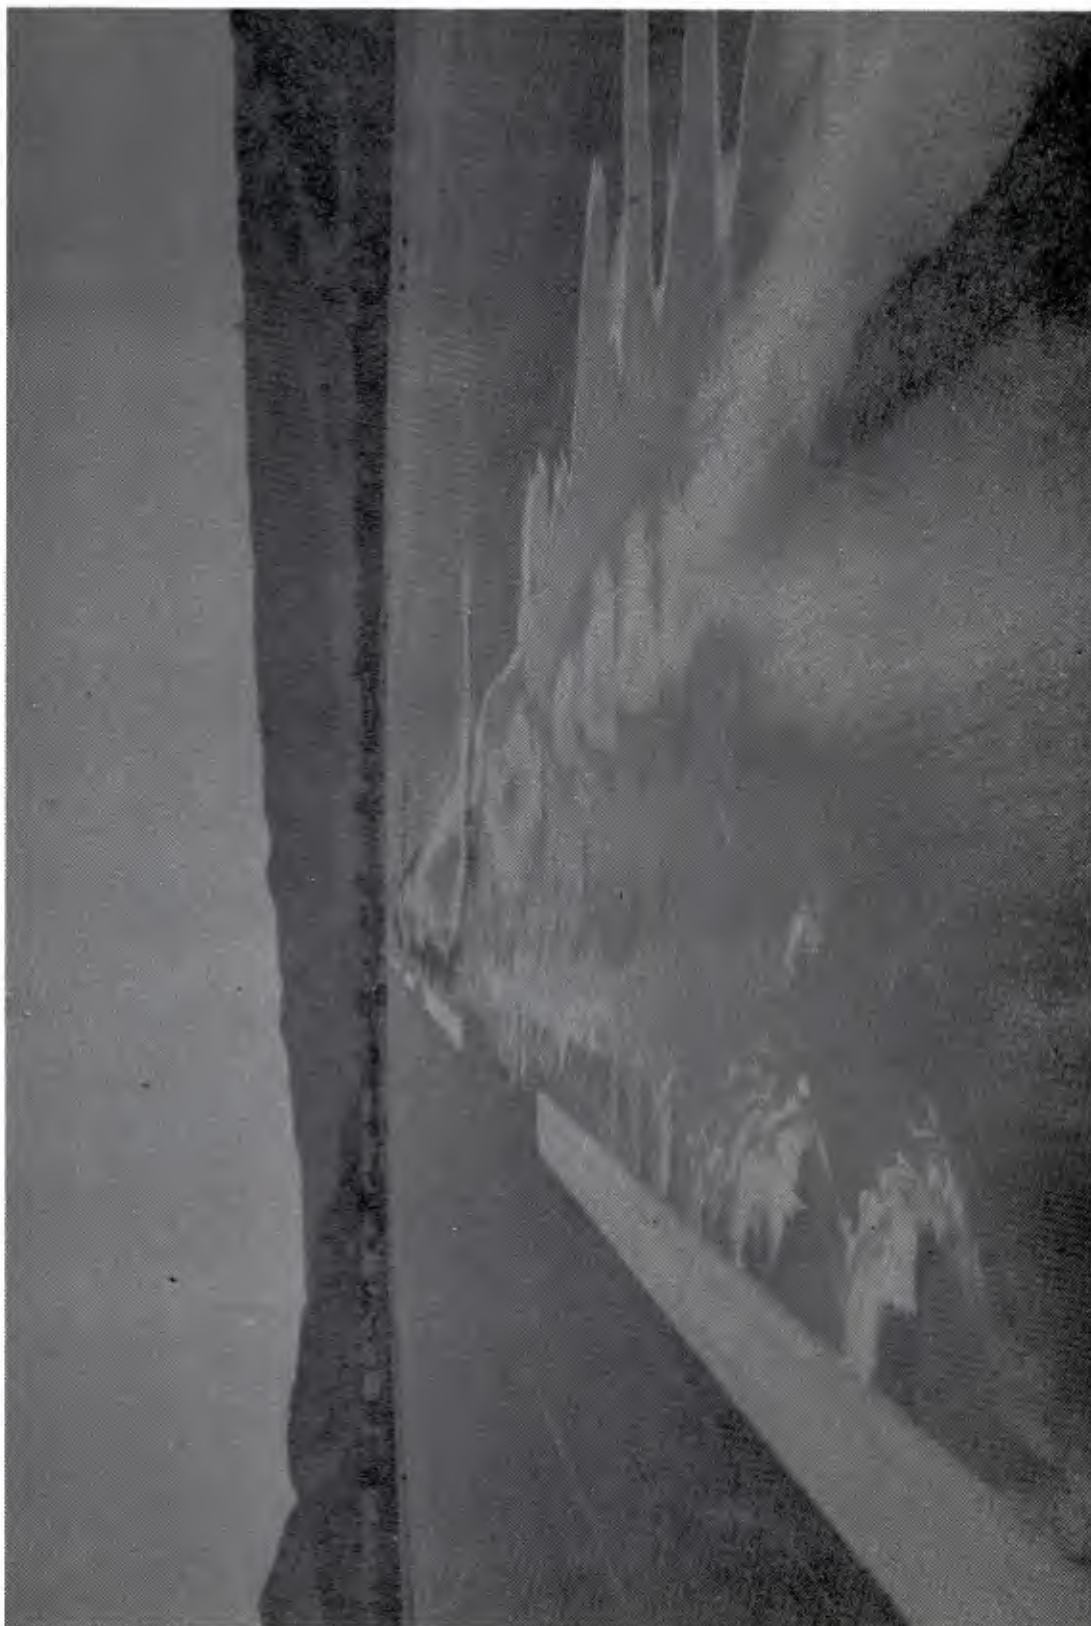
The wet (3 minute) friction coefficients given in Table 4 show that two of the four skid test sections (2 and 4) have frictional resistance which indicates a potential for hydroplaning by some aircraft. These results are attributed to localized ponding of water in these sections as shown in Figure 8. The center 20 feet of the runway has an average transverse slope of 0.3 percent with individual measurements ranging from 0.0 (level) to 0.8 percent. This variation is assumed to be the result of inadequate grade control during construction of the overlay in 1972.

FIGURE 8. PONDED WATER REMAINING IN TEST SECTION 2  
TWENTY MINUTES AFTER WATER APPLICATION

Although some areas of Runway 3-21 at MCALF Camp Pendleton have the potential to cause some aircraft to hydroplane, no remedial measures are recommended at this time. The majority of aircraft operations at this

facility are helicopters and light observation planes. Hydroplaning problems are, of course, nonexistent for helicopters and very unlikely for the OV-10 observation planes. Transient cargo and training aircraft, for example - T-39, C-130, C-131, have the potential to hydroplane on this runway during rainfall conditions. Pilots should be cautioned to use wet landing techniques when puddles are evident.
