" RUNWAY FRICTION MEASUREMENT AND PAVEMENT CONDITION  
SURVEY, USNOLE SAN NICOLAS ISLAND, CALIFORNIA- by

R. B. BROWNIE ,

FEBRUARY 1977, "

NAVAL FACILITIES ENGINEERING COMMAND

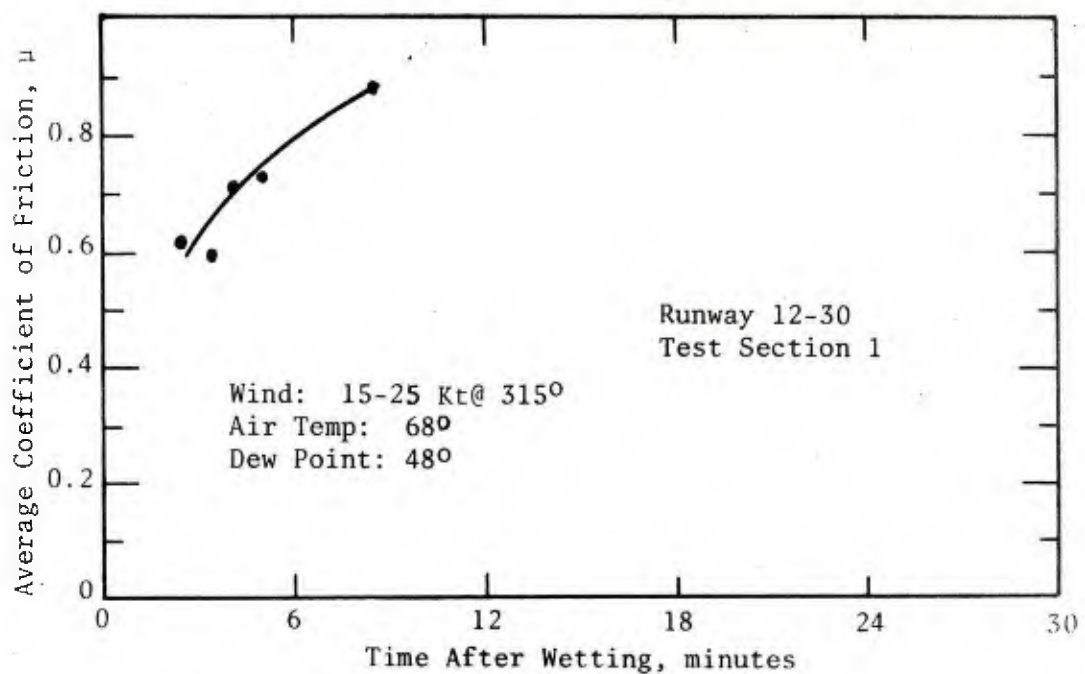
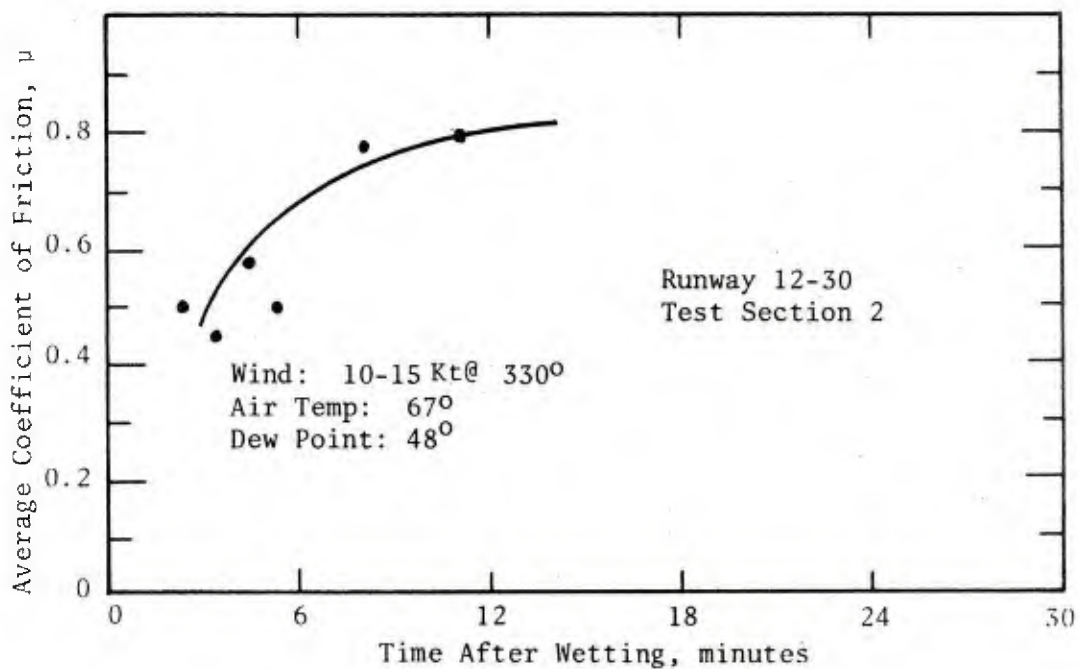
The pavement skid resistance results are reported in terms of  $\mu$ , coefficient of friction, as measured by the Mu-Meter. The actual friction coefficient versus distance traces as recorded by the Mu-Meter during the first run after wetting for each test section are shown in Figures 5 and 6. The traces show the variation of friction coefficient within each test section. Appendix C contains all test results for each Mu-Meter test section.

Figure 6. Friction coefficients versus distance,  
NOLF San Nicolas Island, California

The three-minute  $\mu$  values given in Table 4 show that Test Sections 2 and 3 in the runway interior demonstrated high or some potential for aircraft to hydroplane when the runway is wet. The primary reasons for low friction values in the sections is a lack of surface texture and ponding water. Texture measurements made using procedures developed by NASA and described in Reference 2 gave surface texture depths of 0.009 to 0.013 inches. A surface texture depth of 0.050 inches or greater is recommended in Reference 2. Ponded water was found in Test Section 3 and is attributed to a transverse slope of 0.2 percent and water being retained by ridges of slurry seal where overlaps were made at longitudinal joints. The effect of the ponded water can be seen in Figure 6 showing Run 1 in Test Section 3. The friction coefficient is above 0.60 until the ponded water is encountered and then drops to 0.10 to 0.20.

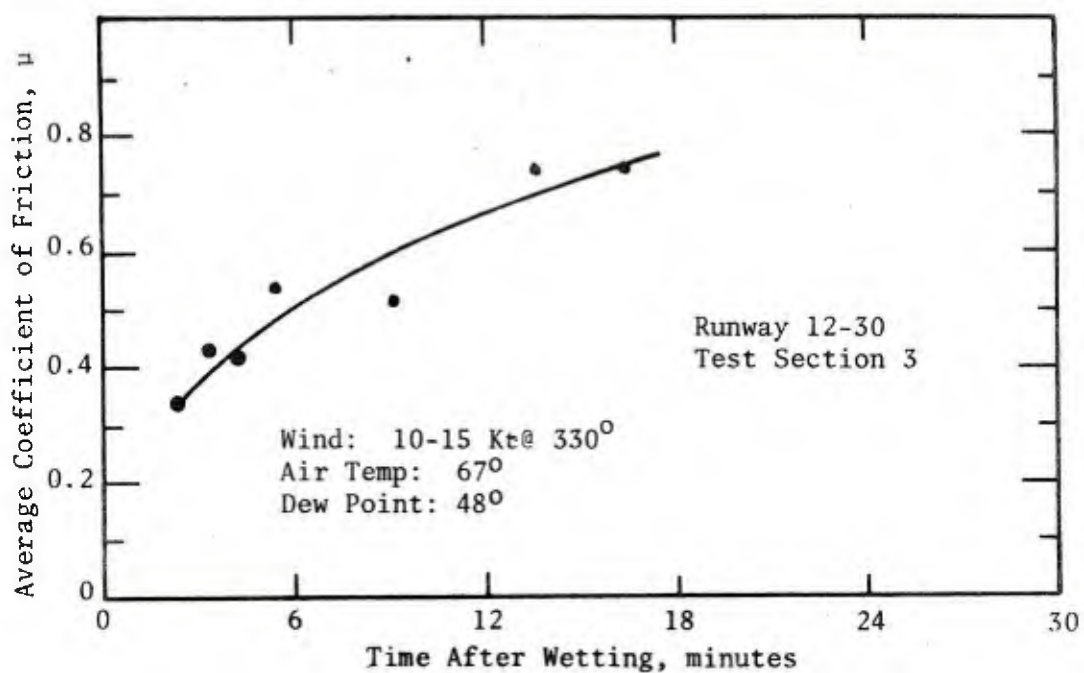
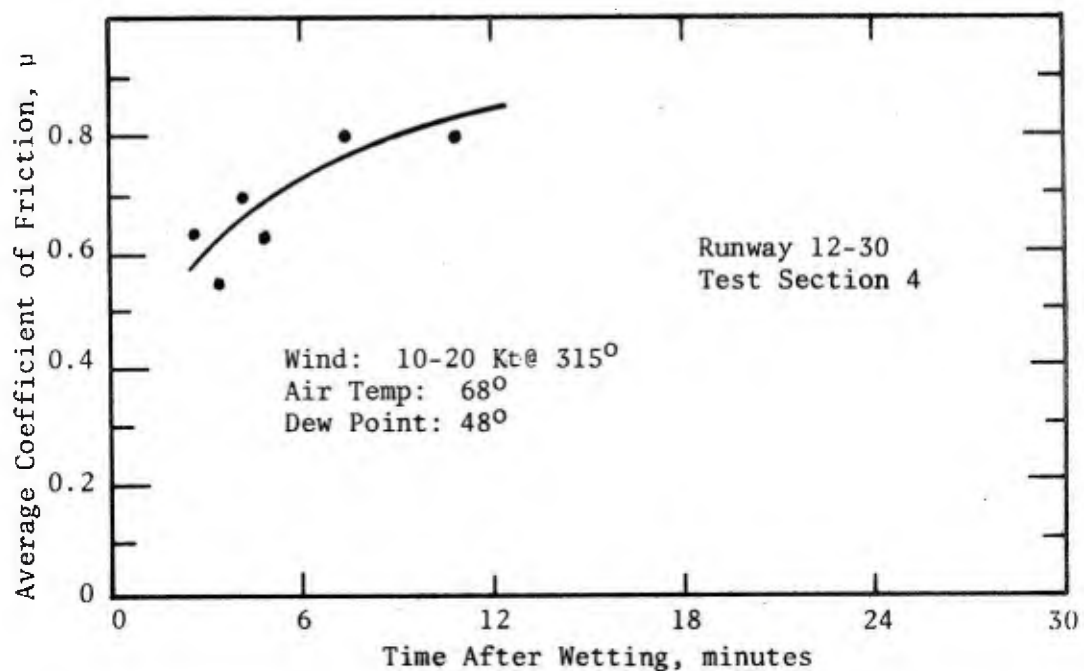
Figures 7 and 8 show changes in surface friction coefficient versus time after wetting for each pavement section tested. (Note that the time intervals after wetting at which skid tests were made often differed from one test to another, due to small variations in water truck speed and Mu-Meter adjustments.) These graphs demonstrate the natural drainage characteristics of the runway surface and the time required to return to an essentially dry condition or a consistently high friction coefficient.

Table 4 presents the average skid resistance values for each skid test section. From the curves presented in Figures 7 and 8 values of  $\mu$  were determined for time periods of 3, 15, and 30 minutes after water was applied. The coefficient determined at 3 minutes after water application corresponds to a wet runway condition, and the coefficient determined at 15 minutes after water application corresponds to a damp runway condition. At 30 minutes after wetting, the friction coefficient can be considered a dry pavement condition. The curves in Figures 7 and 8 were extrapolated, if necessary, to obtain friction coefficients at those time intervals. These data indicate the rate at which the pavement skid resistance properties were recovered after the test sections were wetted. By comparing the actual values of  $\mu$  shown in Table 4 with the expected aircraft response in the associated rating guide, Table 5,

Figure 7. Average Friction Coefficient versus Time,  
NOLF San Nicolas Island, California

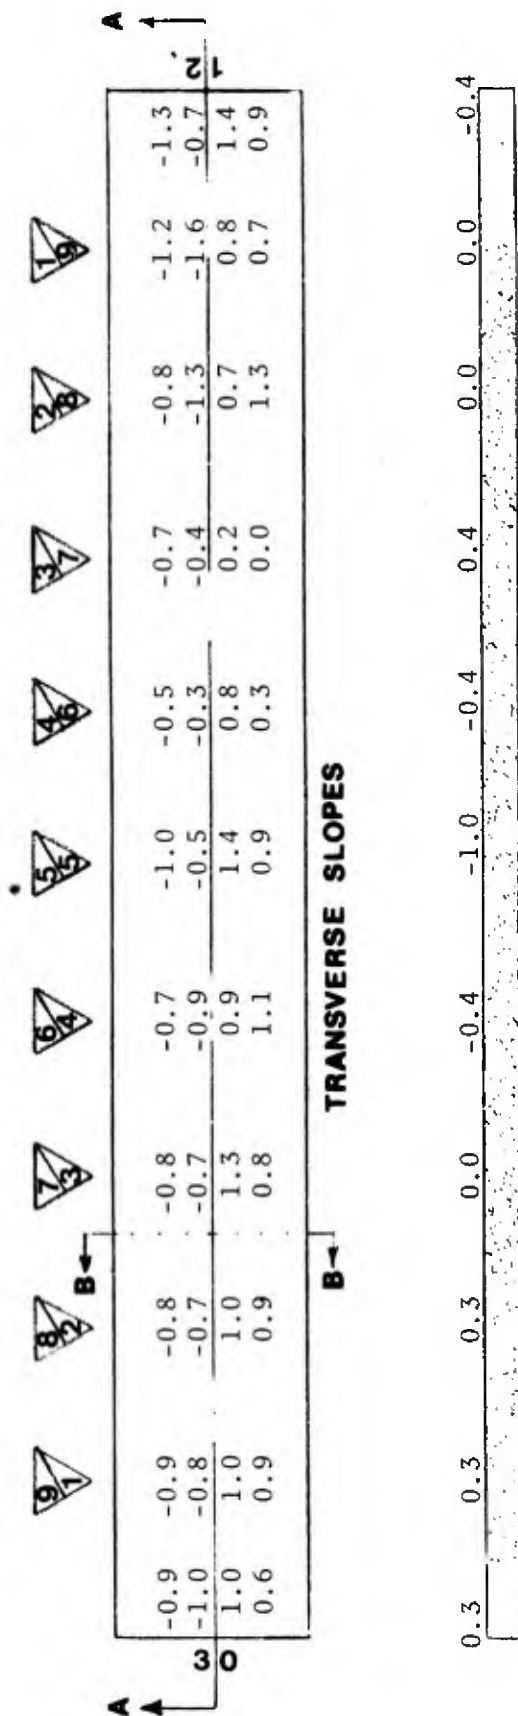
Measured pavement slopes are shown in Figure 9. Positive transverse slopes indicate water drains to the runway edge without crossing the centerline, while negative transverse slopes indicate drainage crosses the runway centerline before draining to the edge. Positive longitudinal slopes indicate rising pavement grades in the direction of increasing runway stations while negative longitudinal slopes indicate falling grades in the direction of increasing stations.

# RUNWAY SLOPE MEASUREMENTS

USNOLF San Nicolas, Island, California
