**THE EVALUATION OF HIGH MOLECULAR WEIGHT METHACRYLATE AS  
A TREATMENT OPTION FOR SHRINKAGE CRACKS**

THESIS

Austin R. Hayes, Captain, USAF

AFIT-ENV-MS-19-M-177

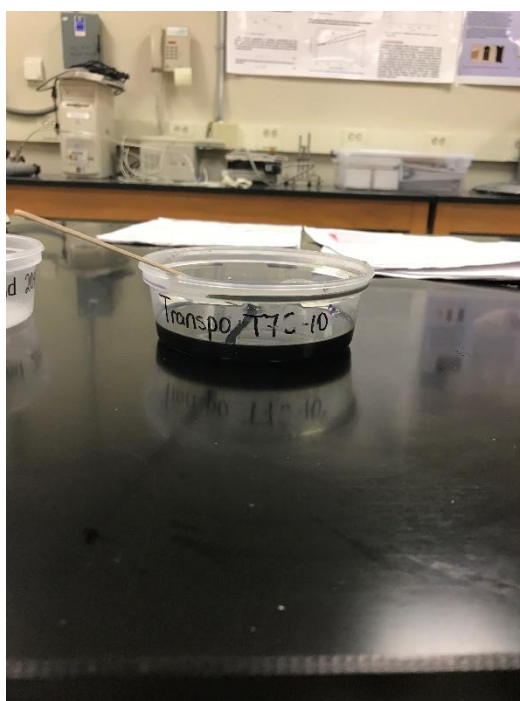
Figure 7. Gel Time Tests

Figure 8. Transpo T70 Gel Time Test

Figure 9. TK-2415 Gel Time Tests

Figure 10. Kwik Bond Gel Time Tests

Figure 11. TK-2110 Gel Time Test

Once the initial set of tests were completed, tests were completed to find the pot life of the material using small disposable containers (Figures 7 to 11). These tests were completed to find the time between the mixing of the initiator and monomer and the polymerization or hardening of the polymer. The pot life is a measure of the working time of the material. These first tests were accomplished on the TK-2415 HMWM by combining the neat monomer, initiator, and promoter using the ratios provided by the manufacturer in a disposable cup and mixing them together. For these tests, 50 mL of the neat monomer, 1.430 mL of the initiator, and 0.508 mL of the promoter were used. The measurements were taken using a graduated cylinder for the neat monomer and micro pipettes for the initiator and the promoter.

The promoter was added in and stirred for a minute, and then the initiator was added in and stirred for another minute. The measured time began once the initiator was introduced to the neat monomer. The material was stirred for five seconds every five minutes until it was noticed that the consistency became similar to Jell-O and could not flow down the container when tipped. The time was recorded at this point. The same procedure was used for the other three sealants using the following mix ratios.

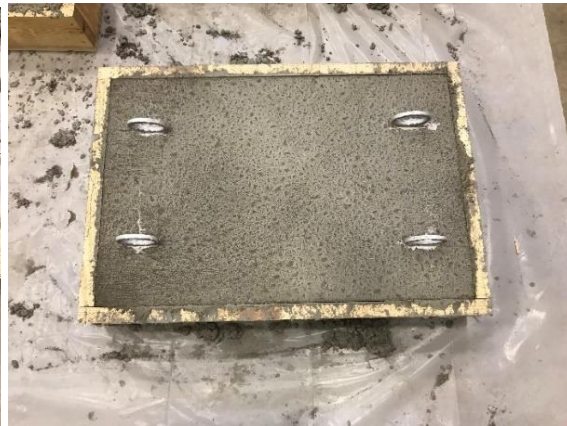
Figure 14. Finished Beam Specimen

Figure 15. Finished Slab Specimen

shoveled into the forms until the concrete reached the top. For the slabs, the concrete was shoveled into the forms until the concrete reached the top (Figure 15). The slab specimens were then vibrated and finished with a hand trowel. The slabs had four handles with rebar placed into the concrete between the two handles on each side before finishing.
