**QUANTIFYING AND MONITORING PERMAFROST EXTENT, CONDITION,  
AND DEGRADATION AT EIELSON AIR FORCE BASE**

THESIS

Theodore J. Labedz, Captain, USAF

**DEPARTMENT OF THE AIR FORCE  
AIR UNIVERSITY**

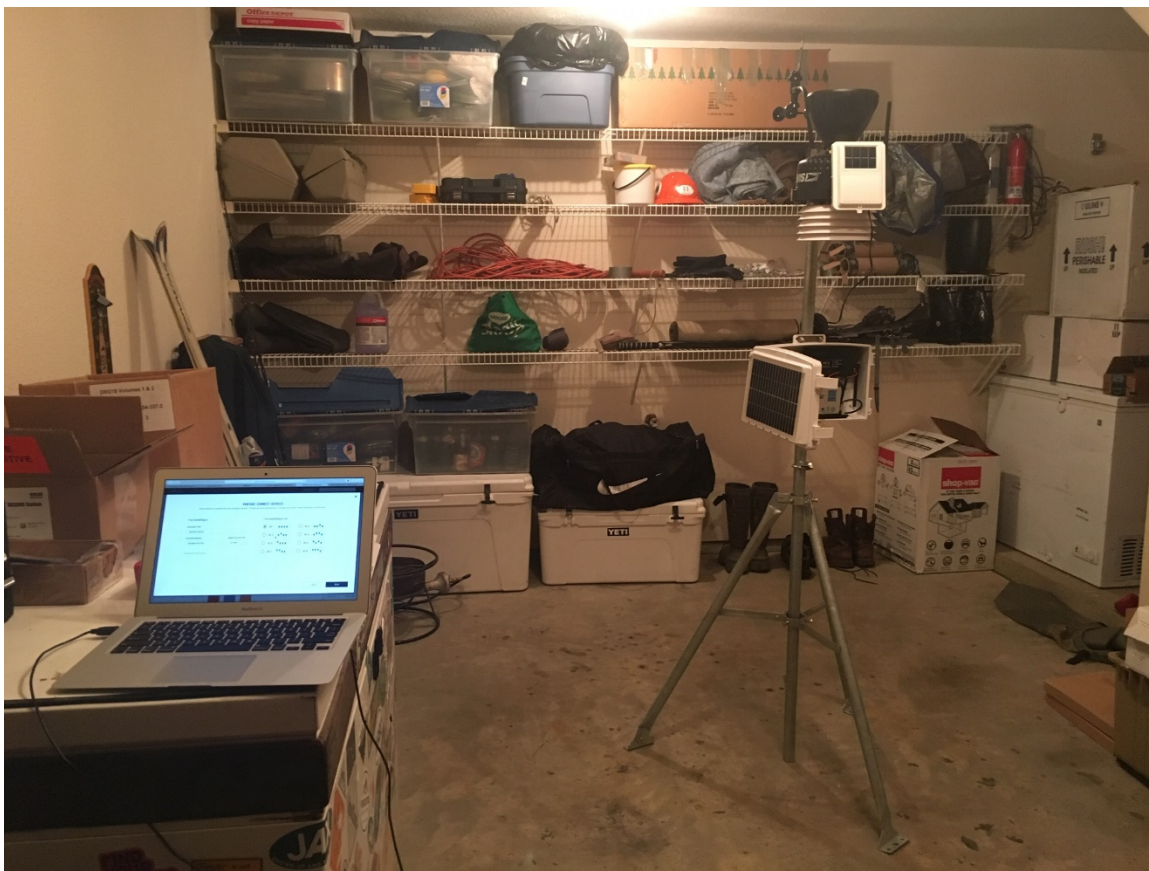
Figure 3.1: Weather Station Assembly, Calibration, and Testing

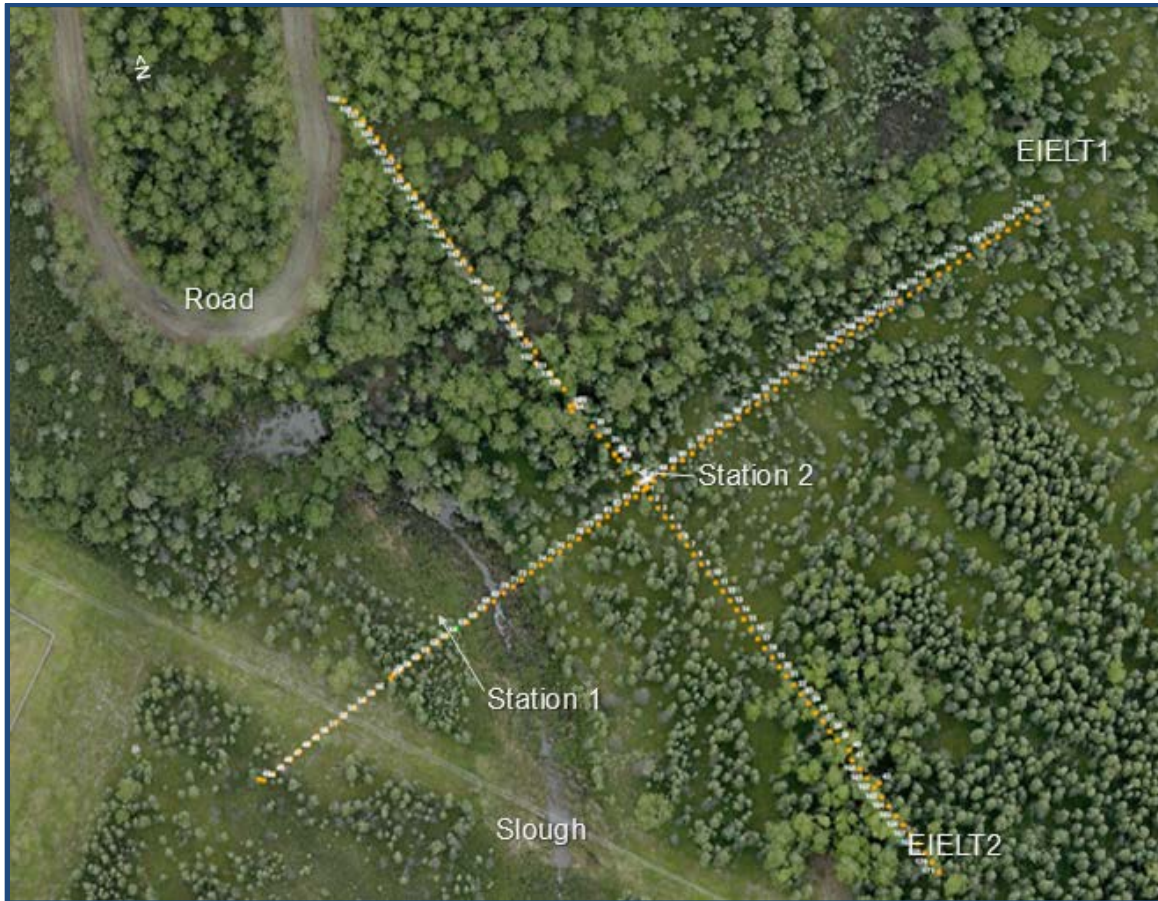
Figure 3.4: ERT and Frost Probe Survey Points [37]

Each of the orange points represents a location where one of the ERT probes was placed into the ground and each gray points symbolize the location where we conducted a frost probe. Figure 3 also depicts how Station 2 is in the center of the two transects and station one is closer to the slough as well as the construction being conducted to beddown the F-35s.

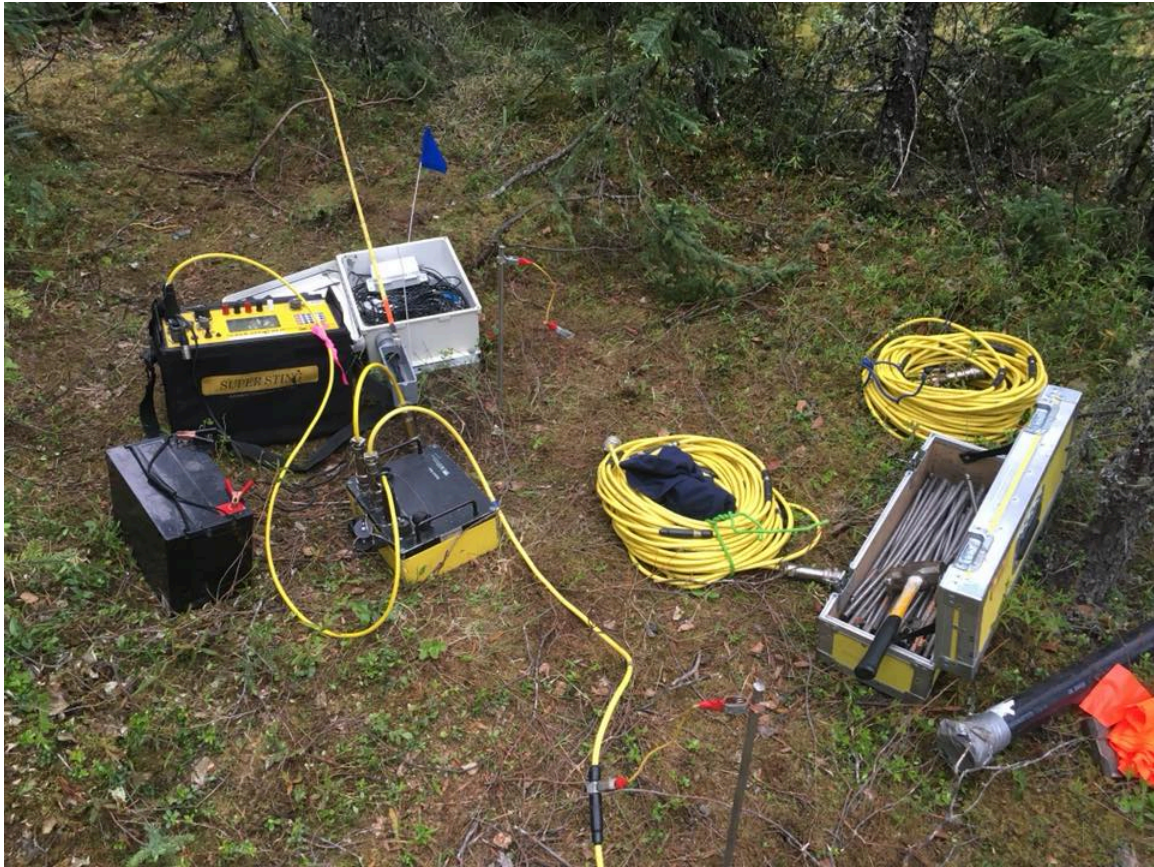
Figure 3.6: ERT Field Equipment

into the woods approximately 200 meters. A sampling of this equipment is pictured in Figure 3.6.

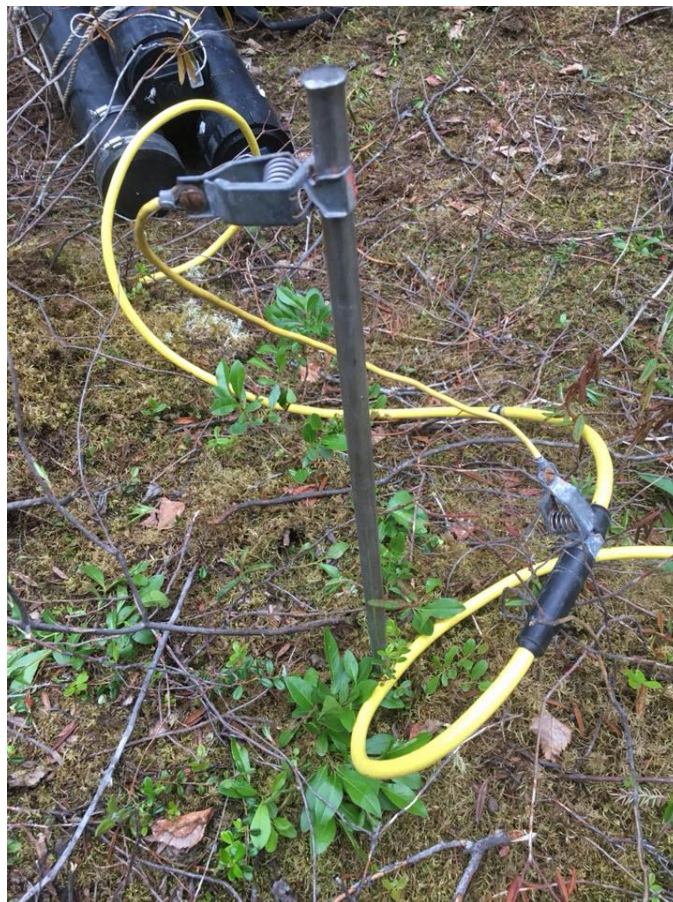
Figure 3.7: Standard ERT Probe Configuration

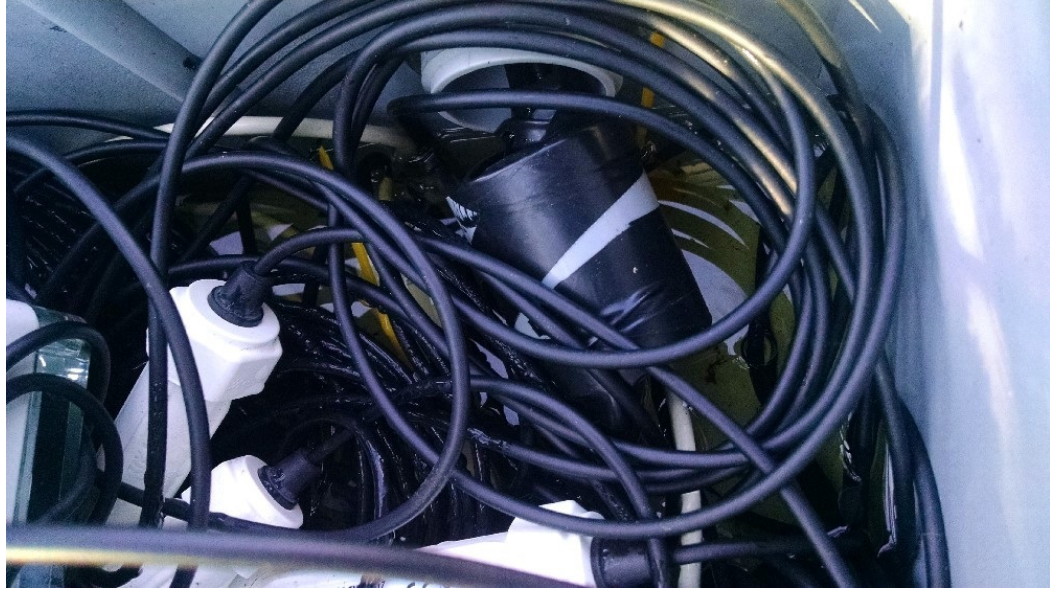
Figure 3.10: Flooded Instrument Housing

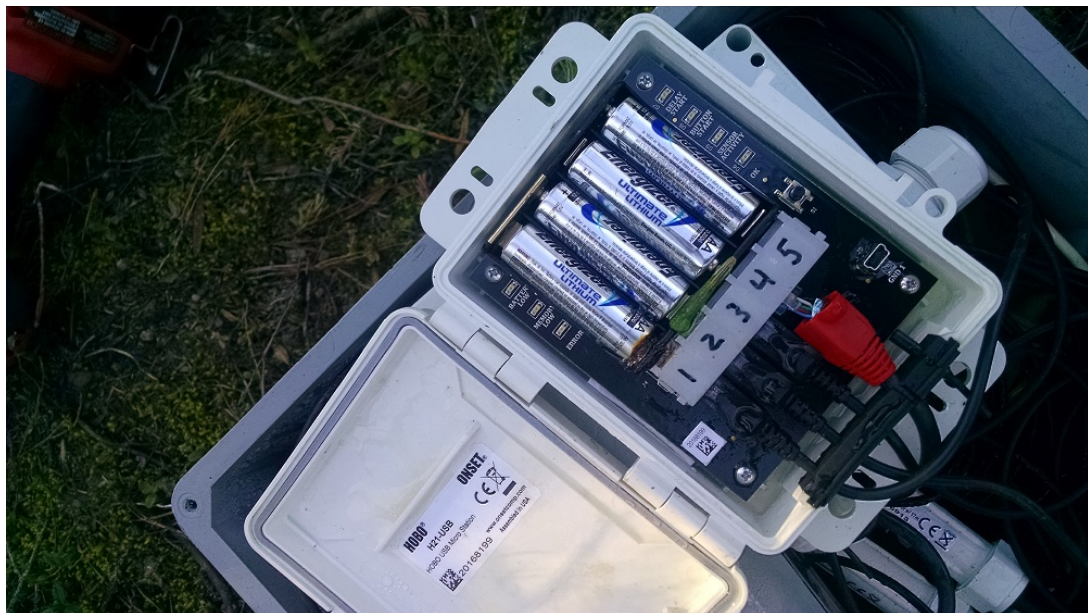
Figure 3.11: Data Logger Damage from Corrosion

Specifically, corrosion was occurring on the data logger battery leads as shown in Figure 3.11.

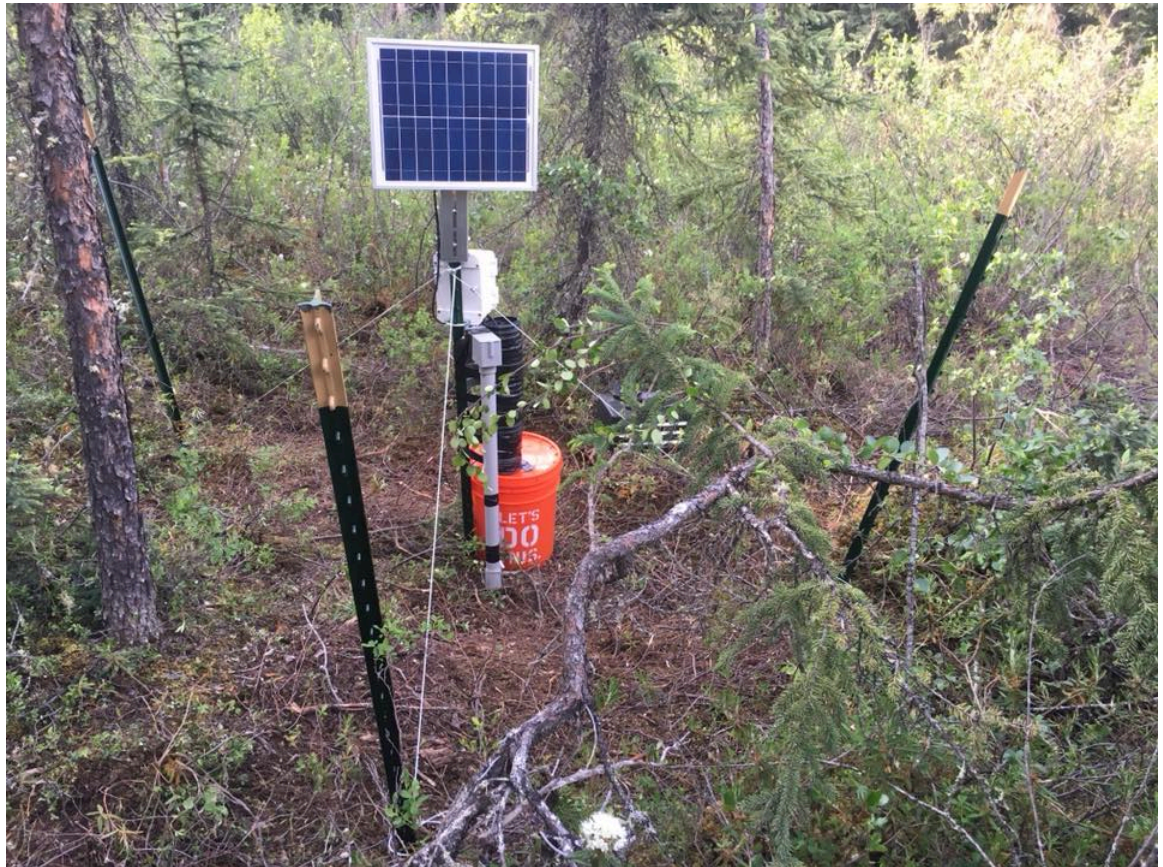
Figure 3.13: Station One Upgrades

After completing all the installations and upgrades there was still several cables and connectors that would be vulnerable to the elements. The most expedient decision I could find was to place them all inside of a plastic five-gallon bucket and seal them against any kind of intrusions from weather or vermin. In case water did penetrate it somehow, I did place some small weep holes in the bottom of the bucket so it could drain. Figure 3.13 shows the completion of Station One.
