## **Ice Control to Prevent Flooding in Ship Creek, Alaska**

Steven F. Daly, Joseph S. Rocks, Marina Reilly-Collette,  
and Arthur B. Gelvin

July 2019

Final Report

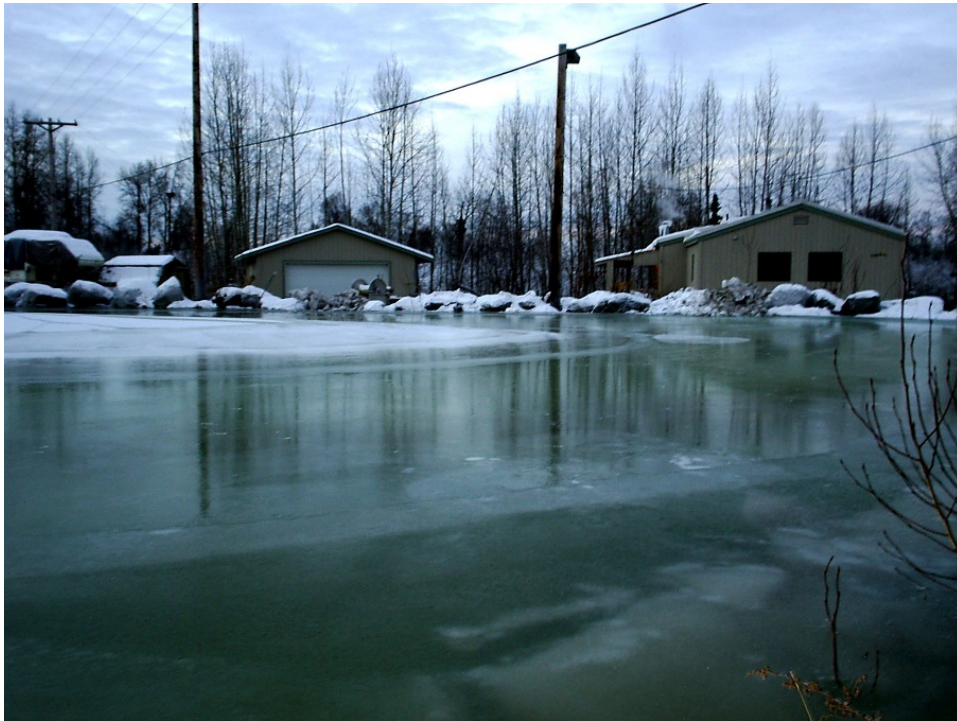
Figure 5. Inundation of buildings at the Fort Richardson Fish Hatchery.  
(Image by Andrea Tesch.)

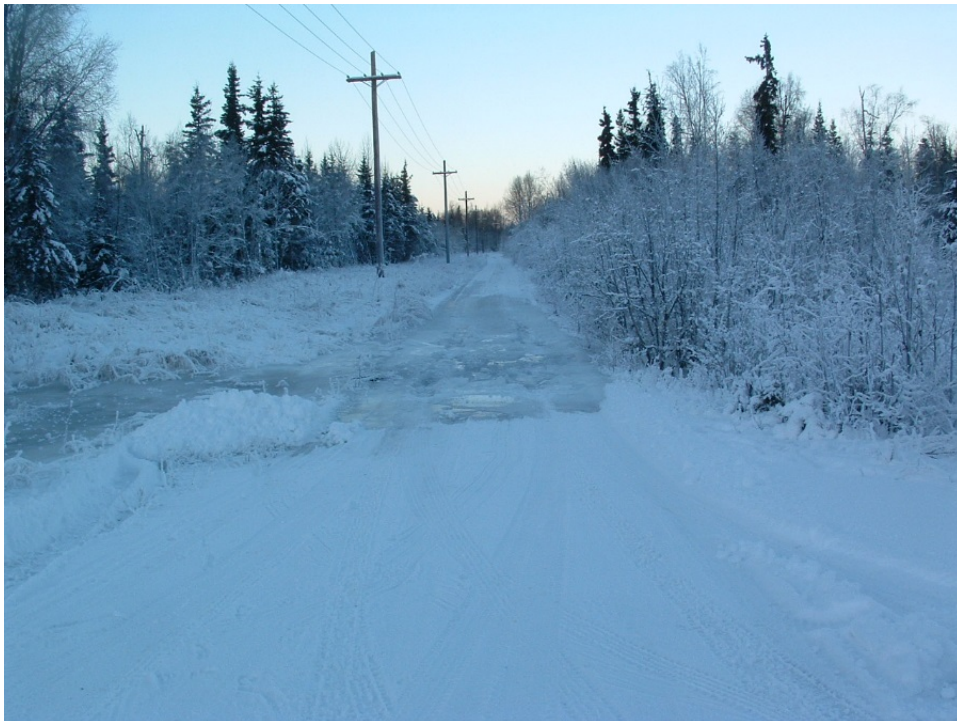
Figure 6. Flooding across the Fort Richardson Fish Hatchery Access Road.  
(Image by Andrea Tesch.)

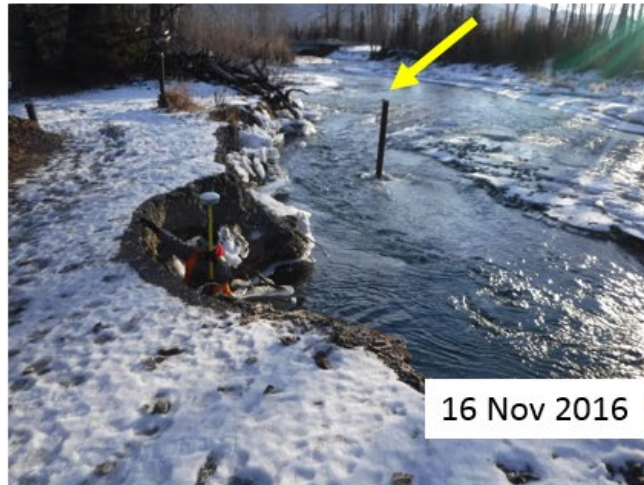
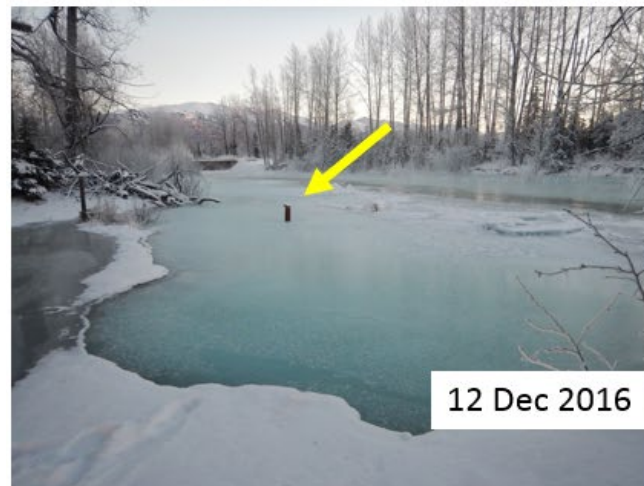
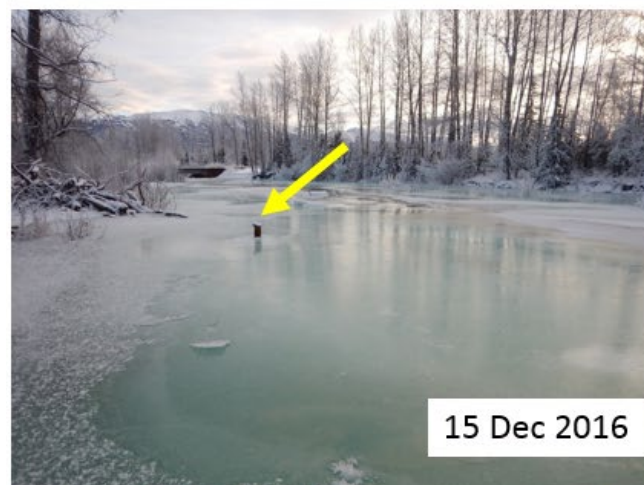
Figure 7. Increase in water level caused by ice formation.

Figure 7 clearly shows the impact of ice on the water levels of Ship Creek. The three images in Figure 7 were taken in November and December of 2016 at the same location on Ship Creek in the flood-prone reach. This location is several hundred feet downstream of Grady Road Bridge (seen in the distance) looking upstream. The location of an old, disused well casing is marked by a yellow arrow in each image. The well casing stands vertically upright and extends approximately 6 ft above the bed of the creek. In the first image, taken on 16 November 2016, there is minimal ice present. Ship Creek is largely open, and the well casing stands in several inches of water. In the second image, taken on 12 December 2016, the creek is largely ice covered. The water level in the creek has risen over 5 ft at this time. Ship Creek is entirely ice covered except for a small open-water channel down the center of the channel. The rise in water level is due entirely to the ice formation in Ship Creek as the flow in the creek has undoubtedly dropped between these dates. The final image was taken on 15 December 2016. Ship Creek had risen several more inches since 12 December.

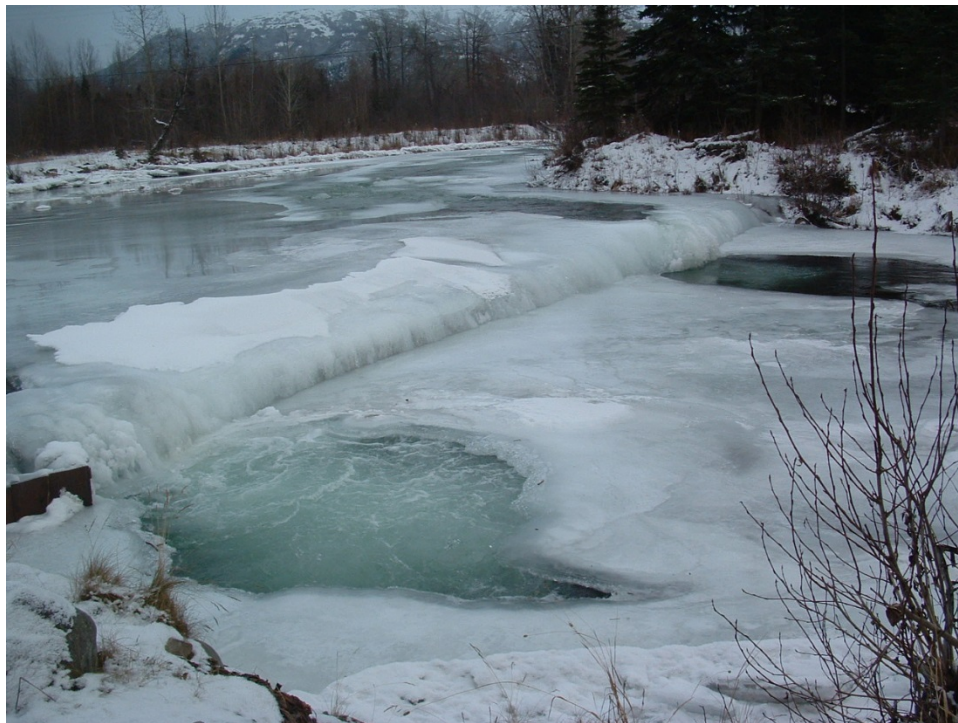
Figure 8. Small dam for Fort Richardson Power Plant (2007–10).  
(Image by Andrea Tesch.)

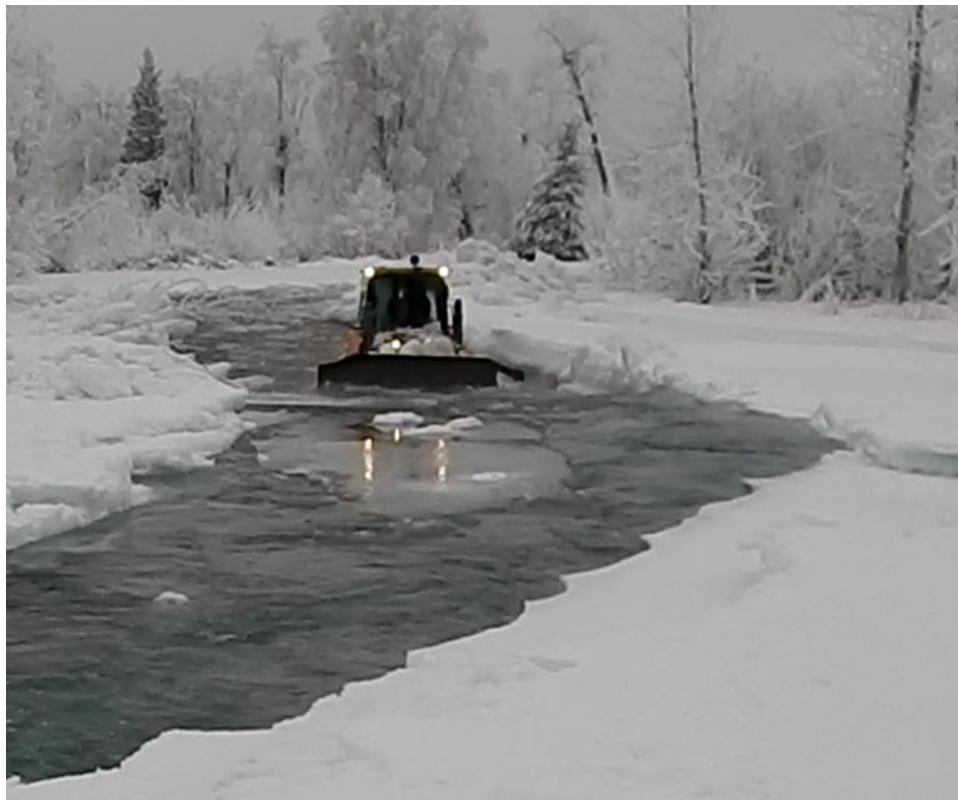
Figure 9. Bulldozer removing ice from the channel bed (January 2017).

a bulldozer in the channel in the upstream direction, with the dozer blade just above the channel bed (Figure 9). This procedure was followed on 13 January 2017 and was very effective in removing ice from the channel bed. The channel flow carried the removed ice downstream. This operation caused the water levels in Ship Creek to drop significantly. The second objective of mechanical removal is to break up and remove the surface-ice cover to provide room for the ice removed from upstream to deposit without raising the creek water levels (Figure 10 and Figure 11). This operation places much more stress on the dozers than simply removing ice from the channel bottom. Figure 12 shows the ice cover of Ship Creek after fracturing.

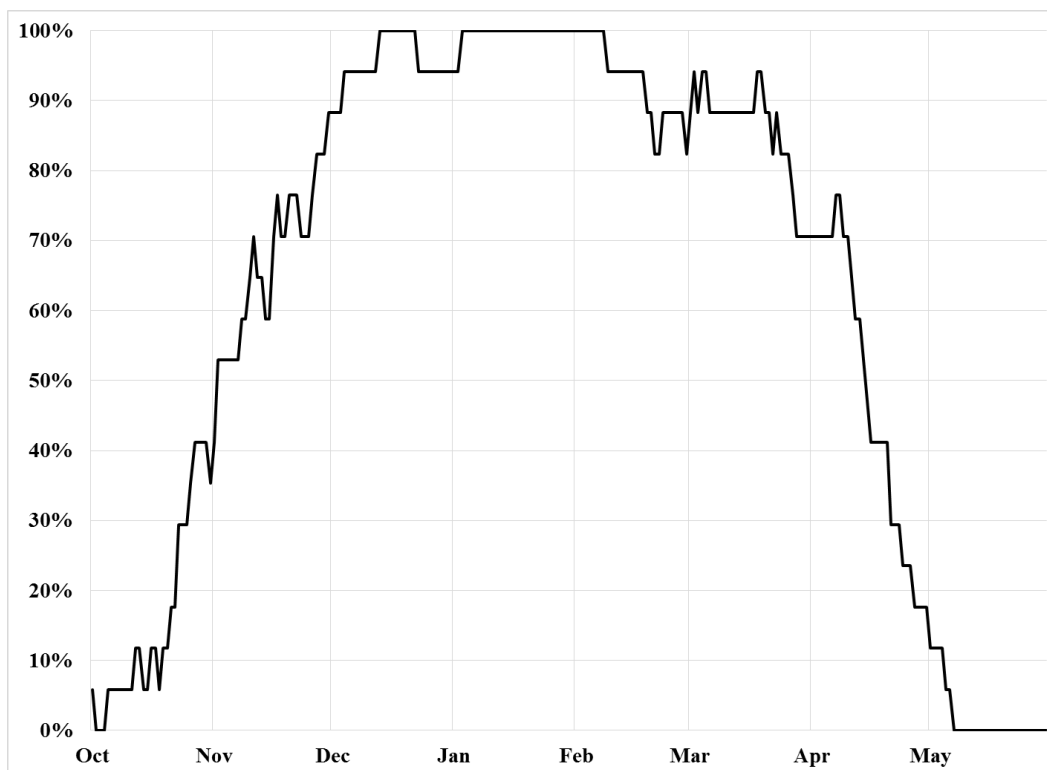
Figure 23. Percentage of winters (2001–17) with ice for each day of winter at the USGS gage.

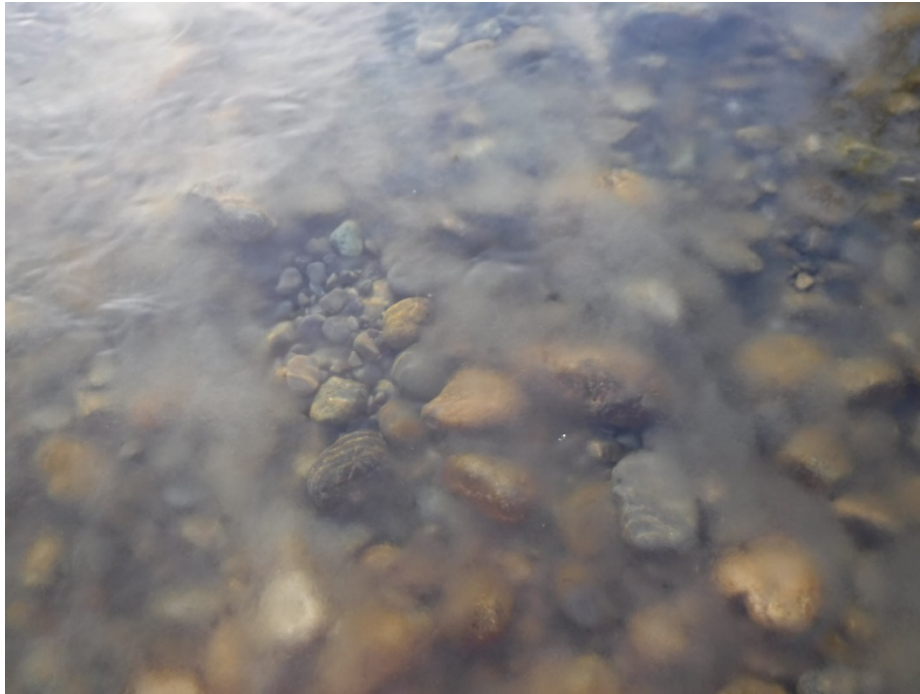
Figure 26. Anchor ice visible underwater (Ship Creek 16 November 2017).

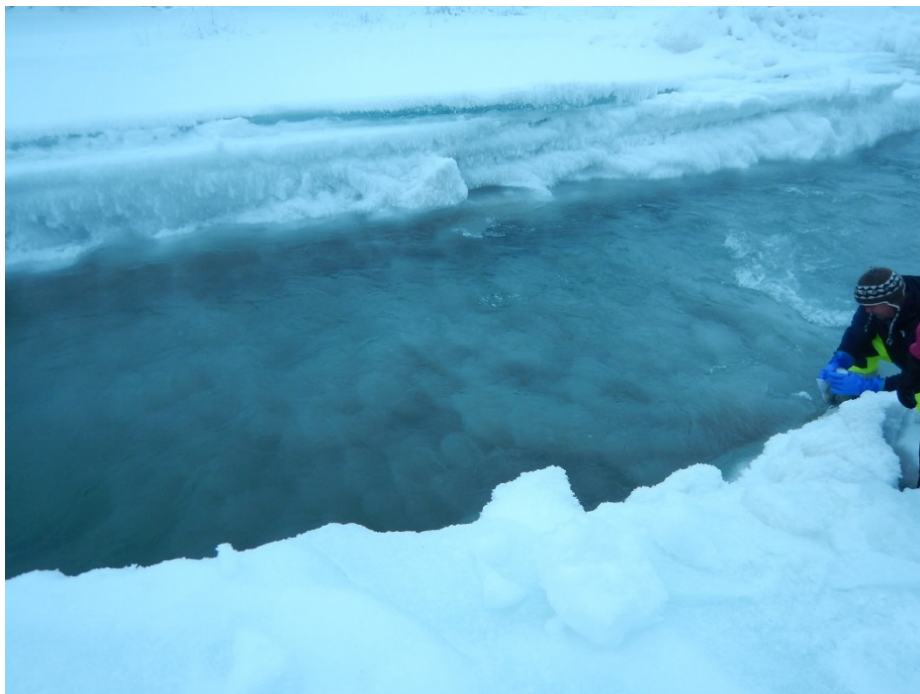
Figure 27. Anchor ice visible underwater (Ship Creek 12 January 2017).

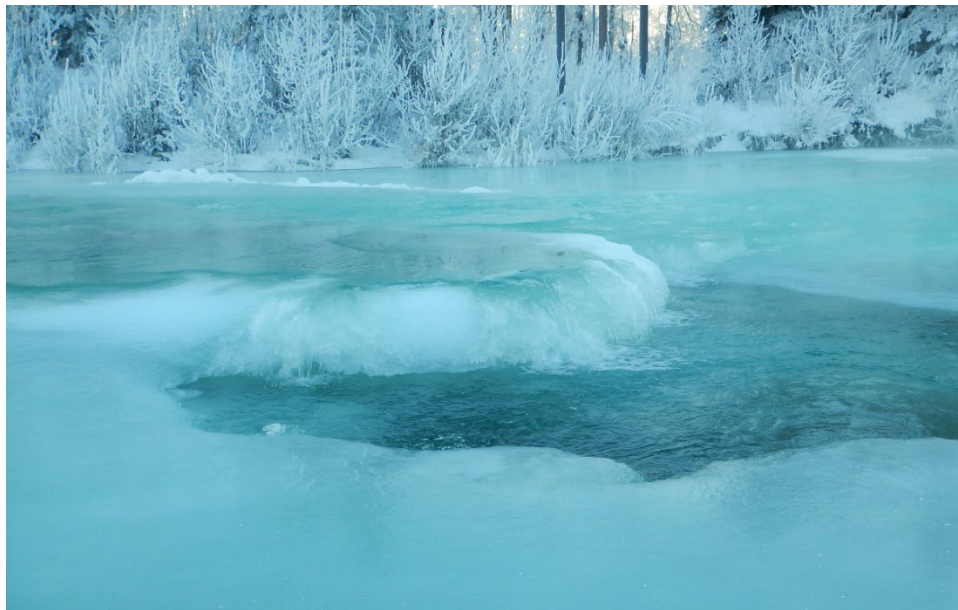
Figure 29. Ice dam and weir (Ship Creek 13 December 2016).

small boulders. In these areas, relatively large depositions occur, leading to the formation of frazil *ice dams* (Dubé et al. 2014) as shown in Figures 28 and 29. Ice dams can have a significant impact on the local flow conditions. They cause increased water levels immediately upstream of their location. The flow often passes over the top of the ice dams in weir-like flow, leading to the formation of *icings*. Icings occur when the water flowing over the ice weir freezes. This leads to continual vertical growth of the ice dams.

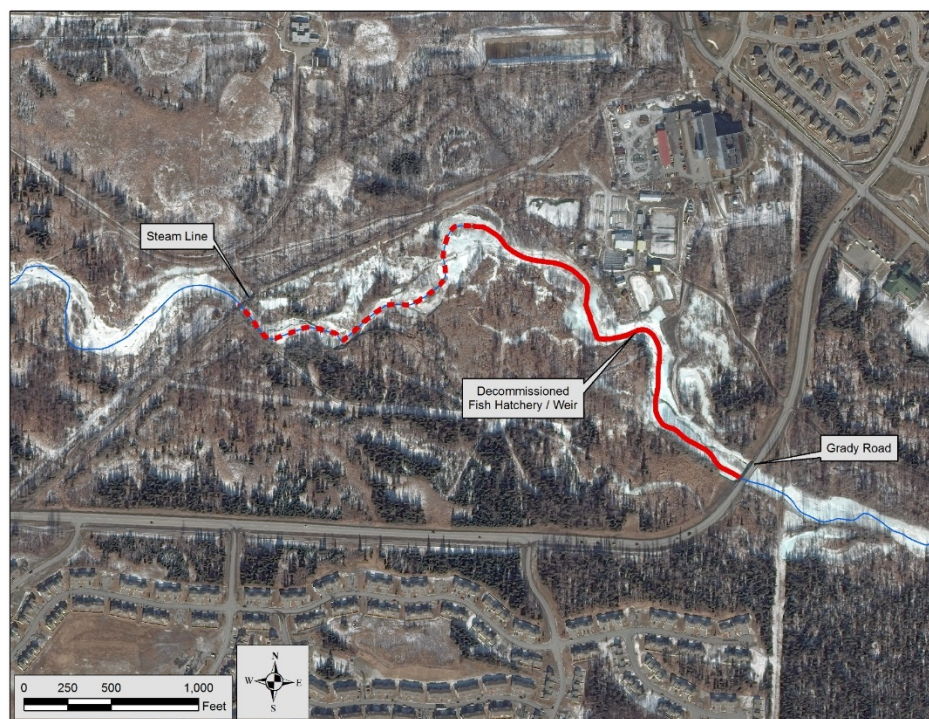
Figure 36. Mechanical removal area of the flood-prone reach (*red line*).

- Closely monitor ice formation in the flood-prone reach of Ship Creek. Anchor ice and ice dams cause the water level of the creek to rise. These ice formations are clearly visible to observers on the banks of the channel. The area to monitor starts at Grady Road Bridge and extends downstream to the section of Ship Creek immediately below the residences in the fish hatchery area. Figure 36 indicates the reach with a solid red line. Most of this area of Ship Creek is visible from the access roads. The formation of anchor ice can begin as early as November. Ice removal was also observed downstream to the steam line bridge, as shown by the dotted red line in Figure 36.

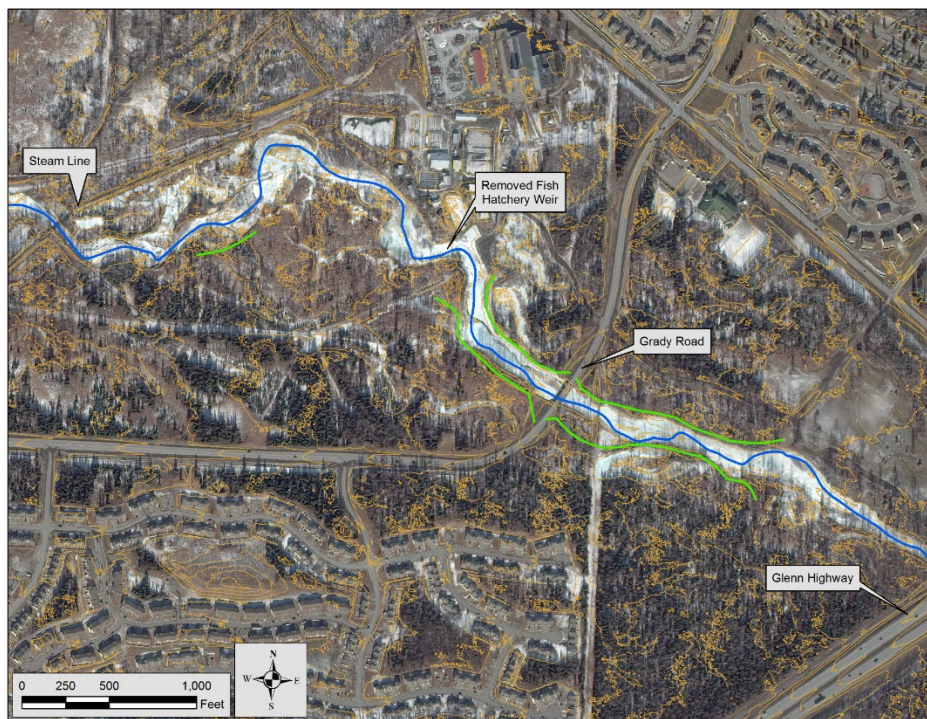
Figure 37. Likely berm locations to contain freeze-up (*green lines*).

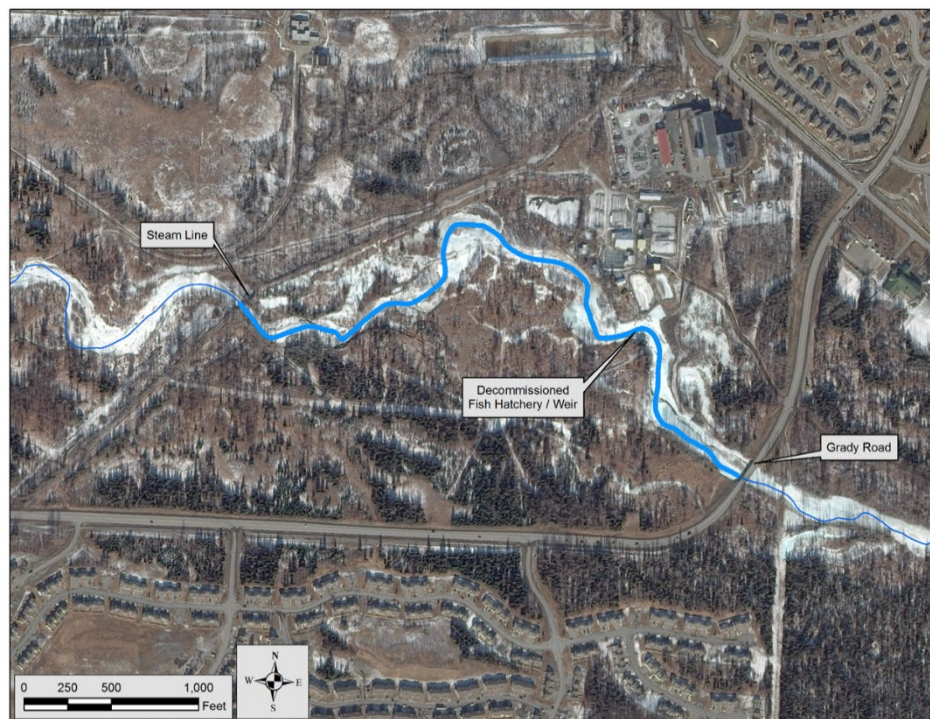
Figure 38. Thermal-suppression Scenario 1, Grady Road Bridge to steam-line crossing.

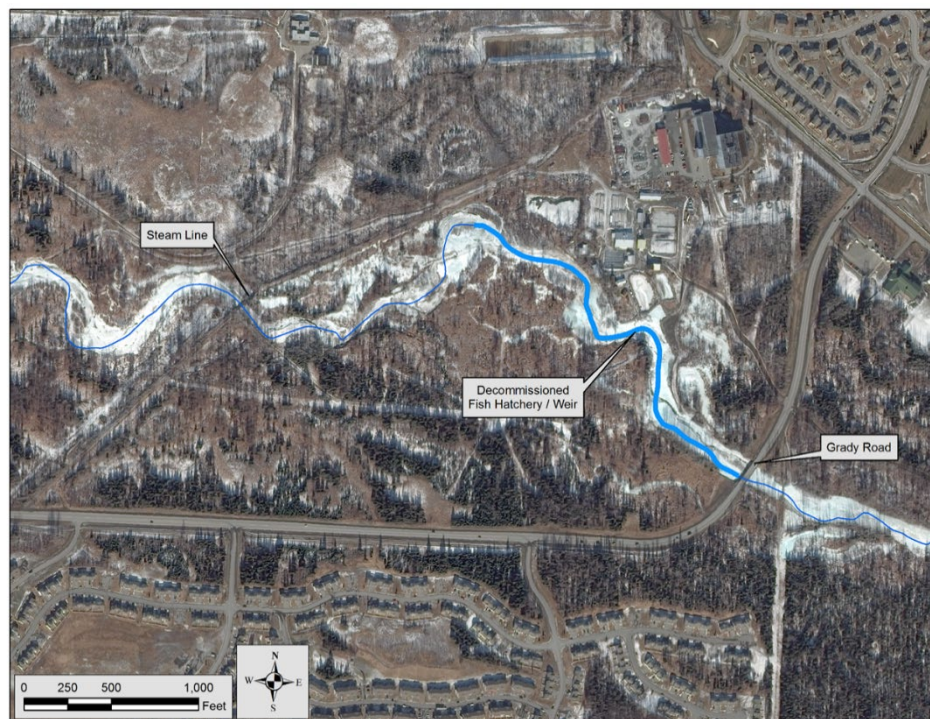
Figure 39. Thermal-suppression Scenario 2, Grady Road Bridge to downstream of the fish hatchery.
