ERDC/CERL TR-19-17

Demonstration of Electro-Osmotic Pulse and Dehumidification Technologies to Mitigate Corrosion in Earth-Covered Magazines

Final Report on Project F08-AR23

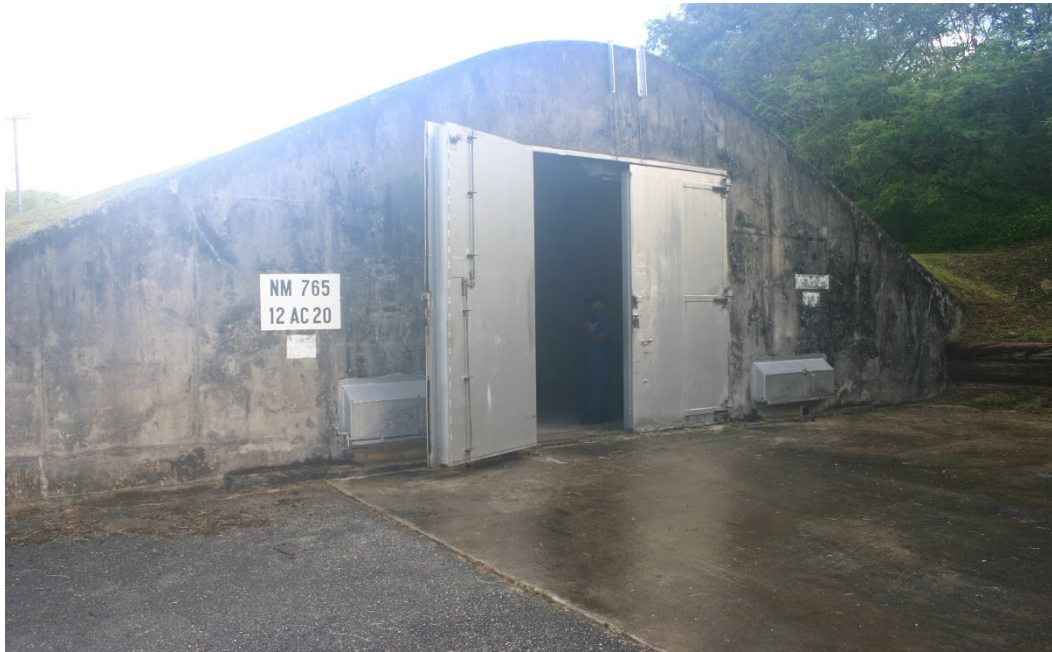
Figure 1. ECM 12AC20 at Guam.

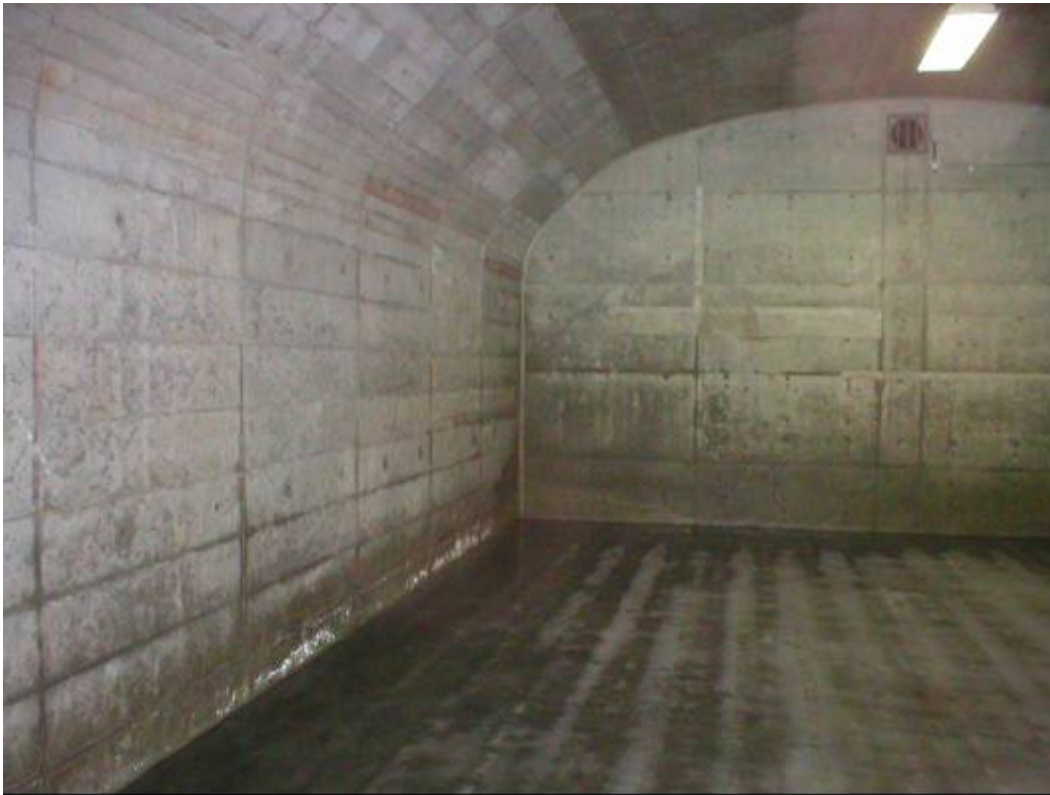
Military installations located in warm marine coastal environments are continually exposed to very high ambient humidity, a chloride-infused atmosphere, and high annual rainfall. These combined conditions promote accelerated corrosion that is highly destructive both to reinforced concrete ECMs and their military-critical contents. This damage is caused by water intrusion through ECM floors, walls, and seams, and by the high ambient humidity that is captured inside the unconditioned structures; ambient high temperatures can accelerate the damage. Aggressive corrosion of a magazine's steel reinforcement materials weaken it enough over time to require premature structural rehabilitation. Figure 2 and Figure 3 illustrate water-intrusion problems in ECMs.

Figure 2. Water intrusion on floor, at left and background, in ECM 12AC20 at Guam.

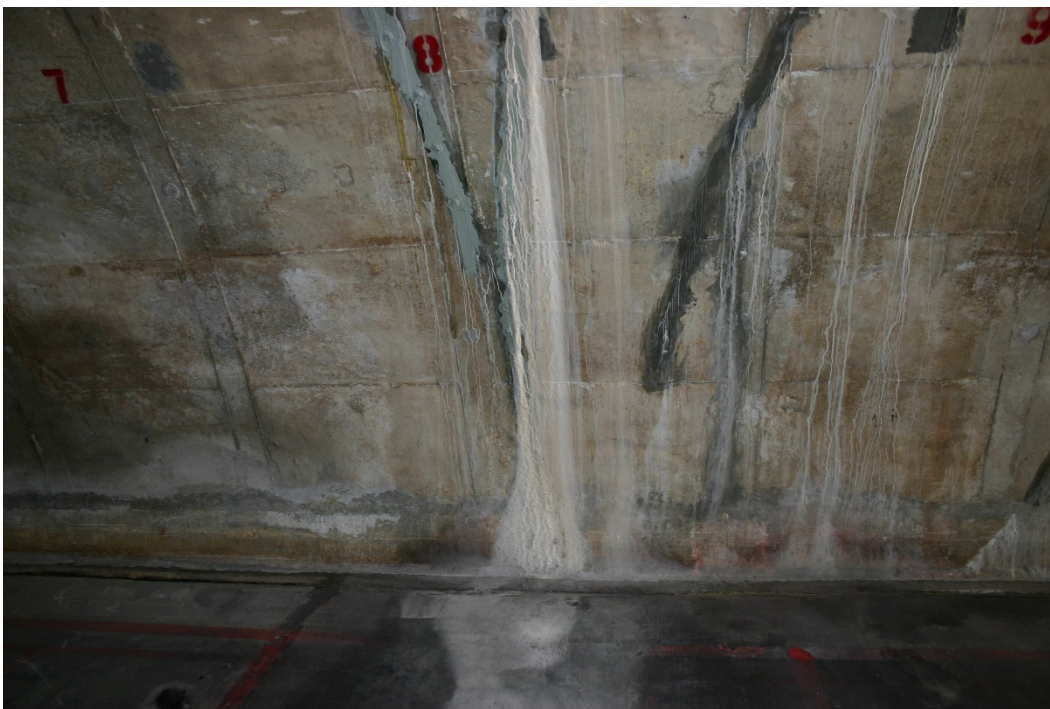
Figure 3. Water intrusion through cracks in ECM 12AC20 at Guam.

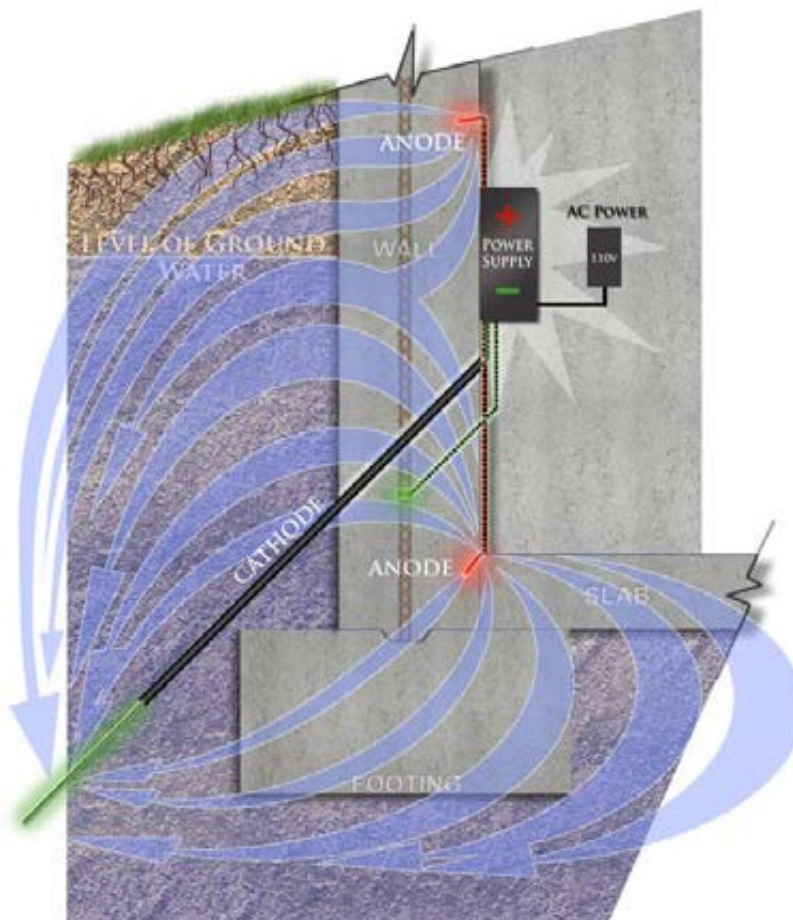
EOP technology exploits the phenomenon of electro-osmosis to move water contained in concrete by applying a pulsating electric field to the structure. One set of electrodes is embedded just below the surface of a structure's concrete floors, walls, or ceilings, and another set is placed either in the surrounding soil or—if the concrete is thick—deep in the concrete itself. A pulsing direct current (DC) voltage is applied to anodic electrodes, which establishes an electric field that permeates the concrete cross-section in reaching the cathodic electrodes. The positive electrical pulse causes cations (e.g., Ca^{++}) and water molecules surrounding them to move from the dry, interior side (anode) toward the wet, exterior side (cathode). The system is designed to move water against the direction of flow driven by the local hydraulic gradient, thus preventing water penetration through a buried or submerged concrete structure. Figure 4 illustrates the general electro-osmotic process, and Figure 5 illustrates what occurs at the pore level.

Figure 4. Diagram of EOP process in a concrete structure.

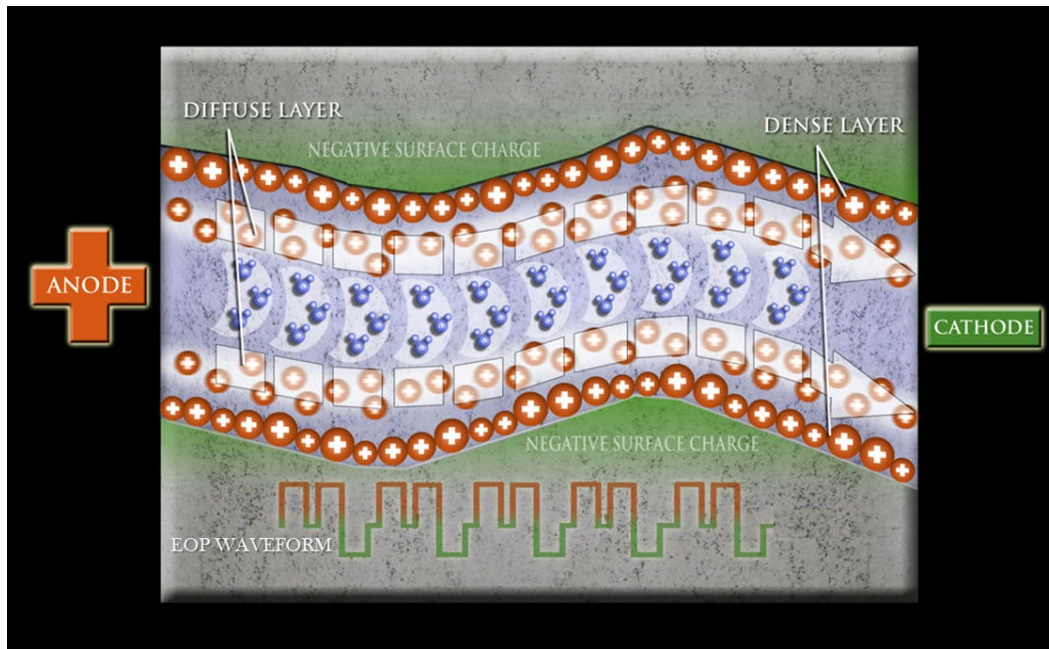
Figure 5. Illustration of electro-osmotic process in a concrete pore. During the electrical positive pulses (highlighted in orange on the EOP waveform) the water is moved from the anode to the cathode.

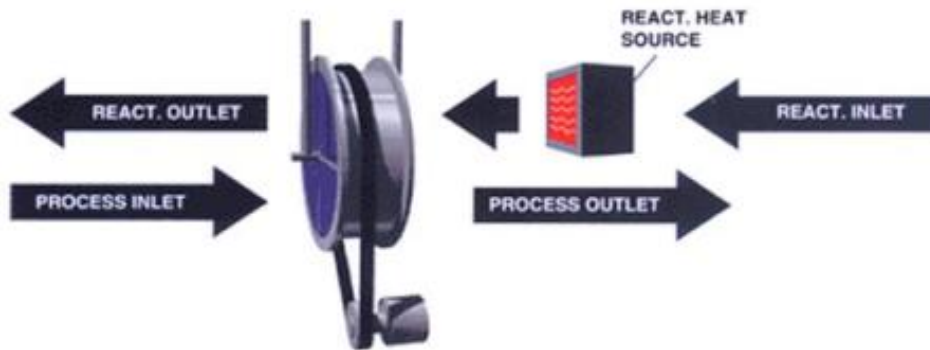
A desiccant system uses a highly effective humidity-absorbing material, such as silica gel, packed into a drumlike cartridge. Because the desiccant material becomes saturated with absorbed moisture during the DH process, the system includes a reactivation capability to dry out the desiccant medium and return it to service. In reactivation, the medium is exposed to a stream of heated air to remove the water before another dehumidification cycle. A typical system will periodically rotate the saturated desiccant out of service using mechanical means and heat to drive off the moisture. After reactivation, the hot, dry desiccant rotates back into the process air stream that cools the desiccant so it can begin the absorption process again. Figure 6 shows a conceptual illustration of the cycle.

Figure 6. Conceptual illustration of desiccant DH process.

The configuration shown in Figure 6 can be used in a closed-cycle system, which is the most efficient design for most desiccant DH applications because it does not bring humid outdoor air into the building. However, a closed-system design was considered undesirable for an ECM due to possible explosive or toxic outgassing from stored ordnance. Consequently, the researchers designed an open-cycle system to prevent the accumulation of hazardous gases inside the ECM. Both the process inlet air source and the desiccant reactivation inlet air is drawn in from outside.

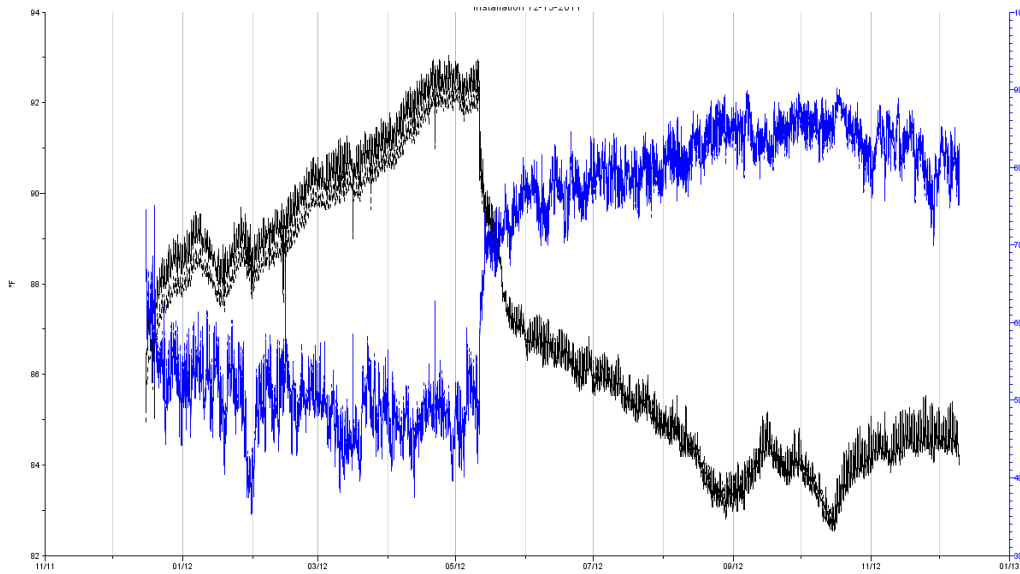
The ECM temperature and humidity data were downloaded after 6 and 12 months of operation (Figure 8). These data show the system maintaining the RH in the 40% to 60% range until mid-May 2012. During this same period the outdoor humidity ranged from 85% to 95% (Figure 9).

Figure 8. Twelve-month temperature and RH data for ECM 12AC20 interior. Temperature data is black (82 °F to 94 °F), RH data is blue (30% to 100%).

The clogged input filter may also have been affecting the temperature in the magazine. From Figure 8 we see that as the intake filter became clogged the temperature in the magazine rose. Then, after the intake filter was cleaned, the temperature in the magazine returned to being only a few degrees above the outdoor temperature. This change occurred because the DH unit once again began to bring in fresh air without obstruction of the intake filter.

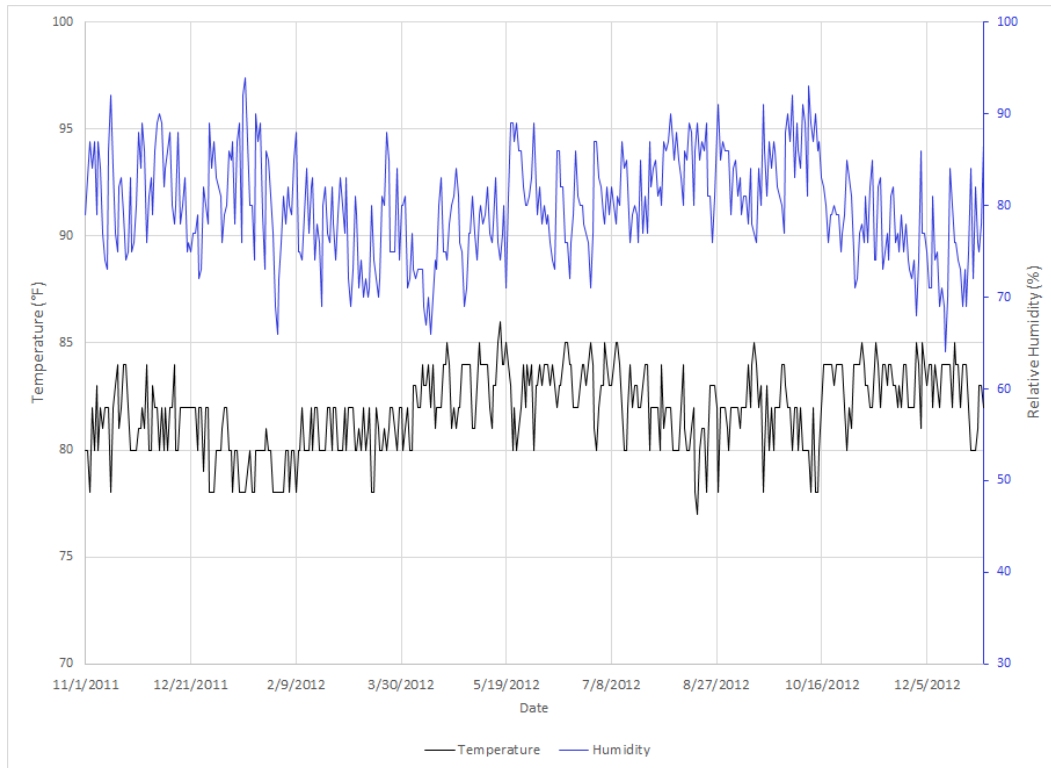
Figure 9. Thirteen-month temperature and RH data for Guam International Airport. Temperature data is black, RH data is blue. *

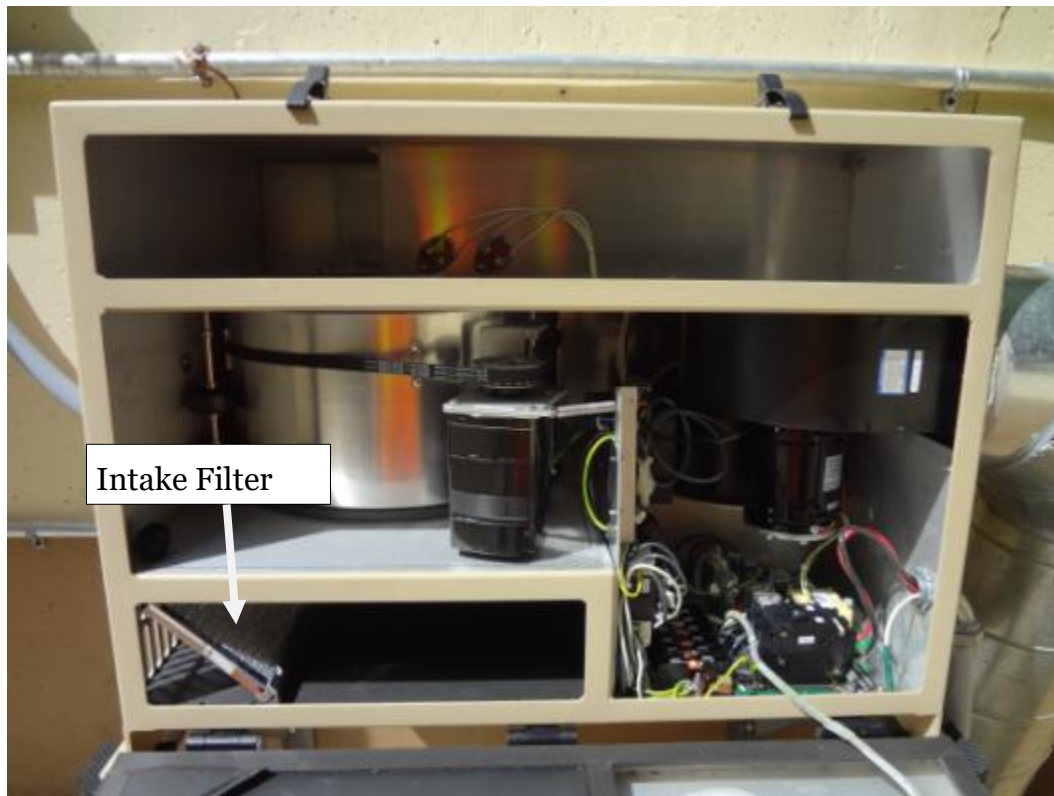
At the six-month interval, the air intake filter (Figure 10 and Figure 11) was found to be clogged. The filter was cleaned, and system performance appeared to recover. Later, at the twelve-month inspection, the air exhaust filter (Figure 12) also was found to be clogged. Since the exhaust filter is in the reactivation air stream, when it clogged it prevented the desiccant material from being reactivated, shutting down the dehumidification process. Both filters were cleaned and the system began to operate properly. The degree the filters were clogged can be seen in Figure 11.

Figure 10. DH unit intake filter shown in operating position.

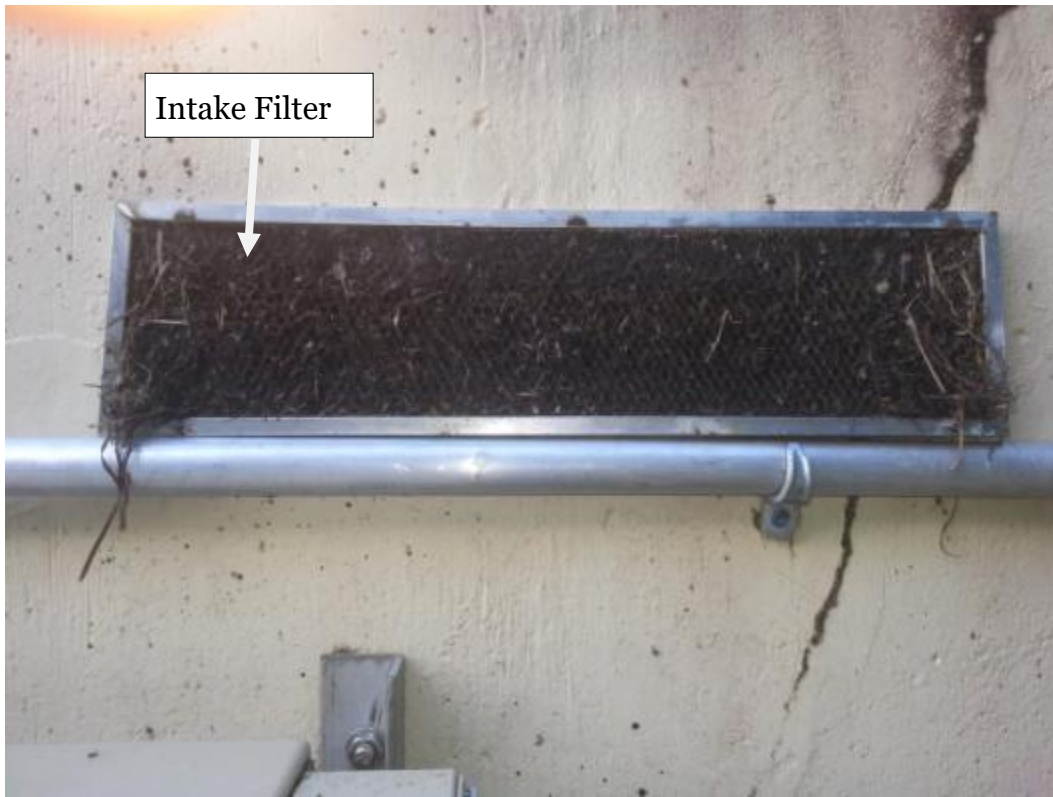
Figure 11. Clogged intake filter (removed for photograph).

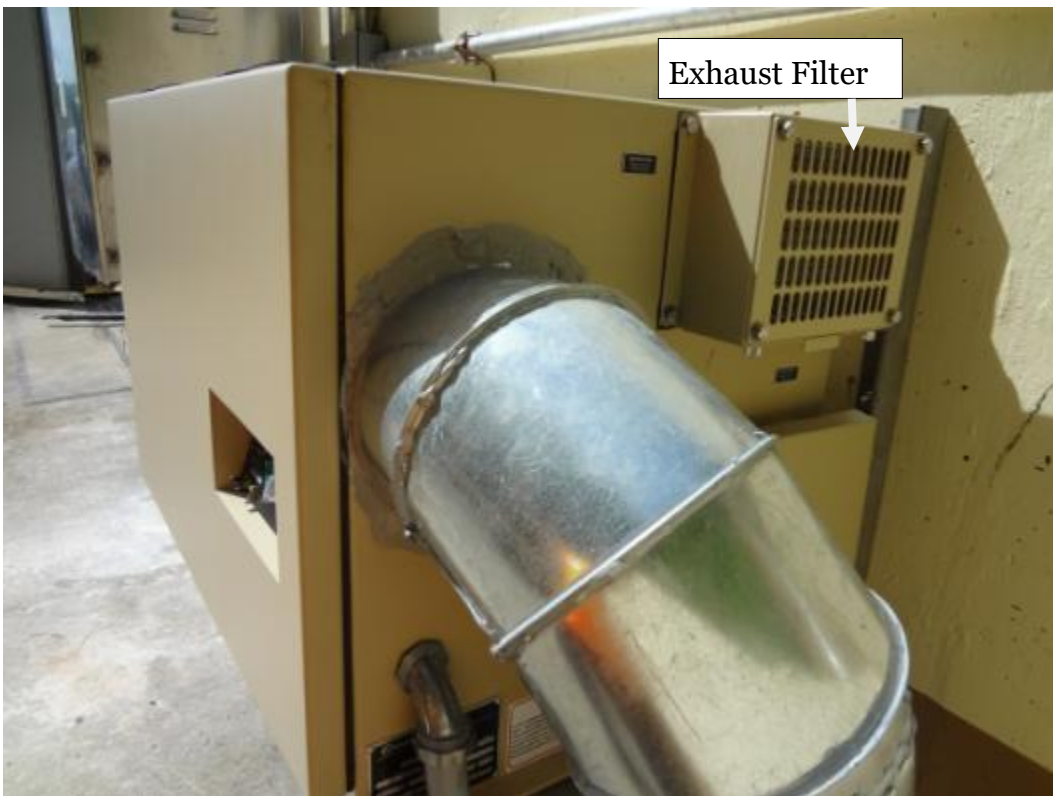
Figure 12. Exterior view DH unit exhaust filter (debris accumulated inside filter housing).

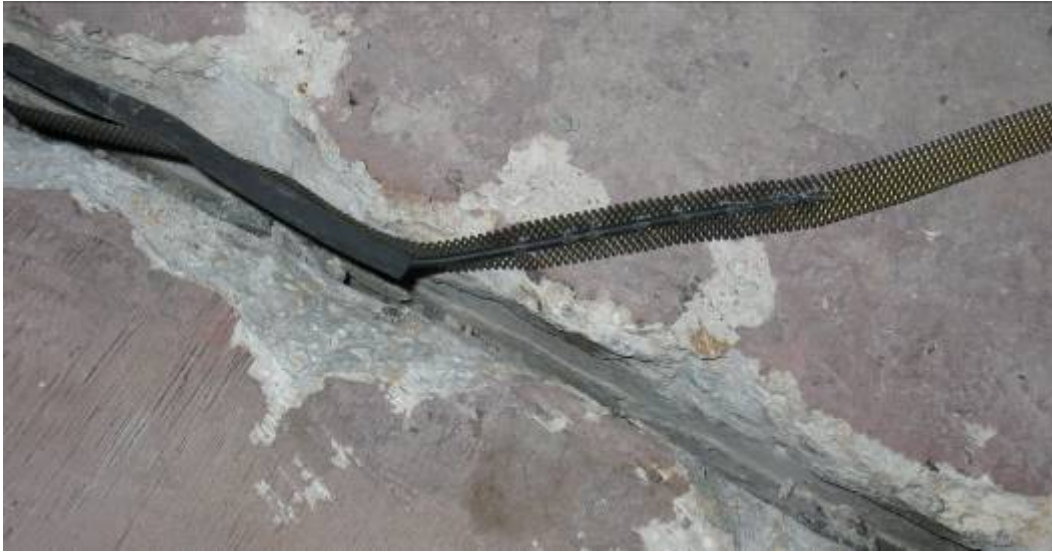
The anode system has a design working life of 20 years and is constructed of mixed metal oxide coated titanium expanded ribbon mesh anodes (Figure A1). These anodes are expected to exceed the design life as consumption is controlled by current output and the set points will be low.

Figure A1. Anode ribbon connected to lead wire.

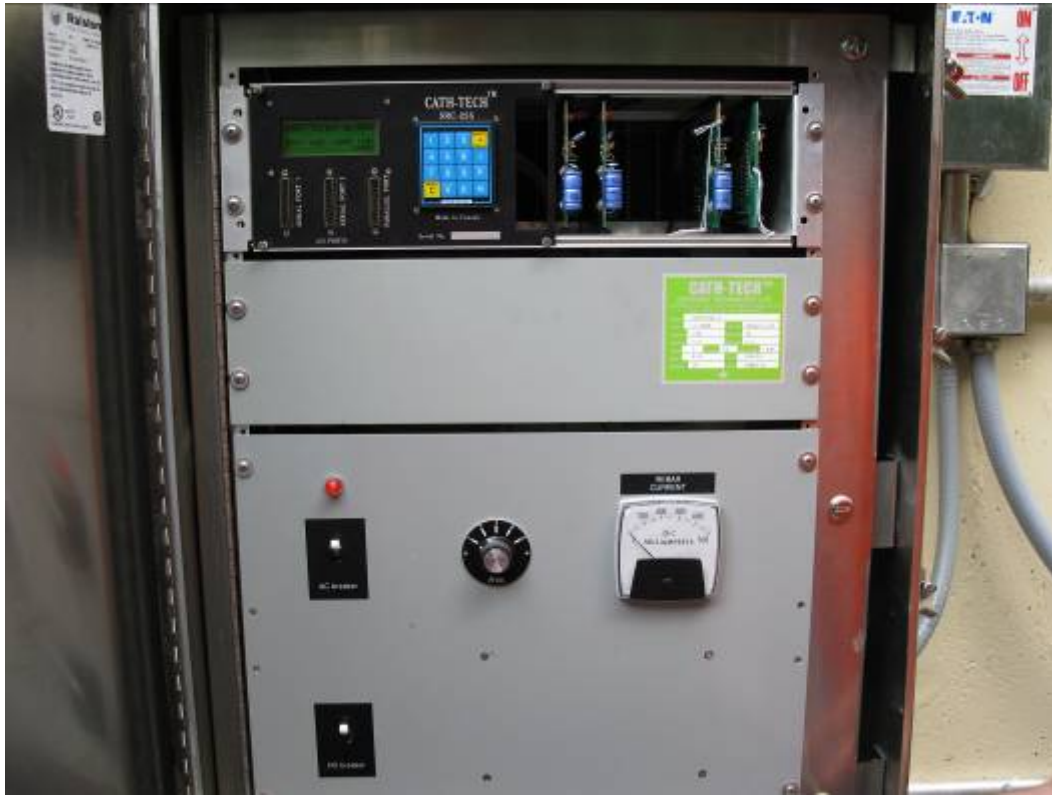
The master control unit (MCU) is a microprocessor controlled rectifier that converts the AC power to DC; the DC output pulse waveform is programmable. The MCU also provides for data collection and logging. The EOP system's operating parameters are recorded once every 24 hours.

Figure A2. MCU main panel.

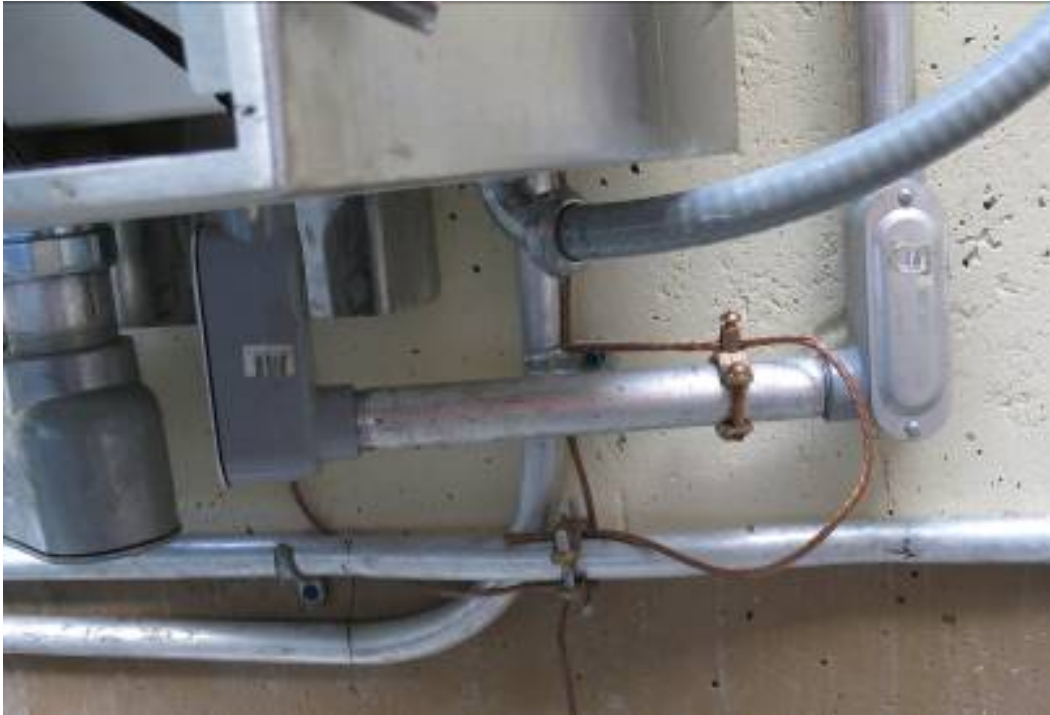
Figure A3. Galvanized conduit and junction boxes.

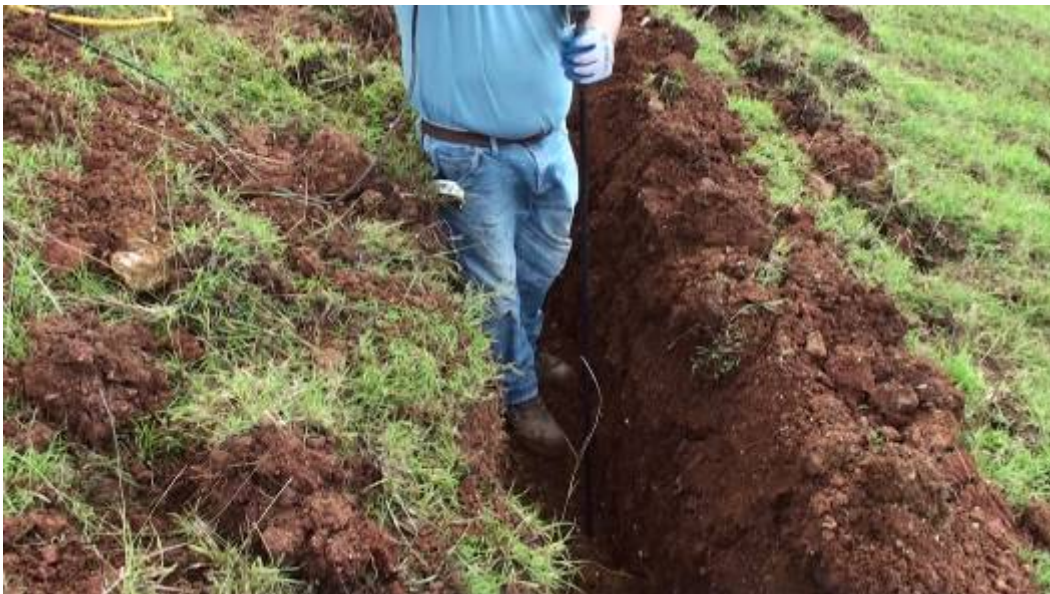
Figure A4. Cathode rod being driven into the ground.

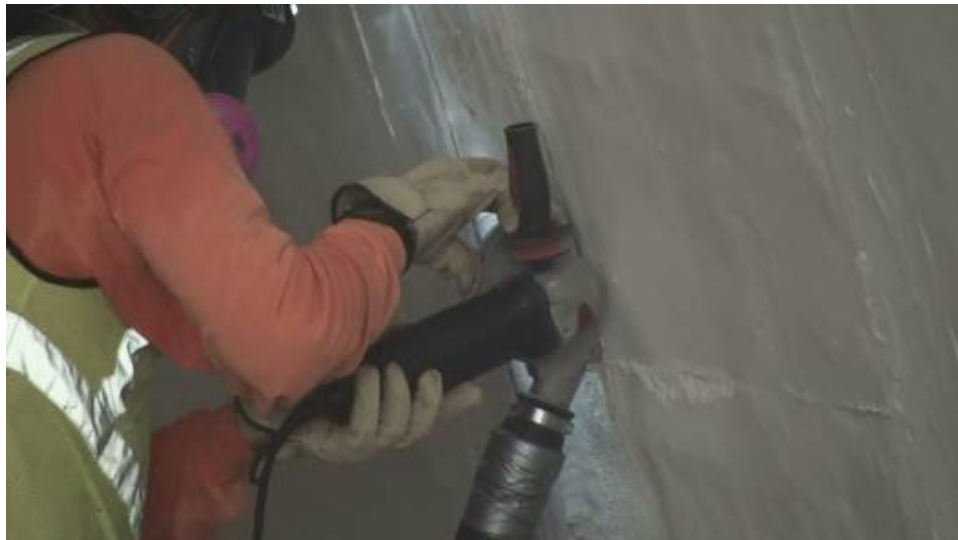
Figure A5. Ceiling cut for anode installation.

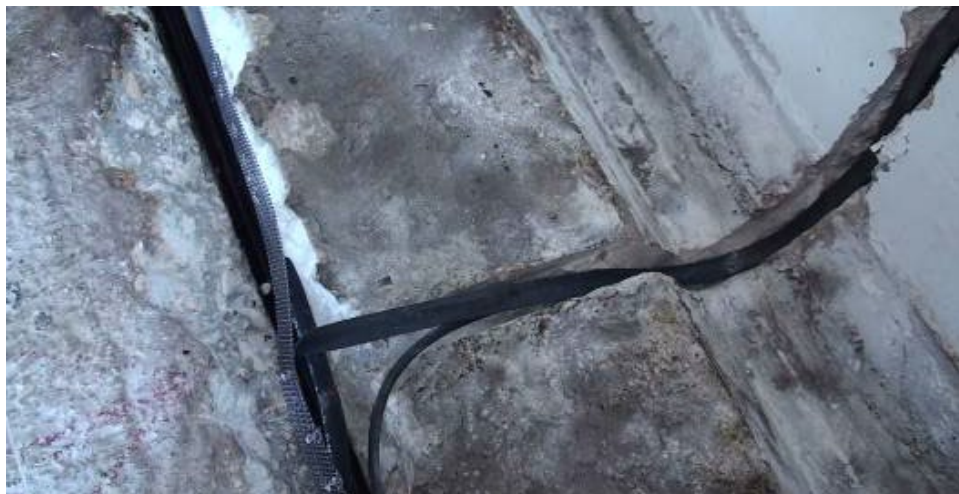
Figure A8. Floor anodes and lead wire.

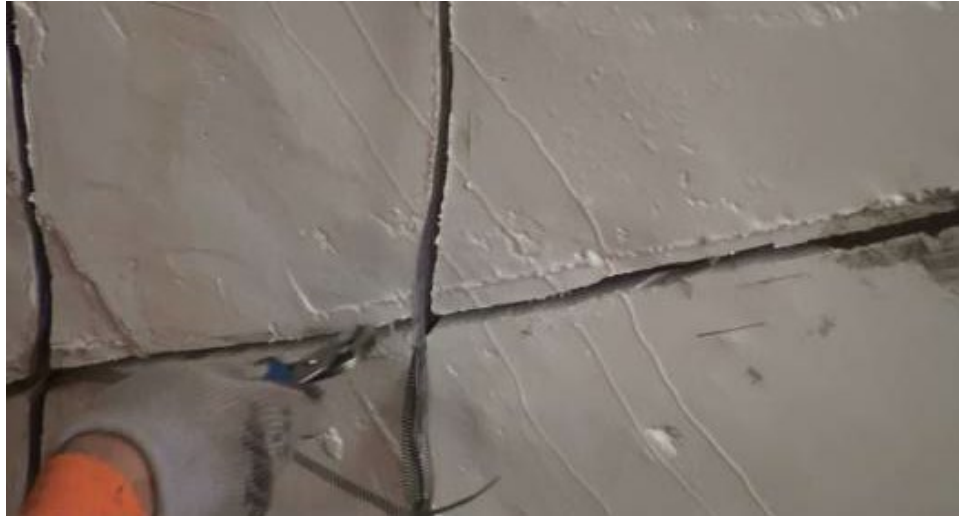
Figure A9. Ceiling anodes.

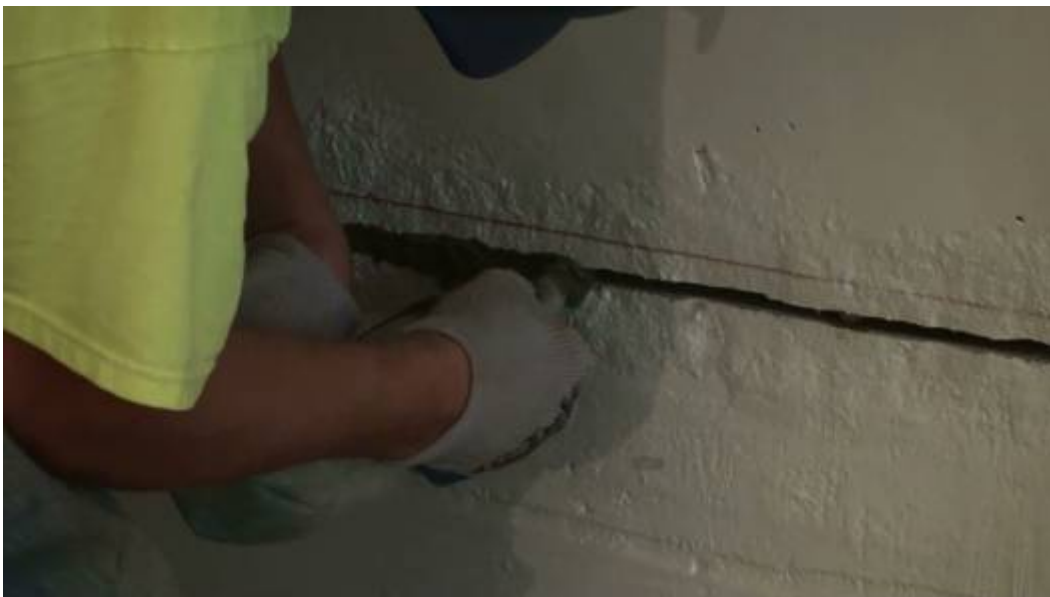
Figure A10. Grouting groove with cement.

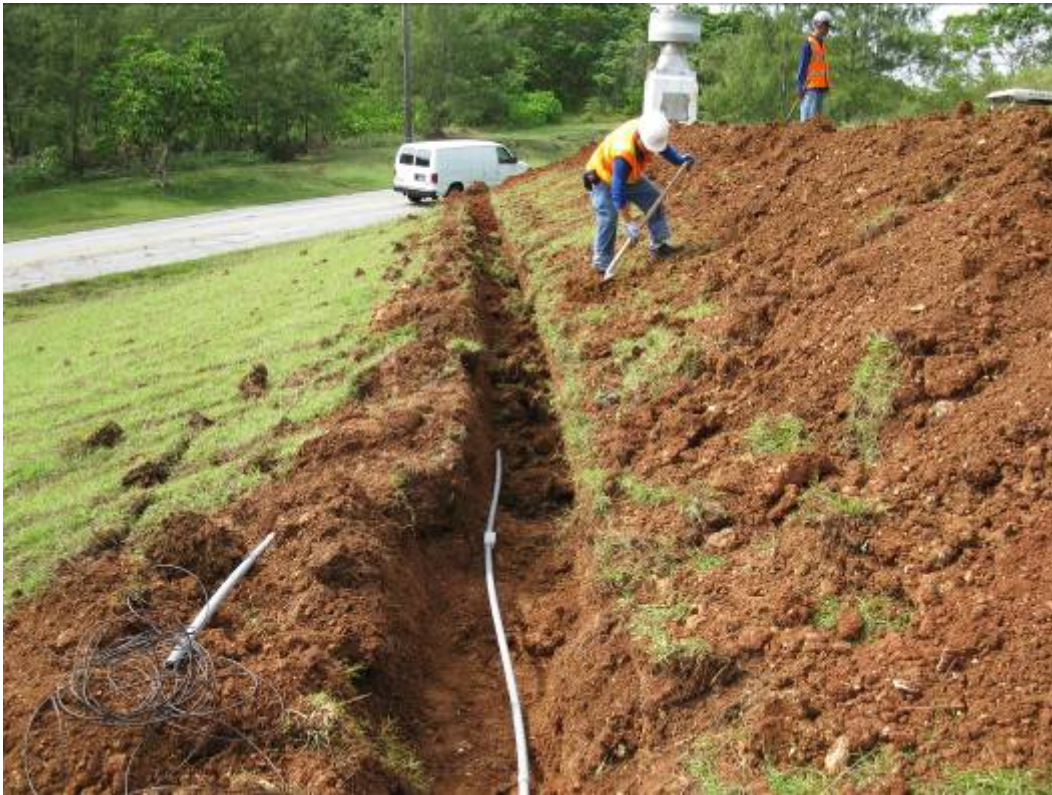
Figure A11. Cathode PVC conduit in trench.

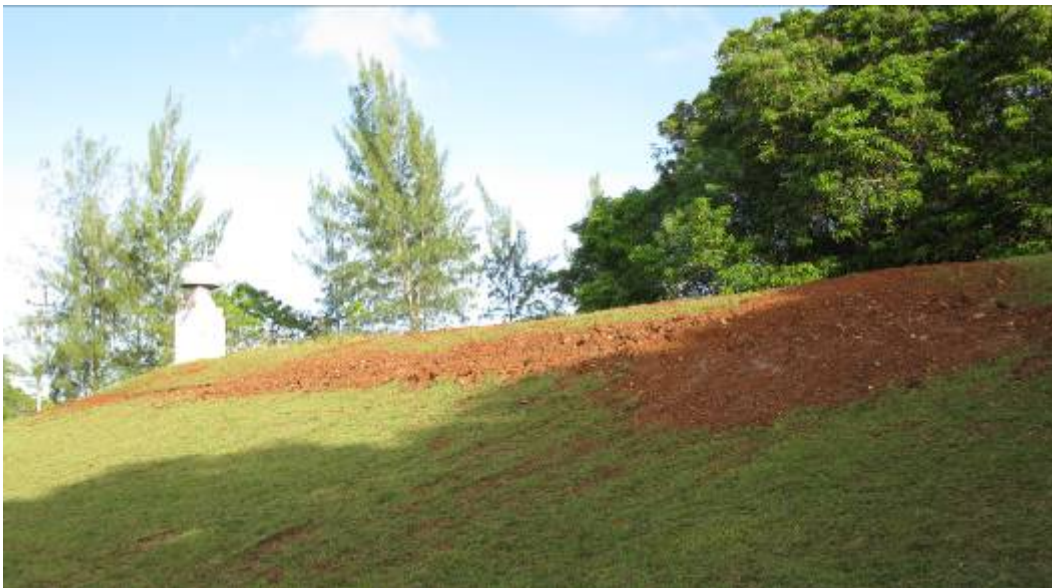
Figure A12. Cathode trench backfilled.

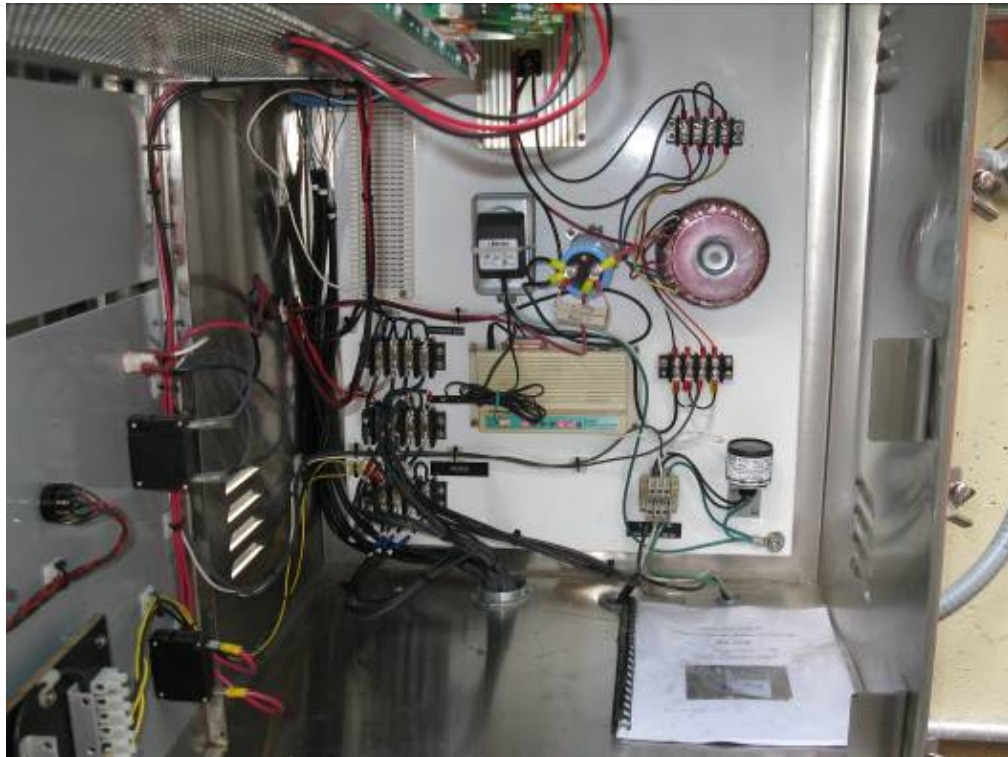
Figure A13. Rectifier wiring.

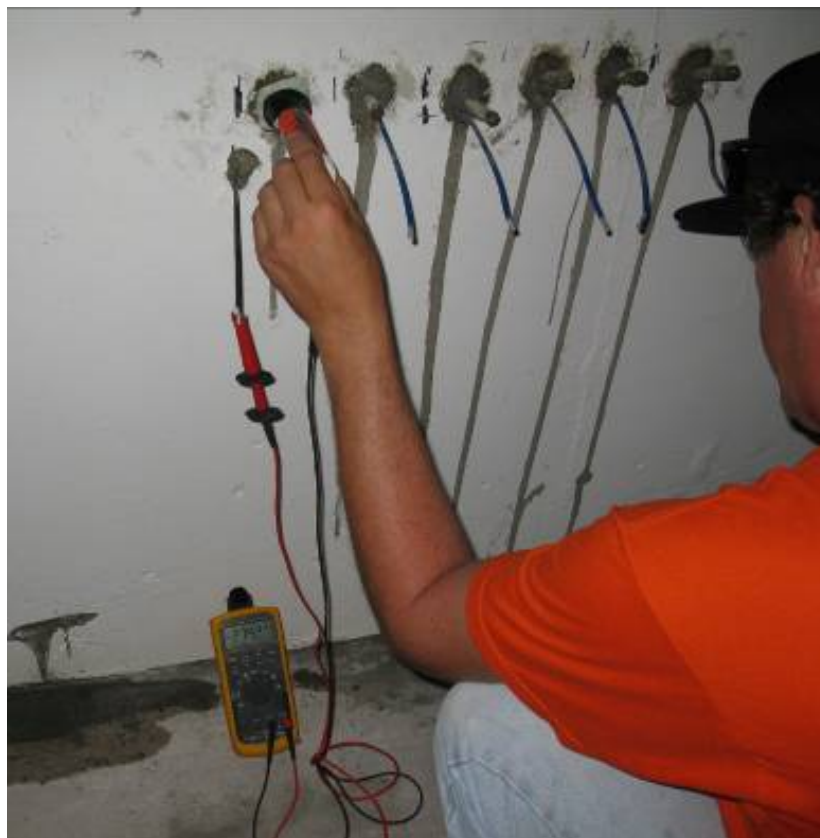
Figure A14. Stray current testing.

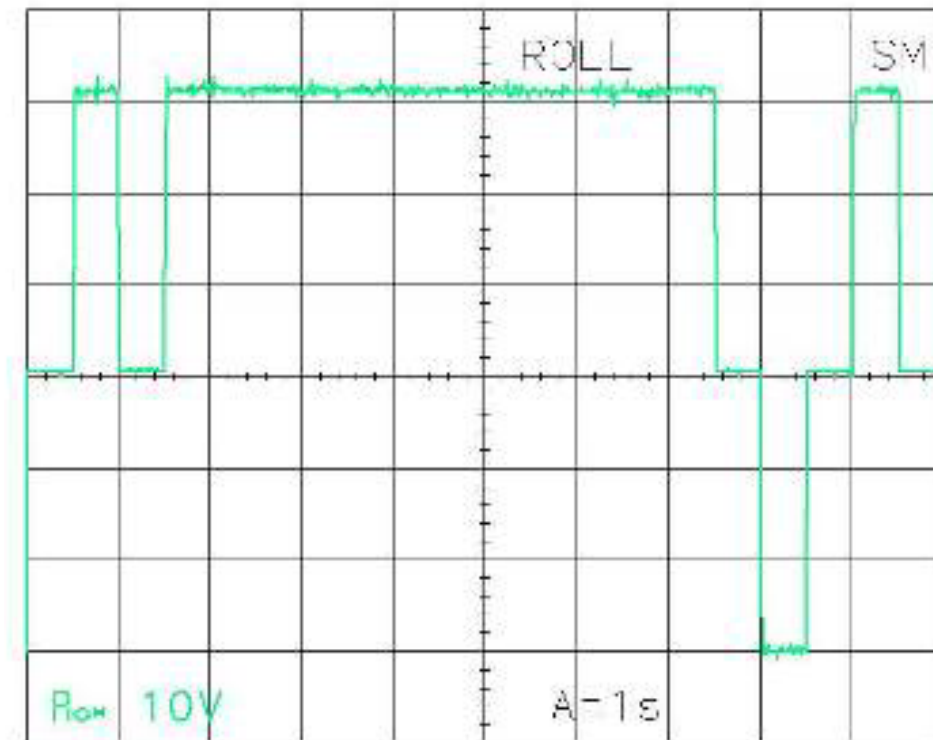
Figure A15. EOP wave form for ECM 12AC20.

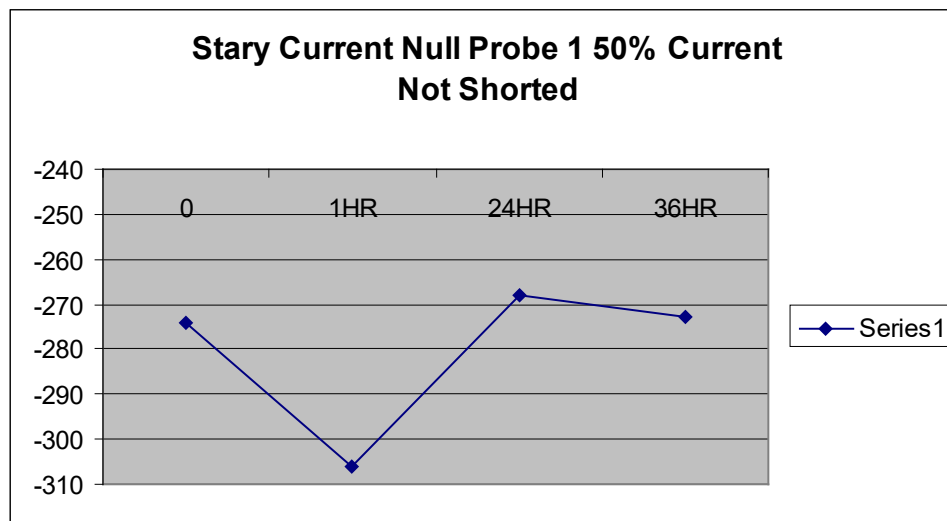
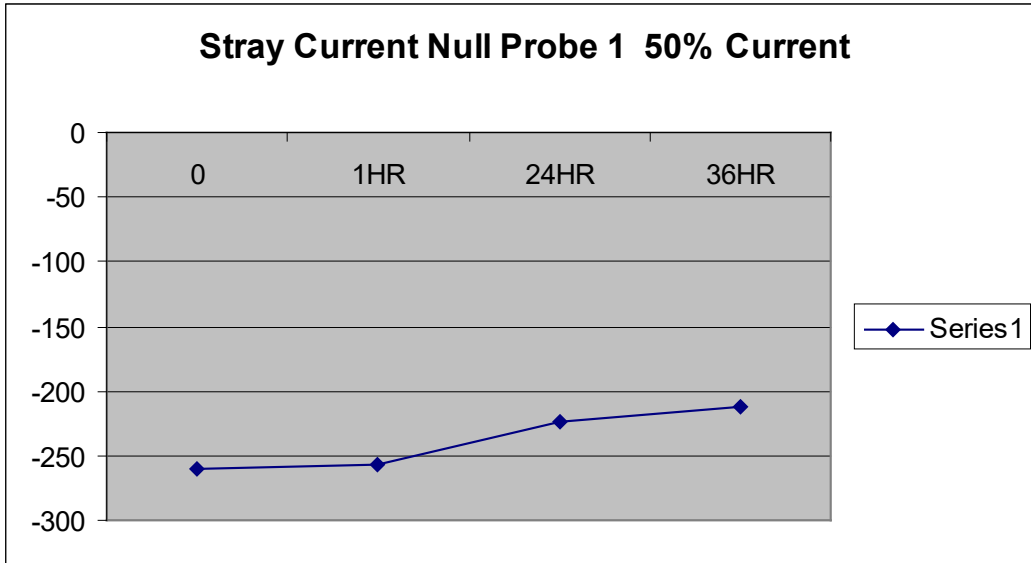
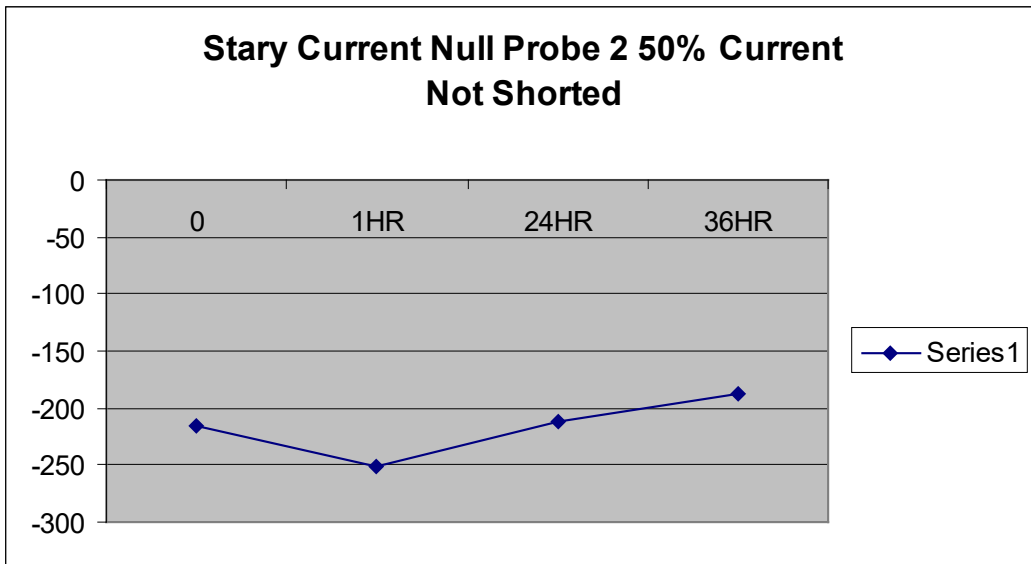
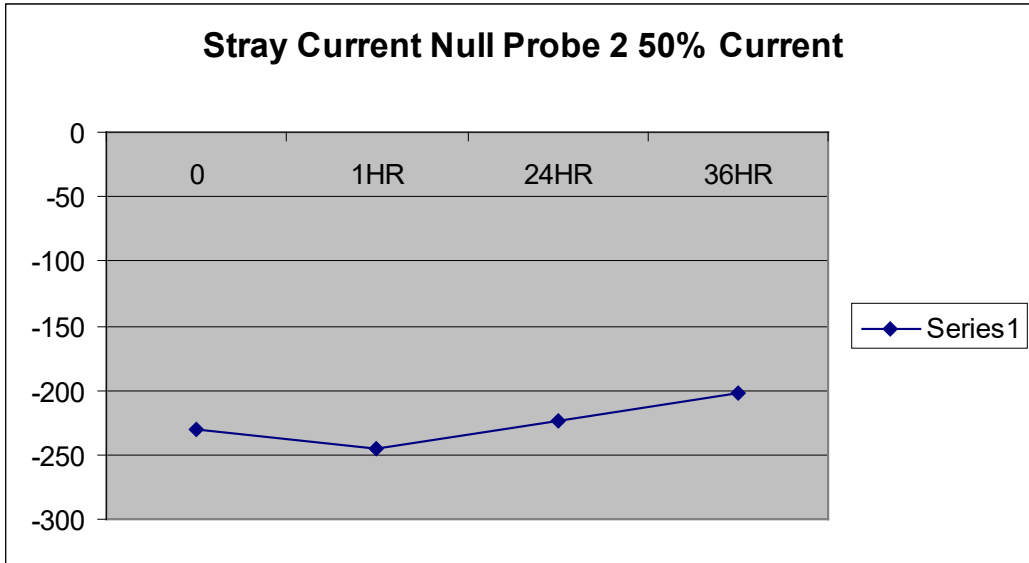
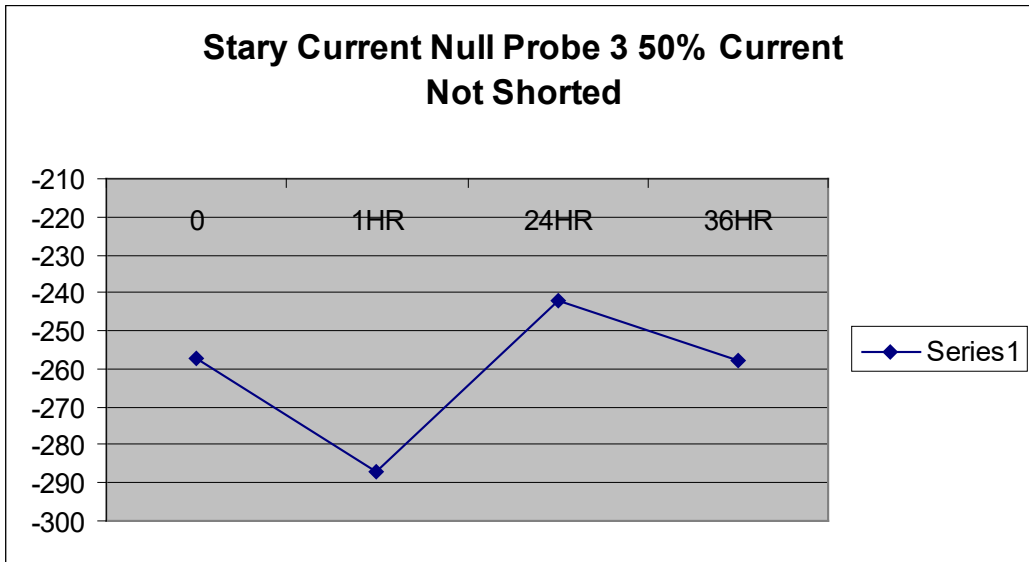
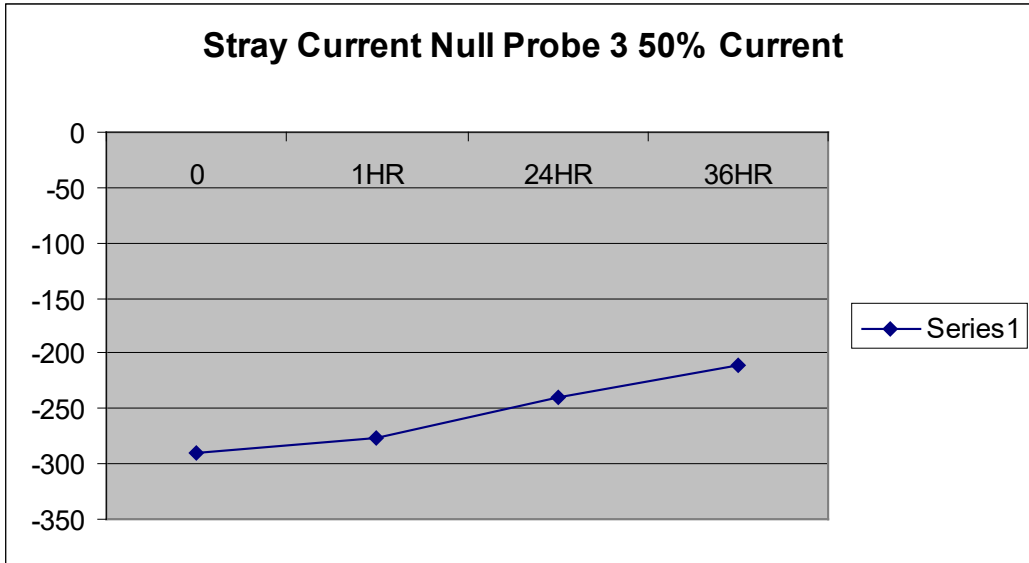
Figure A16. Guam 12AC20 stray current results probe 1 50% current not shorted.

Figure A17. Guam 12AC20 stray current results probe 1 50% current shorted.

Figure A18. Guam 12AC20 stray current results probe 2 50% current not shorted.

Figure A19. Guam 12AC20 stray current results probe 2 50% current shorted.

Figure A20. Guam 12AC20 stray current results probe 3 50% current not shorted.

Figure A21. Guam 12AC20 stray current results probe 3 50% current shorted.

When electric current is passed through concrete, there is a possibility for isolated reinforcing steel (or any other metallic element positioned between the anode and cathode) to become a path for stray current. This occurs because the steel is less resistive than the concrete and offers a “path of least resistance.” The current is potentially harmful to the steel since one end of the steel element will become anodic, causing corrosion of the steel. Such corrosion, if sufficient, can result in cracking and spalling, or corrosion of other metallic elements, all leading to eventual structural damage.

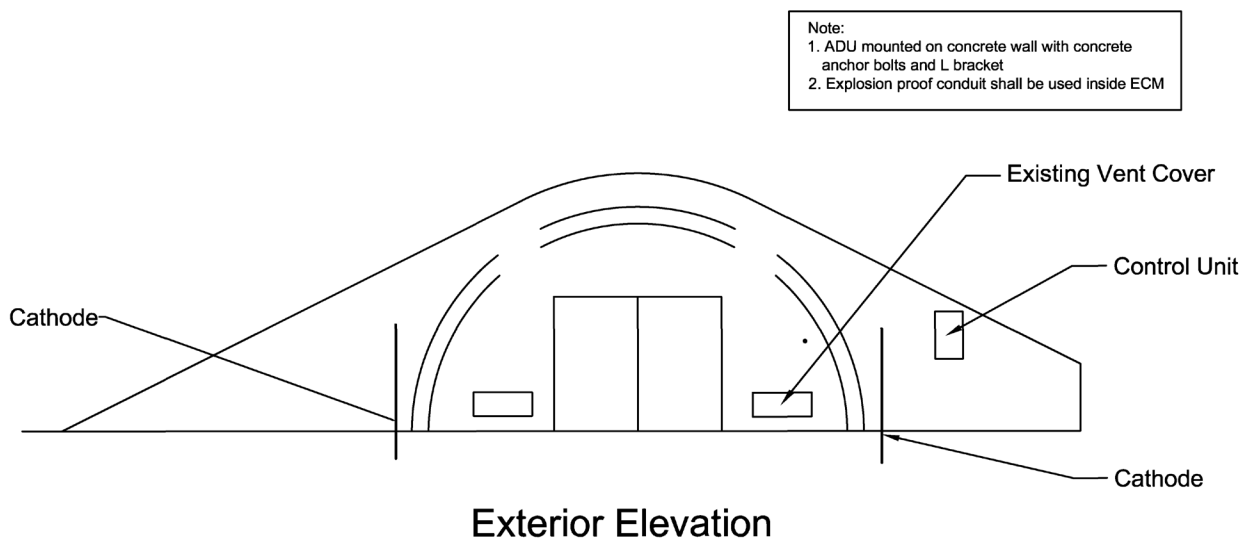
Figure B1. Exterior elevation showing locations of EOP system components for Guam ECM 12AC20.

As-built drawings for the EOP system in ECM 12AC20 at Guam are presented in Figure B1 through B7.
