ERDC/CERL TR-19-17

Demonstration of Electro-Osmotic Pulse and Dehumidification Technologies to Mitigate Corrosion in Earth-Covered Magazines

Final Report on Project F08-AR23

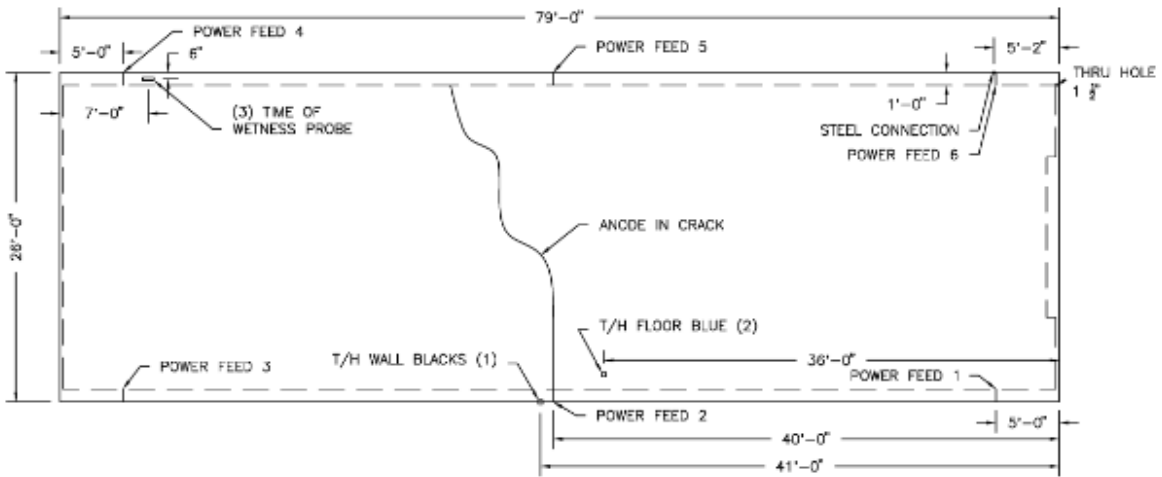
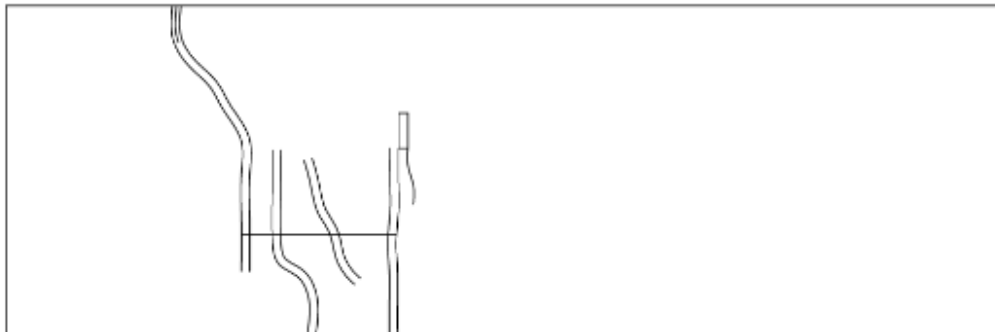
Figure B2. Locations of EOP system anode feeds in the floor and anodes in the ceiling for Guam ECM 12AC20.

① ECM 12AC20
1/8" = 1'-0"

② CEILING ANODE REFLECTED VIEW
1/8" = 1'-0"

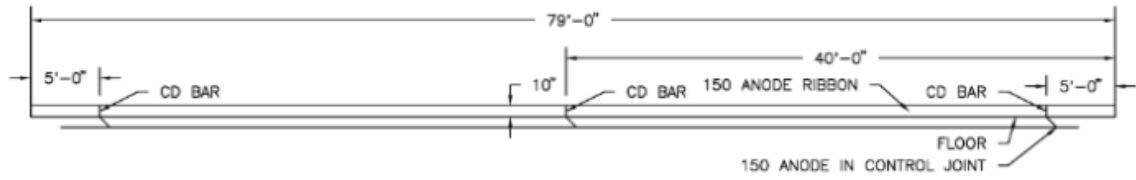
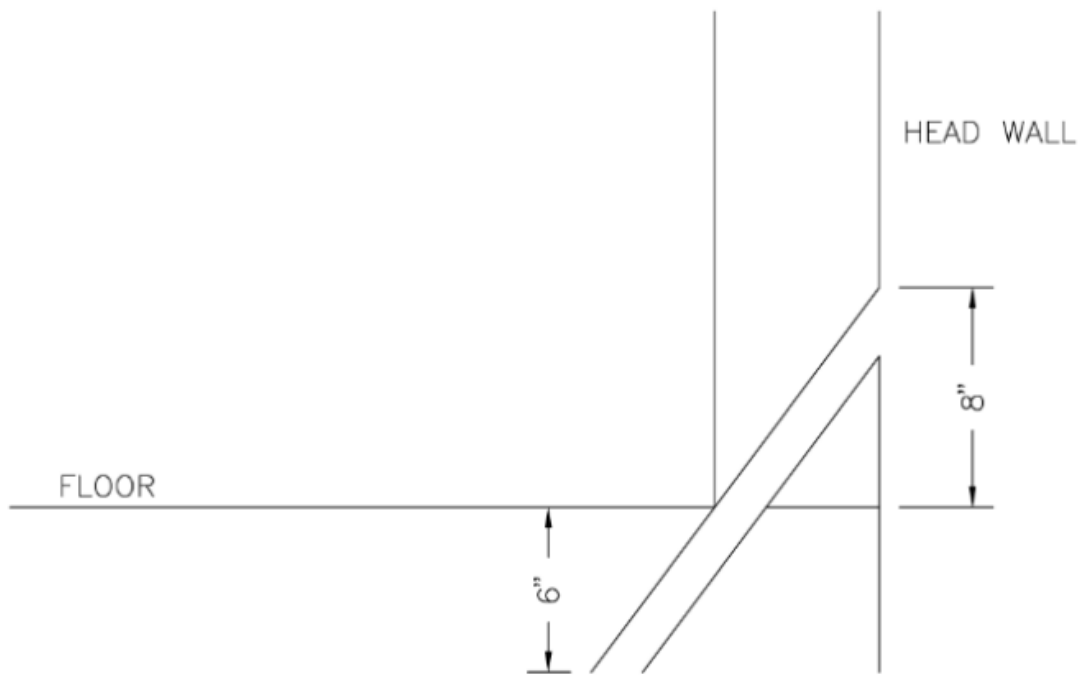
Figure B3. Details of anode wall installation and through hole in headwall for Guam ECM 12AC20 EOP system.

ECM 12AC20
WALL DETAIL
① $\frac{1}{8}" = 1'-0"$

THRU HOLE
DETAIL
② $\frac{3}{8}" = 1'-0"$

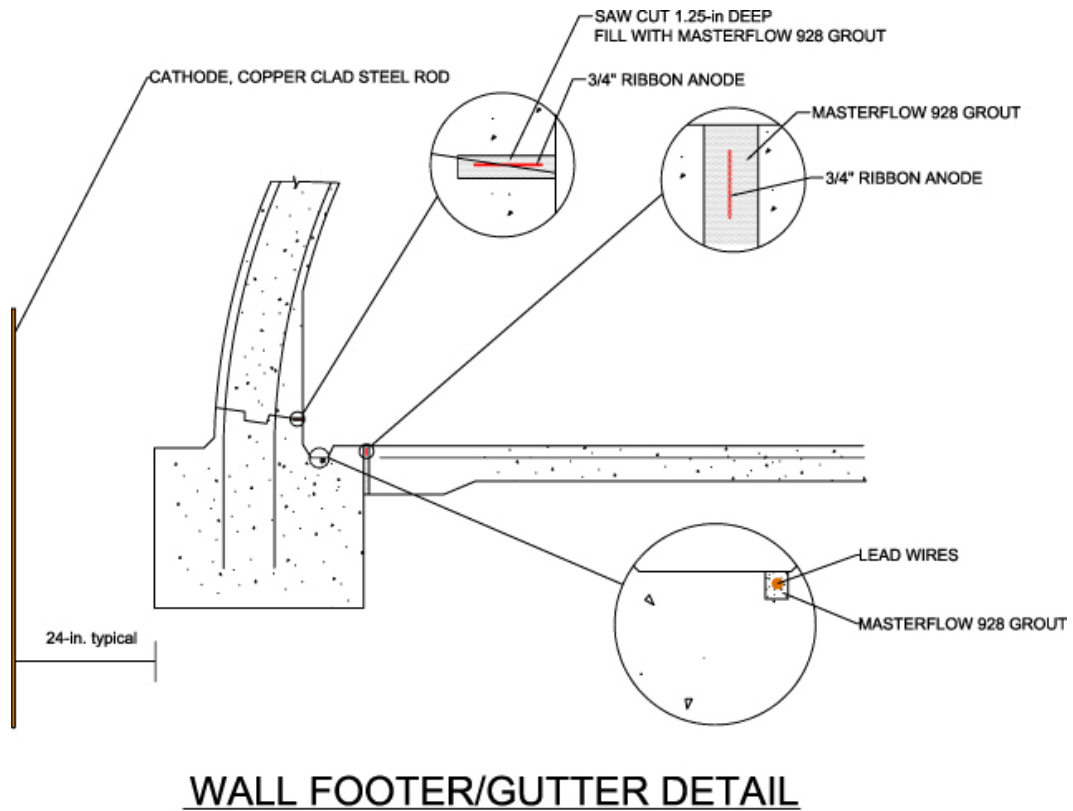
Figure B5. Detail of anode installation in wall footer/gutter for Guam ECM 12AC20 EOP system.

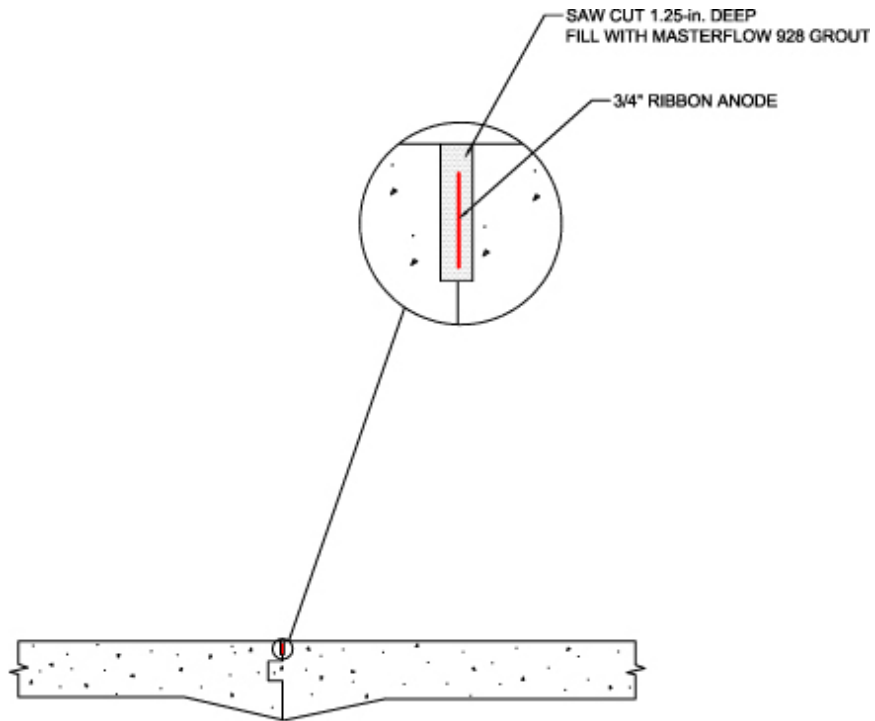
Figure B6. Detail of anode installation in construction joint for Guam ECM 12AC20 EOP system.

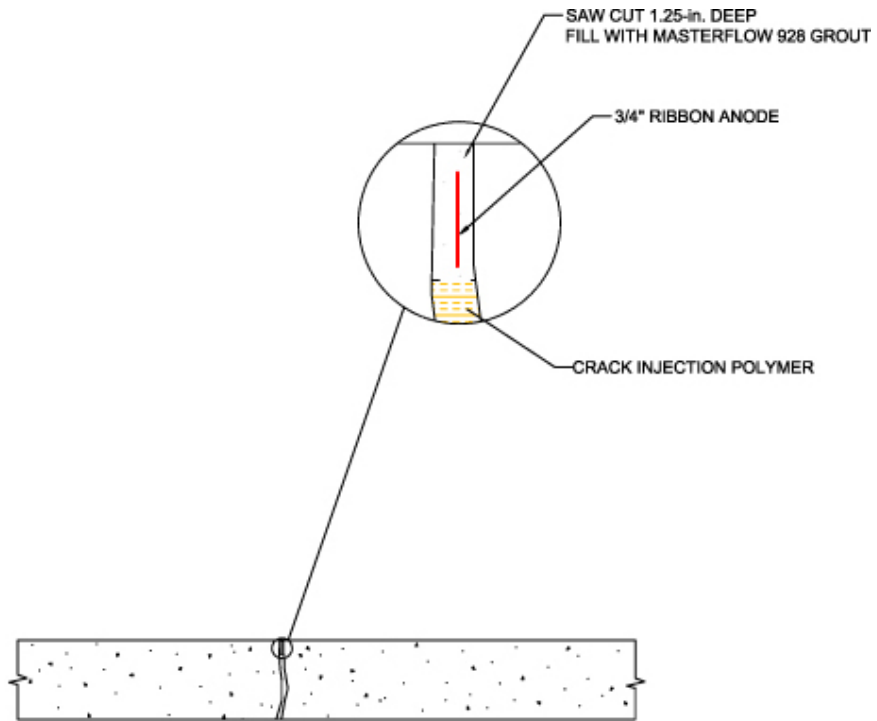
Figure B7. Detail of anode installation in concrete cracks for Guam ECM 12AC20 EOP system.

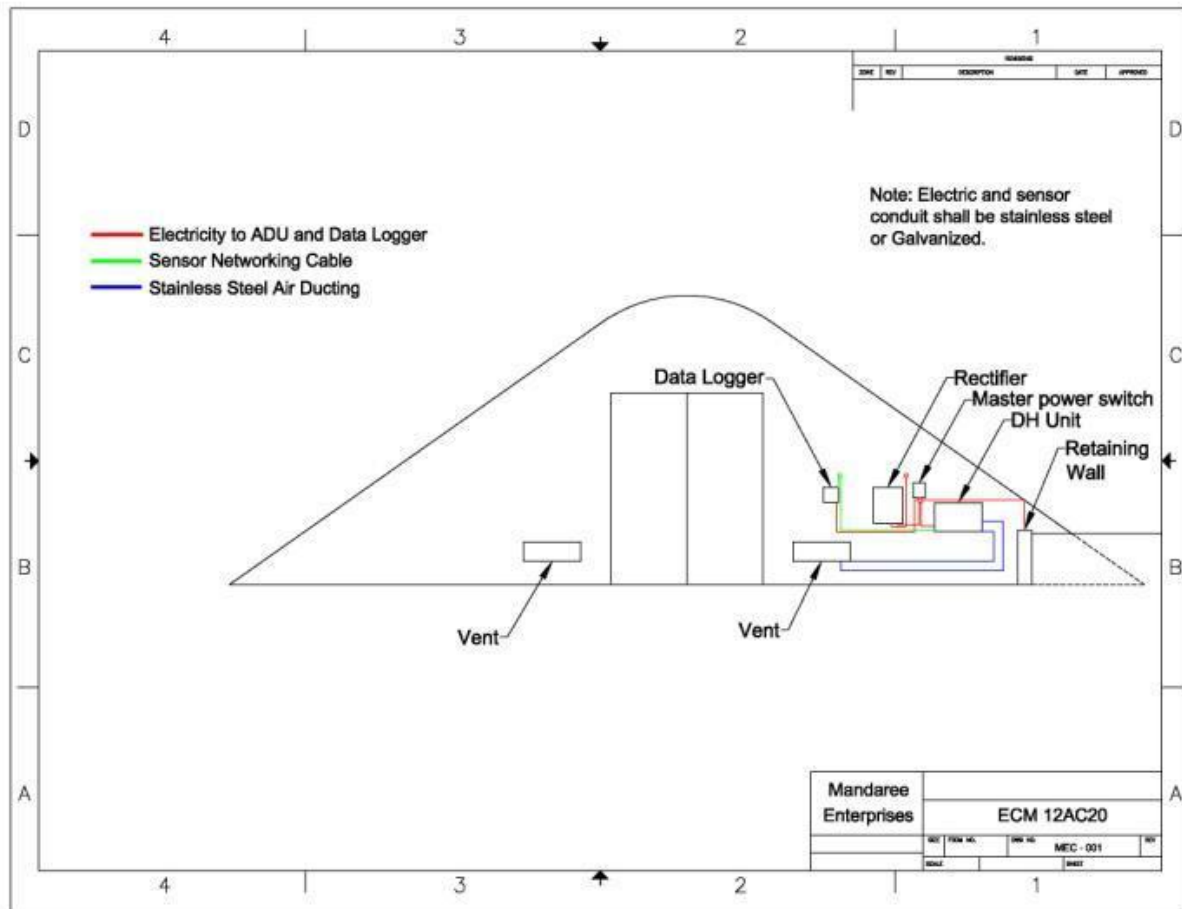
Figure C1. Exterior elevation showing locations of DH system components for Guam ECM 12AC20.

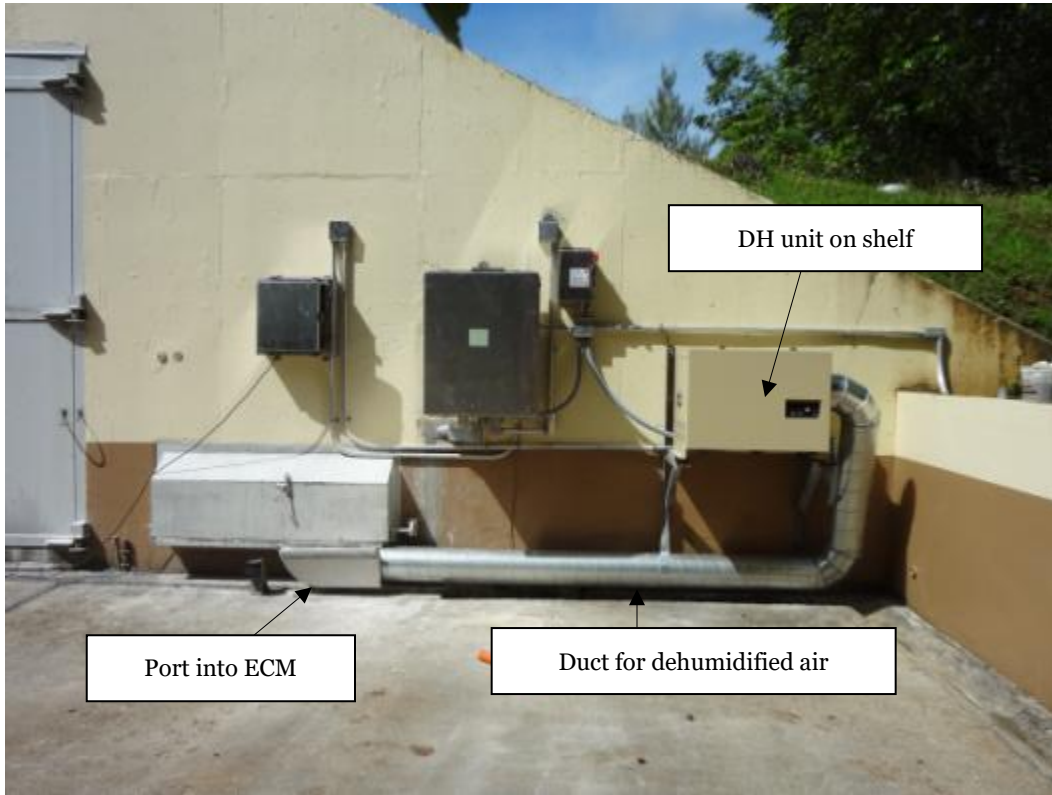
Figure C5. DH equipment installed at Guam ECM 12AC20.

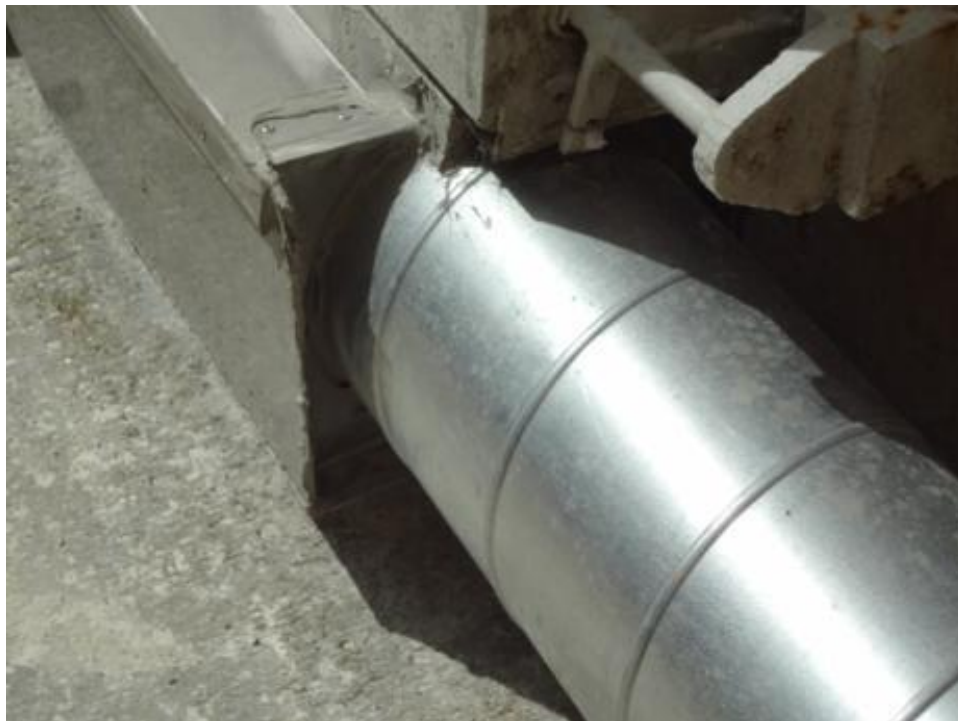
Figure C6. Stainless steel ducting connecting DH unit to ECM air input.

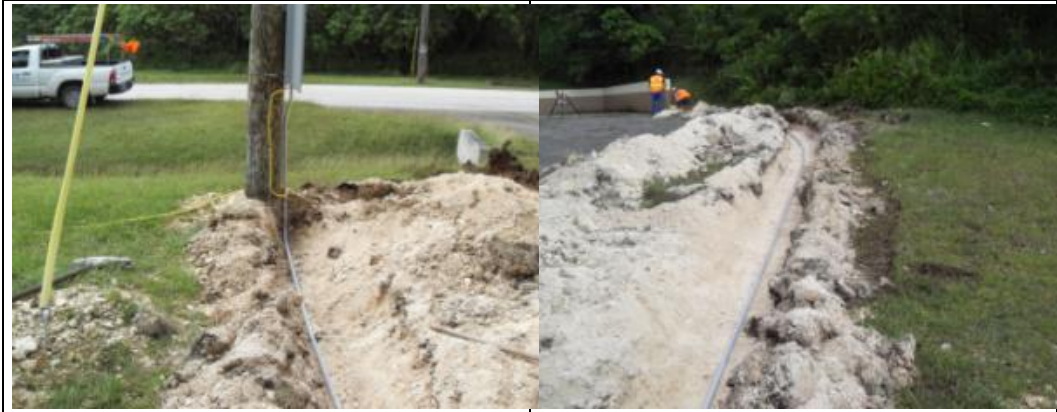
The DH system is in an open-loop configuration (i.e., the air exhausted from the magazine is not recirculated back into the magazine) to avoid accumulation of any outgasses from the munitions. A Munters DEW-300 DH unit (Figure C4) was installed on the headwall of the ECM for dry air introduction. The mounting system was designed for survival in the earthquake and typhoon environment on Guam. Ductwork between the DH equipment and the magazine was installed to not interfere with magazine entry doors and to have minimal impact on grounds maintenance operations (Figure C5). The DH ducting was installed to preserve the existing blast-proof penetrations into the magazine (Figure C6). A buried electrical cable was run to a junction box mounted on the head wall from a utility pole to power both the EOP and DH systems (Figure C7).

Figure C7. Installation of buried electrical line for Guam ECM 12AC20.

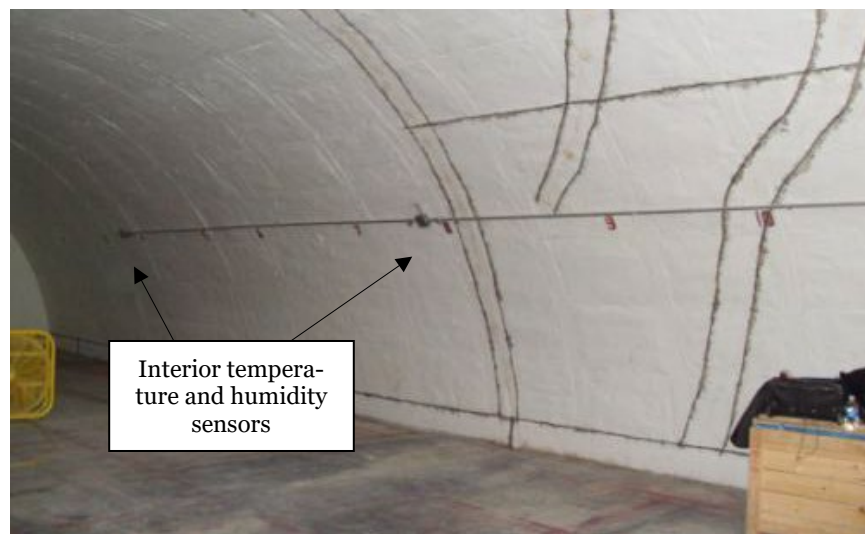
The collection of data for the DH system performance required that temperature and humidity sensors be placed in selected areas within the magazine (Figure C8 and Figure C9). Two sensors were mounted in the ECM for redundancy, and a third sensor was installed for DH system control. These sensors were interrogated through a data logger mounted on the outside headwall in a corrosion and weather-resistant box (Figure C10). Temperature and relative humidity data was downloaded 6 and 12 months after the commissioning of the DH system.

Figure C8. Wall-mounted sensors in ECM 12AC20.

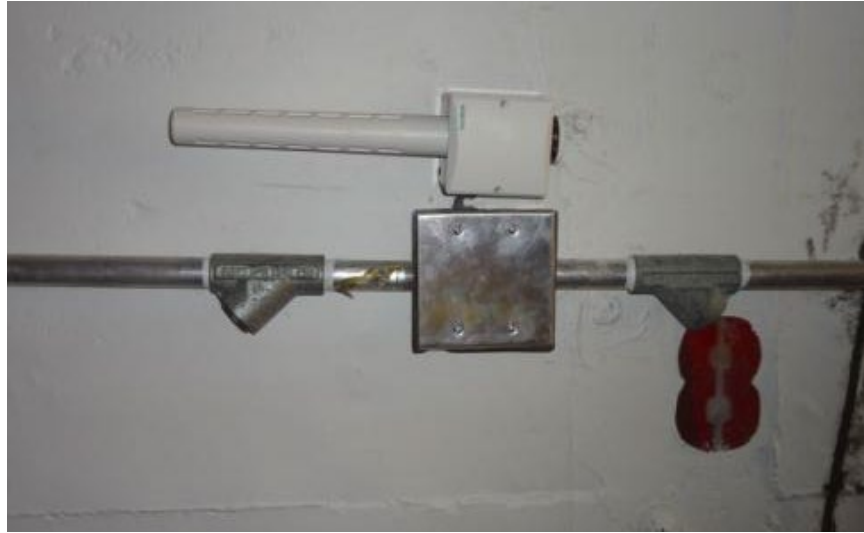
Figure C9. Temperature/RH sensor in ECM 12AC20.

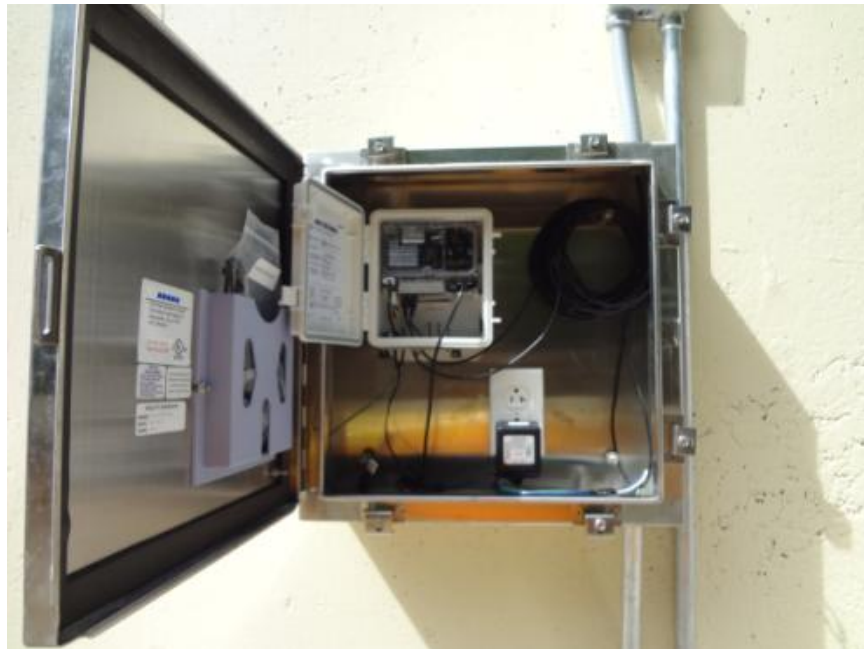
Figure C10. Data logger in a stainless steel weatherproof enclosure outside of ECM 12AC20.
