## **Improved Levee Resilience Through Soil Application of a Natural Organic Polymer**

Field Study: Kaufman Levee No. 1

June 2019

Final Report

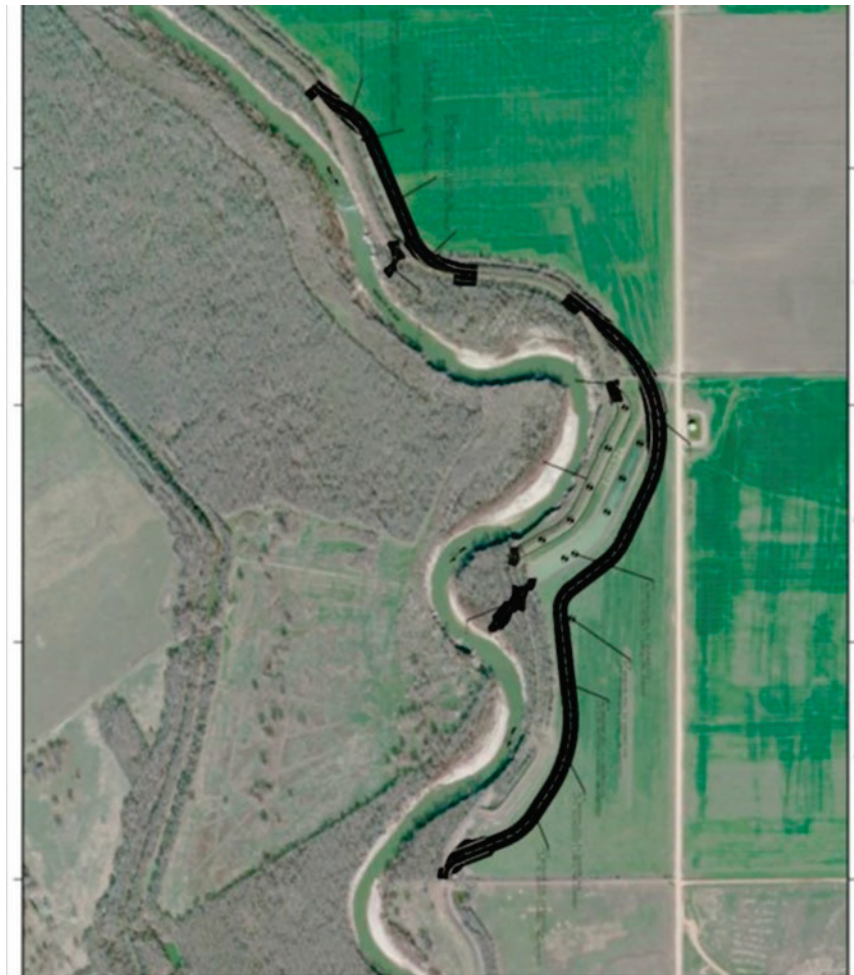
Figure 2. Overview of the levee setback placement and new borrow site (drawing provided by Fort Worth District).

plasticity clays down to a depth of at least 15 feet (ft) (information supplied by Fort Worth District). The high-water flows in 2009 and 2010 undercut the levee bank and resulted in the numerous bank failures that eventually made the levee road narrow and impassable in some places. Local farmers attempted to repair part of the levee in one of the southern-most affected areas during 2013 (Figure 2). The emergency repair plan made by the USACE Fort Worth District defined two new setback levees to be placed behind the existing levee (Figure 2). Materials for this construction project came from the existing levee when it was deconstructed. Additional borrow materials (primarily clays) were provided by Trinity Materials, Inc. located south of the levee construction site. Fort Worth District also completed bank stabilization using two bendway weirs as well as the two setback levees.

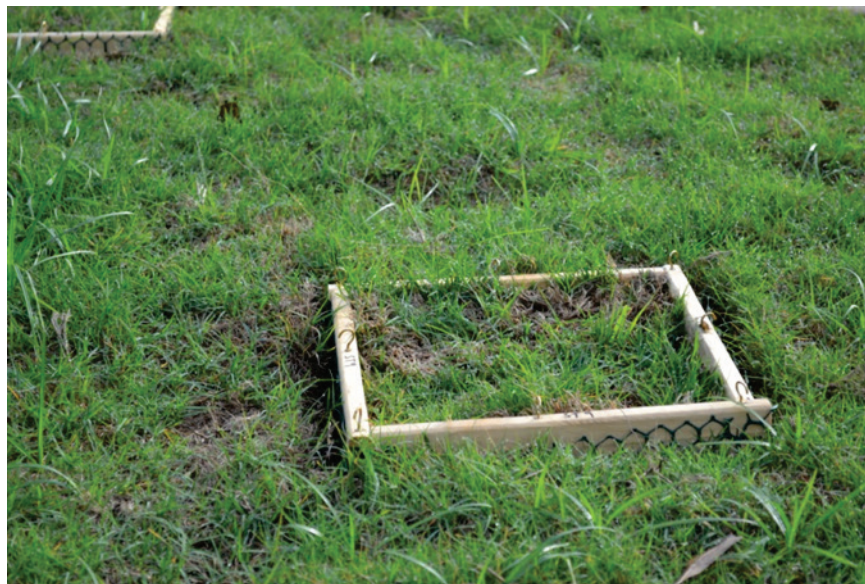
Figure 4. Pull box designed and placed in the field under sod.

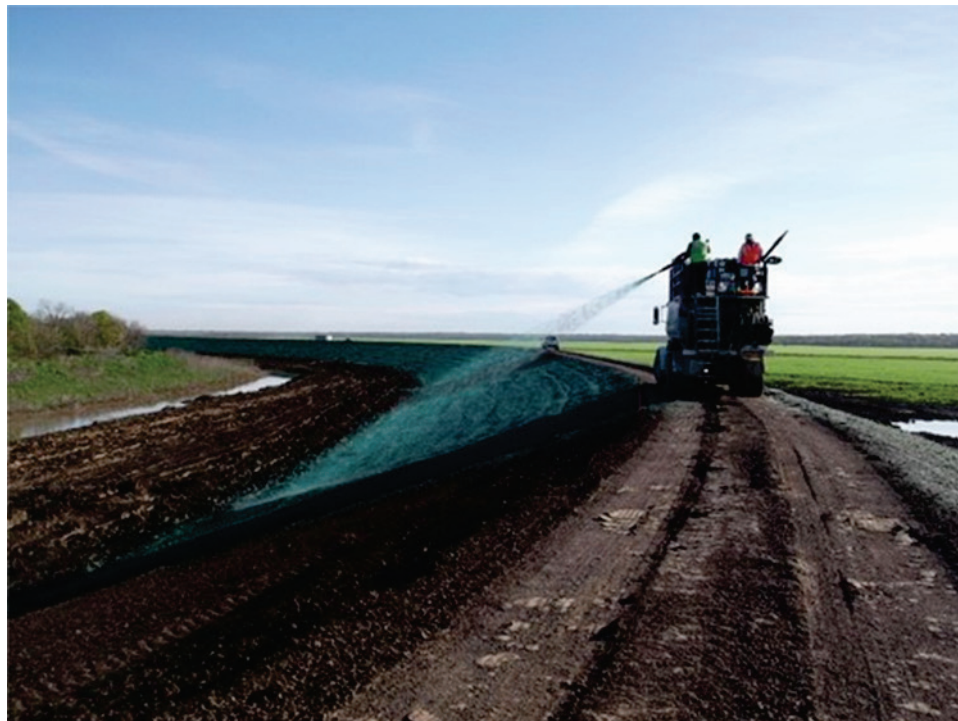
Figure 7. Addition of hydromulch, grass seed and biopolymer to soil on Kaufman Levee, spring, 2014.

The setback levees, referred to as Kaufman Levee No.1, were constructed using material from the original, failed levee along with fill material purchased from Trinity Materials, Inc. The ERDC-EL worked with the contractor and USACE Fort Worth District to perform the field demonstration seeding on Kaufman Levee No.1. Three test areas and a control area (not treated with biopolymer) were selected along the levee, identified by their Global Positioning System (GPS) coordinates, and physically marked with stakes at the corners (Figure 6). Seeding was performed during the spring of 2014, using a standard hydroseeding mixture with the addition of a hydromulch (Figure 7).

There were four treatment areas, including the Control, on the levee (see Figure 7). Six randomly selected areas were used for plant analysis within each area for a total of 24 digital photographs. Figure 18 shows how this software application was used to analyze species density and diversity on the Kaufman levee. The entire collection of digital data can be found in Appendix A.

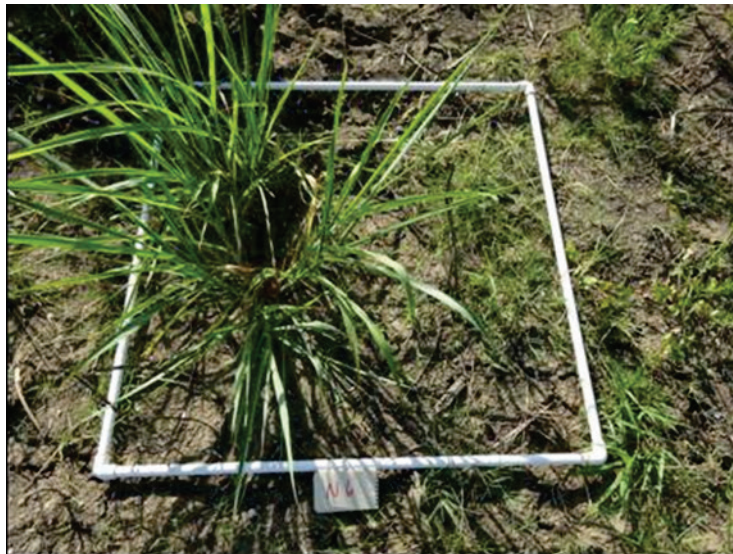
Figure 8. The sampling grid employed to establish plant density and species diversity in the treatment areas on Kaufman Levee.

Several techniques were used in order to evaluate establishment of Bermuda grass on the one-year-old levee repair. Sampling for plant density and species diversity was accomplished using a 1 m x 1 m polyvinyl chloride (PVC) grid (Figure 8). Six points were selected randomly from within each section for grid sampling. Visual identification of species and estimates of species coverage were made by walking the area immediately above the water line.

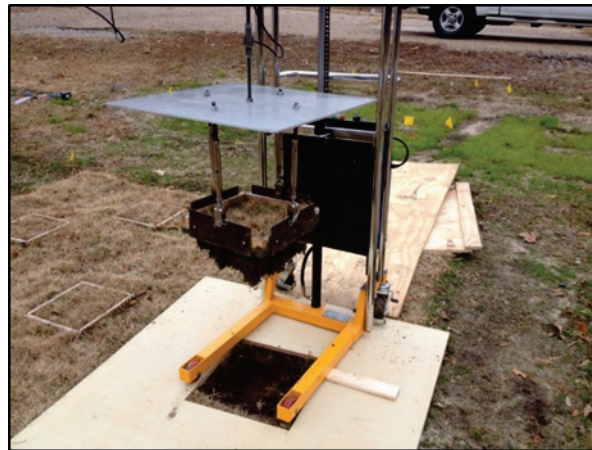
Figure 9. Sod pull-box system with tensiometer in use in the pilot demonstration.

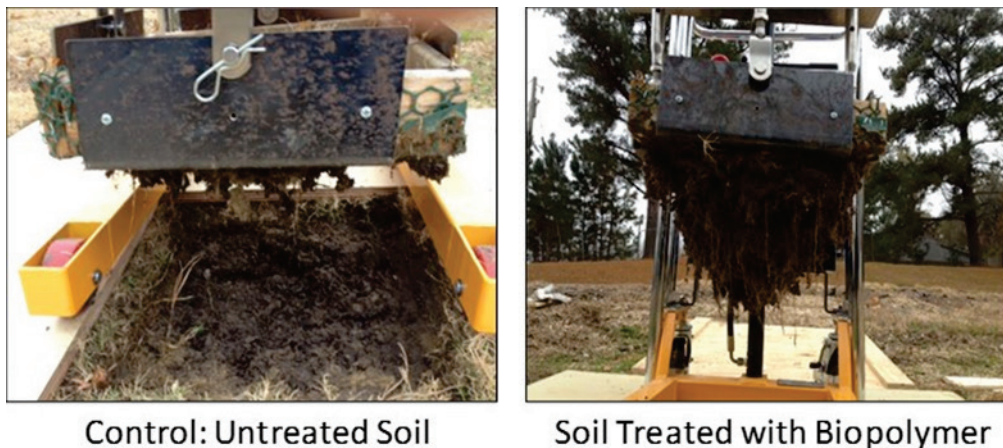
Figure 12. Comparison of root development in overwintered Bermuda grass sod when left untreated (Control – left) or treated with biopolymer (right).

While the withdrawal force results were not beneficial with regards to understanding the integration of sod roots into the soil, the measurement of the mass of soil retained when the pull boxes were removed was beneficial. Differences in the mass of soil adhering to the roots following removal was noted during the pulls. Figure 12 is a photographic comparison of the difference in root mass between the untreated sod and a section of sod grown with biopolymer treatment in the Sand plots.

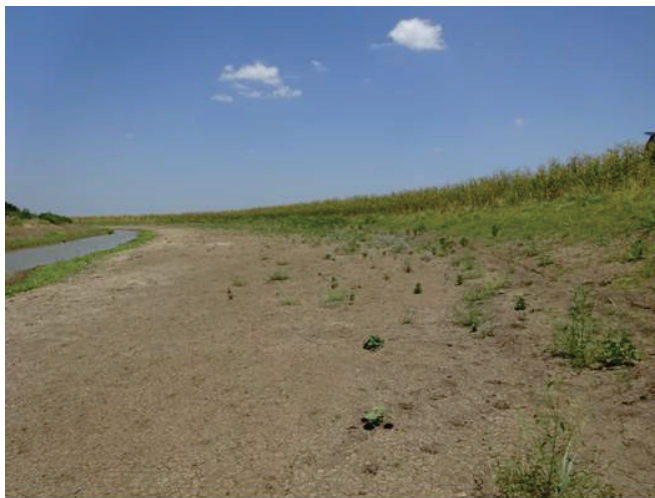
Figure 15. Effect of flooding on vegetation growth on the lower Kaufman Levee.

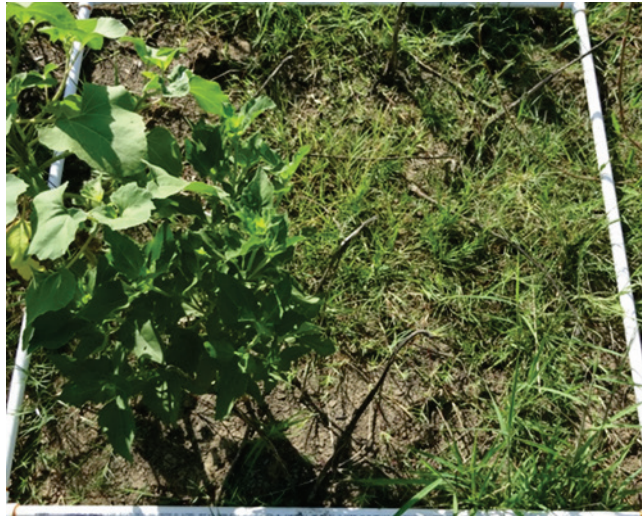
Figure 16. Digital image of one m<sup>2</sup> sampling plot from Kaufman levee.
