NRL/MR/6138--19-9912

Corrosion Control for Navy Ships (CCNS): Improving the Performance of Protective Coatings

*Center for Corrosion Science and Engineering Branch
Chemistry Division*

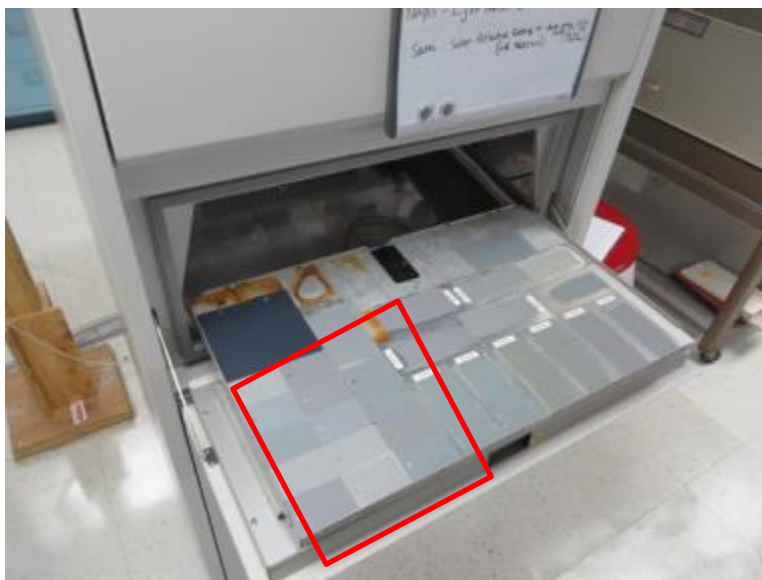
Figure 3 – Test panels in xenon arc test chamber

A picture of the test panels in the xenon arc test chamber is provided in Figure 3. During exposure testing, the panels lay on a flatbed tray that is slightly angled to allow for water runoff. All surfaces inside the chamber are lined with mirror like sheeting to maximize light reflection.

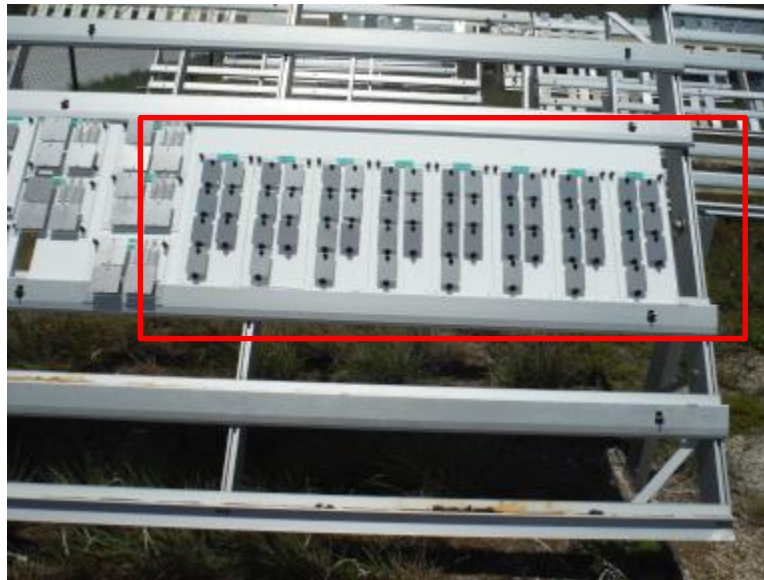
Figure 5 – Test panels on exposure fence in Key West, FL

Test panels were exposed in Key West, FL on a test fence with a 45-degree south facing rack located less than 100 feet from the ocean high tide line per the requirements of MIL-PRF-24635. The average temperature in Key West varies between 68 and 86°F (20 and 30°C) depending on the time of year, with the highest average temperature in August and lowest average in January. On a normal, sunny day the average solar radiation will fluctuate between 800 and 1000 W/m² between 11am and 3pm. A picture of the exposure rack and test panels is provided in Figure 5.

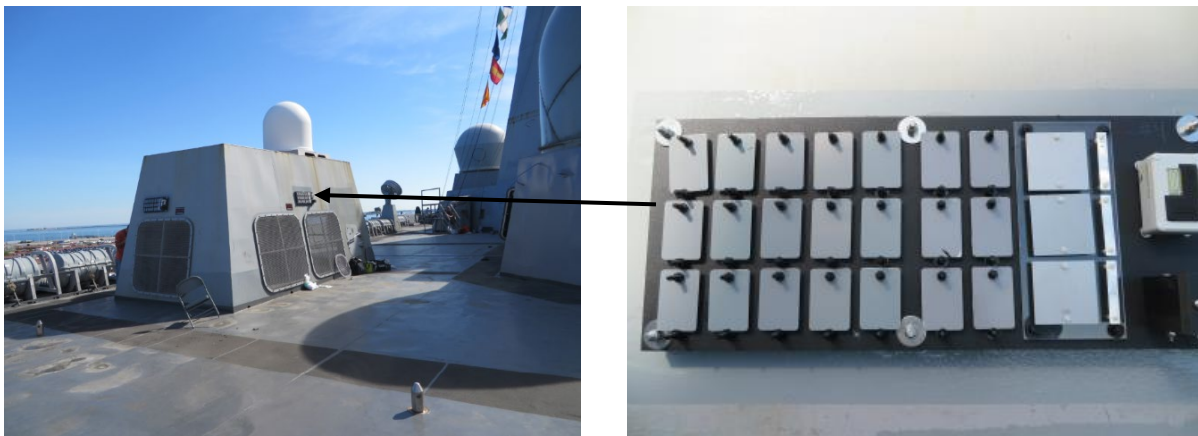
Figure 6 – Exposure rack deployed on an LPD 17 class ship

Test panels were also deployed in 5 different locations on an LPD 17 San Antonio class ship. This provides a unique opportunity to determine how paint degradation and aging on a mobile platform compares to static test panels from either accelerated or natural exposures. The conditions (temperature, solar radiation, time of wetness, etc.) of each exposure location are unknown, however, the placement of the exposure racks in each location should provide information about rate of degradation depending on the exposure conditions. For example, one exposure rack was placed on a catwalk beneath an overhead structure so it should be exposed to less UV light and temperature cycling than the exposure racks placed on an upper level deck that are not sheltered.

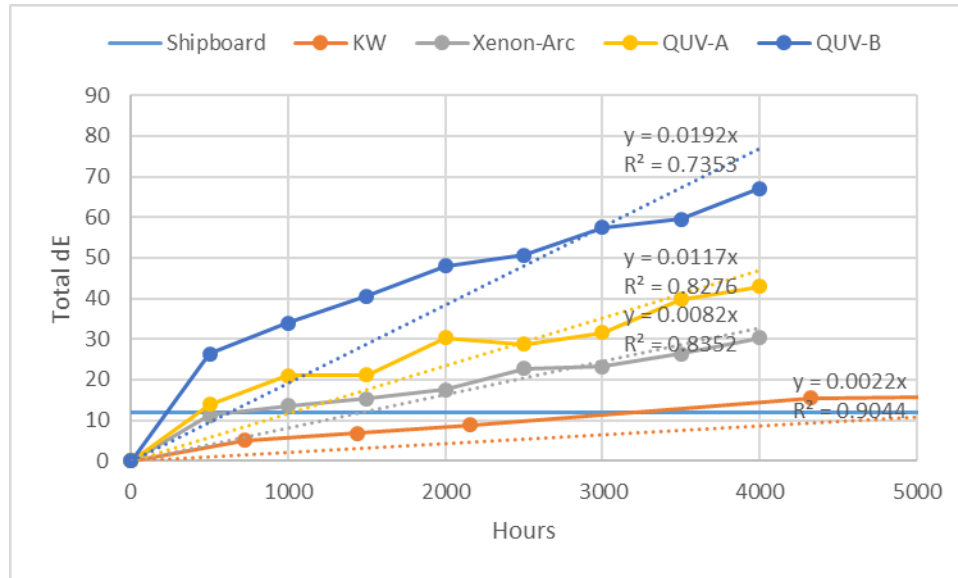
Figure 7 – Total color change (dE) by exposure method

The color of each test panel at different time intervals is measured using CIELab three dimensional coordinates. The magnitude of the color change was determined by calculating the distance between the initial color of the test panel and the color measured at the inspection time interval. The magnitude of color change is referred to as delta E (dE). The data provided in Figure 7 is the summation of dE for all six coatings taken at each measurement interval. The data is organized by exposure method in order to compare severity. The horizontal blue line represents the average value of 3 measurements taken from panels exposed topside on an LPD 17 San Antonio class ship after 1 year of exposure. During that time period, the ship was either pier side or deployed to an unknown location. It was estimated the ship was pier side for 6 months and deployed for 6 months (this applies to all shipboard data in sections 3.2.7.1 – 3.2.7.6). The raw data is provided in Appendix 1.

The total dE for the panel set for the shipboard exposure after 1 year was 11.91. Linear regression was used to fit a line to each set of data to determine a rate of change (or slope, m, of the line). The rate of change for each line was then used to estimate the amount of time it took in each exposure method to equal 11.91 (total change divided by slope). The data for each exposure method is provided in Table 9 below.

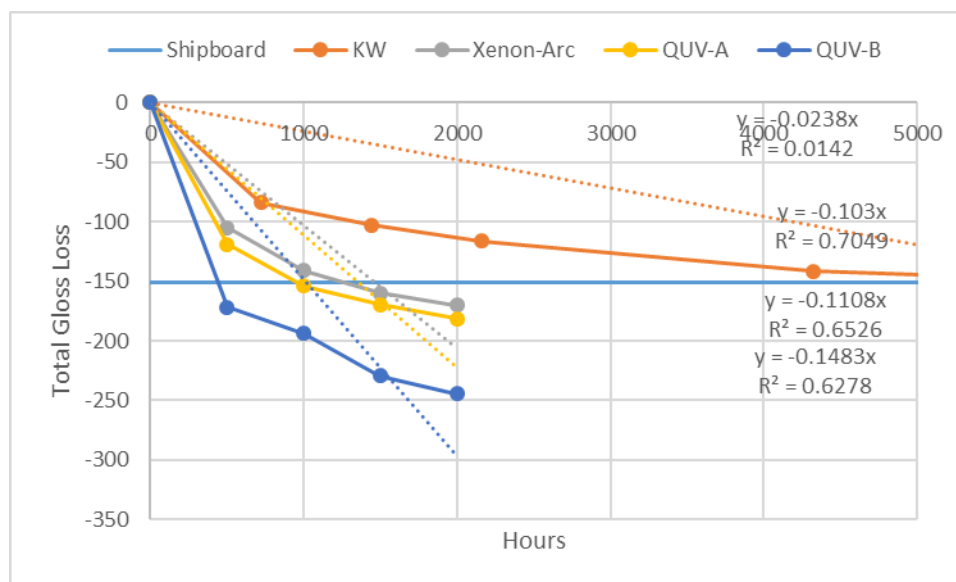
Figure 8 – Total gloss loss data by exposure method

Each gloss measurement taken was an average of 5 readings per test panel. A 60° gloss meter is recommended for semi-gloss coatings and each of the test panels except for the epoxy (paint #3) had an initial gloss in the semi-gloss range. For consistency, the 60° gloss meter was used for all measurements even when the test panels degraded to low gloss coatings. The data provided in Figure 7 is the summation of dE for all six coatings taken at each measurement interval. The data is organized by exposure method in order to compare severity. For the purposes of improving the linear regression model, the accelerated

data was truncated at 2000 hours. The horizontal blue line represents the value measured after 1 year of shipboard exposure. The raw data is provided in Appendix 1.

The total gloss loss for the panel set for the shipboard exposure after 1 year was -150.9 gloss units (GU). Linear regression was used to fit a line to each set of data to determine a rate of change (or slope (m) of the line). The rate of change for each line was then used to estimate the amount of time it took in each exposure method to equal -150.9 (total change divided by slope (m)). The data for each exposure method is provided in Table 10 below.

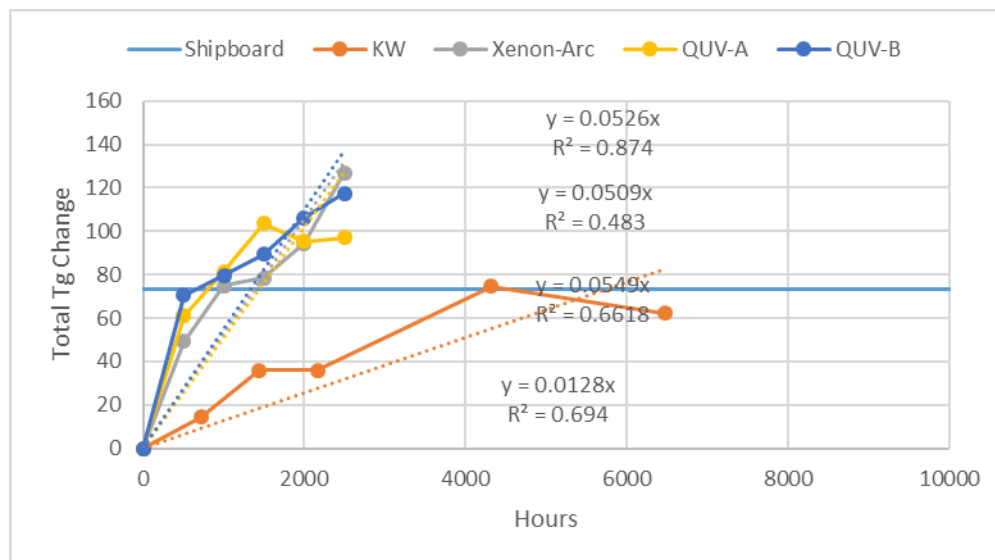
Figure 10 – Total Tg change by exposure method

The Tg is measured in degrees Celsius and the value reported is the midpoint glass transition based on the inflection point of the curve. Samples of coating were removed from the lower half of the test panels using shears in order to obtain a free film. The coating was either peeled or scraped from the cut panels. The data provided in 10 is the summation of Tg change for all six coatings taken at each measurement interval. The data is organized by exposure method in order to compare severity. The horizontal blue line represents the value measured after 1 year of shipboard exposure. The raw data is provided in Appendix 1.

The total Tg change for the panel set for the shipboard exposure after 1 year was 73.2. Linear regression was used to fit a line to each set of data to determine a rate of change (or slope (m) of the line). The rate of change for each line was then used to estimate the amount of time it took in each exposure method to equal 73.2 (total change divided by slope (m)). The data for each exposure method is provided in Table 12 below.

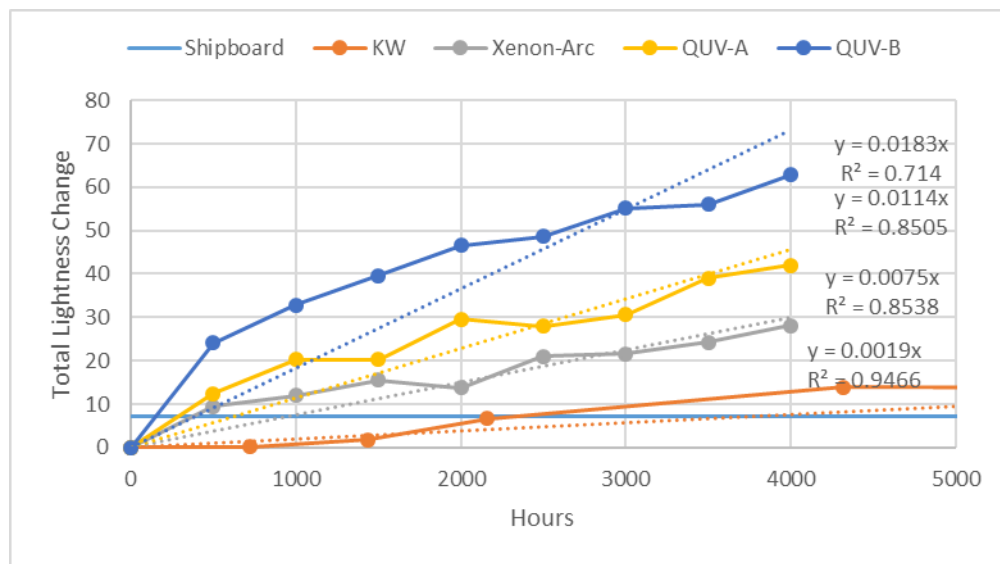
Figure 12 – Total lightness change by exposure method

Lightness, or delta L, was isolated in the CIELab color measurement and used as an indicator for coating chalking. Chalking is the migration The data provided in Figure 12 is the summation of hardness change for all six coatings taken at each measurement interval. The data is organized by exposure method in order to compare severity. The horizontal blue line represents the value measured after 1 year of shipboard exposure. The raw data is provided in Appendix 1.

The total lightness change for the panel set for the shipboard exposure after 1 year was 7.08. Linear regression was used to fit a line to each set of data to determine a rate of change (or slope (m) of the line). The rate of change for each line was then used to estimate the amount of time it took in each exposure method to equal 7.08 (total change divided by slope (m)). The data for each exposure method is provided in Table 14 below.

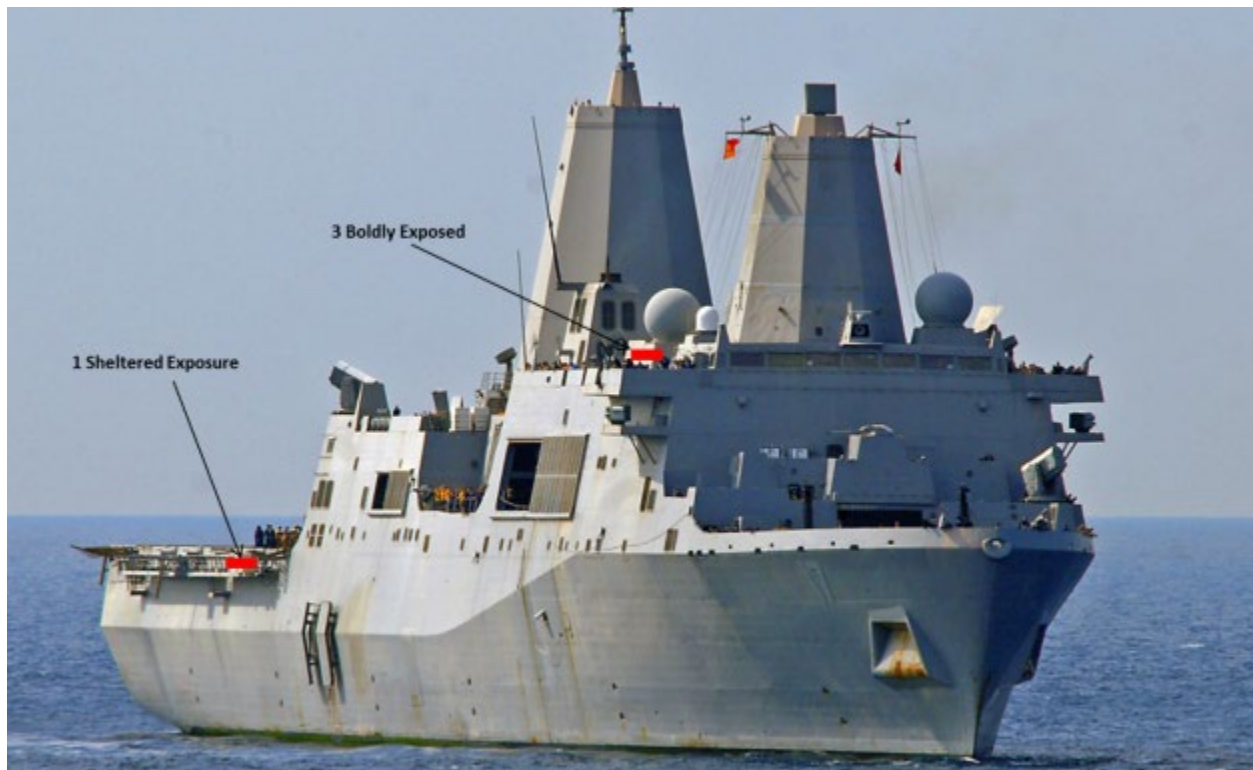
Figure 20 – Exterior locations of exposure racks on an LPD 17 class ship

These locations are shown in Figure 20 and Figure 21.

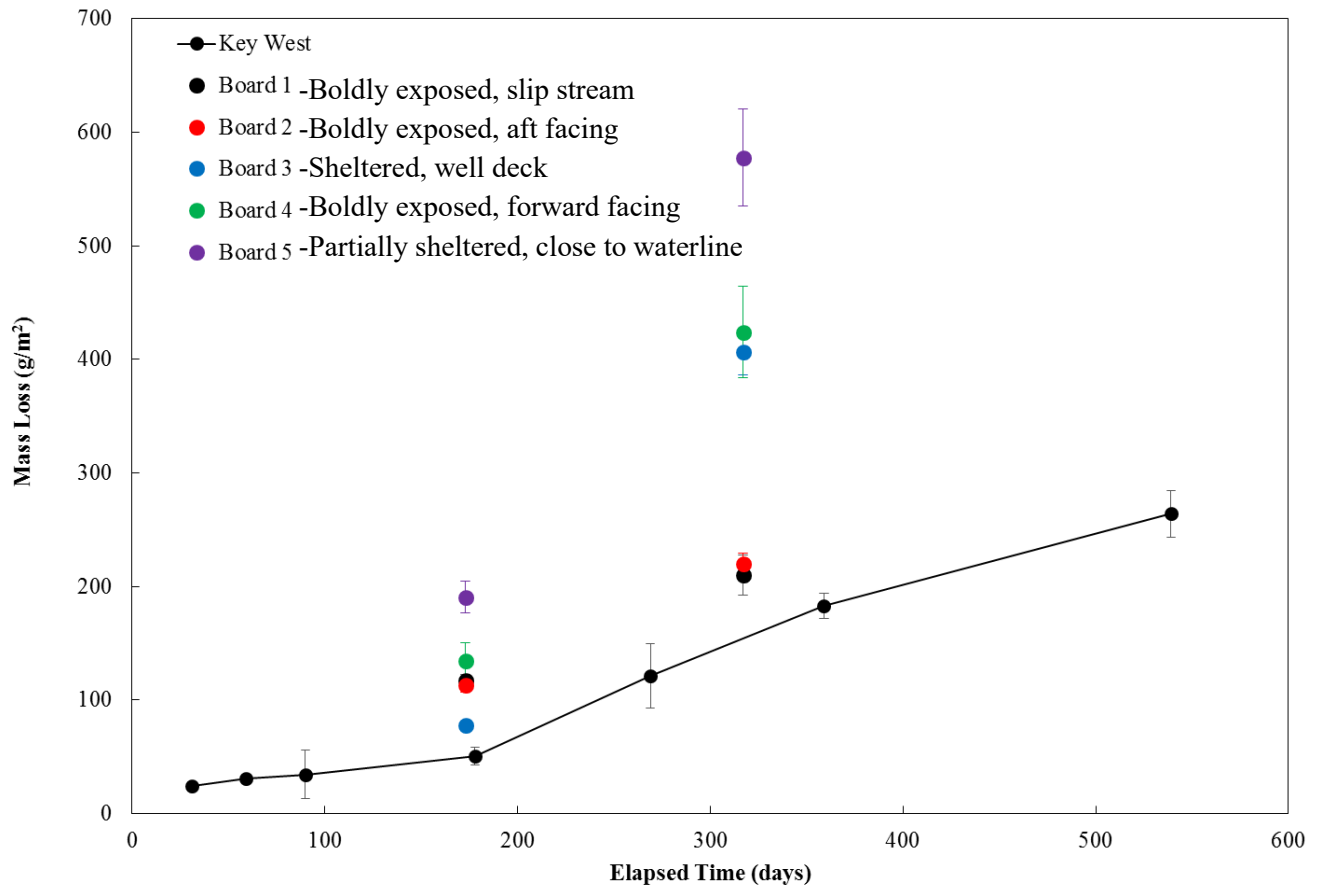
Figure 23 – Mass loss (g/m^2) of C1010 steel samples exposed in Key West, FL (black line) and on-board an LPD 17 San Antonio class ship (colored points). The samples exposed for ~180 days were exposed from SEP2015-MAR2016. The subsequent samples exposed for ~320 days were exposed from MAR2016-JAN2017. These were 2 separate sets of samples and were not exposed during the same time.

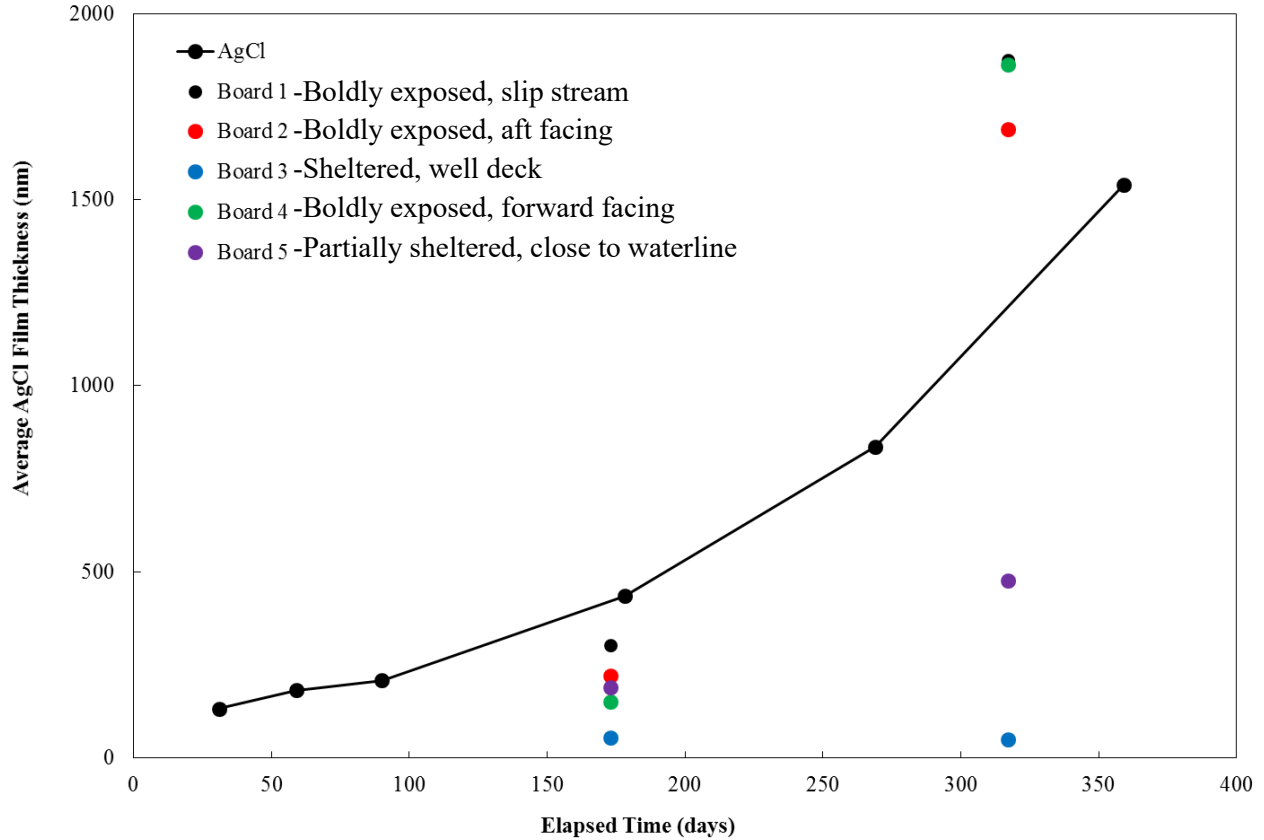
Figure 24 – Average AgCl film thickness (nm) of Ag samples exposed in Key West, FL (black line) and on-board an LPD 17 San Antonio class ship (colored points). The samples exposed for ~180 days were exposed from SEP2015-MAR2016. The subsequent samples exposed for ~320 days were exposed from MAR2016-JAN2017. These were 2 separate sets of samples and were not exposed during the same time.

The AgCl and Ag₂S film thickness calculated from the Ag coupons are given in Figure 24 and Figure 25, respectively. The two sets of shipboard data were separate exposures. The data shows that the film thicknesses on the ship were (overall) less than those seen in Key West. The combination of an observation of a higher mass loss rate on steel and thinner film thickness on Ag from the shipboard data is consistent with more surface rinsing and time of wetness on the samples exposed on the ship. Boards 1, 2, and 4 tend to track with each other which is consistent with their similar exposure locations. Board 5 exhibited the highest corrosion rate of steel which is consistent with a sheltered location which has a longer time of wetness and will promote corrosion through a thin film for a longer period of time. The Ag samples exposed in the well deck had very small film thicknesses, even though they are closer to a water source. This is likely a result of less sunlight in the area of the board which is necessary for Ag corrosion reactions. [1-3]

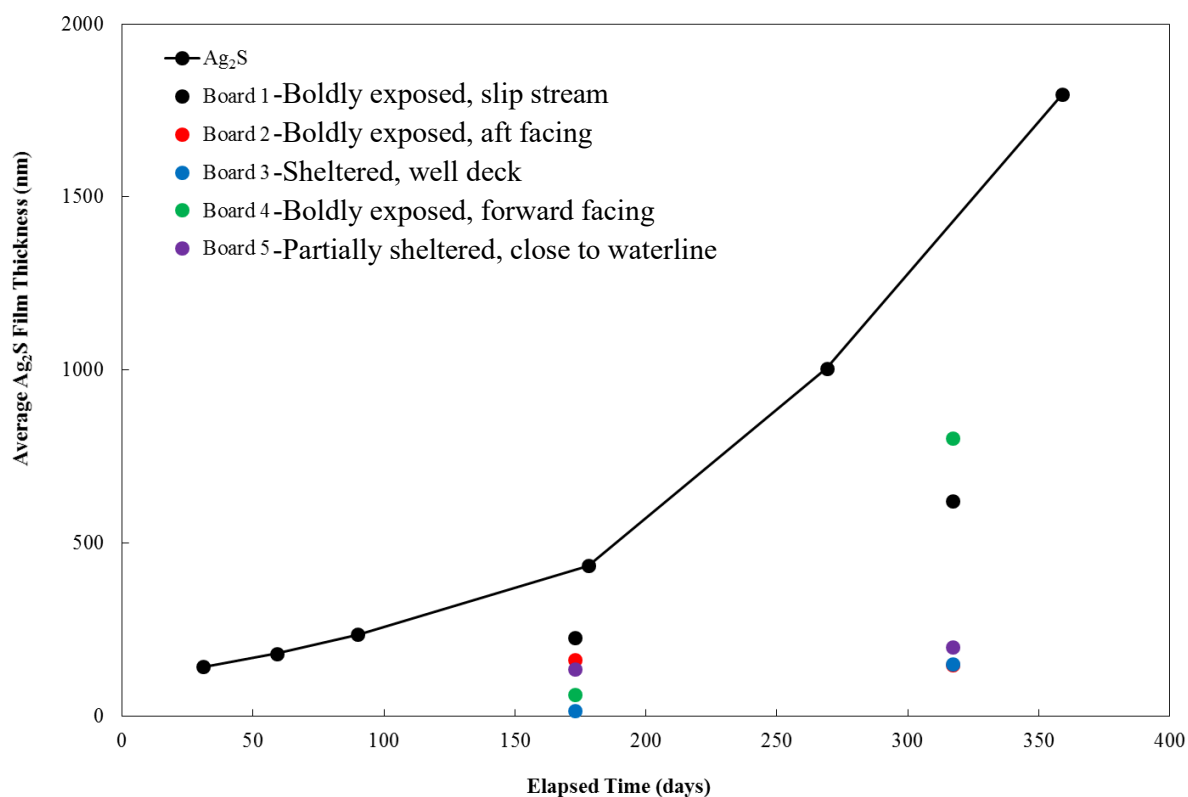
Figure 25 – Average Ag₂S film thickness (nm) of Ag samples exposed in Key West, FL (black line) and on-board an LPD 17 San Antonio class ship (colored points). The samples exposed for ~180 days were exposed from SEP2015-MAR2016. The subsequent samples exposed for ~320 days were exposed from MAR2016-JAN2017. These were 2 separate sets of samples and were not exposed during the same time.

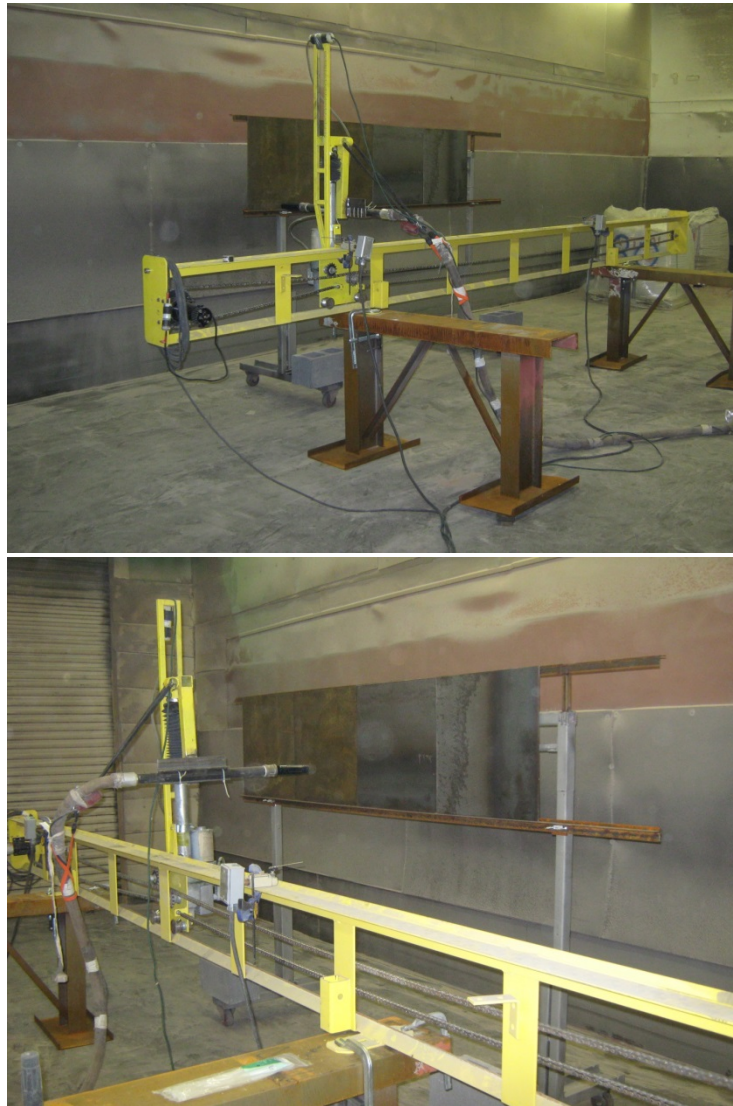
Figure 27 – Semi automated blast nozzle for blasting larger test panels at controlled rates

Larger test panels were contaminated with chlorides on one half of the panel, and then primed. These panels will be exposed to accelerated corrosive testing and tested for adhesion differences before and after exposure testing.

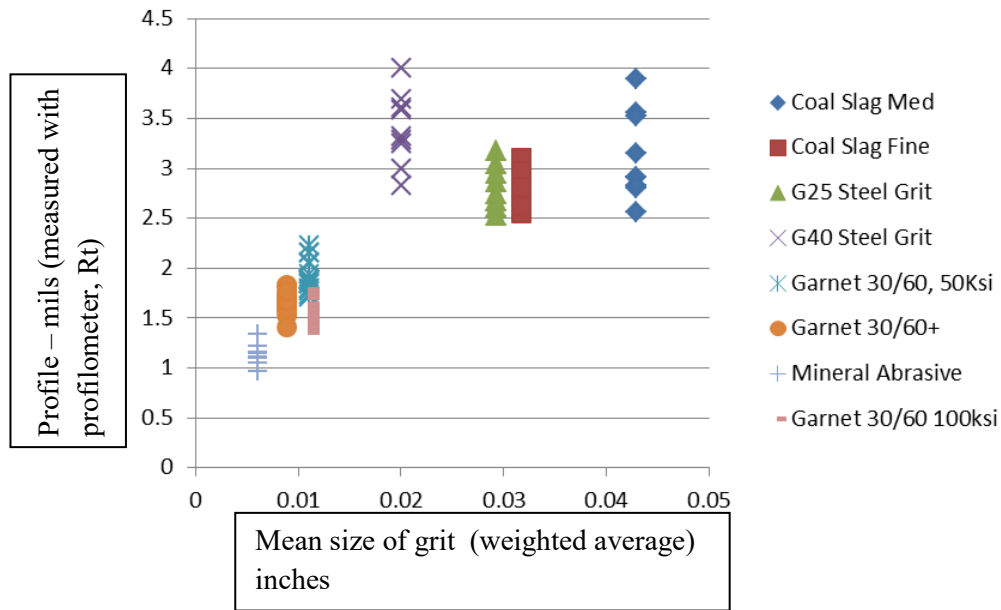
Figure 29 – Mean grit size relationship to profile

Surface profile measurements showed various differences in measured profile for the panels based on the abrasive used and the measurement techniques employed to measure profile. Preliminary analysis of the data indicates that while each of the blasting process variables examined in the testing has at least a small impact on the resultant profile, the primary controlling variable is the mean size of the grit used for blasting (Figure 27). Additionally, an inverse relationship between mean grit size and number of peaks per inch is clear as well, as seen in Figure 28 below.

From Figure 27Figure 28, it is clear that there is a general (not quite linear) relationship between the size of the grit and the profile produced. However, upon closer examination of Figure 27, it is interesting to note that the size/profile relationship seems to hold for the coal slag abrasives (“medium” provides a slightly deeper profile than “fine”), the same cannot be said of the steel grits tested where G40 grit

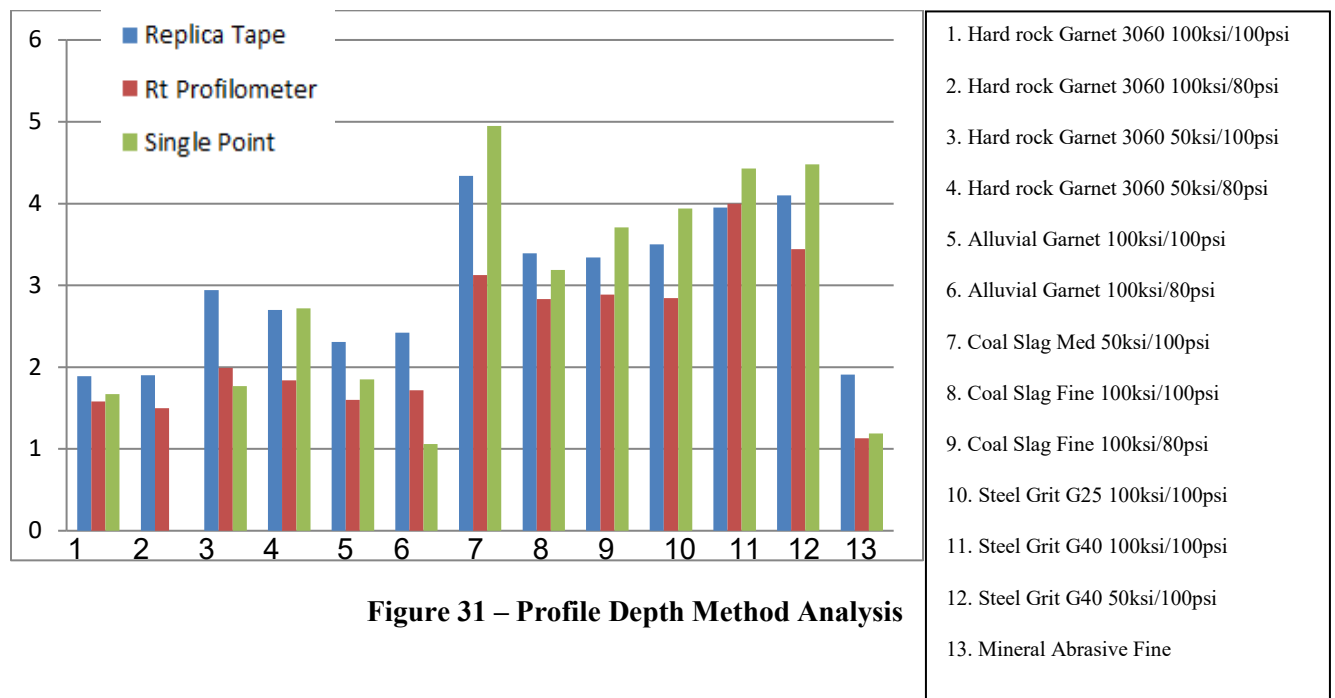
Measurement of profile varied depending on the specific technique used as seen in Figure 29. The replica tape typically provided a measurement that was higher (by 0.5 to 1 full mil) than the stylus and the single point micrometer. Although the single point measurements were sometimes averaged to be higher than the replica tape.

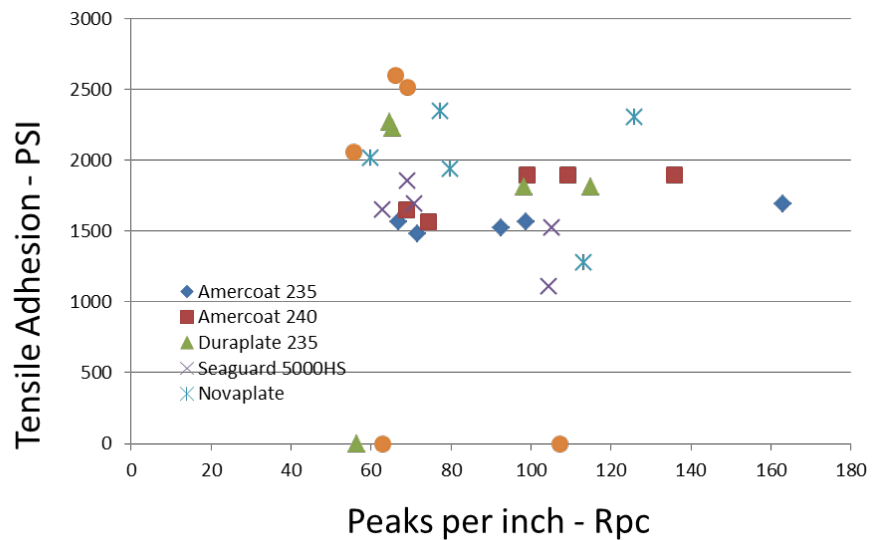
Figure 33 – Adhesion versus depth of profile and peak density, showing no clear relationship.

The initial effort to screen coating performance versus surface morphology used ASTM D4541 pneumatic tensile adhesion testing. This testing showed very little (no significant) difference in adhesion of 4 separate non-skid epoxy primers to surfaces that varied from 1.5 up to 4 mils in profile, peak densities from 50 to over 100 peaks per linear inch, and abrasive morphologies from garnet to steel grit, to slag, to steel shot. The primary conclusion regarding this initial data finds that the adhesion of modern Navy coatings, when applied over chemically clean surfaces that are blasted to roughen and remove millscale – is very good. But this scenario is not indicative of the common scenario that results in early failures of Navy primer coatings. These failures likely involve an external driving force for the loss of adhesion. This driver can be mechanical stress from flexing or temperature cycling of the steel/coating system, or intrusion of water or other chemical contaminants. Additionally, more severe mechanical forces can be applied to primers in some applications (e.g., wear, impact, peel stresses from overlays or attachments).

- Majority of the failures were splitting of the paints combined with glue failures.
 - Amercoat 235 and Duraplate 235 showed mixed failures at substrate combined with paint splitting

- All adhesion measured with PATTI was good to excellent.
- This technique is limited in its ability to discriminate adhesion between surface morphologies
