## Effects of Bank Stabilization on Regional Sediment Management: Lessons Learned from the Kansas River and Grand River Basins

by Aaron Williams and John Shelley

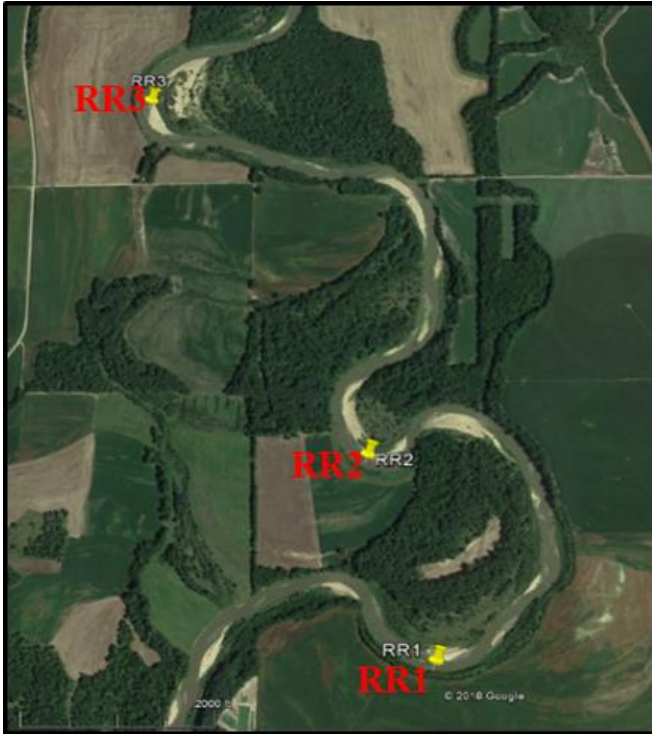
**Table 1. Republican River site map and project summary.**

Republican River			
Site Identifier	RR1	RR2	RR3*
Year Constructed	2004	2006	2004
Erosion Area (ac)	7.5	5.5	10.6
Bank Height (ft)	13.8	13.8	13.8
Erosion Rate (yd <sup>3</sup> /yr)	12,700	8,200	18,100
% Bank Wash Load	71%	55%	49%
20 yr Wash Load Reduction (yd <sup>3</sup> )	180,340	90,200	62,100*
Quantity of Rock (ton)	1,844	1,685	1,727
Volume of Earthwork (yd <sup>3</sup> )	706	645	661
Estimated Project Cost	\$97,000	\$88,000	\$91,000
20 yr Wash Load Dredging Cost	\$1,200,000	\$600,000	\$410,000

\*Project failed after 7 years.

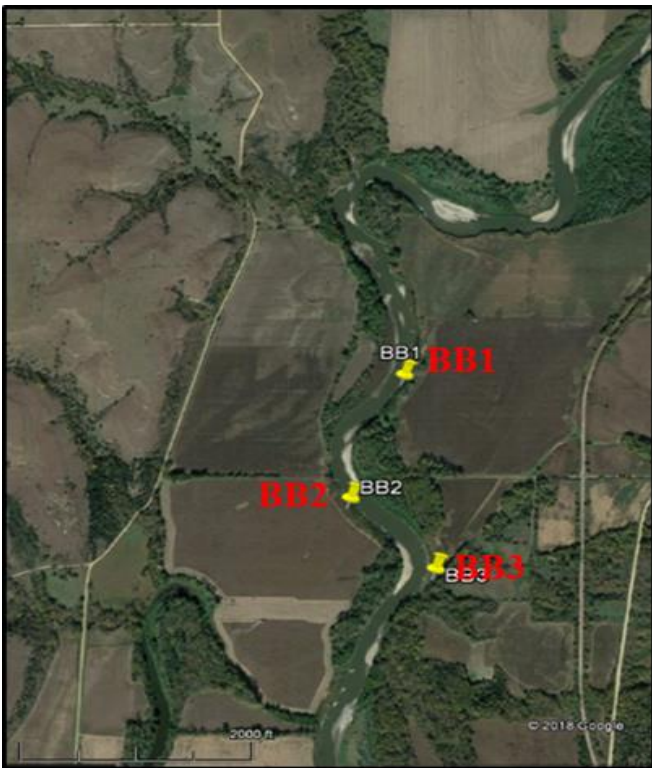
**Table 2. Big Blue River site map and project summary.**

Big Blue River			
Site Identifier	BB1	BB2	BB3
Year Constructed	2003	2010	2010
Erosion Area (ac)	6.2	3.8	2.3
Bank Height (ft)	20.3	19.4	22.3
Erosion Rate (yd <sup>3</sup> /yr)	16,900	7,000	4,800
% Bank Wash Load	72%	61%	60%
20 yr Wash Load Reduction (yd <sup>3</sup> )	243,360	85,400	57,600
Quantity of Rock (ton)	993	1,164*	744*
Volume of Earthwork (yd <sup>3</sup> )	380	446	285
Estimated Project Cost	\$53,000	\$61,000	\$39,000
20 yr Wash Load Dredging Cost	\$1,620,000	\$570,000	\$380,000

\*Rock volume estimated based on project length (no design documents available).

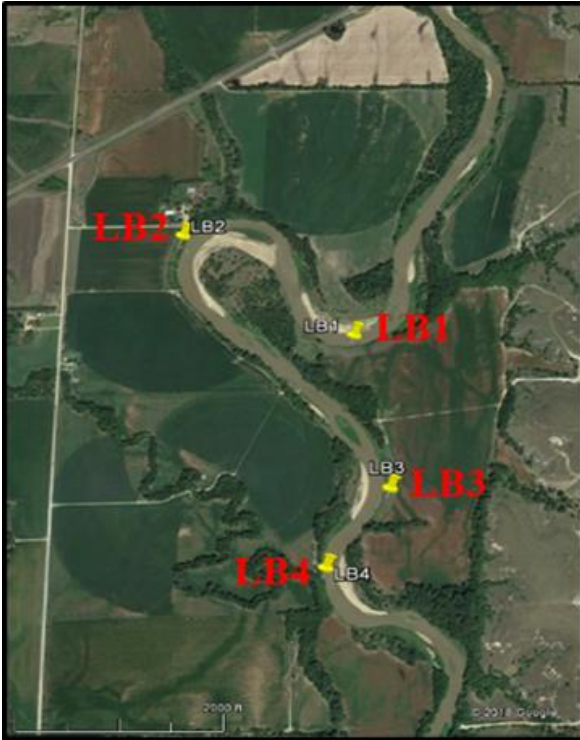
**Table 3. Little Blue River site map and project summary.**

Little Blue River				
Site Identifier	LB1	LB2	LB3	LB4
Year Constructed	2002	2004	2002	2011
Erosion Area (ac)	7.2	7.1	1.5	2.0
Bank Height (ft)	21.0	21.0	17.9	21.0
Erosion Rate (yd <sup>3</sup> /yr)	22,000	18,500	3,900	3,900
% Bank Wash Load	54%	62%	57%	52%
20 yr Wash Load Reduction (yd <sup>3</sup> )	237,600	229,400	44,460	40,560
Quantity of Rock (ton)	1,017	1,080*	2,016	1,121
Volume of Earthwork (yd <sup>3</sup> )	390	414	772	429
Estimated Rock Cost	\$53,000	\$57,000	\$106,000	\$59,000
20 yr Wash Load Dredging Cost	\$1,580,000	\$1,530,000	\$300,000	\$270,000

\*Rock Volume Estimated Based on Project Length (No Design Documents Available)

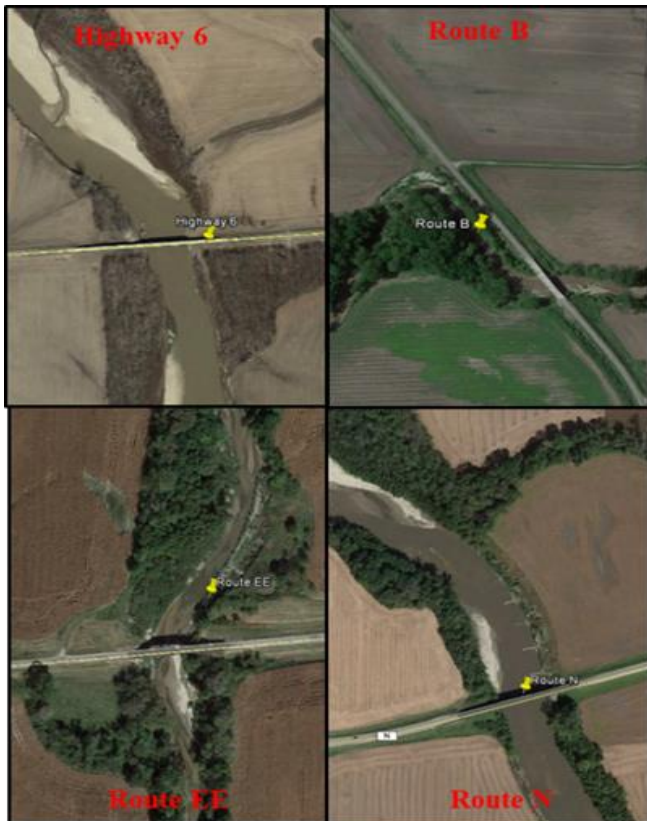
**Table 4. Section 14 site maps and project summary.**

Section 14 (Grand River Basin)				
Site Identifier	Highway 6	Route B	Route EE	Route N
Year Constructed	2005	2012	2011	2013
Erosion Area (ac)	2.4	0.2	1.2	1.2
Bank Height (ft)	25.0	16.0	24.0	26.0
Erosion Rate (yd <sup>3</sup> /yr)	10,756	323	3,098	2,961
% Bank Wash Load	54%	55%	55%	56%
20 yr Wash Load Reduction (yd <sup>3</sup> )	116,200	3,500	34,100	33,200
Quantity of Rock (ton)	10,900	5,140	5,230	4,362
Volume of Earthwork (yd <sup>3</sup> )	2,658	1,365	3,520	1,527
Estimated Project Cost	\$562,000	\$257,000	\$261,500	\$218,100
20 yr Wash Load Dredging Cost	\$780,000	\$20,000	\$230,000	\$220,000

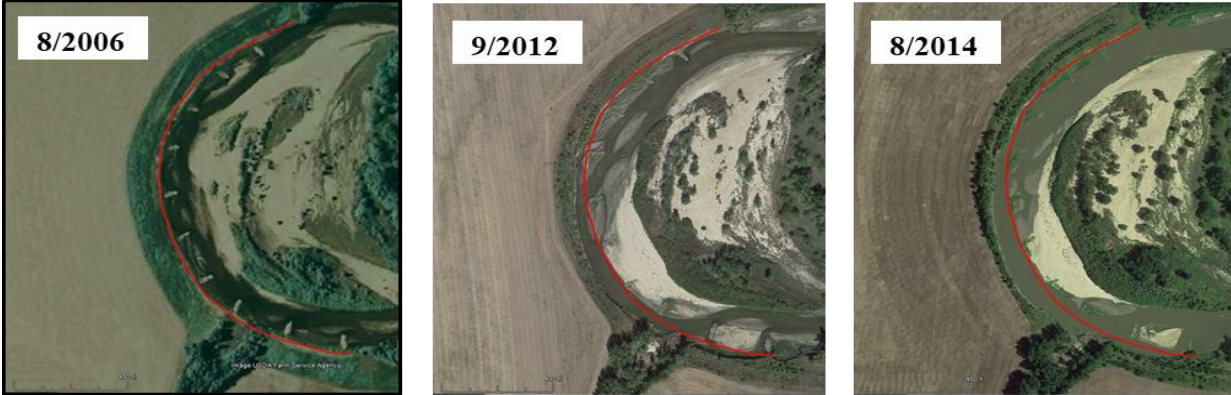
Figure 6. RR3 project site – Post construction (8/2006), After failure (9/2012) and (8/2014). (Red line indicates location of 2006 bank)

Projects RR1 and RR3 were constructed in 2004, and RR2 was constructed in 2006. Based on historic aerial photography, the RR3 project failed between 9/2010 to 9/2012. Flows during this period (Figure 8) indicated the failure most likely occurred in the spring of 2011 when a 50% to 20% annual exceedance (2- to 5-year) flow event occurred. All three projects experienced the same event, and the best functioning project was completed more recently. Flows in the Republican River around the anticipated failure of project RR3, including results of a Log Pearson III Flood Frequency analysis, are included in Figure 8.

None of the Republican River projects have full longitudinal toe protection. The fully functional project (RR2) has some limited toe protection on the downstream end of the project. The success of Project RR2 is not an indicator of the merits of toe protection due to the projects atypical design, described above. Conversely both non-fully functioning projects (RR1 and RR3) lack both keys behind weirs and toe protection. As the failure mode for RR1 and RR3 is flanking, the lack of keys and toe protection seems to be the likely reason for their failure. The difference in level of success between the similar designs of RR1 and RR3 indicate that additional factors such as bank material and channel plan-form characteristics play a major role in the success of bank stabilization projects.

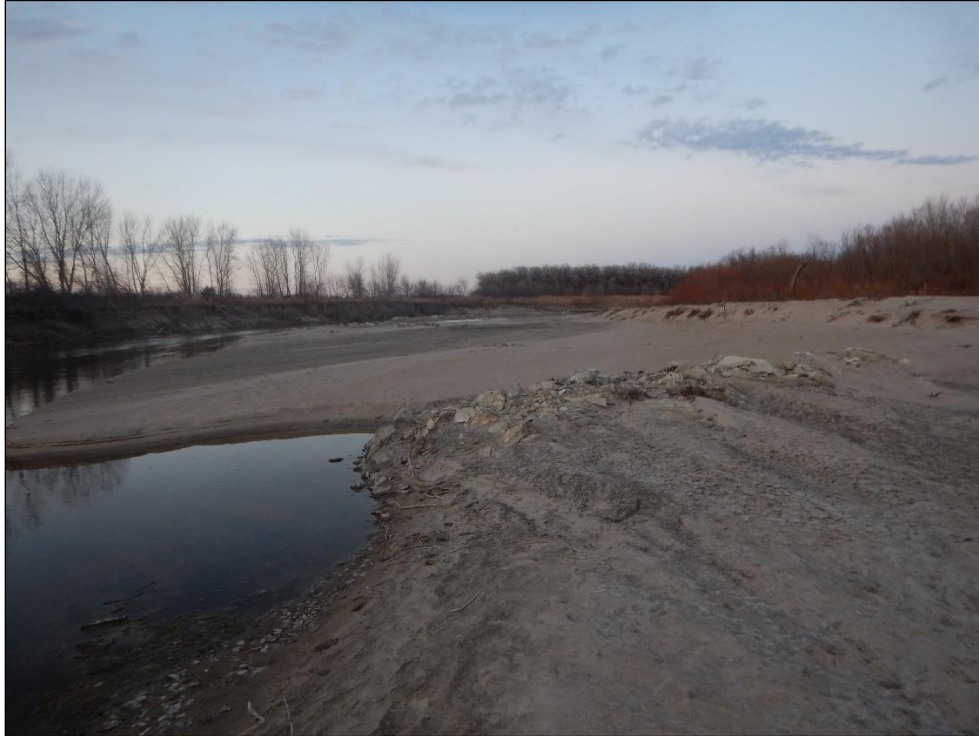
Figure 7. RR1 failure – Flanked structure buried in point bar.

**PROJECT FAILURES:** While designers strive to ensure bank stabilization projects are successful, knowledge can be gained from project failures. The three Republican River projects analyzed in this study are very near each other and were constructed around the same time but have varying degrees of success. A general location map of the Republican River projects is shown in Figure 5. Project RR3, the most upstream project on the Republican River, failed completely. The bendway weirs are now buried in the point bar on the opposite bank (Figures 6 and 7) allowing approximately 48,000 yd<sup>3</sup> of additional sediment to be eroded from the bank. Project RR1 is mostly functioning; however, flanking of two weirs has occurred, which has reduced the project effectiveness and useful life. Project RR2 is fully functional with no flanked weirs but has an atypical design from the other streambank protection projects analyzed in this study. The major project features of RR2 were rock closure structure to prevent flow through a side channel that had formed during high flows. Aerial photos showing the progression of the project RR3 failure are included in Figure 6. Figure 7 shows a flanked structure on project RR3, when the photo was taken during a field assessment in November 2017.

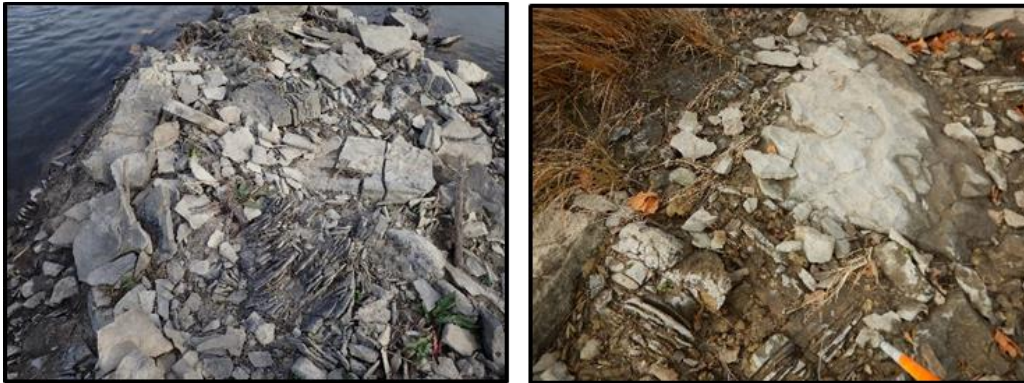
Figure 9. Weathering and degradation of bendway weir rock at RR1.

**ROCK DEGRADATION:** Rock quality degradation was occurring at most sites. This appeared more problematic for bendway weirs because fragmenting rock could be readily washed away from weir tips and crests. These sites were still providing bank stabilization, even though the weirs were sustaining damage. Figure 9 shows rock degradation of bendway weirs observed during field assessments. The rock has fractured, effectively reducing its size and ability to resist erosive forces. Design documentation, including rock size, gradation, and quality is not available for these projects; therefore, the cause of rock degradation is unable to be deduced.

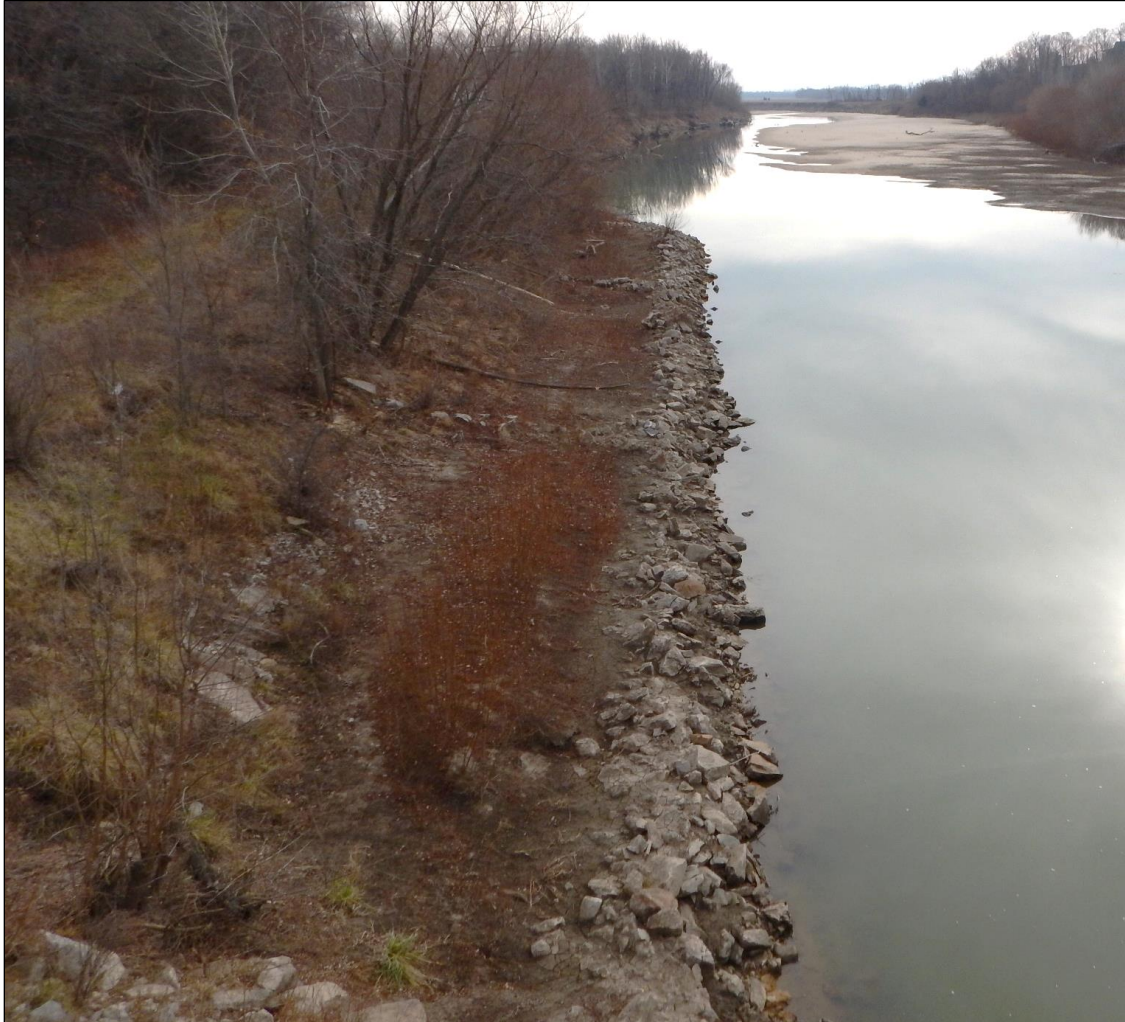
Figure 10. Successful baffle dike with longitudinal peaked stone toe protection and tiebacks at Highway 6 Section 14 project. Note significant sediment deposition between dikes.

The projects with baffle dikes and toe protection appeared universally successful at trapping sediment and stabilizing the bank, with vegetation being established within a couple years. Examples showing successful baffle dikes and toe protection are shown in Figure 10.

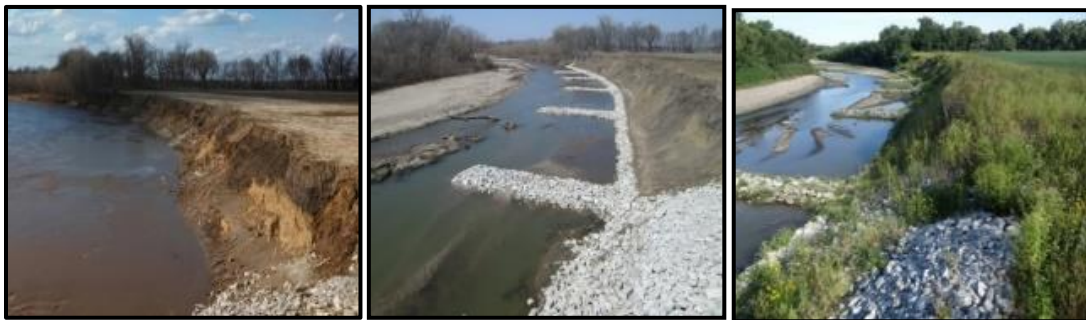
Figure 11. Successful bendway weirs with toe protection – Initial condition (left photo), after construction (middle photo), current condition Highway N (right photo).

The projects with bendway weirs were likewise effective if sufficient toe protection or keys were included in the design to prevent flanking. Examples showing successful bendway weirs with toe protection are shown in Figure 11.
