Carbonation Processes in Submerged Concrete in a Simulated CO₂ Invasive Fish Barrier System

Robert D. Moser, Tyler R. Johnson, Mary C. Madden,
Charles A. Weiss Jr., Wendy R. Long, Mason A. McKechnie,
and David L. Smith

February 2020

Final report

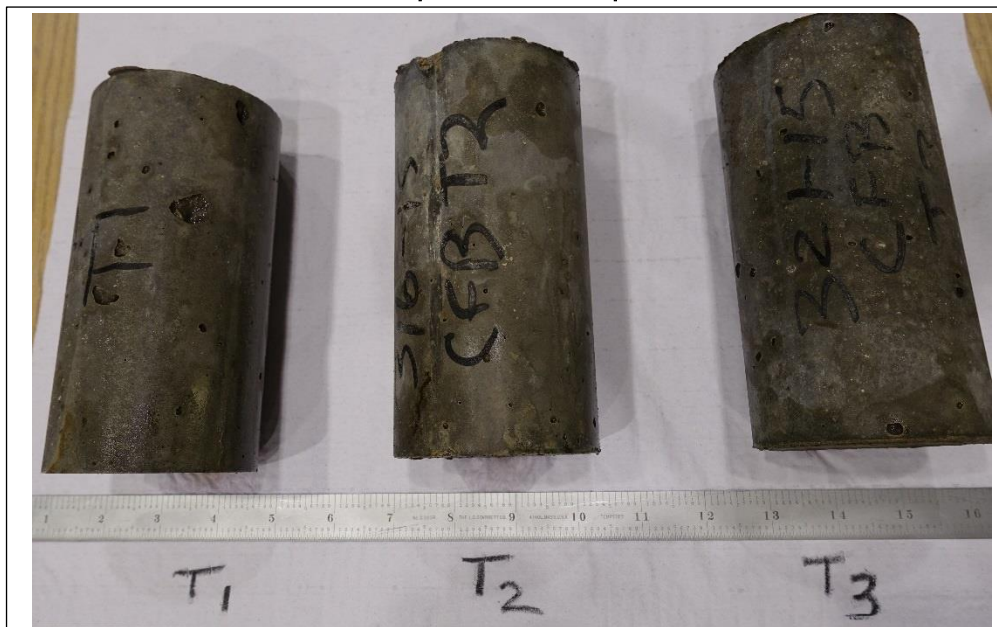
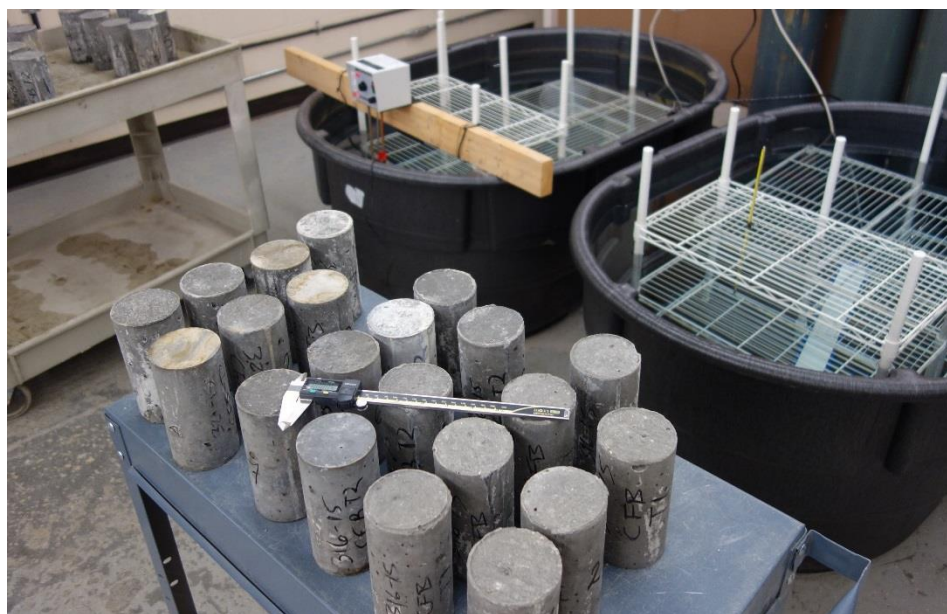
Figure 1. Photograph of concrete cylinder specimens T1, T2, and T3 near experimental setup.

(a) Photographs of specimens T1, T2, and T3.

(b) Photographs of experimental setup.

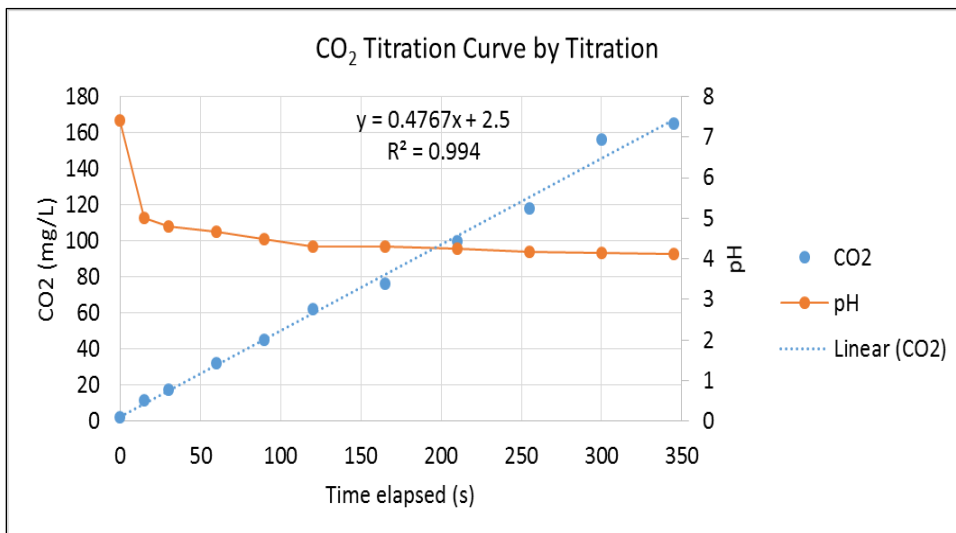
Figure 5. pH calibration for tank one and tank two (a-b).

(a) Tank one [21±2 °C] titration/pH curve.

(b) Tank two [40±2 °C] titration/pH curve.

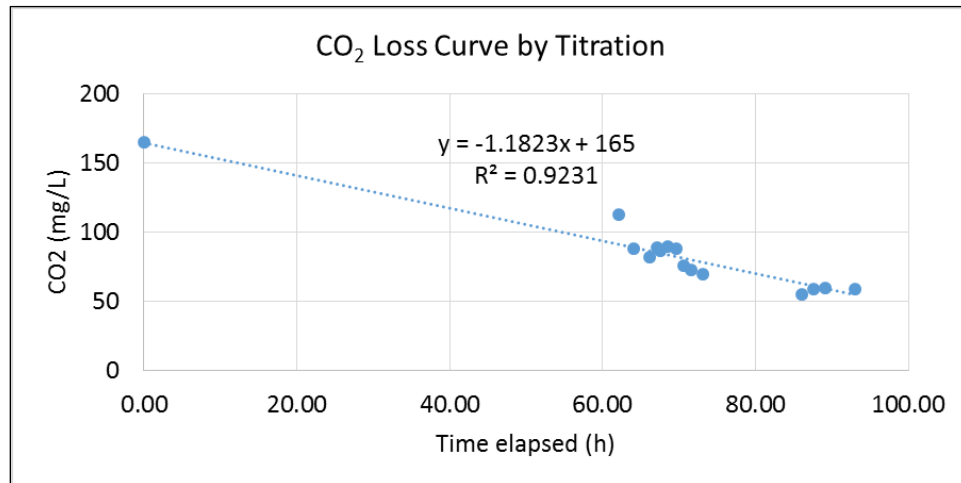
Figure 6. Tank carbonation adjustment (a-b).

(a) Tank one (T1) CO₂ evaporation curve [21±2 °C]

(b) Tank two (T2) CO₂ evaporation curve [40±2 °C].

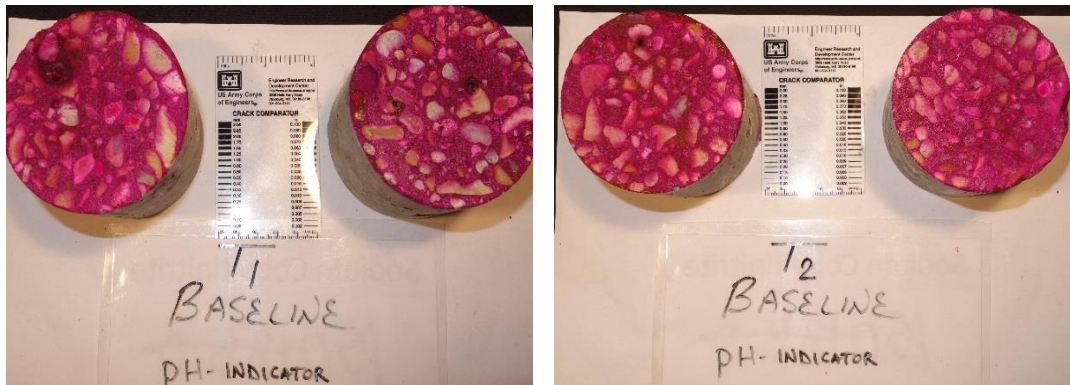
Figure 7. Baseline measurement specimens (T1, T2, and T3).

The phenolphthalein (pH) indicator analysis was run for each of the 3-in. x 6-in. concrete cylinder specimens (T1, T2, and T3) at test ages of 7, 28, 56, 90, 180, 365, 545, and 730 days of exposure to 74 mg/L CO₂ (see Figure 7 through Figure 15). The pH indicator spray was also applied to the cement and fly ash paste cubes at the same time intervals. The pH indicator spray was applied to concrete cylinder specimens and cement and fly ash paste cubes exposed to CO₂ concentrations of 225 mg/L at test ages of 180 and 365 days. The pH indicator solution was applied to the freshly exposed (cut) specimen surface. The specimens with newly applied pH indicator were photographed with a reference scale (Figure 7). Observations were recorded; in the event of notable carbonation penetrating the specimen surface, further analysis was conducted. Results of these tests are compared to the exposed day-one baseline samples to determine the inward movement of carbonation. At the test age of 90 days, the formation of a precipitate forming on the outer surface of the concrete and paste specimen was noted for the first time; this precipitate is explained in further detail in subsequent sections. The formation of precipitates and visually apparent changes in the surface of samples continued to progress beyond 90 days through the 730-day observations (see Figures 11 through Figure 13). From this point, further analysis such as microscopy, SEM, TGA, and XRD were performed in the event of visible changes due to carbonation within the specimen. These tests give a more comprehensive analysis of what reactions are occurring.

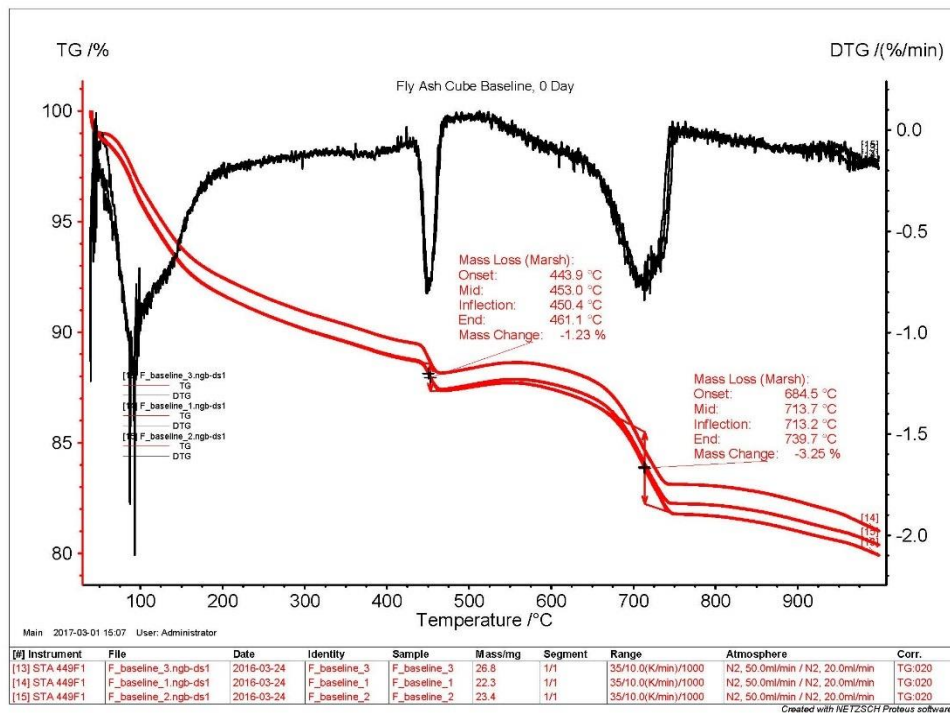
Figure 18. TGA analysis results (a, b, c, d, and e).

(a) TGA analysis of cement paste cube (paste) baseline.

(b) TGA analysis of fly ash cube (paste) baseline.

(c) TGA analysis of cement paste cube (paste)-28 days.

(d) TGA analysis of cement paste cube (surface powder)-90 days.

(e) Cement paste cube (surface powder) 0- to 180-day TGA mass loss.

The results of the thermogravimetric Analysis (TGA) for the specimens are shown in Figure 14 for test days 0, 28, 90, and 180. From these results, it was concluded that the chemical fish barrier carbonation system did have an effect on the concrete and paste specimens. The TGA data found in Figure 14a indicates that a mass loss occurred between the temperatures of 450 and 500°C representing a loss of calcium hydroxide and a secondary mass loss occurring between 600 and 900°C of 14% representing a loss of calcium carbonate.

The TGA data shown in Figure 18d indicates carbonation is more defined within the specimen at later ages, i.e., test day 90. It was also noted during the pH indicator analysis that the formation of a precipitate began on the outer surface of the concrete and paste specimens at 90 days. However, there was no mass loss in the range that would typically see calcium hydroxide at approximately 450-550°C; however, a substantial mass loss was seen in the range that would typically see calcium carbonate, which is approximately 600-800°C. It appears that calcium ions are precipitating out and then reacting with carbonic acid and/or free CO₂ in solution to form calcium carbonate on the surface of the specimen. The rough surfaces on the specimen and concrete structures have the potential to be great nucleation sites. The data also suggest researchers are seeing carbonation occur internally in the cement paste.

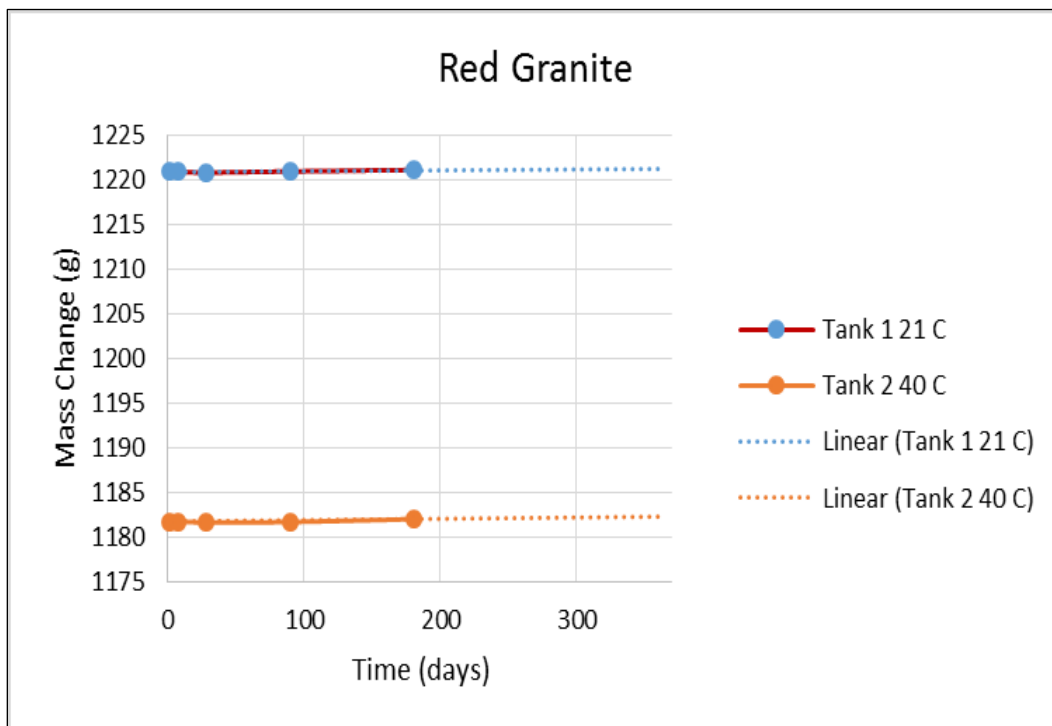
Figure A3. Mass change as a function of time for red granite.

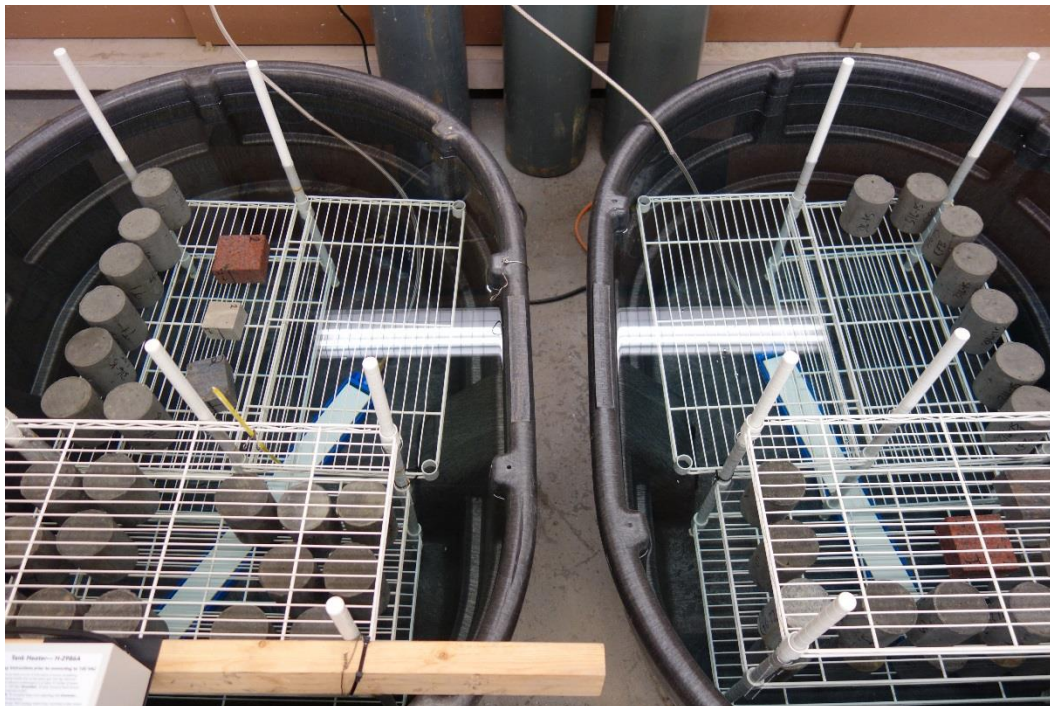
Figure A6. Gray limestone, red granite, and gray quartzite specimens.
