## **Improved Vehicle Mobility by Using Terrain Surfacing Systems**

John F. Rushing and Daniel E. Harder

April 2020

Final report

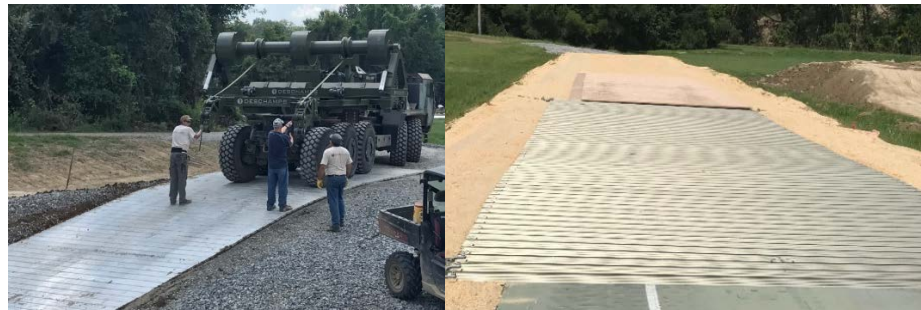
(a) Aluminum matting 1

(b) Aluminum matting 2

Aluminum matting 1 (Figure 1a) is a rolled matting system comprised of aluminum planks approximately 4.3-m wide and 23-cm long. These planks lock together using a hinge that allows the sections to roll up onto a truck-mounted launching system. The launching system, which is integrated into a standard flat rack, can be picked up by a Palletized Loading System (PLS), Common Bridge Transporter (CBT), or other military vehicles that can load such pallets. The length of matting on the launcher depends on the weight capacity of the vehicle being used, but is typically 15 to 30 m. For this study, the launcher was delivered with approximately 45 m of matting. Each plank is made from a hollow box with small vertical supports inside to provide strength. The ends are capped to prevent debris from entering the cavities. The surface is smooth, bare aluminum with small ridges every few centimeters to provide traction. Planks are held together with a long H-shaped rod that slides inside of C-shaped grooves on each side of the adjoining planks. Small bolts prevent this H-shaped rod from sliding out. On flat surfaces, the matting simply sits atop the ground; the system has a set of anchors for use on slopes or when lateral movement is a concern. If the path needs to be extended, mats can be placed end to end and the planks locked together. If the path needs to be widened, mats are placed next to each other but are not connected.

Aluminum matting 2 (Figure 1b) is a rolling matting system comprised of aluminum planks approximately 4.6-m wide and 23-cm long. These planks lock together using a hinge that allows the sections to roll up onto a truck-mounted launching system. The launching system is compatible with the same types of vehicles as Aluminum matting 1. The length of matting on the launcher depends on the weight capacity of the vehicle being used, but is typically 15 to 30 m. The system used in this study was supplied with approximately 30 m of matting. The entire plank is anodized and colored grayish-green. Planks are locked together at the end with a small latch that prevents the planks from sliding out. Also included in the system are planks half the width of the roadway, which makes it easier to join and separate long stretches of matting. On flat surfaces, the matting simply sits atop the ground; the system has a bracket and set of anchors for use on slopes or when lateral movement is a concern. If the path needs to be extended, mats can be placed end to end and the planks locked together. If the path needs to be widened, mats are placed next to each other but are not connected. The mat can be placed with either side up with no change in driving characteristics.

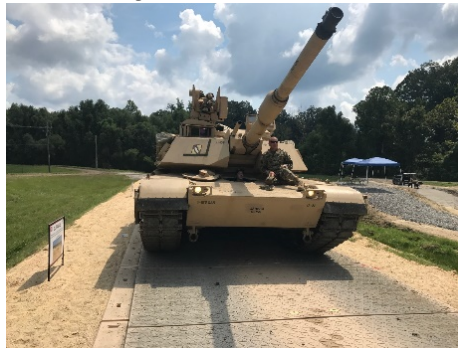
(c) Thermoplastic matting

Thermoplastic mats (Figure 1c) are large, heavy-duty, panels measuring approximately 2.4 m by 4.3 m with a useable surface of 2.1 m by 4 m and 0.3 m of overlap and underlap around the edges. They are placed in a grid and joined together with locking pins that drop into rectangular grooves and twist 90 degrees to lock in place. Each panel weighs approximately 476 kg and must be placed with a forklift or other material handling equipment. The surface is smooth plastic with ridges added for traction. Each panel is hollow with an internal structure to provide support and is sealed to prevent water or debris from entering the cavities.

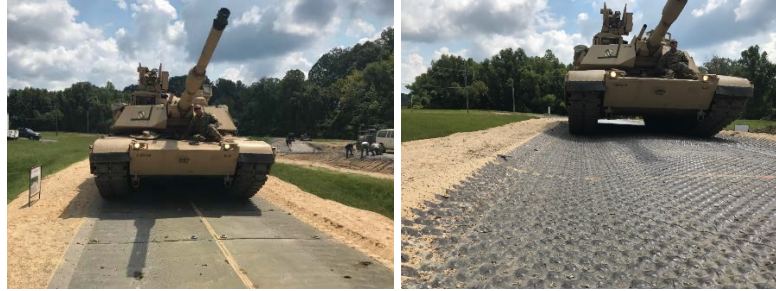
(d) Fiberglass matting 1 (e) Fiberglass matting 2  
 Figure 1. Matting systems evaluated for river bank stabilization.

The fiberglass matting 1 system (Figure 1d) is comprised of square fiberglass panels arranged in a grid to create a driving surface. This matting system was held together in place with 1.2-m screw anchors, which were installed through holes in adjoining mats. Each mat has a useable surface of 1.8 m by 1.8 m with 20 cm of overlap or underlap on each side, providing a logistics footprint of 2 m by 2 m. Holes are located in the corners to allow anchors to be placed and to connect the mats. Each panel weighs approximately 54 kg and can be carried and emplaced by two people. The top surface of the mat has an aggressive diamond-shaped embossed pattern for traction. The mats are placed by hand, and the screw anchors are installed with a hydraulic impact drill and 50-mm socket.

Fiberglass matting 2 (Figure 1e) is a lightweight mat used for rapid ground improvement over medium-strength sands and soils. The mat consists of fiberglass measuring 4.3 m by 18.3 m with an egg crate/waffle pattern. The mat can be rolled up and deployed with a squad of soldiers but is most easily placed using a forklift and one to two people. A ratchet strap or rope holds the roll together while in storage. If a longer or wide path is required, mats are placed next to each other, but they are generally not connected to each other. Short rebar style anchors, which are approximately 0.46-m long with a flat “T” head, can be used to hold the mat in place by hammering them through reinforced holes along the edge of the mat. The mat has an aggressive texture added to the surface in addition to the wavy structure of the mat. Each mat weighs about 438 kg.

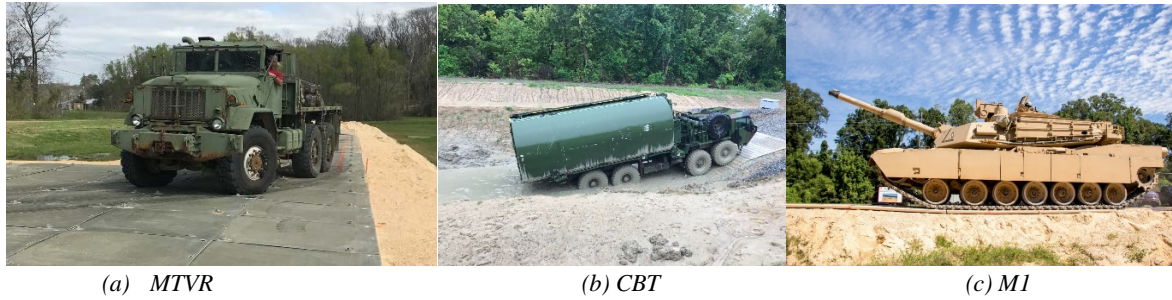
Figure 2. Test vehicles used in the study.

The MTVR (Figure 2a) is a 3-axle, medium cargo vehicle used by the U.S. Marine Corps with a capacity of 9.1 tonnes. Its empty weight is 13,880 kg. The loaded weight during testing was 20,230 kg, and tire pressure was maintained at 240 kPa. This vehicle was used for all testing on sand and on medium-strength soil for this effort.

The CBT (Figure 2b) is a 4-axle, heavy cargo vehicle used by the U.S. Army with a nominal capacity of 9.1 tonnes. A CBT A2 model was used for this test. The CBT A2’s empty weight was 17,330 kg. Its loaded weight for testing was 26,400 kg, and the tire pressure was maintained at 450 kPa. This vehicle was used for all testing across the sloped and marsh test sections in its normal and in its 8x8 drive settings.

The M1A2 Abrams (Figure 2c) main battle tank is a heavy, armored tracked vehicle with a 120-mm canon. Reported weight during testing was 64,400 kg; however, actual vehicle weight was not measured. Its ground pressure is approximately 75 kPa. This vehicle was used as the tracked vehicle for all test sections.

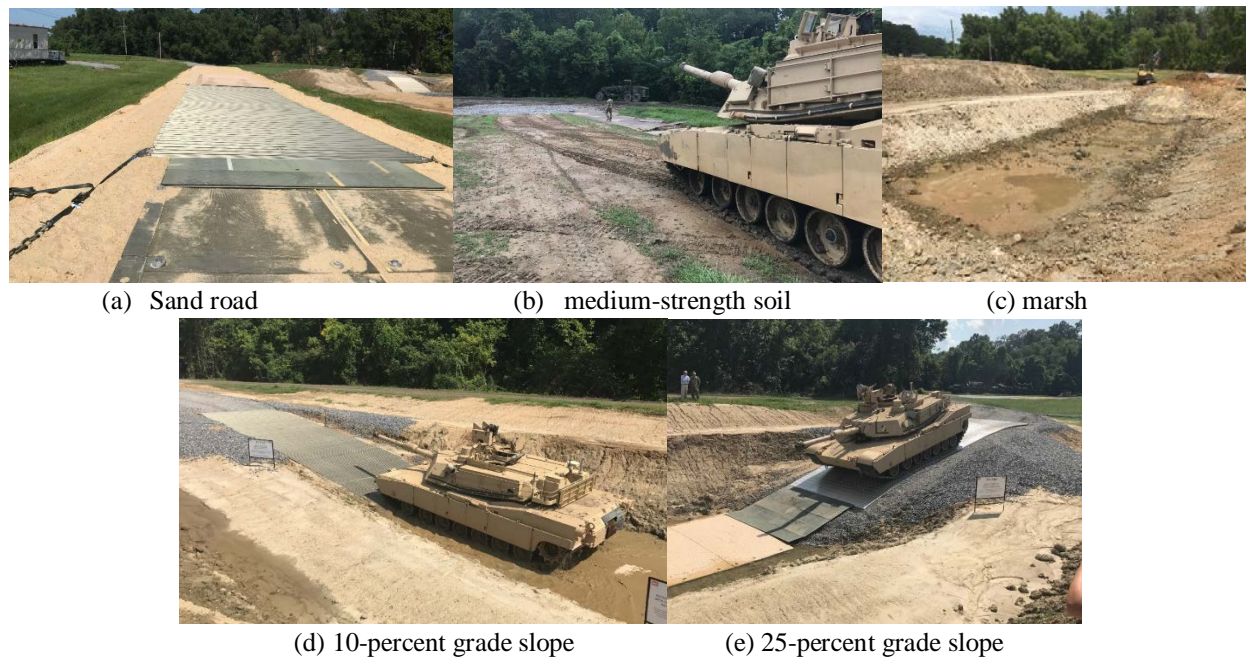
Figure 3. Site conditions used for testing.

The sand test area (Figure 3a) was prepared using a local concrete sand classified as poorly graded sand (SP) by the Universal Soils Classification System (USCS). This material is cohesionless, poorly graded, and provides adequate compressive strength but little shear strength. These properties present difficulty when crossing large numbers of ground vehicles due to accumulated rutting that develops.

The medium-strength soil test area (Figure 3b) used the native material at the test site which classified as lean silt (ML) according to the USCS. Prior to testing, a grader removed the upper 3 to 5 cm of soil and vegetation. The resulting bare soil consisted of a clayey silt with moderate cohesion and bearing capacity. This type of soil experiences difficulty supporting large numbers of ground vehicles due to rutting developed from the lack of bearing capacity. To ensure no significant strength changes existed between individual test sites, soil strength measurements were performed within one day of initiating traffic testing on each item.

The marsh test area (Figure 3c) represented the weakest soil conditions and areas that may exist in low lying floodplains or coastal tidal regions where matting would be essential for wheeled vehicle crossings. To prepare the test area, a pit was excavated beneath the grade of the field site to a depth of approximately 2.4 m. This depth was the water table due to a surrounding lake. The soil at the bottom of the pit classified as lean clay (CL) according to the USCS. The pit was approximately 5-m wide and 30-m long with sloped edges for stability. A sump pump was used to dewater the pit prior to any testing.

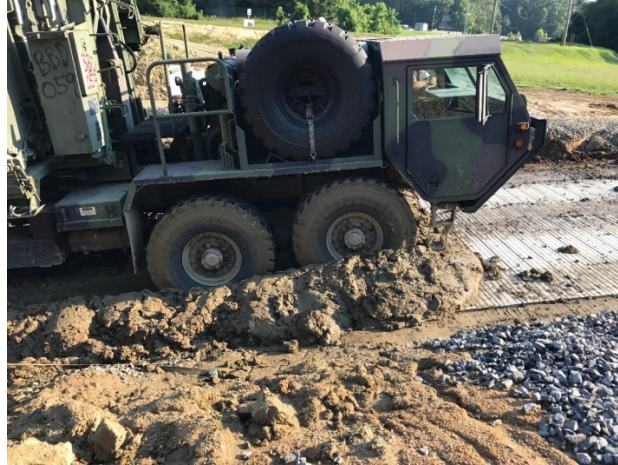
Figure 4. Testing slopes with mud placed on mats.

Traction on the matting was expected to be influenced by the absence or presence of water and soil that was deposited on the mat surfaces during crossings. To understand the effects of these conditions, crossings were conducted in a dry and muddy condition. The dry condition was observed during the initial crossings after the mats were first laid. After this condition was observed, a muddy condition was created by placing a layer of soft mud across the full width of the mat, 0.3-m thick and 5.5-m long from the bottom of the mat (Figure 4). The mud was prepared by mixing local soil with water until a consistency existed that would represent that of approximately 15-cm-slump concrete mixture. The mud was placed onto the mats using a skid steer loader and bucket attachment.

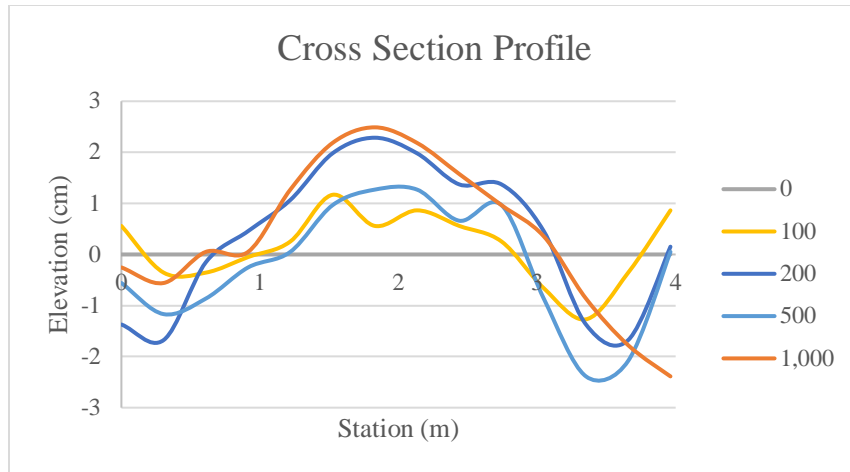
Figure 5. Representative cross section profile data for Fiberglass Matting 1 on sand..

Figure 5 shows the cross-section profiles for the Fiberglass matting 1 on the sand test area for varying traffic intervals. These data are typical of cross section profiles showing accumulating rutting with increased vehicle traffic. Remaining data are not presented in this paper for brevity but can be found in Harder and Rushing (2018).

The cross-section profile shows that additional soil formed upheaval in the center of the mat between the wheel paths and along the edges. These data show approximately 4.5 cm of total difference between the highest and lowest elevations. Overall, the Fiberglass matting 1 successfully sustained 1,000 combined passes of vehicle traffic.
