ARL-TR-8980 • JUNE 2020

High-Build Plural Polyurea Protection for Vehicle Torsion Bars: Final Report

Thomas A Considine, Thomas E Braswell, and Brian E Placzankis
Weapons and Materials Research Directorate, CCDC Army Research Laboratory

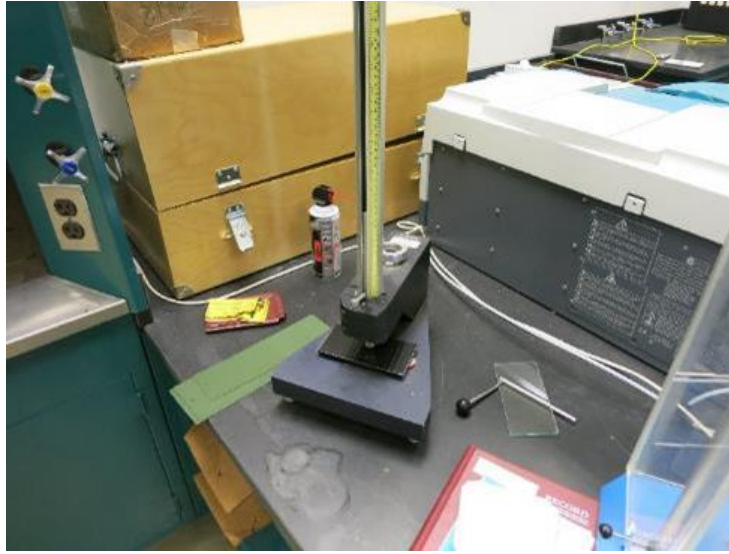
Fig. 2 Impact tester

Impact testing was performed on test coupons featuring the HBP coatings prepared by Aalberts and a set of test coupons prepared by ARL to represent the taped bars (Fig. 2). These panels were primed with MIL-DTL-53022 Type IV and wrapped in polyethylene electrical tape to approximate the EF-9 polyethylene tape used in the current process. Impact testing was done at 60 cm (~24 inches) and 100 cm (~39 inches) using a 4-lb weight for impacts of 96 inch-lbs and 156 inch-lbs. A second and more severe improvised impact test was then performed by dropping a pipe wrench from 9 ft onto the test panels for an impact force of 972 inch-lbs (Fig. 3). This testing was done based on observations and reports that the bars are easily damaged during shipping, storage, and even installation itself from the installers walking on them (Figs. 4 and 5). Damage was observed and photographed.

Impact testing was conducted on panels representing all three systems. A Byk Gardner Heavy Duty Impact Tester equipped with a 4-lb weight was used in initial testing. Impact strikes were made at 96 inch-lbs and 156 inch-lbs. Figures 14–16 show the results from these impacts.

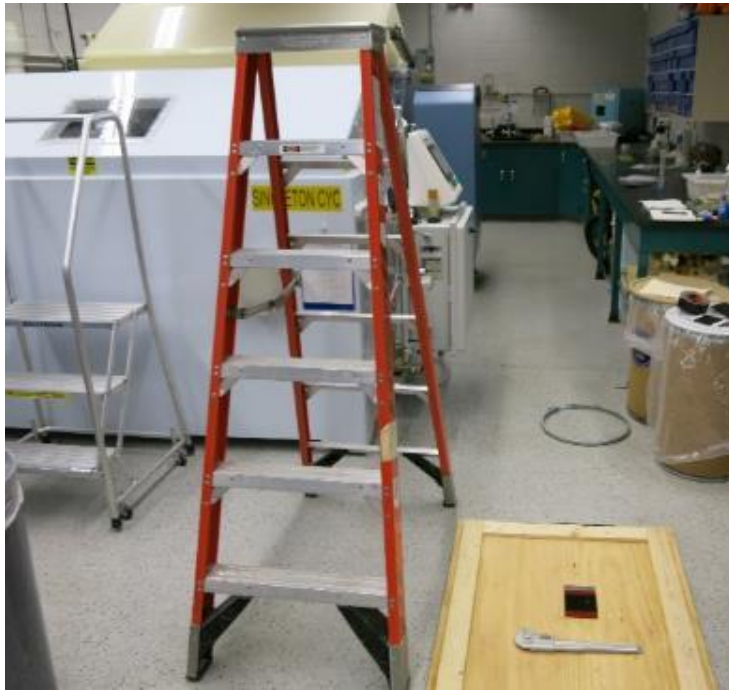
Fig. 3 Improvised impact test

Due to the nearly nonexistent damage noted to both the Line-X and Dragonhide systems in conventional heavy impact testing, a second and much more severe improvised impact test was conducted by dropping a pipe wrench from 9 ft straight down onto the test panels. The pipe wrench had a mass of 3.3 lb and impacted at 972 inch-lbs based upon the vertical orientation and end area of the tool. This additional test was devised to replicate a severe real-world production or maintenance issue in which a tool is accidentally dropped onto a bar and to further assess the mechanical limits of these systems. As noted before, just walking on the currently fielded taped bars is sufficient to damage them. This modified test was approximately 10 times more severe than the previous impact tests, the effects of which can be seen in Figs. 17–19. The damage to the taped samples was quite severe, as before, with the impact penetrating through the tape and primer, damaging the substrate of the panel itself. The tape was torn, distended, and suffered loss of adhesion all around the impact zone. With the Line-X, the impact was absorbed but left two areas of delamination on either side of the impact zone. In contrast with the previous impacts where the coating was able to recover to its original appearance over time, no such healing was observed in the months between testing and the writing of this report. There was no penetration through the coating. Damage to the Dragonhide system was, as before, more difficult to visually observe. A pen was used to indicate the damage in Fig. 15. This damage consists of two small, straight parallel lines, each about 1 mm wide. There was no evidence of delamination or penetration of the coating. Additional testing performed by Aalberts as part of process validation determined the elongation of Dragonhide to be anywhere from 180% to 400%, whereas the elongation of the Line-X had a much narrower window of 140% to 160%. Further testing revealed a shore hardness of Dragonhide to be 45D, and 55D for Line-X. The more elastic Dragonhide, coupled with the fact that it is a softer coating than the Line-X, may explain why the coatings had such visually dissimilar results from a similar impact. The Dragonhide was able to absorb and disperse the force more easily than the Line-X due to those properties discussed previously.

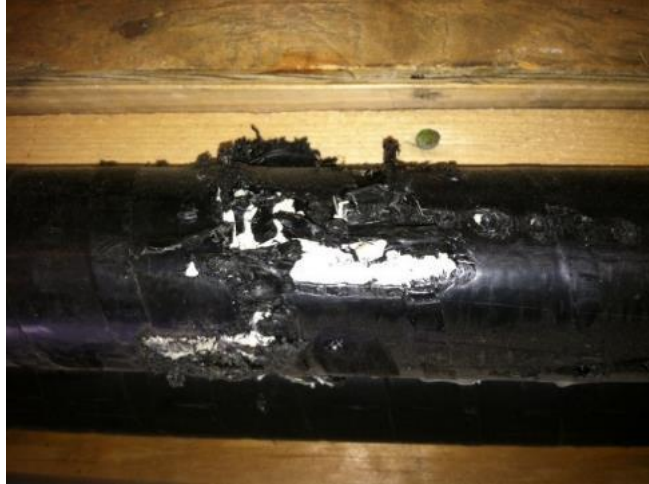
Fig. 4 Taped bar damaged in shipping

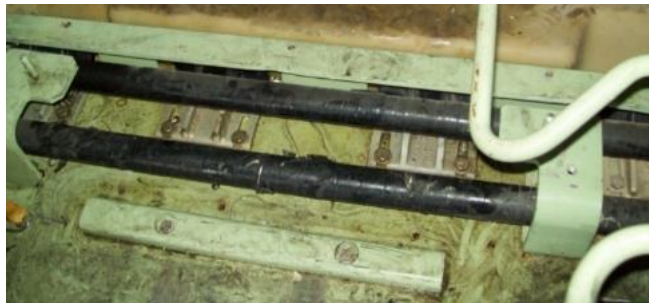
Fig. 5 Taped bars damaged during vehicle assembly

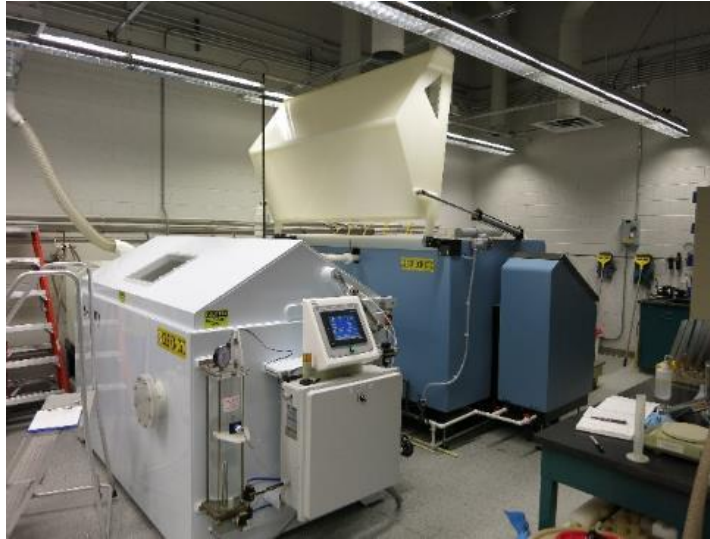
Fig. 6 Cyclic corrosion test chambers at ARL

Five panels of each system were placed into ASTM B117 (ASTM International 2018) neutral salt fog and GMW14872 (General Motors 2018) cyclic corrosion testing. A Singleton CCT-80 cyclic corrosion chamber (Fig. 6) and an Autotechnology Model 22 salt (NaCl) fog chamber (Figs. 7 and 8) were used for this phase of testing. Both tests were run in accordance with the relevant specifications. Neutral salt fog testing conditions are a continuously atomized 5% NaCl fog at 95 °F and saturated humidity. Salt fog testing was verified using daily

fog collection rates, wet and dry bulb temperatures, tower temperature, and the specific gravity and pH of collected fog. Cyclic corrosion was run according to GMW14872, EXT, and C conditions and includes four spray cycles followed by four ambient periods over the course of 8 h, followed by an 8-h high humidity period (120 °F, 100% relative humidity [RH]), and concluded with an 8-h dry period (140 °F, <30% RH). Panels in salt fog were inspected for blistering and delamination at 336, 504, 672, 1008, 1512, and 2016 h and 10, 20, 30, 40, and 60 cycles, respectively.

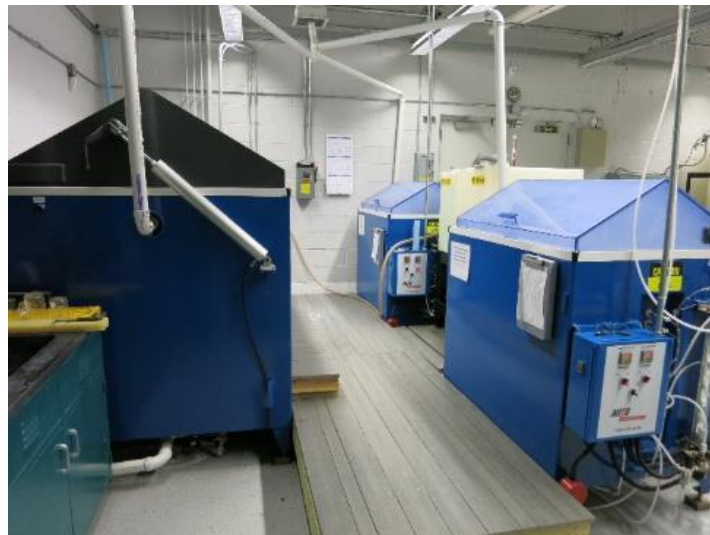
Fig. 7 B117 chambers at ARL

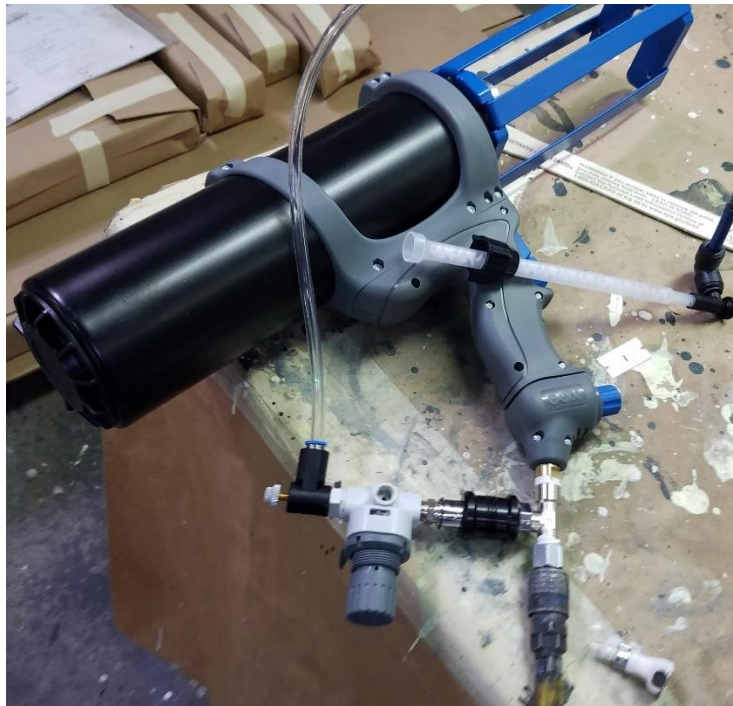
Fig. 10 Pneumatic dual cartridge epoxy gun setup

A touch-up procedure was identified and tested by Aalberts and ARL for the Dragonhide 1000 system. As there is no touch-up procedure for either the tape or AAV platform that does not involve sending bars back to a facility for rework, this demonstration was limited in scope. A few decommissioned torsion bars from various programs were made available for Aalberts and ARL to use. Following an empirical approach, ARL and Aalberts were able to provide a viable working touch-up procedure for Dragonhide on torsion bars that can be performed in the field. A pneumatic dual cartridge epoxy gun with static mixing applicator nozzle (Fig. 10) was used to apply the coating to a damaged area of a bar (Fig. 11).

A touch-up procedure utilizing a pneumatic dual part epoxy gun and cartridges was tested by Aalberts and ARL through trial and error, using several scrapped torsion bars. ARL and Aalberts tested various spray patterns, pressures, and techniques in order to obtain the ideal coating surface for touch-up of a contoured surface. The results can be seen in Fig. 31. The procedure for touch-up was written into the certified process used at Aalberts in torsion bar applications. The ARL team then traveled to Line-X headquarters in Huntsville, Alabama, in order to receive training in application procedures, including the Line-X touch-up process. ARL was able to verify that the Line-X touch up procedure was sufficient, resulting in a surface virtually indistinguishable from the original, unblemished surface. This touch-up procedure was also written into a certifiable process to be used by military applicators.

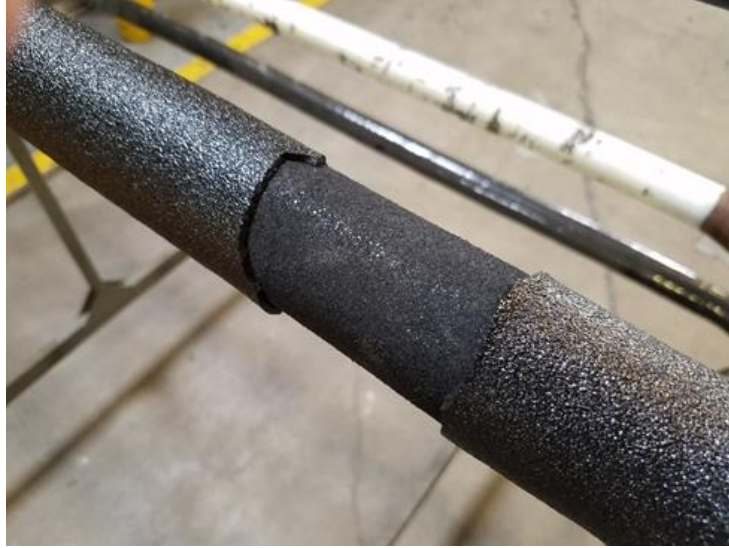
Fig. 11 Torsion bar used in touch-up testing

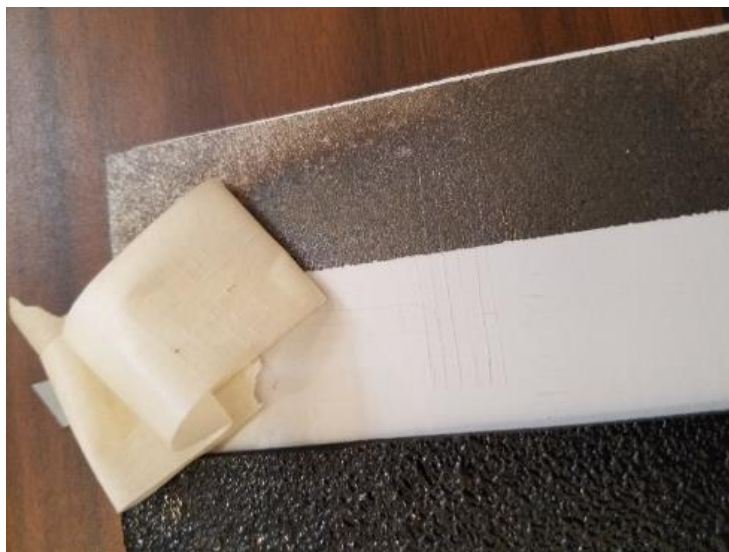
Fig. 12 Cross hatch on MIL-DTL-53022 type IV

Dry tape adhesion was performed on abrasive blasted and shot peened surrogate panels. The adhesion measured was that of the primer to the substrate. Across all test coupons, not a single panel rated lower than a 5B. It can be ascertained that there were no issues with the application procedure for either system, or with the Bonderite M-NT 7400 used in the Dragonhide stackup. Examples of these adhesion tests can be seen in Figs. 12 and 13.

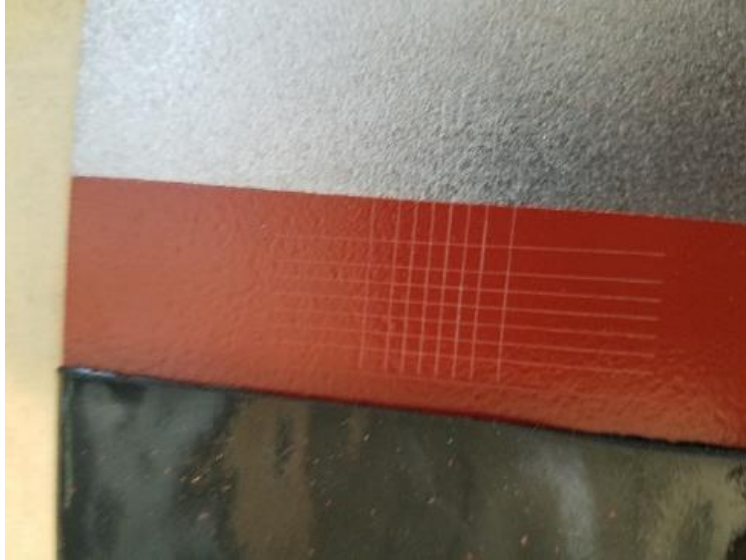
Fig. 13 Cross hatch on XPM primer

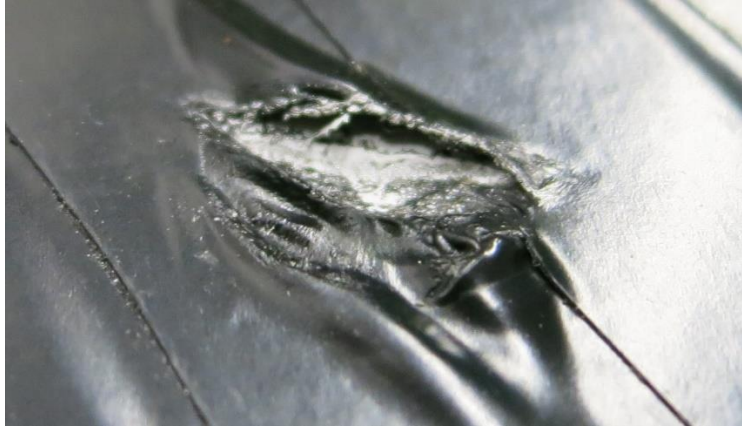
Fig. 17 Improved impact test on tape

All testing performed on the taped panels confirmed reports from the field concerning the low durability of the taped system in place currently on the Bradley torsion bars. The tape application is not resilient (as tested) even with minor impacts, and typically delaminates locally when impacted. When this system is penetrated, the primer is left exposed to the impact as well. As seen in Fig. 17, a strike of just under 100 inch-lbs is enough to damage the primer. Without a primer and pretreatment system in place after impact, there is no longer any corrosion

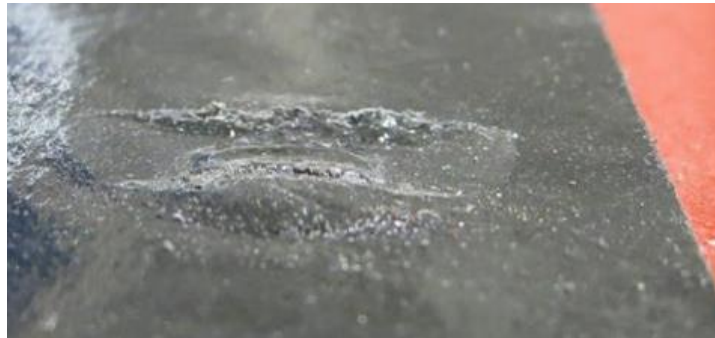
Fig. 18 Improved impact test on Line-X

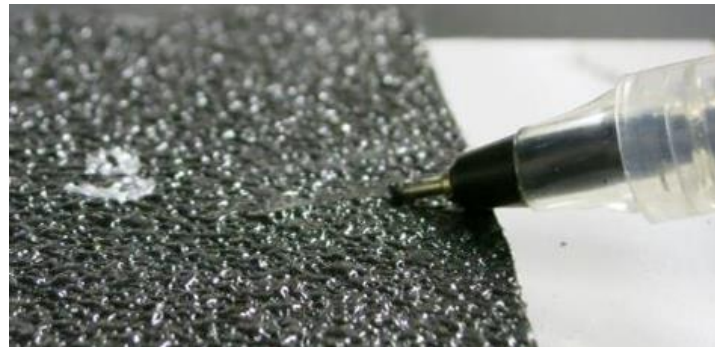
Fig. 19 Improved impact test on Dragonhide

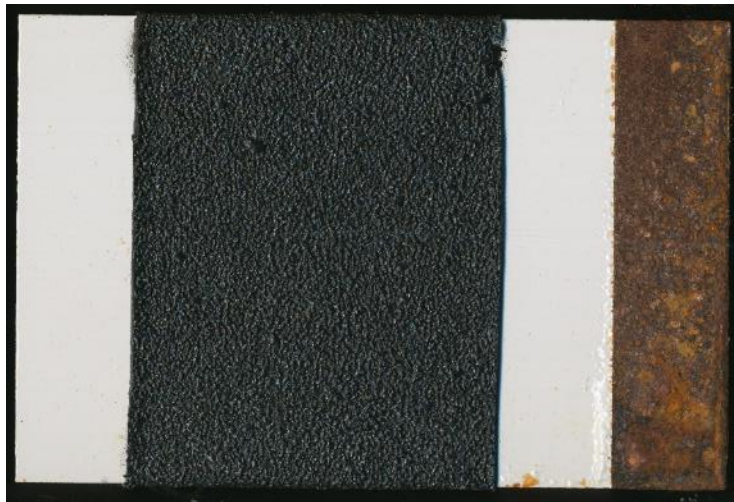
Fig. 21 Representative sample of Bonderite/53022/Dragonhide system at 30 cycles GMW14872

Cyclic corrosion was initially run to 30 cycles as per the requirements for primers in TT-C-490, and inspected every 10 cycles. The photos of the results at 30 cycles can be seen in Figs. 20 and 21 and in Table 2.

At 30 cycles, there is minimal corrosion in the coated areas. There was more blistering emanating from the uncoated area at the bottom and the edges of the XPM/Line-X panels than there was on the Bonderite/53022/Dragonhide panels, but

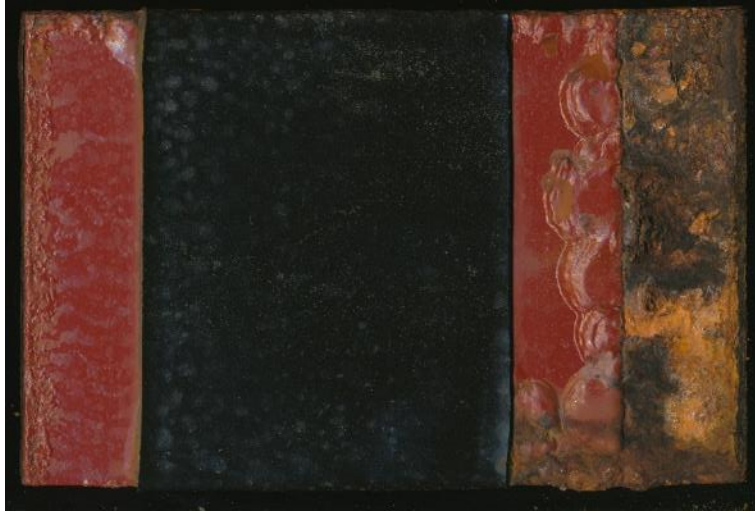
Fig. 22 Representative sample of XPM/Line-X system at 60 cycles GMW14872

The cyclic corrosion test was extended to 60 cycles to present a worst-case situation. These results are presented in Figs. 22 and 23 and in Table 3.

After 60 cycles, the entirety of the XPM primed area is covered in blisters, with large-scale blistering and delamination emanating from the bare, untreated area on the bottom of the panel. Areas coated by the Line-X adjacent to blistering in the primed areas of the panel had begun to lift with the blisters. Though this was double the required duration of cyclic corrosion as per TT-C-490 requirements, this could prove problematic when in the field on assets that are subjected to a marine environment, as in the case of the AAV. The propagation of corrosion on the 53022-primed panels was not as advanced as on the XPM-primed panels. Much of the field remained unblistered, and those blisters that were present originated from the edges and pretreated/bare area at the base of the panel. No portion of the Dragonhide coated area showed signs of blistering under the coating raising any part of it. Working in concert, the combination of the Bonderite M-NT 7400 and the MIL-DTL-53022 Type IV worked considerably well at preventing corrosion at double the required durations specified in TT-C-490.

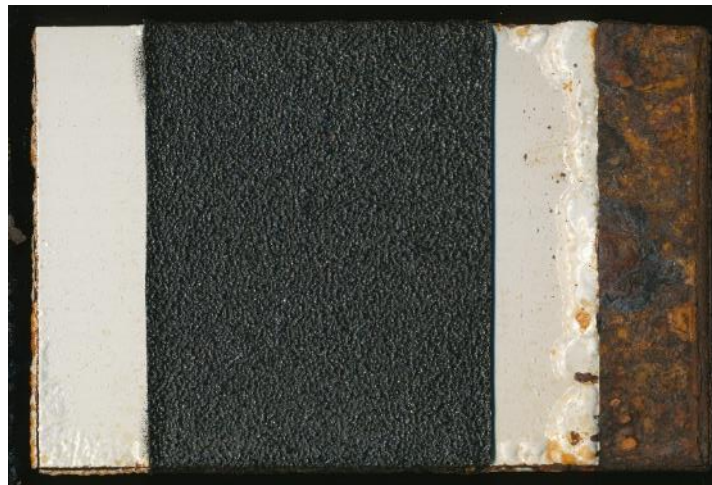
Fig. 23 Representative sample of Bonderite/53022/Dragonhide system at 60 cycles GMW14872

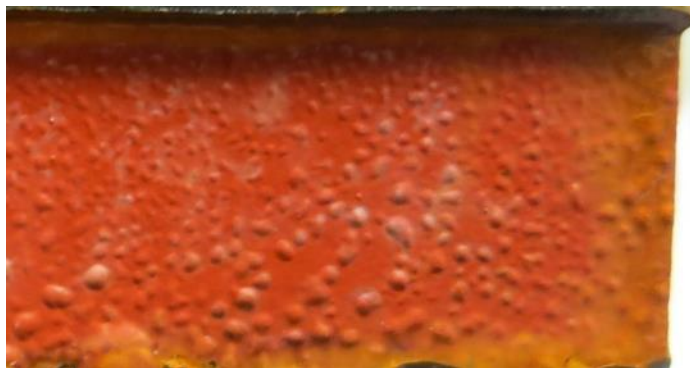
Fig. 24 Close up of blistering on XPM primed panels

In neutral salt fog testing, the XPM primer did not meet the requirements of TT-C-490. By 336 h, the minimum salt fog test duration in 490, the entirety of the primed area was covered in blisters (Fig. 24). Several of the panels tested had already begun to show lifting of the Line-X from blistering under the coating. As in the cyclic testing, the stackup of Bonderite 7400, 53022 Type IV, and Dragonhide outperformed the requirements outlined in TT-C-490. Testing on both sets of panels again continued to double the required duration. After 2016 h of salt fog exposure, the Bonderite-pretreated and 53022-primed panels performed exceptionally well. As can be seen in Fig. 25, there is minimal blistering that radiates from the edges of the panel and no blistering in the field at all. Unlike in the cyclic exposure, there is no blistering advancing into the primer from the pretreated/bare area of the panel at the bottom.

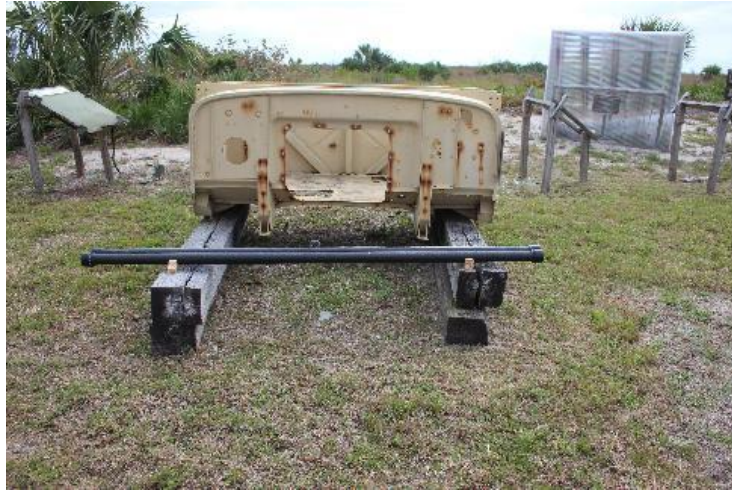
Fig. 26 AAV torsion bar set deployed at CCAFS

A set of AAV torsion bars, one bearing the Line-X stackup system and one with the Dragonhide stackup, were placed in March of 2017 (Fig. 26). Panels of these stackup systems were placed into outdoor exposure 3 months prior. The torsion bars also incurred an unplanned period of seawater immersion, lasting less than 30 days, due to the impact of Hurricane Irma in September 2017 (Fig. 27). Outdoor exposure testing completed two years at CCAFS in December 2018 and March 2019 for panels and bars, respectively. Both sets of bars and panels will continue on in testing until failures are observed. Photographs of the test panels at 24 months are pictured in Figs. 28 and 29. The panels primed with the XPM all show minimal corrosion under the primer near the interface of the primed and unprimed area, but not nearly to the degree seen in cyclic testing. Additionally, there is some corrosion along the other edges of the coupons. The samples primed with 53022 also display some corrosion along the edges and unprimed/primed interface, but to an even lesser degree than seen on the XPM-primed panels. These observations are in line with those from the accelerated testing in the lab. The fifth panel of each set in Figs. 28 and 29 show corrosion in the bottom center of the primed area. These panels were reused from the cross hatch tests, and as such, the scribes go through the coating to the substrate. The severity of the corrosion on the XPM primer is, as expected, much higher than that of the 53022 primer. All 10 test panels do show a degree of color change of the high-build system, with the black fading to a dark gray and a significant amount of dulling of the glossiness of the coating. This change in color and gloss is reflected in the observable results of the bars (Fig. 30).

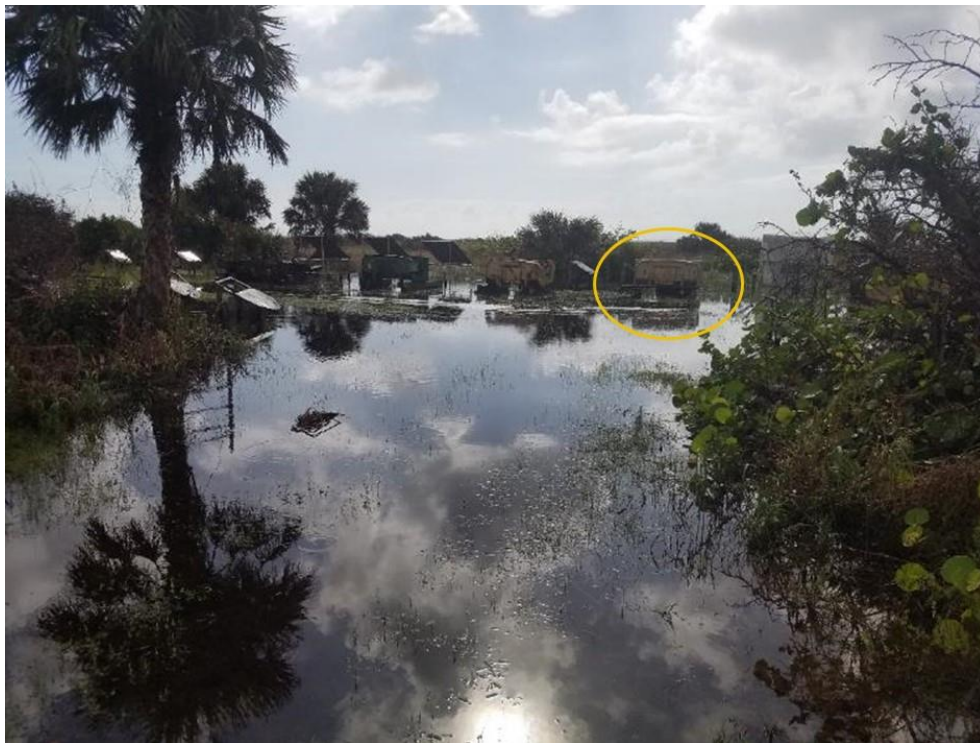
Fig. 27 Torsion bars emerging from flooded deployment area at CCAFS

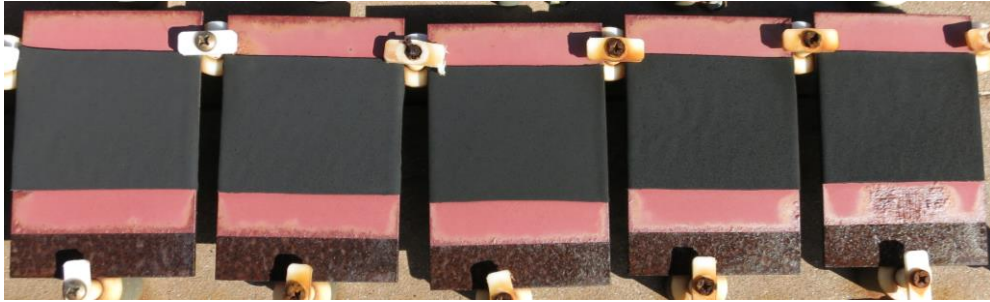
Fig. 28 Line-X system after 24 months of outdoor exposure at CCAFS

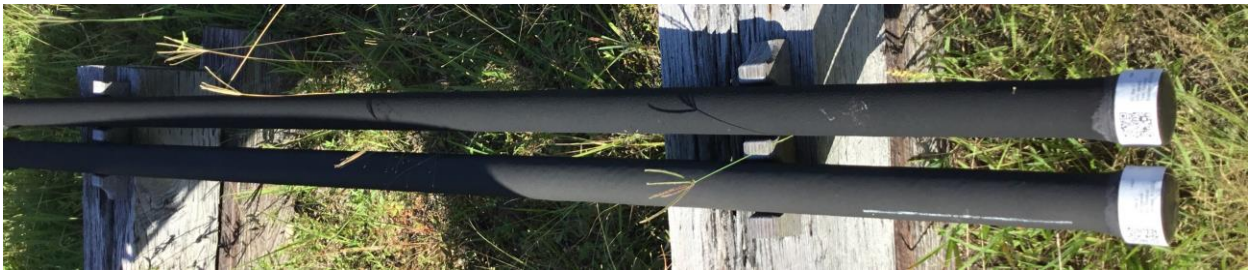
Fig. 30 Dragonhide (top) and Line-X (bottom) bars after 24 months of outdoor exposure at CCAFS

No failures have been observed on either torsion bar as of December 2019, more than two years after the seawater immersion caused by Hurricane Irma.

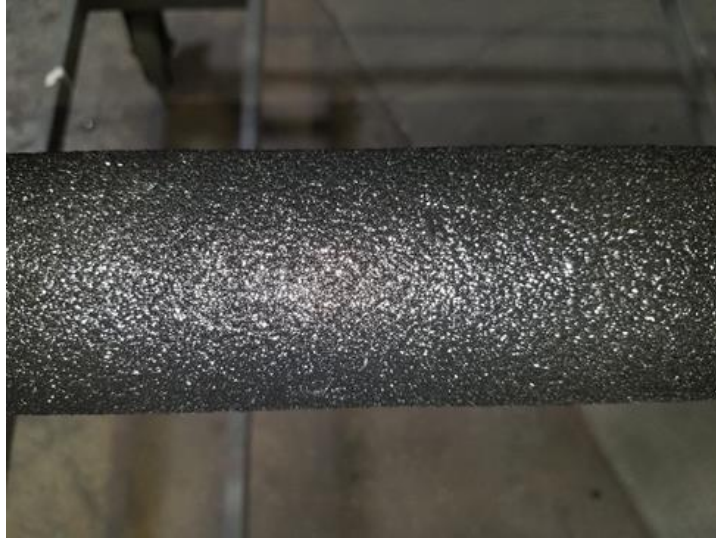
Fig. 31 Torsion bar touch-up procedure result
