Post-Project Monitoring of a Navigation Solution in a Dynamic Coastal Environment, Smith Island, Maryland

Year One of Post-Project Monitoring

July 2020

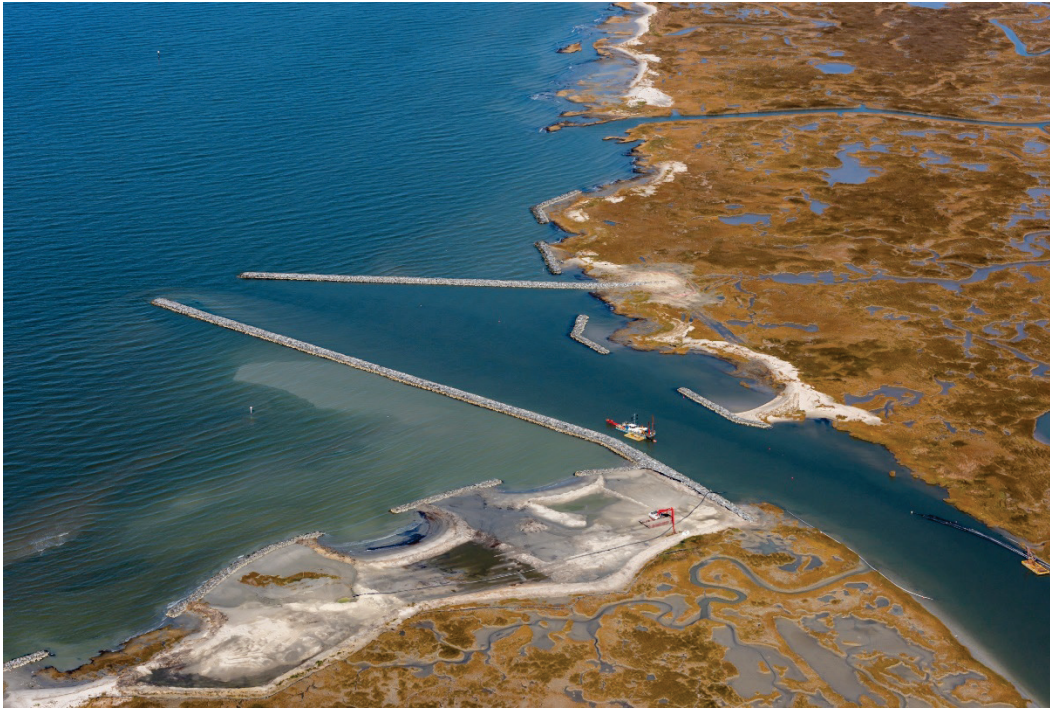
Figure 2. Aerial view of the completed jetties and sill at the Rhodes Point Navigation Project in June 2018, prior to dredging of the channel (photo credit: Coastal Design & Construction, Inc).

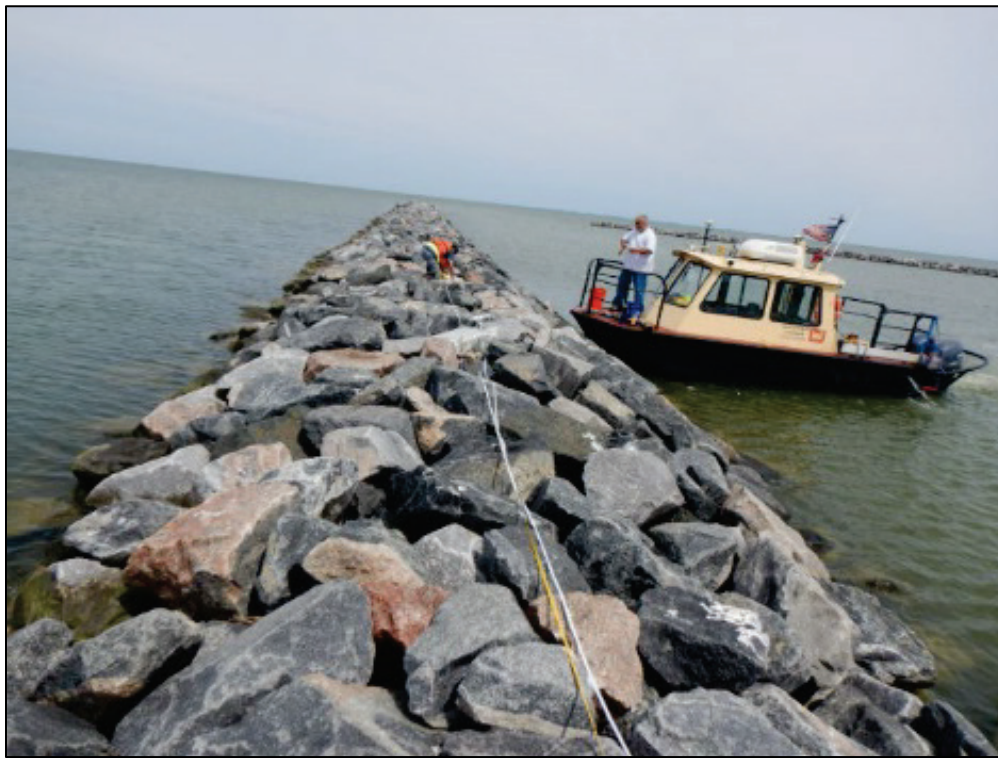
Figure 5. Crew setting up transects for future analysis of structural stability.

Points were taken near the waterline, at approximately mid slope, at the top of slope, on the left and right sides, and on the jetty centerline. Large sturdy rocks were selected for the point locations, and most points (except those that were near or in the water or had algae on top of them) were spray marked. Photos of each marked point was taken. For each point, the following were recorded: station, point location along the transect, point elevations, photo number, and the approximate latitude and longitude of the photos.

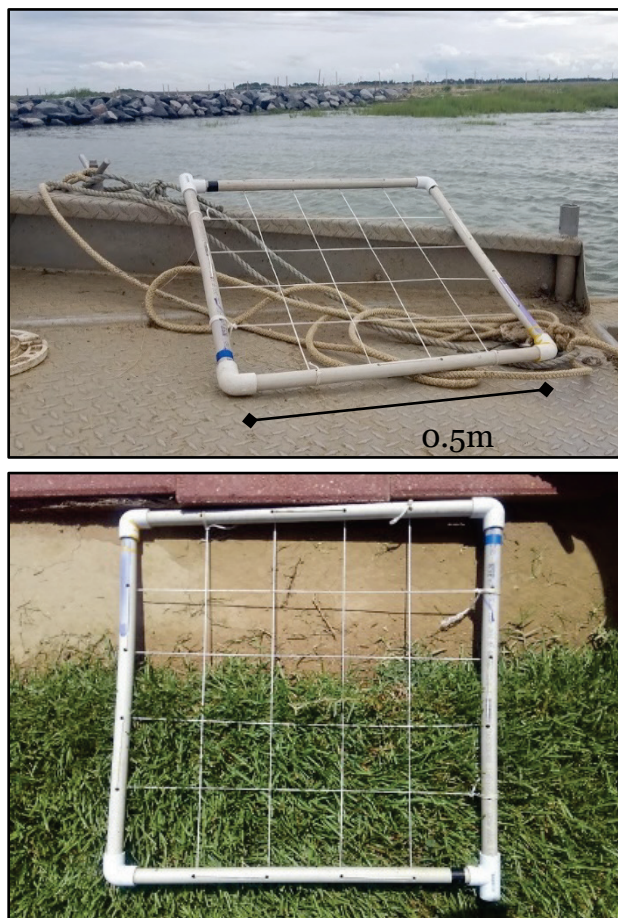
Figure 6. Top: SAV sampling quadrat. Bottom: Example of quadrat with 15 squares having vegetation present, resulting in 60% coverage.

Sampling was conducted during the growing season of both SAV species on June 24–25, 2019. SAV abundance was measured using a 0.5 m² quadrat divided into twenty-five 10 × 10 cm squares (Figure 6). A grid cell was considered covered when at least one SAV shoot was located within the grid cell. Species coverage for each species and total coverage within a quadrat were determined by the number of cells each species occupied within the quadrat. Quadrat samples were taken at odd intervals of quadrat flips from the starting point. A global positioning system coordinate was taken for each quadrat sample. In areas of completely uniform coverage along transects, quick visual scans were conducted to save time.

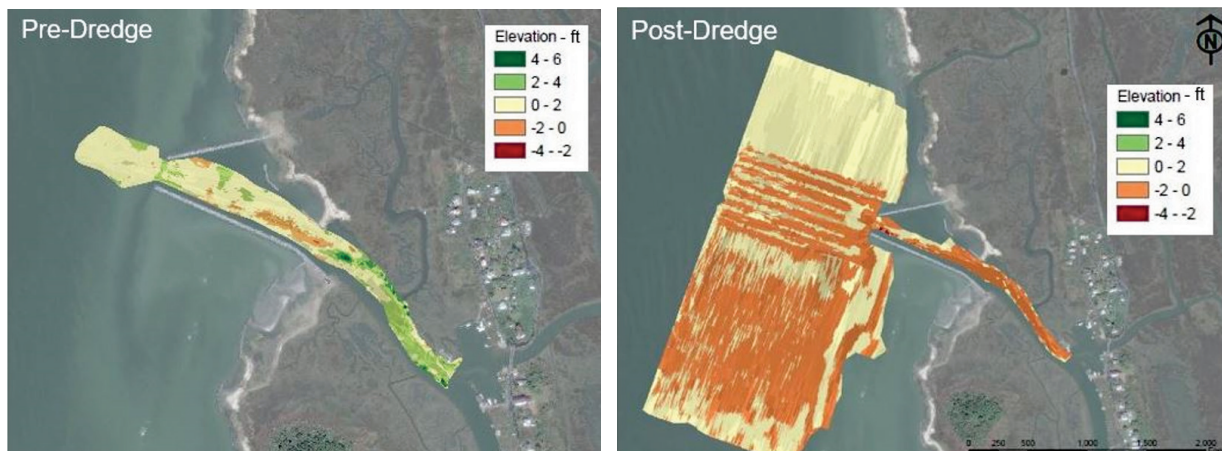
Figure 8 shows comparison of the channel condition for two different time periods. The pre-dredge condition (top) is a comparison of the change in channel elevation for a time period prior to dredging (November 2017–June 2018). Although dredging had not yet occurred, the structures were completed in June 2018. For that period, most of the channel experienced a small amount of scouring, although within the interior of the channel, accretion is evident moving inland. The channel was dredged in November 2018. The bottom section of Figure 8 shows a post-dredge comparison of changes in channel condition, between February 2019 and July 2019. During this time, most of the channel is below the previous elevation, including the interior where scouring appears to have occurred. Some sediment build up appears present at the mouth of the channel. When evaluating the survey point data more closely, the change in elevation between February and July 2019 is a matter of a few inches at the most; therefore, additional time is needed to determine the post-construction change.

Figure 8. Changes in channel elevation for pre-dredge conditions (comparison of November 2017 to June 2018) and post-dredge conditions (comparison of February 2019 to July 2019).

- Prior to construction, surface sediment outside of the channel was categorized as silt and clay; however, post-construction (after dredging) sediment is characterized as poorly graded sand (i.e., well-sorted) (Figure 11, Area Y and Z).
- Post-construction, material on the interior of the channel has become more silty, transitioning from poorly graded (i.e., well-sorted) sand during February 2019 to sandy silt in June 2019 (Figure 11, Area X).
- Based on the post-dredge bathymetric survey data comparison, the north side of the channel has gained material from February 2019 to July 2019 (Figure 8, post-dredge).
- Material has accumulated outside of the channel/jetty mouth from February 2019 to July 2019 (Figure 8, post-dredge).

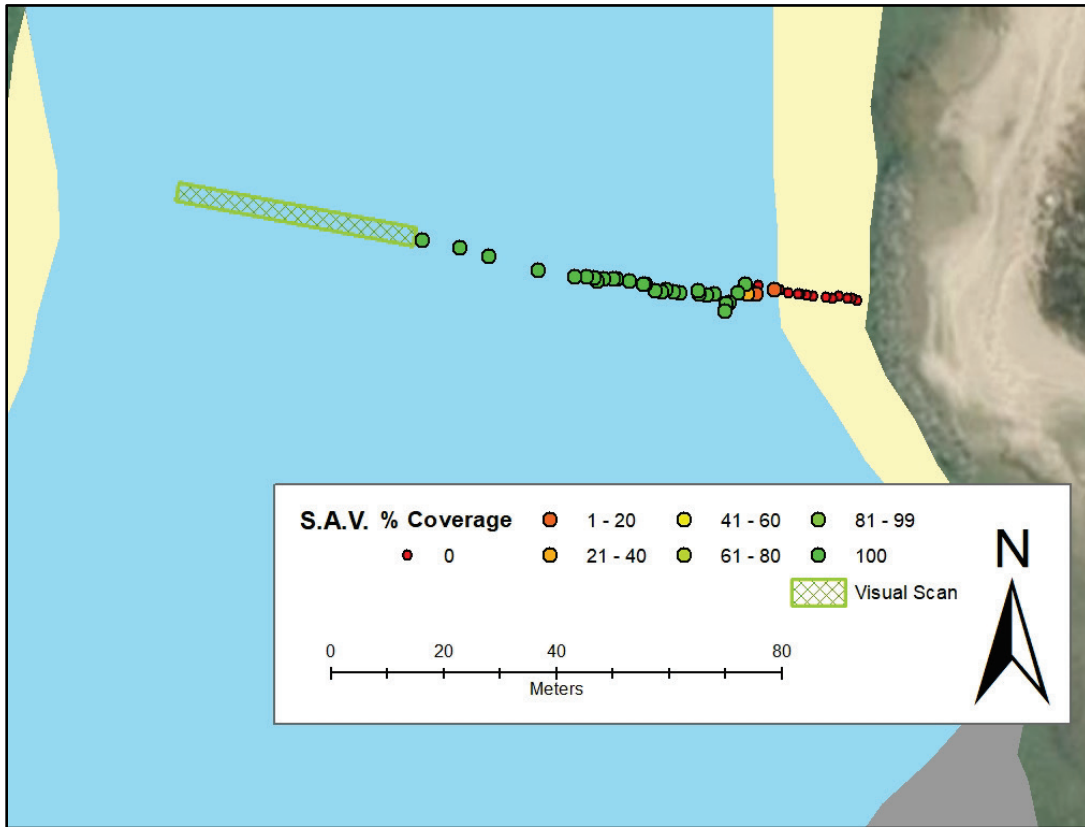
The reference transect consisted of 44 quadrat samples and a 45 m visual scan (Figure 13). All the points and visual scan had SAV mapped in 2016 and 2017. There was no SAV in the portion close to shore where SAV was mapped in 2016 (equivalent to 13 quadrat samples on the transect); however, 30 of 31 quadrat samples overlapping the area where SAV was mapped in both 2016 and 2017 had SAV present with 93% having complete SAV bottom coverage. Based on small leaf size, it appeared that *Ruppia maritima* was spreading in a shoreward direction to where SAV

Figure 13. SAV survey results within the reference area. The yellow-shaded polygon is the 2016 SAV coverage, the grey-shaded polygon is the 2017 coverage, and the blue-shaded polygon is where SAV occurred in both 2016 and 2017.
