**TENSION-TENSION FATIGUE BEHAVIOR OF NEXTEL™720/ALUMINA-  
MULLITE CERAMIC COMPOSITE AT 1200°C IN AIR AND IN STEAM**

THESIS

AFIT-ENY-MS-20-J-078

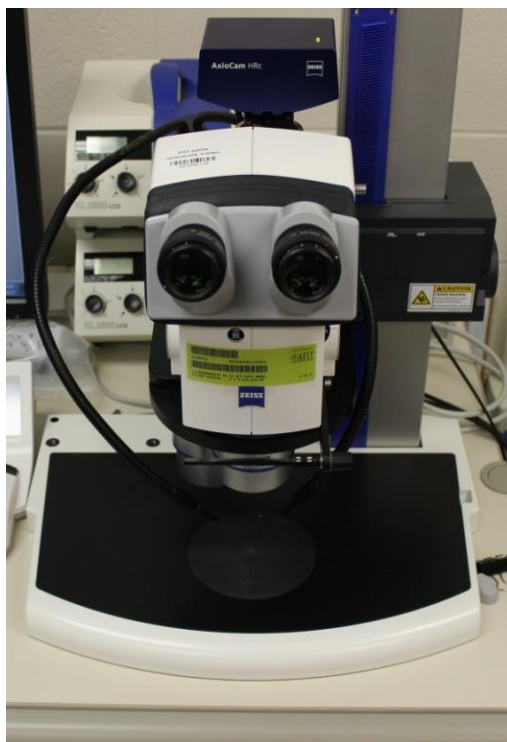
**Figure 15. Zeiss Discovery V12 optical microscope equipped with an AxioCam HRc digital camera**
