TECHNICAL REPORT 3561

October 2020

**Report for Dive Survey in Support of  
Pearl Harbor Bulkhead 1461  
Quay Wall Construction/Refurbishment Project**

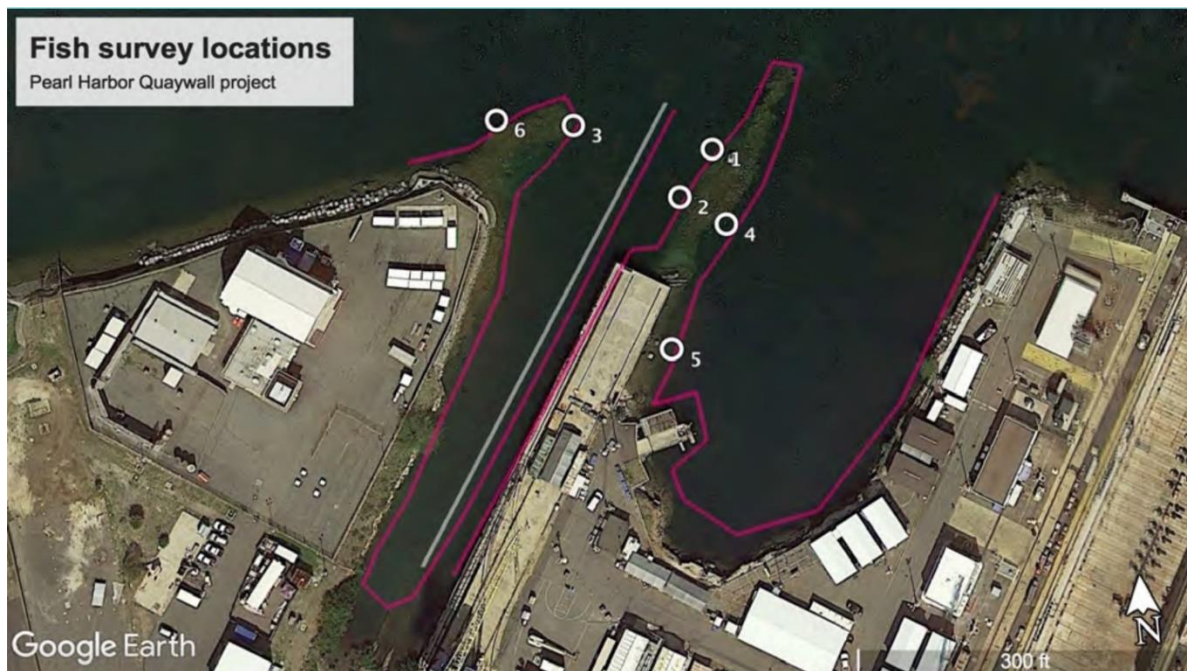
Figure 6. Approximate locations of fish surveys.

- White circles indicate locations surveyed using NOAA PIFSC stationary diver methods.
- Pink line shows swim path for roving-diver surveys.
- Gray line shows location of cog rail.

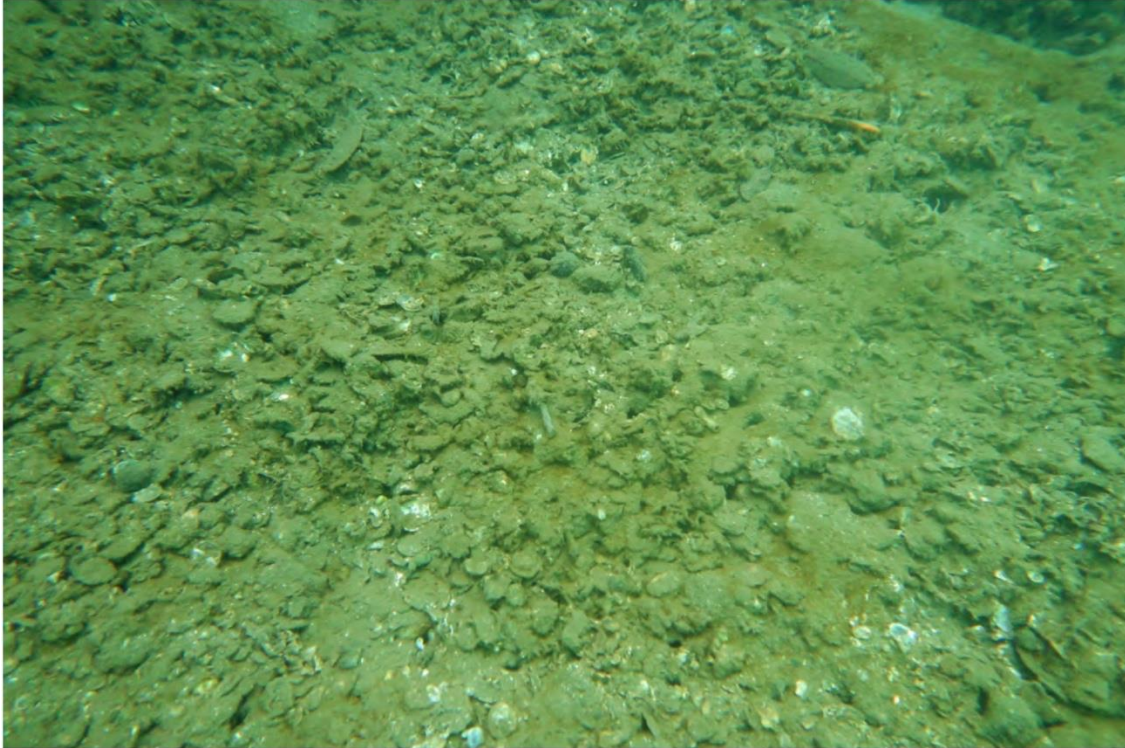
- Image 2383 detailed in Table 1.

Beginning at the fine unconsolidated sediment junction and extending upward to a depth of between 15 and 3 ft (4.6–0.9 m), there was often a coarse rubble slope. These rubble slopes are generally unstable and unconsolidated. In some areas, this rubble slope was absent, and fine unconsolidated sediment abutted the solid rock spurs. The rubble slopes were not all the same. Most consisted of a mix of natural and anthropogenic rock or concrete fragments overlaying coarse to medium grained sand. At some locations, the rubble was dominated by oyster shell hash (Figure 10).

Figure 10. Example of a rubble and shell-hash slope depauperate of living organisms.

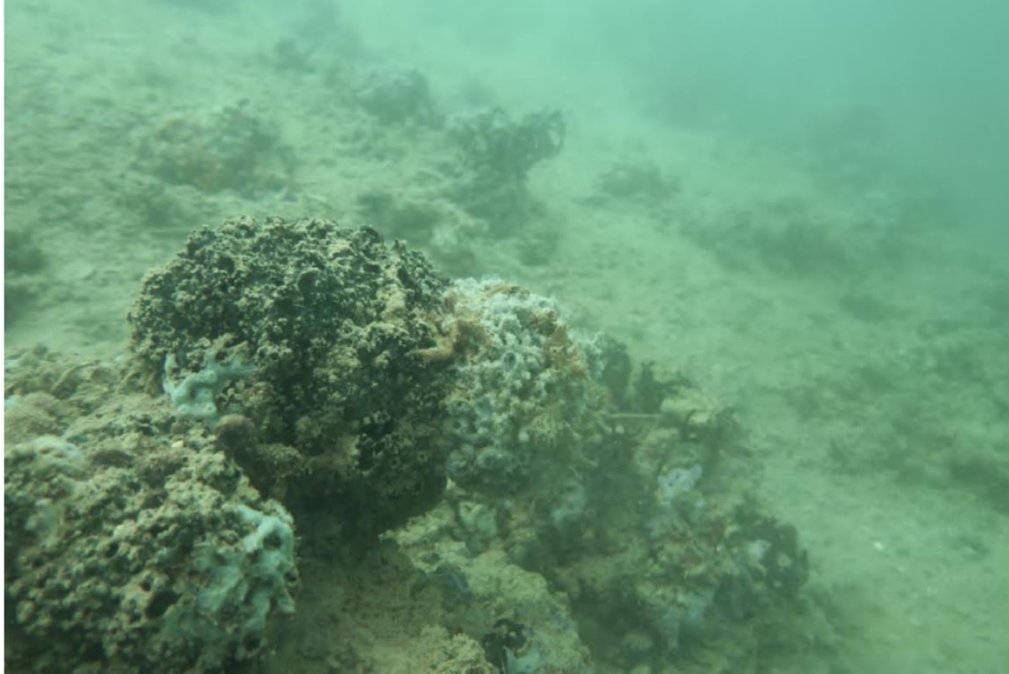
- Image 2372 .detailed in Table 1.

Natural limestone rock spurs (Figure 11) descended to depths of 5–20 ft (1.7–7 m). In most areas around the spurs, this substrate graded into rubble, and then fine sediments, but, as noted above, in some places fine sediments abutted the rock walls directly.

Figure 11. Example of sloping side of one of the rock spurs, supporting a fouling community dominated by sponges.

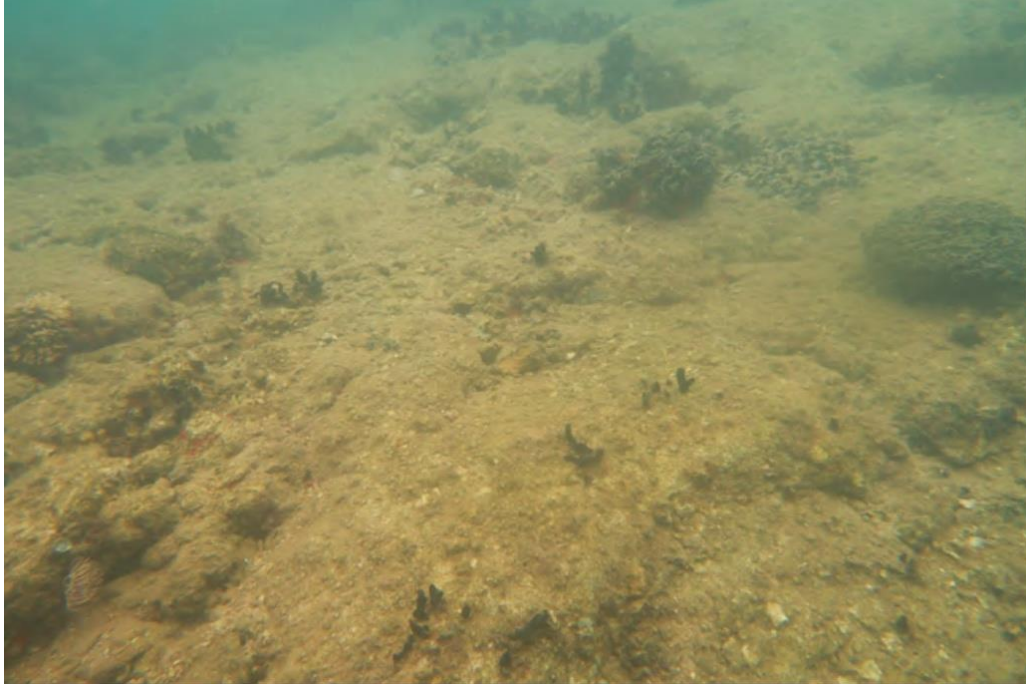
Figure 12. Example of the top of the eastern spur; depth at time of photo approximately 2 ft.

Tops of the natural limestone rock spurs were found in < 5 ft (1.7 m) of water, with significant portions exposed to the air, or awash during low-low tidal cycles (Figure 12). At the end of the quay, the top of the natural rock spur is covered with numerous, large pieces of concrete that are subaerially exposed (Figure 13).

- Image 2480 detailed in Table 1..

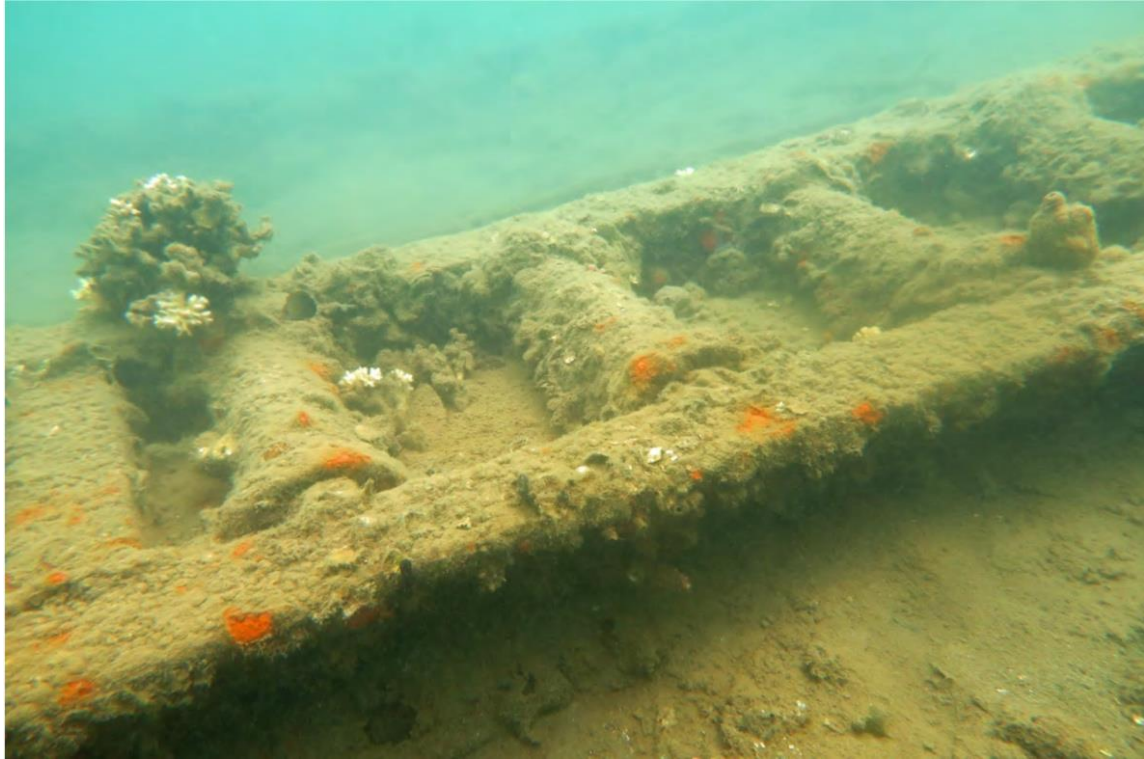
The second most substantial example of anthropogenic material is the concrete structure supporting the cog rail vessel launching and retrieval system (Figure 15). It extends from the shore to a depth of over 45 ft (15.7 m; Figure 13).

- Image 2400 detailed in Table 1..
- The concrete base extends down the length of the western inlet.
- Transects R1, R2, R3 completed on the cog rail.

Figure 15. Section of the cog rail on its concrete base.

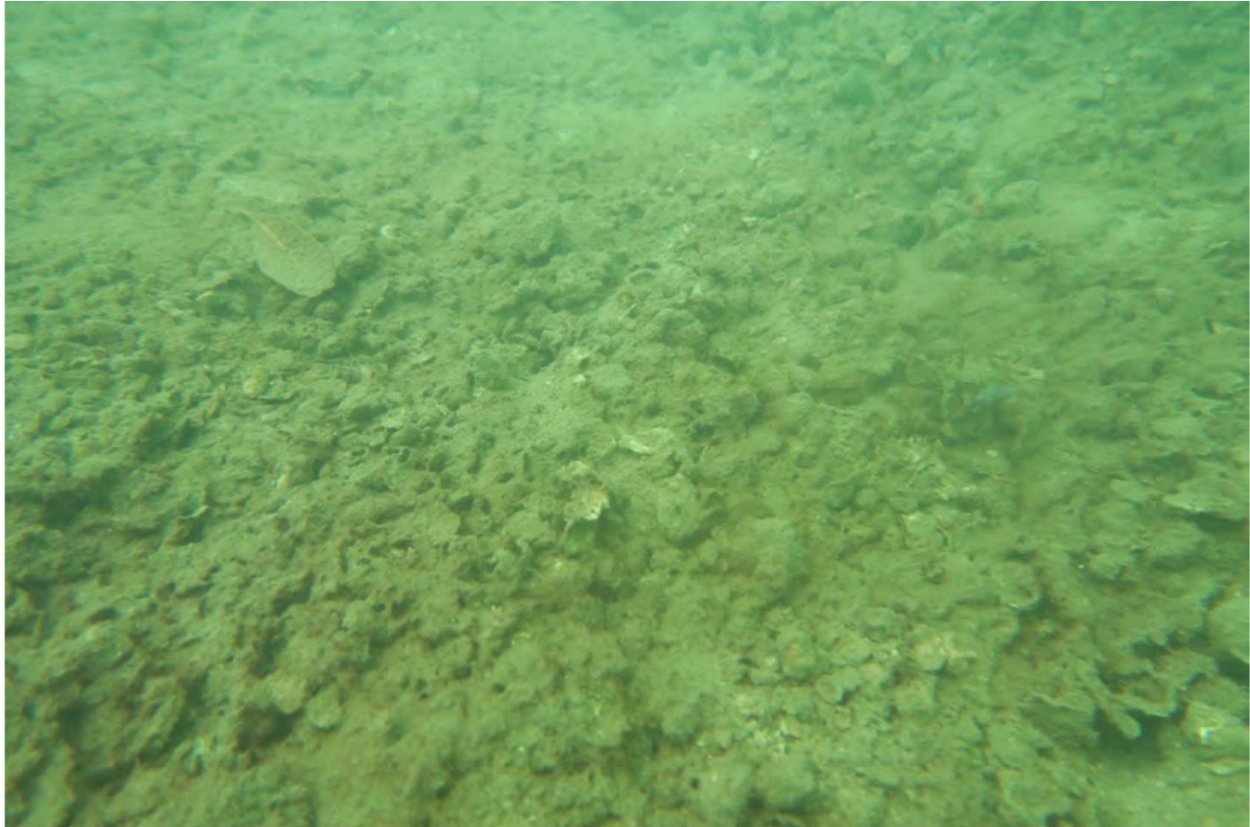
Figure 18. Another example of a rubble slope in the project area, depauperate of living organisms.

Rubble slopes occurred in some areas between the rock spurs and fine sediments on the inlet floors. The rubble slopes were relatively depauperate of macroscopic sessile benthic organisms (Figures 10, and Figure 18), and thus were not surveyed for quantitative or georeferenced data collection.

- Image 2408 detailed in Table 1.

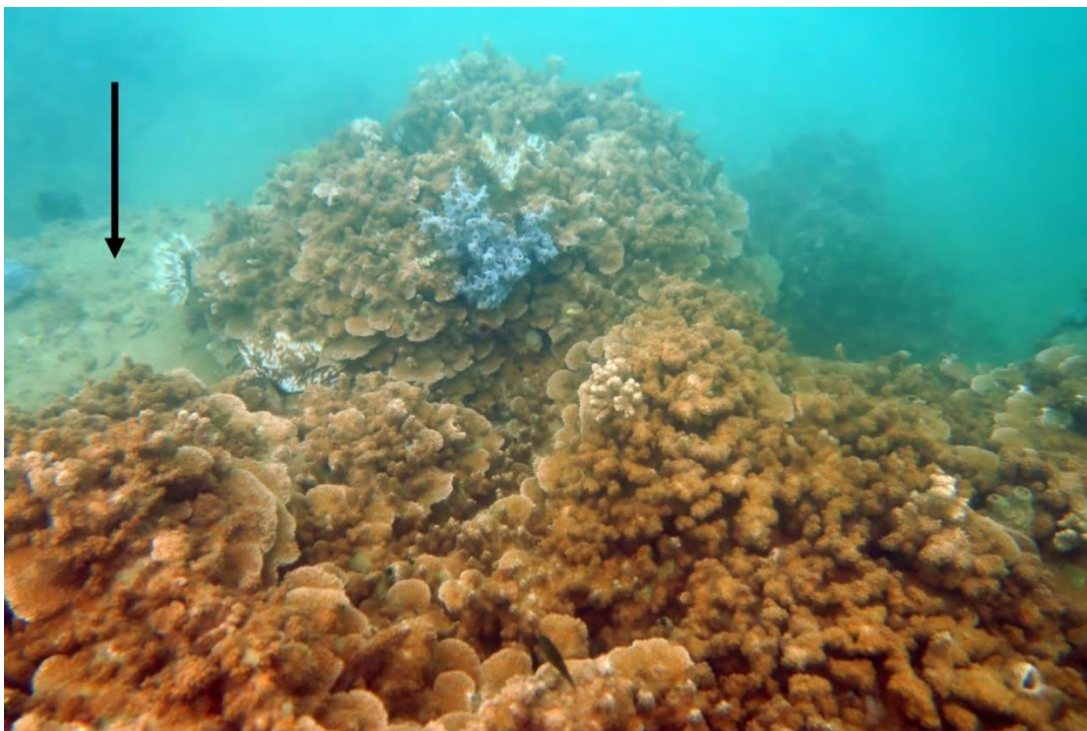
Figure 20. *Montipora capitata* colony/complex, growing on a concrete block.

Most of the larger concrete blocks support sponges and some support scleractinian corals. The largest complex of Rice Coral (*Montipora capitata*) observed was located on such a block along the western edge of the western inlet; it measured 2.5m in its maximum dimension (Figure 20). Other debris items, such as chairs, bicycles, tires, and I-beams are also heavily fouled. Especially when debris items are found on the unconsolidated sediments that make up most of the project site, as they provide hard substrate onto which habitat-forming organisms such as corals and sponges prefer to settle. An interesting observation is that old bottles observed at the site, and at other locations around the harbor, appear to be a preferred substrate for *Leptastrea purpurea* colonies to settle (Figure 21).

- Concrete block denoted by arrow, measured 2.5 m in its maximum dimension.
- Location: western side of the western inlet.

Two *Montipora capitata* coral patches were also identified; the largest colony/complex (shown in Figure 20) was just landward of the end of transect 4 (M1, Figure 26; see Figure 9 for transect locations). This colony/complex was approximately 2.5 m in its maximum dimension. At the seaward end of the eastern spur between 30 and 40 ft deep, a number *Montipora capitata* colonies were grouped together (M2, Figure 26). The four largest colonies each measured 30cm in their maximum dimension.

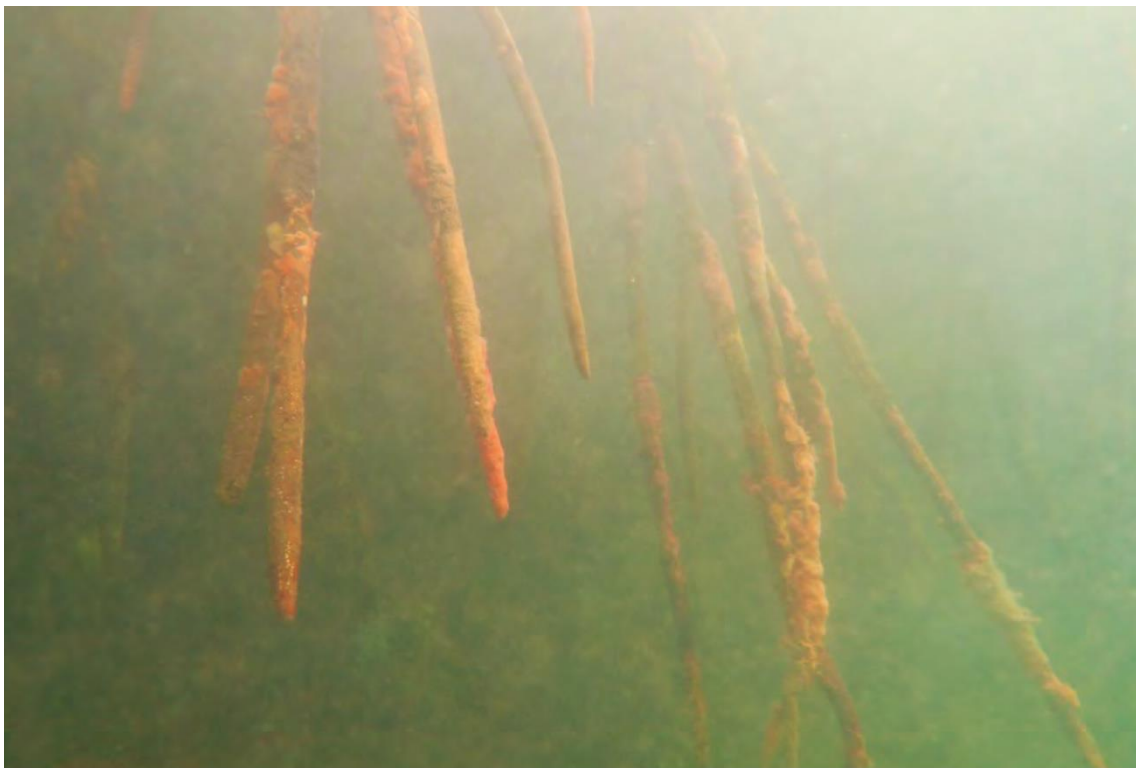
Figure 28. Mangrove roots from *Rhizophora mangle* on the western side of the western inlet.

In addition to several mangrove propagules that were sighted in the sediment at the landward heads of both inlets, there was a small area in which mangrove roots from *Rhizophora mangle* overhung the western side of the western inlet (Figures 26, 28).

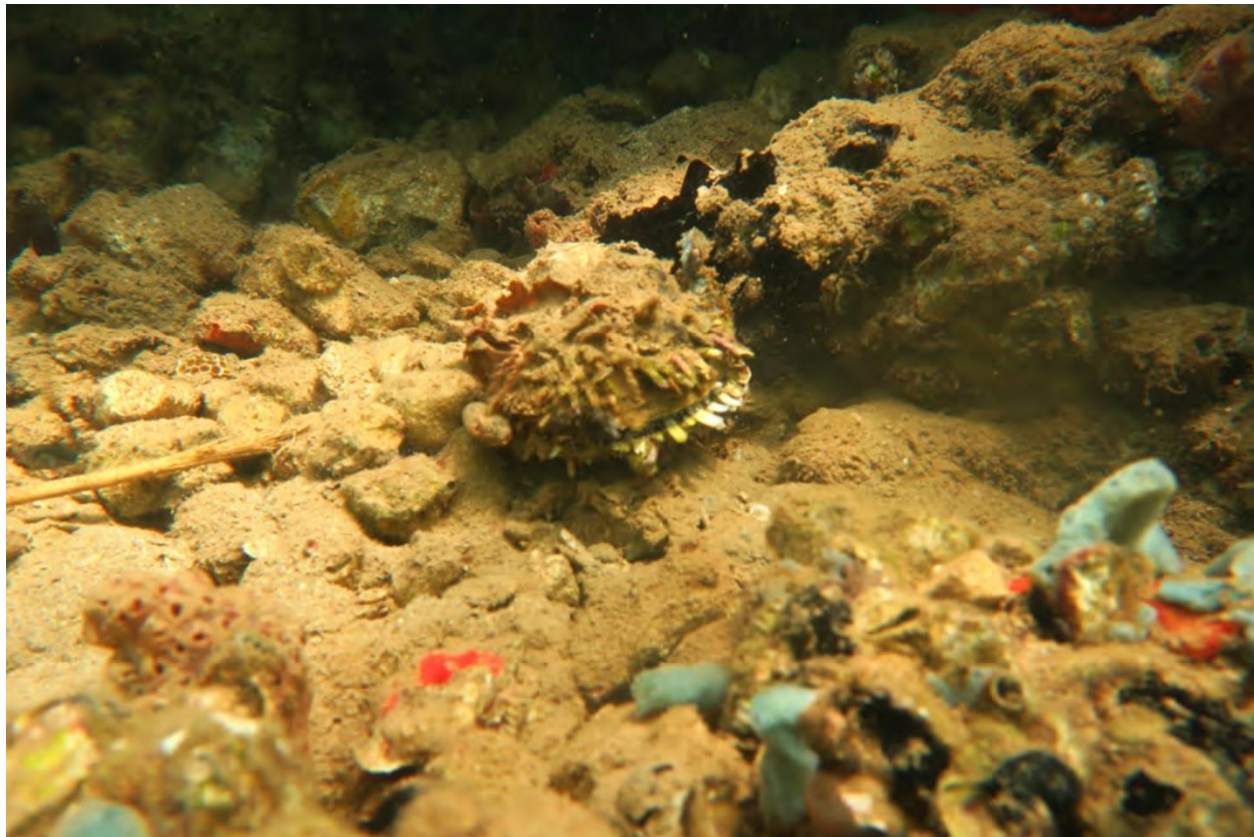
Figure 31. Pearl oyster observed on the eastern spur.

There were 2 species of large oysters within the survey area, based upon field level identification: the cliff oyster (*Spondylus violacescens*) and the black-lipped pearl oyster (*Pinctada margaritifera*). Other smaller, unidentified oysters and bivalve species were also present. Two pearl oysters were sighted during the initial reconnaissance surveys: one at the west/southwest end of where Transect 1 was later conducted at a depth of approximately 18 ft (6.3 m), and the other near the far tip of the Western spur at about 35 ft (12.2 m). A third pearl oyster was seen and photographed during the habitat quantitation dives on the east side of the quay wall (Figure 31). One of the pearl oysters was measured at 24cm across. The locations of these observations, as well as one of the cliff oysters that was photographed, are noted on Figure

- Image 3423 detailed in Table 1.

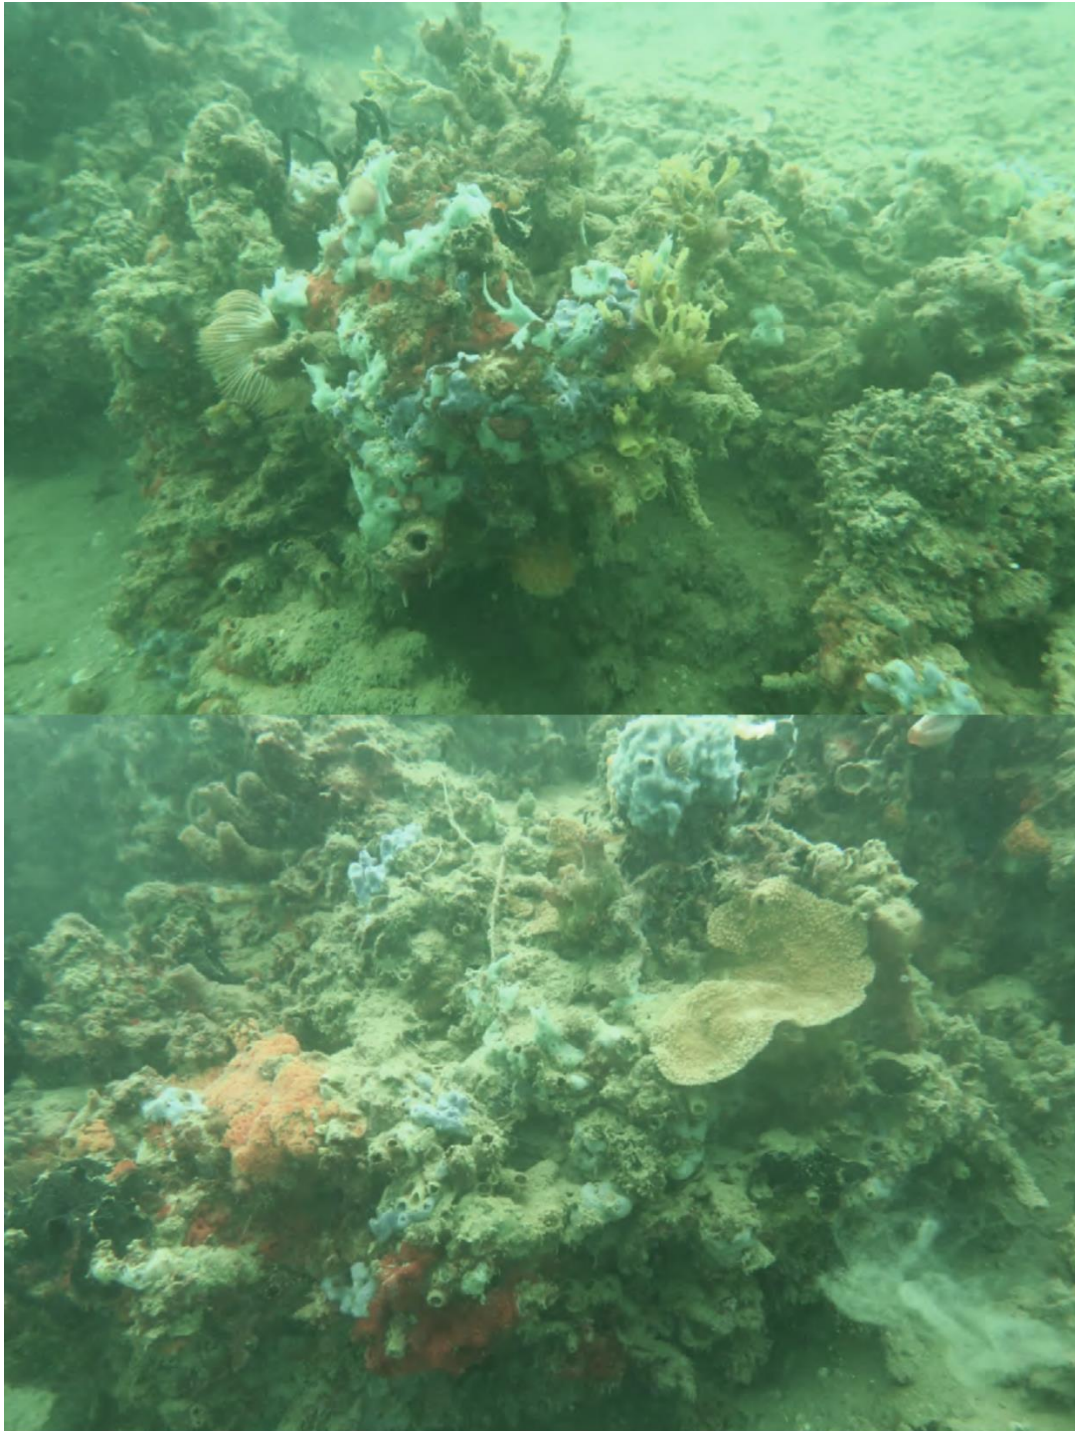
Figure 32. Examples of the diverse invertebrate communities observed at the project site.

The sponge fauna at the quay wall site is quite diverse, as was the polychaete community (Figure 32). Identifying sponges to species requires sampling and microscopic identification of spicules. Numerous sea cucumbers from the family Synaptidae were sighted, field identified as the Conspicuous sea cucumber (*Opheodesoma spectabilis*; Figure 33).
