ARL-TR-9000 • JULY 2020

Comprehensive Assessment of Overall Quality of Several Specimens from an As-Cast FeMnAl Steel Alloy Ingot via X-ray Computed Tomography

by William H Green, Bryan A Cheeseman, Daniel M Field, and Krista R Limmer

Weapons and Materials Research Directorate, CCDC Army Research Laboratory

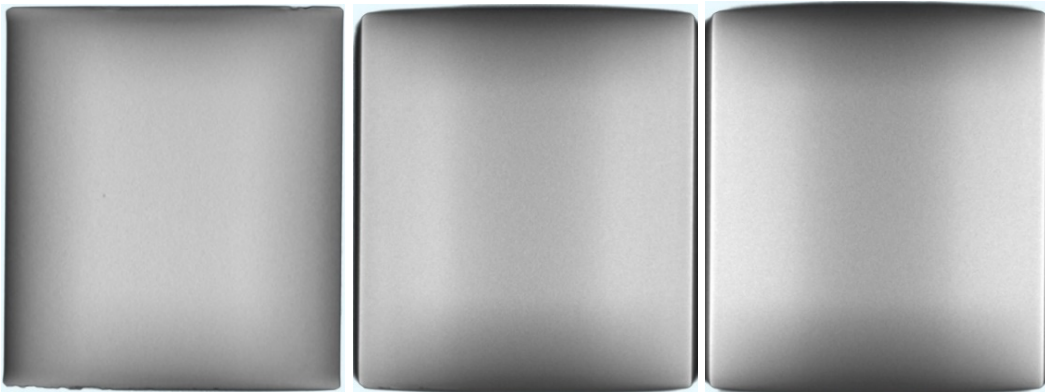
Fig. 3 Front views (76.2×76.2 mm/ 3×3 inches) just inside (i.e., 1 or 2 mm) the front surface, about one-quarter of the way through, and about halfway through the block on the left, middle, and right, respectively

As can be seen in Figs. 3–6, block A2 has very little detectable porosity or void content. The top-left image in Fig. 6 shows some porosity near the back of the block and a medium-sized void in the front-right area of the block. However, the front, side, and top view images without any discontinuity indications are much more typical of block A2.

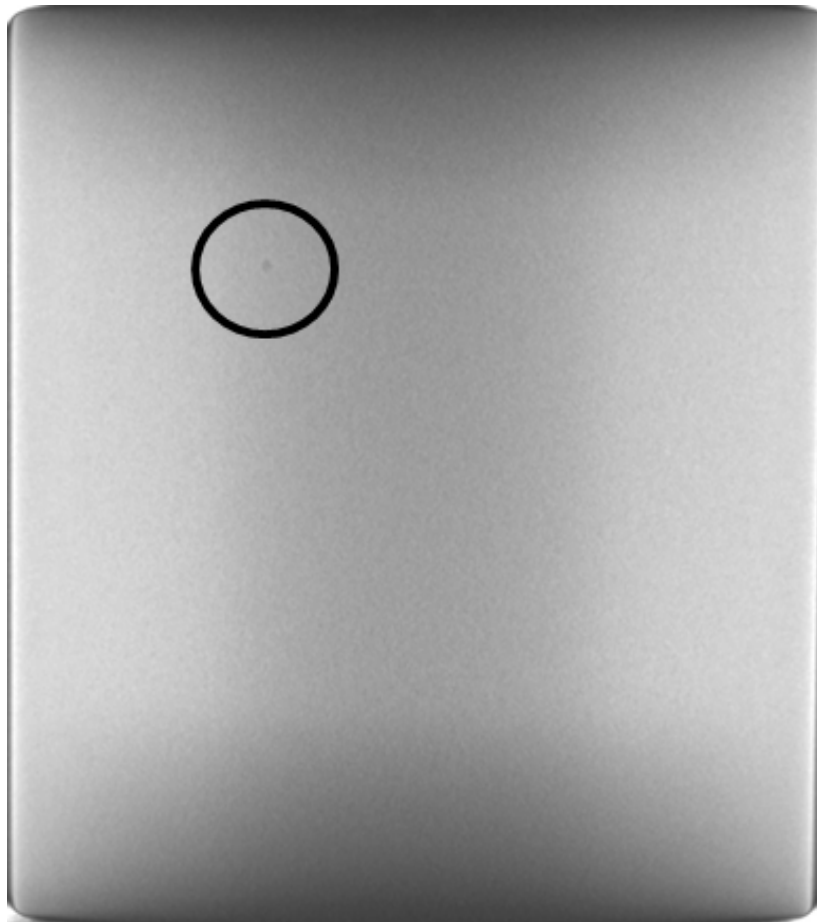
Fig. 4 Front view image of a small void indication (circled) in the interior of the block

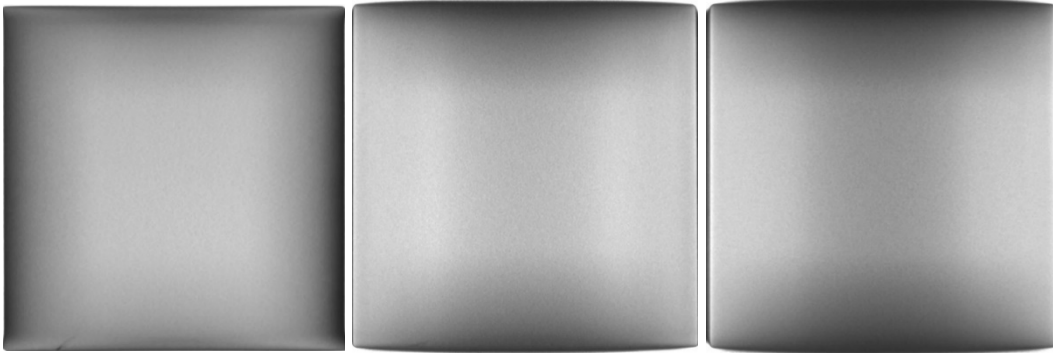
Fig. 26 Front views just inside the front surface, about one-quarter of the way through, and about halfway through the block on the left, middle, and right, respectively

As can be seen from Figs. 26–30, block B3 has no detectable porosity or voids and a small crack. Again, it is unknown if the crack or the full extent of it existed before the sectioning process. The crack is surrounded by black outlined boxes in the right image of Fig. 27 and the left image of Fig. 30 due to both its shortness and faintness. It is also boxed in the right image of Fig. 30. Block B3 is also missing material along one edge as shown in the images on the left in Figs. 27 and 28 on the right-hand side. The top-right image in Fig. 29 also shows missing material in the top-right corner.

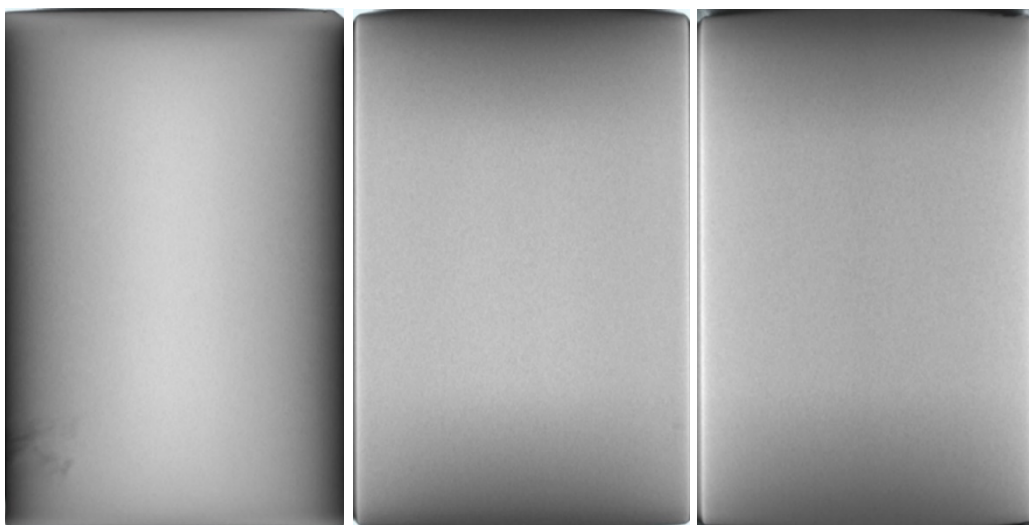
Fig. 33 Side views just inside the right-side surface, about one-quarter of the way through, and about halfway through the block on the left, middle, and right, respectively

As can be seen in Figs. 31–37, block B4 has some small void and crack content, with the crack starting on the outside of the block. It is unknown if the crack or the full extent of it existed before the sectioning process. The crack is surrounded by black outlined boxes in Fig. 37 due to both its shortness and faintness. Small void indications are shown and circled in Figs. 32, 34, and 36. Block B4 is the only B block without missing material along an edge or at a corner, and it does not have extensive porosity or void content. Blocks B1, B2, and B4 all have detectable small voids. Blocks B2, B3, and B4 all have a small crack, which may have been present in whole or in part before the sectioning process. Blocks B1, B2, and B3 are all missing expanses of material along an edge or at a corner. Block set B is considered to be of lower overall quality than block set A as determined by the number of detectable discontinuity features and their severity.
