NRL/MR/6138--20-10,198

# Effect of Surface Preparation Method on MIL-PRF-24667 Nonskid Performance

February 19, 2021

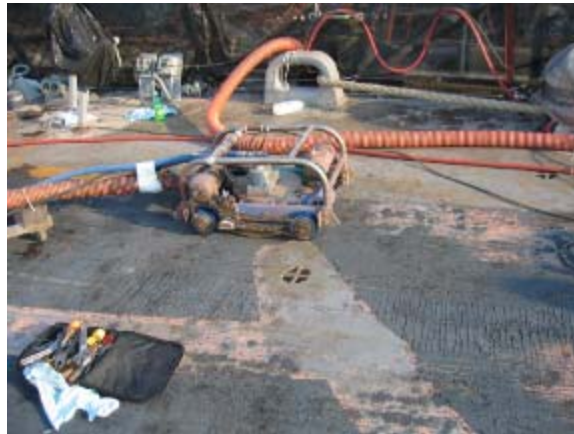
Figure 1 – Nonskid removal by UHPWJ on a flight deck

MIL-PRF-24667 [1] nonskid coating systems are applied to exterior and interior decks on US Navy (USN) surface ships and aircraft carriers to provide a slip resistant surface for aircraft and people. The coating system is comprised of an epoxy primer applied directly to the steel deck for corrosion protection and a tough nonskid top coat that can withstand mechanical damage caused by aircraft landing gear, safety chains, and the movement of equipment. The nonskid coatings are applied over steel and aluminum decks that are prepared by abrasive blasting, ultra-high pressure waterjet (UHPWJ) cleaning, or power tool cleaning. The type of surface preparation selected is typically dependent on the location on ship where the nonskid system is applied. For example, a flight deck can only be prepared by UHPWJ or abrasive blasting to ensure the nonskid coating system can withstand the rigorous environment of flight deck operations. The most common method of surface preparation across the USN Fleet is UHPWJ according to NACE/SSPC-SP WJ-2 [2] because it does not require expensive containment to protect nearby people and equipment during operation, it efficiently removes the old nonskid coating with minimal clean-up, and cleans the steel by removing chlorides and other contaminants. An example of UHPWJ equipment being used to remove nonskid on a flight deck is provided in Figure 1.

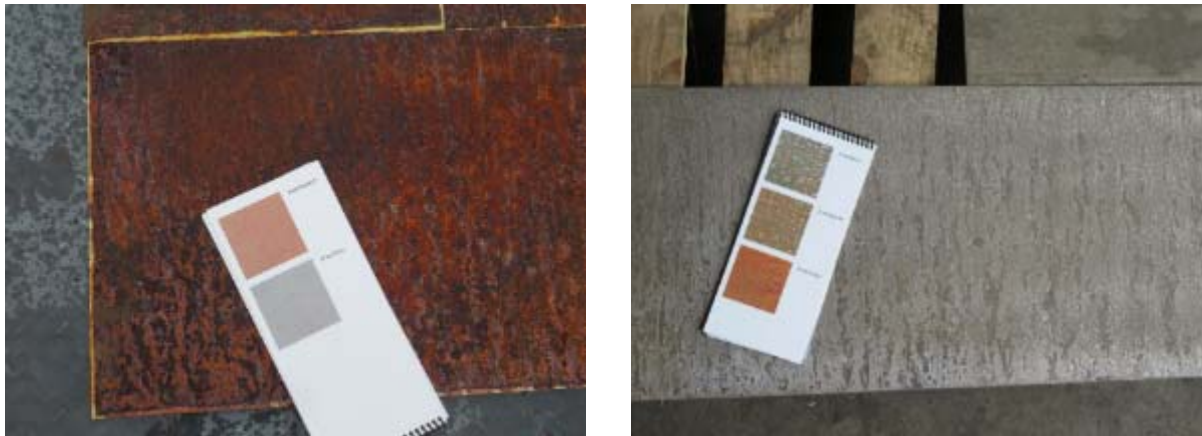
**Figure 2 – Test panel after salt spray (left) and after UHPWJ (right) to remove rust and chlorides**

After the test panels were cleaned by UHPWJ, the final surface preparation (step 6) was performed using a blast cabinet. Two different types of blast media were used for final preparation. 36 mesh aluminum oxide (AlOx) was used to produce the SP10 Grit and SP6 Grit surfaces, and a 50/50 blend of S390/S550 steel shot was used to produce the SP10 Shot surfaces.

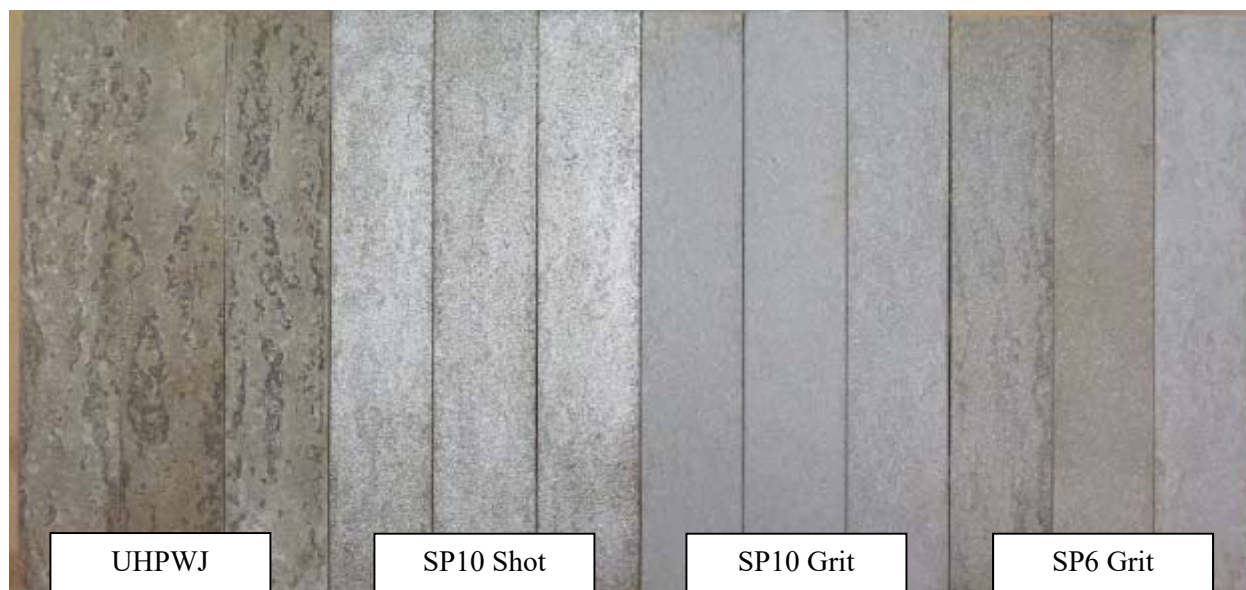
Figure 3 – Images of final surface preparation for test panels

Images of three 2"x12"x0.125" test panels for each surface condition after final surface preparation are provided in Figure 3. The black staining that developed during the pre-weathering step could not be removed by UHPWJ. The SP10 Shot and SP6 Grit panels had faint shadows of the black staining that remained on the surface, whereas the black staining was mostly removed on the SP10 Grit test panels. Light flash rust also developed on the surface of the test panels after UHPWJ. The flash rust was partially removed when the panels were prepared by SP6 Grit, and completely removed by the SP10 Grit and SP10 Shot surface preparation methods; close-up images of the test panel surfaces are provided in Figure 4.

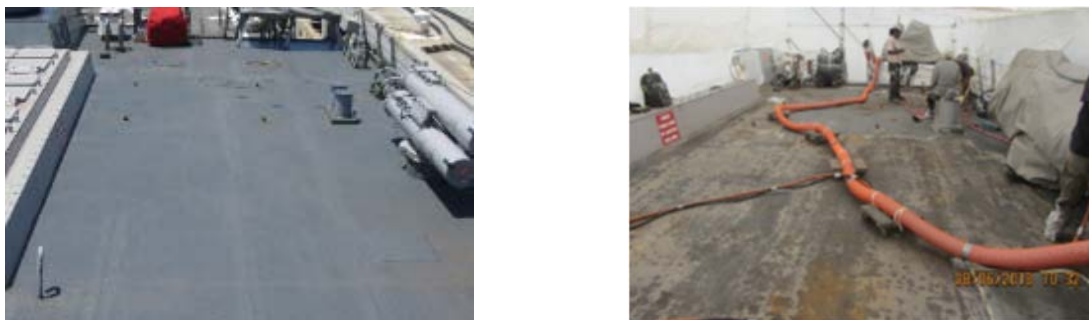
**Figure 5 – Initial condition of DDG missile deck (left) and after UHPWJ (right) to remove nonskid coating**

The nonskid coating was removed using a combination of UHPWJ and power tools and revealed a severely pitted and stained steel deck, as seen in Figure 5.

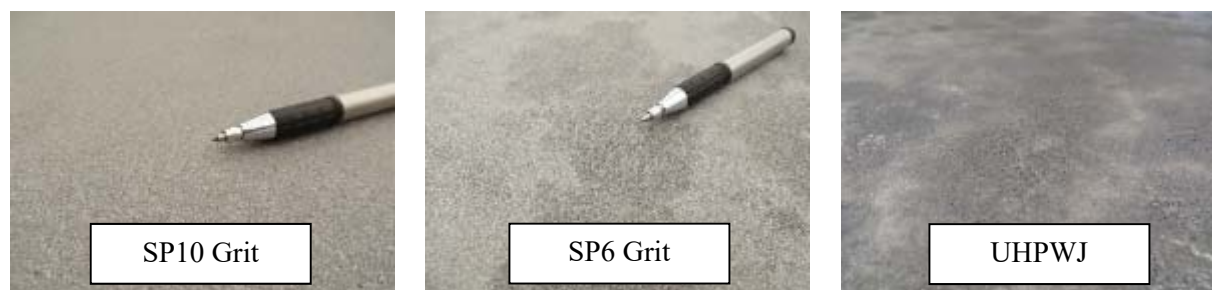
Figure 7 – Close-up images of each surface condition on the DDG missile deck

Images of each final surface condition for sections 1, 2, and 3 are provided in Figure 6. Similar to the test panels, there is more black staining associated with the SP6 Grit and UHPWJ surfaces, while only faint shadows in the SP10 Grit surface. The flash rust was heavier in section 3, where UHPWJ was the final surface preparation; close-up images are provided in Figure 7.

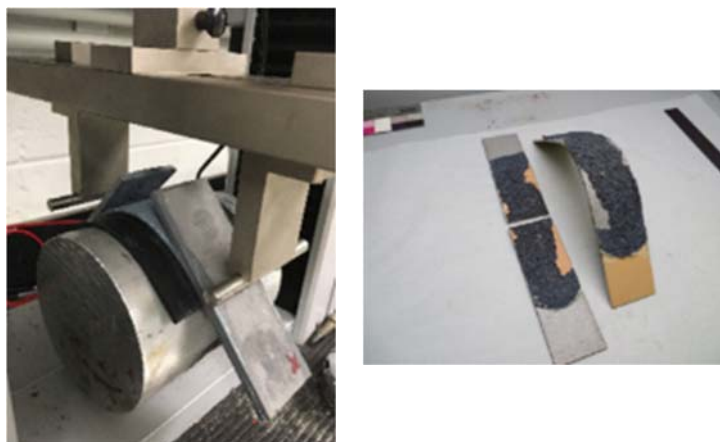
**Figure 9 – Peel resistance test setup (left) and test panel after the mandrel bend (right)**

The nonskid peel resistance test is a custom test developed by NRL that uses a 5" mandrel to mechanically bend the nonskid panel that has two 2"x6"x1/8" peel tabs adhered to the nonskid surface using a toughened epoxy adhesive to create a sandwich panel. During the test, the sandwich panel is bent around a mandrel and the peel tabs begin to separate such that the panel/coating stack-up will begin separating at the weakest layer. A picture of the test setup and an example of a bent nonskid panel with the peel tabs separated after the peel resistance test is provided in Figure 9.

Pictures of the peel resistance test panels have been provided in Figure 21 – Figure 24. The pass/fail criteria established was nonskid system shall not delaminate from the substrate when a peeling force was applied using the test setup previously described. Notably, Nonskids A, B, and C were all composition D nonskid coatings, meaning they were formulated with a lightweight aggregate package, such as glass or plastic; whereas Nonskid D was formulated with the traditional Composition G aggregate, aluminum oxide. During the peel test, Nonskids A, B, and C failed cohesively within the nonskid layer of the sandwich panel, and it was noted that there were loose glass and/or plastic particles that could be easily brushed from the nonskid layer that was split in half (i.e., half the nonskid layer remained adhered to the bend panel and the other half remained adhered to the peel tab, as represented in Figure 9).

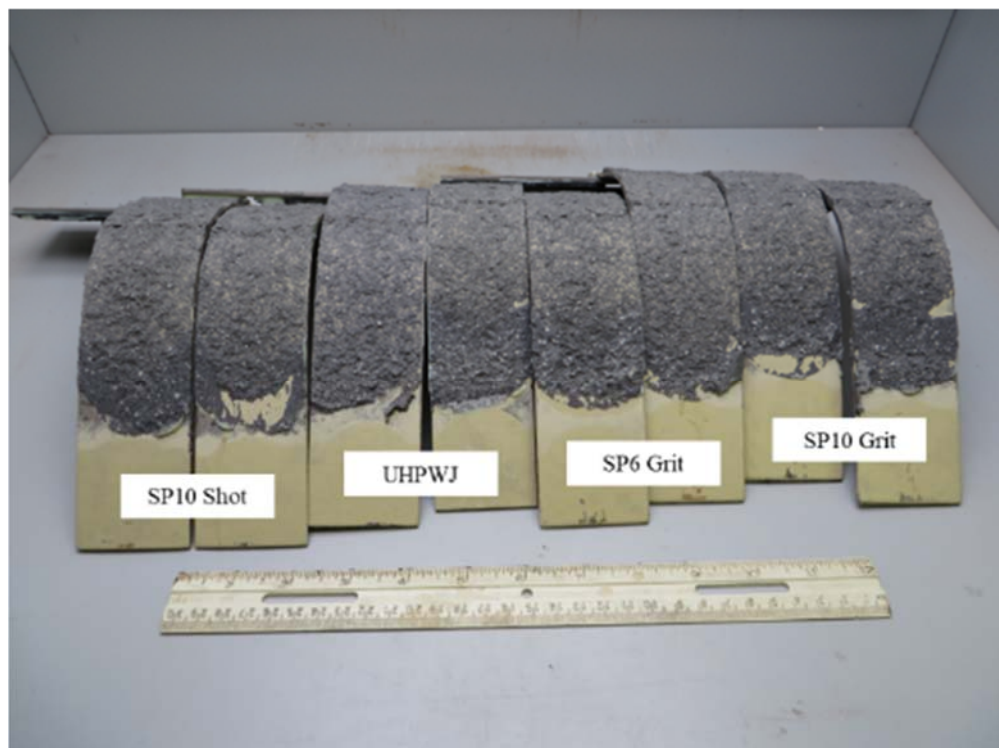
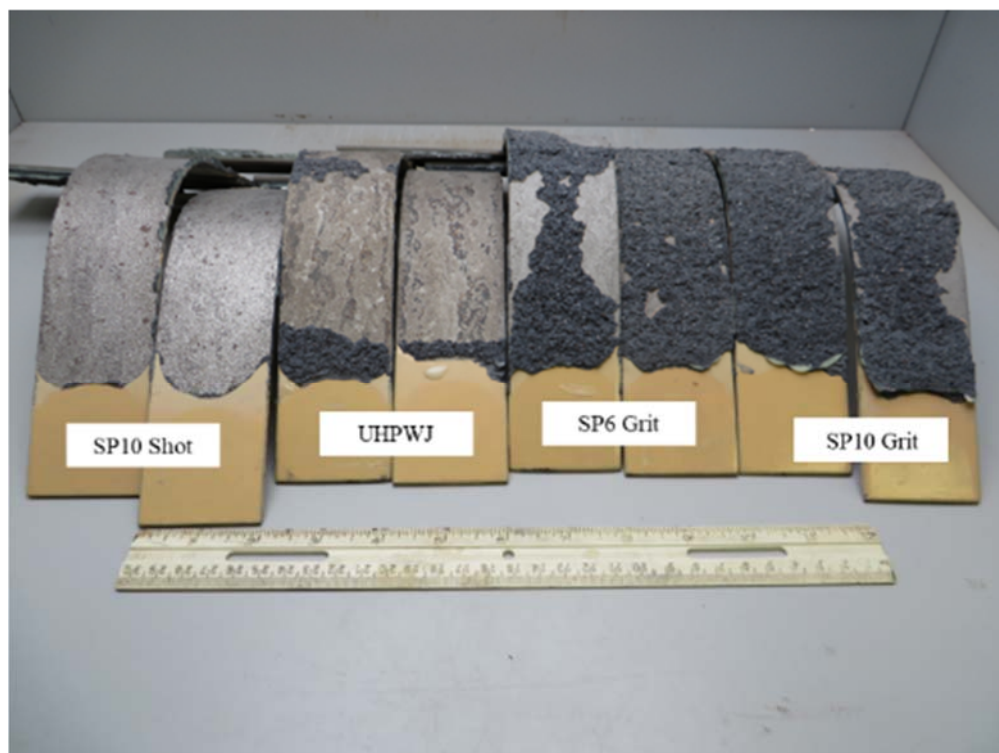
Figure 21 – Peel resistance results for Nonskid A

Figure 22 – Peel resistance results for Nonskid B

**Figure 23 – Peel resistance results for Nonskid C**

**Figure 24 – Peel resistance results for Nonskid D**

Because the cohesive strength of the nonskid layers for Nonskids A, B, and C were low, the substrate/primer interface was never stressed to the point that a proper evaluation could be made regarding the adhesion of the nonskid system to the various surface preparation methods. However, for Nonskid D, the cohesive strength of the composition G nonskid was greater, and the substrate/primer interface was stressed, which showed a clear trend regarding adhesion of the nonskid system applied over the various surface preparation methods. For Nonskid D, the nonskid system had the worst adhesion over SP10 Shot, followed by UHPWJ, SP6 Grit and finally SP10 Grit.

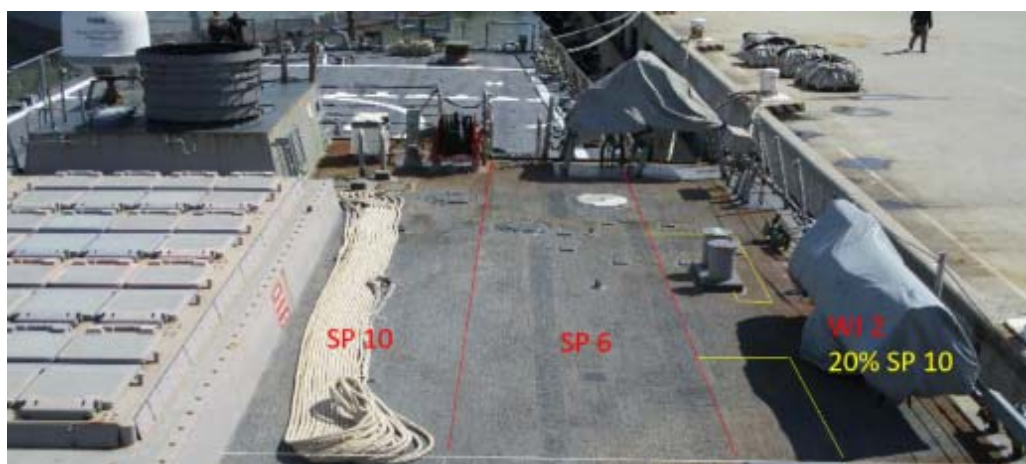
Figure 40 – 19 month follow-up inspection of the shipboard nonskid test on a DDG missile deck

A follow-up inspection of the demonstration areas on the missile deck of a DDG was performed on 24 March 2020, 19 months after the original installation; an overall picture of the deck condition is provided in Figure 40, and close-ups are provided in Figure 41 – Figure 43. Overall the condition of the deck was very good. All demonstration sections had rust staining from adjacent bulkheads, foundations, or access covers where applicable. Some severe staining and surface rust “build up” was evident in isolated areas; potentially caused by repair work (metal shavings) and poor drainage. It was difficult to evaluate the adhesion of the nonskid coating in the three different sections, but gentle probing did not indicate any nonskid failure, and there was no underlying corrosion or bleed through. Some spot repairs were made in the SP6 Grit section but it was likely caused by mechanical damage that occurred during the shipyard availability.

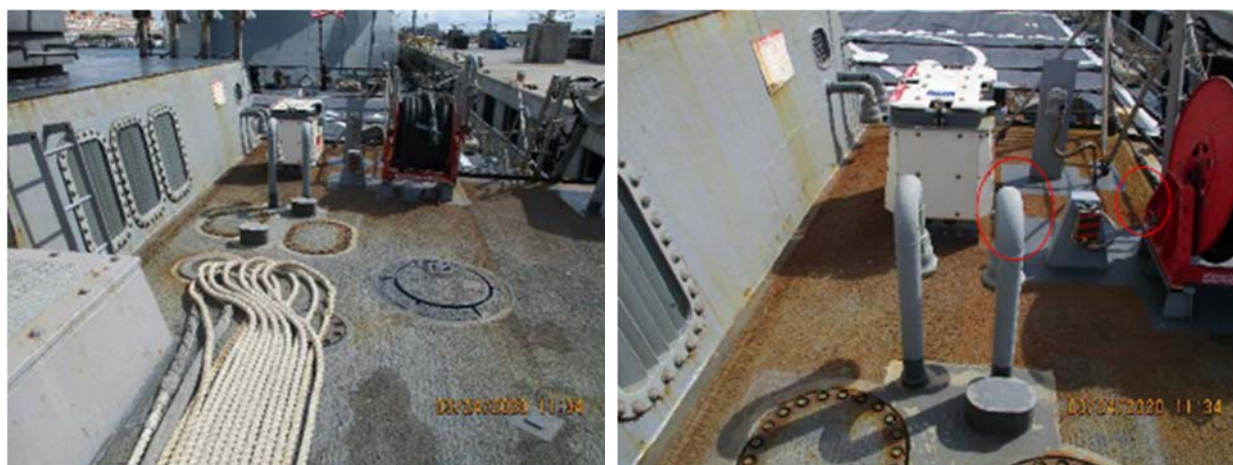
**Figure 41 – Close-ups of section 1 that received 100% SP10 Grit surface preparation of the deck and appendages**

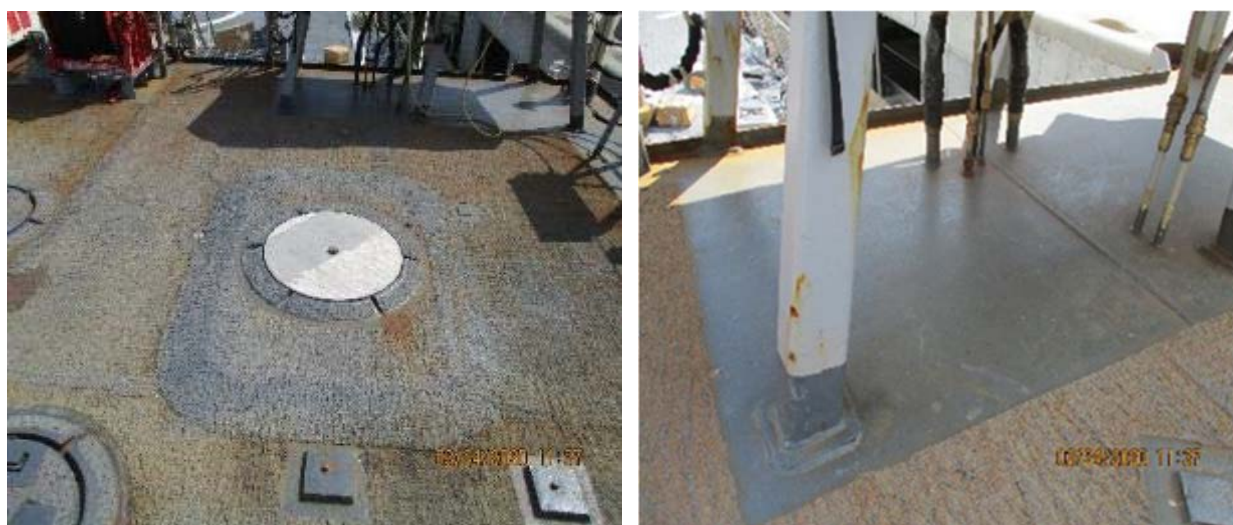
**Figure 42 – Close-up of section 2 that received 100% SP6 Grit surface preparation of the deck and appendages**

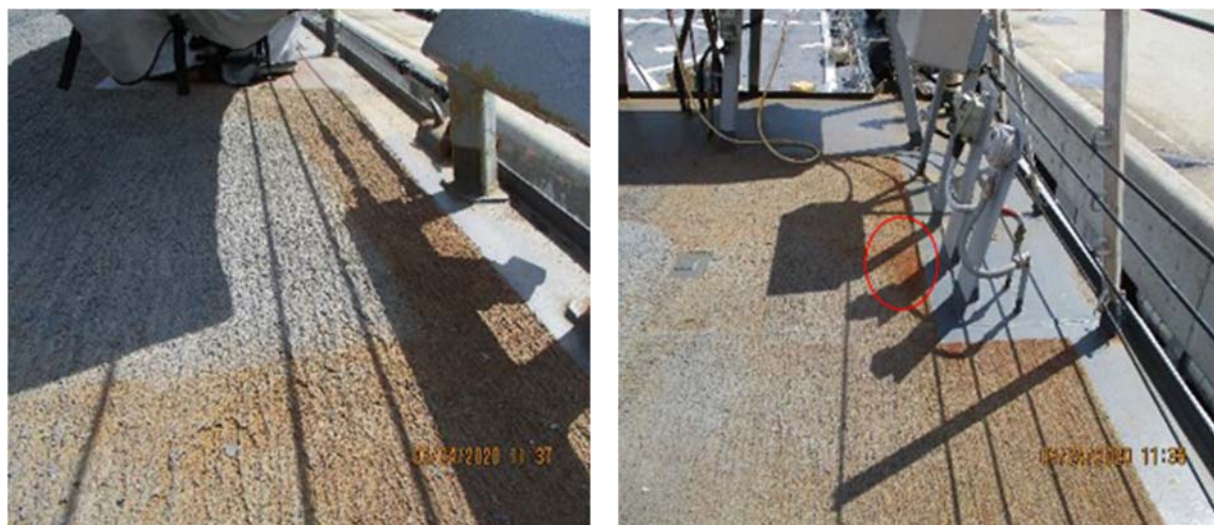
**Figure 43 – Close-up of section 3 that received 20% SP10 Grit/80% UPHWJ surface preparation of the deck and power tool cleaning of deck edges and appendages not accessible by UHPWJ**
