Camp Perry Historic District Landscape Inventory and Viewshed Analysis

Final Technical Report (TR)

Under Project 467080, "Camp Perry, OH Hist Dist Boundary Review and Viewshed Analysis"

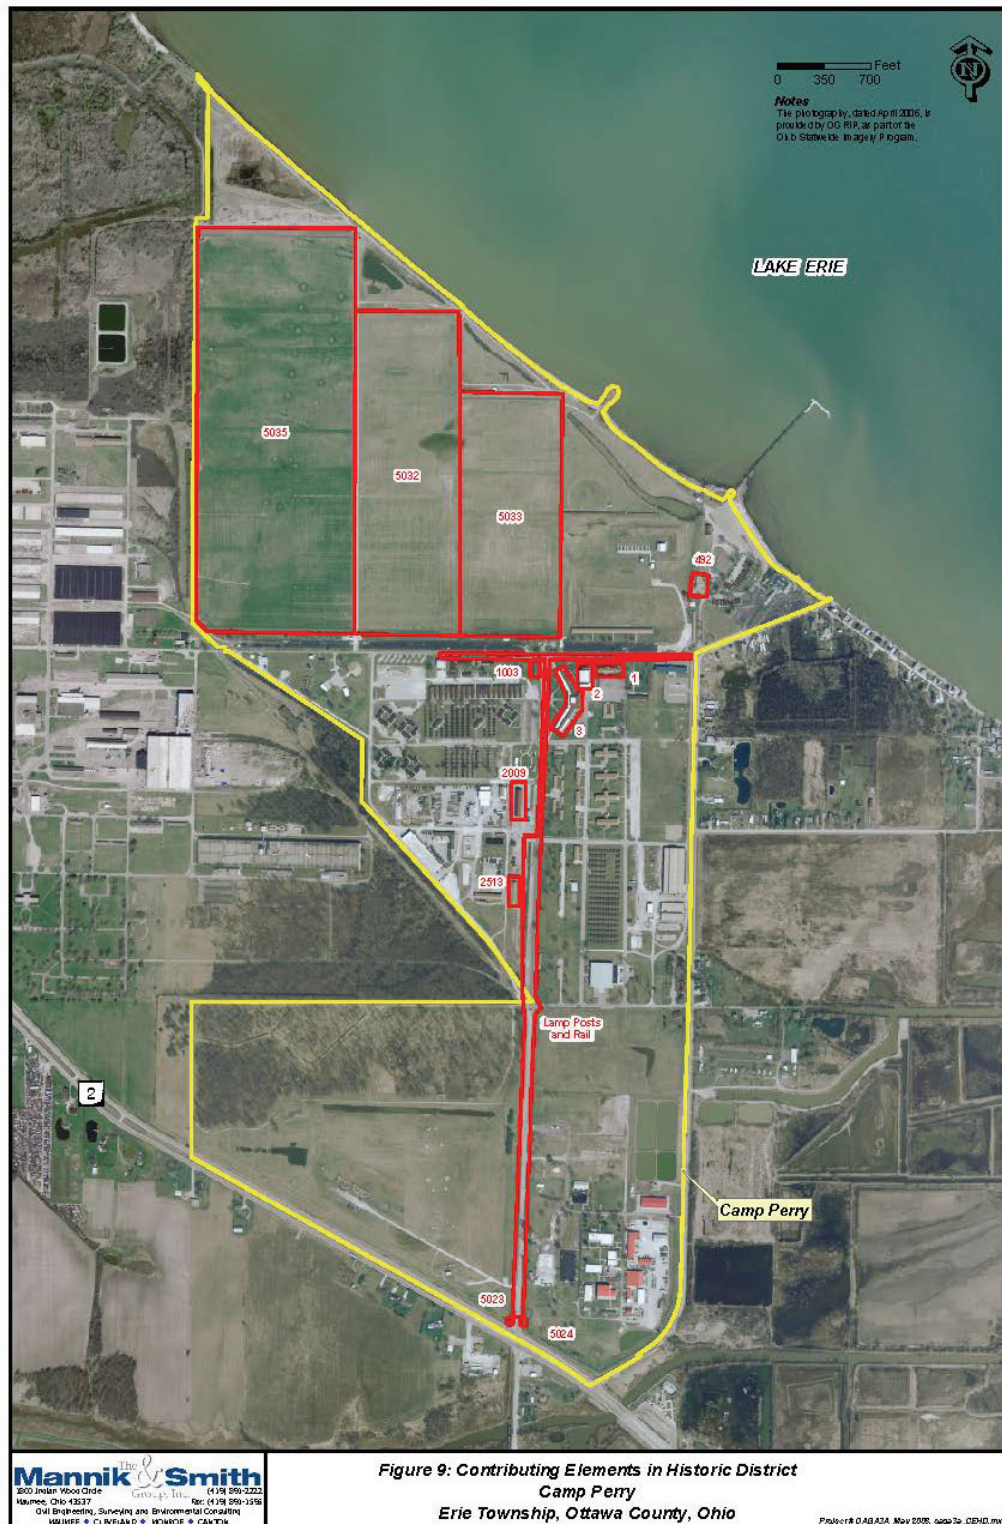
Figure 2. Initially proposed discontinuous historic district boundaries and contributing resources, 2008 (courtesy of Mannik & Smith).

Initial correspondence from the SHPO (3 December 2008) requested the OHARNG reconsider the proposed historic district boundaries (Figure 2). The SHPO felt that the boundaries should be larger than proposed, and that

Range 5031 (Petrarca Range) should be included as a contributing resource. The SHPO also felt that the boundary needed to encompass the areas of hutments on the east and west sides of Niagara Road because they contribute to the broader setting and sense of place as well as to the overarching spatial organization of Camp Perry. Figure 3 shows the revised historic district boundaries and the addition of Range 5031 as a contributing resource to the historic district. A letter from the SHPO, dated 26 August 2009, concurred with the new boundaries of the Camp Perry Historic District.

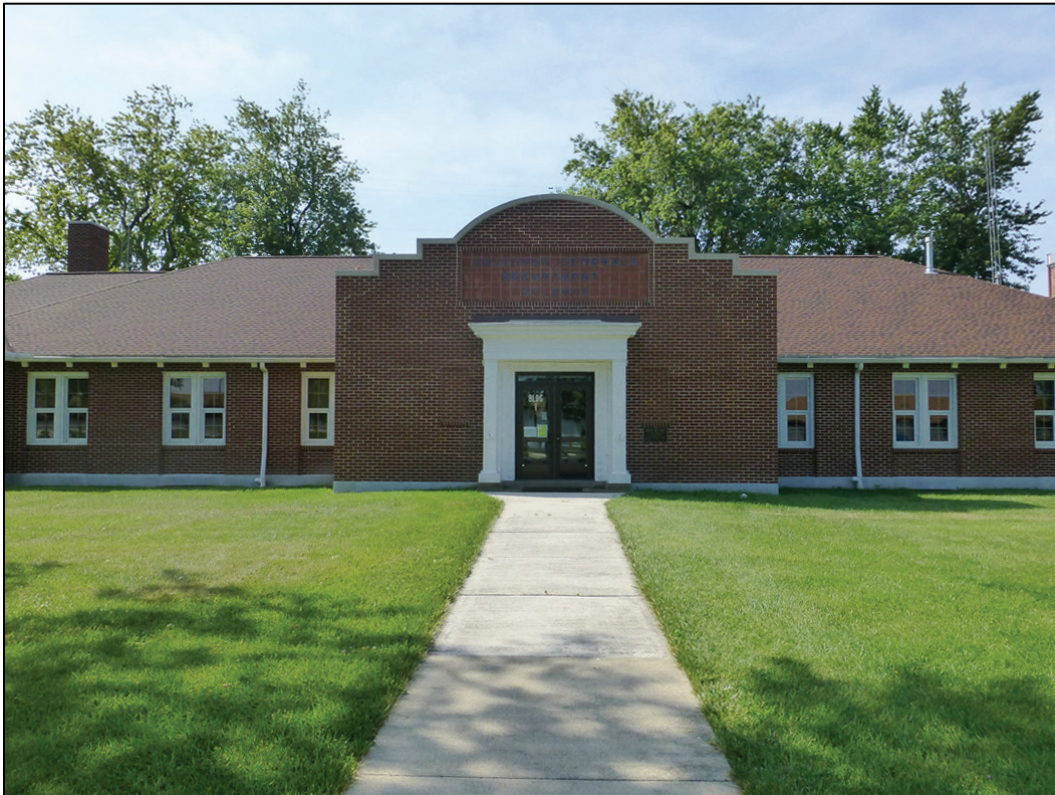
Figure 5. North side of Building 1 (ERDC-CERL 2017).

in 2008 by MSG. Rehabilitation was completed on Building 1 in 2013 in accordance with the Secretary of Interior (SOI) Standards for Treatment of Historic Properties (SOI Standards; Weeks and Grimmer 1995) and in consultation with the SHPO. Rehabilitation included a new roof, replacement of the skylight and windows, and masonry cleaning and repairs. The current headquarters building is pictured in Figures 5 and 6.

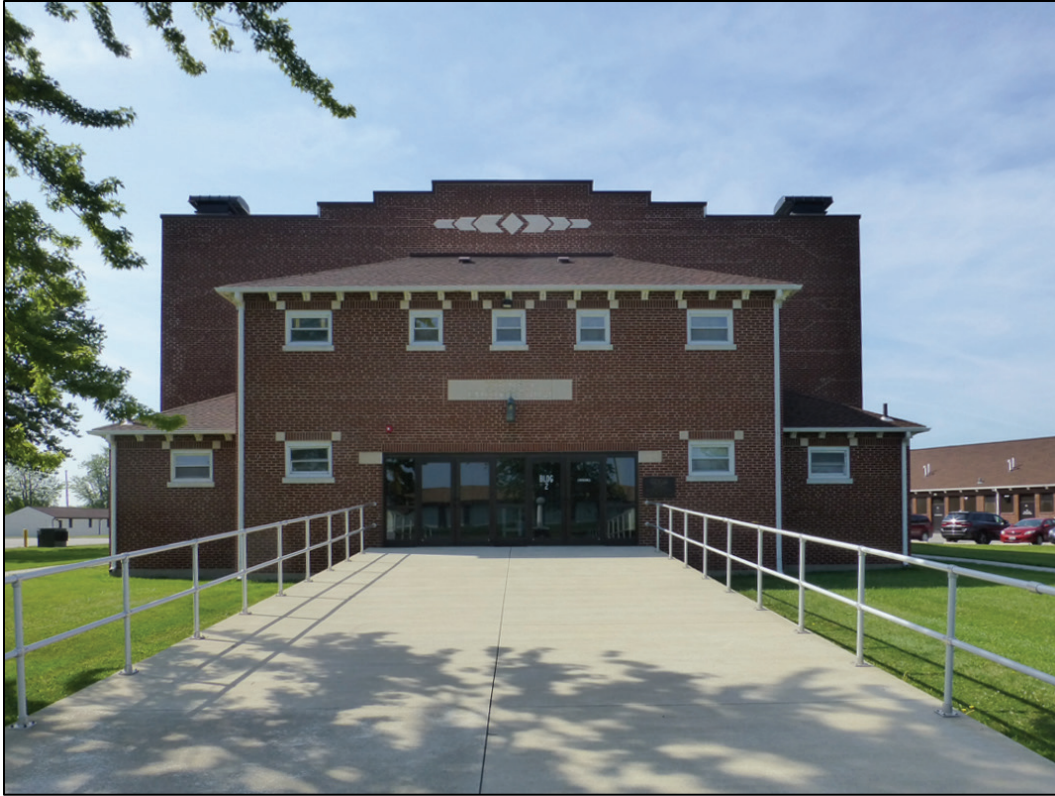
Figure 7. North side of Building 2 (ERDC-CERL 2017),

Building 2 (Figure 7) was constructed in 1937-38. It was initially documented on an OHI form in 1993 by McQuillin and Assoc. and recommended eligible in 2008 by MSG. Rehabilitation was completed on Building 2 in 2015 in accordance with the SOI Standards (Weeks and Grimmer 1995) and in consultation with the SHPO. Rehabilitation in 2015 included masonry cleaning and repairs. Additional rehabilitation was completed in July 2018 in consultation with the SHPO. Rehabilitation in 2018 included new windows and doors, repair and/or replacement of interior and exterior lighting, and renovation of the interior lobby and auditorium.

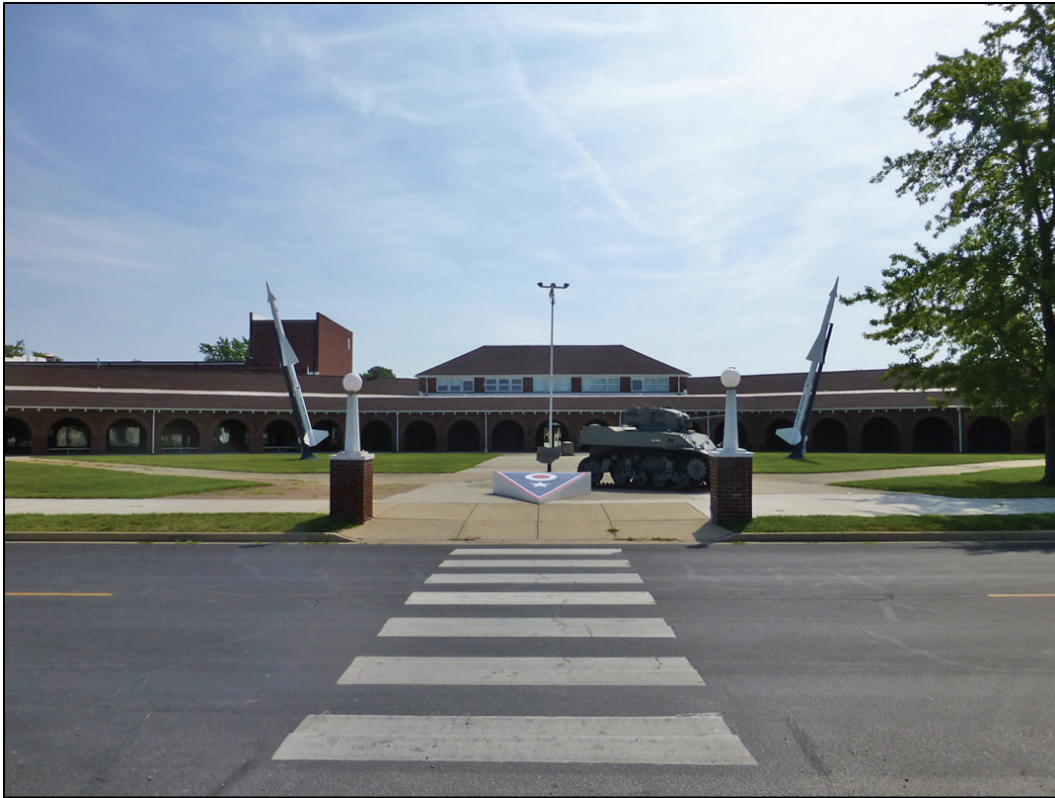
Figure 8. Looking east at Building 3 (ERDC-CERL 2017).

Building 3 was constructed in 1936. It was documented on an OHI form and recommended eligible in 2008 by MSG (Figures 8–11). Rehabilitation is planned for Building 3 in 2020 or 2021 to be consistent with the SOI Standards (Weeks and Grimmer 1995).

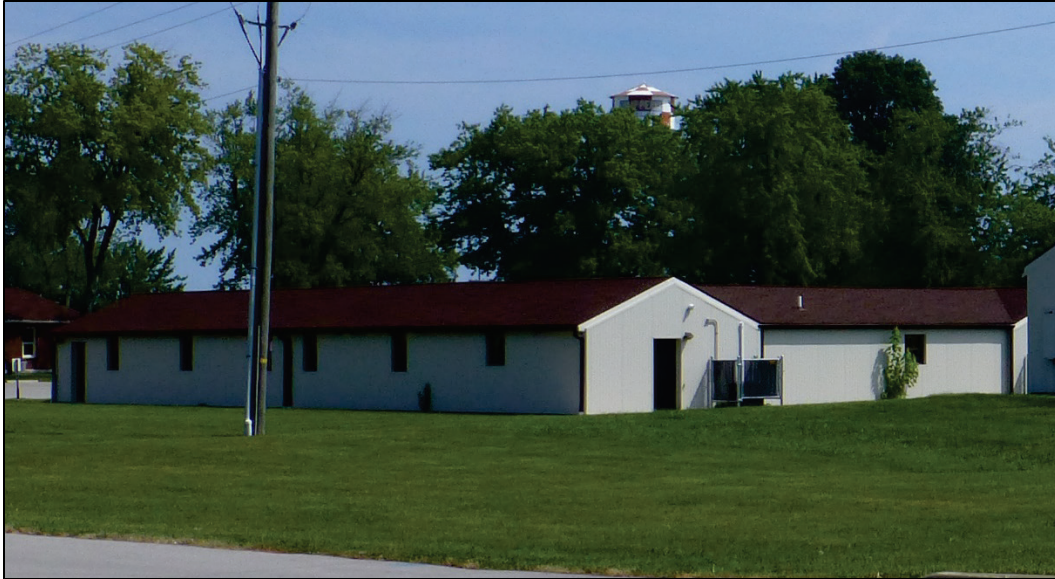
Figure 13. Northeast oblique of Building 5 (ERDC-CERL 2017).

Building 5 was constructed in 1942, documented on an OHI form in 1993 by McQuillin and Assoc., and recommended not eligible in 2008 by MSG. Building 5 was joined with Building 6 between 1960 and 1972 resulting in the current U-shape. It has been reclad with insulated steel siding and has new windows and doors (Figure 13).

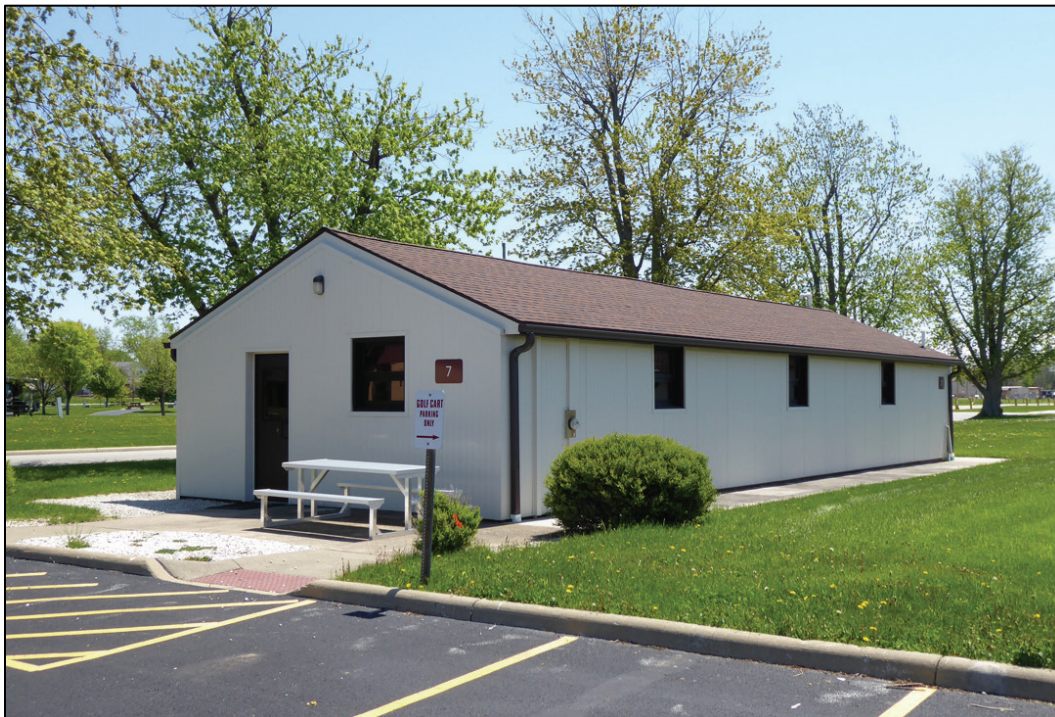
Figure 14. Southeast oblique of Building 7 (ERDC-CERL 2019).

Building 7 was constructed in 1942, and it was documented on an OHI form and also recommended not eligible in 2008. It has been re clad with insulated steel siding and has new windows and doors (Figure 14).

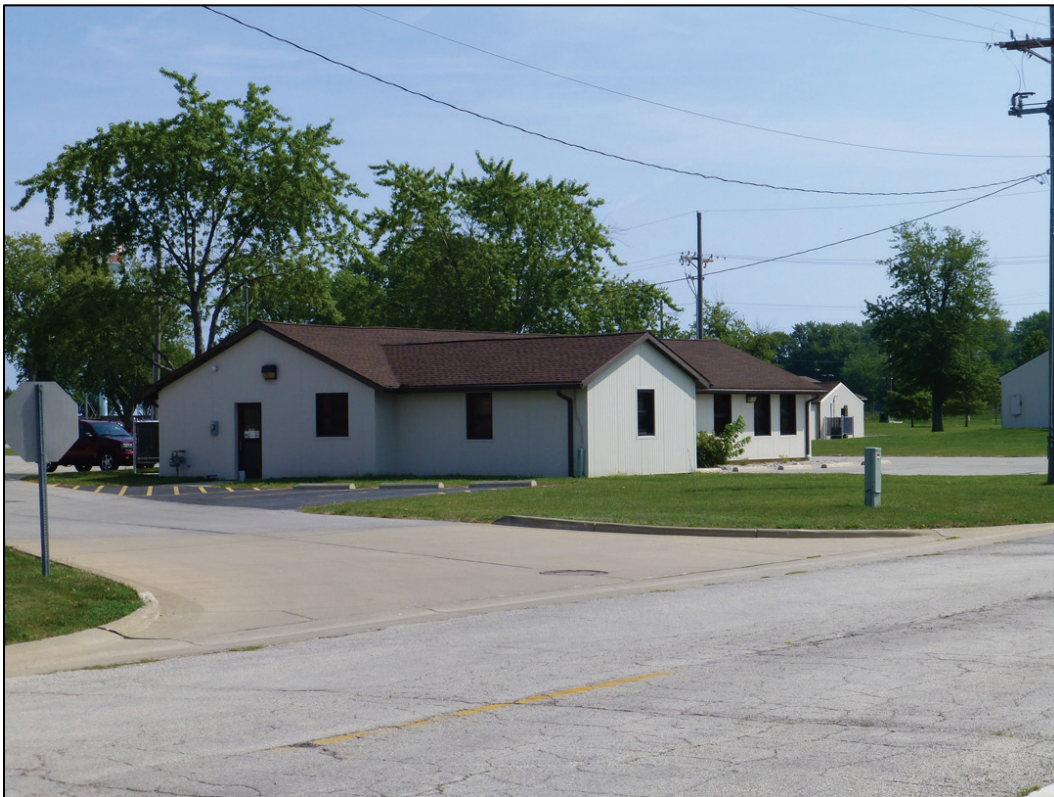
Figure 15. Looking northeast at Building 8 (ERDC-CERL 2017).

Building 8 was constructed in 1942, documented on an OHI form in 1993 by McQuillin and Assoc., and recommended not eligible in 2008 by MSG. It has been reclad with insulated steel siding and has new windows and doors (Figure 15).

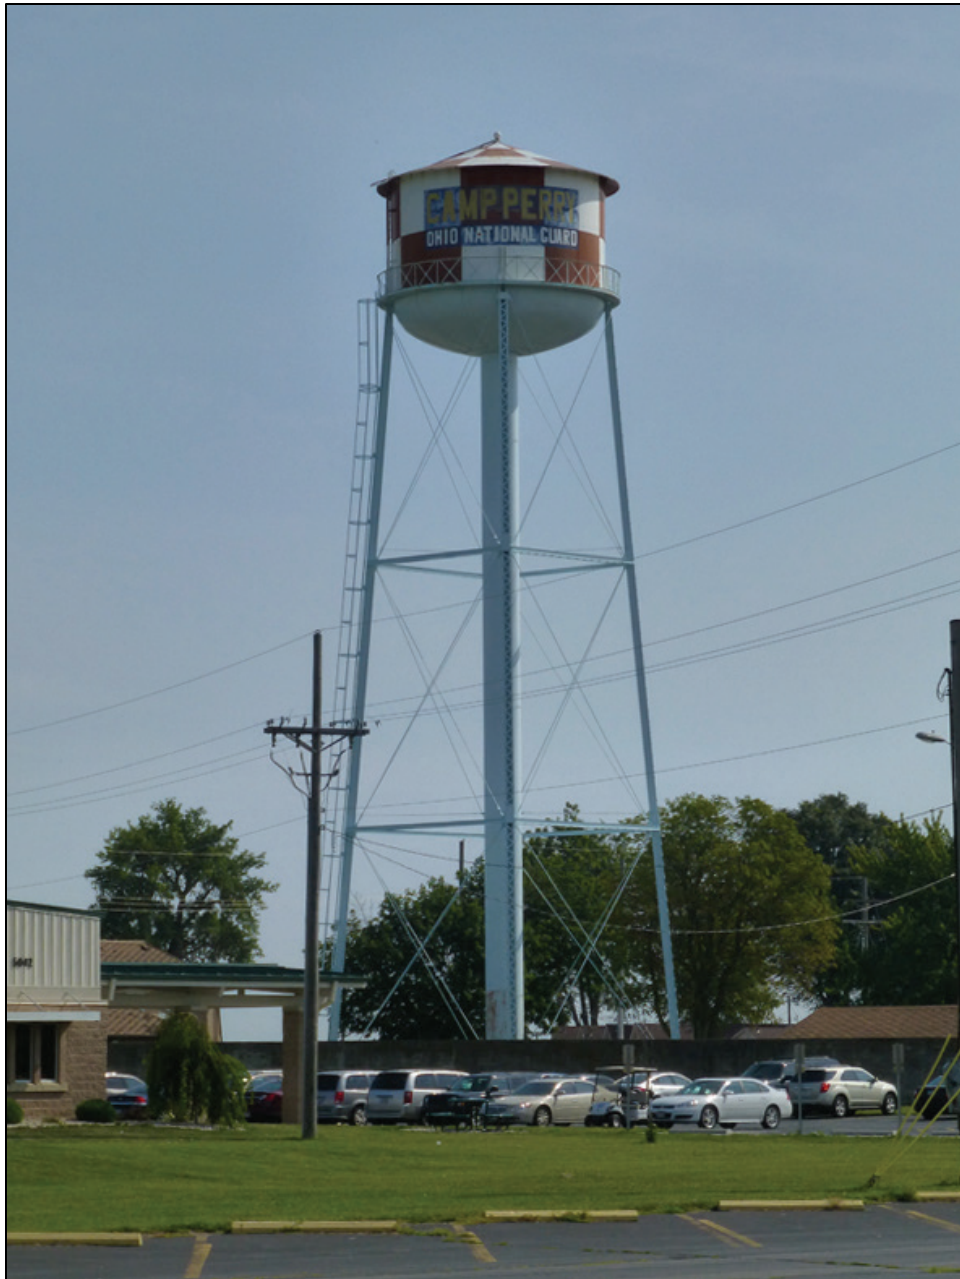
Figure 19. Looking north at Building 301 (ERDC-CERL 2017).

Building 301 was constructed between 1930 and 1937, documented on an OHI form in 1993 by McQuillin and Assoc., and recommended not eligible in 2008 by MSG (Figure 19). Although it was not initially recommended eligible, the Northern Water Tower will be preserved as stipulated in the MOA discussed in Section 2.10. This water tower represents the last extant component of the water treatment facility that has supplied water to Camp Perry.

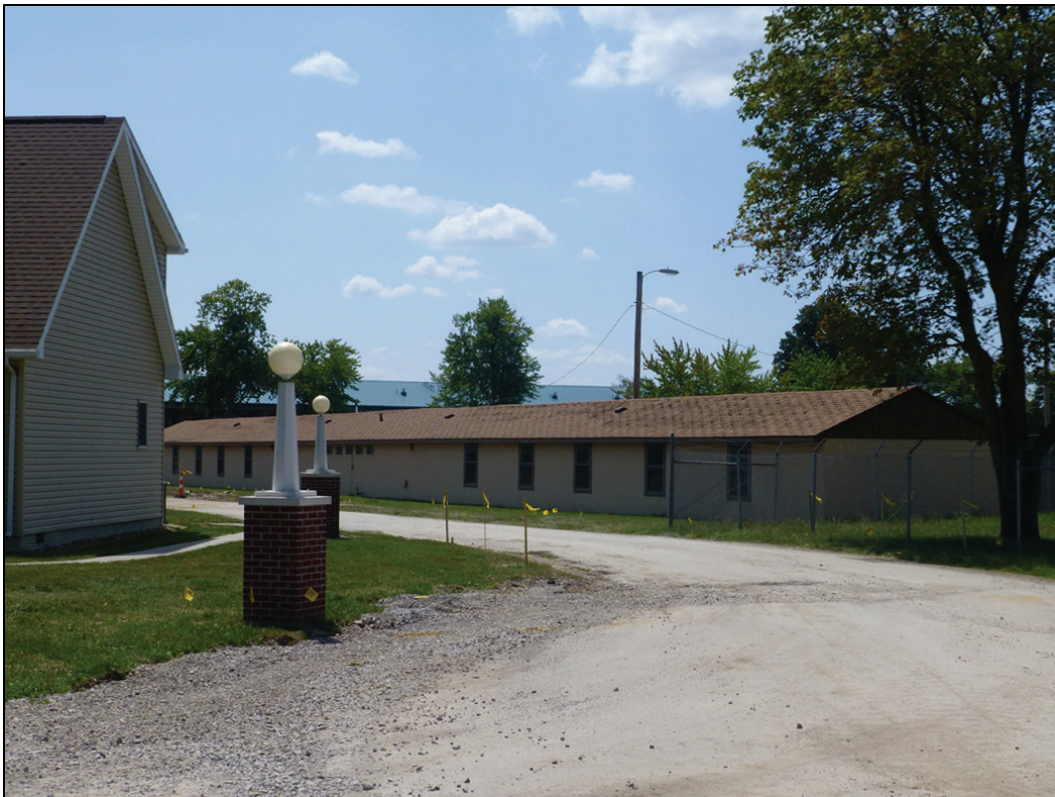
Figure 20. Looking southwest at Building 302 (ERDC-CERL 2017).

Building 302 and Building 303 were constructed in 1942 as two separate buildings. They were joined together sometime between 1960 and 1972 and renumbered as Building 302 (Figure 20). Building 302 was documented on an OHI form in 1993 by McQuillin and Assoc. and recommended not eligible in 2008 by MSG. The OHARNG consulted with the SHPO in 2016 regarding demolition of this building. The SHPO concurred that Building 302 was not a contributing resource to the historic district and demolition of the building would have no adverse effect to historic properties. Demolition was completed in 2019.

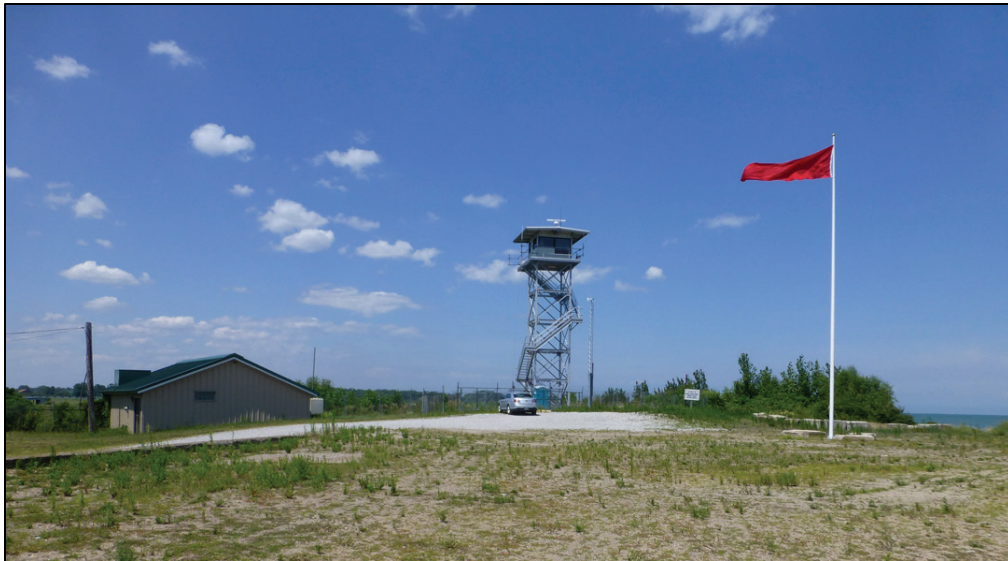
Figure 21. Looking west at Building 401 on the left and at Building 5008 on the right (ERDC-CERL 2017).

Building 401 was constructed in 1938. The lift station was documented on an OHI form in 1993 by McQuillin and Assoc. and recommended not eligible in 2008 by MSG. In 2010, a new roof and insulated steel siding were added to the building (Figure 21).

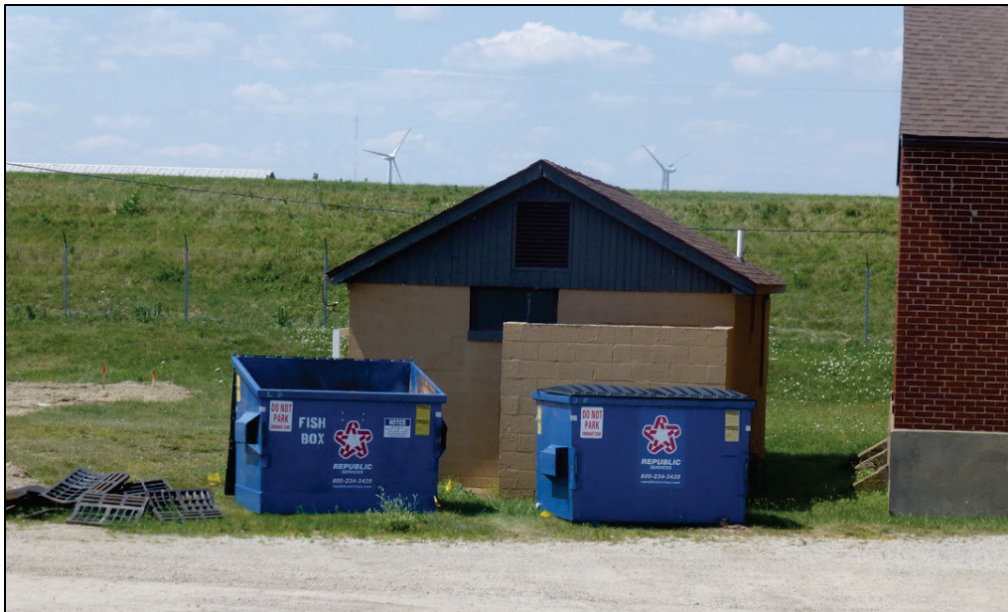
Figure 22. Looking west at Building 402 (ERDC-CERL 2017).

Building 402 was constructed in 1965 and documented on an OHI form and also recommended not eligible in 2008 by MSG (Figure 22).

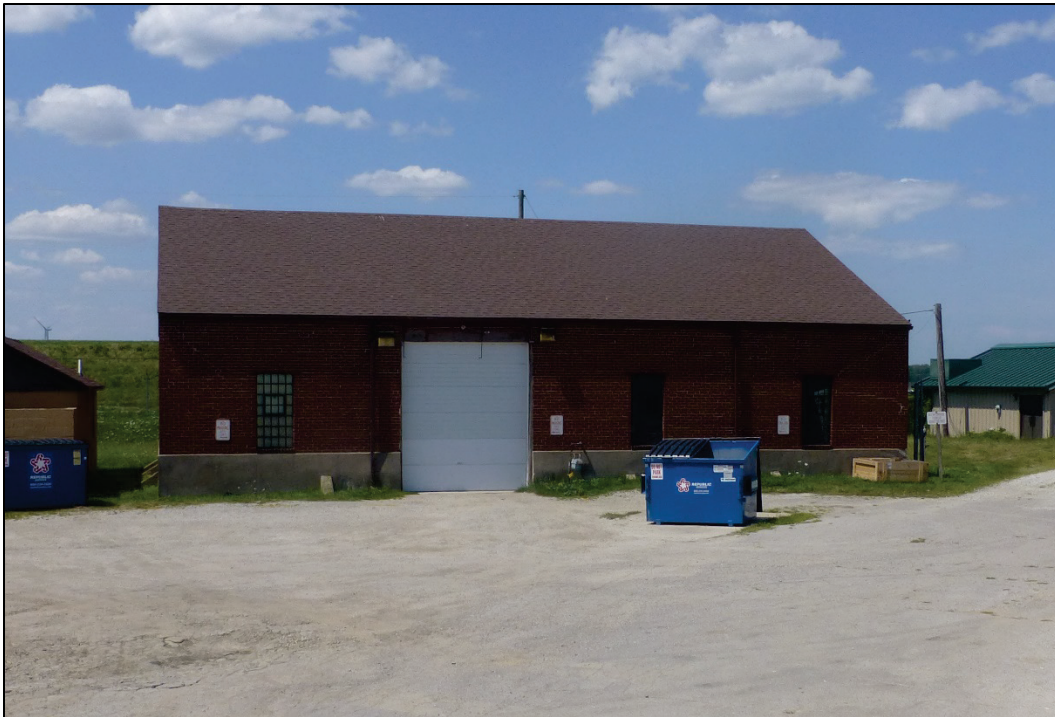
Figure 23. Looking west at Building 403 (center) with Building 402 slightly visible on left and Building 402 slightly visible to right (ERDC-CERL 2017).

Building 403 was constructed in 1938 and was documented on an OHI form and also recommended not eligible in 2008 by MSG (Figure 23).

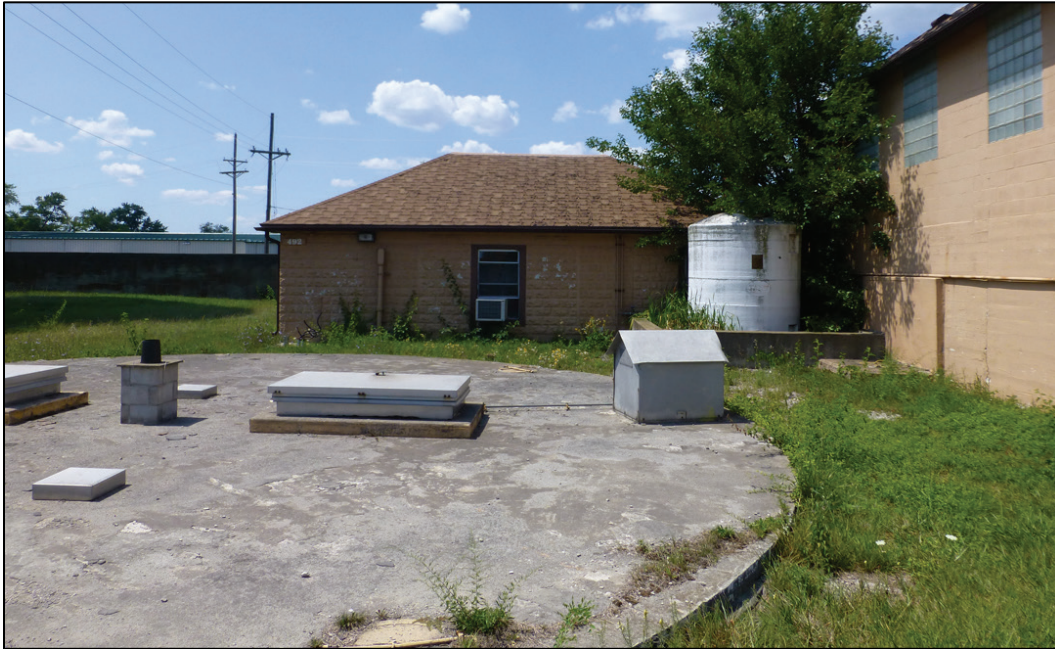
Figure 24. Looking east at Building 492 (1907 portion in center) with newer addition to right and well (Building 493) in foreground (ERDC-CERL 2017).

Building 492 (Figures 24 and 25) was constructed in 1907 (expanded in 1923 and 1942), documented on an OHI form in 1993 by McQuillin and Assoc., and recommended eligible in 2008 by MSG. Based on historic aerial photos of the area (from Camp Perry Directorate of Public Works [DPW]), the building has been modified multiple times between 1907 and the 1940s. This includes either modification or replacement of the original 1907 building, addition of a second building, construction of the north water tower, demolition of the stand pipe, and installation of new cover over concrete holding tanks. While it has been assumed that the current building was constructed in 1907, the current building has a different shape and footprint than what can be seen on early 1900s aerial views. It is likely that the original building was replaced in the 1920s along with construction of the larger building off the northeast corner. The Water Treatment Plant was demolished in 2019. An MOA was developed in consultation with the SHPO in order to resolve the adverse effect. In accordance with stipulations identified in the MOA, the OHARNG will preserve the northern water tower (Bldg. 301) and preserve historic elevations and plans of the water treatment plant at the Adjutant General's Department, State Historian Office.

The well on the Real Property list dates to 1907 (Figure 24). It is visible in early 1900s historic photographs and aerial views (see Figure 296, p. 199).

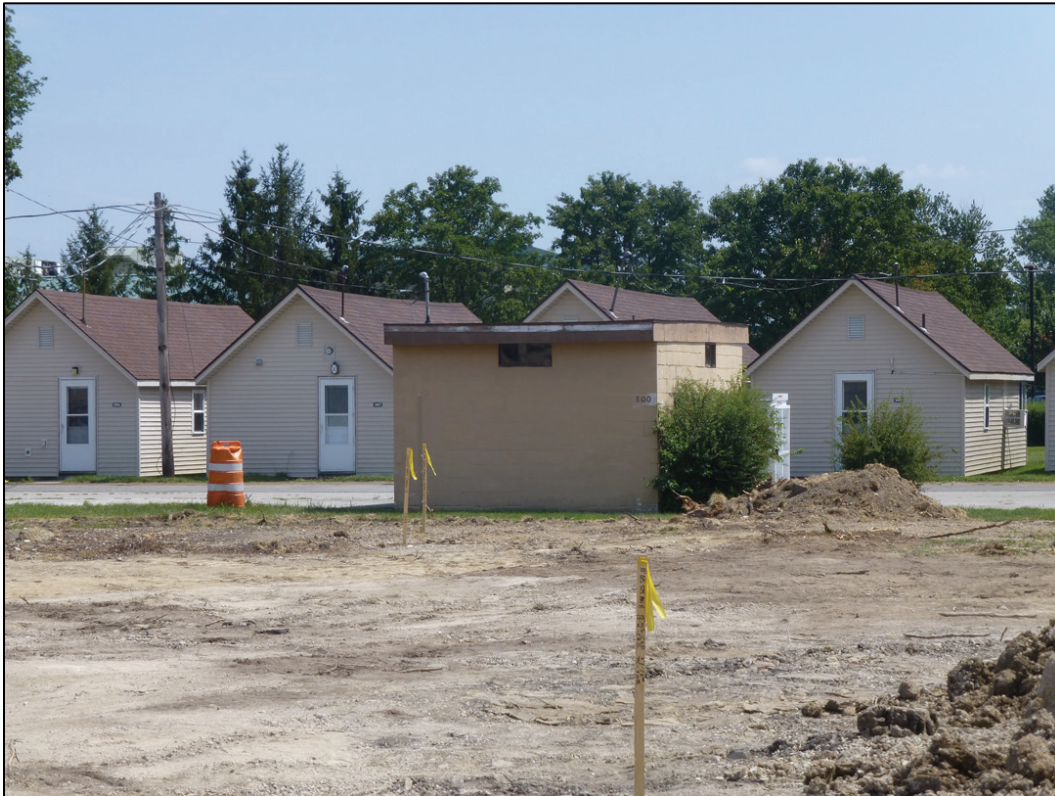
Figure 26. Looking south at Building 500 (ERDC-CERL 2017).

Building 500 (Figure 26) was documented on an OHI form and also recommended not eligible in 2008 by MSG. OHARNG property records indicated the construction date of Building 500 was 1942. However historic aerial photographs indicate that the original 1942 era building was likely demolished between 1960 and 1972. The original building was a long garage that ran north and south in the cottage area (see Figure 200, 1943 site plan, p. 143). This long building is no longer visible on the 1972 aerial photograph of the area. There appears to be another considerably smaller building standing in the location of the former long garage. Given the change in the footprint of the buildings in this area between 1960 and 1972, it is likely the original Building 500 was demolished sometime between 1960 and 1972 and a new smaller Building 500 was constructed in its place shortly afterwards. This building was demolished in spring 2018 as part of the cottage replacement project, which was initiated in 2007 (see Section 2.5).

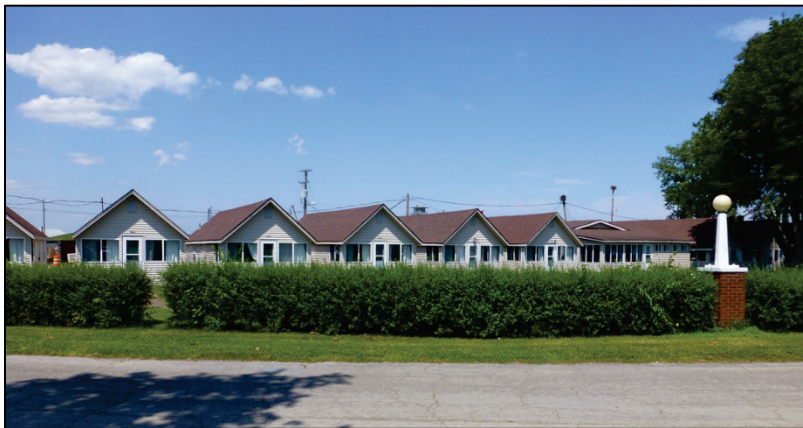
Figure 27. Looking west at row of cottages, Building 505 (on far right) to Building 511 (on far left) (ERDC-CERL 2017).

Buildings 501, 502, 503, 504, 505, 506, 507, 508, 509, 510, 511, 512, 513, 514, 515, and 516 were constructed between 1936 and 1942. They were documented on OHI forms and recommended not eligible in 2007 by MSG (Figures 27–29). Buildings 514, 515 and 516 were demolished in 2017 as part of the cottage replacement project, which was initiated in 2007 (see Section 2.5). The remaining cottages have been reclad with vinyl siding and have new windows and doors. The remaining cottages are currently being demolished as funding becomes available as part of the cottage replacement project.

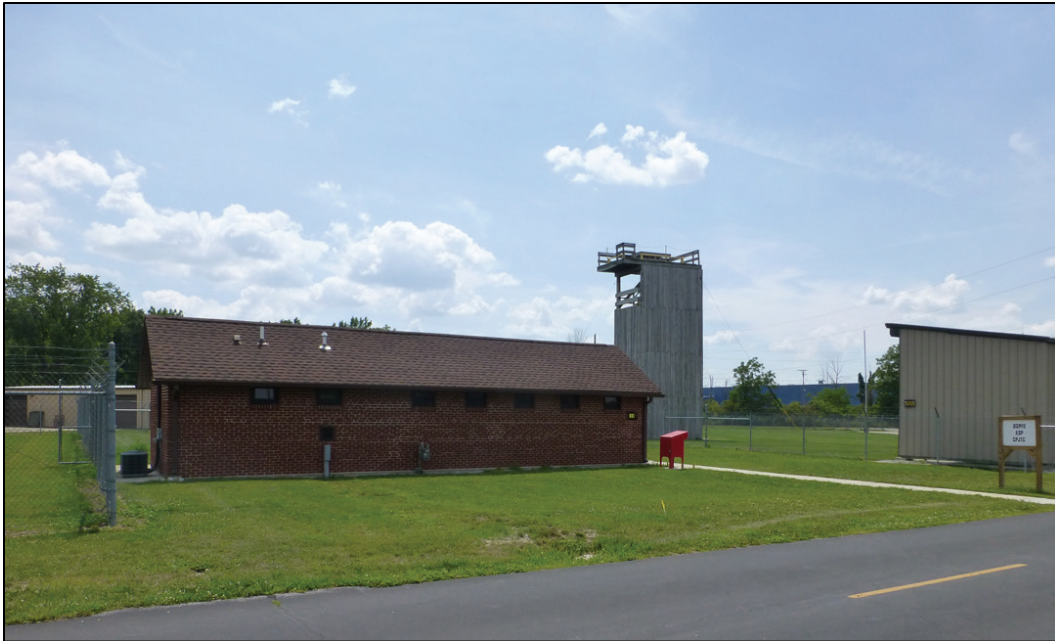
Figure 34. Looking south at Building 801 (ERDC-CERL 2017).

Building 801 was constructed in 1938, documented on an OHI form in 1993 by McQuillin and Assoc., and was recommended not eligible in 2008 by MSG (Figure 34). The interior of this building has been remodeled for use as an administration office. The OHARNG initiated consultation with the SHPO in a letter dated 27 June 2014 regarding maintenance and upgrades of several buildings including Building 801. The OHARNG determined that none of the buildings were eligible for the NRHP individually or as contributing resources to the historic district and that proposed work on these buildings would have no adverse effect on historic properties. The OHARNG assumed concurrence as no response was received within 30 days from SHPO regarding this project. In addition, the OHARNG consulted with the SHPO regarding construction of three buildings near Building 801 in 2012 and 2014. Building 801 was within the APE of these three proposed projects. The OHARNG determined Building 801 was not a historic property and that there would be no adverse effect to the historic district with the construction of these buildings. The SHPO did not object to the determination that Building 801 was not eligible individually or as a contributing resource to the district.

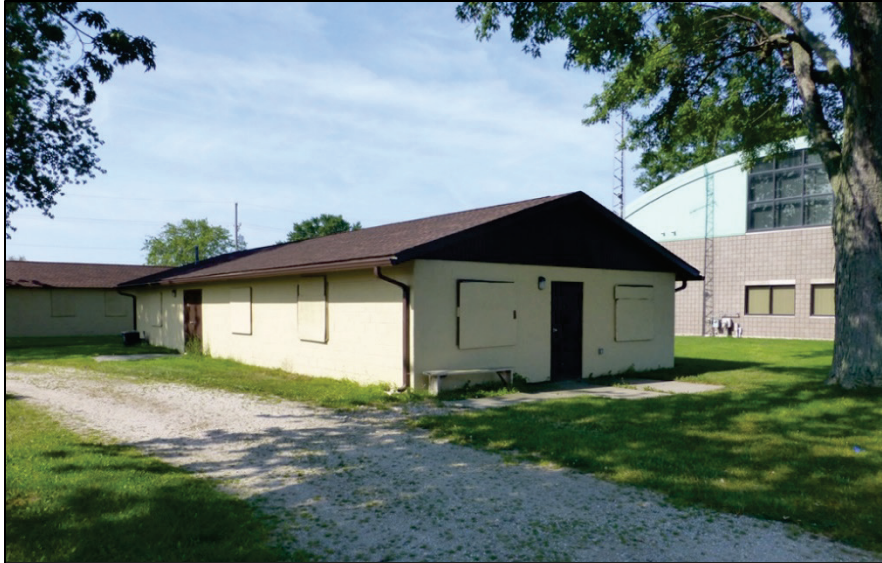
Figure 35. Northeast oblique of Building 902 (ERDC-CERL 2017).

Building 902 was constructed in 1942. It was documented on an OHI form and recommended not eligible in 2008 by MSG (Figure 35). It has new windows and doors.

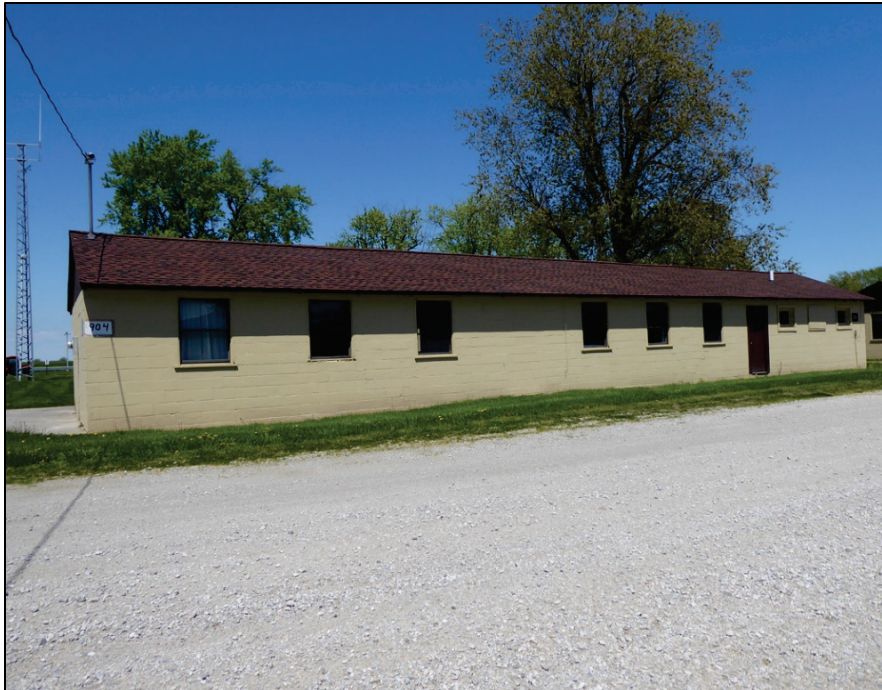
Figure 36. Northeast oblique of Building 904 (ERDC-CERL 2017).

Building 904 was constructed in 1942. It was documented on an OHI form and recommended not eligible in 2008 by MSG. Several exterior openings have been bricked in at an unknown time. It has new windows and doors (Figure 36).

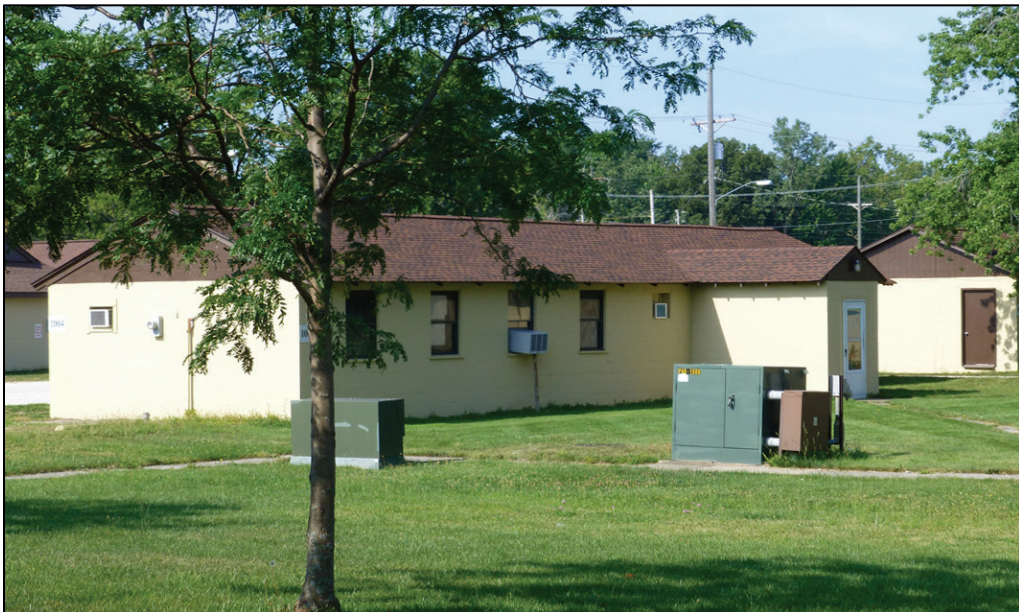
Figure 42. Northeast oblique of Building 1000 (ERDC-CERL 2017).

Building 1000 was constructed in 1942, and it was documented on an OHI form and also recommended not eligible in 2008 by MSG. It has new windows and doors (Figure 42).

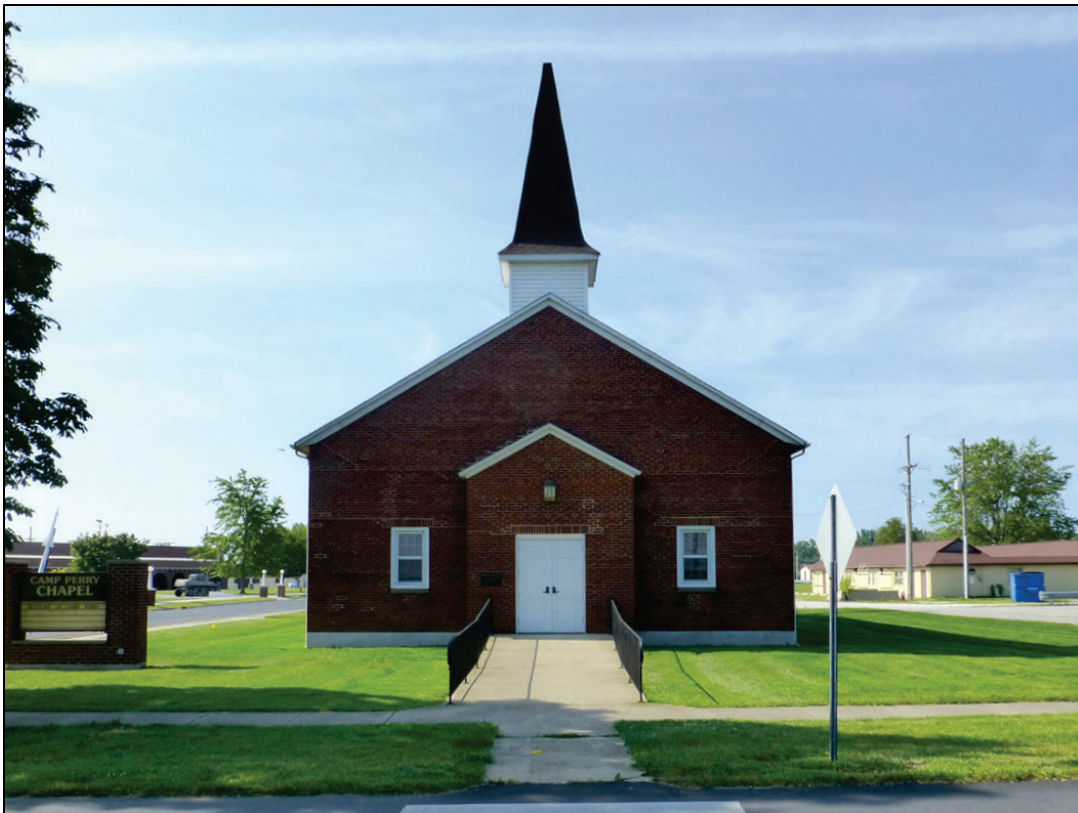
Figure 43. Looking south at Building 1003 (ERDC-CERL 2017).

Building 1003 (Figures 43 and 44) was constructed in 1942. It was documented on an OHI form and also recommended as eligible in 2008 by MSG. Rehabilitation was completed on Building 1003 in 2013 and 2015. Rehabilitation in 2013 included repainting and refinishing the interior, masonry cleaning and repairs, repairs to the steeple, removing a non-original awning over the main entrance, and replacing main entrance doors with more historically compatible doors. Additional rehabilitation occurred in 2015 that included installation of new windows that were more historically compatible.

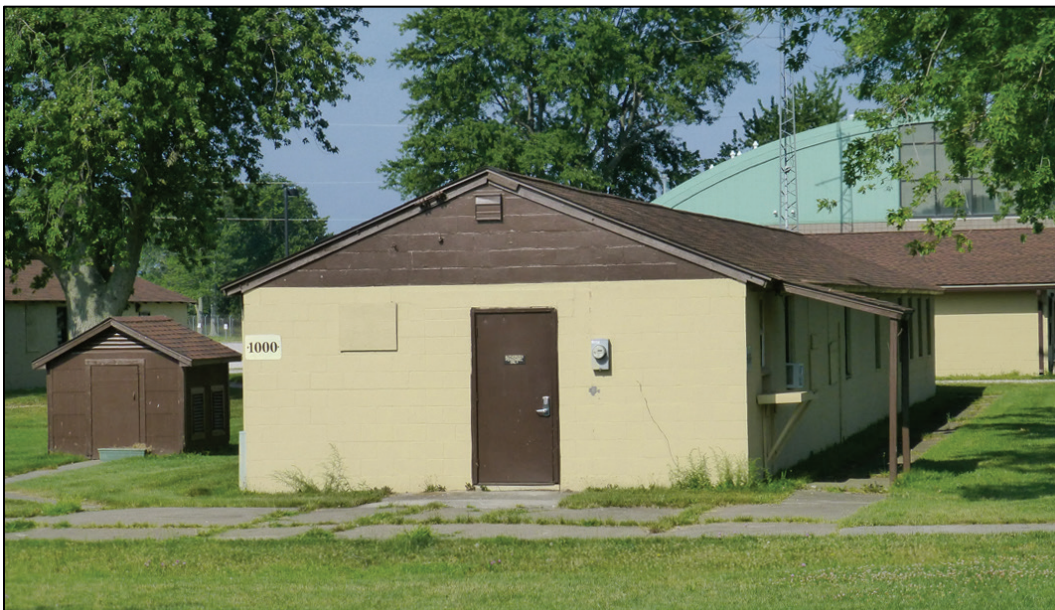
Figure 45. Looking west at Building 1004 (ERDC-CERL 2017).

Building 1004 (Figure 45) was constructed in 1942, and it was documented on an OHI form and also recommended not eligible in 2008 by MSG. It has new windows and doors.

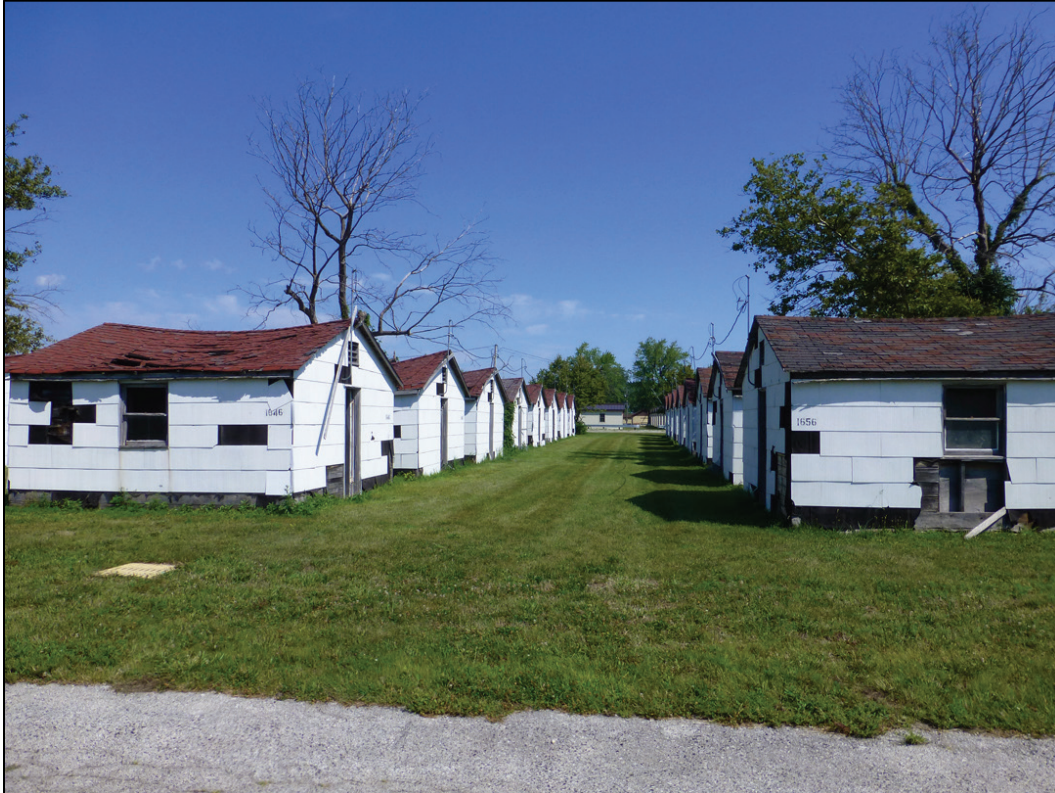
Figure 46. Looking north at hutments (ERDC-CERL 2017).

Hutments 1620–1666 (Figure 46) were constructed in 1942, documented on OHI forms in 1993 by McQuillin and Assoc., and recommended not eligible in 2008 by MSG. All remaining hutments in this area are planned for demolition by 2021.

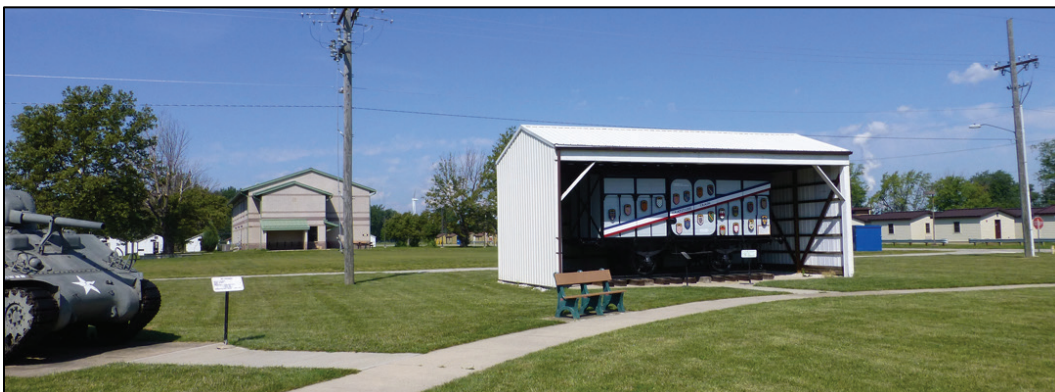
Figure 49. Looking west at Gratitude Train monument (Building 1751) and canopy (Building 1749) (ERDC-CERL 2017).

The French Gratitude Train or “Merci Train” Monument is one of the 49 cars that made up the “Forty and Eight Train” that was gifted to the United States by France in 1949, in response to the U.S. Friendship Train of 1947. The 49 boxcars were designated as one for each state, with one to be shared between the District of Columbia and Hawaii. The boxcar has been at Camp Perry since the early 1950s. In 1986, the boxcar was restored (Bovia 2004, 71–72). The train stood at Memorial Plaza until the tornado hit in 1998, and then it was moved to the current location and the roof was replaced. A metal canopy, Building 1749, was constructed over the monument in 2005 (Figure 49).

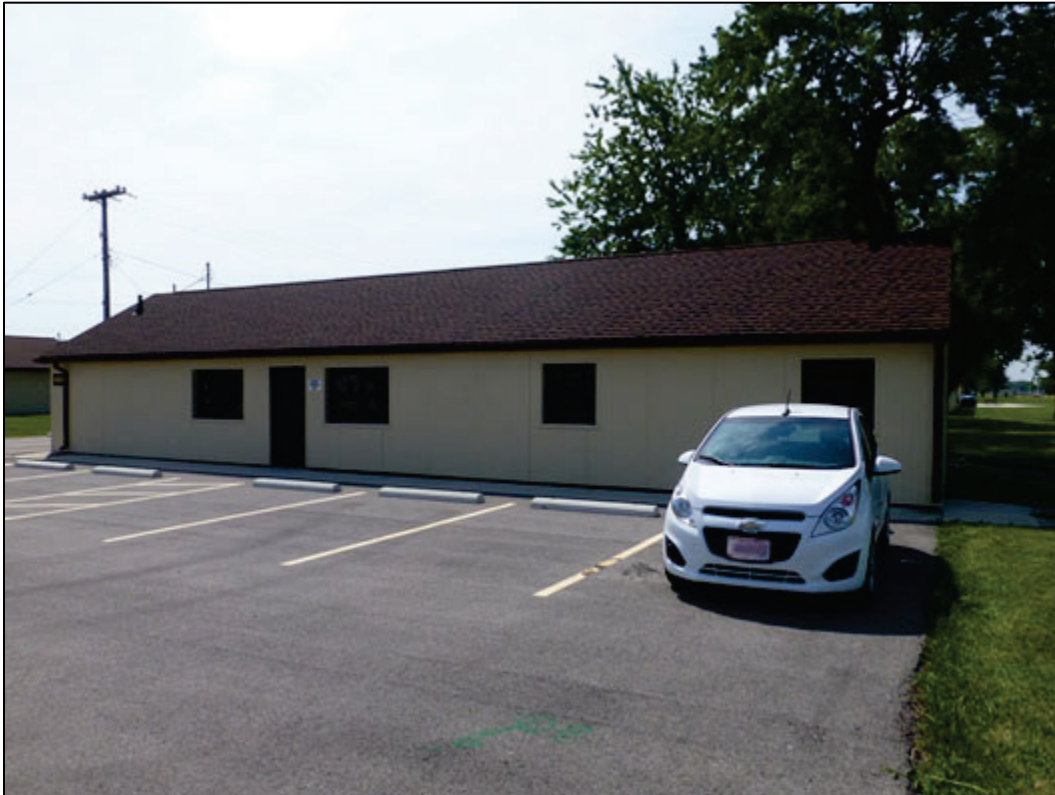
Figure 50. Looking south at Building 1800 (ERDC-CERL 2017).

Building 1800 was constructed in 1942, and it was documented on an OHI form in 1993 by McQuillin and Assoc., and recommended not eligible in 2008 by MSG. It has been reclad with insulated steel siding and has new windows and doors (Figure 50).

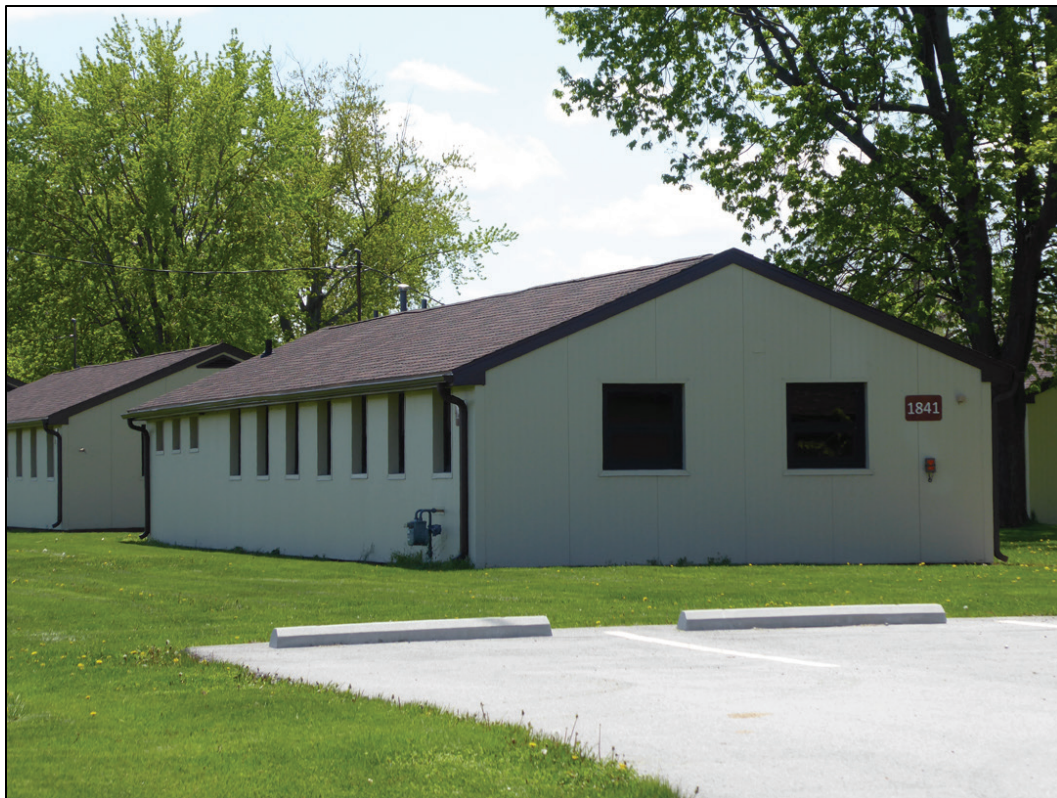
Figure 55. Southwest oblique of Building 1841 (ERDC-CERL 2019).

Buildings 1841, 2143, and 2300 were constructed in 1942, and Building 2101 was constructed in 1945. These buildings were documented on OHI forms in 1993 by McQuillin and Assoc., and recommended not eligible in 2008 by MSG. They have been reclad with insulated steel siding and have new windows and doors (Figures 55–58).
