Camp Perry Historic District Landscape Inventory and Viewshed Analysis

Final Technical Report (TR)

Under Project 467080, "Camp Perry, OH Hist Dist Boundary Review and Viewshed Analysis"

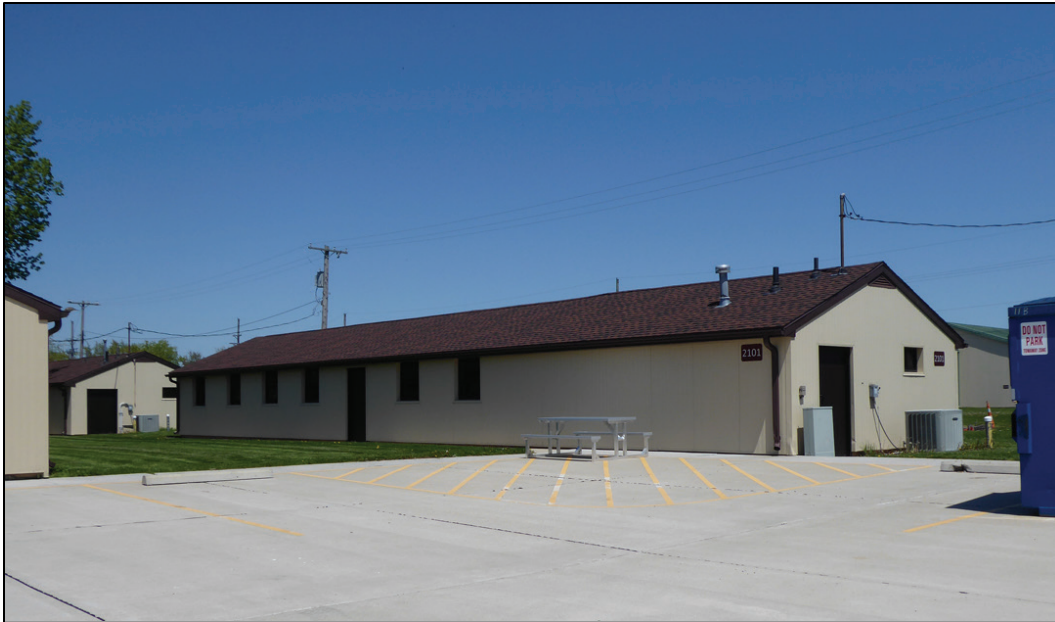
Figure 56. Northeast oblique of Building 2101 (ERDC-CERL 2019).

Buildings 1841, 2143, and 2300 were constructed in 1942, and Building 2101 was constructed in 1945. These buildings were documented on OHI forms in 1993 by McQuillin and Assoc., and recommended not eligible in 2008 by MSG. They have been reclad with insulated steel siding and have new windows and doors (Figures 55–58).

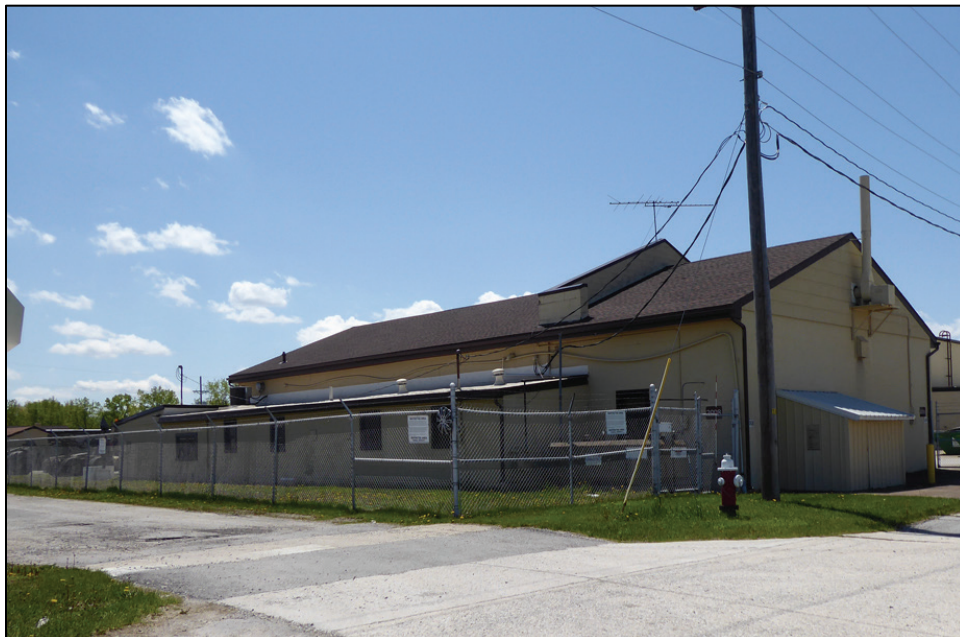
Figure 59. Southwest oblique of Building 2008 (ERDC-CERL 2019).

Building 2008 was constructed in 1942, documented on an OHI form in 1993 by McQuillin and Assoc., and recommended not eligible in 2008 by MSG (Figure 59). The exterior of this building received masonry repairs and was painted in 2014. In 2015, all new windows were installed. The SHPO concurred that there would be no adverse effect to the historic district with these two projects.

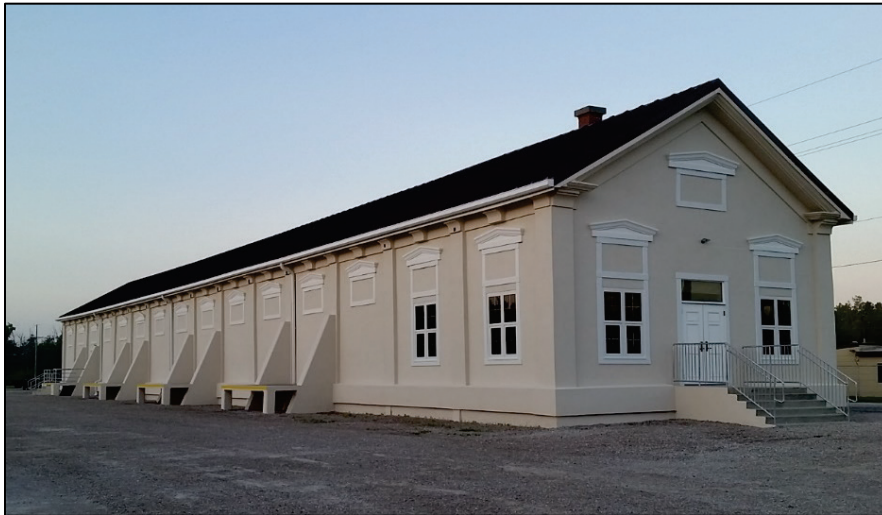
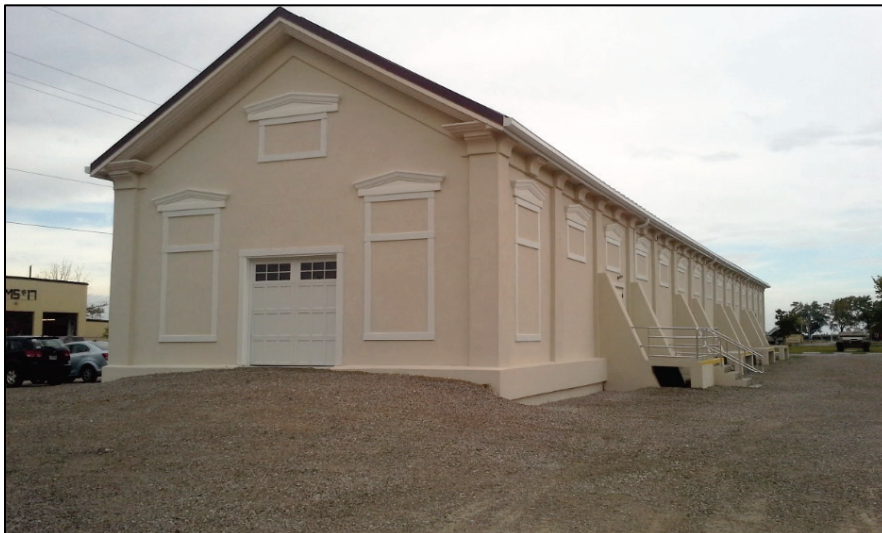
Figure 60. Looking west at Building 2009 (Camp Perry 2017).

Building 2009 was constructed in 1907, documented on an OHI form in 1993 by McQuillin and Assoc., and recommended eligible in 2008 by MSG. Rehabilitation was completed on Building 2009 in 2018 in accordance with the SOI Standards (Weeks and Grimmer 1995) and in consultation with the SHPO. Rehabilitation included repairing areas of spalling on exterior concrete walls, replacing exterior doors and windows, repainting the exterior walls and metal roof, repairing or replacing pediments as necessary, repairing masonry on the chimney, replacing wood deck and stairs with concrete stair system, and removing current wood panels over old openings (Figures 60 and 61).

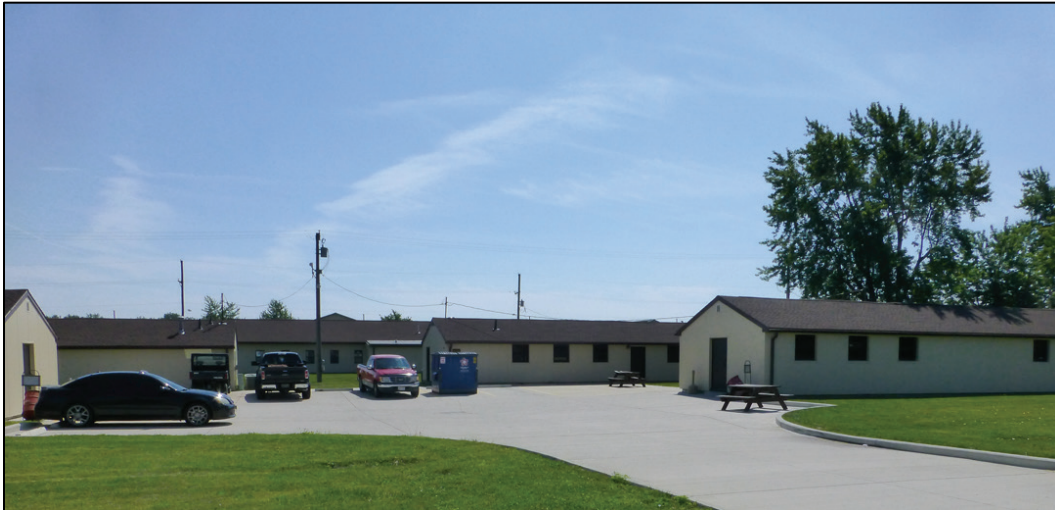
Figure 67. Looking east at Building 2142 on the right with Building 2143 behind (ERDC-CERL 2017).

Buildings 2100 and 2142 were constructed in 1942, documented on OHI forms in 1993 by McQuillin and Assoc., and recommended not eligible in 2008 by MSG. They have been re clad with insulated steel siding and have new windows and doors (Figure 67).

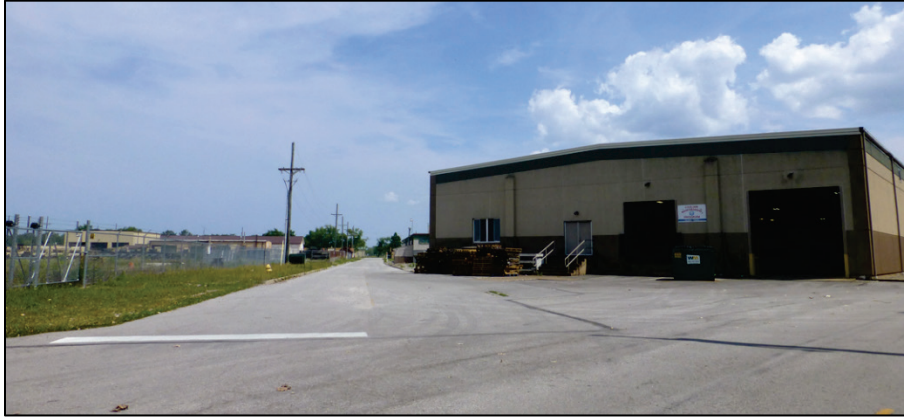
Figure 69. Looking southeast at Building 2500 (ERDC-CERL 2017).

Building 2500 was constructed in 1942, documented on an OHI form in 1993 by McQuillin and Assoc., and recommended not eligible in 2008 by MSG. It has been re clad with insulated steel siding and has new windows and doors (Figure 69).

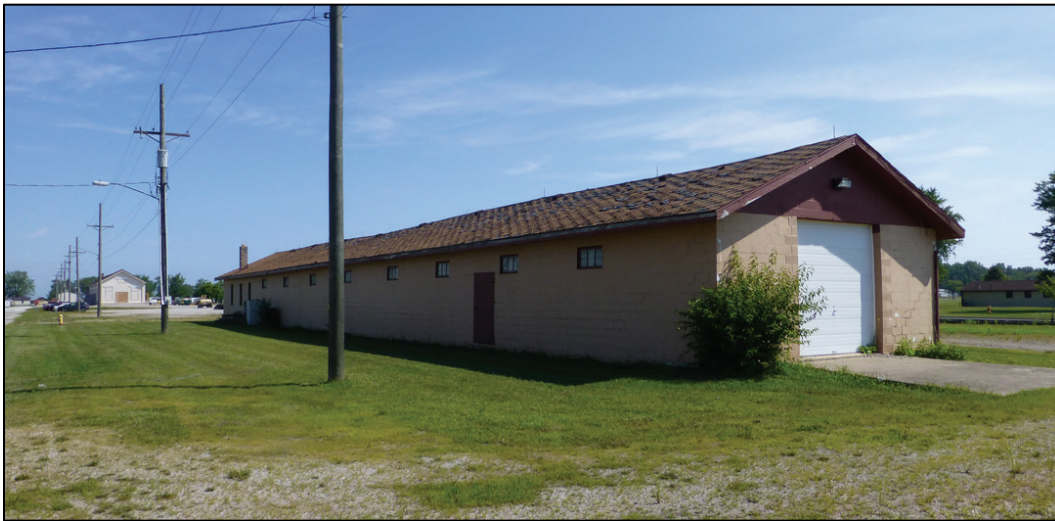
Figure 74. Southwest oblique of Building 2513 (ERDC-CERL 2017).

Building 2513 was constructed in 1942, and it was documented on an OHI form and also recommended eligible in 2008 by MSG. Building 2513 (Figure 74) was demolished in 2018. An MOU was developed in consultation with the SHPO to mitigate adverse effects of the demolition. Mitigation included development of an Ohio Historical Marker discussing the importance of historic rail access to the facility. The marker was installed in September 2019.

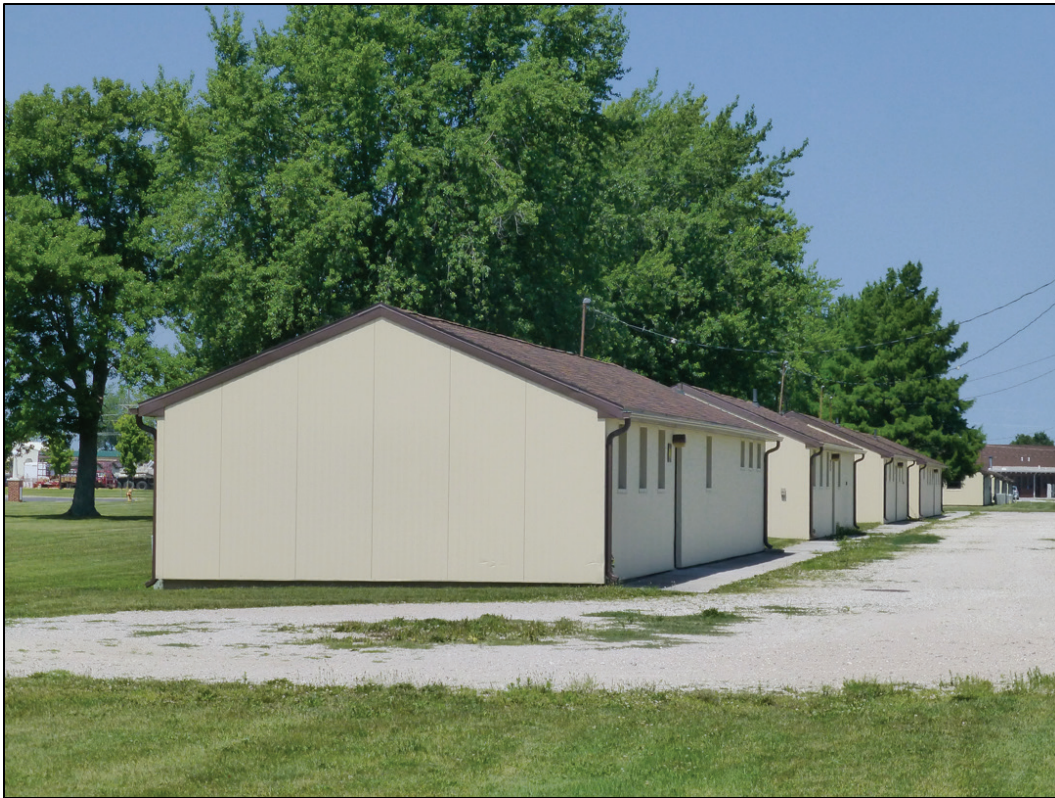
Figure 75. Looking northwest towards 2746, 2702, 2648, and 2603 (ERDC-CERL 2017).

Buildings 2603, 2648, 2702, and 2746 were constructed in 1942, documented on OHI forms in 1993 by McQuillin and Assoc., and recommended not eligible in 2008 by MSG. All four were reclad with insulated steel siding and have new windows and doors (Figure 75).

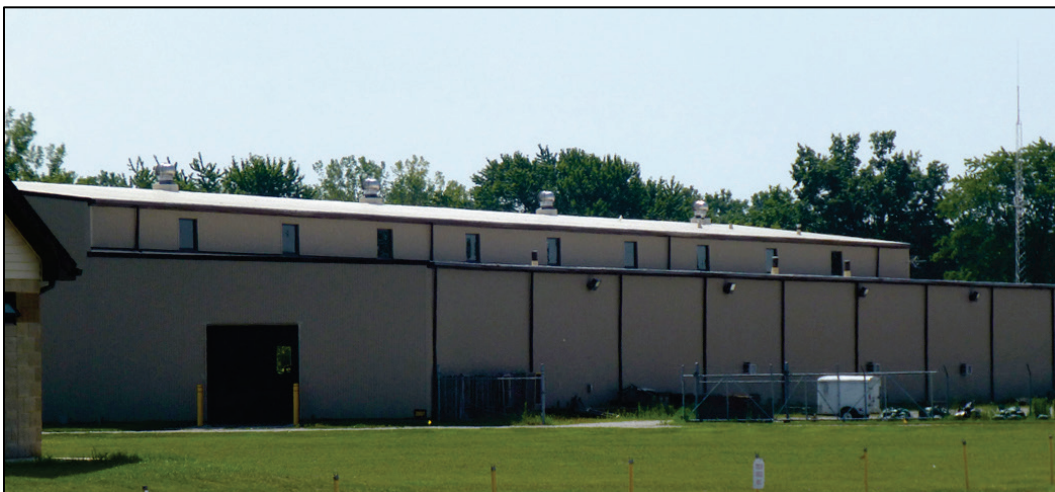
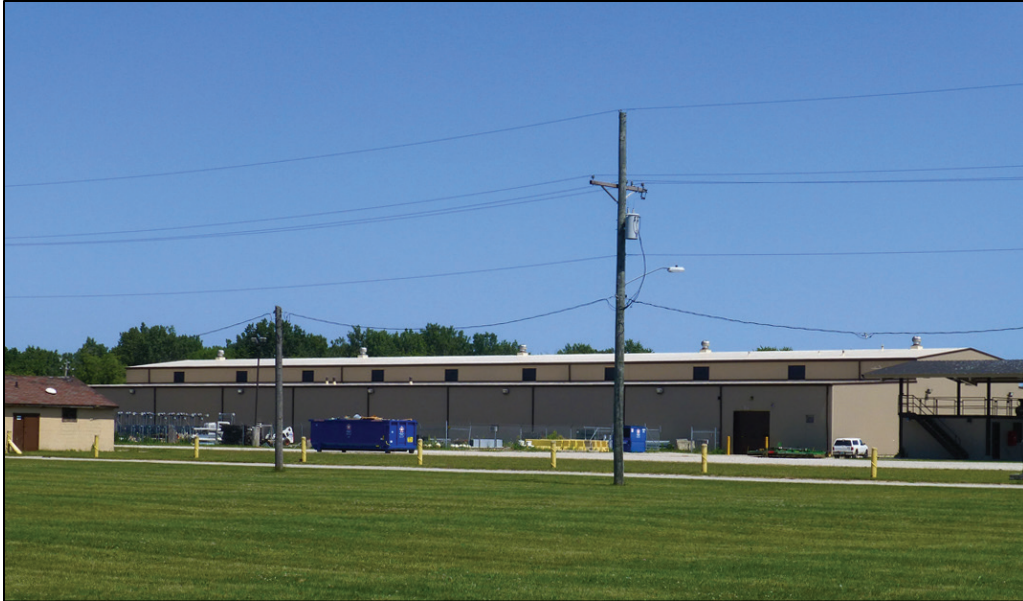
Figure 76. Looking southeast at Building 2807 (ERDC-CERL 2017).

Building 2807 was constructed in 1943, documented on an OHI form in 1993 by McQuillin and Assoc., and recommended not eligible in 2008 by MSG. It has been re clad with insulated steel siding and has new windows and doors (Figure 76 and 77).

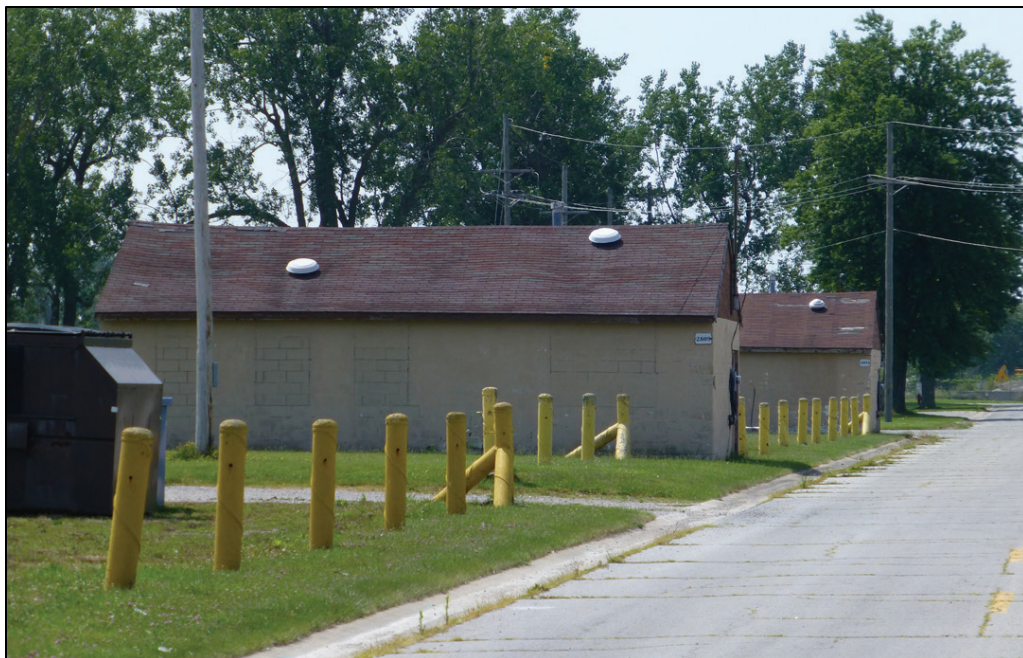
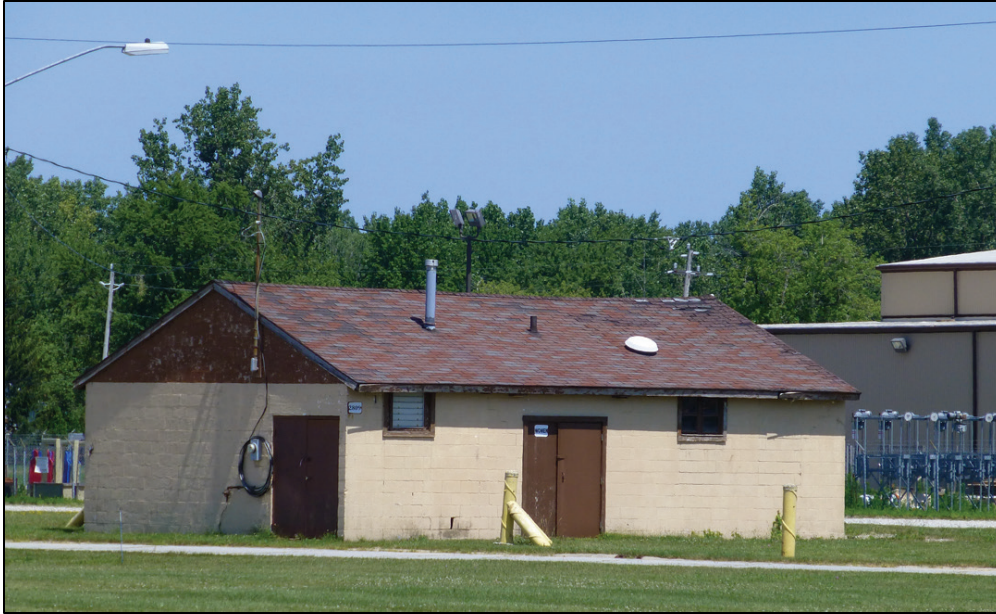
Figure 78. Looking south at Building 2809 (ERDC-CERL 2017).

Building 2809 was constructed in 1942, documented on an OHI form in 1993 by McQuillin and Assoc., and was recommended not eligible in 2008 by MSG. It had replacement doors and filled in windows (Figures 78 and 79). Building 2809 was demolished in 2018. Section 106 consultation was completed with the SHPO in 2016.

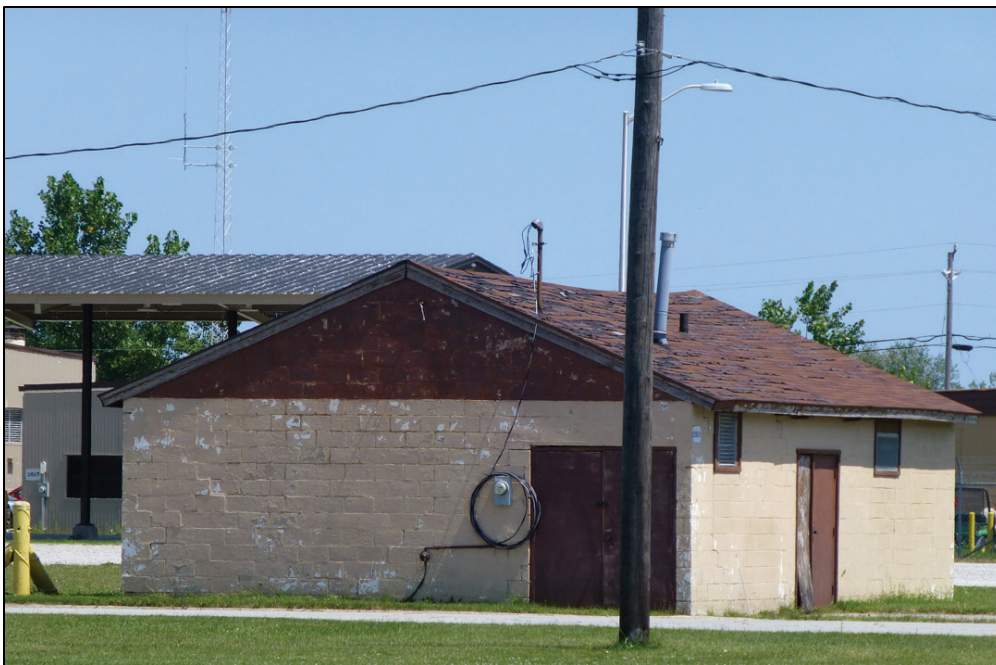
Figure 80. Southwest oblique of Building 2811 (ERDC-CERL 2017).

Building 2811 was constructed in 1942, documented on an OHI form in 1993 by McQuillin and Assoc., and recommended not eligible in 2008 by MSG. It had replacement doors and filled-in windows (Figure 80). Building 2811 was demolished in 2018. Section 106 consultation was completed with the SHPO in 2016.

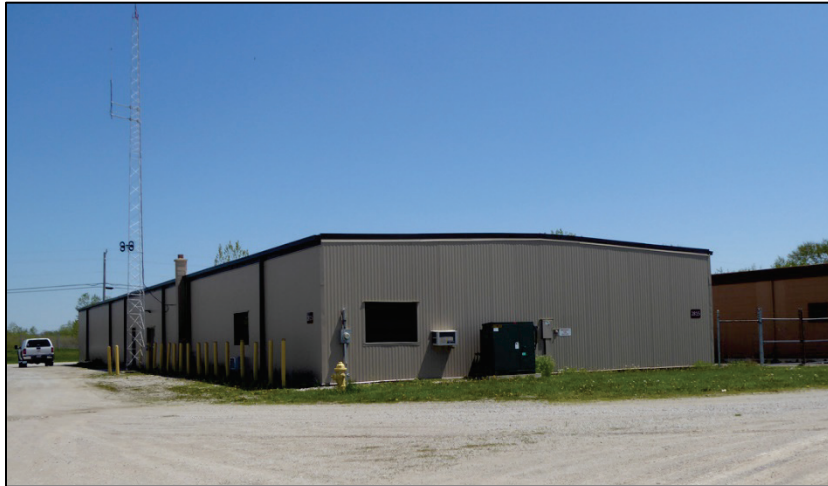
Figure 81. Southeast oblique of Building 2815 (ERDC-CERL 2019).

Building 2815 was constructed in 1942, documented on an OHI form in 1993 by McQuillin and Assoc., and recommended not eligible in 2008 by MSG. It has been re clad with insulated steel siding and has new windows and doors (Figure 81).

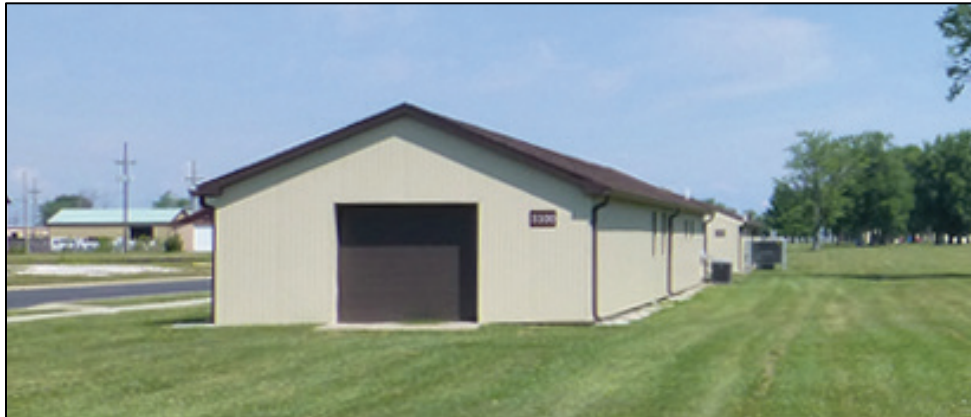
Figure 87. Looking north at Building 3100 (ERDC-CERL 2017).

Buildings 3000 and 3100 (Figure 87) were constructed in 1942 as classrooms, documented on OHI forms in 1993 by McQuillin and Assoc., and recommended not eligible in 2008 by MSG. Both were re clad with insulated steel siding and have new windows and doors.

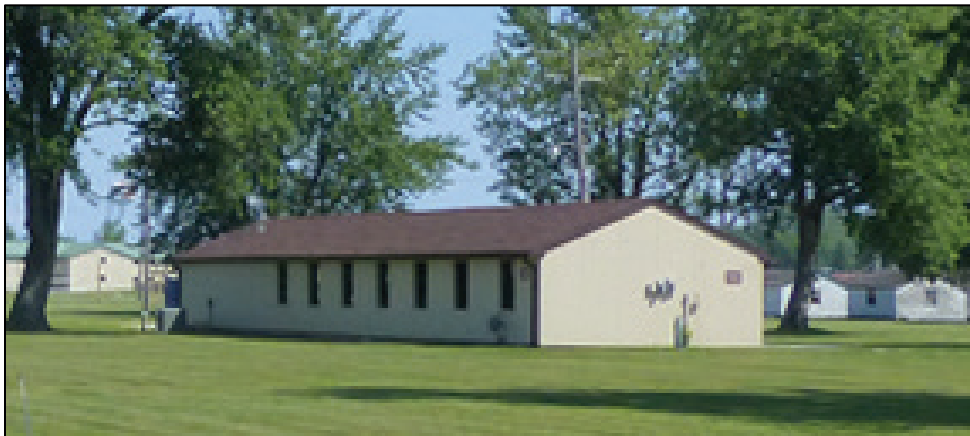
Figure 88. Looking north towards Building 3082 (ERDC-CERL 2017).

Building 3082 was constructed in 1942, documented on an OHI form in 1993 by McQuillin and Assoc., and recommended not eligible in 2008 by MSG. It was re clad with insulated steel siding and has new windows and doors (Figure 88).

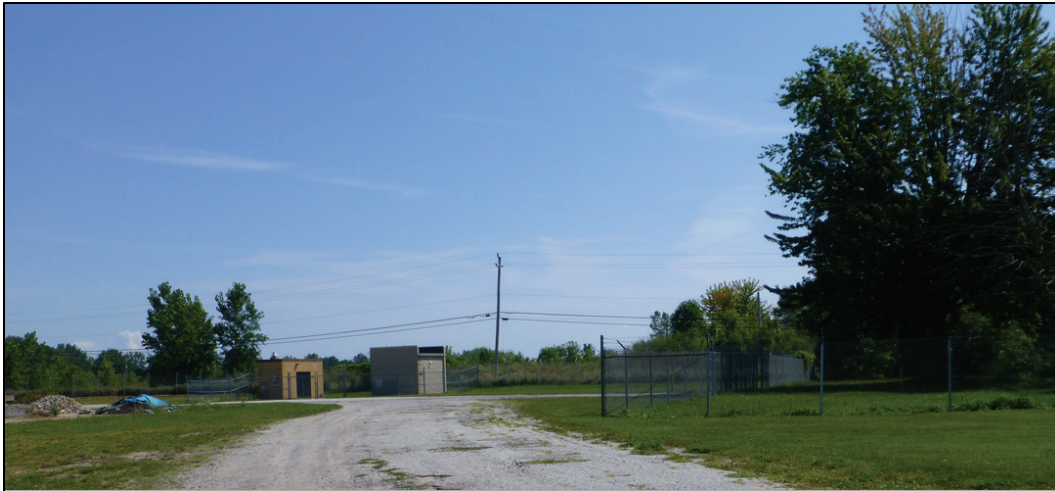
Figure 89. Looking east at Building 3203 (ERDC-CERL 2017).

The original Building 3203, constructed in 1942, was demolished. A new building and pumps were constructed by Ottawa County in 2005 (Figure 89). The county will be responsible for maintaining the lift station.

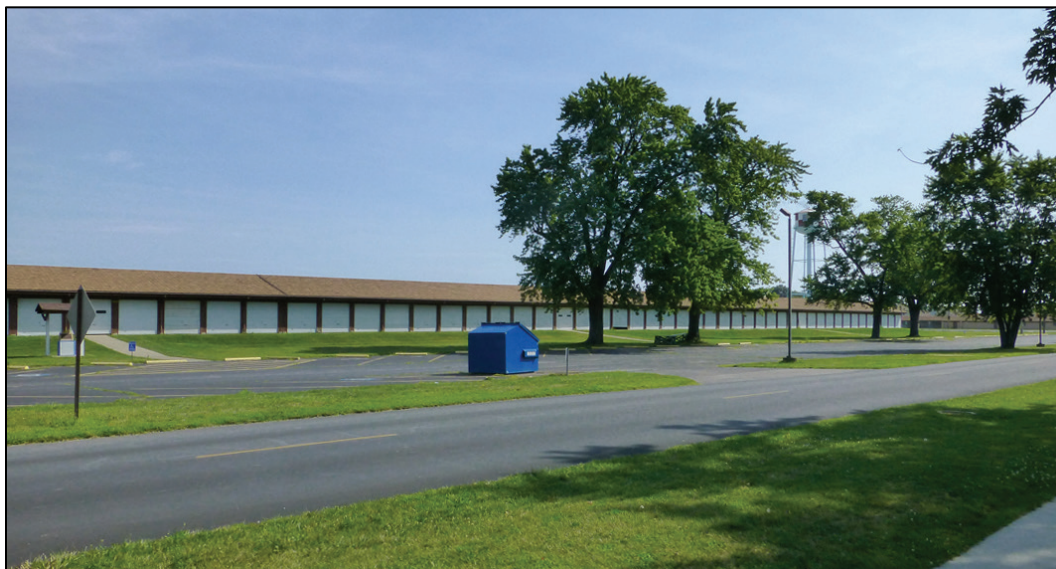
Figure 99. Looking north at Building 5039 (ERDC-CERL 2017).

Building 5039 was constructed in 1984 and has not been evaluated (Figure 99).

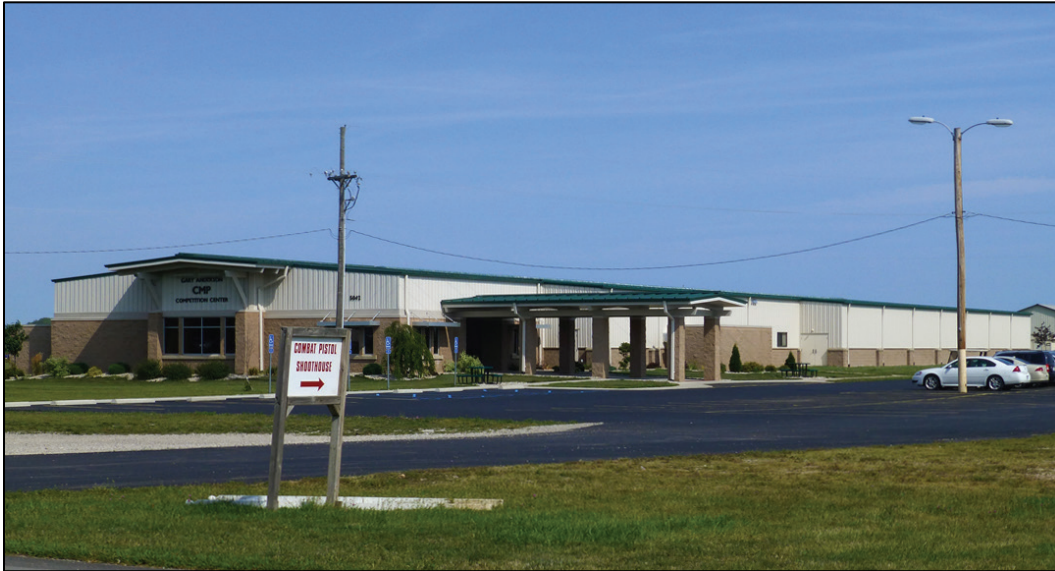
Figure 100. Southeast oblique of Building 5042 (ERDC-CERL 2017).

Building 5042 was constructed in 2006 and has not been evaluated (Figure 100).

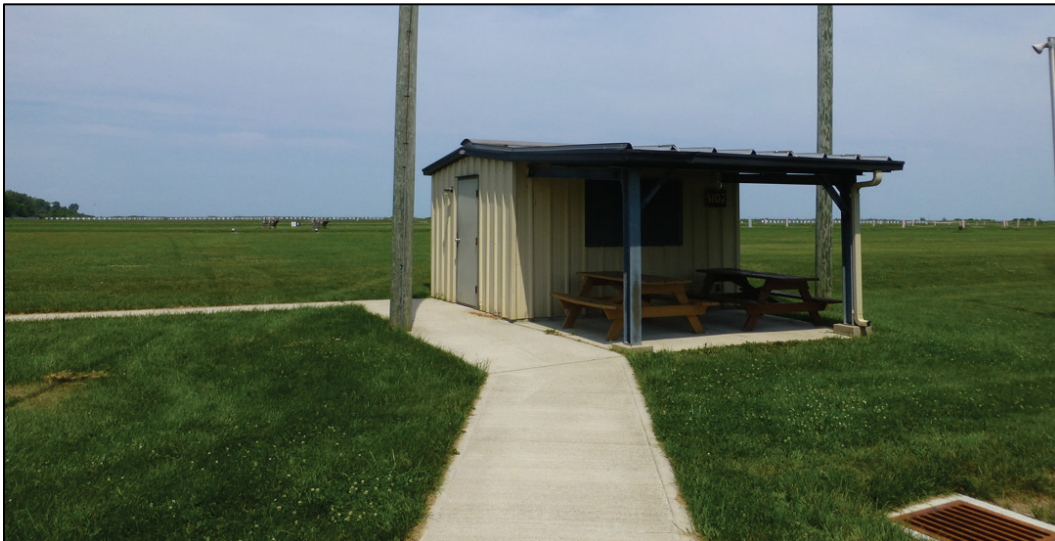
Figure 101. Looking north with Building 5102 (ERDC-CERL 2017).

Building 5102 was constructed in 1996 and has not been evaluated (Figure 101).

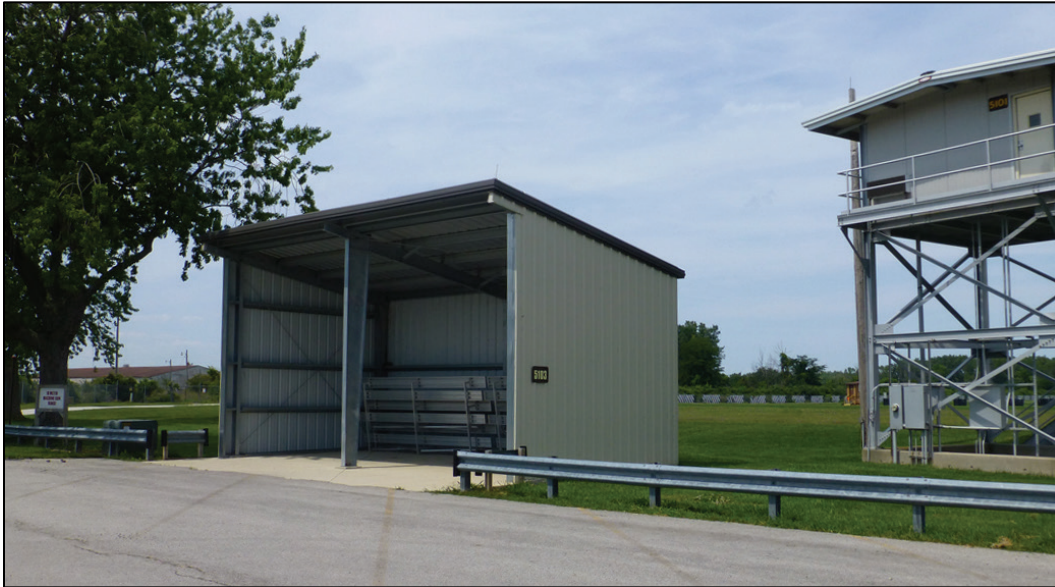
Figure 102. Looking northeast at Building 5103 (ERDC-CERL 2017).

Building 5103 was constructed in 1996 and has not been evaluated (Figure 102).

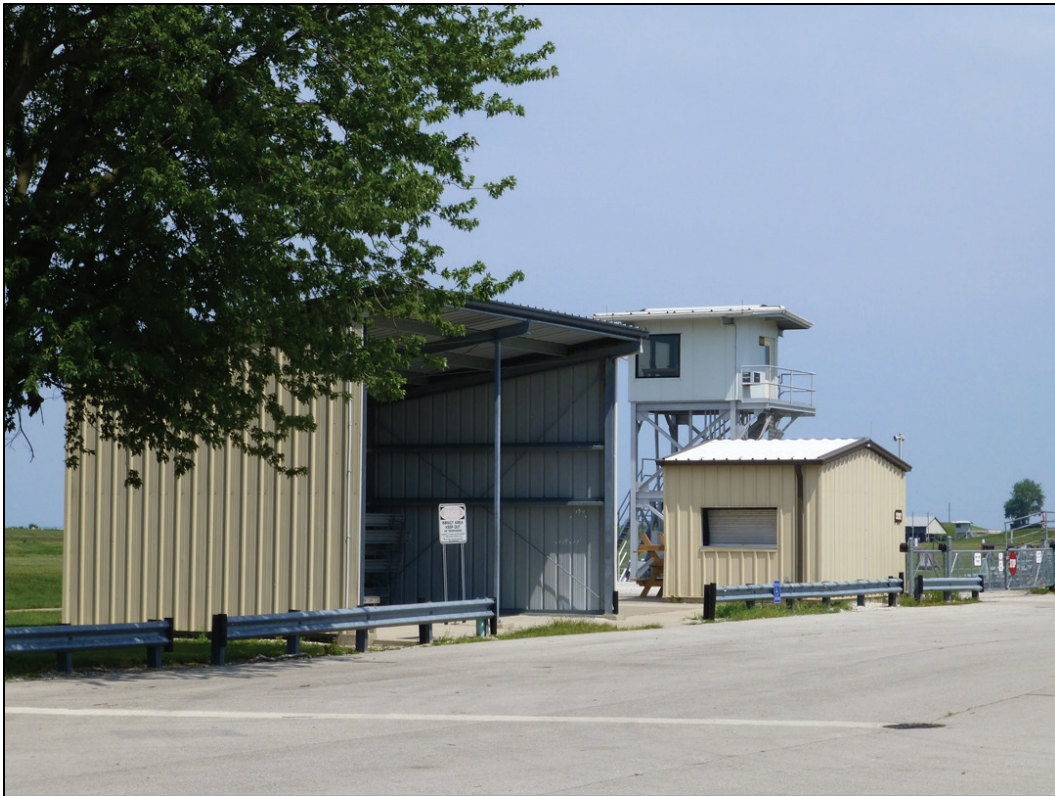
Building 5202 was constructed in 1995 and has not been evaluated (Figure 103).

Building 5203 was constructed in 1995 and has not been evaluated (Figure 103).

Figure 103. Looking northeast with Building 5203 in foreground and Building 5202 to the right (ERDC-CERL 2017).

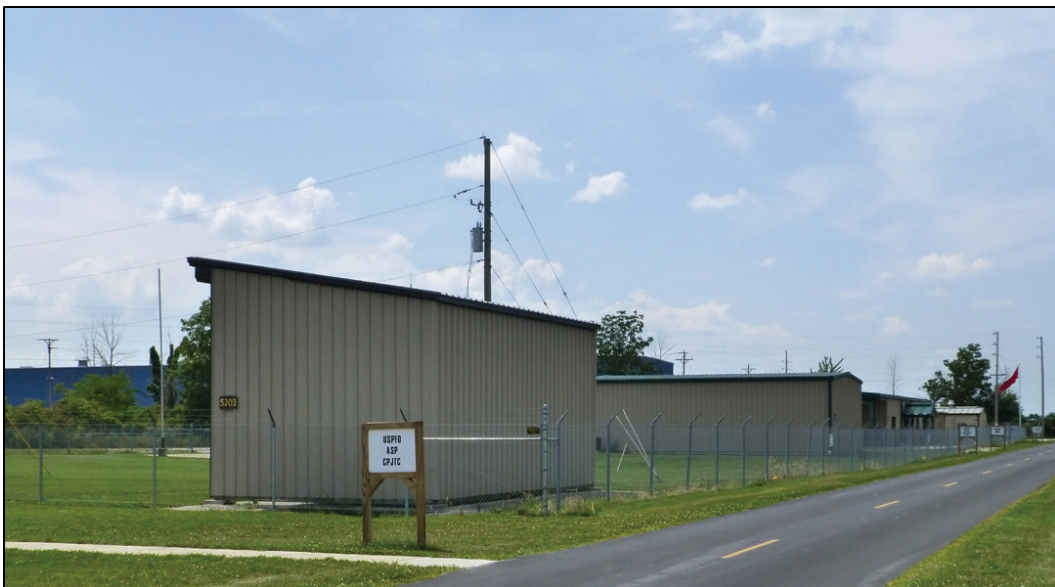
Figure 104. Looking southwest at Building 5204 (ERDC-CERL 2017).

Building 5204 was constructed in 1995 and has not been evaluated (Figure 104).

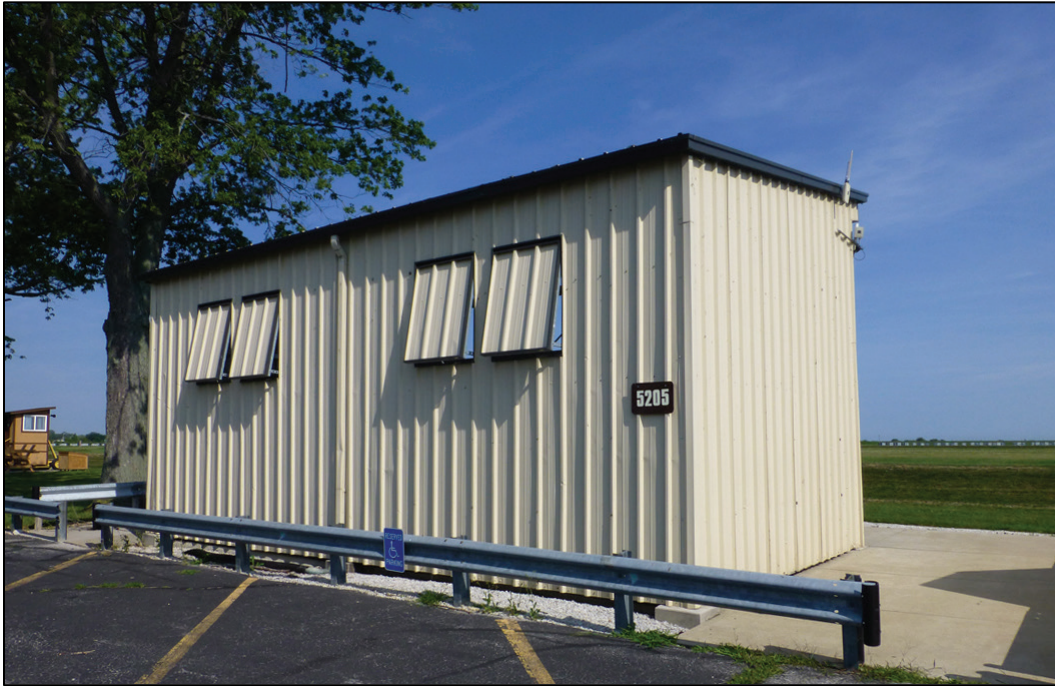
Figure 105. Southeast oblique of Building 5205 (ERDC-CERL 2017).

Building 5205 was constructed in 1980 and has not been evaluated (Figure 105).

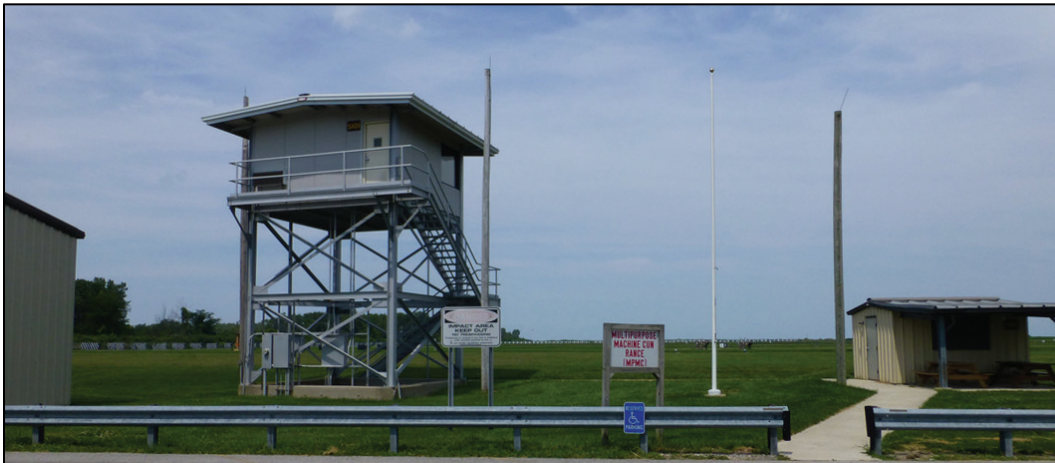
Figure 106. Looking north at Building T5101 on the left (ERDC-CERL 2017).

Buildings T5101 (Figure 106), T5201, and T5301 were constructed in 1995 and have not been evaluated.

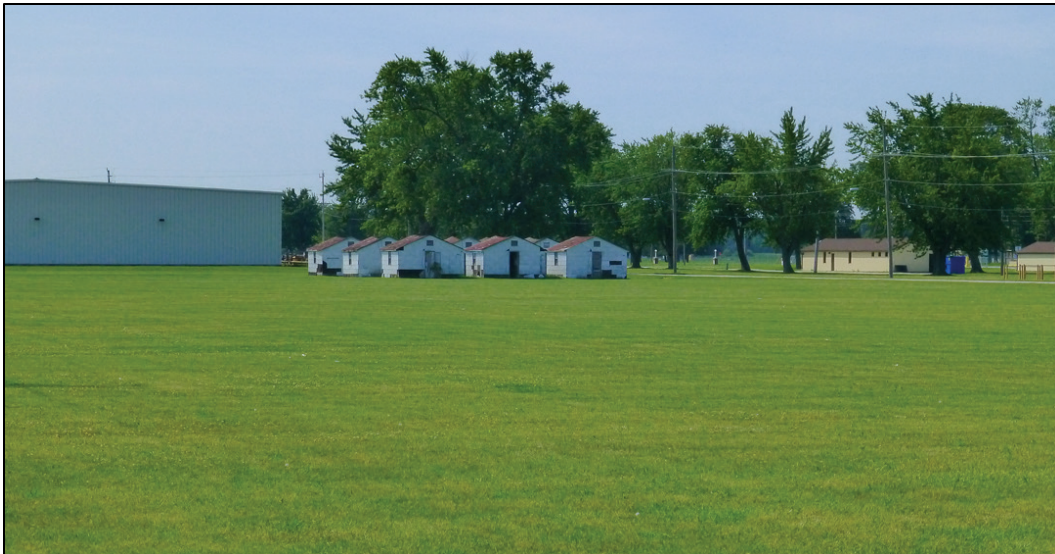
The nine hutments standing in this area were constructed in 1942, documented on OHI forms in 1993 by McQuillin and Assoc., and recommended not eligible in 2008 by MSG. Hutments KK2, KK3, KK4, LL2, LL3, LL4, MM2, MM3, and MM4 were being preserved in place as stipulated in the 2009 MOA (Section 2.6) (Figures 107 and 108). Unfortunately, with no preservation plan in place, these 9 hutments have deteriorated beyond repair. In May 2020, the OHARNG and SHPO began consultation regarding demolition of these nine hutments and alternate mitigation measures. In an effort to minimize the adverse effect of demolishing the nine hutments, the OHARNG has proposed reconstructing one or more hutments for educational purposes in the designated memorial area of Camp Perry. This project will be ongoing until at least 2021.

Figure 107. Looking south over former hutment area towards hutments KK 2-4, LL 2-4, and MM 2-4 (ERDC-CERL 2017).

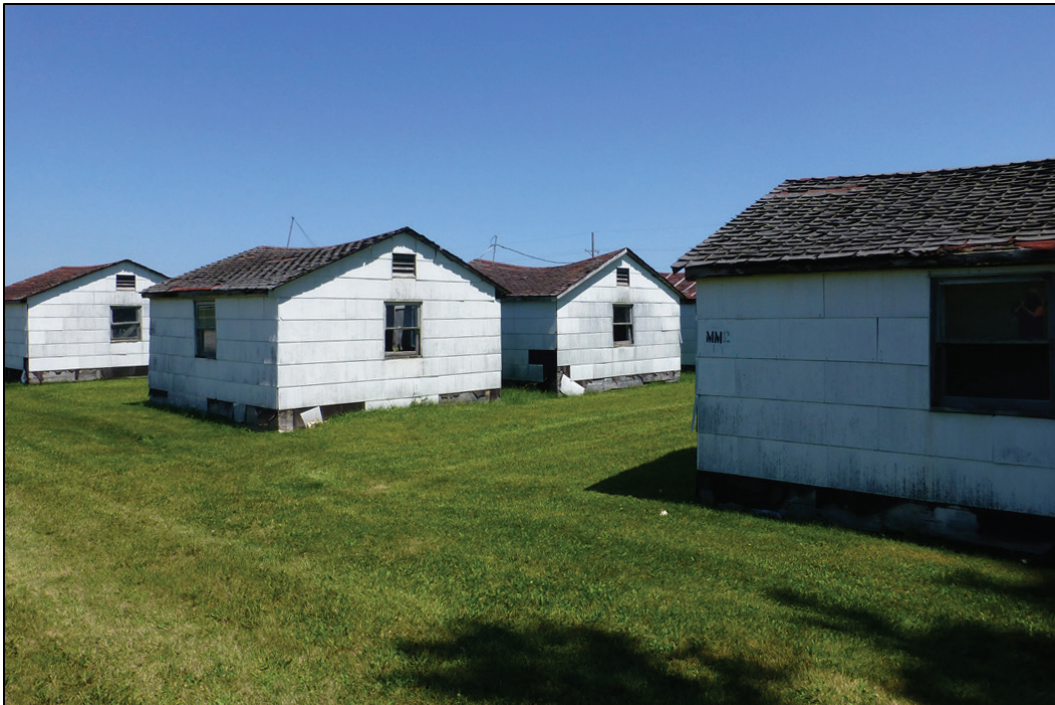
Figure 108. Looking northeast toward hutments KK 2-4, LL 2-4, and MM 2-4 (ERDC-CERL 2017).

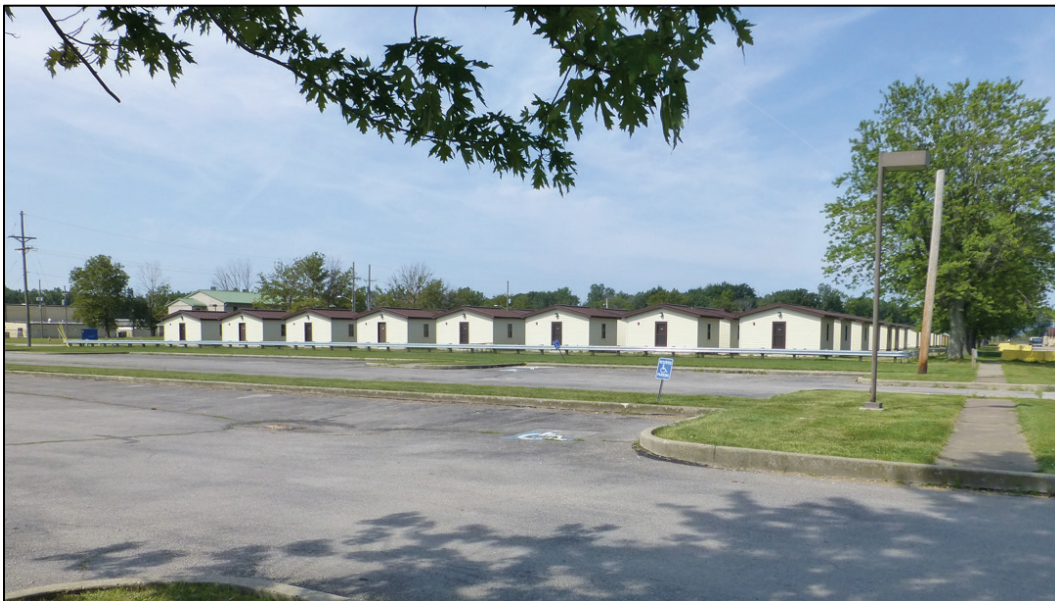
Hutments in this area were constructed in 2014, and they have not been evaluated (Figure 109 and 110). The hutments surround latrine/showers CD and EF (see Section 3.90).

Figure 109. Looking west at hutments from Niagara Road (ERDC-CERL 2017).

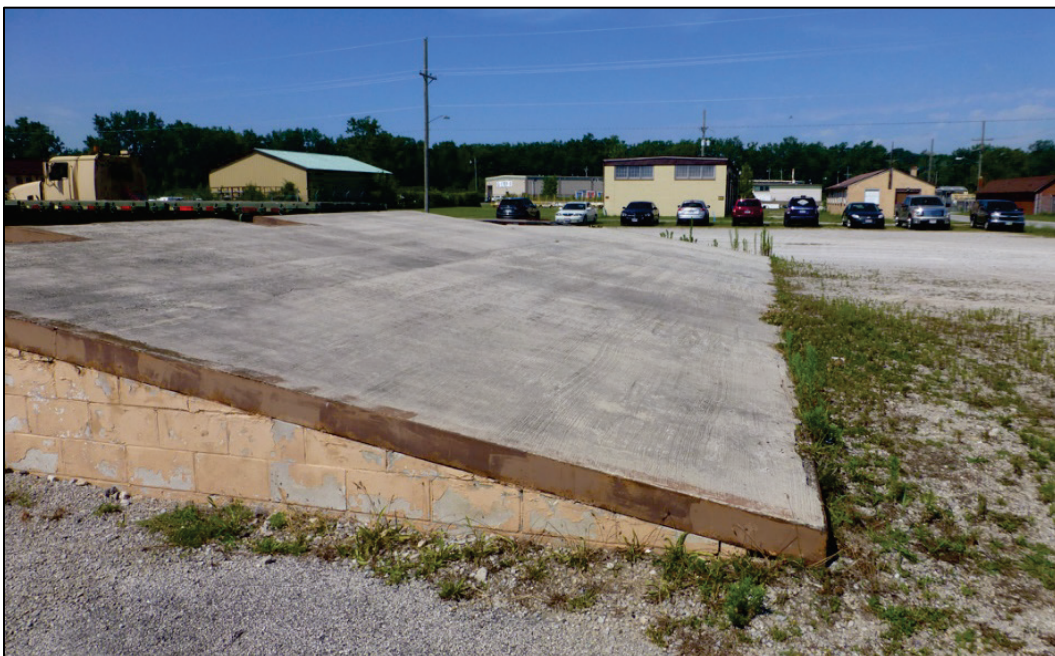
Figure 111. Looking east at the loading dock (ERDC-CERL 2017).

Real Property has the loading dock as being built in 2000. While the concrete pad on top is from 2000, there may be a small portion of the older dock under the concrete pad (Figure 111).

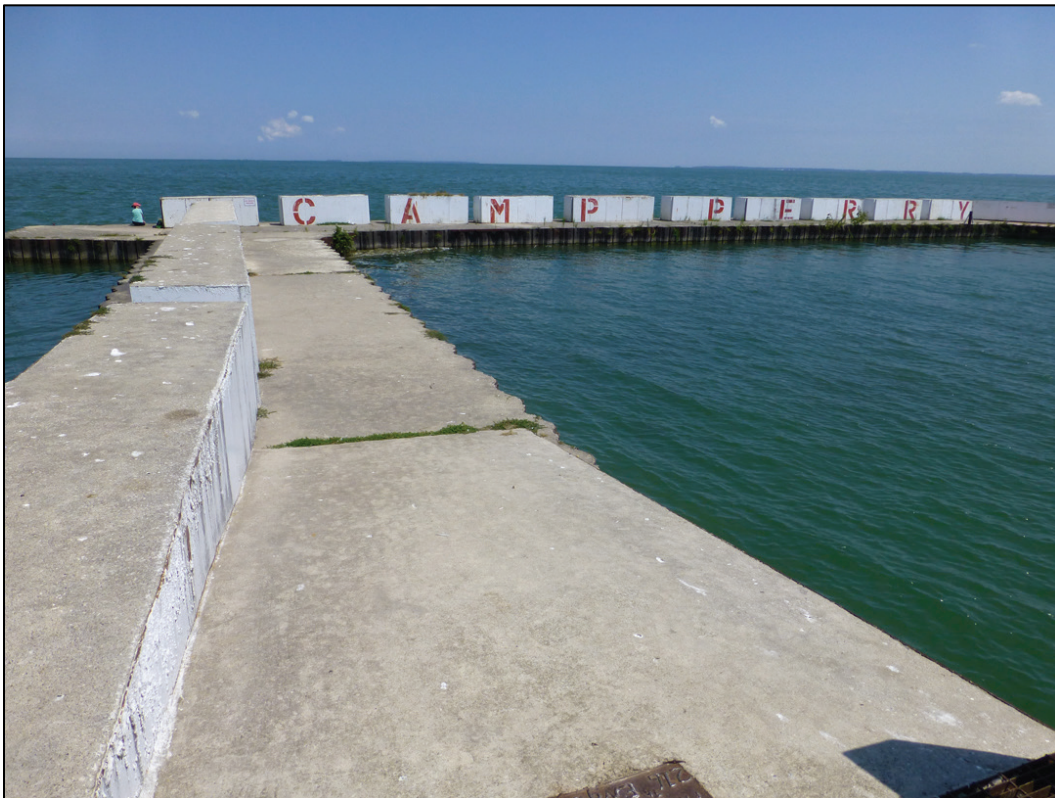
Figure 112. Looking north at breakwater (ERDC-CERL 2017).

According to Camp Perry, the current pier and bridge was constructed in 1985. According to Bovia (1992), a temporary pier was first constructed at the current location in 1906 to support boat passengers from Port Clinton to Camp Perry. In 1927, 75 feet of the pier and boat landing were washed away due to a northeast storm. A new pier was built in 1934, and rehabilitation on 1,100 feet of pier and dock was completed in 1975–1977. It is likely the breakwater (Figure 112) was constructed around the time of the original construction of the facility, as it appears in historic photographs and aerials since establishment. The pier and bridge out to the breakwater, however, appear different in historic photos and aerials over the years. A pier is present on maps and aerials in the 1930s and 1940s. Between 1960 and 1972, however, the pier is no longer visible on aerial photos. In 1985 the pier re-appears as extending to the existing breakwater. It is possible the first portion of the pier from the shore to the bridge is original and has not been altered.

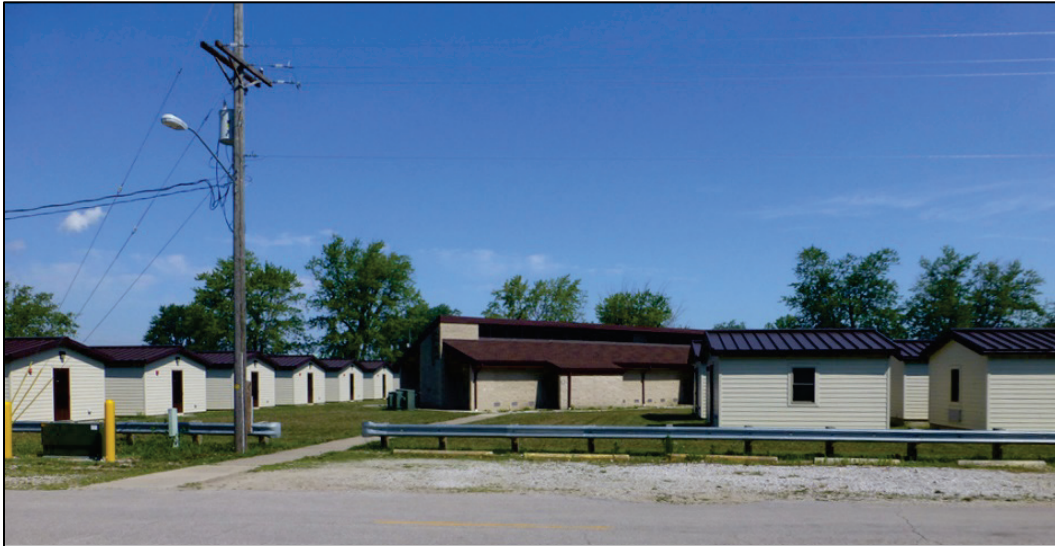
There are two of these latrine/shower buildings that were constructed in 1980 (Figure 113).

Figure 113. Looking north at latrine (Building EF), in center (ERDC-CERL 2017).

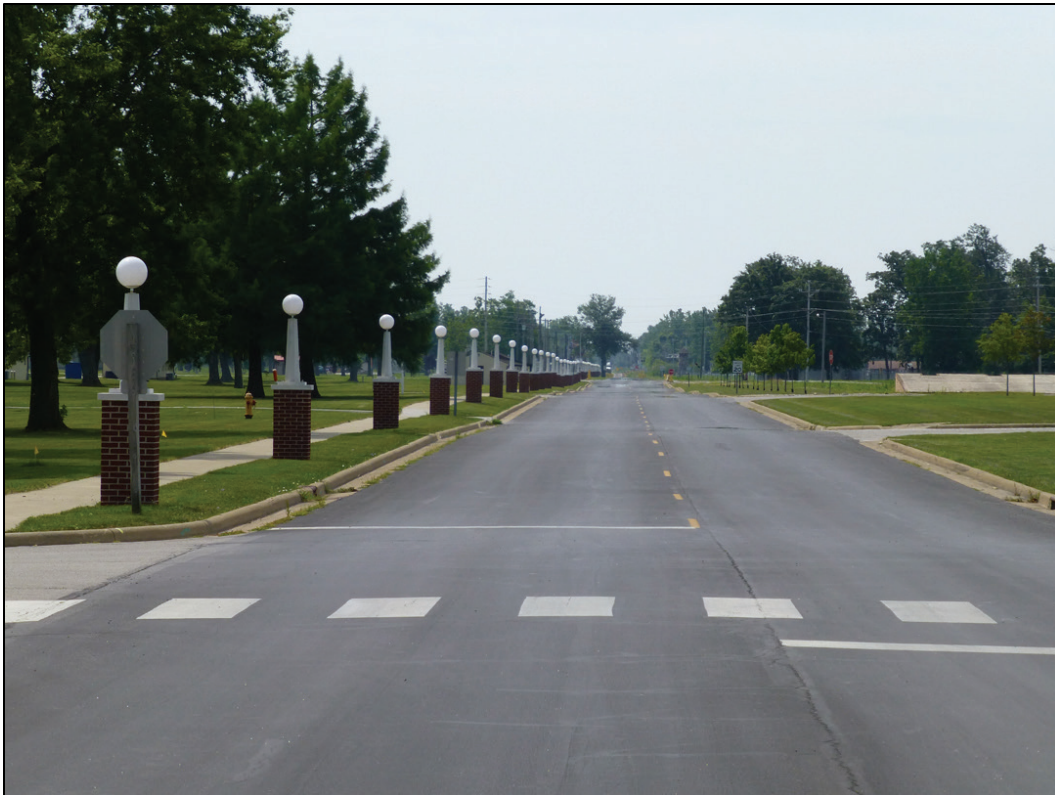
Street lamps (Figure 114) were originally constructed in 1936 along Niagara Road (Figure 115), Lawrence Road, and Critchfield Road (Figure 116). Most street lamps along Niagara Road have been reconstructed (Figure 117), and street lamps along Lawrence Road are in the process of being reconstructed.

Figure 114. View south of street lamps on the east side of Niagara Road (ERDC-CERL 2017).

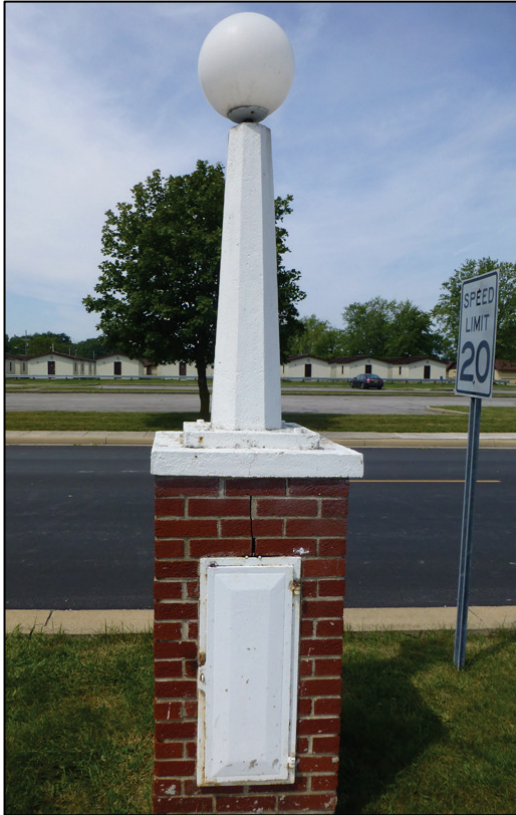
Figure 115. Original street lamp post on Niagara Road near Building 3 (ERDC-CERL 2017).

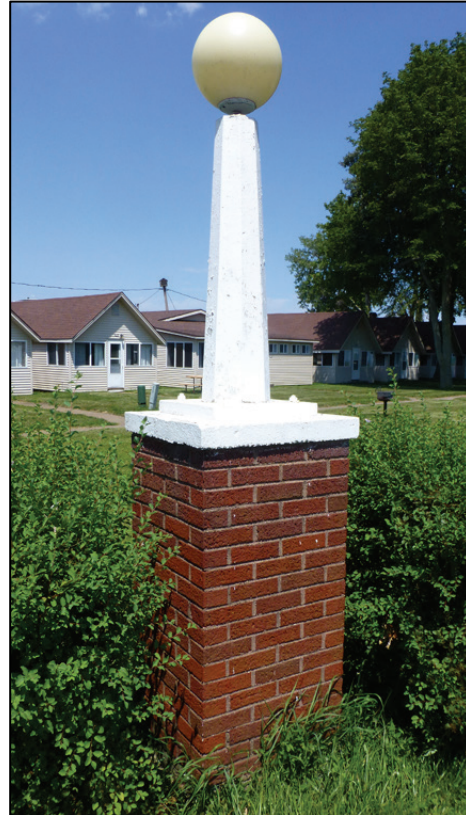
Figure 116. Original street lamp post on Critchfield Road near Building 508 (ERDC-CERL 2017).
