Camp Perry Historic District Landscape Inventory and Viewshed Analysis

Final Technical Report (TR)

Under Project 467080, "Camp Perry, OH Hist Dist Boundary Review and Viewshed Analysis"

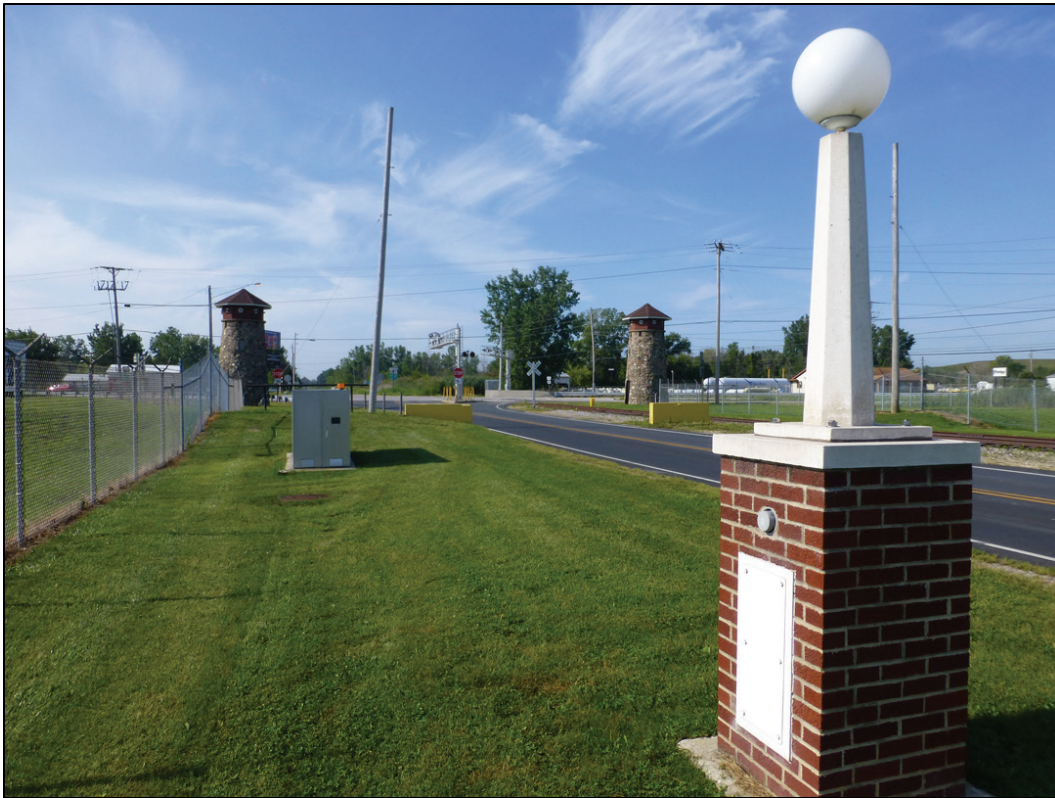
Figure 117. Reconstructed street lamp post on Niagara Road near the Main Gate (ERDC-CERL 2017).

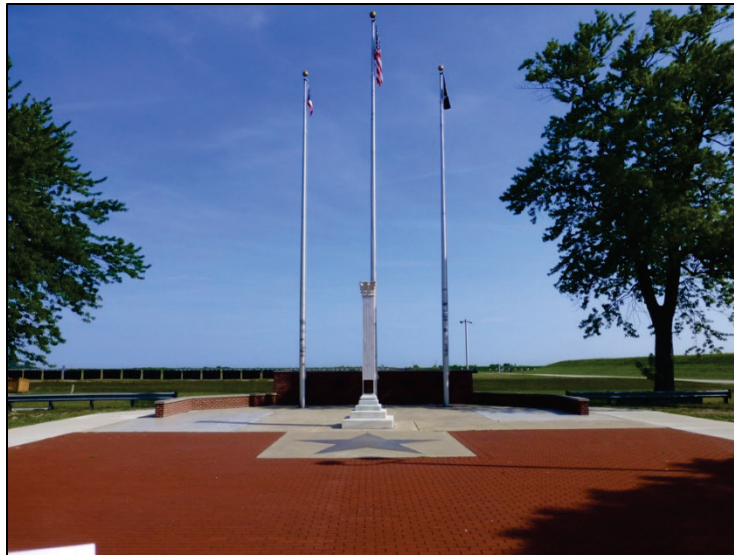
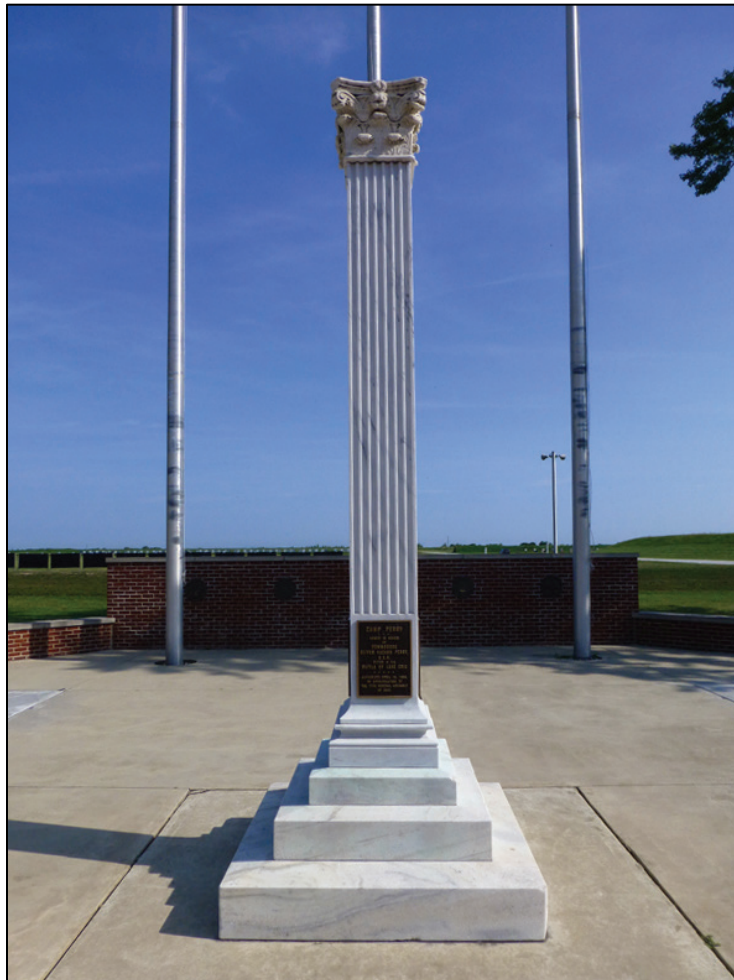
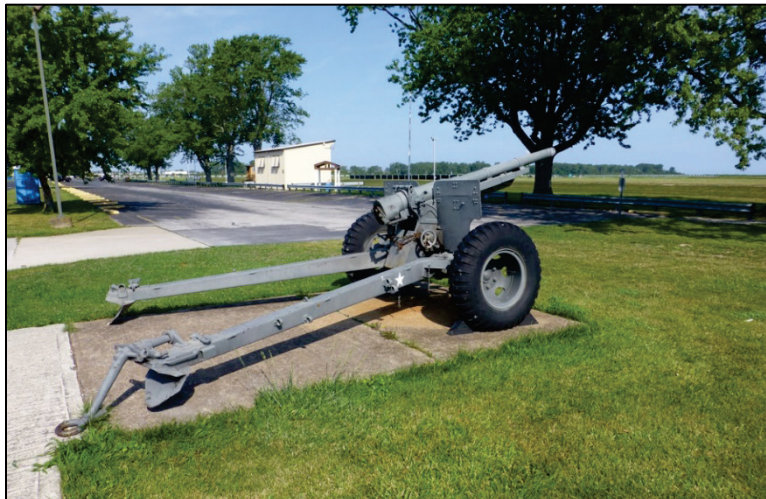
Shooter Memorial Plaza (Figures 118–121) contains three flagpoles (5010, 5011, and 5012), all of which were added in 2002. One of the flagpoles (5011), replaced the original flagpole, destroyed by the 1998 tornado. The plaza also contains the current Critchfield Monument. The original monument was constructed in 1936 and located in front of the Post Exchange (PX). The monument suffered damage in the 1998 tornado. The shaft of the original monument was destroyed, but the marble slabs at the base and the marble cap are original. After the restoration, the monument was moved from the PX to the plaza in 2002. Two guns (not on real property) are located on either side of the plaza. It is not known when the guns were added to the plaza area.

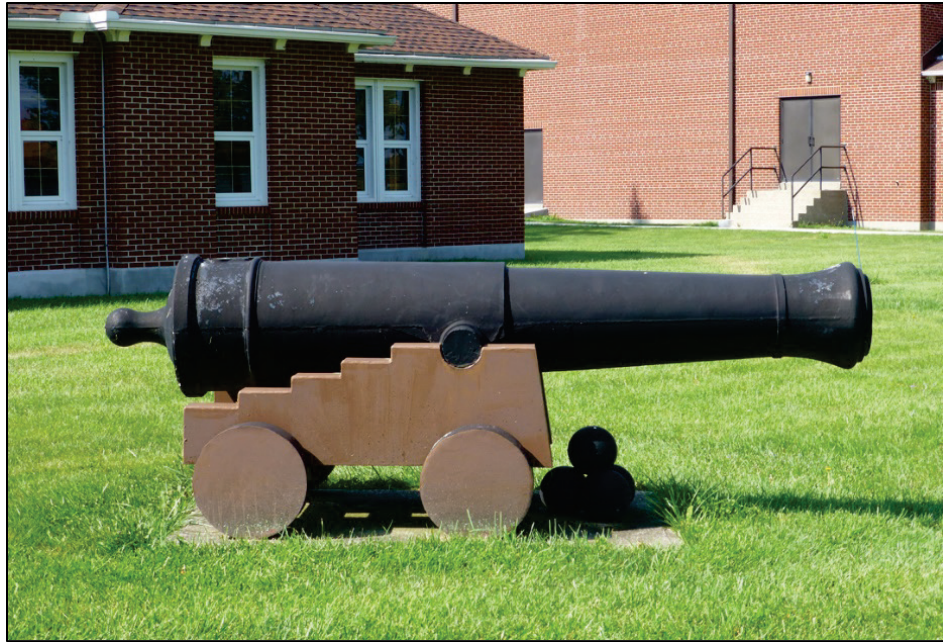
There are two cannons on either side of the entrance sidewalk from Lawrence Road to the front entrance of Building 1 (Figure 122). It is not known when these cannons were added to the landscape.

Figure 122. Cannon in front of Building 1 (ERDC-CERL 2017).

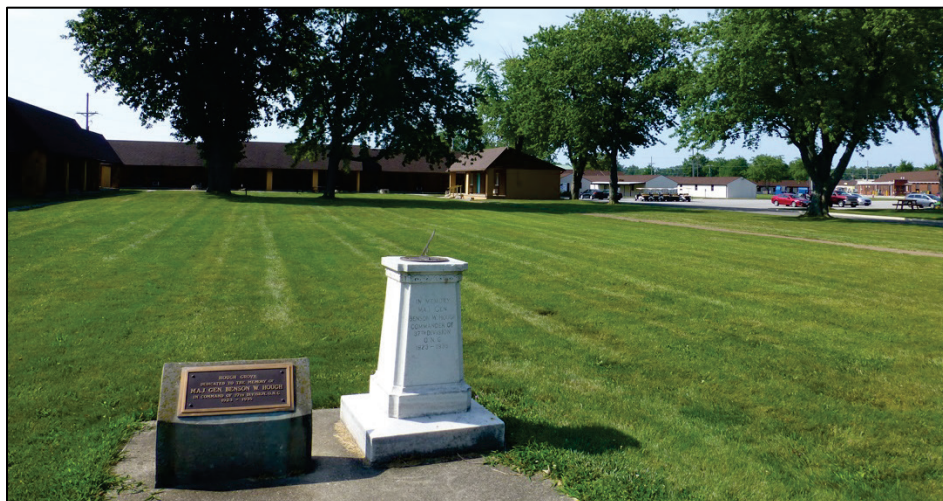
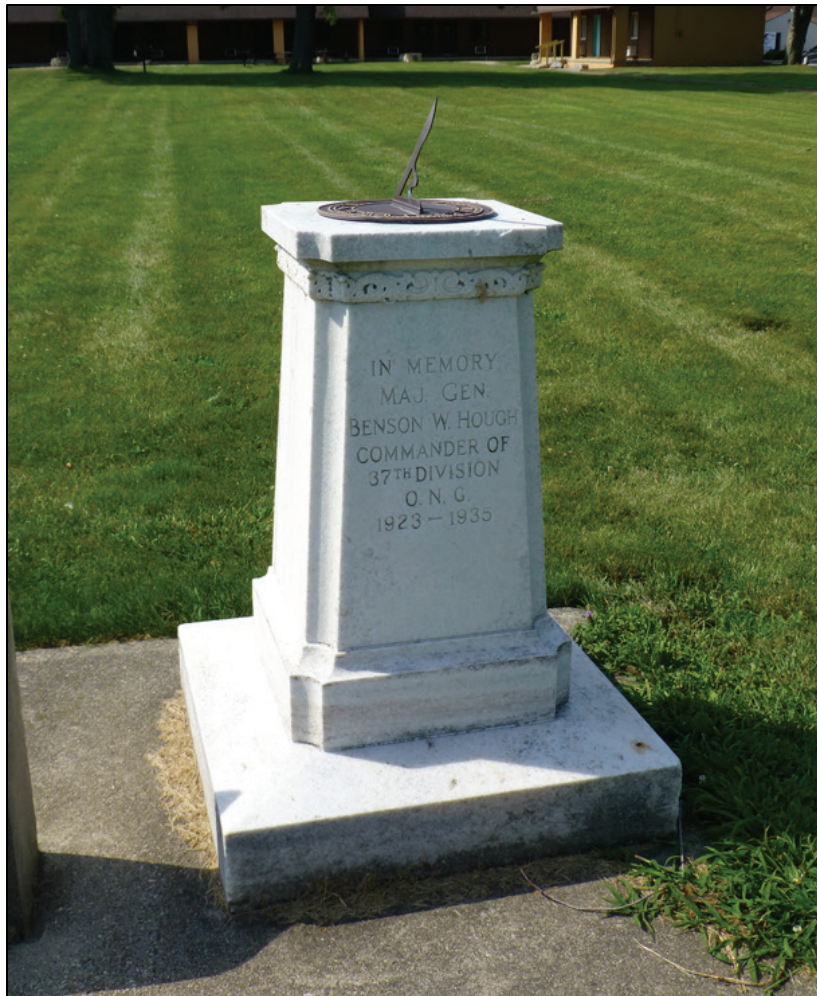
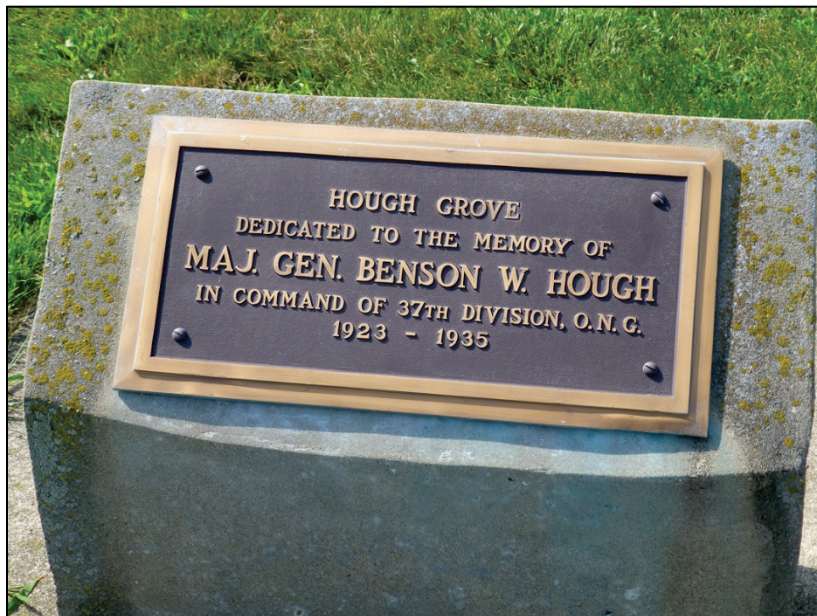
The Hough monument consists of a sun dial and a mounted plaque near the sidewalk that is close to Building 170 on Lawrence Road (Figures 123–125). No date was found for when these objects were added to the landscape.

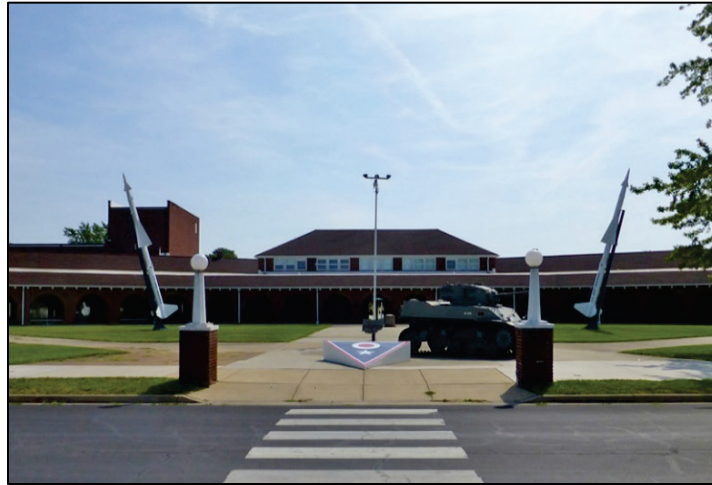
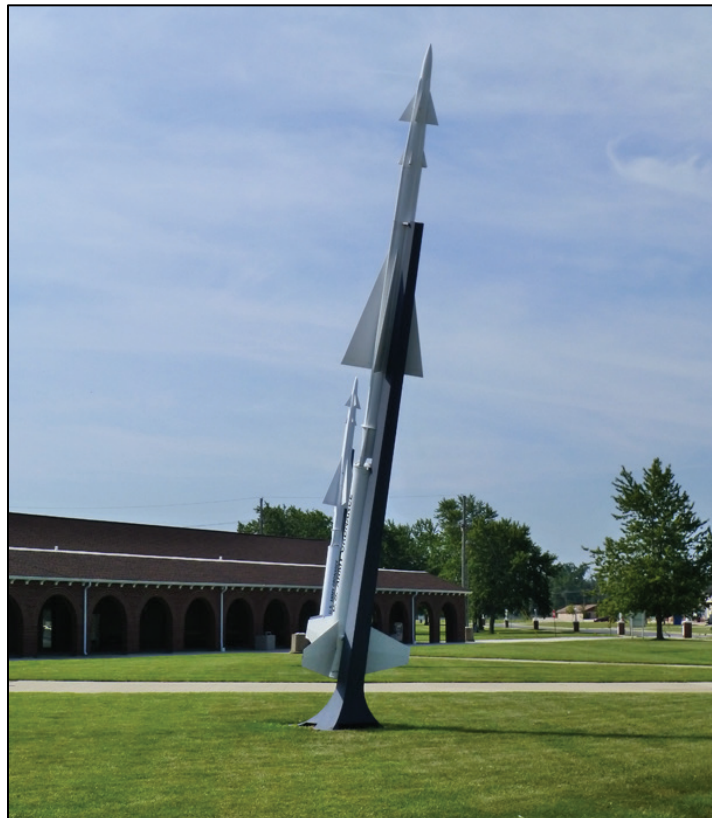
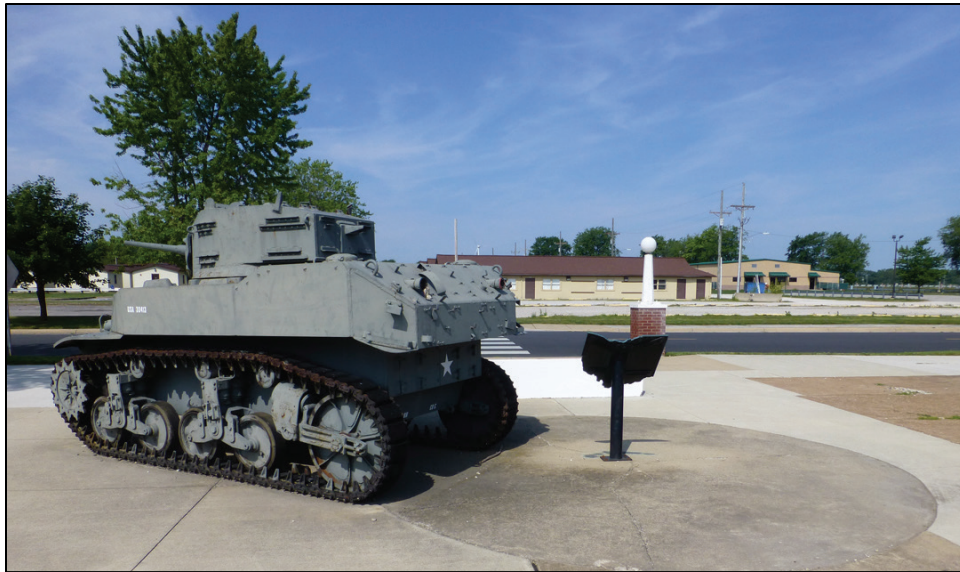
Two types of Army materiel form a monument in front of Building 3 (Figure 130) consisting of two missiles (one is shown close up in Figure 131) and a tank (Figure 132). No date was found for when these objects were added to the landscape.

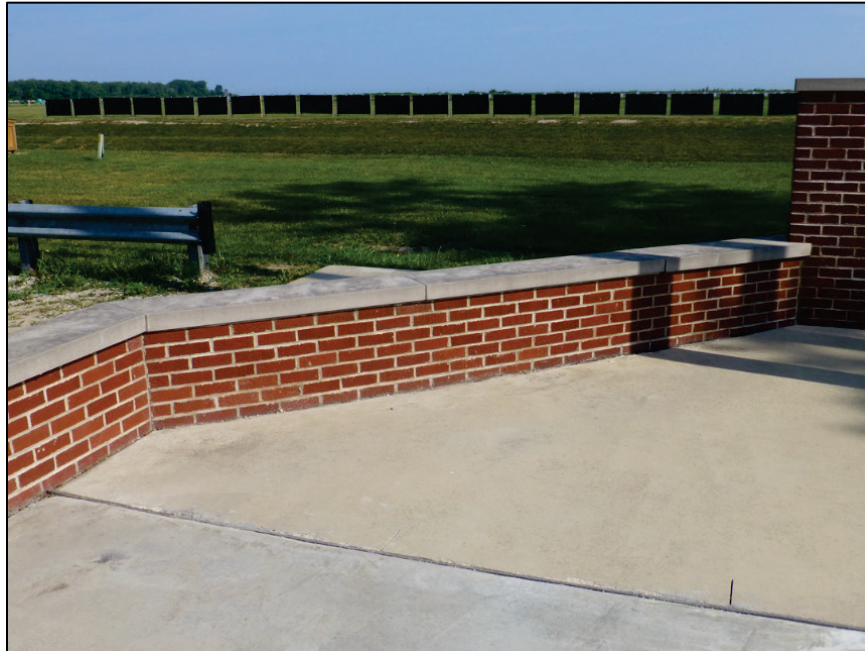
There is little seating provided anywhere at Camp Perry. There is a brick wall with a concrete top on the north side of Shooter Memorial Plaza (Figure 144), and a few plastic benches on the east and west sides of that plaza (Figure 145). It is likely these were added at the time of construction in 2003.

Figure 144. Bench wall in Shooter Memorial Plaza (ERDC-CERL 2017).

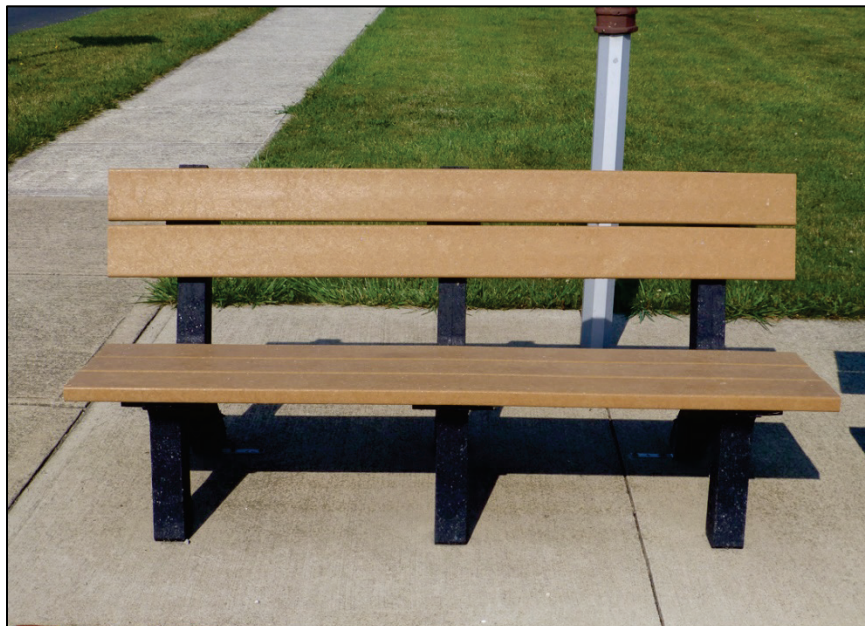
Figure 145. Plastic bench in Shooter Memorial Plaza (ERDC-CERL 2017).

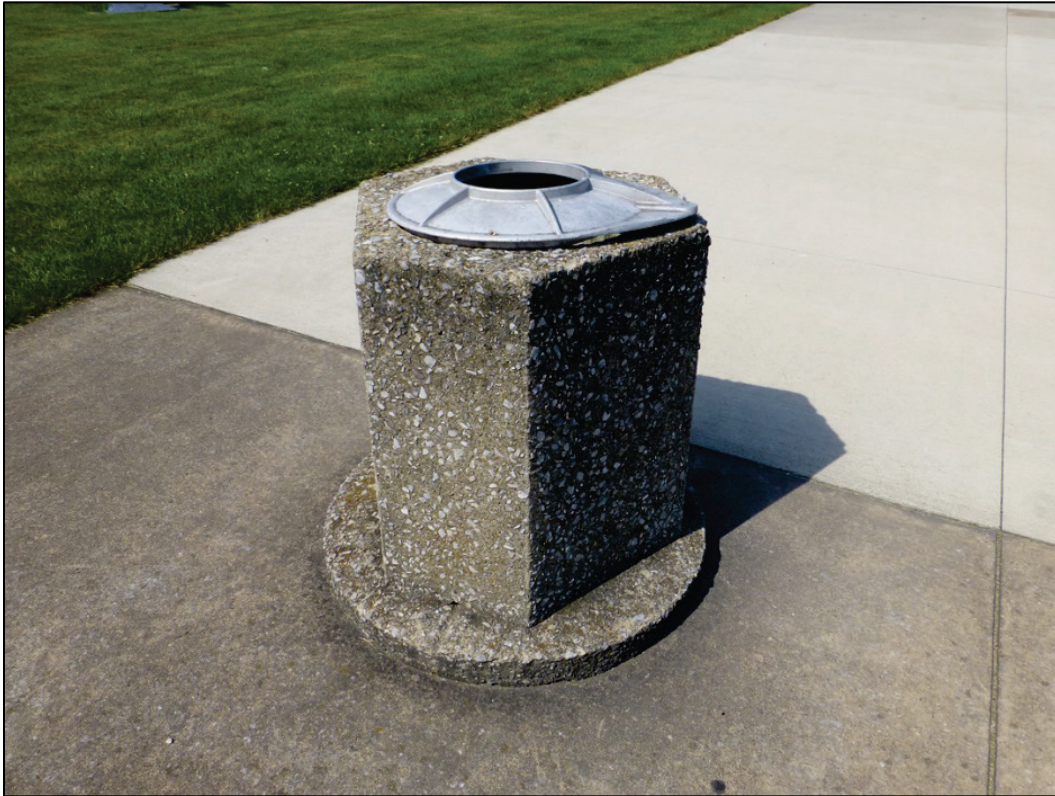
There are only a few trash receptacles at Camp Perry, with most of them located in the public area west of Building 3 (Figure 146).

Figure 146. Trash receptacle in front of Building 3 (ERDC-CERL 2017).

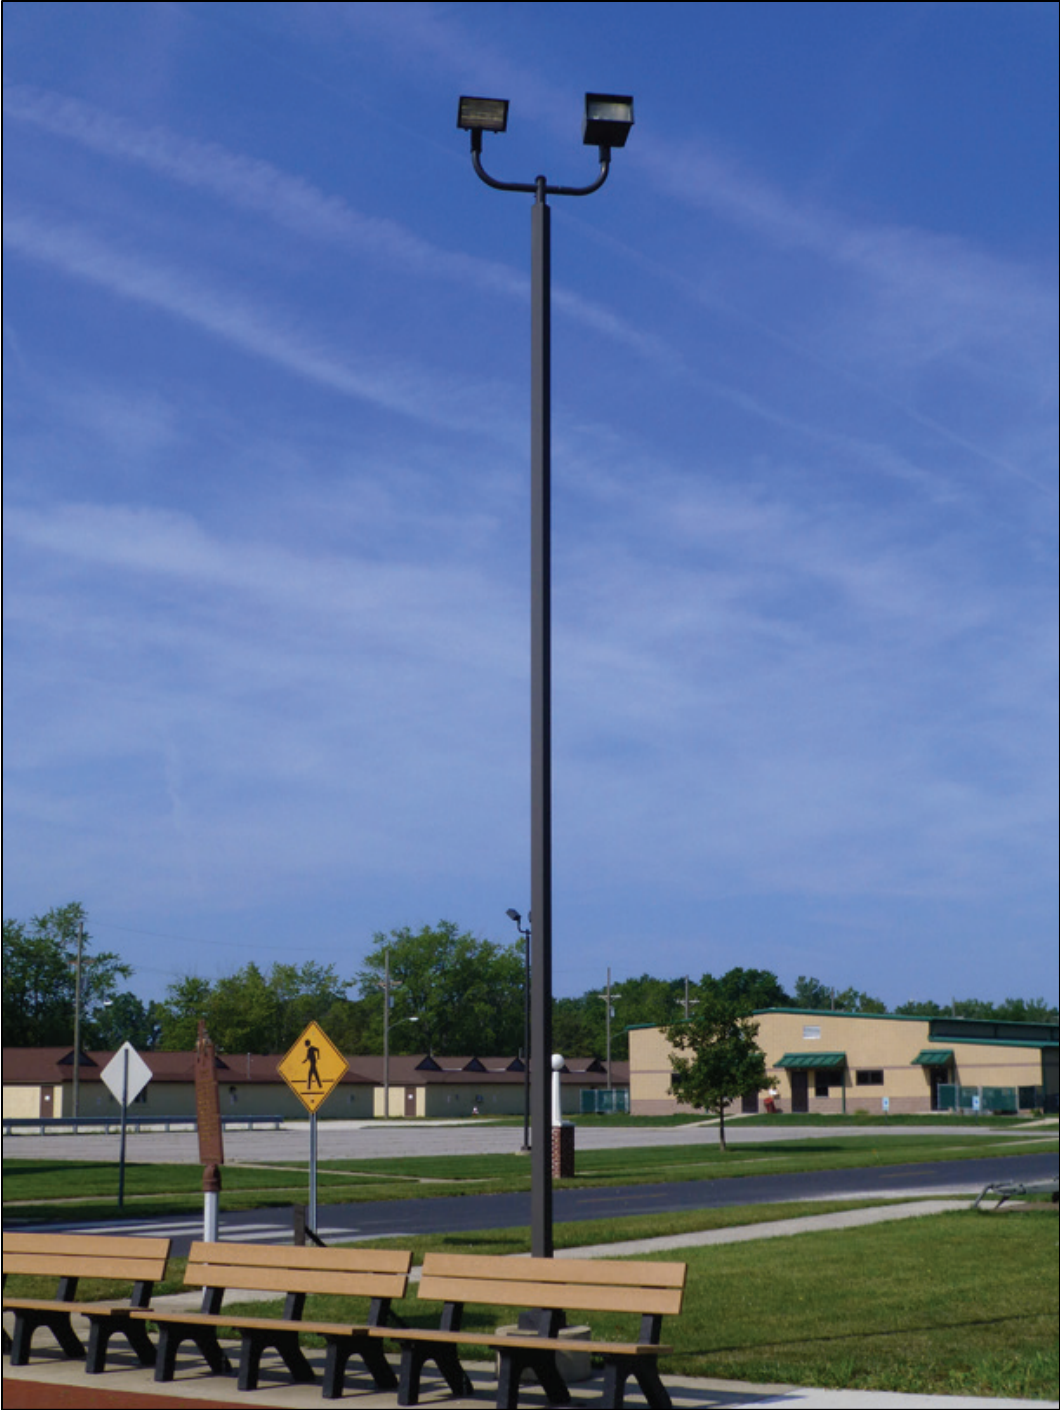
Besides the brick and concrete street lamps, there is not a cohesive lighting scheme at Camp Perry; only Shooter Memorial Plaza has “designed” light standards (Figure 147). Parking lots have an odd assortment of poles and lights.

Figure 147. Lighting in Shooter Memorial Plaza (ERDC-CERL 2017).

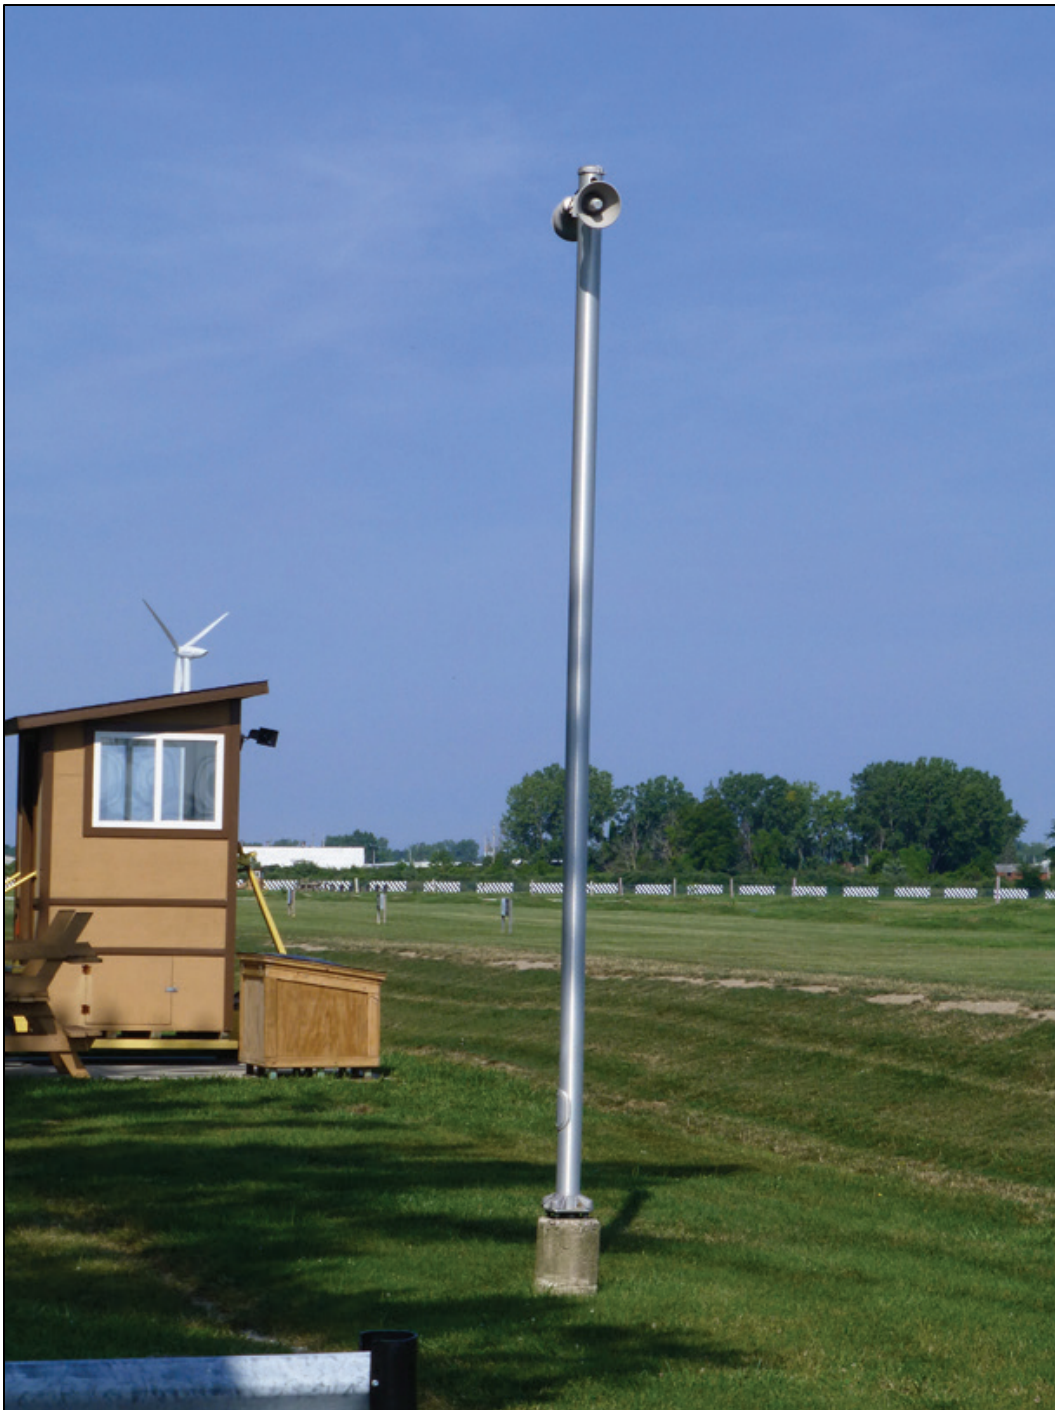
Camp Perry has a multitude of miscellaneous features scattered around such as “big voice” speakers (Figure 148), cast iron poles (Figure 149), and galvanized metal guardrails (Figure 150).

Figure 148. Example of big voice speakers (ERDC-CERL 2017).

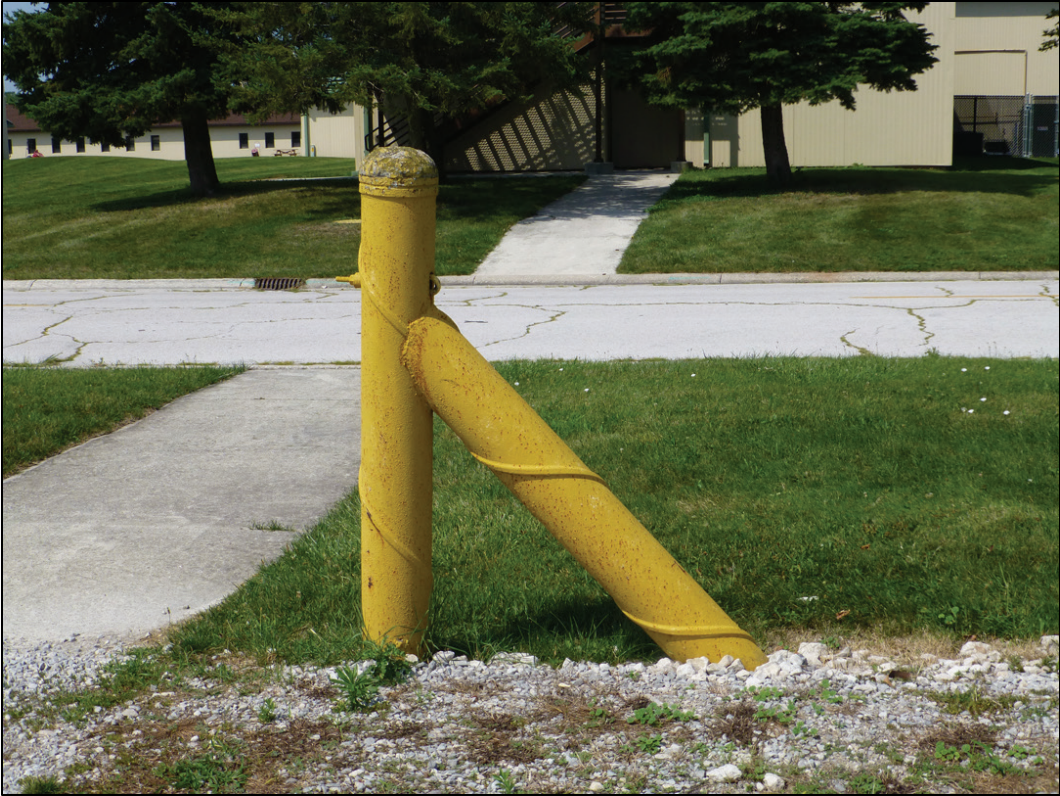
Figure 149. Example of cast iron poles (ERDC-CERL 2017).

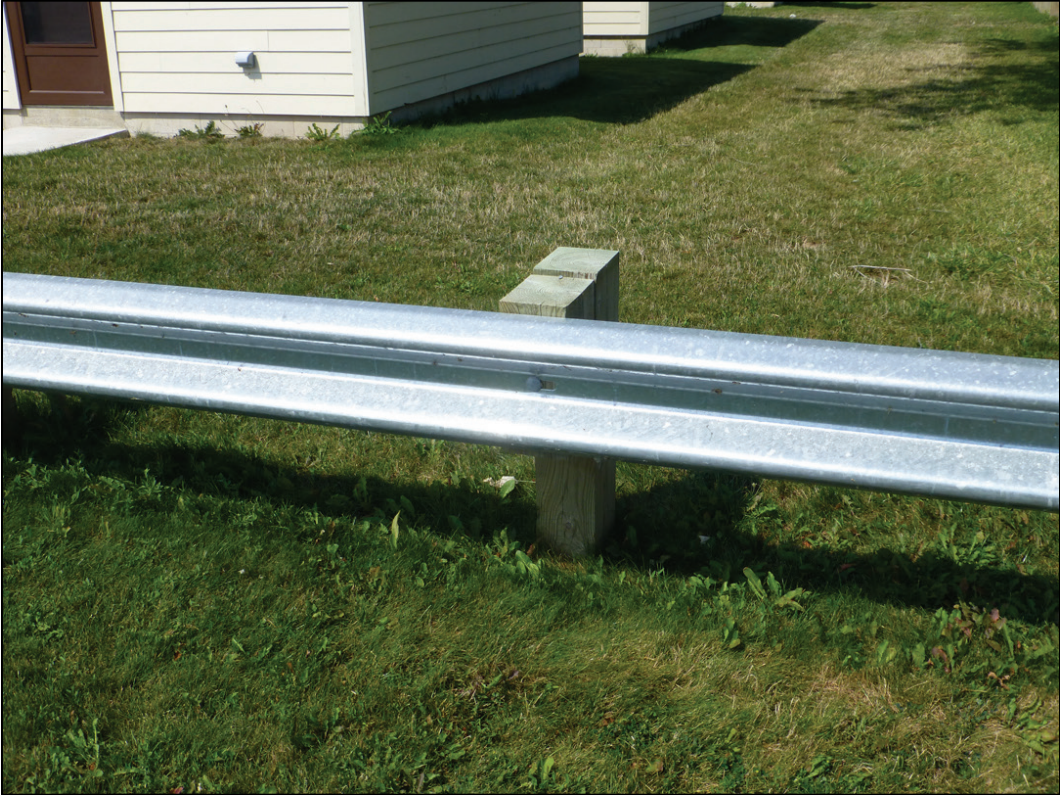
Figure 150. Example of metal guardrails (ERDC-CERL 2017).

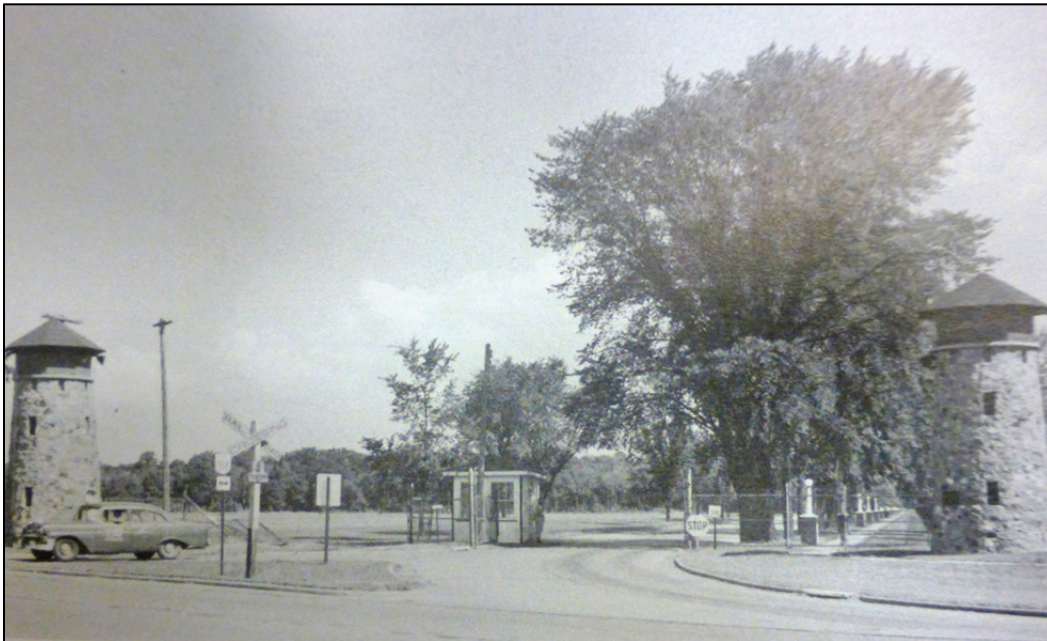
The Main Gate consists of two round stone towers, one tower on the east side and one on the west side of Niagara Road (Figures 152–154).⁵ Each stone tower is capped with a brick structure and a wood roof. On each side of the brick structures are red beacon lights, eight per structure. The towers were constructed in 1937 by the State of Ohio. Today, the guard hut has been removed and chain-link fencing added to restrict access to the installation. According to the historic photos, some of the lamp posts have been removed. The two stone towers are contributing to the historic district.

Figure 152. Historic view of the Main Gate in the early 1950s (Camp Perry).

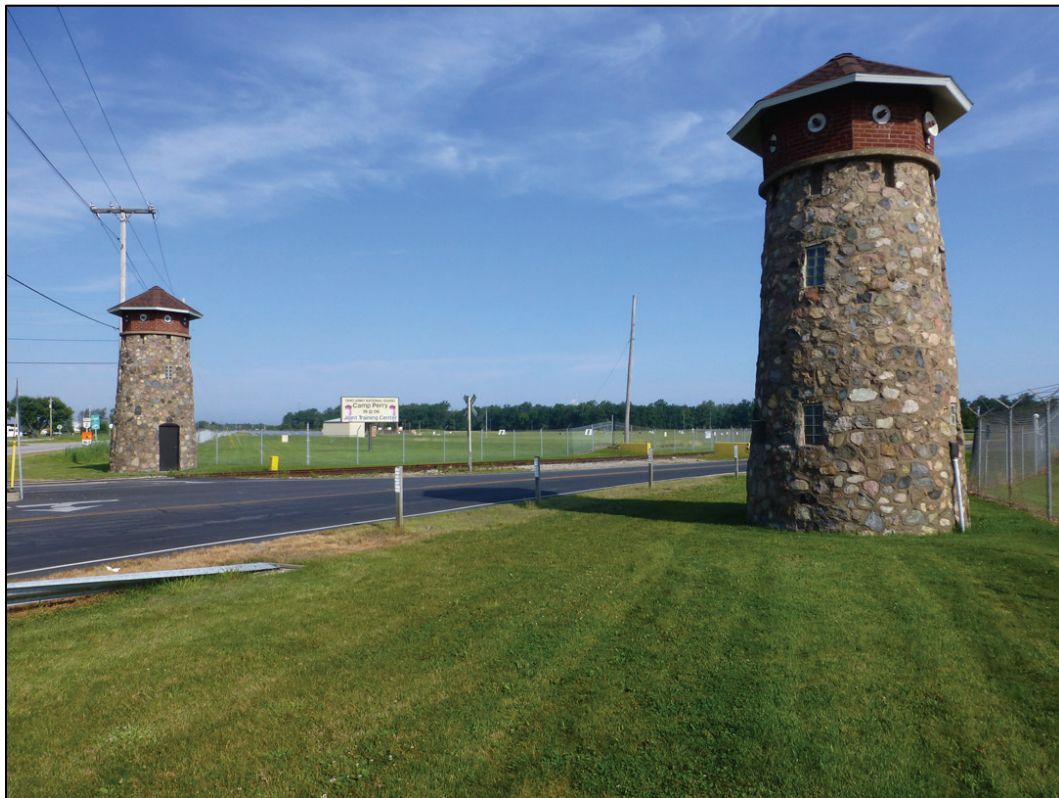
Figure 154. Looking northwest at Main Gate (ERDC-CERL 2017).

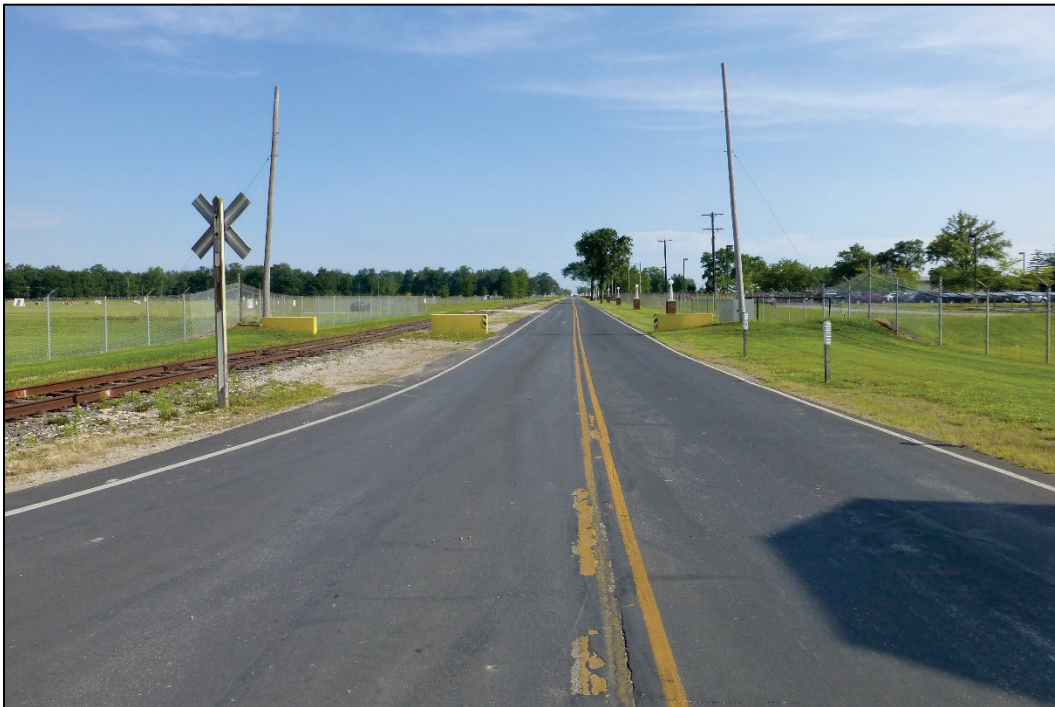
Niagara Road is a north-south road that dates to 1907. The east side of the road was lined with street lamps in 1936, and the railroad was on the west side of the road (Figures 155 and 157). These lamps have a brick base, a concrete shaft, and glass globe (Figure 156). Today some of the lamp posts have been removed as well as the street trees. The street lamps are contributing objects to the historic district.

Figure 156. View north of Niagara Road, with the railroad spur at left and street lamps to the right (ERDC-CERL 2017).

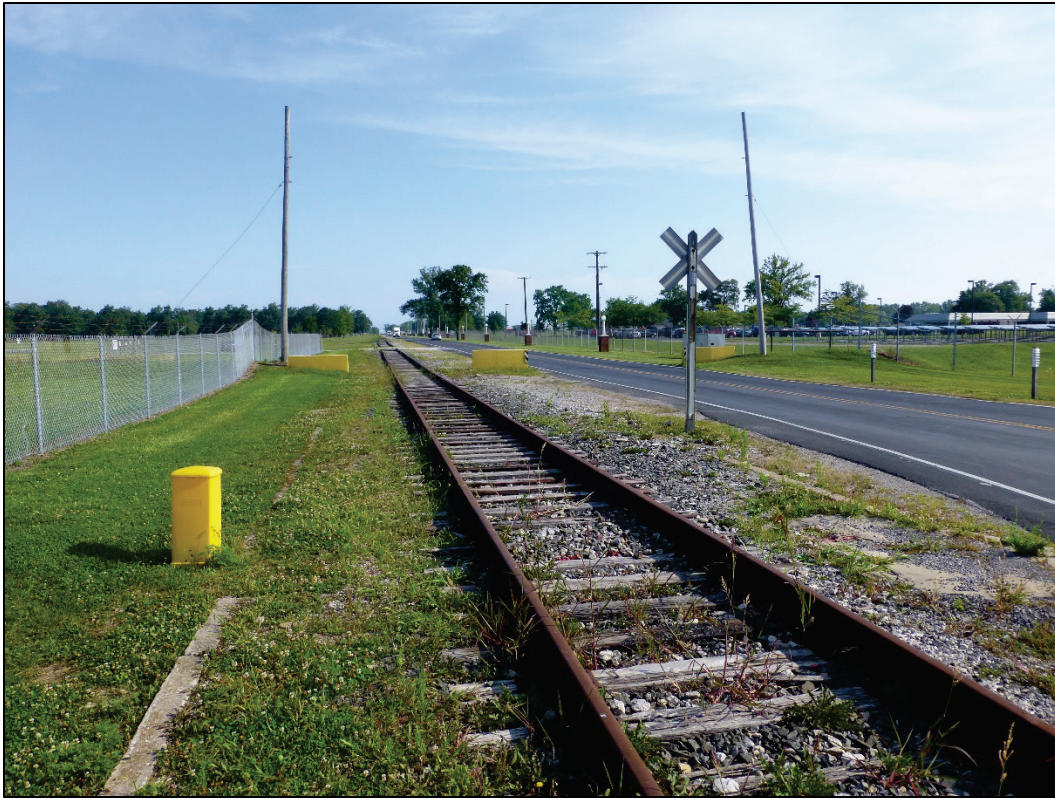
Figure 157. View north of the railroad spur (ERDC-CERL 2017).

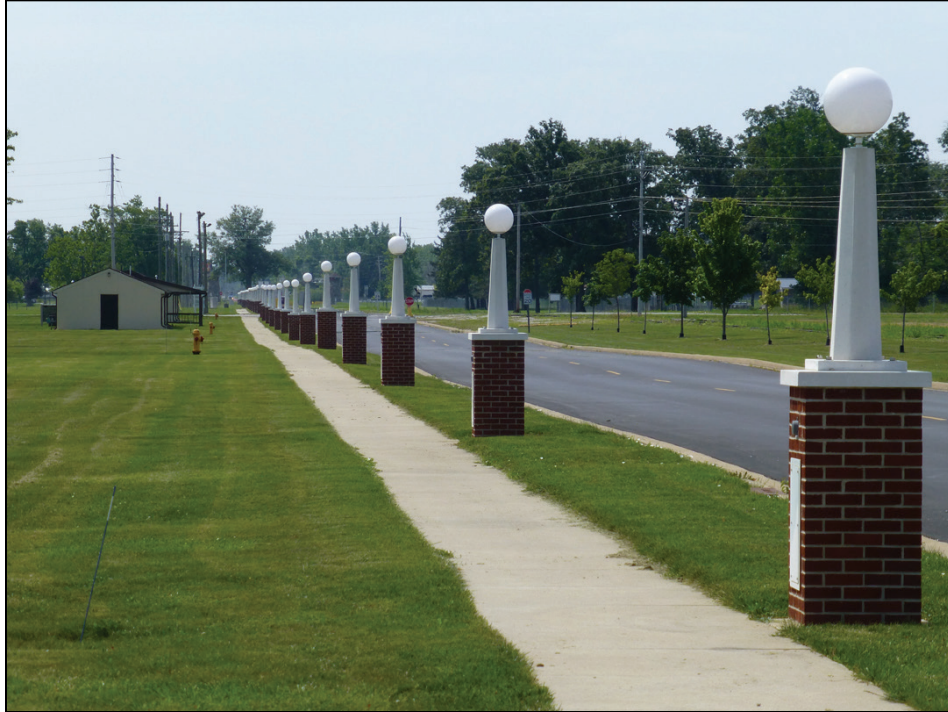
Figure 165. Looking north at the 1936 street lamps along Niagara Road in Area A (ERDC-CERL 2017).

Like most areas at Camp Perry, Area A has undergone massive changes since the period of significance. The area contains the contributing 1936 street lamps along Niagara Road (Figure 165), which replaced the earlier goose-neck style street lamps (Figure 166).

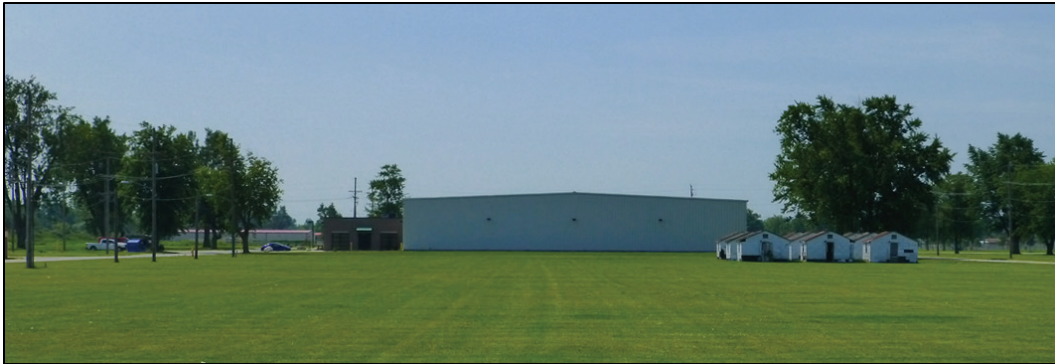
Like most areas at Camp Perry, Area B has seen massive changes from the period of significance. Building 3300 is a massive intrusion into Area B (Figures 175 and 176). The nine remaining hutments (Figures 176 and 177) do not give the feeling of how many hutments were once in this area, and they lack context without a shower and latrine building.

Figure 175. Looking south over Area B (ERDC-CERL 2017).

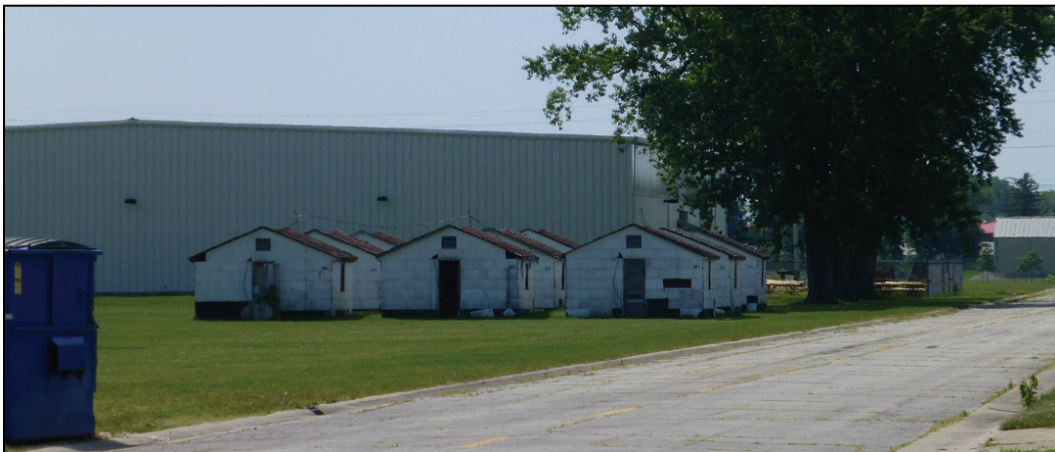
Figure 176. Looking south in Area B towards hutments and Building 3300 (ERDC-CERL 2017).

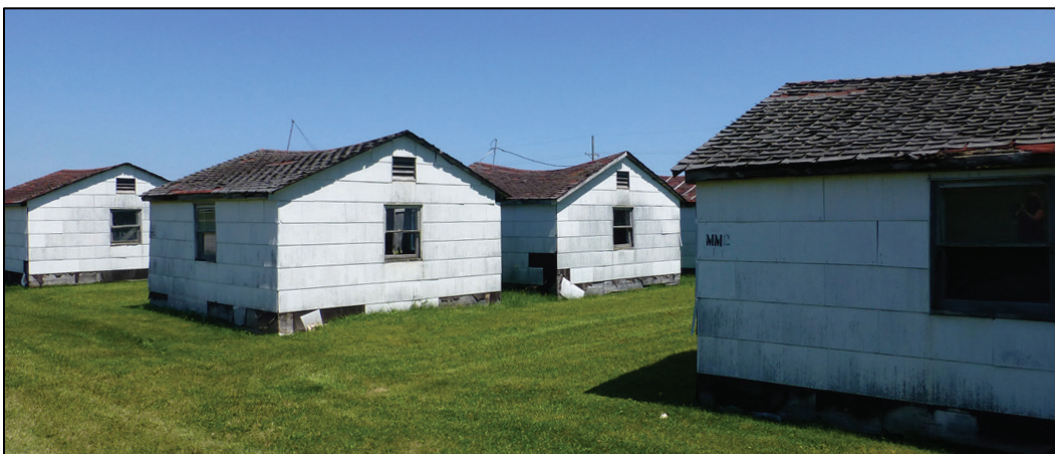
Figure 177. Looking northeast in Area B at the hutments (ERDC-CERL 2017).

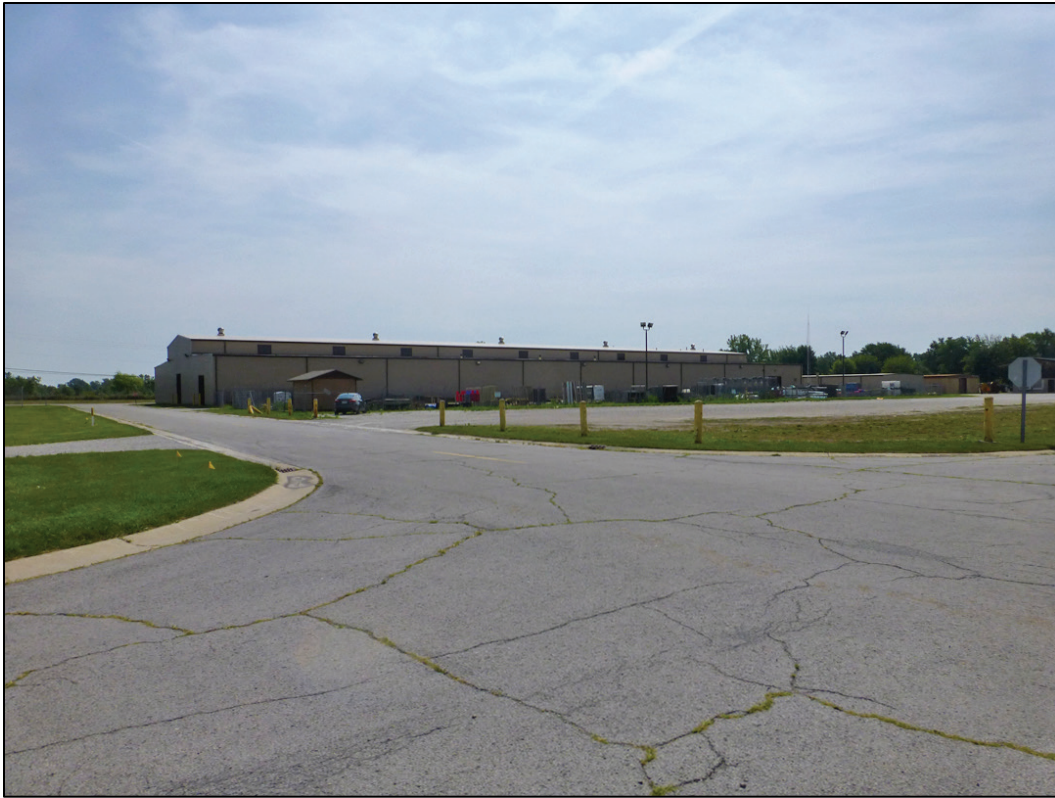
Like most areas at Camp Perry, Area C has seen massive changes from the period of significance. The remaining buildings do not give the feeling of a WWII area (Figures 183 and 184).

Figure 183. Looking southeast over Area C (ERDC-CERL 2017).

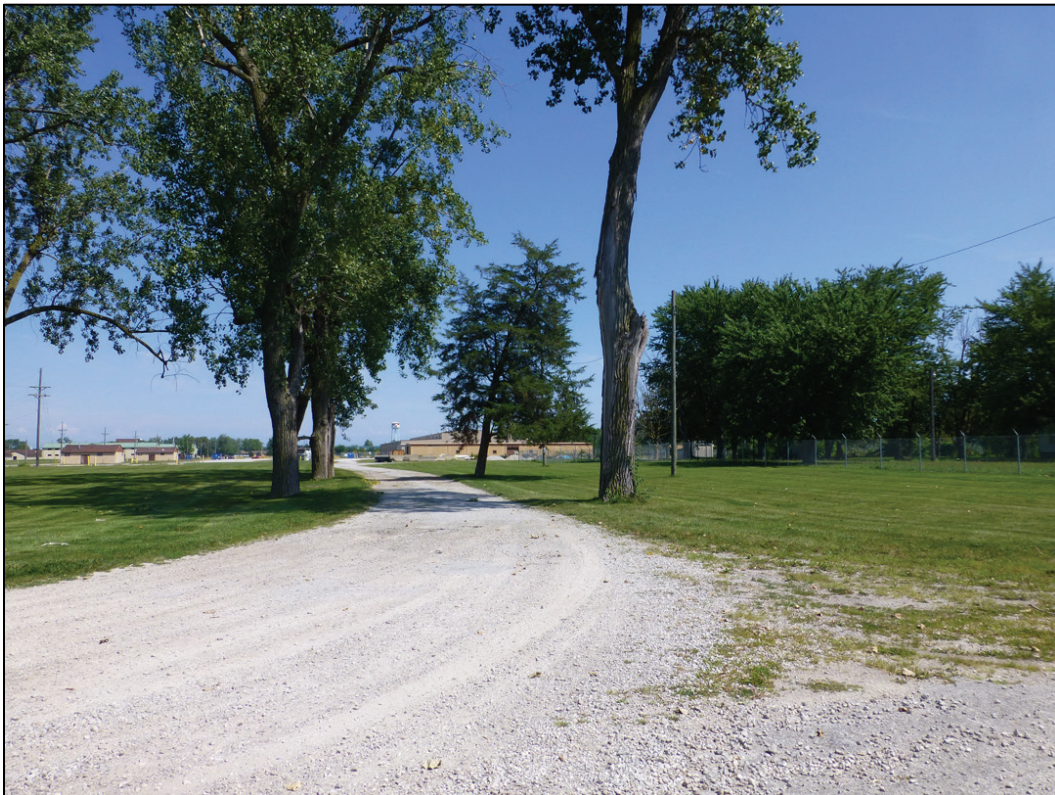
Figure 184. Looking north over Area C (ERDC-CERL 2017).

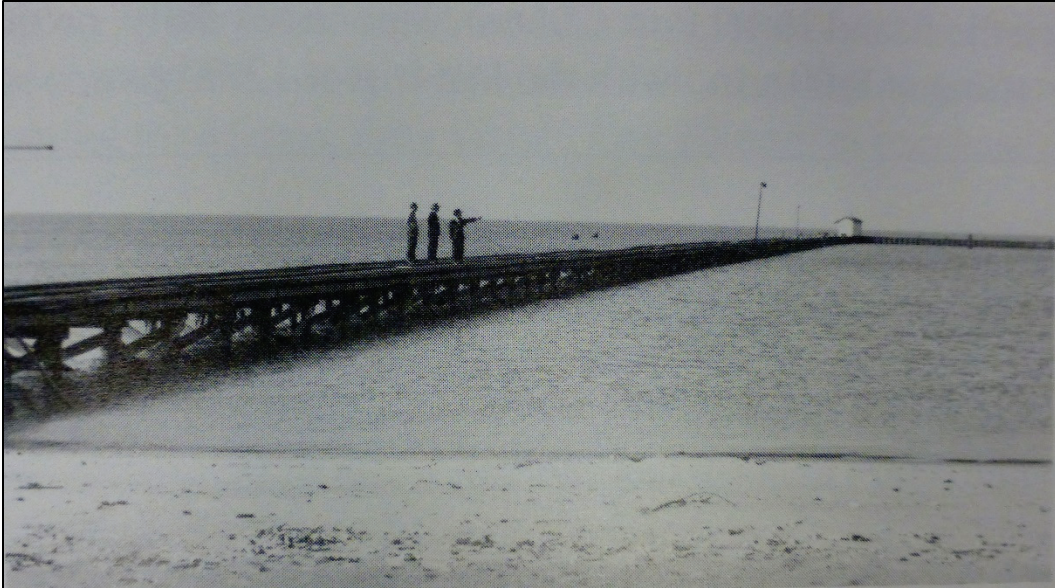
By 1943, the clubhouse, water treatment plant, and ice house were extant, and the rest of the area was filled with hutments and officers' quarters (Figure 200 and Figure 203). In 1936, the brick and concrete street lamp posts were erected along the looping road. A pier led out towards the breakwater in Lake Erie. According to Bovia (1997, 360), a new 835-foot pier was added in 1934 (Figures 201 and 202). The new pier was made of piling and stone and was 6 feet wide; it replaced an old wooden pier, most likely built in 1906, that had mostly washed away. While it is documented that the pier was rehabilitated in 1975–1977 (Bovia 1992, 177, see Figure 204), in looking at the historic aerials from Camp Perry's DPW, there was no pier to the breakwater between 1960 and 1972. A new metal pier with a bridge extending to the breakwater, was built in 1985. According to Camp Perry staff, it is possible that a section of pier along the shore is original and has not been altered.

Figure 201. Photograph of pier that was added in 1934, date unknown (Camp Perry).
