Camp Perry Historic District Landscape Inventory and Viewshed Analysis

Final Technical Report (TR)

Under Project 467080, "Camp Perry, OH Hist Dist Boundary Review and Viewshed Analysis"

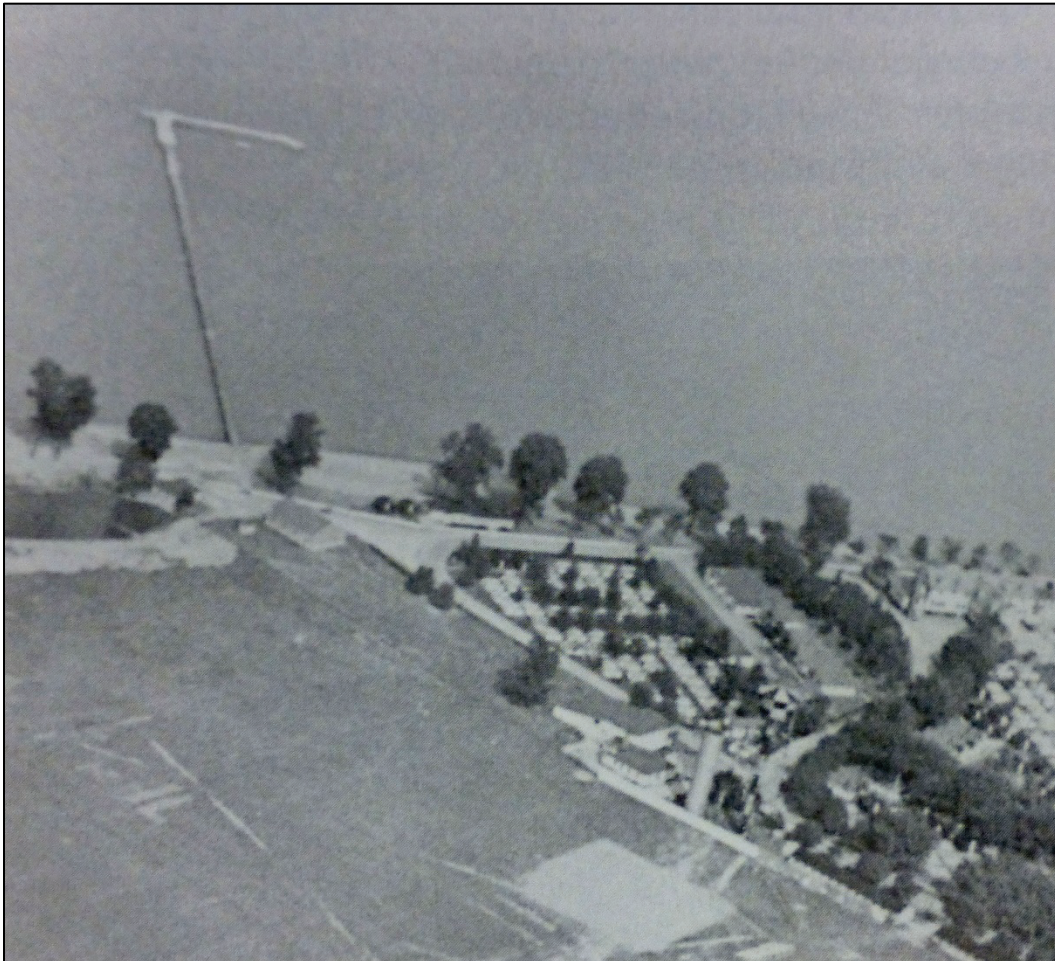
By 1943, the clubhouse, water treatment plant, and ice house were extant, and the rest of the area was filled with hutments and officers' quarters (Figure 200 and Figure 203). In 1936, the brick and concrete street lamp posts were erected along the looping road. A pier led out towards the breakwater in Lake Erie. According to Bovia (1997, 360), a new 835-foot pier was added in 1934 (Figures 201 and 202). The new pier was made of piling and stone and was 6 feet wide; it replaced an old wooden pier, most likely built in 1906, that had mostly washed away. While it is documented that the pier was rehabilitated in 1975–1977 (Bovia 1992, 177, see Figure 204), in looking at the historic aerials from Camp Perry's DPW, there was no pier to the breakwater between 1960 and 1972. A new metal pier with a bridge extending to the breakwater, was built in 1985. According to Camp Perry staff, it is possible that a section of pier along the shore is original and has not been altered.

Figure 202. Aerial of new pier and breakwater, 1934 (Camp Perry).

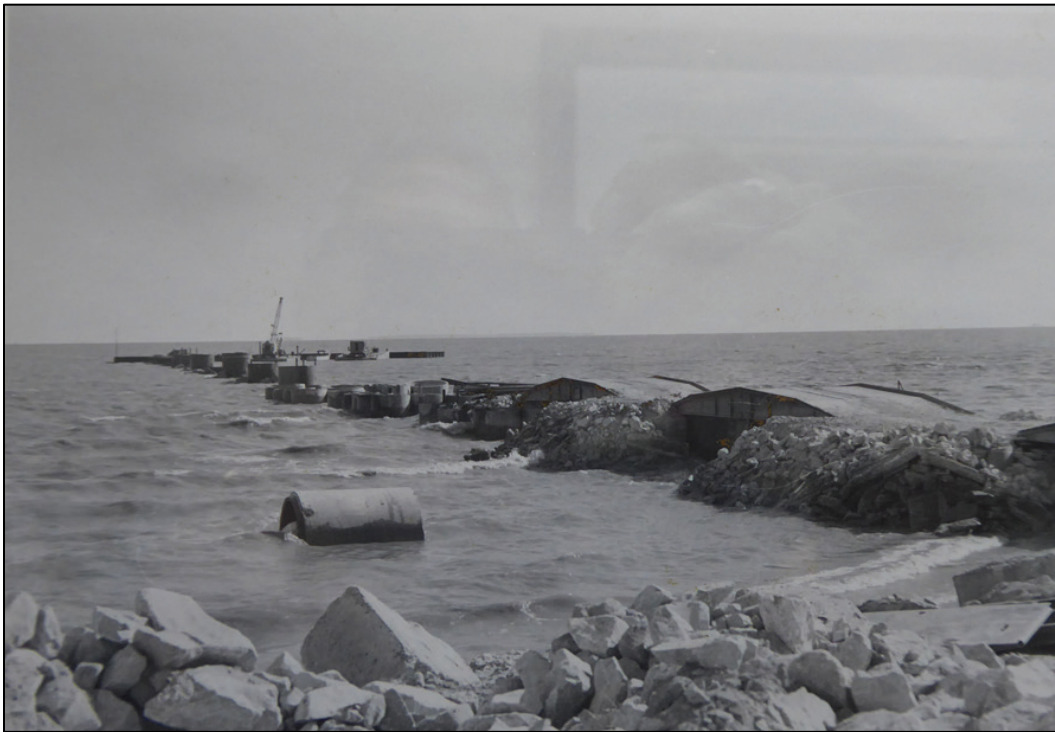
Figure 204. Photo showing reconstruction of pier in 1975 (Camp Perry).

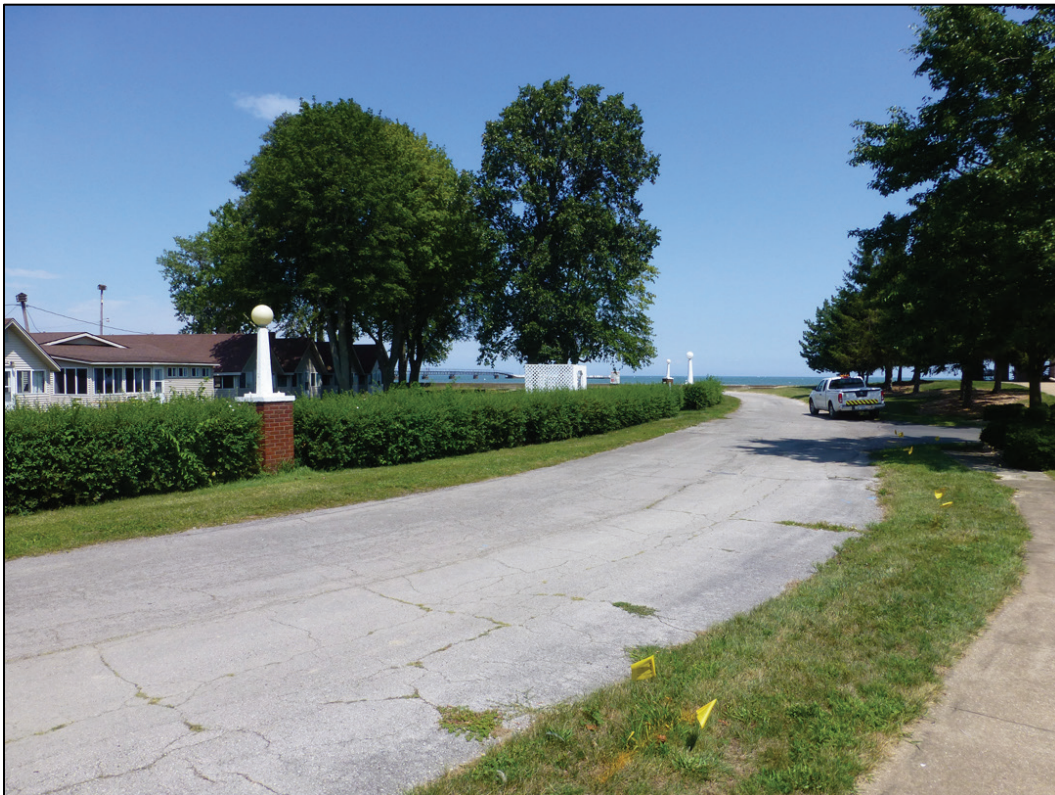
In 2017 (Area E shown in Figure 205), the looping road (Critchfield Road) and its brick and concrete street lamp posts were extant (Figures 207 and 208) along with the 16 officers' quarters from WWII. The clubhouse was replaced by a convention center in 1997 (Figure 206). The water treatment plant was demolished in 2019 and the ice house was still extant (Figure 209). Two WWII classrooms were joined together (Building 302) and transformed into transient officers' quarters (Figure 212). Finally, in 2008, a series of

Figure 207. Looking north along Critchfield Road in Area E (ERDC-CERL 2017).

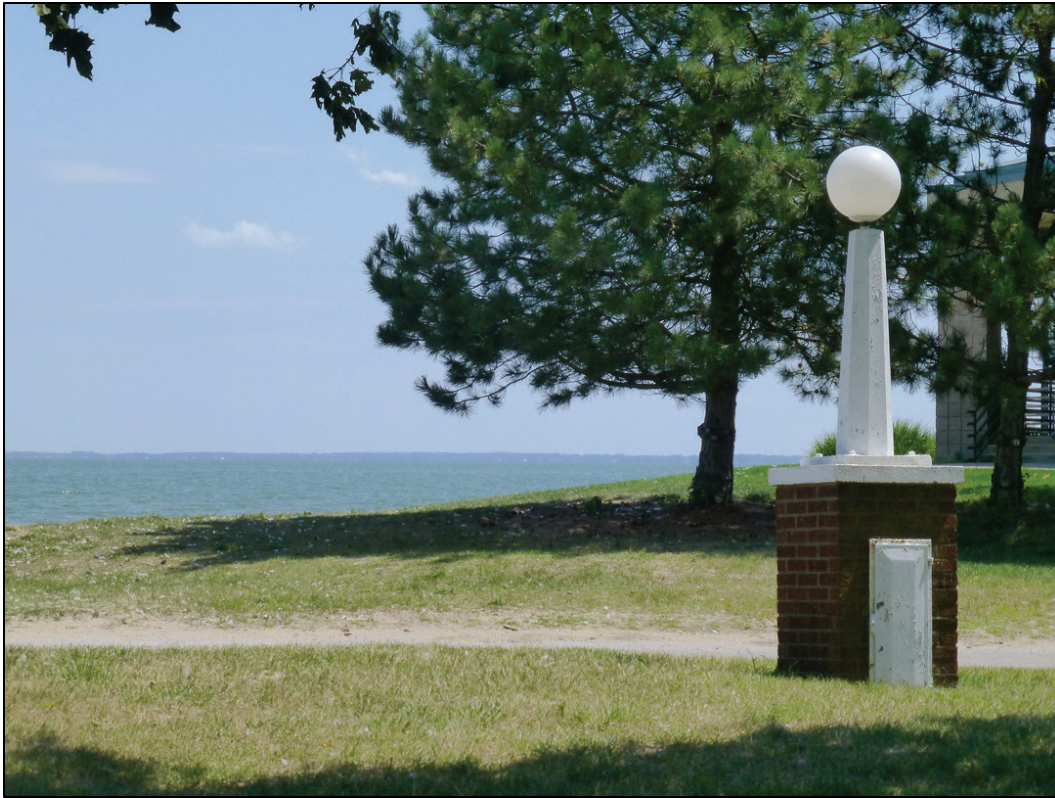
Figure 208. Looking north towards Lake Erie and a street lamp in Area E (ERDC-CERL 2017).

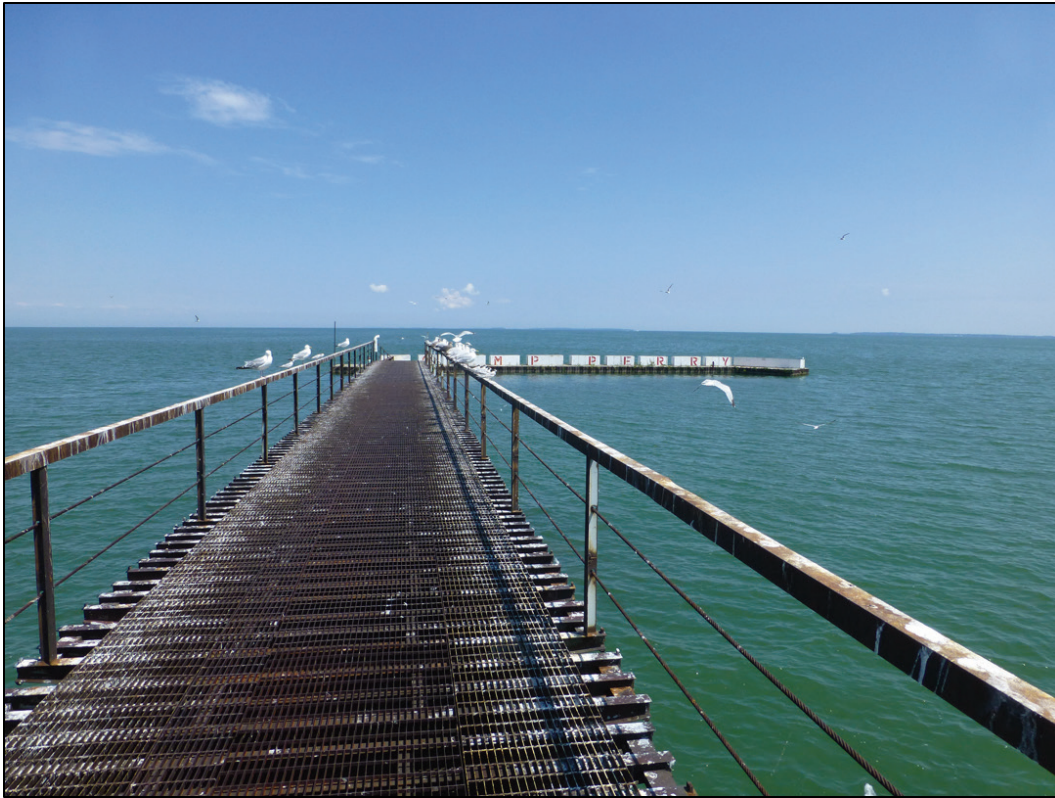
cottages were added between Critchfield Road and the installation boundary. The pier, bridge, and breakwater were extant (Figures 210 and 211).

Figure 210. View north of bridge toward breakwater (ERDC-CERL 2017).

Like most areas at Camp Perry, Area E has seen many changes after the period of significance, especially with the removal of the hutments and the clubhouse. The road system, street lamps, original portion of the pier, and breakwater were still extant in 2017. Since 2017, the additional phases of the cottage replacement project have moved forward (see Section 2.5). This has resulted in ongoing demolition of the remaining cottages and associated structures in this area to make room for new cottages.

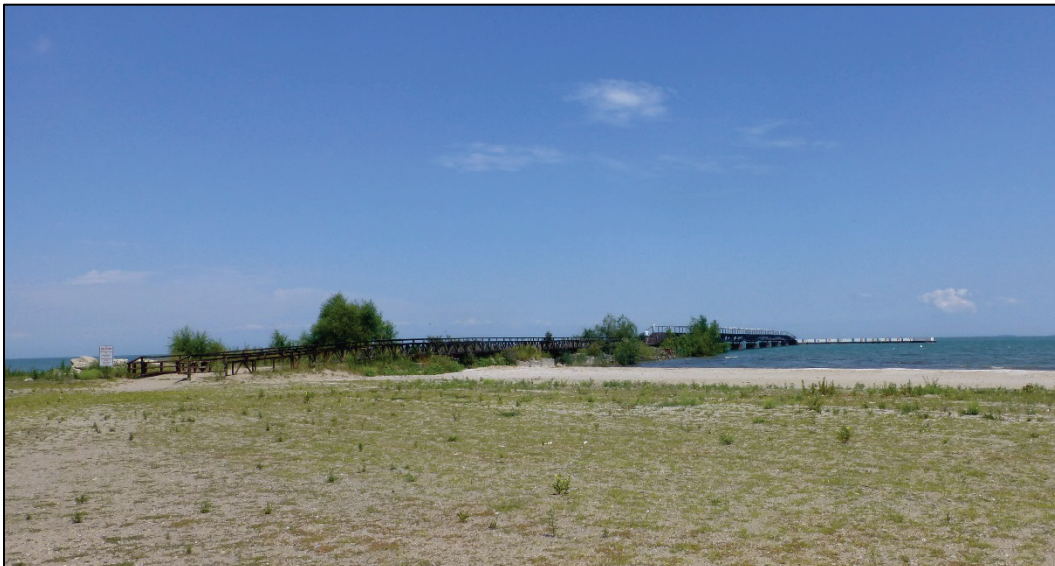
Figure 211. View of pier, bridge, and breakwater (ERDC-CERL 2017).

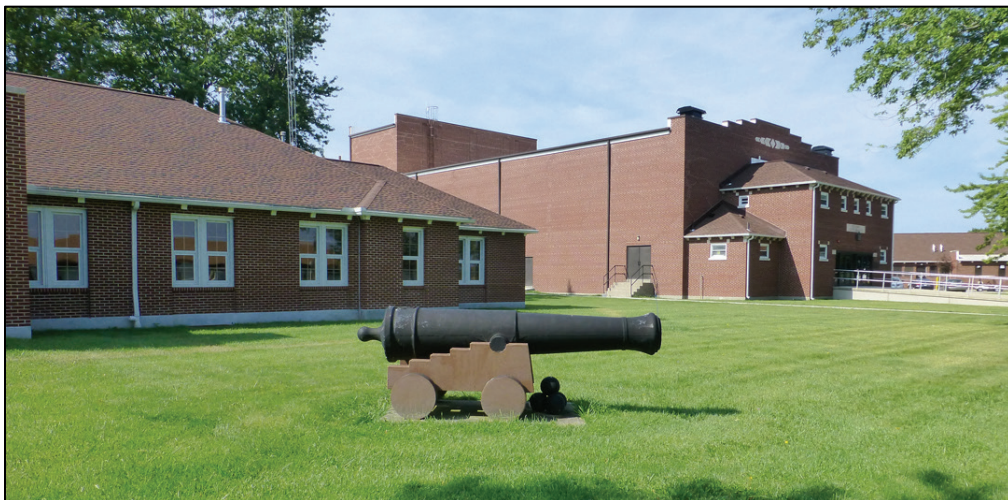
Figure 223. Looking south at Building 3 in Area F (ERDC-CERL 2017).

By 1943, the entire area was formalized with three large brick structures (Figure 218). Building 1 housed the headquarters, Building 2 was an auditorium (Figure 219), and Building 3, the largest building, housed the PX, commissary, post office, and other organizations. These three buildings date to the mid-1930s. The southeast portion of Area F was filled with nine WWII temporary buildings, which had replaced the YMCA. The brick and concrete street lamps were placed along Niagara and Lawrence Roads in 1936.

In 2017, Area F still functioned as the civic heart of Camp Perry (Figure 221–224), and the 1930s buildings and street lamps were extant. The WWII buildings in the southeast portion of the area were reclad with insulated steel siding and had replacement windows and doors. A large indoor range building (Building 5039) was added to the area on the north side of Lawrence Road in 1984 (Figure 220).

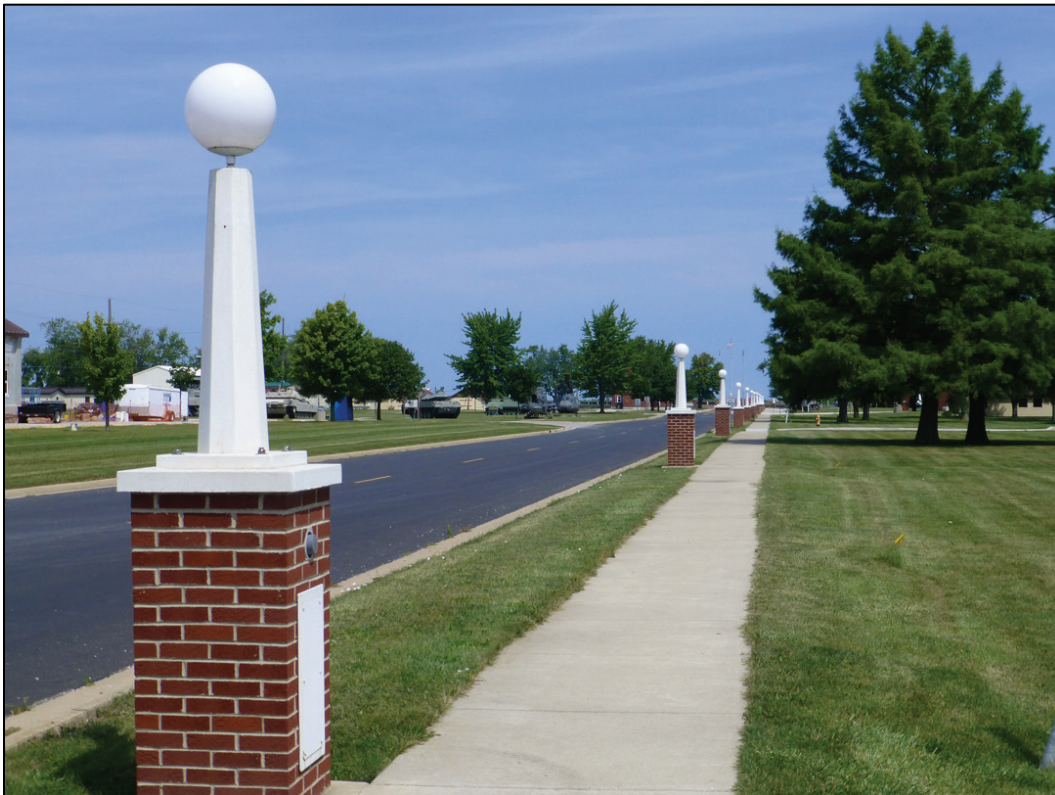
Figure 235. Looking north at the 1936 street lamps along Niagara Road in Area G (ERDC-CERL 2017).

By 1943, the eastern portion of the area was filled with hutments, the center portion was filled with new mess halls, and the western portion contained administrative buildings (Figure 229). The brick and concrete street lamps were placed along Niagara Road in 1936.

1983 (Figure 232). Like most areas at Camp Perry, Area G has seen massive changes from the period of significance. (Figure 235).

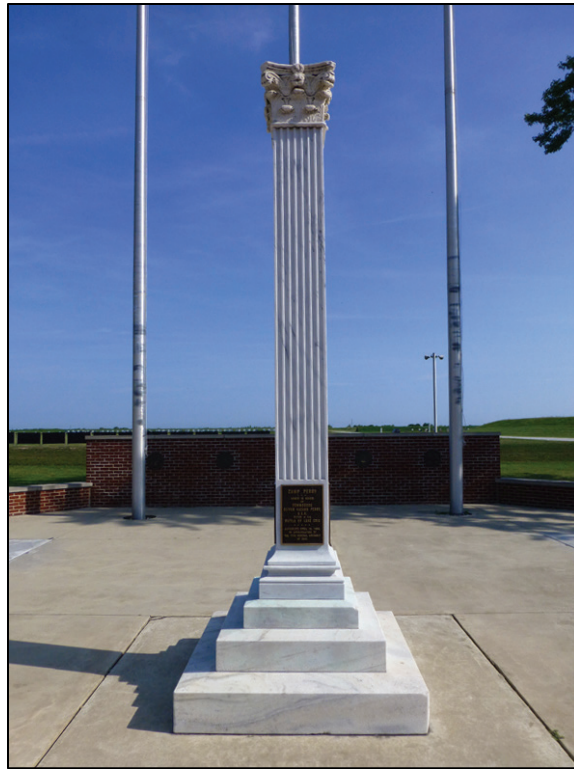
Figure 241. View north towards the flagpoles and the reconstructed Critchfield Monument in Shooter Memorial Plaza (ERDC-CERL 2017).

Shooter Memorial Plaza dates to 2002–2003 and consists of a paved area at the foot of Niagara Road, and it holds a variety of monuments, memorials, and flagpoles (Figure 240). The original Critchfield Monument was heavily damaged in a 1998 tornado. The shaft of the monument was destroyed, but the cap and marble base were saved (Figure 242). Its original location was in front of Building 3 (Figure 238), but when it was reconstructed it was moved to Shooter Memorial Plaza in 2002 (Figure 241). A view to the plaza is shown in Figure 243.

This object was damaged during the tornado in 1998. It was restored (the marble slabs at the base are original but the shaft was rebuilt) and moved to Shooter Memorial Plaza from the front of the PX. While moved from that location, it still retains integrity of association, design, materials, and workmanship. It features prominently in the views and viewsheds along Niagara and Lawrence Roads. It is a contributing object at Camp Perry.

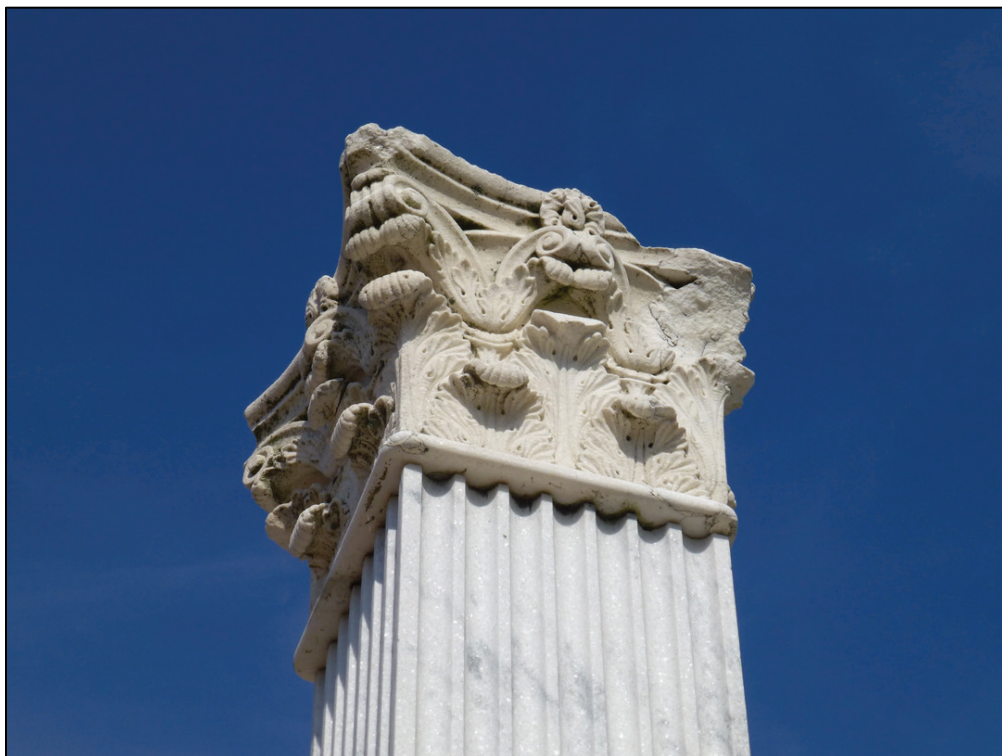
Figure 242. Detail of the original portion of the Critchfield Monument in Shooter Memorial Plaza (ERDC-CERL 2017).

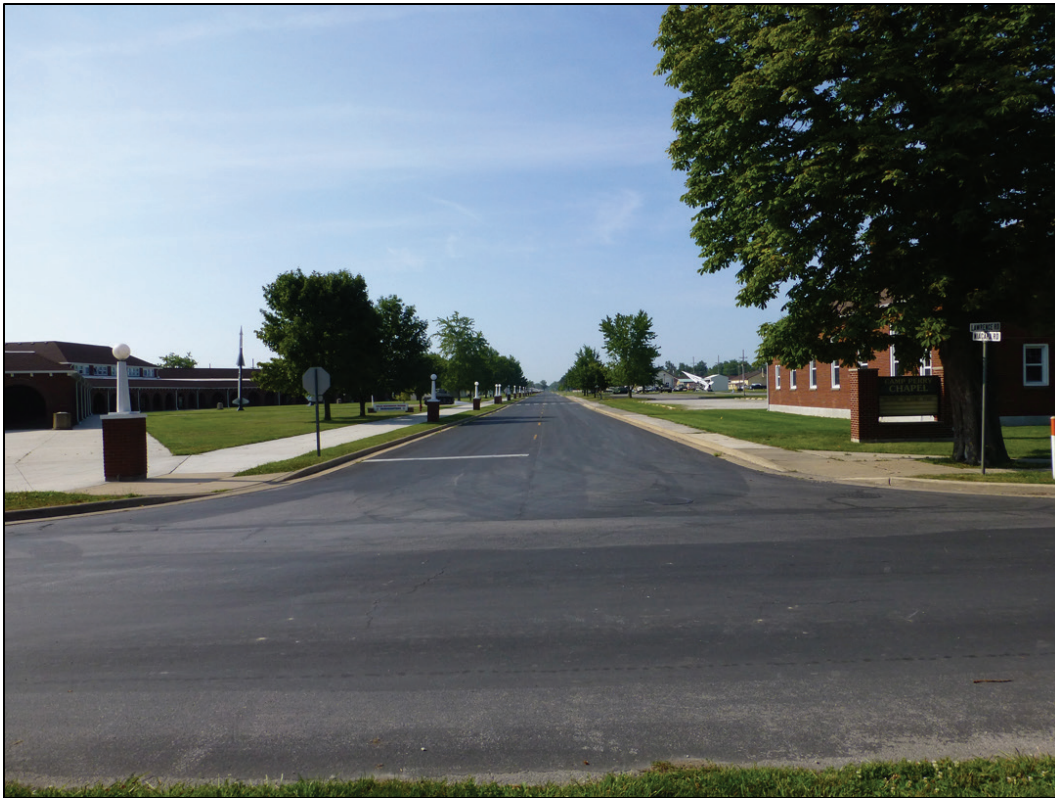
Figure 243. Looking south along Niagara Road, with the 1936 street lamps on the left and the chapel on the right (ERDC-CERL 2017).

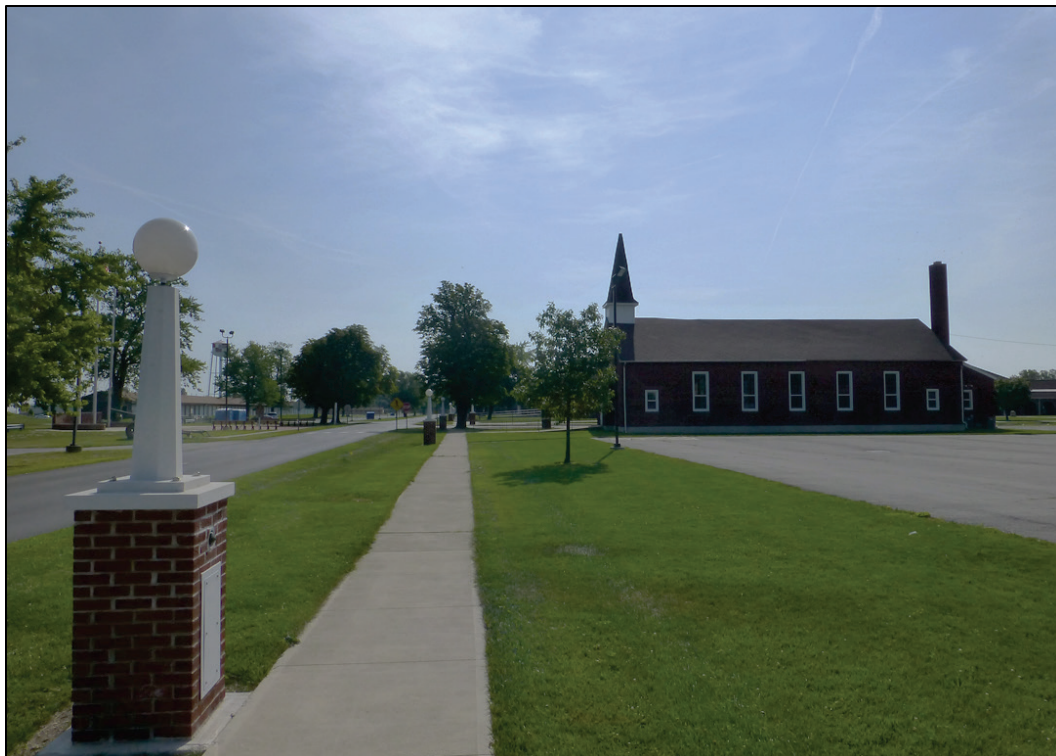
Figure 249. Looking east along Lawrence Road towards the chapel with a reconstructed 1936 street lamp on the left in Area I (ERDC-CERL 2017).

By 1943, the eastern portion of the area was filled with mess halls and hutments on the southern side (Figure 246). The center had latrines and showers, while administrative buildings were on the northern side. A brick chapel was constructed in 1942 on the southwest corner of the intersection of Lawrence and Niagara Roads. The chapel (Figure 247) was located across Niagara Road from Building 3. A WWII recreation building was south of the chapel. The brick and concrete street lamps were placed along Lawrence Road in 1936.

Like most areas at Camp Perry, Area I has seen extensive changes from the period of significance (Figures 250 and 251) (Building 1003, see Figure 249).

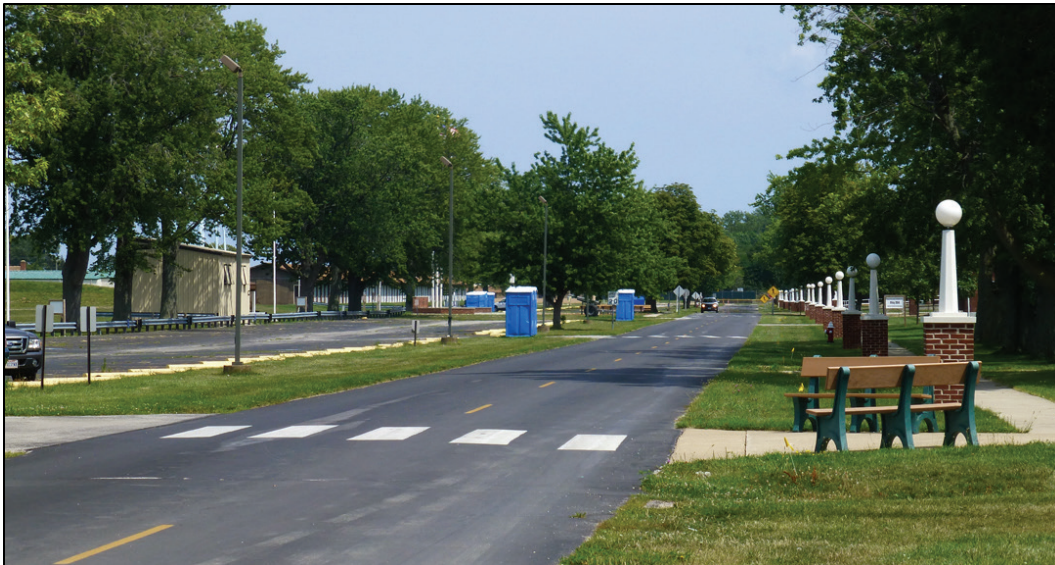
Figure 250. Looking east down Lawrence Road with the 1936 street lamps on the right (ERDC-CERL 2017).

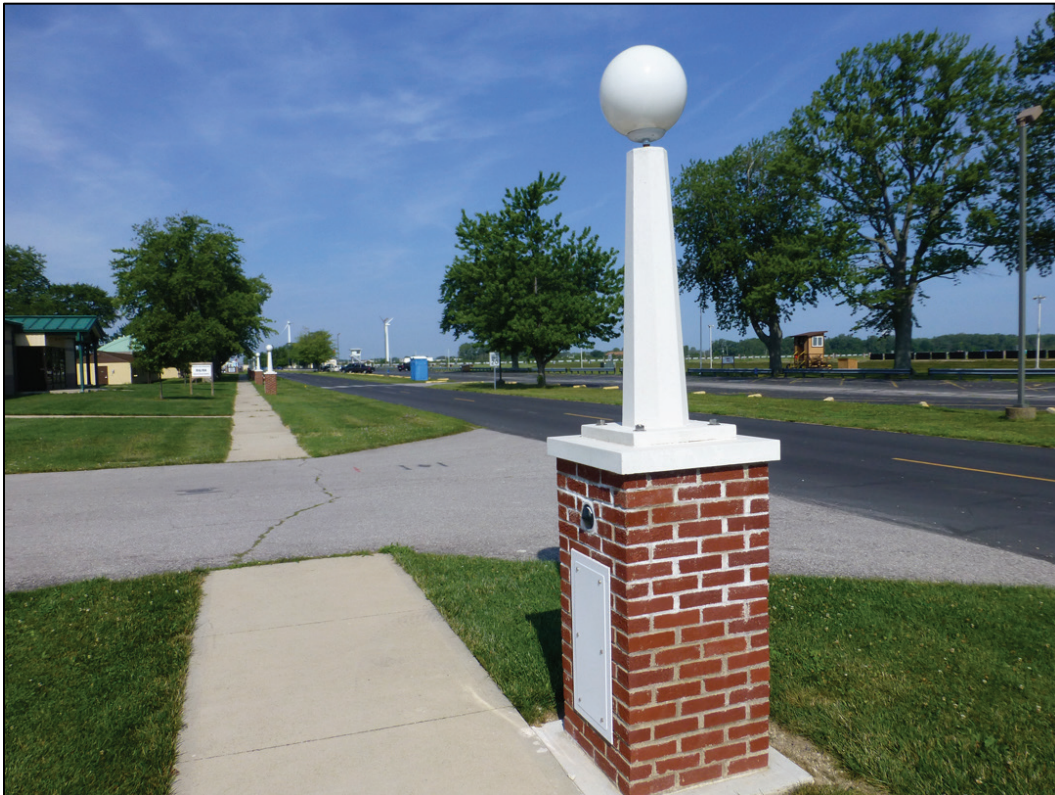
Figure 251. Looking west along Lawrence Road with the reconstructed 1936 street lamps in Area I (ERDC-CERL 2017).

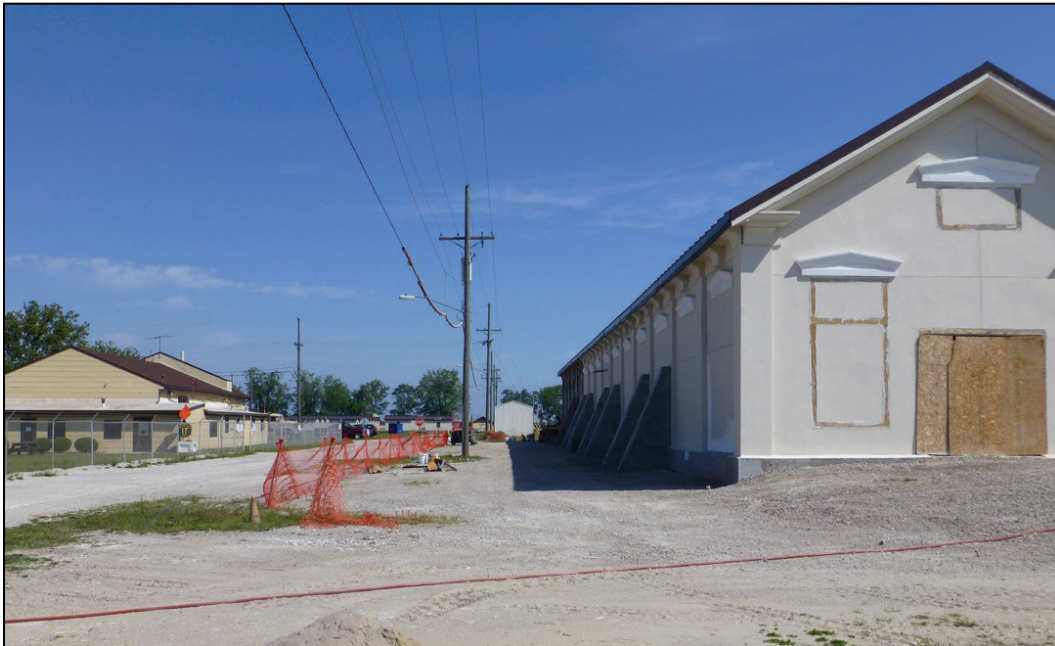
Figure 277. Looking north, with the 1907 warehouse (Building 2009) on the right, and a WWII era building on the left (Building 2008) (ERDC-CERL 2017).

In 2017 (Figure 276), most of the WWII buildings were gone, leaving only four of them (Bldgs. 2008, 2011, 2023, and 2024). The depot was demolished, but the warehouse (Bldg. 2009) from 1907 was still standing and was undergoing rehabilitation work (Figure 277). This 1907 warehouse is a contributing building to the historic district. A view down Trippe Road in 2017 is shown in Figure 278.

Like most areas at Camp Perry, Area L has seen massive changes from the period of significance. The area does not have character-defining features except for the warehouse (Building 2009).

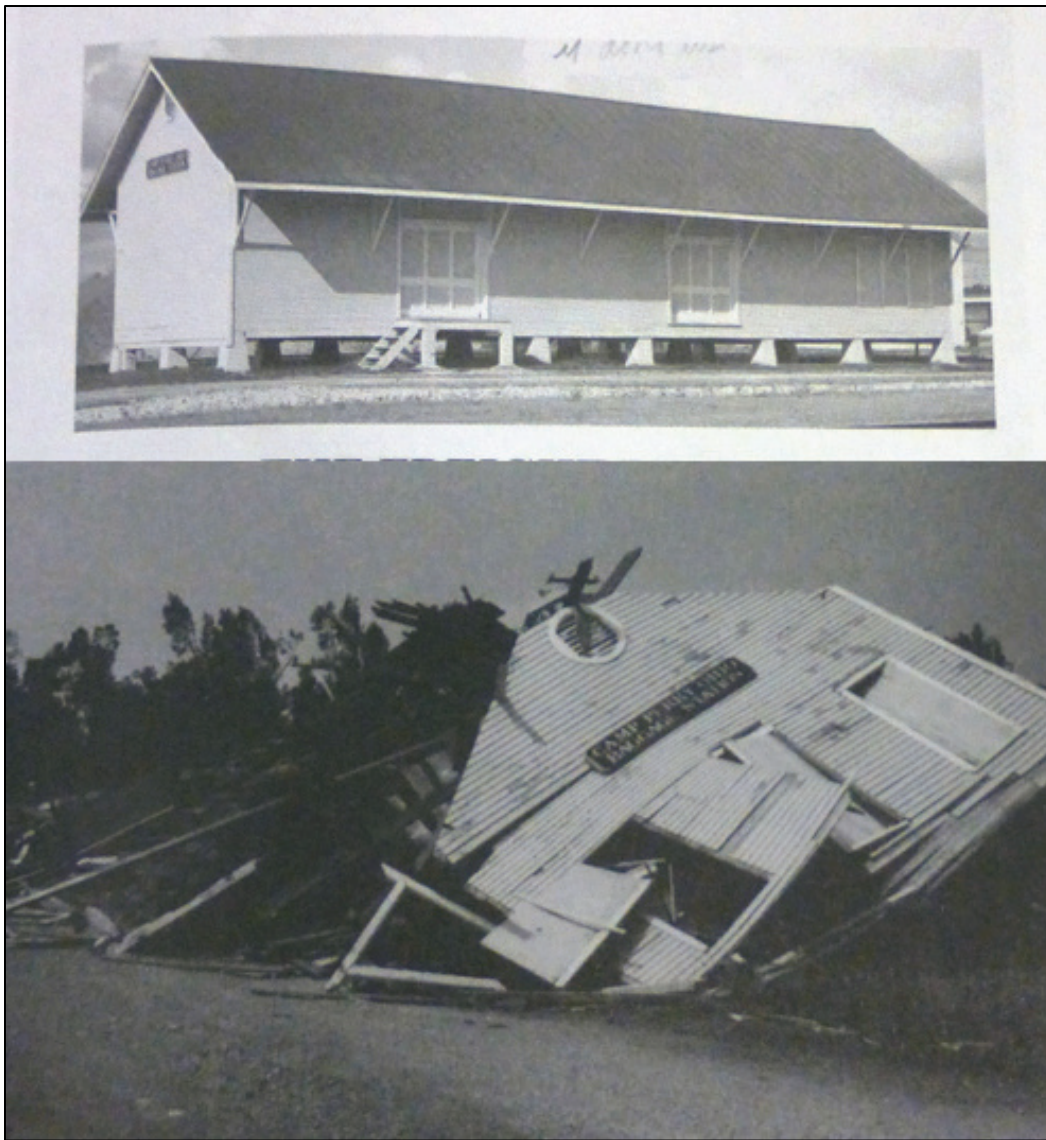
Figure 281. Images of former freight depot, which was destroyed by tornado in 1998 (Camp Perry).

Area M is bounded by Davey Road on the west, Trippe Road on the north, and Niagara Road on the east. The most notable features of this area were the various railroad sidings and the railroad spur along Niagara Road. There was a freight depot in the southern section in 1907 (Figures 279 and Figure 281). A warehouse and a commissary were added to the area by 1927 (Figure 280).

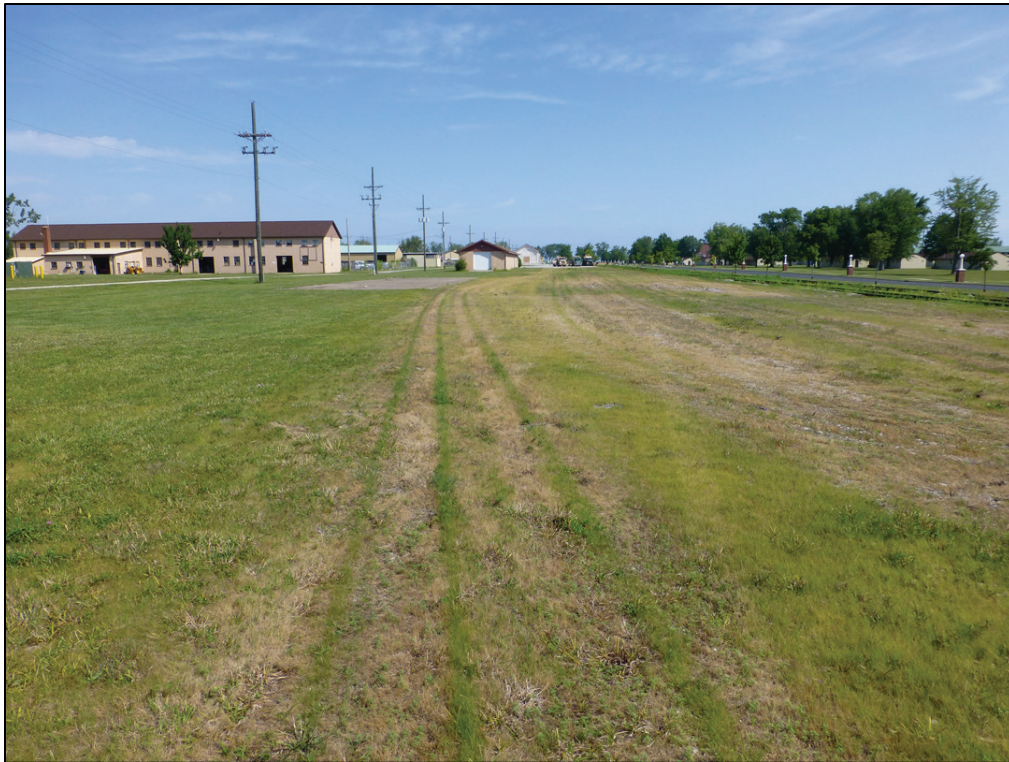
Figure 284. Looking north into Area M [note lack of railroad siding]
(ERDC-CERL 2017).

By 2017 (Figure 283), most of the WWII buildings were removed or heavily modified. Many of the railroad sidings were also removed (Figures 284 and 285), leaving only those closest to Niagara Road.

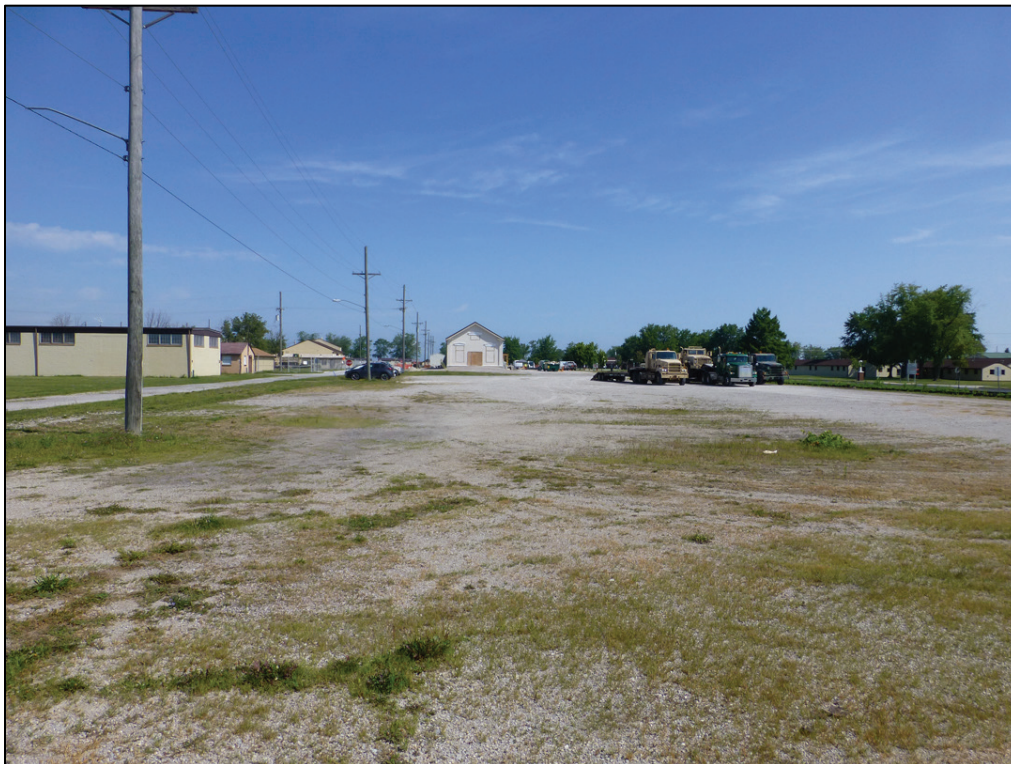
Figure 285. Looking north in Area M towards Building 2009 (the 1907 warehouse building)
[note lack of railroads sidings] (ERDC-CERL 2017).

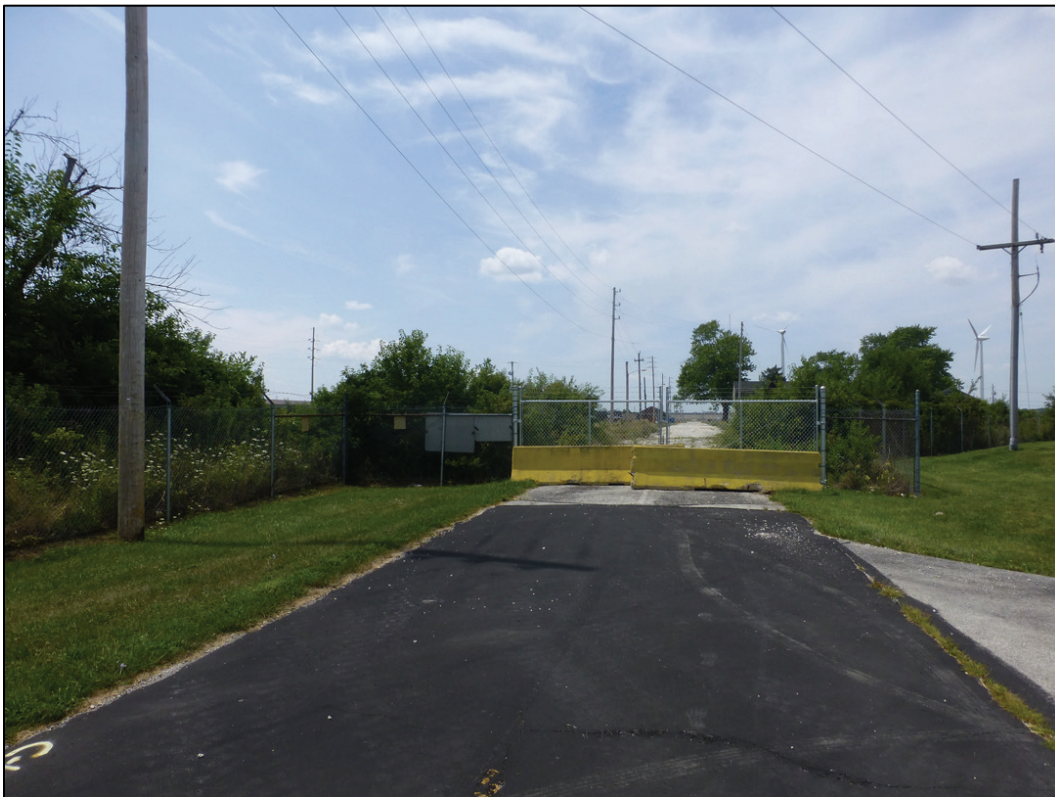
In 2017 (Figure 290), this area was used for range parking (Figure 291) and support buildings like grandstands, storage, and observation towers (Figures 293–295). A blocked portion of Lawrence Road is shown in Figure 292.

Figure 292. Looking west on Lawrence Road at the blocked access to the former Erie Proving Ground (ERDC-CERL 2017).

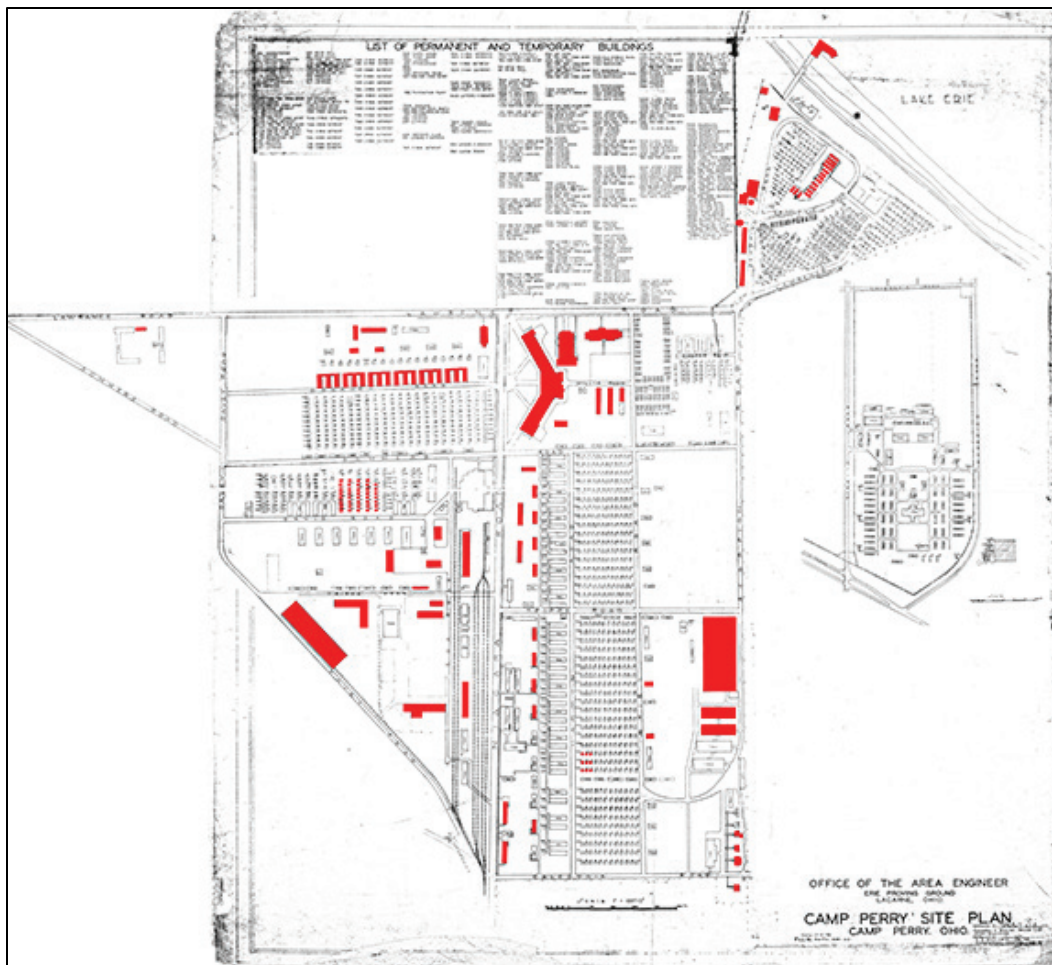
The following map shows the buildings that remain from the 1943 map (Figure 313) in red. The second map shows which of those buildings still have integrity (Figure 314).

Figure 313. Map of pre-1943 buildings that are extant in 2017 (OHARNG Archives, modified by ERDC-CERL).

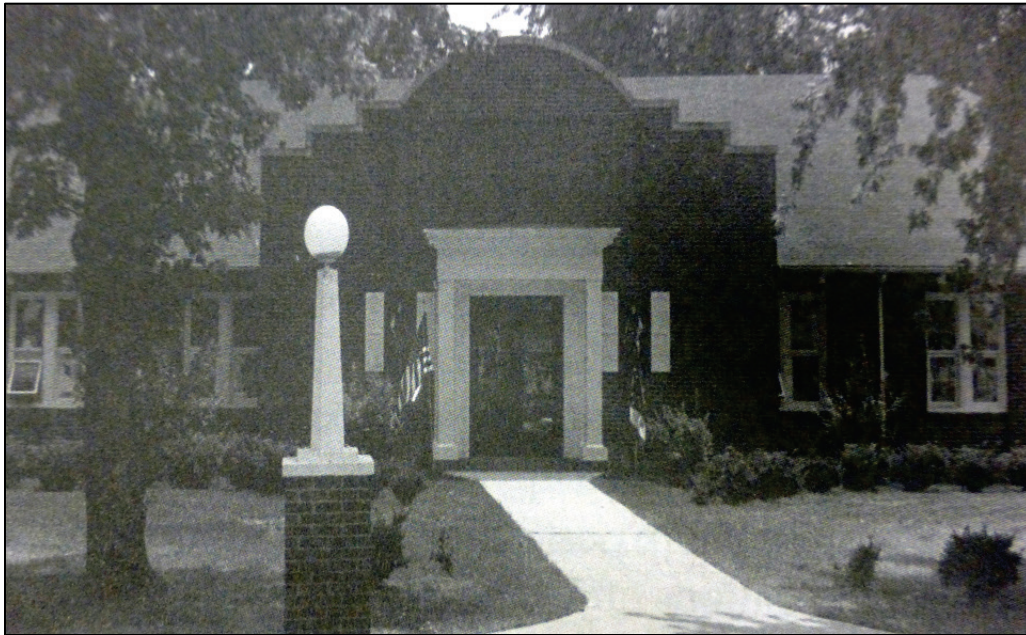
In other photos, the groves of trees located to the right along Niagara Road are not visible in a 1931 aerial (Figure 317), so they were possibly added during 1936–37 planting efforts. Figure 318 shows many foundation plantings in front of Building 1. These are gone today.

Figure 318. Photograph of headquarters building (Building 1) showing foundation plantings, date unknown.

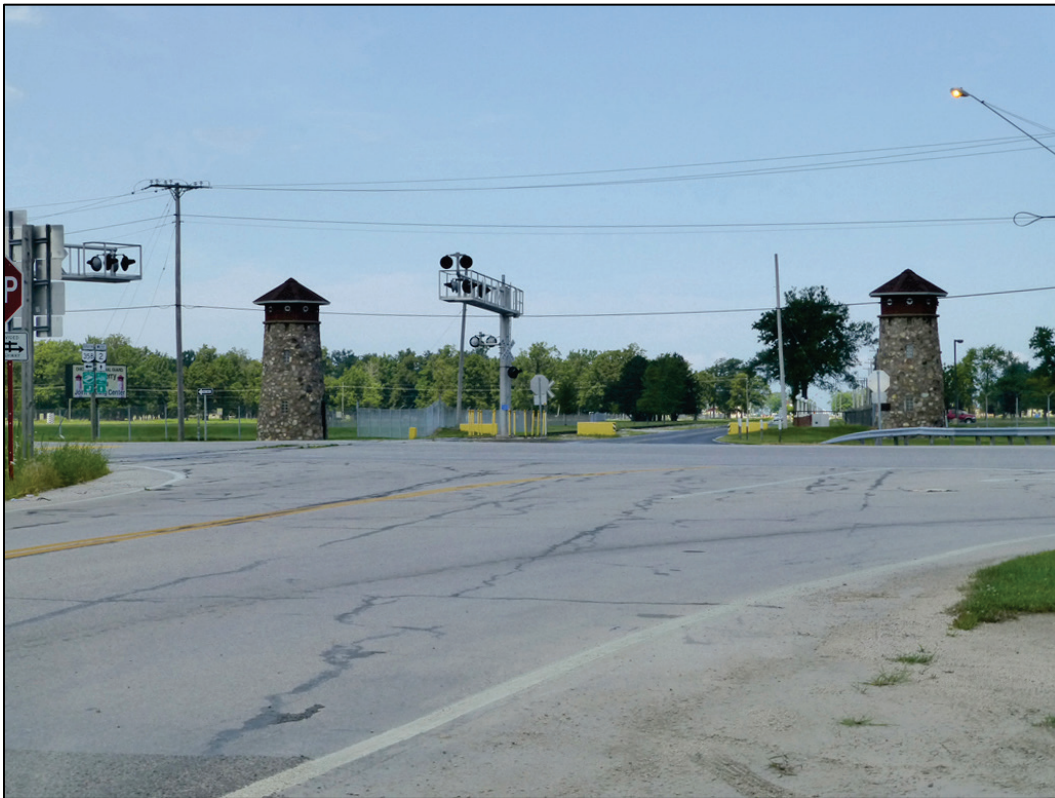
Figure 322. View of Camp Perry entrance gate (ERDC-CERL 2017).

The view of the entrance gate is the main view to those passing by Camp Perry and to those entering the cantonment. The historic stone towers at the main gate (Figure 310) feature prominently in the view, along with the reconstructed lamp posts and historic railway. This view has high level of significance and a high level of integrity due to the location, setting, design, association, workmanship, materials, and feeling of the entrance, the gates and lamp posts.

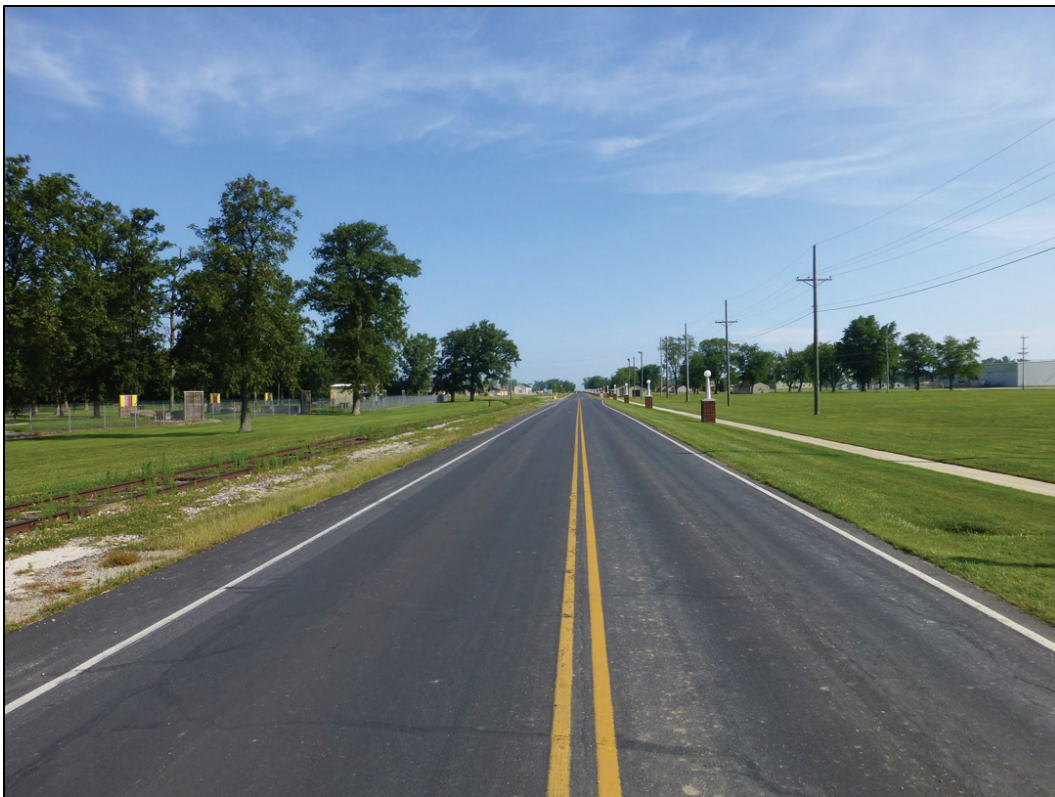
Figure 323. View north from Main Gate to Shooter Memorial Plaza (ERDC- CERL 2017).

The view along Niagara Road as one enters the cantonment is flanked by the reconstructed lamp posts on the right and historic railway on the left (Figure 323). This view has high level of significance and a high level of integrity although the street trees on the east side of the road are no longer extant. This view retains the setting, location, materials, feeling, design, and association as the entrance corridor to Camp Perry.

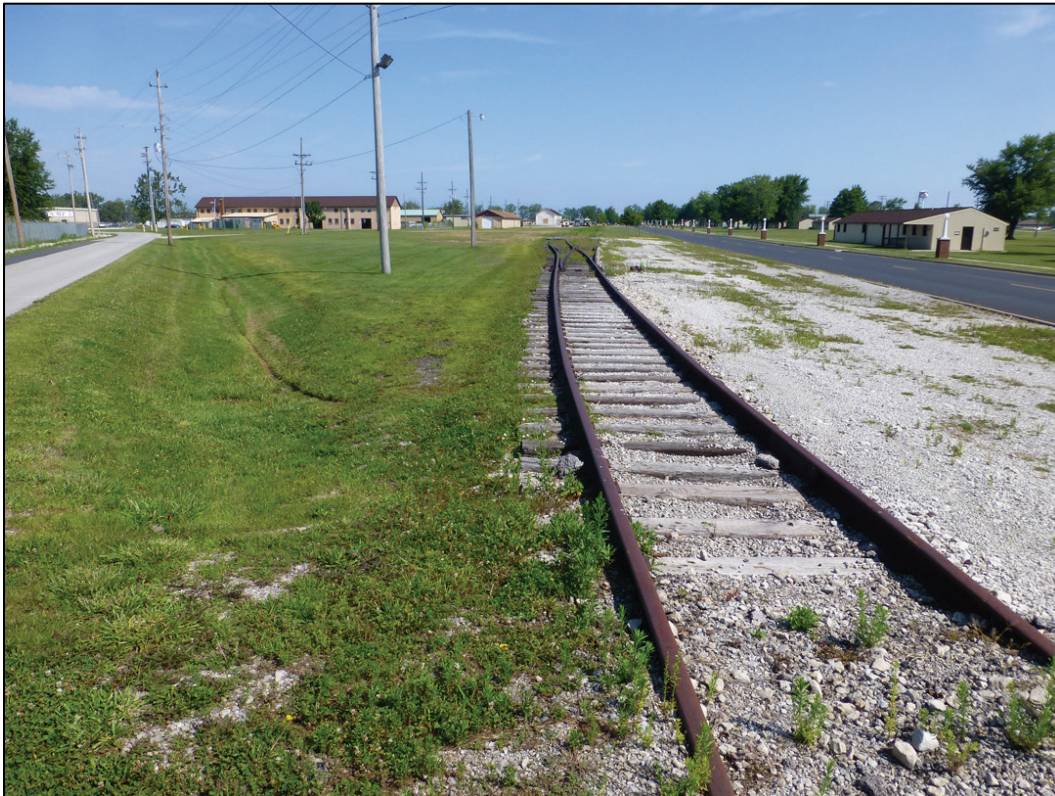
Figure 324. View north from Niagara and Caledonia Roads intersection showing railroad line, Niagara Road, and 1936 street lamps (ERDC-CERL 2017).

The view standing at the intersection of Niagara Road and Caledonia Road is the former entrance to Camp Perry. This view includes landscape character-defining features such as the rail line, and the road and the street trees (Figure 324), as well as the contributing lamp posts. This view has high level of significance as part of the entrance corridor and a high level of integrity as it retains the setting, location, materials, feeling, design, and association of Camp Perry although it is no longer the entrance.

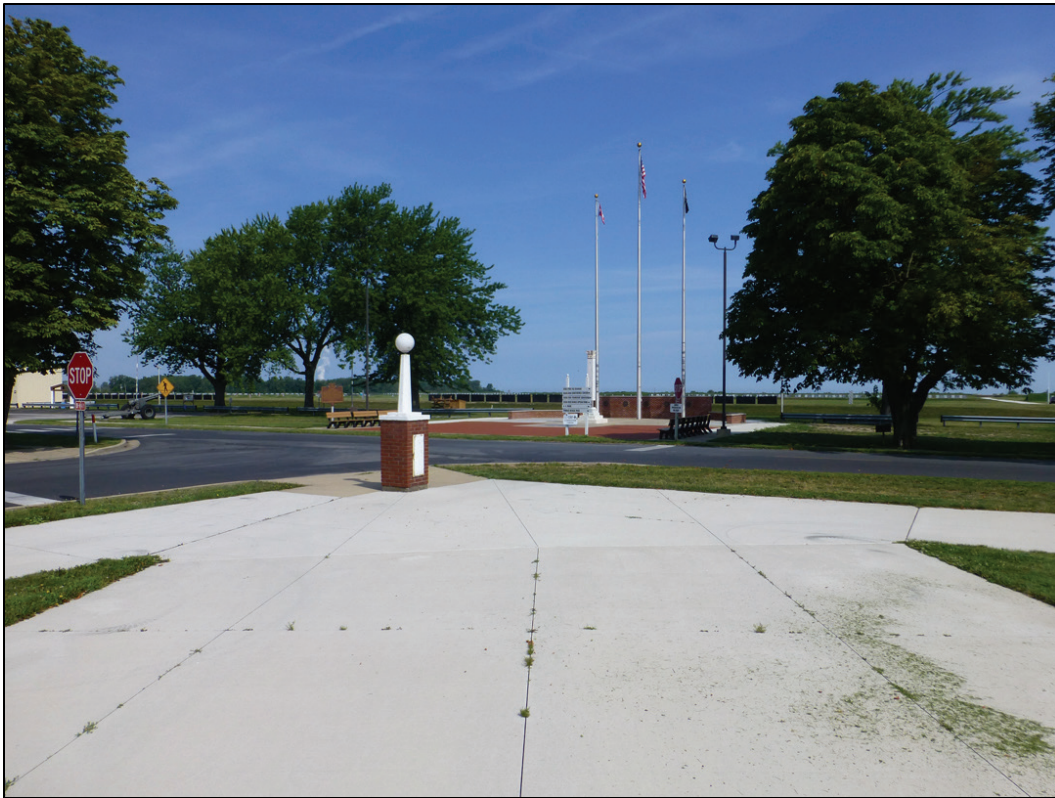
Figure 325. View northwest from PX to Shooter Memorial Plaza (ERDC-CERL 2017).

Historically the location of the flagpole marks the heart of the administration of the installation, so this view has high level of significance for Camp Perry (Figure 325). While the flagpole and memorial plaza are new construction, although using compatible brick material, the view of the ranges and street trees are consistent, so the integrity is high. It retains integrity in location, materials, feeling, and association.
