Camp Perry Historic District Landscape Inventory and Viewshed Analysis

Final Technical Report (TR)

Under Project 467080, "Camp Perry, OH Hist Dist Boundary Review and Viewshed Analysis"

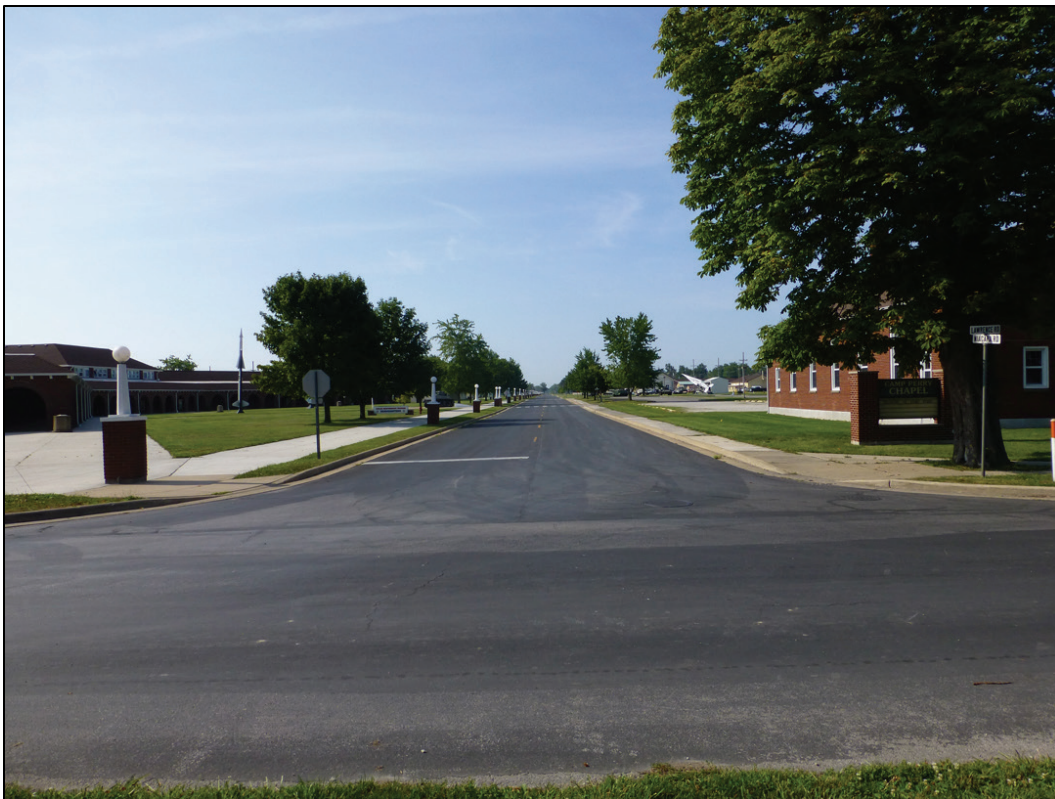
Figure 326. View south from Shooter Memorial Plaza up Niagara Road to Main Gate (ERDC-CERL 2017).

This view includes historic buildings, such as the chapel and the PX, as well as the street lamps and street trees, and the new memorial plaza (the former site of the Mess Hall). This view has high level of significance for Camp Perry since it captures the administrative heart of the installation. It retains integrity of location, setting, materials, feeling, workmanship, design, and association (Figure 326).

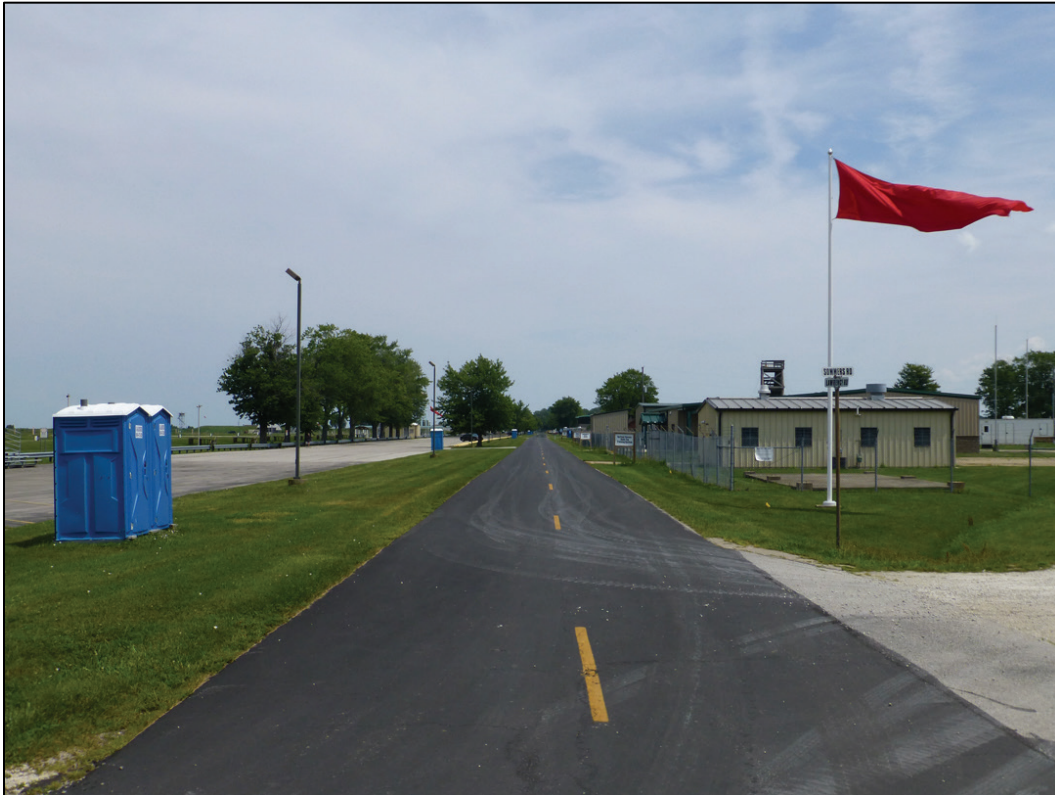
Figure 327. View east down Lawrence Road (ERDC-CERL 2017).

This view contains the historic ranges and the trees lining the ranges (Figure 327). This view has high level of significance as the ranges are key to the mission of Camp Perry. It retains integrity of location, setting, feeling and association.

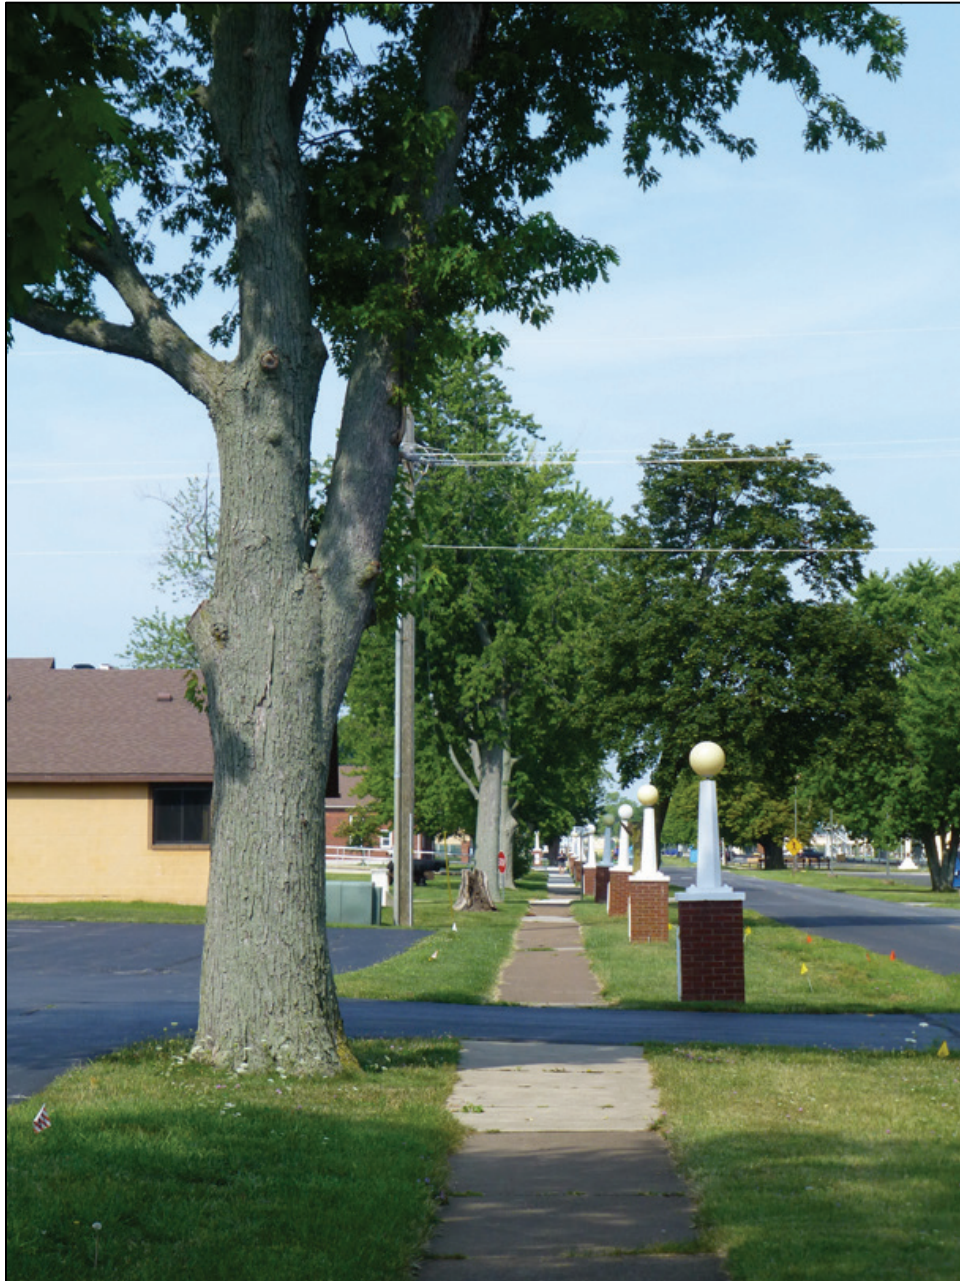
Figure 328. View west down Lawrence Road (ERDC-CERL 2017).

This view along Lawrence Road shows the street lamps and street trees (Figure 328) as well as Buildings 1 and 2. This view has medium level of significance due to noncontributing buildings, and has a medium level of integrity (location, setting, association, materials, and design).

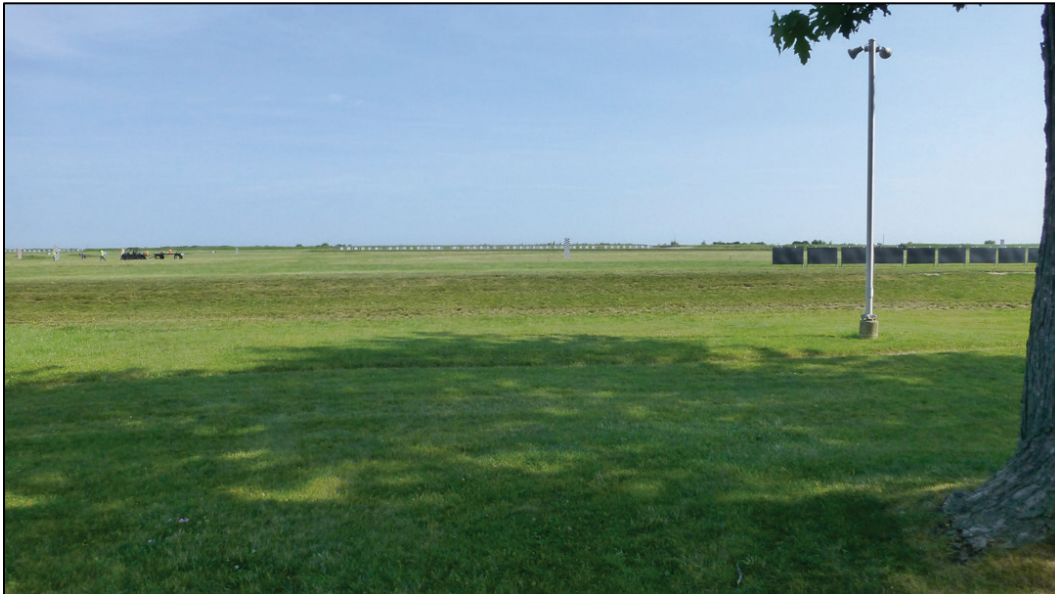
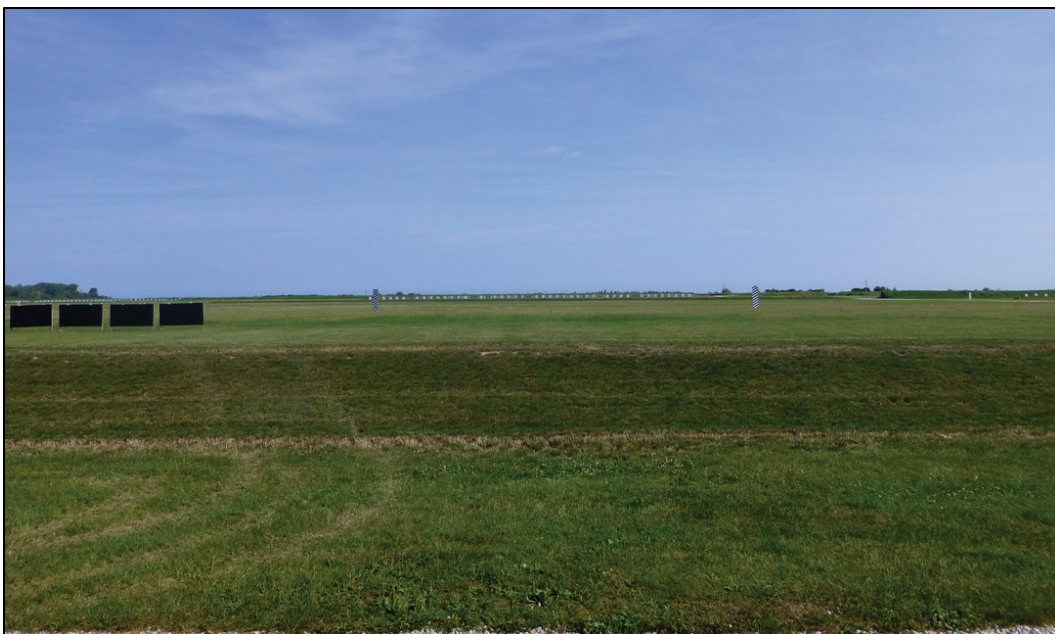
The ranges are key contributing resources of the Camp Perry Historic District and integral to the mission. The views from each firing point toward the lake are historic viewpoints (Figures 329 and 330). These views have high levels of significance and high levels of integrity of design, setting, association, feeling, and location.

Figure 329. View north on Viale Range (ERDC-CERL 2017).

Figure 330. View north on Young Range (ERDC-CERL 2017).

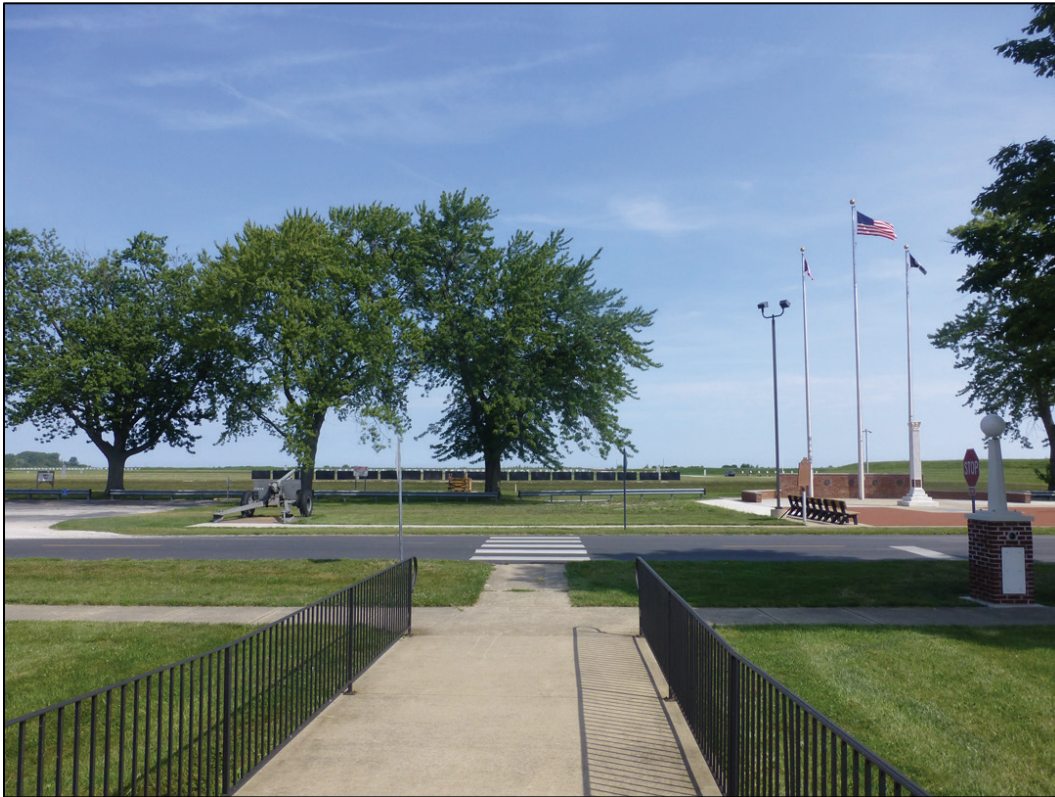
Figure 331. View north from chapel towards firing range (ERDC-CERL 2017).

The view north from the chapel building toward the lake and range and flagpole are important views from this historic building that are still open and unobstructed today (Figure 331). This view has high level of significance since it ties the chapel and the ranges and has a high level of integrity (design, setting, location, feeling, and association).

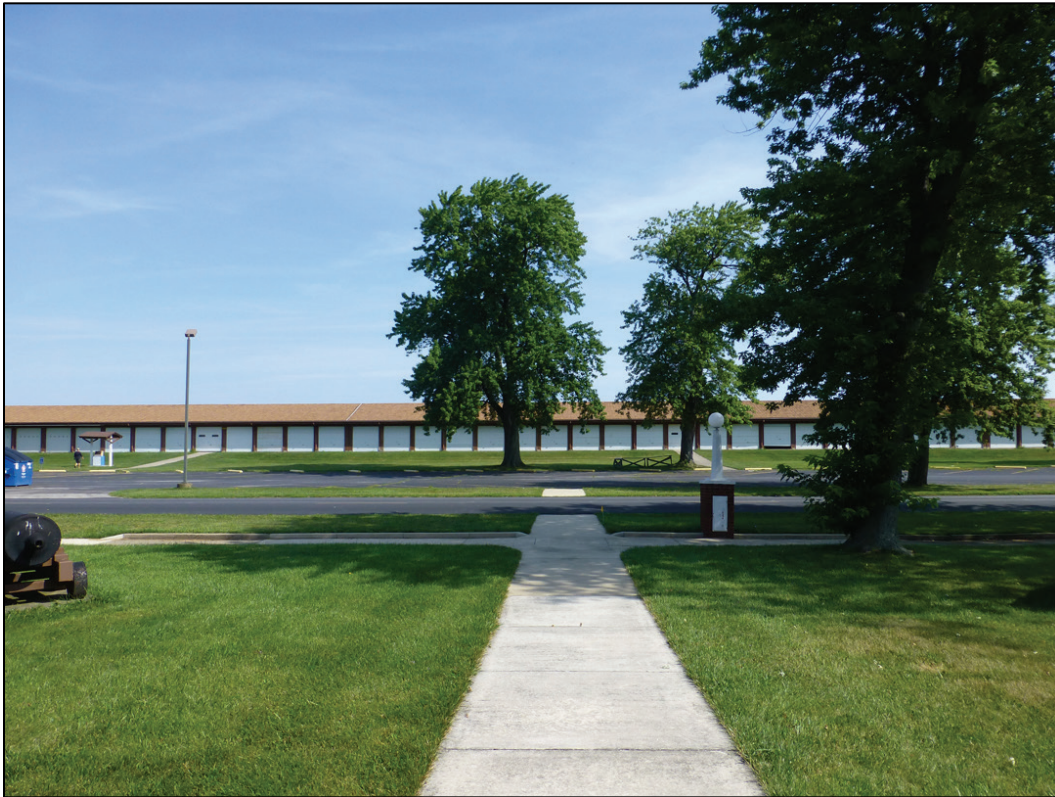
Figure 332. View north from headquarters building entrance to firing range is now blocked by Building 5039 (ERDC-CERL 2017).

The addition of Building 5039 to this historic view from Building 1 has affected the integrity and the association with the ranges (Figure 332). This view has a high level of significance since it ties the administration buildings and the mission-critical ranges. It has a low level of integrity due to noncontributing building blocking the view to the ranges.

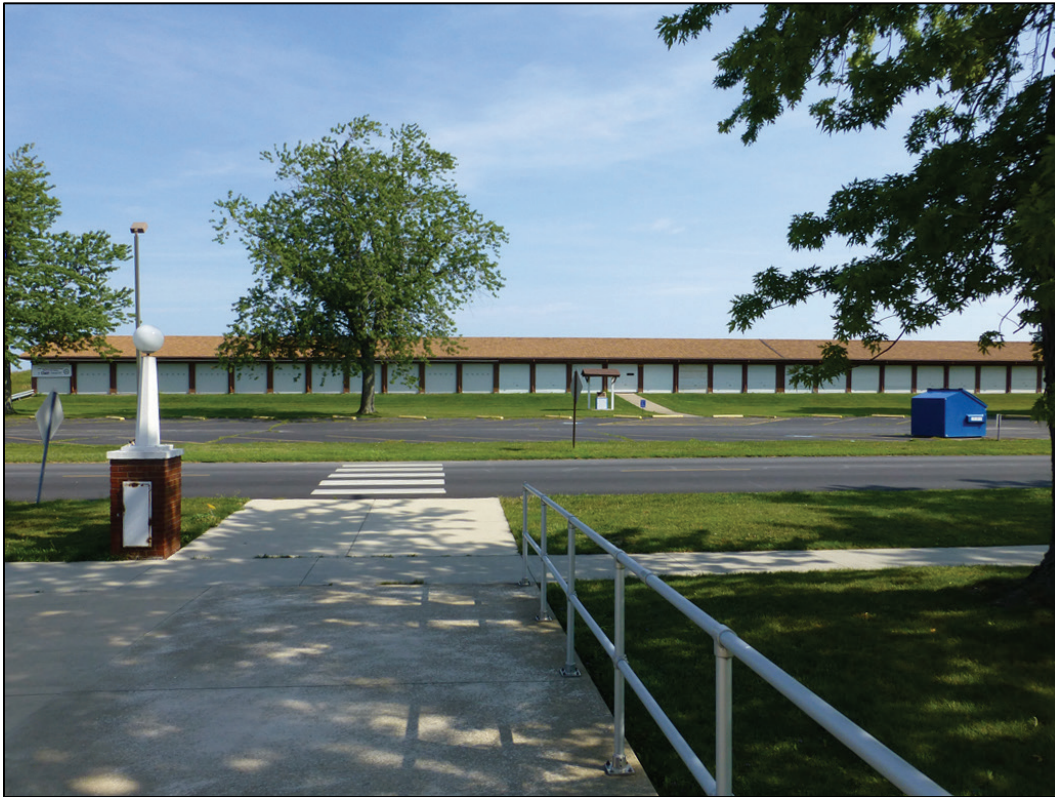
Figure 333. View north from auditorium entrance to firing range is now blocked by Building 5039 (ERDC-CERL 2017).

The addition of Building 5039 to this historic view from Building 2 has affected the integrity and the association with the range (Figure 333). This view has high level of significance since it ties the auditorium and the mission-critical ranges. It has a low level of integrity due to noncontributing building blocking the view to the ranges.

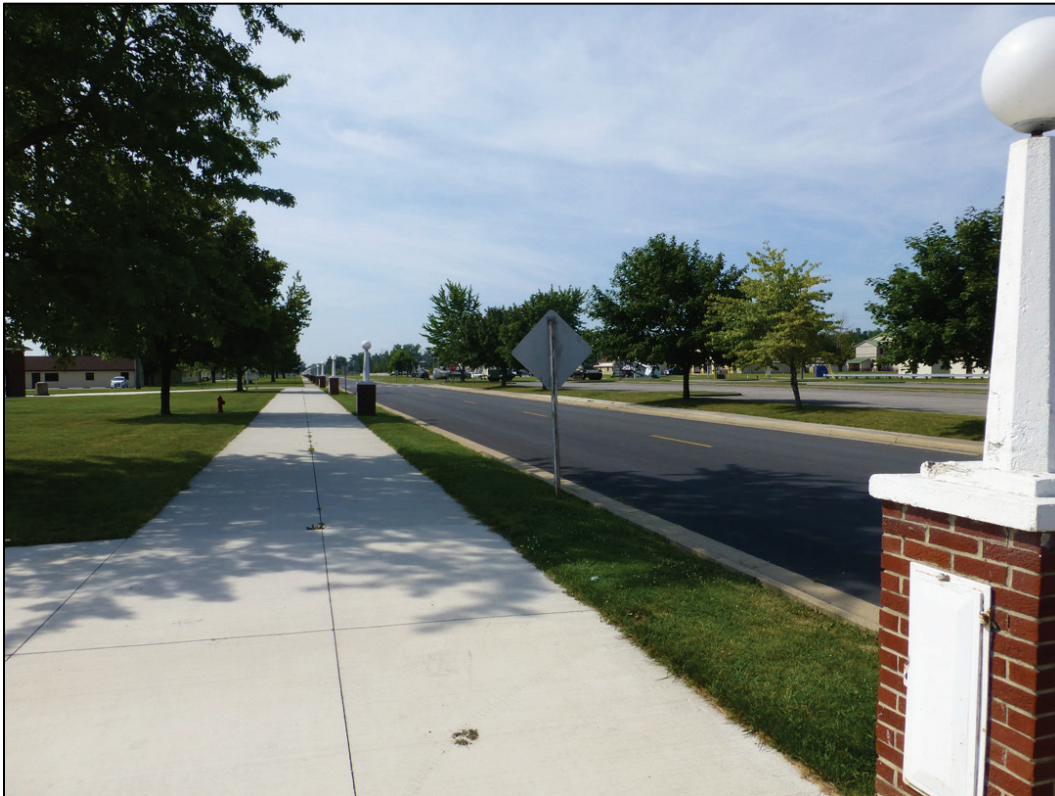
Figure 334. View southwest from PX to location of former 1907 mess hall (ERDC-CERL 2017).

While historically the association and connection from the PX to the former mess hall would have been an important one, the loss of the mess hall has affected the integrity of this view (Figure 334). This view has a high level of significance due to the connection of the PX, the sidewalks and the site of the mess hall. It has a medium level of integrity (location, setting, materials, and association) since the sidewalk, street trees, reconstructed lamp posts, and main entrance road to Camp Perry are intact.

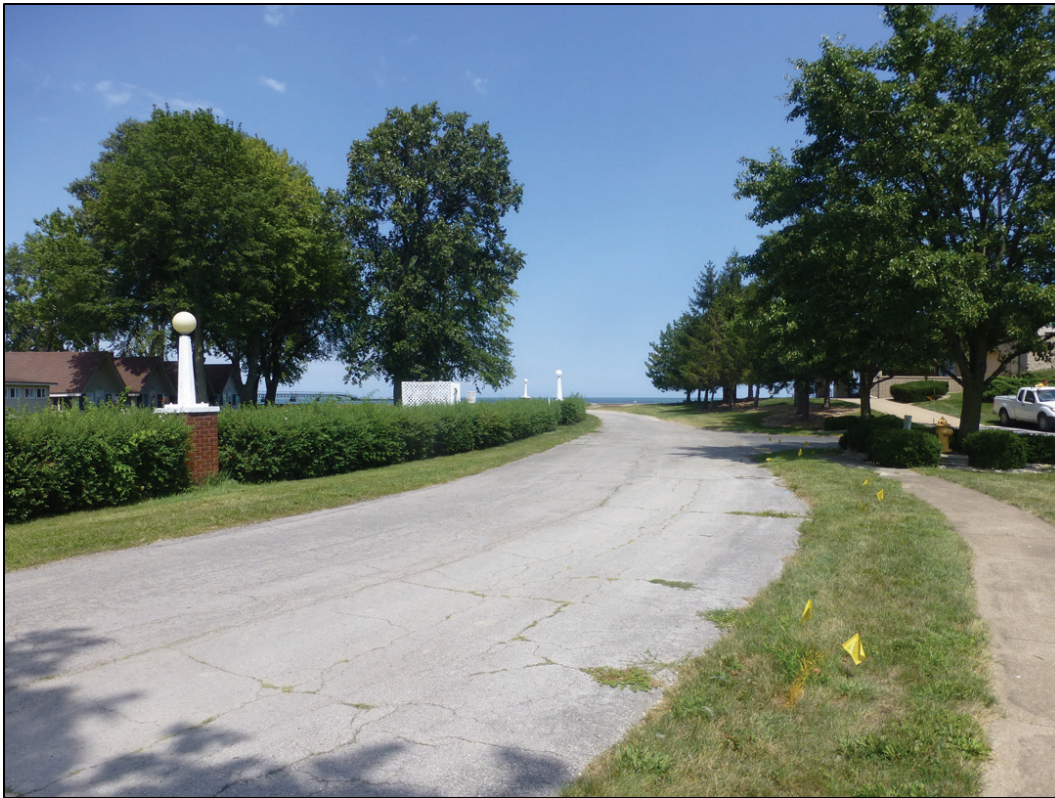
Figure 335. View north towards lake from Critchfield Road (ERDC-CERL 2017).

The view along the curvilinear Critchfield Road to the cottages and beach has been affected by the construction of the new conference center. The lamp posts and street trees in the view are character-defining features of the landscape, as is the vegetation between the lamp posts (Figure 335). This view has high level of significance but a low level of integrity as the historic clubhouse has been demolished and cottages are slated for demolition.

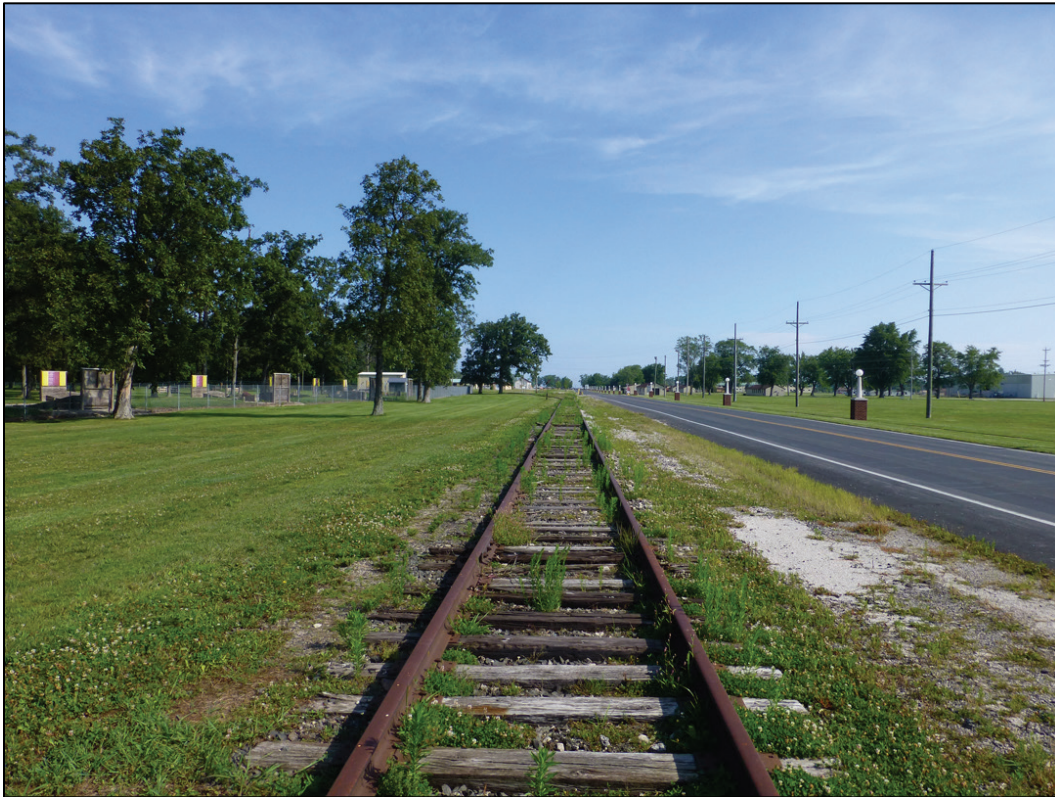
Figure 336. View looking north along railroad and Niagara Road from the main gate (ERDC-CERL 2017).

The rail line is a key historic element of the landscape at Camp Perry as it was important in the location, design, and layout of the cantonment (Figure 336). This view has high level of significance since it ties the rail line, Niagara Road, and the lamp posts. It retains integrity of setting, location, materials, design, feeling and association.

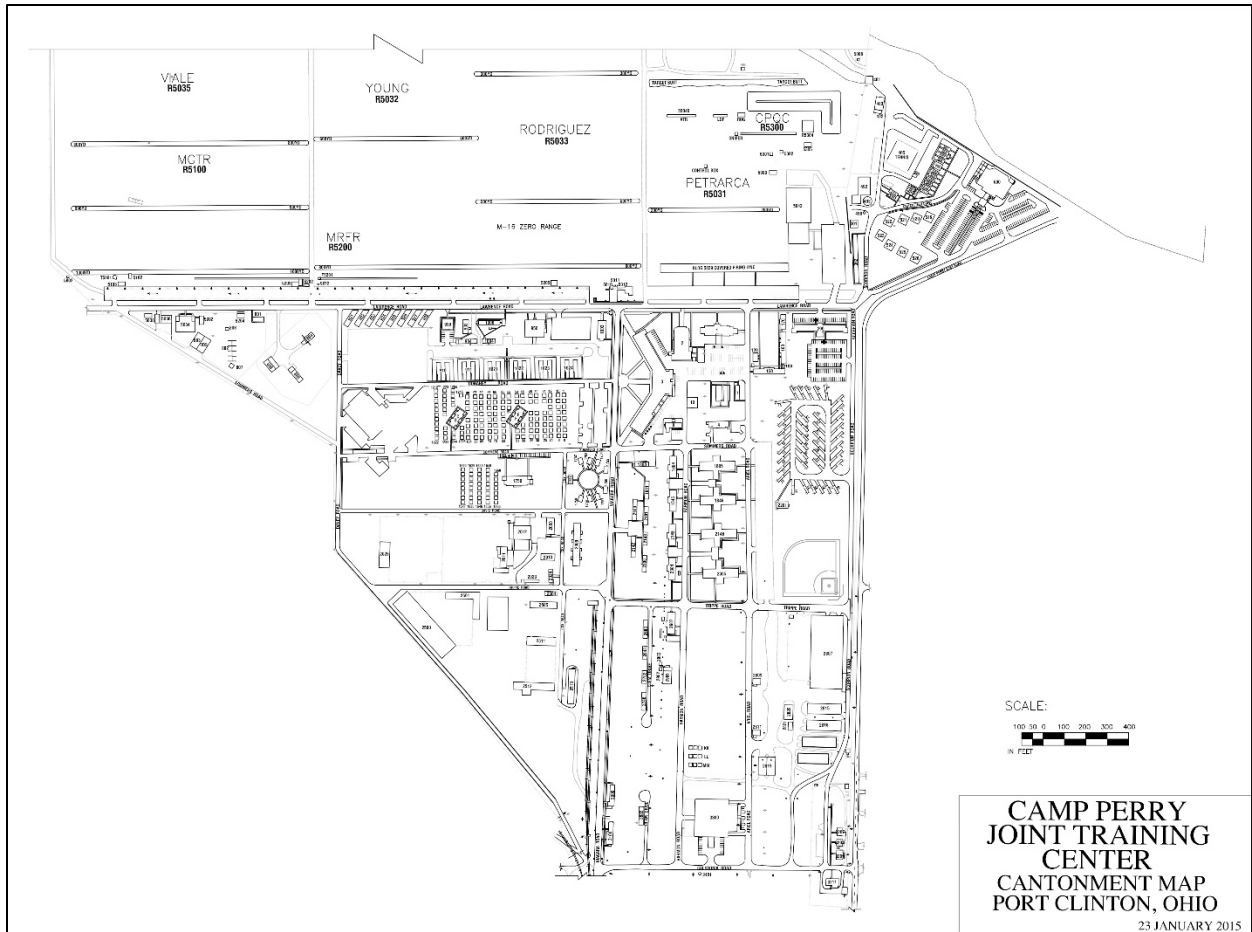
Figure A-4. 2015 Map of Camp Perry (OHARNG).
