FRACTURE RESISTANCE OF THREE MONOLITHIC CAD/CAM
MANUFACTURED IMPLANT SUPPORTED CROWNS CEMENTED TO A TI-BASE
CONNECTOR

A manuscript

In Partial Fulfillment of the Requirements for the Degree of
Master of Science in Oral Biology

May 2019

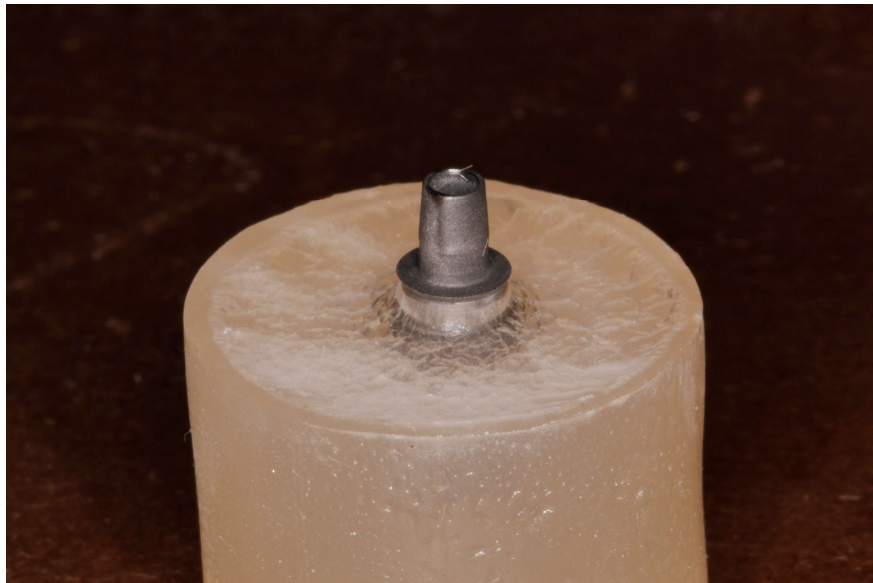
Figure 1. Tibase secured to implant embedded in acrylic

To simulate osseointegrated implants, sixty Nanotite Tapered Certain 5.0 X 10mm implants (3i Biomet, Carslbad, CA) were imbedded in acrylic material with 2mm of collar exposed to simulate clinical bone loss (ISO 14801). Orthodontic Acrylic (Dentsply-Sirona) was mixed according to manufacture directions. Implants were held in place by a jig and placed in a standardized mold with unset acrylic. Samples were cured under pressure at 40 psi to ensure adequate cure. Sixty Sirona Tibase titanium inserts were inserted into the implants and secured with the included abutment screw. (See Figure 1) All abutment screws were torqued to 20NCM with an implant driver. After ten minutes all abutment screws were torqued a second time to compensate for screw relaxation. All Tibase samples were then air abraded with 50 micron aluminum oxide.

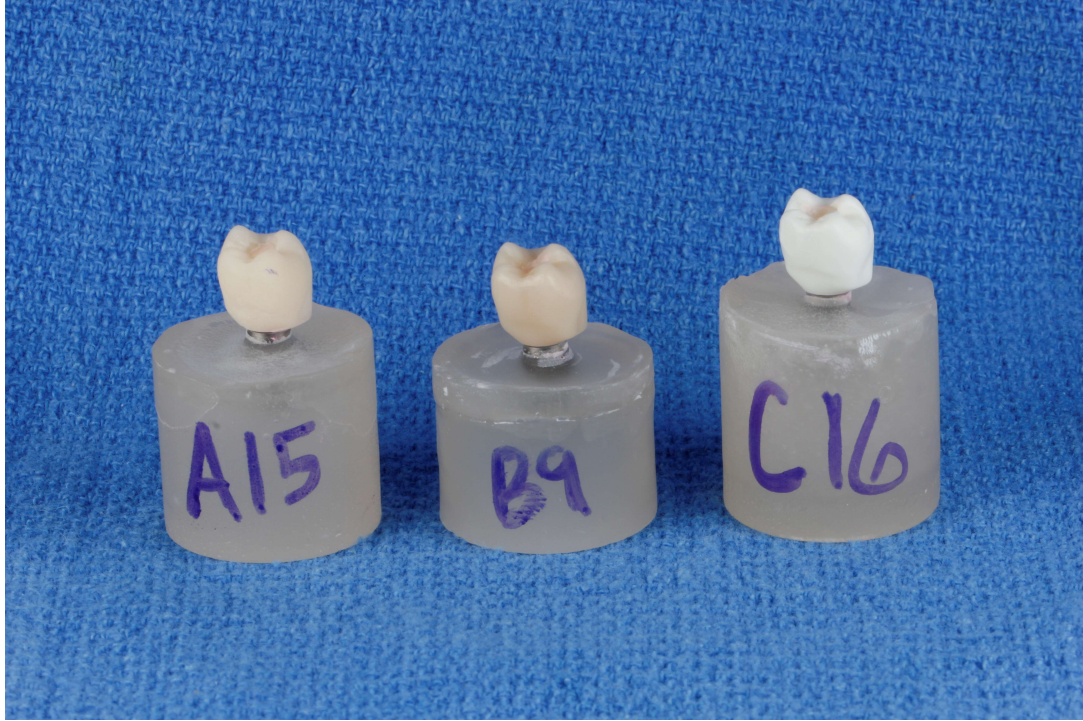
Figure 2. Enamic, Emax, and InCoris samples

Three groups of twenty monolithic ceramic implant restorations were fabricated utilizing a Sirona MCLX lab mill (Dentsply Sirona) from either lithium disilicate (Emax Abutment blocks, Ivoclar Vivadent LOT X20995, X25997, X21168, W11446); a hybrid ceramic (Enamic, Vita Zahnfabrik, Bad Sackingen, Germany LOT 82260, 66000, 75630, 82260) and zirconia (Incoris ZI Dentsply-Sirona York PA LOT 2018054874, 2018236040). Emax crowns underwent crystallization in a Programat Oven (Ivoclar Vivadent) per manufacturer specifications. Zirconia specimens were sintered in a Sirona HTC inFire Speed Sintering Lab furnace (Dentsply Sirona) per manufacturer guidelines. Enamic crowns did not require any further processing.

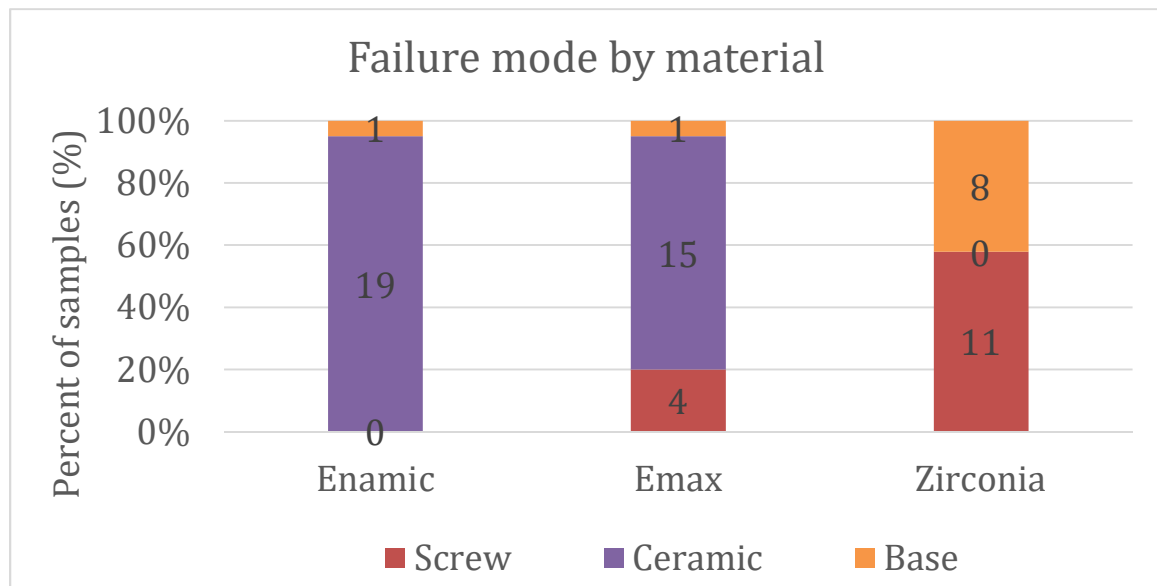
Figure 4. Failure mode by material.

A total of 59 specimens were included in the final analysis of failure mode and fracture strength. One zirconia specimen was damaged while determining failure mode and was excluded from the study. Three modes of failure were noted during the experiment. Specimens either suffered catastrophic fracture of ceramic with the Tibase intact (FCTI), fracture of the abutment screw (FAS), or failure of the acrylic base with the restoration intact (Restoration intact, Base Broken RIBB). Enamic had zero fractured abutment screws, 19 FCTI (95%) and 1 RIBB (5%), Emax had 4 FAS (20%), 15 FCTI (75%) and 1 RIBB (5%). Zirconia had zero ceramic failures, 11 FAS (58%), and 8 RIBB (42%). (See Figure 4)

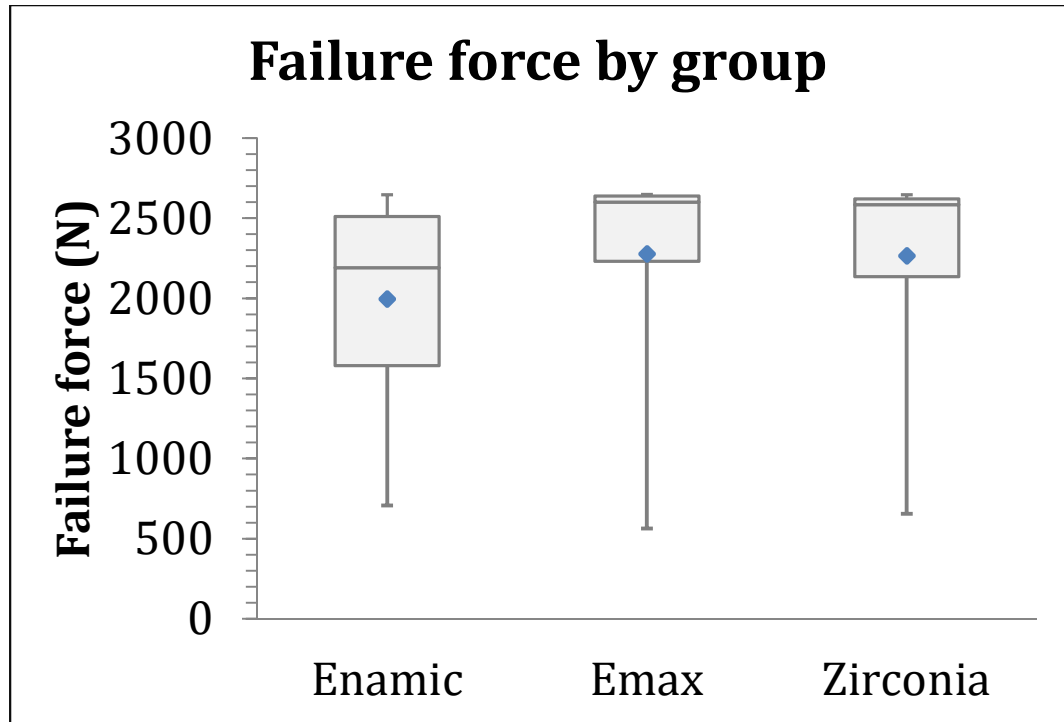
Figure 5. Failure force by group.

When evaluating force at failure, Enamic showed a mean failure force of 1995N with a minimum failure force of 708N and maximum failure force 2647N. Emax showed a mean failure force of 2227N with minimum failure force of 564N and maximum force of 2,647N. Zirconia showed a mean failure force of 2,265N. Minimum force was 656N and maximum force was 2646N. There was a marginal difference in mean fracture force ($p < 0.089$) (See Figure 2)
