# **HAZARD MAPPING FOR INTRASTRUCTURE PLANNING IN THE ARCTIC**

## **THESIS**

AFIT-ENV-MS-21-M-201

**AIR FORCE INSTITUTE OF TECHNOLOGY**

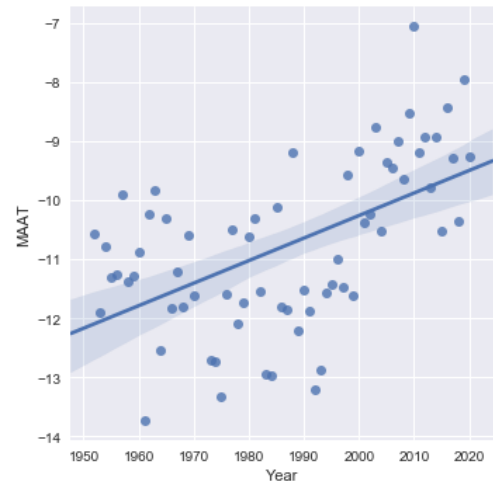
The results of the Ordinary Least Squares (OLS) regression indicate an average increase of between 0.025 and 0.05 degrees Celsius per year for the last 68 years, with an R-squared of 0.295 and a 95% confidence level. The model shown in Figure 15 is statistically significant with a p-value less than 0.05, which suggests a moderate positive correlation between the MAAT and the year. These results support the conclusion that there is an increased risk of changes to the thermal balance of the terrain based on increasing air temperatures and that weather-related design parameters must be updated to improve the lifespan of facilities. This also indicates an increased risk to current and future infrastructure if maintenance and community planning efforts are not undertaken. The 10-year moving average, seen as the red line in Figure 14 additionally supports the interpretation of a more drastic warming over the past two decades in particular. This observation is supported by similar observations that coastal permafrost began degrading significantly in the early 2000s as a result of increased air temperatures and decreased sea ice (Thoman et al., 2020).

Figure 15. Model Outputs and Line of Best Fit for MAAT

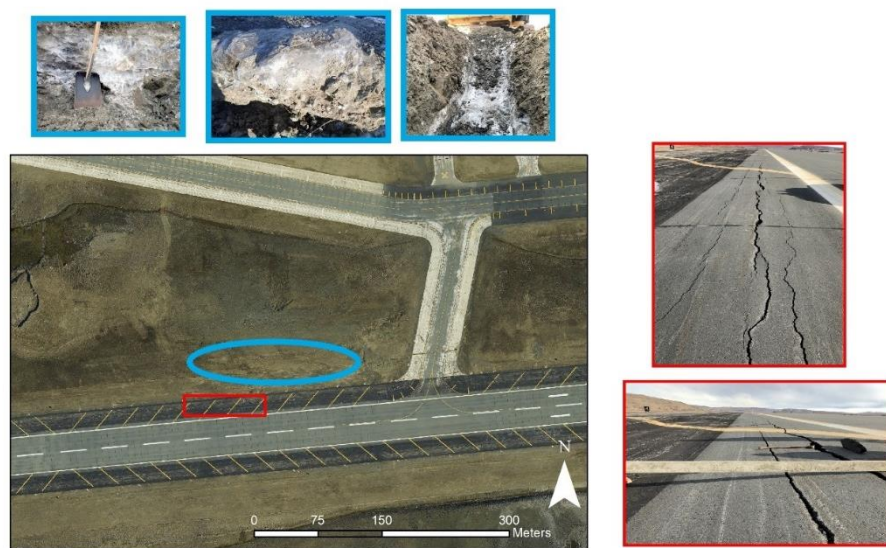
The results of this study naturally lend themselves to follow-on case studies. During the completion of this research, a four-day rain event caused severe damage on the airfield, as shown in Figure 28. Severe depressions appeared in the shoulder almost overnight which posed serious risks to the runway from loss of lateral confinement. Although cracks were sealed and fill was placed in the larger fissures before the freeze in September, this continues to pose a serious risk as the shoulders remain uninsulated and pockets of massive ice have been found in the area. With historical aerial photographs to identify visible permafrost features, a relationship can be established between the excavated massive ice and segregated ice, shown at the top of Figure 28,

Figure 28. Severe Airfield Damage and Nearby Massive Ice
