# HAVE DOUBLE VISION

## Flight Test Evaluation of Stereo Vision System for Relative Position and Navigation for Automated Aerial Refueling

### FINAL TECHNICAL INFORMATION MEMORANDUM

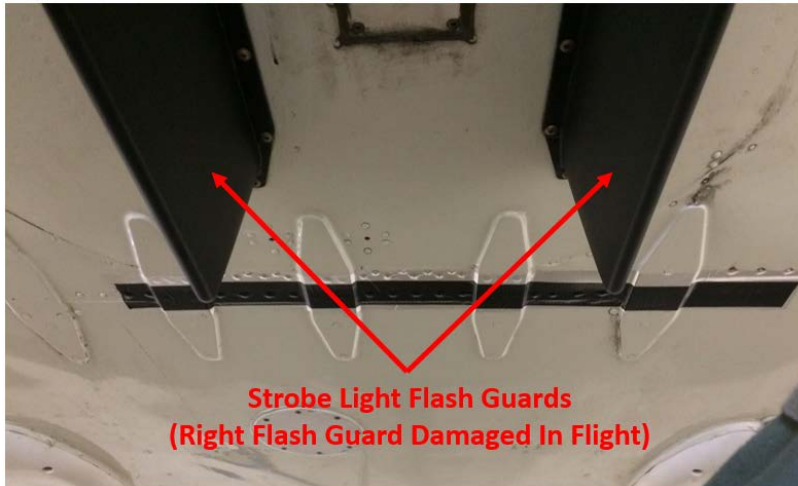
**Figure 5: Strobe Light Flash Guard Visual Reference**

Second, the primary visual formation position reference identified during the initial flight was unavailable after flight 4. During flight 4, the strobe light glare shield on the bottom of the aircraft was damaged. Figure 5 shows the location of the damaged visual reference. Detailed descriptions of all other in-flight visual references that were used are located in Appendix E. Since the strobe light glare shield was partially hanging and the risk of it separating from the aircraft existed, the flight 4 mission was terminated. The cause of the damage was either a fatigued strobe light glare shield or the increased turbulent flow due to the camera system which was mounted forward of the strobe light glare shield. The removal of the strobe light glare shield after the flight resulted in less consistency in the contact position during the remaining flights.

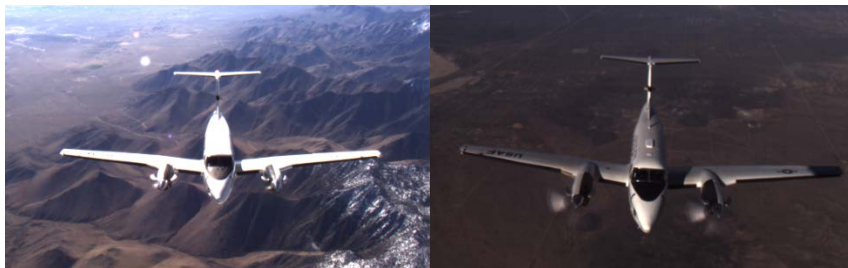
**Figure 9: Camera Exposure Setting Differences from 15,000  $\mu$ s to 5,000  $\mu$ s**

Third, the images obtained by the EO and IR cameras lacked optimization. The default camera software settings were not appropriate in bright sunlight, especially when combined with background reflections (i.e. from snow). EO camera adjustments made during later flights with faster exposure times appeared to have improved performance, however insufficient data were collected to make a statistical determination of this effect. The IR camera settings were extremely sensitive, and the required process to make changes in flight made real time adjustments impractical. Figure 9 shows two EO images with different exposure settings where the left image the white in the wing is washed out and no detail can be seen. The right image shows a gradient across the wing which was thought to be favorable to the ICP algorithm. More gradient would enable the ICP algorithm to identify more points in the left and right images to create a better model. A lack of gradient would not present as many points along the wing to match a specific feature in each image pair. Further investigation was required for a definitive answer due to insufficient data for statistical analysis.

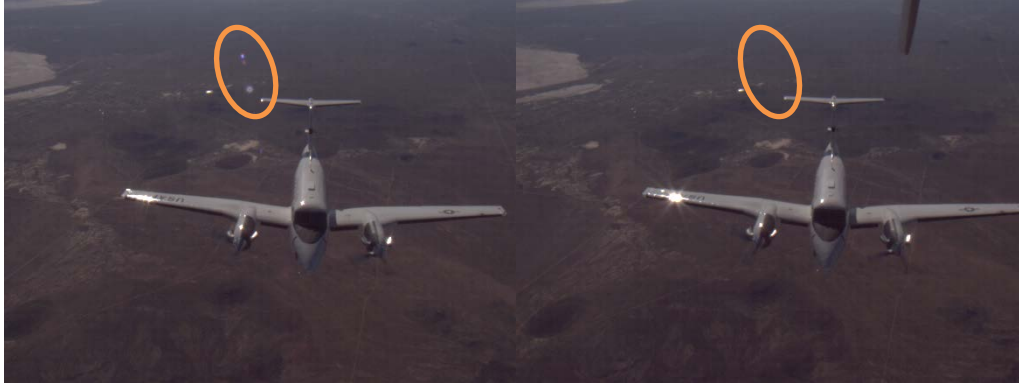
Flight 6 Image Pair #161779 L and R, RMS 12.58 meters

Flight 6 Image Pair #161785 L and R, RMS 0.0557 meters

**Figure 13: Image Pair with High and Low RMS error showing similar L/R Asymmetry**

A closer evaluation of the noise produced no clear cause. For example, Figure 13 shows an example where there is glare in the left camera frame but not the right camera frame for both image pairs. Image 161779 has high RMS error while 161785 has low RMS error. Additional analysis is necessary to determine specifically what is contributing to the translational and rotational error. Overall the RMS error could potentially have use as in intrinsic performance measurement, but is currently only marginally useful.

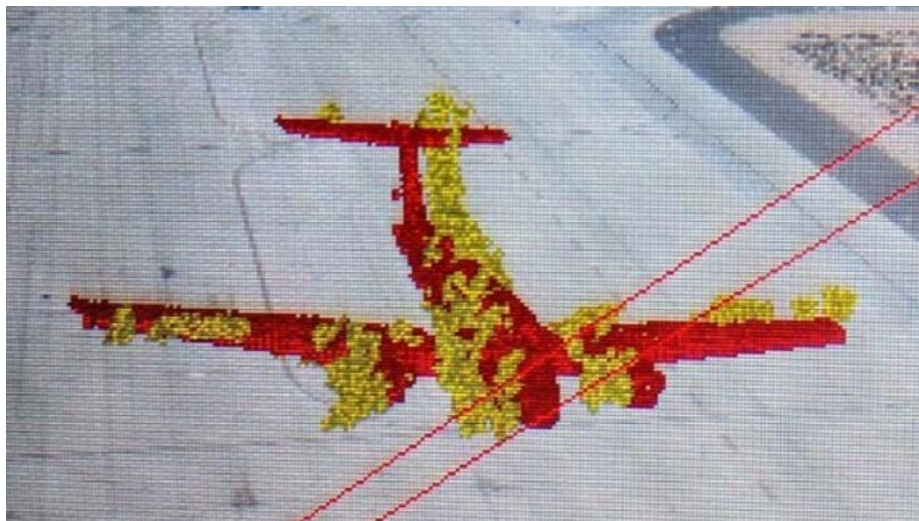
**Figure 1. C-12 Reference Model and Point Cloud.**

The real-time viewer was brought up in the transit to the Isabella MOA at 1150L. The text file directions on the computer desktop were useful. The system displayed the range to the test aircraft if the range was under 100 meters. The contact position was typically at about 36-38 meters slant range. Range was measured from the camera tray on 158 to the point cloud center of mass on 161. Yellow point cloud dots were concentrated on the fuselage and engine nacelles. More points were located near the USAF markings on top of the wings, which was a good sign that the lower exposure settings were helpful. The ICP algorithm tried to match a red colored C-12 reference model to the point cloud. This match was pretty good for position, but was quite jumpy for attitude. Future systems using ICP could augment the attitude calculation with smoothing inputs from the ownship IMU (or other techniques) to keep the system from matching to obviously incorrect attitudes. One issue noted with matching the aircraft position was that yellow point cloud dots were occasionally placed on background clouds or snowy mountains. These far away dots were small in number, but their large distance from the centroid of the other points caused the red C-12 reference model to jump aft by up to 5 meters or so as displayed on the real-time viewer. The system operator didn't notice if the range readout was also jumping around. Future flights should continue to use the real-time viewer and should complete the airborne systems operator survey. See Figure 1 for a photo of the point cloud and reference model.
