REPORT NO. P-1021

DATE 31 January 1934

REPORT OF PROGRESS
ON
ANTIFOULING COATINGS

NAVAL RESEARCH LABORATORY
BELLEVUE, D. C.

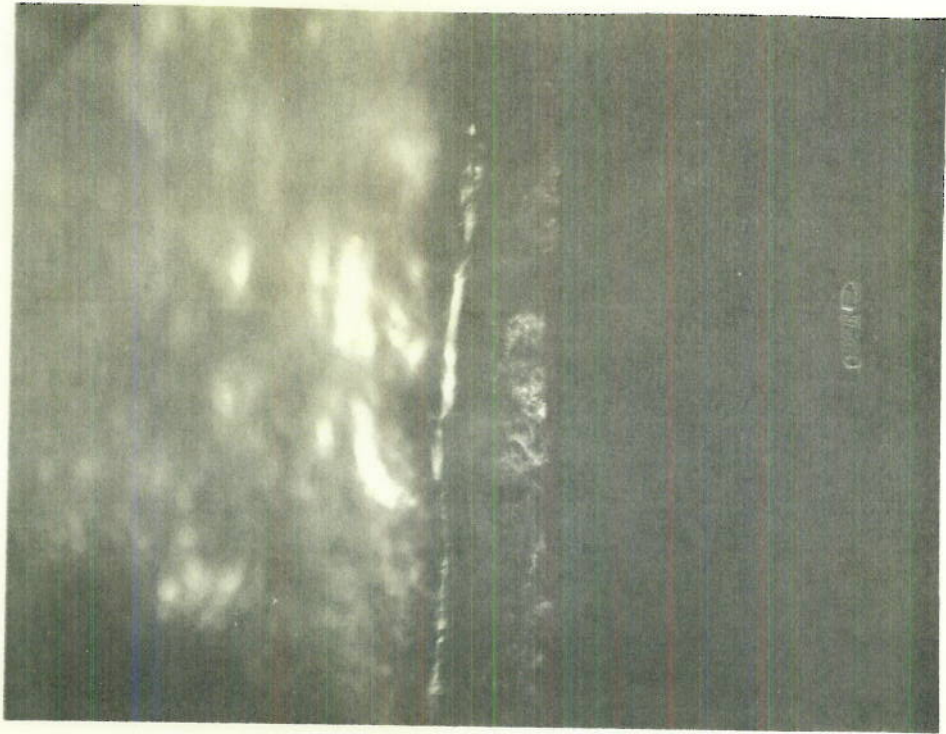
Plate 12

Plate #12 is the same specimen under high magnification. The reaction or bonding zone can be more clearly distinguished.
