Phytomanagement of Soil and Groundwater at the Niagara Falls Storage Site (NFSS) Using Hybridized Trees

September 2021

Final report

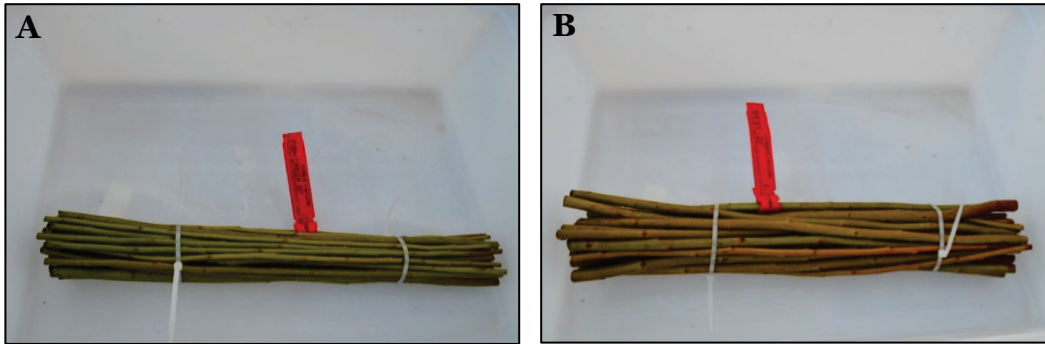
Figure 3. 20 in Fish Creek (A) and SX61 (B) cuttings soaking in water until planting.

All trees were planted on an approximate 6 ft spacing between rows and 18 in between individual trees within a given row. This is a tree planting density of 4,480 trees per acre. Tree cuttings used for this effort were 10 in in length and planted in loosened, disked soil approximately 9 in deep, with 1 in left above ground level. The soil around each cutting was packed by foot for each tree planted. Since the initial planting, two coppicing events have occurred (Dec 2016 and Jan 2018). Field piezometers were installed in October 2017 by LRB personnel to monitor changes in groundwater level. Radionuclide concentrations in subsurface water were also monitored by the LRB team from samples collected from MW. Plant tissues and soil cores were collected from the test plot in a randomized fashion and shipped to the ERDC’s EL for analyses to determine the levels of radionuclides detected in plant tissues and soil. The LRB team will carry out continuous monitoring of radionuclide concentrations in tree leaves to determine whether the trees will translocate contaminants from the soil at various growth and life-cycle stages.

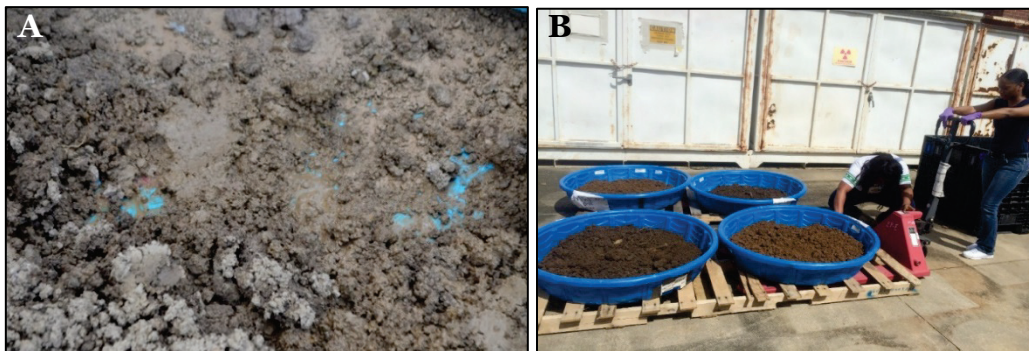
Figure 4. Soil drying process, (A) wet and (B) dry, after removal from 55 gal drums.

Soil samples were collected from various locations at the NFSS and shipped to ERDC in a 55-gal drum. The soil samples were collected near MW 958, MH06, MH09, and MW505 (see Figure 1 for MW and MH locations). Each sample was separated in plastic bags by lower and upper layers, sealed, and placed inside the 55-gal drums. The lower soil layers were collected from NFSS at depths between 6 and 16 in, and upper soil layer were collected at depths between 0 and 6 in. Soils were removed from the drums and placed in 36 in diameter polyethylene pools at a depth of 10 in to air-dry at room temperature (Figure 4). After drying, the soils were homogenized with shovels and rakes. Following soil homogenization, subsamples were collected, and geochemical analyses (for example, total metals, U and Th concentrations, pH, cation exchange capacity, and total organic carbon) were performed using standard USEPA methods 9045 and 9081 (pH and CEC, respectively) and modified USEPA methods 3051 A SW-846 and 6020 (U and Th) (USEPA 2000; USEPA 1986; USEPA 2007; USEPA 1994).

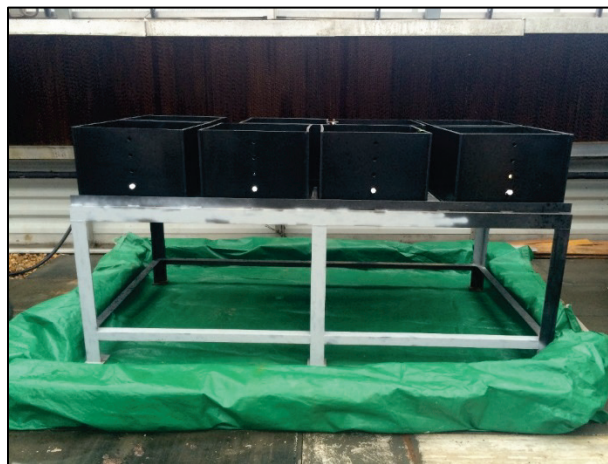
Figure 5. 12×12×12 in black containerized greenhouse growth containers.

The greenhouse experiment included 12×12×12 in containerized high-density polyethylene boxes (Figure 5), which were layered with pea gravel, sand, and soil (Figure 6). A 3 in (7.62 cm) layer of pea gravel was placed at the bottom of the growth chamber to prevent sediment from clogging the drainage holes throughout the leachate collection. A layer of nonwoven geotextile was placed atop the pea gravel and draped around the inside of the growth chambers. A 3 in (7.62 cm) layer of coarse sand was placed on top of the geotextile and compacted before the contaminated soils were added. A 6 in (15.24 cm) layer of soil was placed over the sand layer and compacted to form a sediment layer approximately 12 in deep. The containers are designed to use a nonreactive tubing and shut-off valves to allow for the collection of leachate and were placed on fabricated iron stands.

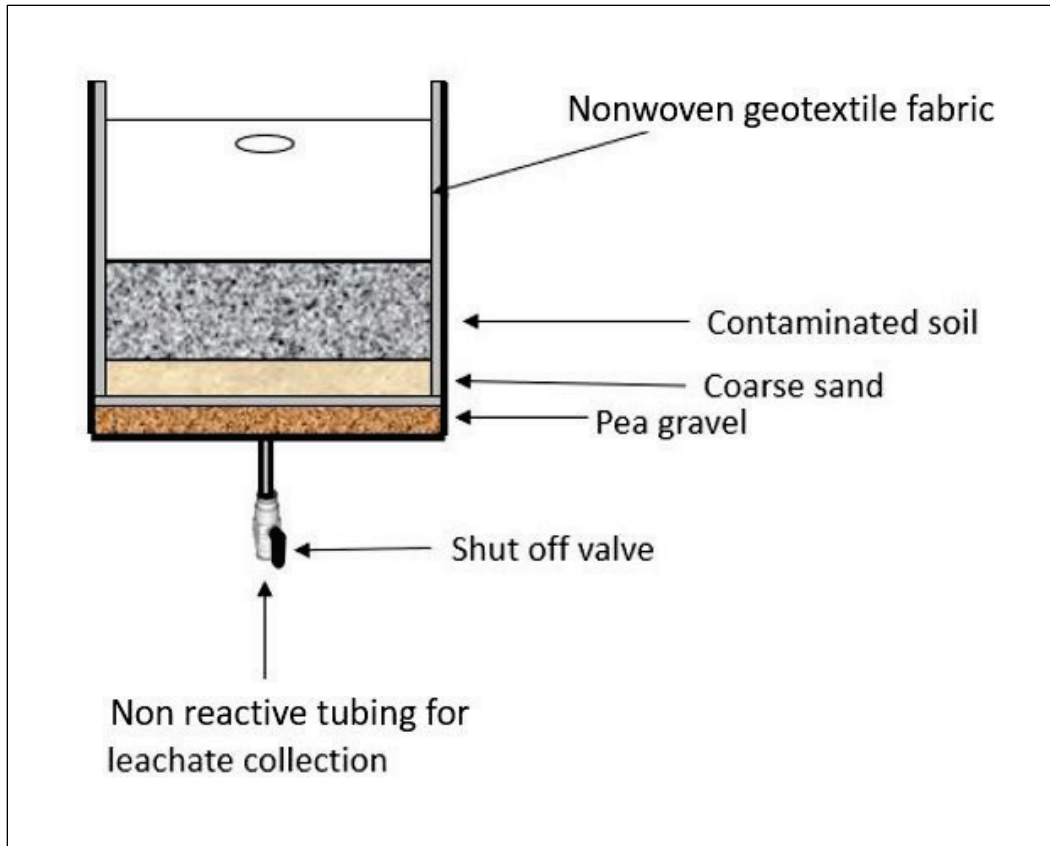
Figure 6. Schematic of containerized growth chamber.

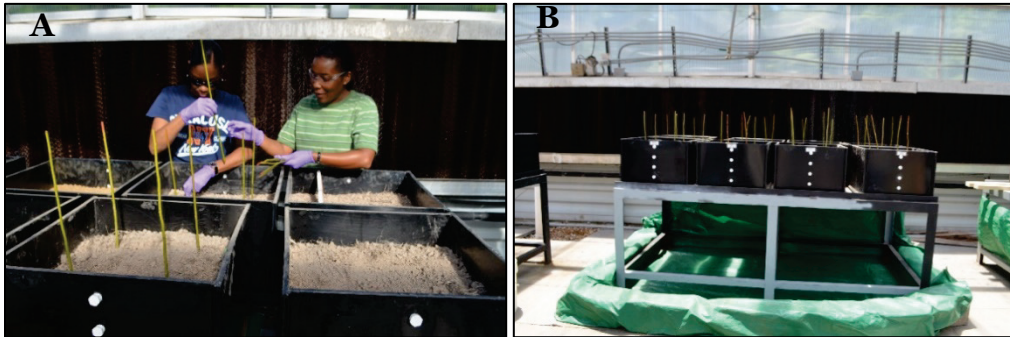
Figure 7. (A) Planting of Fish Creek and SX61 cuttings and (B) eight growth containers with planted cuttings.

On the basis of available soil volume, 12 growth chambers were employed in this study, eight for the planted containers and four smaller containers for the controls. Experimental chambers consisted of two growth containers for each soil location, with either Fish Creek or SX61. For the control chambers, there was one container for each soil. In the planted chambers, four of the 20 in Fish Creek and SX61 cuttings were planted in the contaminated NFSS soil and irrigated using DI (Figures 7A and B). The greenhouse setup was located at an ERDC greenhouse in Vicksburg, Mississippi, with ambient conditions ranging between 32 ± 5 °C during the day and 21.1 ± 5 °C at night and a natural photoperiod of 12h:12h light:dark cycle. ONSET HOBO data loggers monitored the relative humidity, temperature, and lighting. The plants were manually irrigated weekly with DI water as needed. The soil moisture content was monitored to maintain soil field capacity. Weekly growth assessments included measurement of tree height:the vertical distance from the top of the soil surface, which is the base of the shrub, to the top of the highest branch on the shrub. Plant growth and U and Th accumulation in tree stems, leaves, and roots were determined at the termination of the study. Soils removed

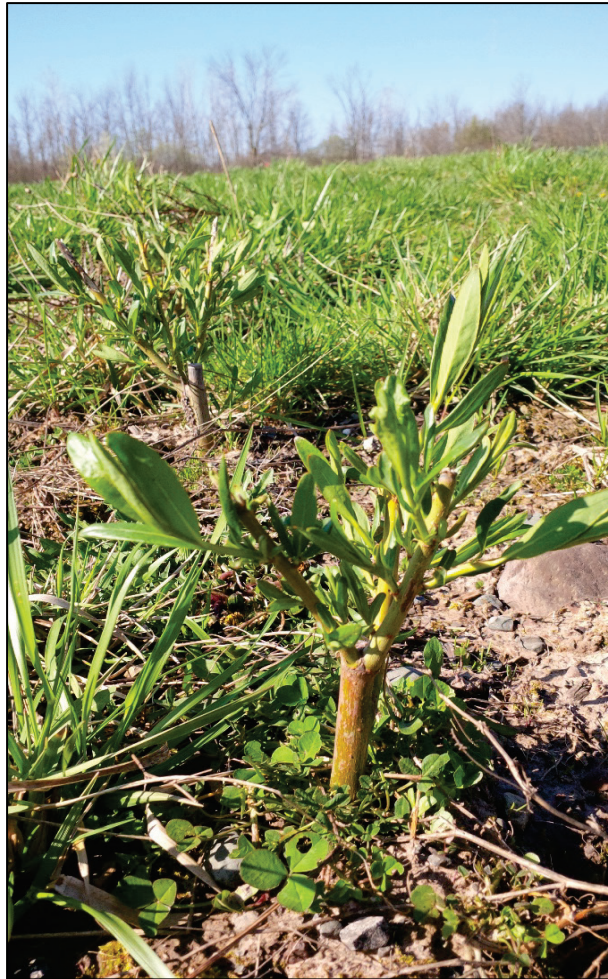
Figure 8. Shrub willows growth 11 months after initial planting and eight months following initial coppicing (April 2017).

Photos of the shrub willows documented growth and rate of biomass increases. After planting the willow tree cuttings (May 2016), the trees grew for eight months and coppiced (January 2017) to promote higher biomass yields for the upcoming spring (Figure 8). No soil or plant tissue samples were collected for the first year of planting to avoid any damage or unnecessary disturbance to the site. One year after planting, shrub willows had reached heights up to 7 ft (Figure 9). After sixteen months, the shrub willow plot exhibited good biomass growth (Figure 10). Four months later, in January 2018, the willow shrubs reached dormancy during the winter/snow season (Figure 11.)

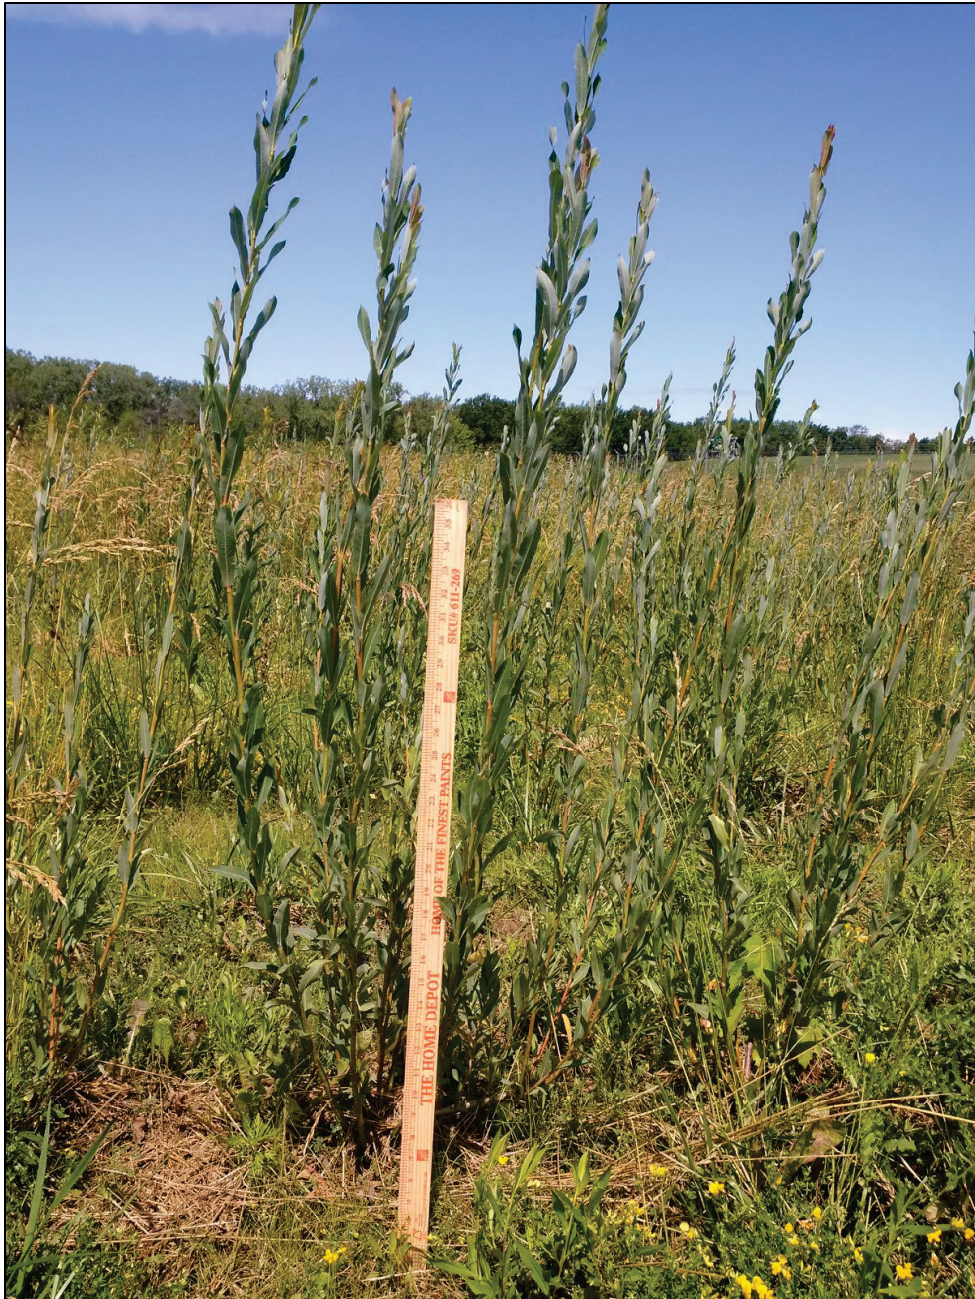
Figure 9. Shrub willows one year after initial planting (June 2017).

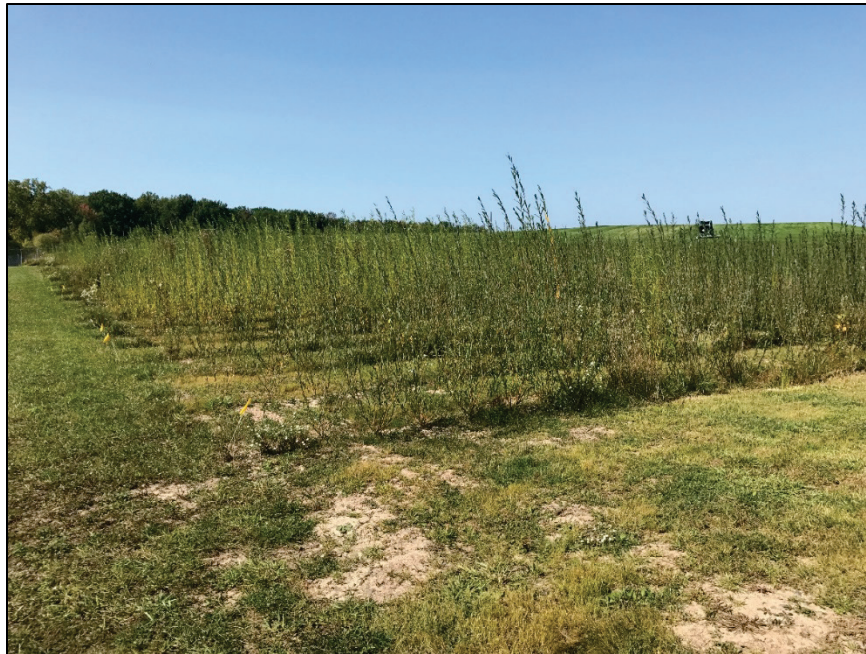
Figure 10. Shrub willow plot nine months after initial coppicing and 16 months after initial planting (September 2017).

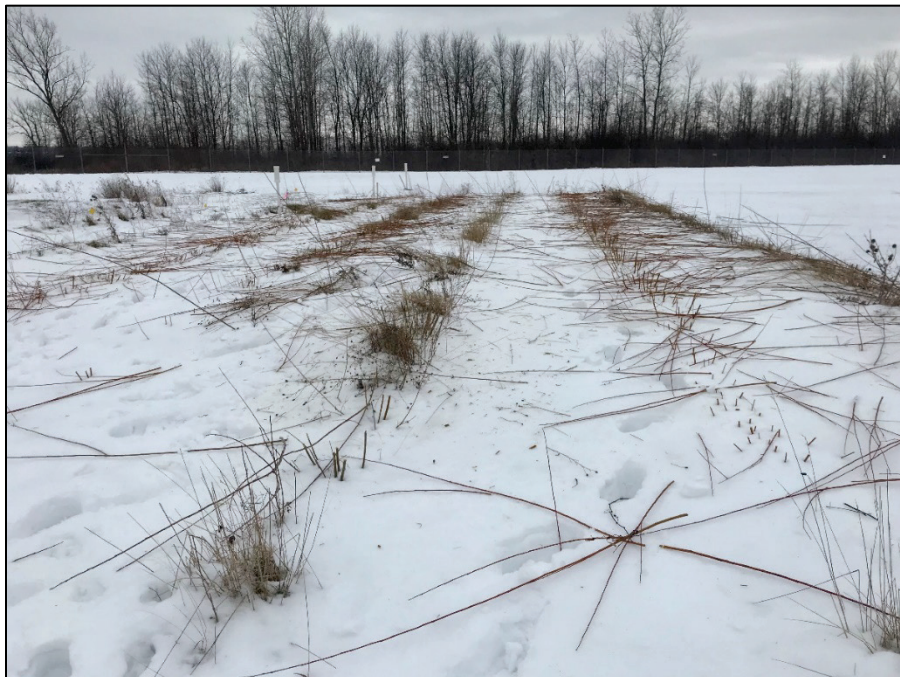
Figure 11. Test plot after coppicing of the shrub willows (Jan 2018).

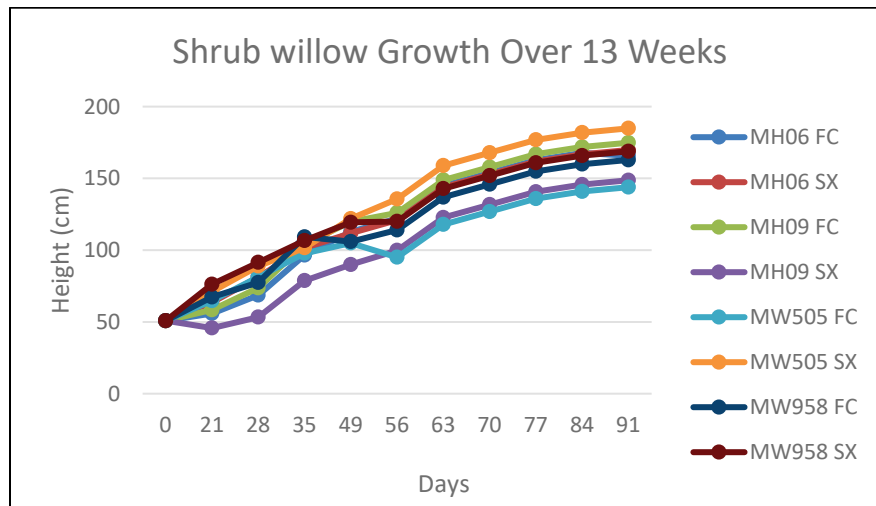
Figure 12. Fish Creek and SX61 shrub willow growth over 13 weeks (up to 91 days).

Both shrub willows grew rapidly during the greenhouse study. The stem heights of both species grown in all eight soils went from 50.8 cm to an average of 164.93 cm after 13 weeks (Figure 12). Stems developed in just seven days (Figure 13). In one month, there were yellowing of leaves observed in SX61, likely resulting from a lack of nutrients, particularly N (Figure 15) (USEPA 1986). Brown spots were observed on some of the leaves around day 56 (Figure 16), usually an indication of leaf disease caused by pathogens (that is, bacteria or fungi) (Uchida 2000).

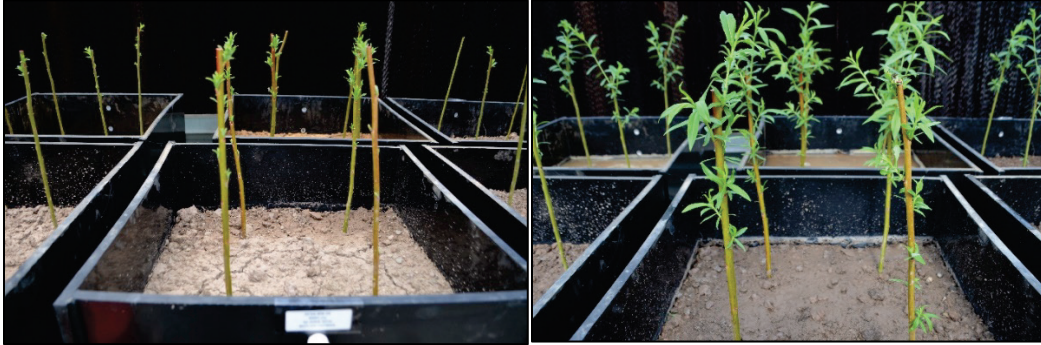
Figure 13. SX61 shrub willow at day seven (front row left) and at day 14 (front row right) grown in MH06 area soils.

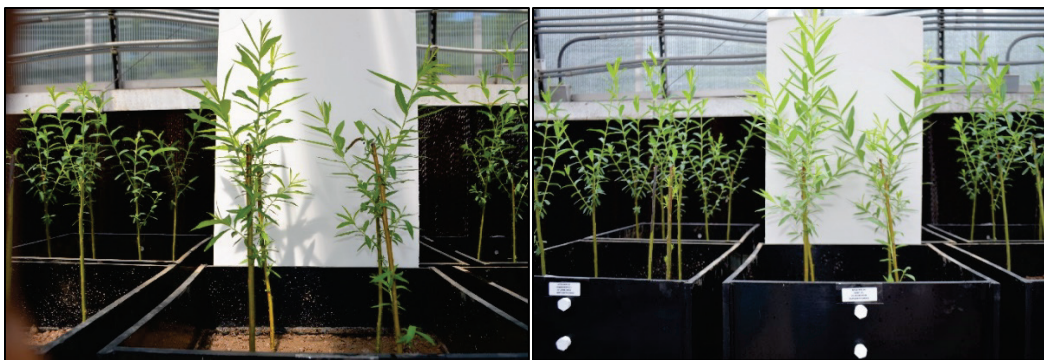
Figure 14. SX61 shrub willows grown in MH06 area soils at day 21 (front row left) and at day 28 (front row right) grown in MH06.

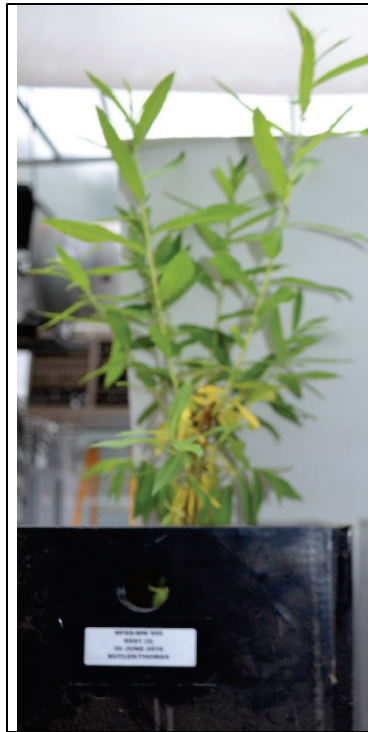
Figure 15. SX61 shrub willow grown in MW505 area soils at day 28 showing yellowing of leaves.

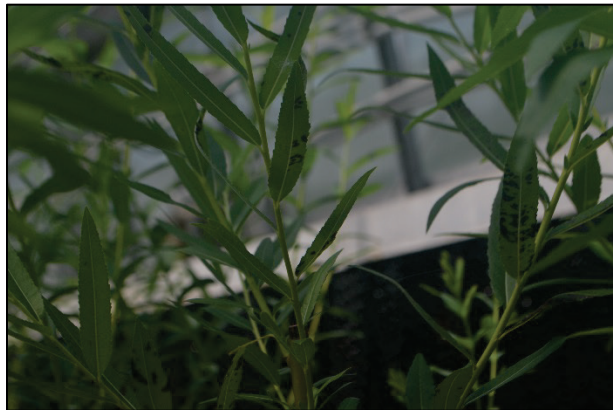
Figure 16. SX61 shrub willow grown in MW505 area soils at day 35 showing leaf brown spots.

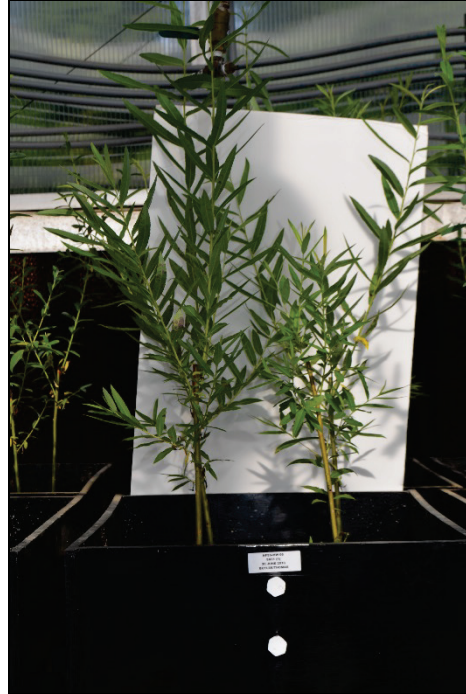
Figure 17. SX61 shrub willow grown in MW06 area soils at day 56.

Shrub willow SX61 attained an overall greater biomass relative to Fishcreek, with a general trend of greater stem lengths (Figure 17). However, this outcome was expected, as SX61 cuttings were notably larger than Fischcreek cuttings (Figure 18). Comparing soil types and effects on plant growth, it appears the largest plants for both willow hybrids were observed in MW09 and MW958 soils. This observation is likely attributed to the higher Total Kjeldahl Nitrogen (TKN) concentrations present in the

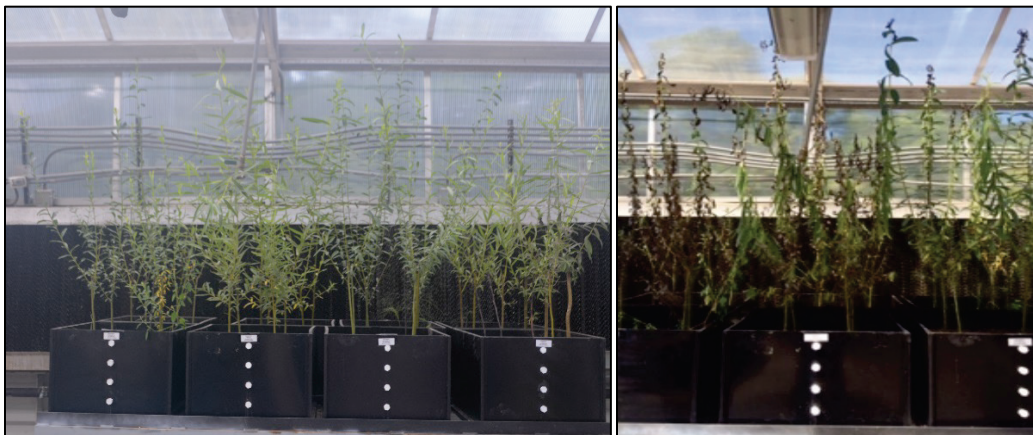
Figure 18. All eight containerized growth chambers at day 63 (left) and SX61 grown in MH06 area soils at day 91 (right).

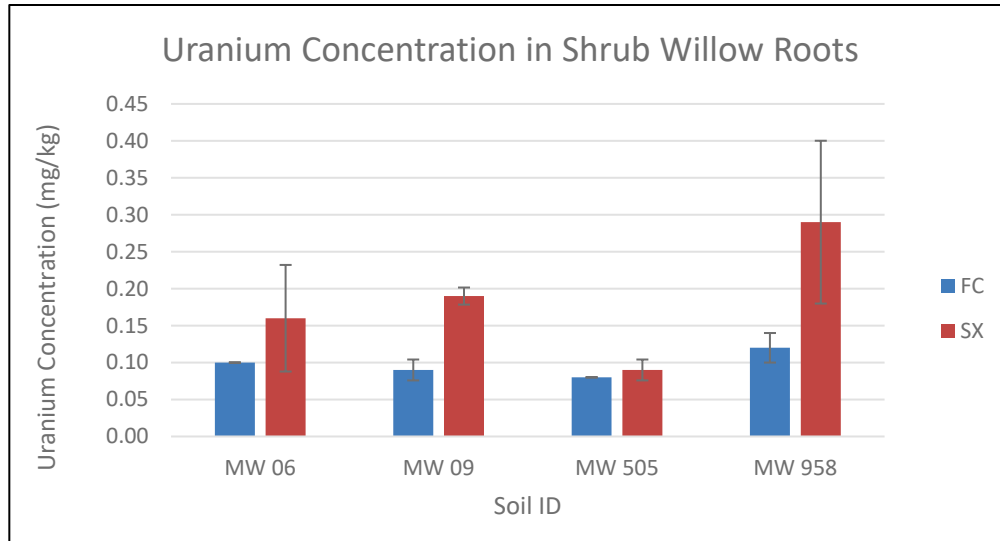
Figure 19. Bar graph showing concentration of U in shrub willow roots.

In addition to having a larger biomass, shrub willow hybrid SX61 accumulated higher concentrations of U in roots compared to the Fishcreek hybrid, although the total amount of accumulated U was still quantitatively minuscule (approximately 0.1%). This trend was observed for each of the four soil types. According to background measurements of the tested soils, a correlation between TKN and U sorption to Fishcreek and SX61 plant roots was observed, as sorption increased TKN concentrations were elevated (Table 10). However, the general mechanism of U uptake in plant roots is poorly understood, and it is therefore unclear if microbial activity influenced U sorption by plant roots. No correlation between cation exchange capacity (CEC) and U sorption or translocation was observed for either shrub willow hybrid. Uranium sorption and translocation data are shown in Figures 19 and 20, respectively.

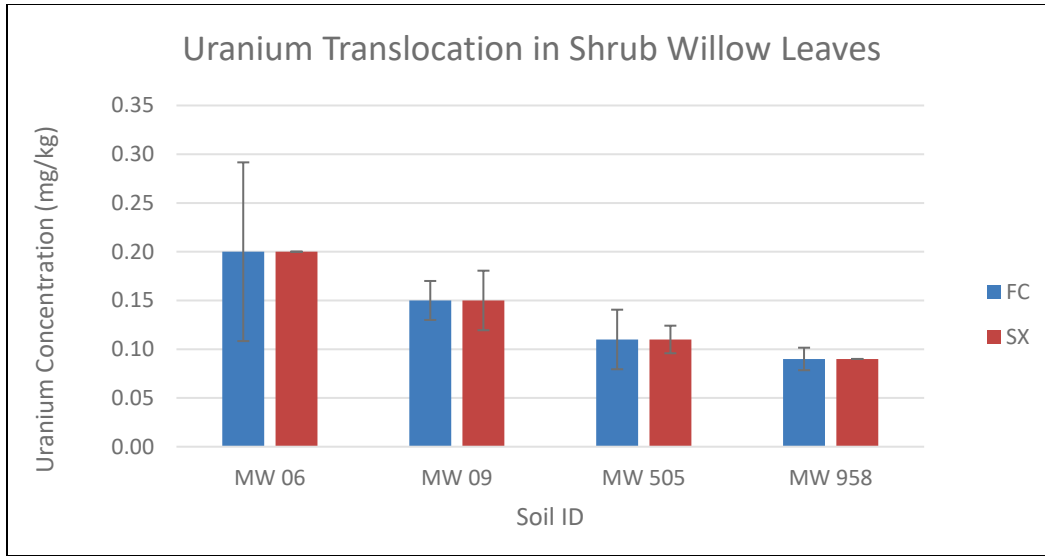
Figure 20. Bar graph showing U translocation into Fishcreek and SX61 leaves.

Uranium uptake and translocation in shrub willow hybrids Fishcreek and SX61 were modest in magnitude, with an average accumulation in leaves of both hybrid types approximately 0.1% relative to soil concentrations. Soil background measurements, plant biomasses, and U concentrations reported in test soils and plant tissues are detailed in Figure 20 and Tables 11–14.

Uranium concentration data for shrub leaves and stems indicated that hybrid willow SX61 translocated equivalent U concentrations relative to Fishcreek in each of the four soils (Figure 20). Fishcreek and SX61 hybrid types accumulated approximately 0.02%, 0.007%, 0.006%, and 0.008% U from MW 06, MW 09, MW 505, and MW 958 soils, respectively. Very little to no U was detected in the stem tissues of either plant.
