## **Backward Erosion Testing: Magnolia Levee**

September 2021

Final report

Under Project A1070, “Investigation into Embankment Failure Mechanisms;” Funding  
Account Code U4375173; AMSCO Code 031398

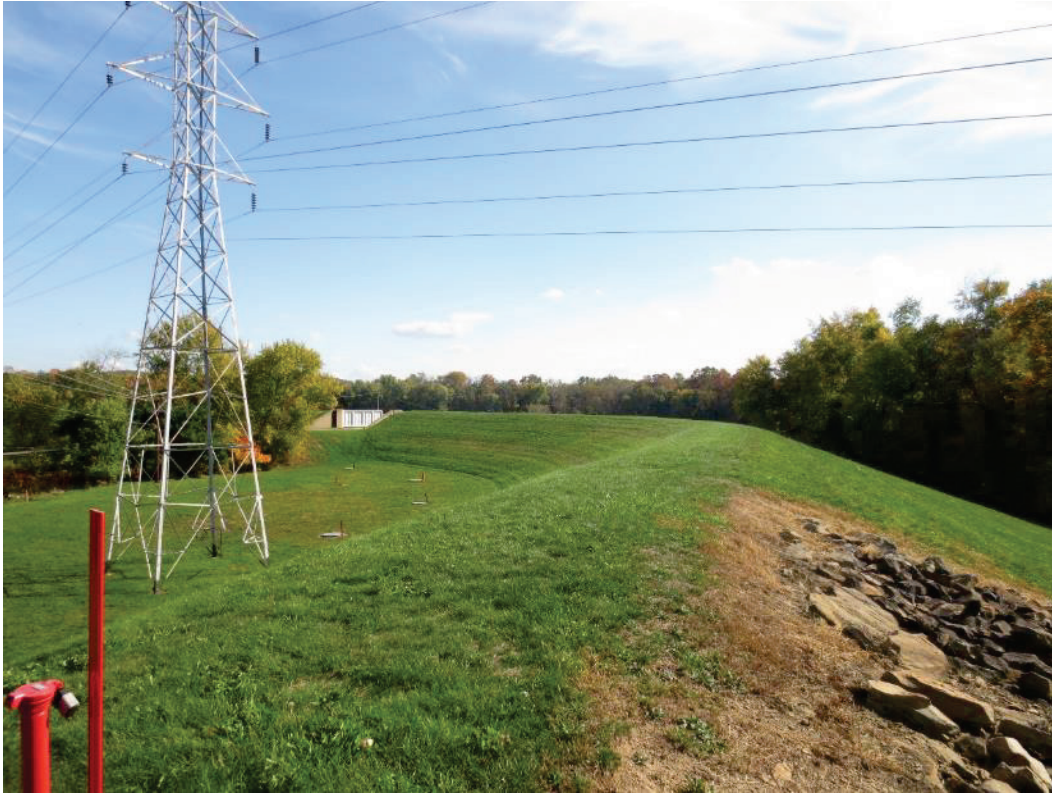
Figure 2. Looking south on the Magnolia Levee crest.

This levee was classified as a high-risk structure according to a semiquantitative risk assessment (SQRA) performed in 2015. The risk was primarily driven by BEP of the foundation, but I-wall instability and concentrated leak erosion along foundation corrugated metal pipes also contributed to the total project risk. The project entered an issue evaluation study (IES) in 2016 to reduce uncertainties and better quantify the project risks. As part of the IES, bulk samples of glacial outwash were collected from Oster Sand and Gravel Quarry. The quarry is located 5 river miles downstream of Magnolia Levee and 3 miles upstream from Bolivar Dam along Sandy Creek. As shown in Figure 1, the quarry is east of Bolivar and Magnolia. Figure 2 shows a view from the top of the crest of the levee.

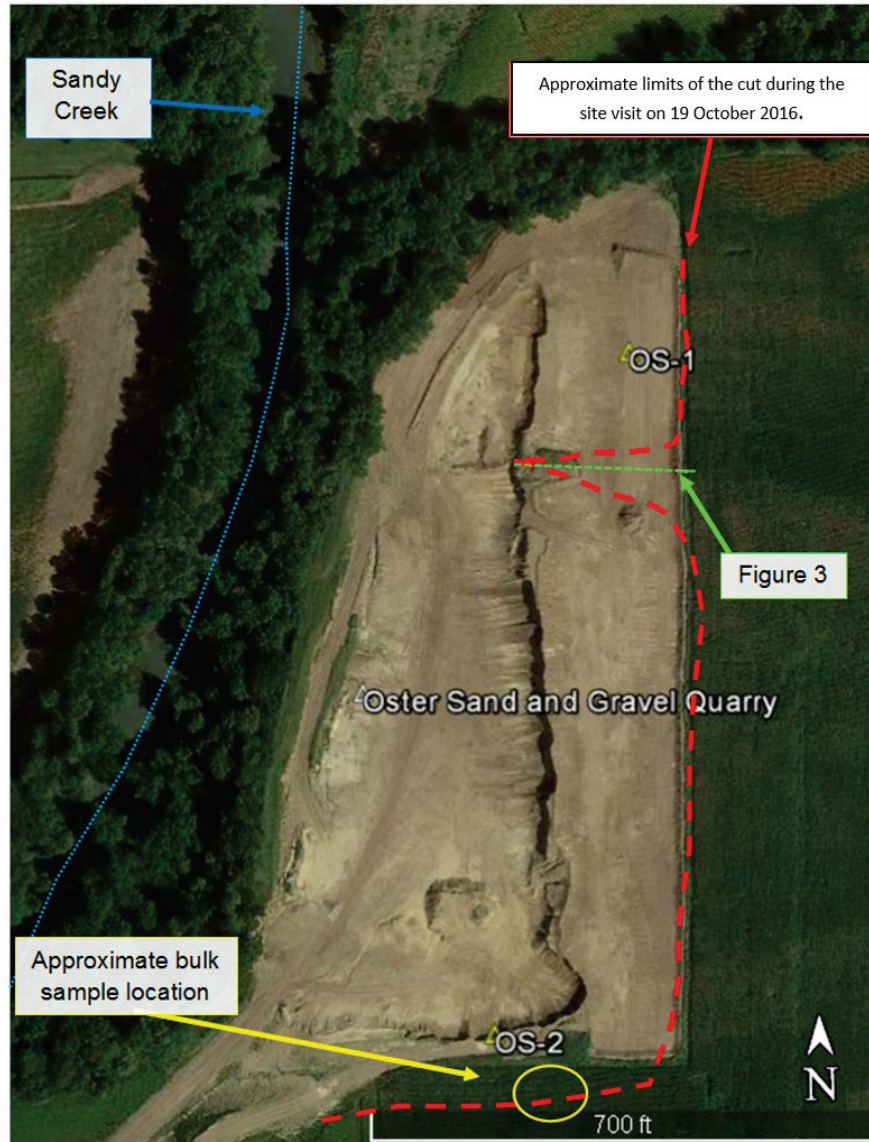
Figure 3. Plan view showing Oster Sand and Gravel Quarry with the approximate bulk sample location. The *red dashed line* represents the approximate limits of the cut on 19 October 2016.

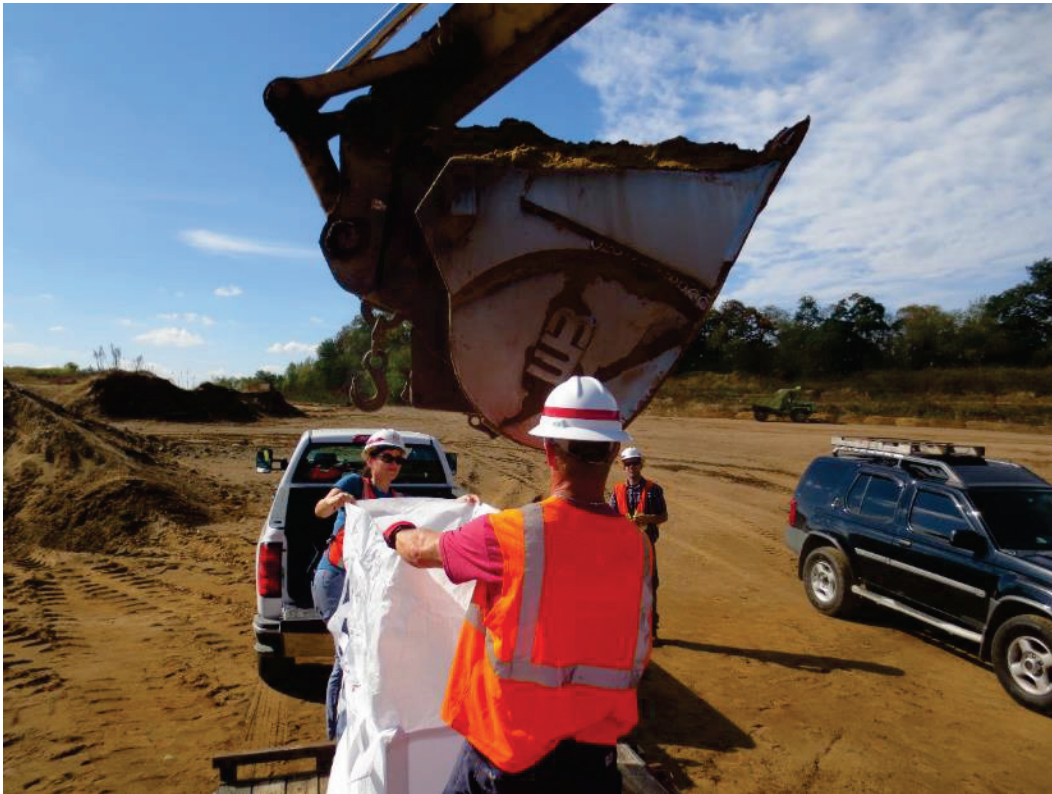
Figure 7. Soil collected was placed in plastic bags to transport from the quarry to the laboratory facilities.

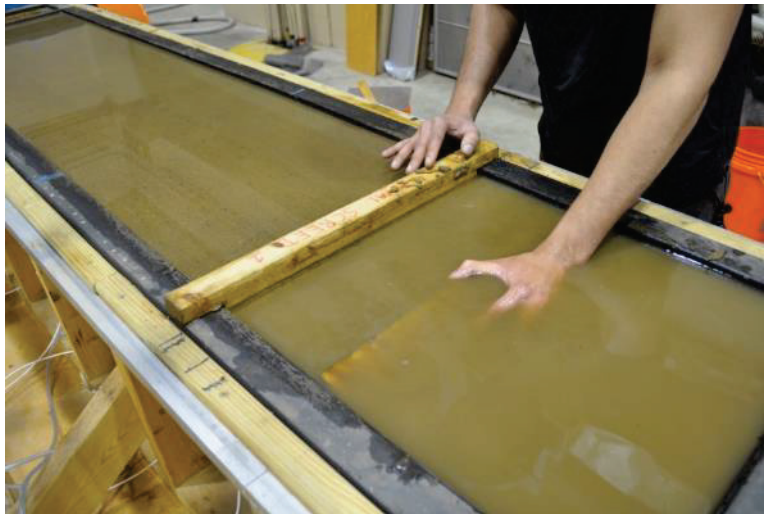
Figure 11. Sample preparation (Test S1-1).

Using a scoop, the soil was carefully wet pluviated (rained) into the flume. Wet pluviation was used to obtain nearly isotropic permeability of the soil samples (Chapuis et al. 1989). In addition, dry gravel was placed behind the upstream filter wall to diffuse the inflow, resulting in a uniform flow distribution and a uniform boundary condition at the upstream side. The samples were prepared either loose or dense. Loose samples were prepared by avoiding any vibrations when pluviating the sand in the flume. Dense samples were obtained by tamping the soil with a rod and using a rubber mallet with a flat piece of wood. The downstream slope of the sample was carefully prepared with a flat piece of wood (Figure 11). Any soil particles that rolled down the slope during preparation were caught using a trap downstream and not considered for sample density calculations. A screed was used to level the top of the sample when finalizing the preparation. Finally, the dry weight of the sample and measurements for volume were used to calculate the unit weight and relative density. Sample volumes were adjusted for volume change because of the bladder pressurization.

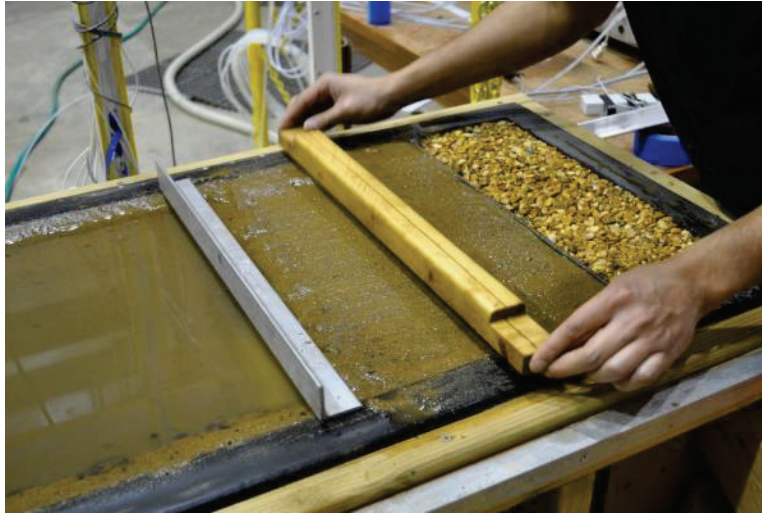
Figure 12. Additional layers along the side walls of flume and in front of the upstream wall (Test 1).

After initial sample inspection, additional small layers of the same material with a width of  $\sim 2$ – $2.54$  cm were placed along the edges of the long walls of the flume (Figure 12). These small layers were added to ensure uniform contact of the sample when the bladder was inflated. Additionally, a thin layer of the material was placed in front of the upstream wall. This layer covered the whole width of the sample and was

30 cm long. This layer was added after observing poor contact between the soil and the acrylic near the upstream wall during trial tests.

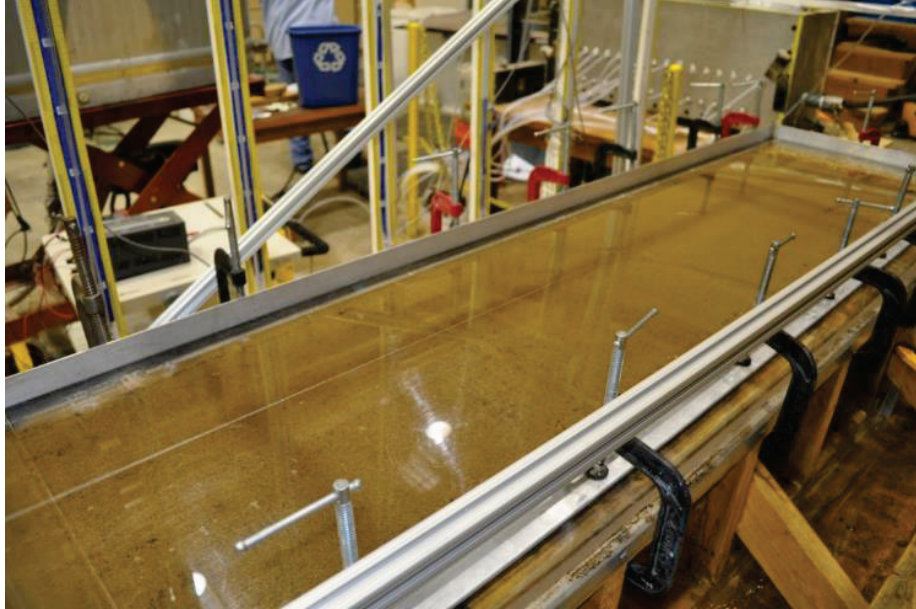
Figure 13. Sample with acrylic top and bladder pressurized for contact (Test S1-4).

At this moment, the sample was ready to be loaded with the bladder. Using a modified triaxial apparatus as a source of pressurized de-aired water, the bladder was pressurized in increments of 6.9 kPa (1 psi) until the top of the sample was in contact with the acrylic top. This process could take hours, and the maximum pressure of the bladder was between 41.4 kPa (6 psi) to 55.2 kPa (8 psi). After obtaining a good contact between the sample and the acrylic top (Figure 13), the seating pressure was decreased to 19.0 kPa (2.75 psi) for testing. The water level of the pressurized triaxial apparatus was recorded, and the bladder valve was closed once the water

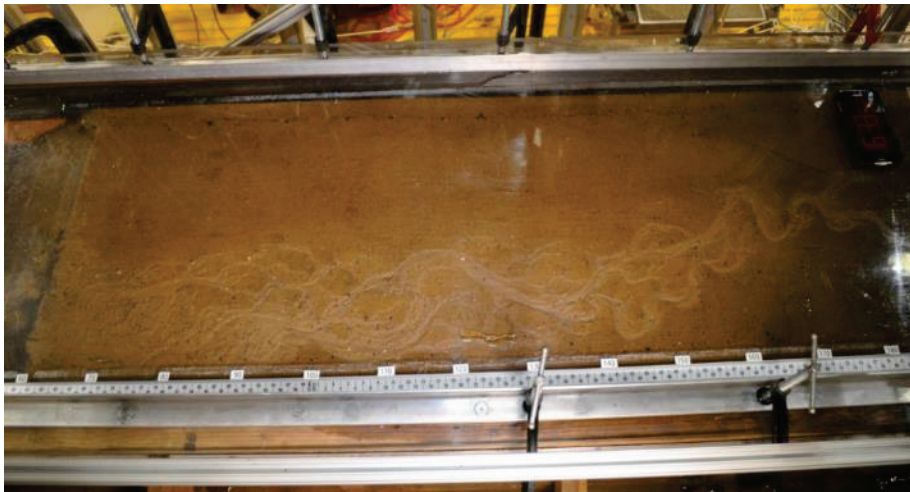
Figure 15. Developed pipes meandering from downstream (*left*) to upstream (*right*) in Test S1-5.

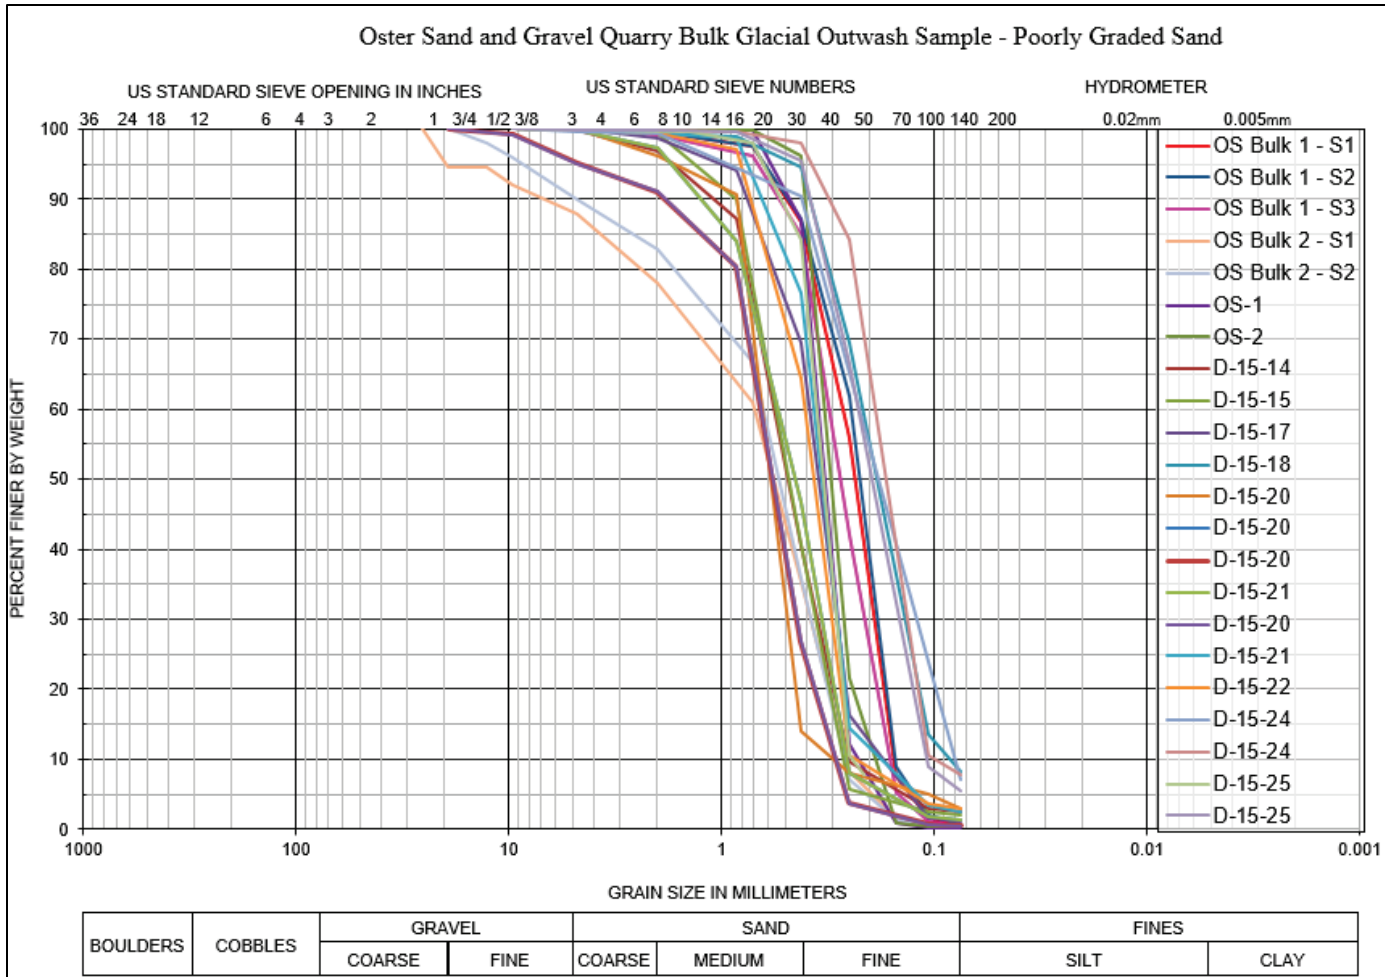
Figure 17. Gradations of samples from Magnolia Levee 2016 foundation explorations (D-15-XX) and from a continuous SP deposit from Oster Quarry (OS-1, OS-2, and OS Bulk 1–S-1, S-2, and S-3).

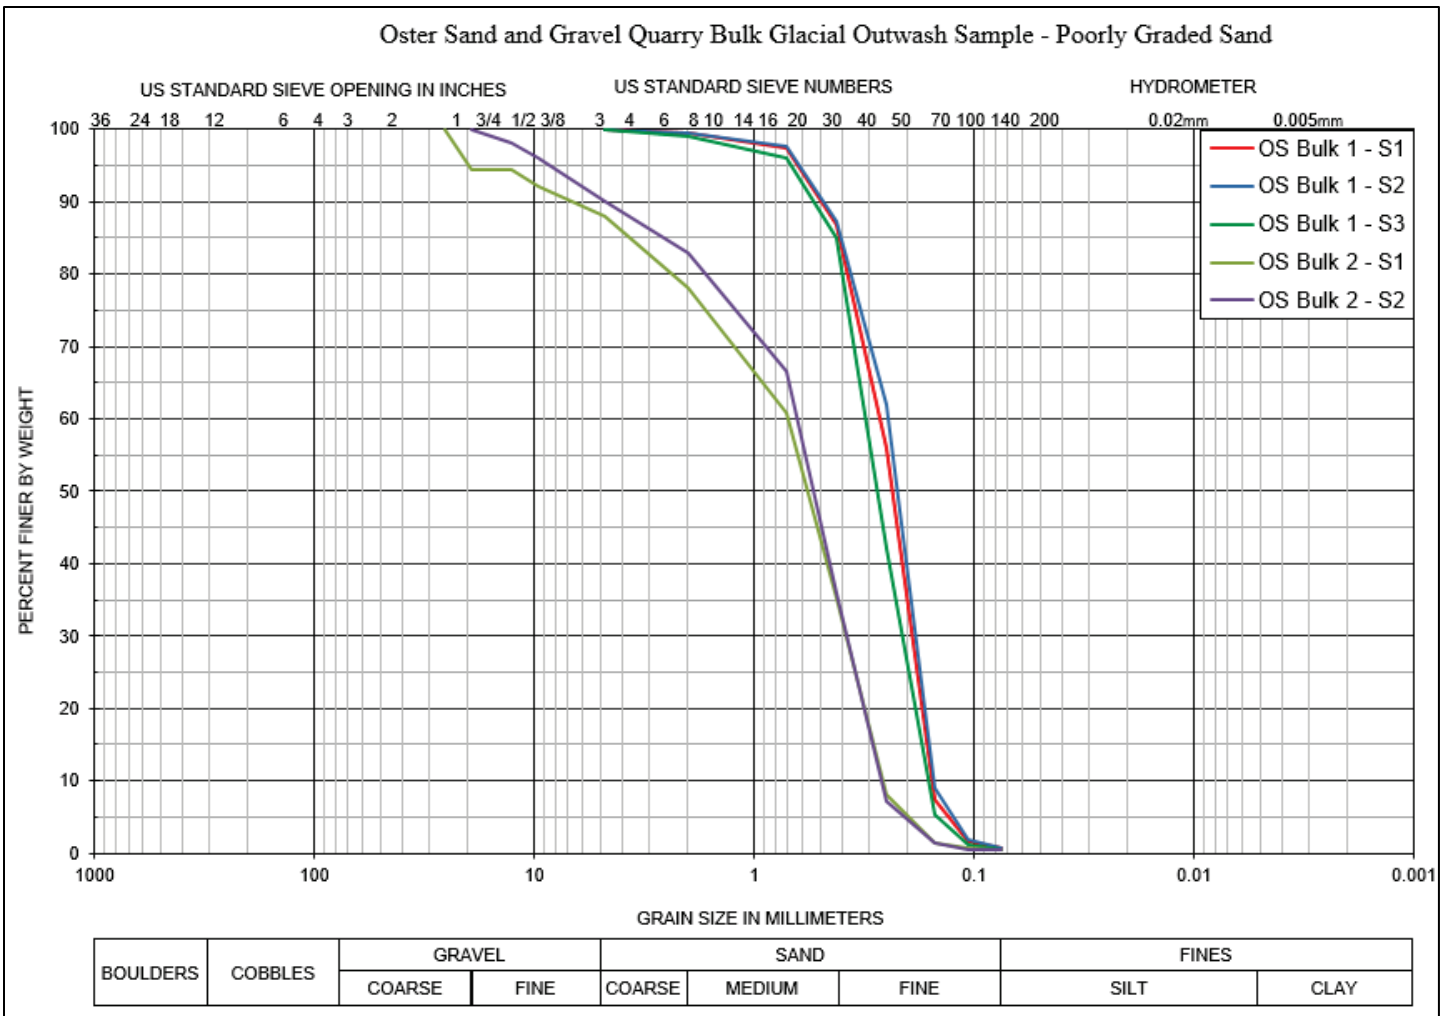
Figure 18. Gradation curves of the two bulk samples.

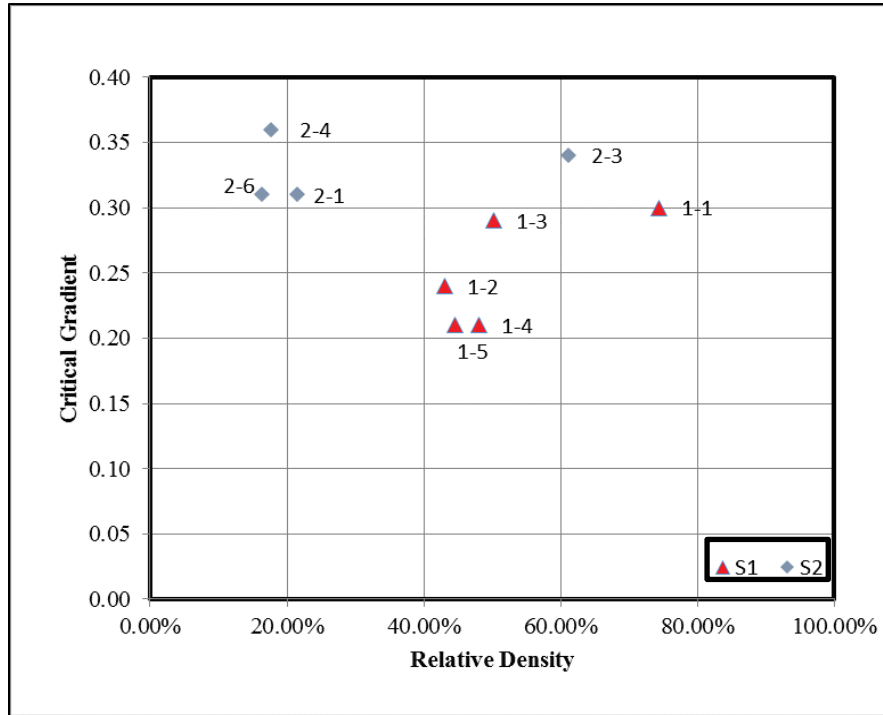
Figure 19. Horizontal critical gradients at piping versus relative density.

The estimate for relative density ( $D_r$ ) for the actual foundation material of Magnolia Levee was 40%. This estimate of the foundation material was at a depth where BEP was possible in this levee. The experimental study, therefore, sought to obtain samples with  $D_r$  close to 40%. Densities of S1 samples that were prepared in loose condition (no tamping involved) ranged from 43%  $D_r$  to 50%  $D_r$ , approximately. However, the densities obtained of the S2 loose samples ranged from 16% to 22%. The average  $C_u$  of S1 samples was 1.6, while the average  $C_u$  of S2 was 2.5. In general, the critical gradient required for BEP was found to be higher at lower void ratios. Table 3 and Table 4 provide a summary of the sample properties of each test along with their critical gradient for piping. Figure 19 and Figure 20 show the plotted results of critical gradient at piping versus relative density and void ratio of each test. A summary sheet for each test is presented in Appendix A.

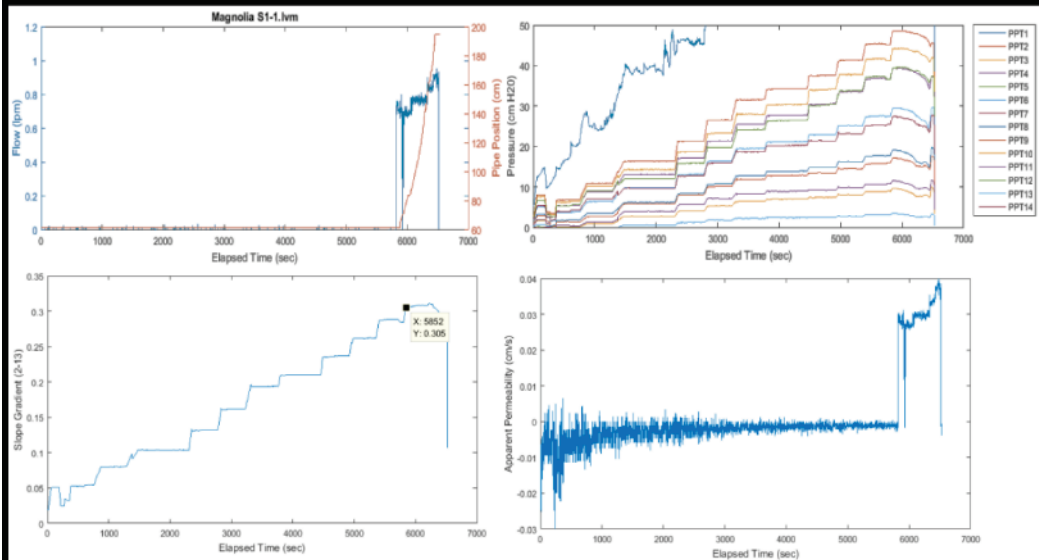
Initial Conditions		Results (at Initiation of Piping)	
Soil Weight for First Slope	421.300 kg	Time at Piping	22:52:54
Soil Volume	0.260482 m <sup>3</sup>	Critical Gradient (Slope)	0.30
Dry Unit Weight	15.867 kN/m <sup>3</sup>	Flow Rate	0.710 L/min
Porosity	0.389	Average Velocity	8.49E-03 cm/s
Sample Length	177.000 m	Sample Permeability	2.832E-02 cm/s
Area	0.139 m <sup>2</sup>		
Relative Density	74.41%

**Notes:** Sample was prepared on 08-09MAR2016. Test was conducted on 09MAR2016 with FMG84. Flow meter started acquiring measurements at 22:52:23 (30 seconds before piping started). Sample permeability and velocity at piping estimated from flow at the moment of piping. Sample piped on the left side of sample and progressed toward the center of the sample. Sample was confined to a bladder pressure of 7 psi and seating pressure of 2.75 psi. Additional sand was placed 30 cm from the upstream wall, and approximately 2 cm on the left and right sides of sample. The total sample length was 177.4 cm (slope at 61.6 cm and upstream wall at 239, with the plexiglass flush with the downstream side of the flume). PPTs for gradient were 2-13. In the video recorded for the test, the piping initiated at 01:37:34.

Total Head Contours at Initiation of Piping (units in cm)

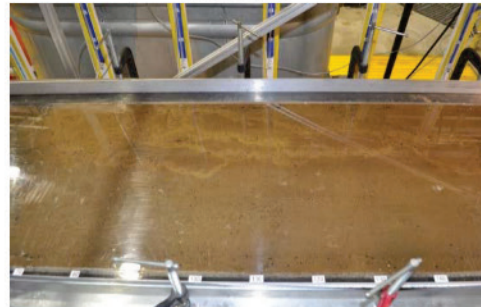
After Piping

Sand Type	<u>Magnolia S1</u>	Date	<u>31-Mar-17</u>
Test Number	<u>4</u>	Start Time	<u>16:29:36</u>
Tested by	<u>A.M., B.B.</u>	End Time	<u>17:58:08</u>

Initial Conditions		Results (at Initiation of Piping)	
Soil Weight for First Slope	395.140 kg	Time at Piping	17:17:35
Soil Volume	0.257830 m <sup>3</sup>	Critical Gradient	0.210
Dry Unit Weight	15.034 kN/m <sup>3</sup>	Flow Rate	0.653 L/min
Porosity	0.421	Average Velocity	7.81E-03 cm/s
Sample Length	177.0 cm	Sample Permeability	3.72E-02 cm/s
Area	0.1393 m <sup>2</sup>		
Relative Density	48.09%

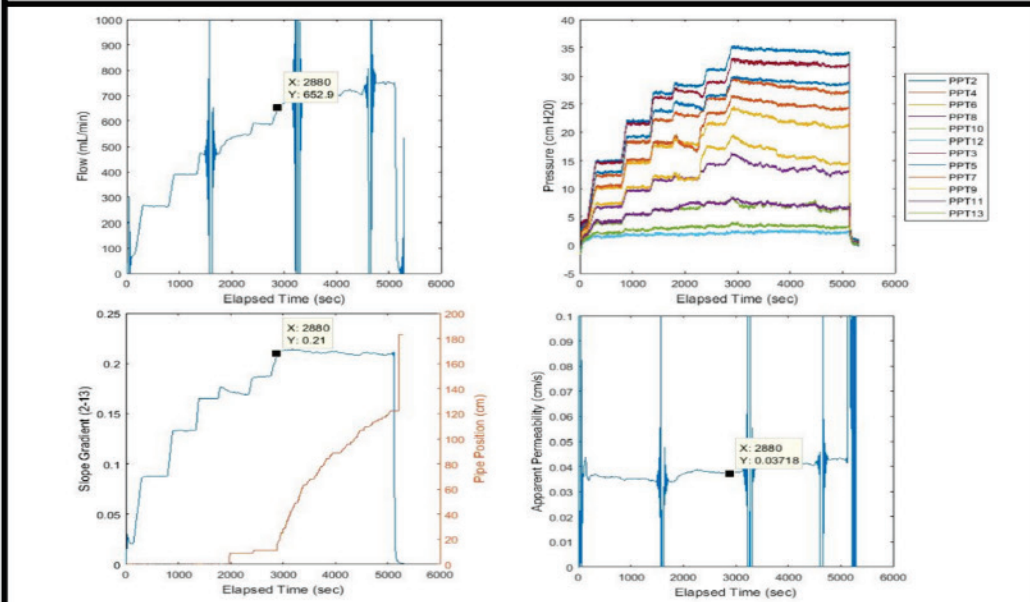
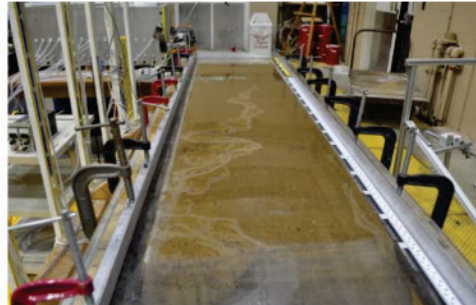
**Notes:** Sample was prepared on 30MAR2017. Test was conducted on 31MAR2017 with the load cell. Sample permeability and velocity at piping estimated from flow at the moment of piping. Some movement occurred during the test, and a small 9-cm-long pipe formed and stopped. Initiation and continuous piping started on the right side of sample and progressed toward the center of the sample at 17:17:35. A second pipe began to form on left side at the end of test. Sample was confined to a bladder pressure of 6 psi and seating pressure of 2.75 psi. Additional sand was placed 30 cm from the upstream wall, and approximately 2 cm on the left and right sides of sample for good contact. The total sample length was 177.0 cm (slope at 62.0 cm and upstream wall at 239, with the plexiglass flush with the downstream side of the flume).

Total Head Contours at Initiation of Piping (units in cm)

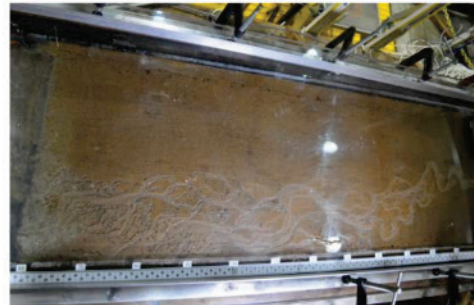
Sand Type	<u>Magnolia S1</u>	Date	<u>31-Mar-17</u>
Test Number	<u>5</u>	Start Time	<u>15:26:53</u>
Tested by	<u>A.M., B.B.</u>	End Time	<u>16:29:15</u>

Initial Conditions		Results (at Initiation of Piping)	
Soil Weight for First Slope	396.020 kg	Time at Piping	15:51:28
Soil Volume	0.260199 m <sup>3</sup>	Critical Gradient	0.21
Dry Unit Weight	14.931 kN/m <sup>3</sup>	Flow Rate	0.635 L/min
Porosity	0.425	Average Velocity	7.60E-03 cm/s
Sample Length	177.0 cm	Sample Permeability	3.59E-02 cm/s
Area	0.1394 m <sup>2</sup>		
Relative Density	44.60%

**Notes:** Sample was prepared on 9MAY2017. Test was conducted on 10MAR2017 with the load cell. Sample permeability and velocity at piping estimated from flow at the moment of piping. No movement occurred during the test until piping initiation. Piping started on the left side of sample and progressed toward the center of the sample at 15:51:28. Sample was confined to a bladder pressure of 6 psi and seating pressure of 2.75 psi. Additional sand was placed 30 cm from the upstream wall, and approximately 2 cm on the left and right sides of sample for good contact. The total sample length was 177.0 cm (slope at 62.0 cm and upstream wall at 239, with the plexiglass flush with the downstream side of the flume).

Total Head Contours at Initiation of Piping (units in cm)

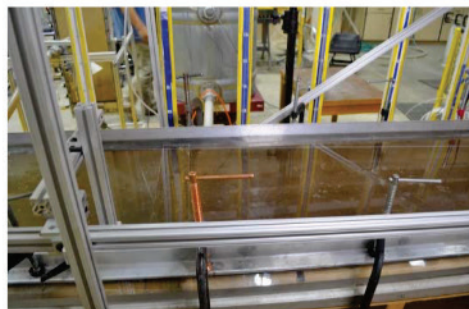
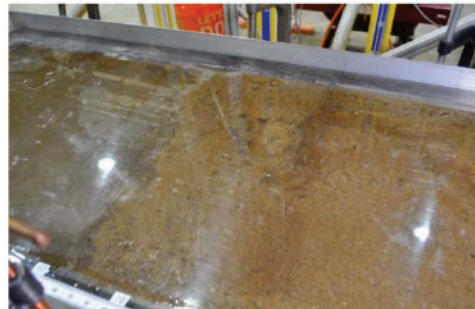
Sand Type	<b>Magnolia S2</b>	Date	<b>19-Apr-17</b>
Test Number	<b>1</b>	Start Time	<b>15:53:18</b>
Tested by	<b>A.M., B.B.</b>	End Time	<b>17:36:23</b>

Initial Conditions		Results (at Initiation of Piping)	
Soil Weight for First Slope	421.400 kg	Time at Piping	17:22:08
Soil Volume	0.257139 m <sup>3</sup>	Critical Gradient	0.31
Dry Unit Weight	16.077 kN/m <sup>3</sup>	Flow Rate	1.951 L/min
Porosity	0.383	Average Velocity	2.33E-02 cm/s
Sample Length	175.5 cm	Sample Permeability	7.37E-02 cm/s
Area	0.1394 m <sup>2</sup>		
Relative Density	21.56%

**Notes:** Sample was prepared on 18APR2017. Test was conducted on 19APR2017 with the load cell. Sample permeability and velocity at piping estimated from flow at the moment of piping. A 9-cm-long pipe formed on left side before piping initiated. At 17:22:08, continuous progression on the left side of sample started and two pipes formed on center and right side. Sample was confined to a bladder pressure of 6 psi and seating pressure of 2.75 psi. Additional sand was placed 30 cm from the upstream wall, and approximately 2 cm on the left and right sides of sample for good contact. The total sample length was 175.5 cm (slope at 63.5 cm and upstream wall at 239, with the plexiglass flush with the downstream side of the flume).

**Total Head Contours at Initiation of Piping (units in cm)**

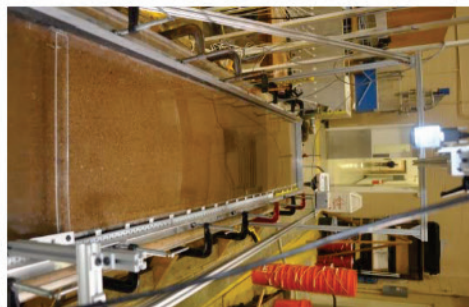
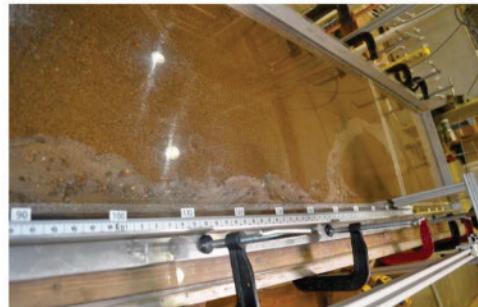
Sand Type	<b>Magnolia S2</b>	Date	<b>28-Apr-17</b>
Test Number	<b>3</b>	Start Time	<b>11:41:42</b>
Tested by	<b>A.M., B.B.</b>	End Time	<b>12:22:34</b>

Initial Conditions		Results (at Initiation of Piping)	
Soil Weight for First Slope	437.360 kg	Time at Piping	12:15:30
Soil Volume	0.251102 m <sup>3</sup>	Critical Gradient	0.34
Dry Unit Weight	17.087 kN/m <sup>3</sup>	Flow Rate	1.560 L/min
Porosity	0.344	Average Velocity	1.87E-02 cm/s
Sample Length	176.0 cm	Sample Permeability	5.50E-02 cm/s
Area	0.1394 m <sup>2</sup>		
Relative Density	61.17%

**Notes:** Sample was prepared on 27APR2017. Test was conducted on 28APR2017 with the load cell. Sample permeability and velocity at piping estimated from flow at the moment of piping. At 12:15:30, continuous piping initiated along the left abutment and moved towards the center. Sample was confined to a bladder pressure of 8 psi and seating pressure of 2.75 psi. Additional sand was placed 30 cm from the upstream wall, and approximately 2 cm on the left and right sides of sample for good contact. The total sample length was 176 cm (slope at 63 cm and upstream wall at 239, with the plexiglass flush with the downstream side of the flume).

Total Head Contours at Initiation of Piping (units in cm)

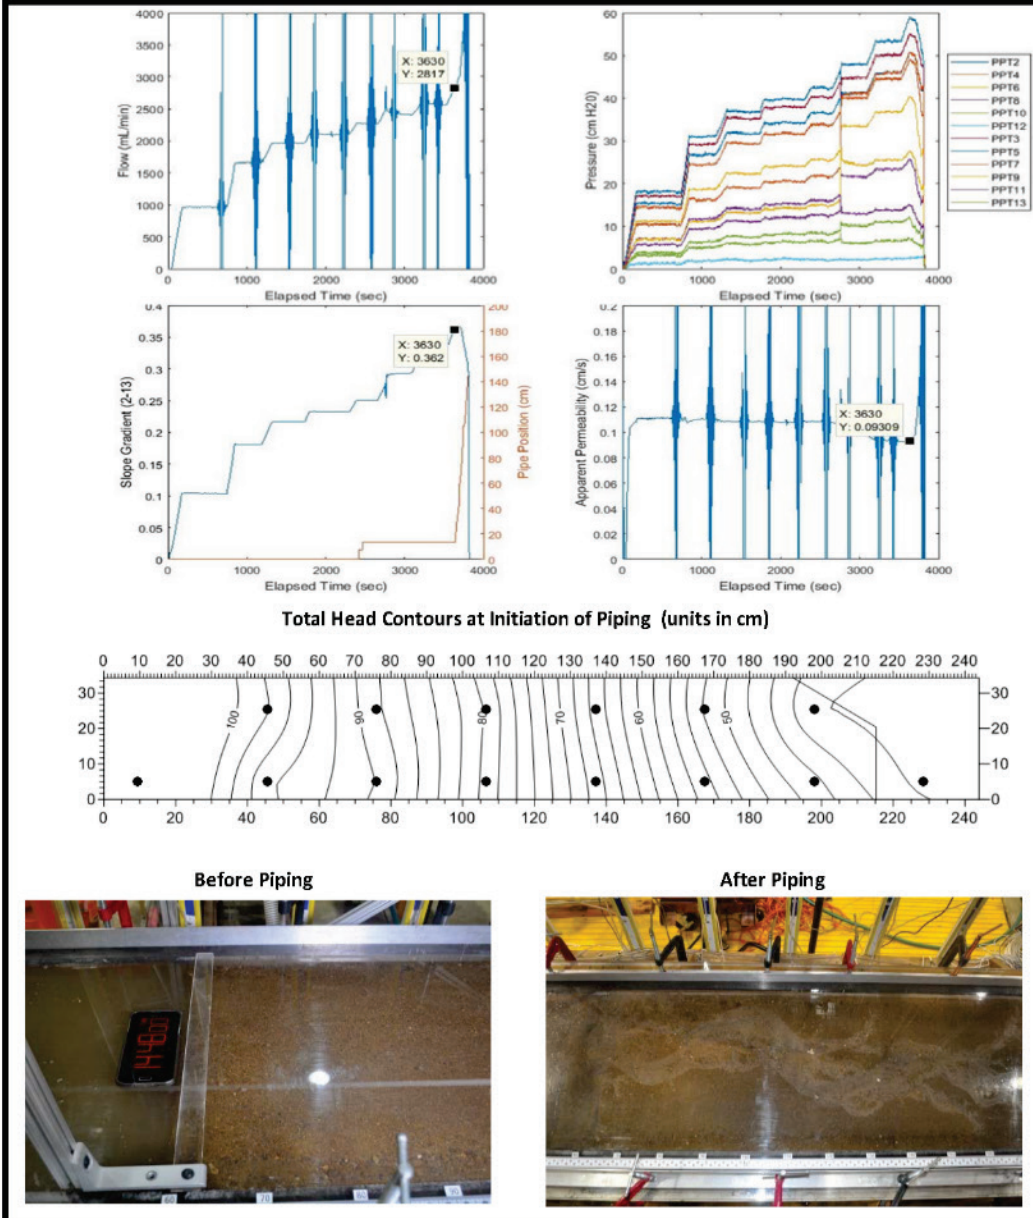
Sand Type	<u>Magnolia S2</u>	Date	<u>3-May-17</u>
Test Number	<u>4</u>	Start Time	<u>16:02:02</u>
Tested by	<u>A.M., B.B.</u>	End Time	<u>17:05:56</u>

Initial Conditions		Results (at Initiation of Piping)	
Soil Weight for First Slope	425.840 kg	Time at Piping	17:02:32
Soil Volume	0.261330 m <sup>3</sup>	Critical Gradient	0.36
Dry Unit Weight	15.985 kN/m <sup>3</sup>	Flow Rate	2.817 L/min
Porosity	0.386	Average Velocity	3.37E-02 cm/s
Sample Length	176.0 cm	Sample Permeability	9.31E-02 cm/s
Area	0.1394 m <sup>2</sup>		
Relative Density	17.73%

**Notes:** Sample was prepared on 02MAY2017. Test was conducted on 03MAY2017 with the load cell. Sample permeability and velocity at piping estimated from flow at the moment of piping. A 10-cm-long pipe slowly formed on the right side. At 17:02:32, continuous piping initiated along the right abutment and moved towards the center. Sample was confined to a bladder pressure of 6 psi and seating pressure of 2.75 psi. Additional sand was placed 30 cm from the upstream wall, and approximately 2 cm on the left and right sides of sample for good contact. The total sample length was 176 cm (slope at 63 cm and upstream wall at 239, with the plexiglass flush with the downstream side of the flume).
