# Thermal Camera Reliability Study: FLIR One Pro

By Quincy G. Alexander and Christo V. Lunderman

**PURPOSE:** The purpose of the effort described herein is to verify the reliability of the FLIR One Pro Gen 3 (FLIR One) unit through systematic experiments that compare the temperature perceived by the unit to the temperature measured by contact sensors on different materials through a range of temperatures.

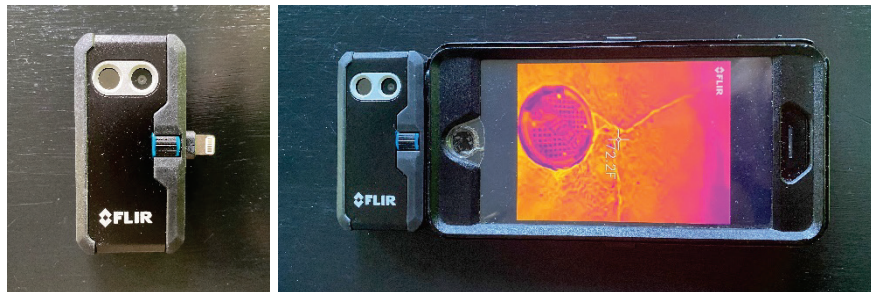
Figure 1. FLIR One Pro device and connection to mobile device with app.

**BACKGROUND:** The FLIR One unit was proposed for a larger study due to the relatively low cost (retail approximately \$399),<sup>1</sup> thermal resolution, and the integrated visible spectrum camera. When connected to a mobile device, the FLIR One mobile app is used as the viewfinder and to control operation of the camera. The individual unit and the unit attached to a mobile device are shown in Figure 1. The thermal images captured using the FLIR One are taken at a resolution of 160 x 120 pixels in a "compressed image format," to minimize storage size and the complimentary software automatically upscales the images to 640 x 480 pixels (Alfonso 2019). The corresponding visible spectrum images are taken at resolution of 1440 x 1080 pixels. The FLIR One specifications state an object temperature range of -20°C to 400°C (-4°F to 752°F) and accuracy of  $\pm 3^{\circ}\text{C}$  (5.4°F) or  $\pm 5\%$ .<sup>1</sup>

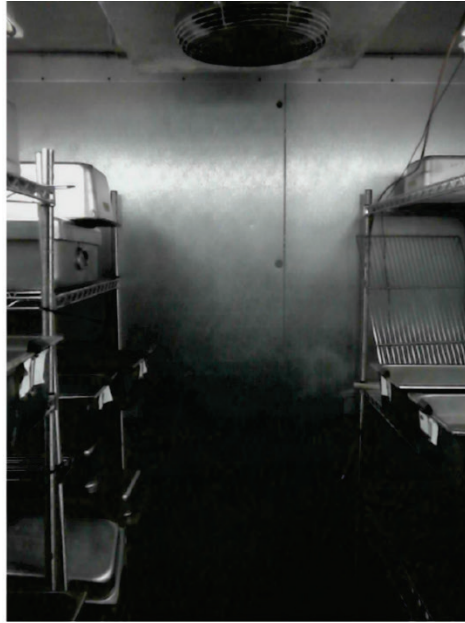
Figure 5. (a) Environmental chamber (b) thermal gradient during heating and (c) thermal gradient during cooling.

As seen in Figure 4, during the heating period (5:00 am – 11:00am), the test sample was warmer than the ambient air temperature measured by the thermocouple but aligns very well during the cooling period. This is because the thermocouple was positioned lower than the steel plate test sample in the chamber, aligning with the position of the concrete sample (Figure 2(c)). When heating, there was a significant temperature gradient along the height of the chamber, with the warmest air (~130 °F) near the top and cooler air (~88 °F) near the bottom (Figure 5 (b)). During cooling, however, the temperature variation along the height was not significant, ranging from 20 °F to 28 °F (Figure 5 (c)). As such, the thermocouple and test sample align well during the cooling period (11:00 a.m. –12:00 a.m.).

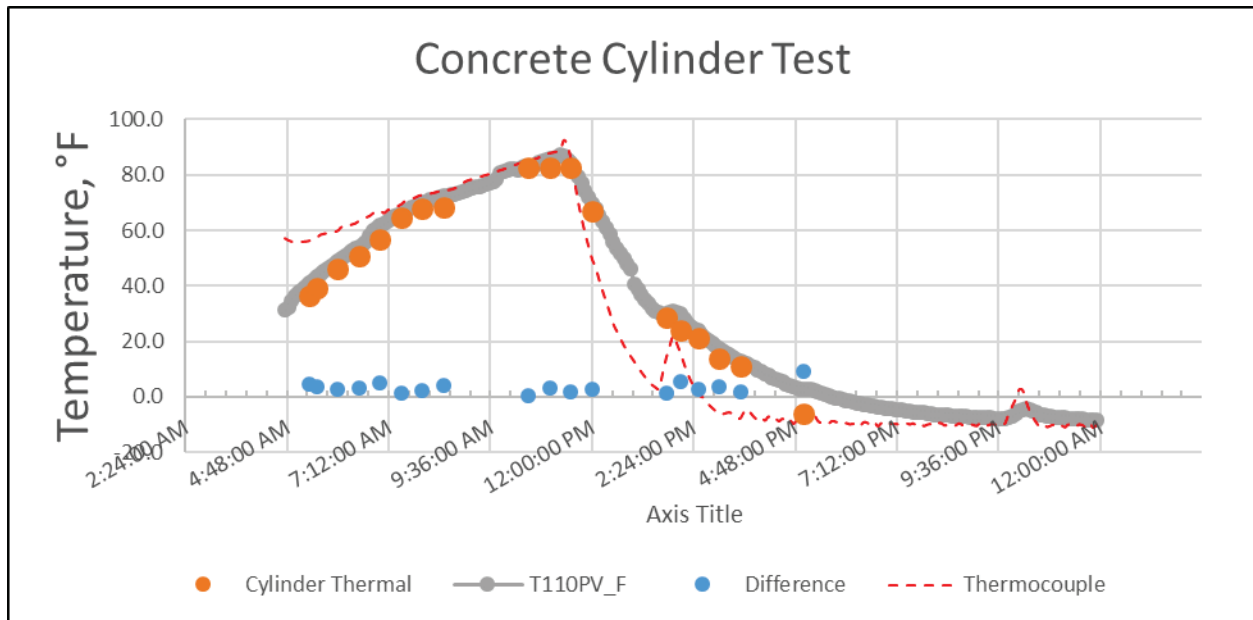
Because of the larger thermal mass of the concrete cylinder, Figure 6 shows there is a larger lag between the change in temperature relative to the thermocouple, as compared to the steel plate test. However, the high and low temperatures of the sample and the thermocouple correspond well.

Figure 6. Temperature-time history comparison of thermistor and thermal imaging temperature measurement.

**Concrete cylinder.** The results for the concrete cylinder are provided in Table 2 and Figure 6. The average temperature difference between the surface-mount thermistor measurement and the thermal image values for the concrete cylinder was 3.3 °F. The object temperature for test 18 was below the minimum specified range for the camera, and the camera performed poorly in that range. All tests within the specified object temperature range showed a temperature difference less than or equal to the specified accuracy of 5.4 degrees, except Test 14, which showed a difference of 5.6 °F. During the time period of Test 14, there was a sudden rise and fall of the chamber temperature and the larger difference may simply be due to the approximation of time when the image was taken.

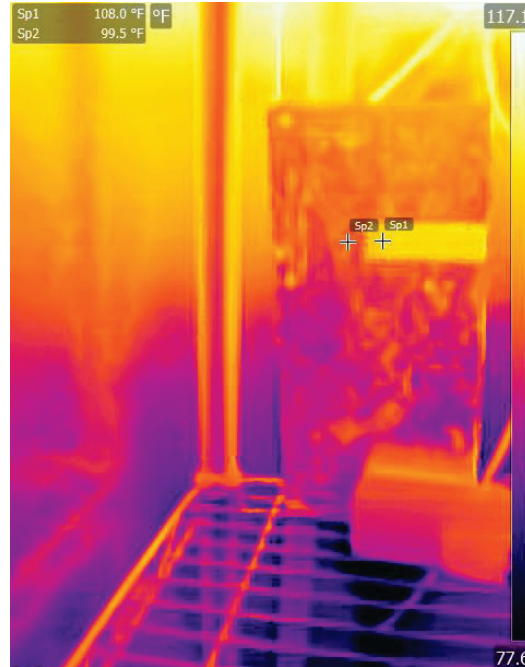
Figure 7. Thermal image of emissivity test setup for steel plate.

**Emissivity.** The infrared images were tuned to the known emissivity of the black tape (0.95), however, the appropriate value for the steel plate and the damaged concrete cylinder could be determined by adjusting the local emissivity value of a point on the material near the black tape, so the perceived temperatures match. Average emissivity values for different steel and concrete finishes are provided in Table 3.<sup>1</sup> For the concrete test sample, the temperature from a spot measurement taken near the black tape typically aligns with the temperature of the black tape, therefore, the assumed emissivity value of 0.95 can be assumed to be accurate. This is consistent with the published value for rough concrete.

For the steel test sample, the temperature from a spot measurement taken near the black tape was typically significantly different from the measured temperature on the black tape. The temperature varied from 5 °F -15 °F degrees at the high and low temperature extremes. This would imply that the emissivity of the steel plate was lower than 0.95. To better understand the appropriate emissivity value, the back of the plate was used for calibration. Similar to the primary test, an electrical tape target was placed on the back of the plate, as shown in Figure 7, and used to calibrate for emissivity. A nearby point was measured and the local parameters at the point were changed to a value where the two temperatures aligned. Using this approach, the emissivity value for the steel plate was determined to be approximately 0.82. This falls within the range of the published oxidized and weathered steel values, therefore it seems reasonable.

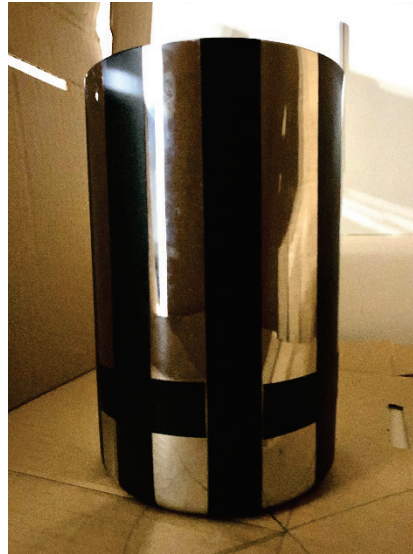
A metallic container, 4-inch in diameter by 6-inch tall was used to evaluate the impact of curvature on perceived infrared measurements. The container was filled with water to maintain a consistent temperature. Vertical strips of black electrical tape were added to identify the viewing angle of 0, -45, and 90 degrees. Additionally, a horizontal band of electrical tape was placed 1-1/2-inches, centered, from the bottom of the container. The FLIR Pro thermal camera was placed 4-1/2 inches from the container for the imaging. The thermal image was taken, and spot measurements were collected at the vertical tape locations and at intermediate targets centered between the vertical strips. The plan configuration is illustrated in Figure 8 and the interrogated image is shown in Figure 9.

Figure 8. Test configuration and container with tape.

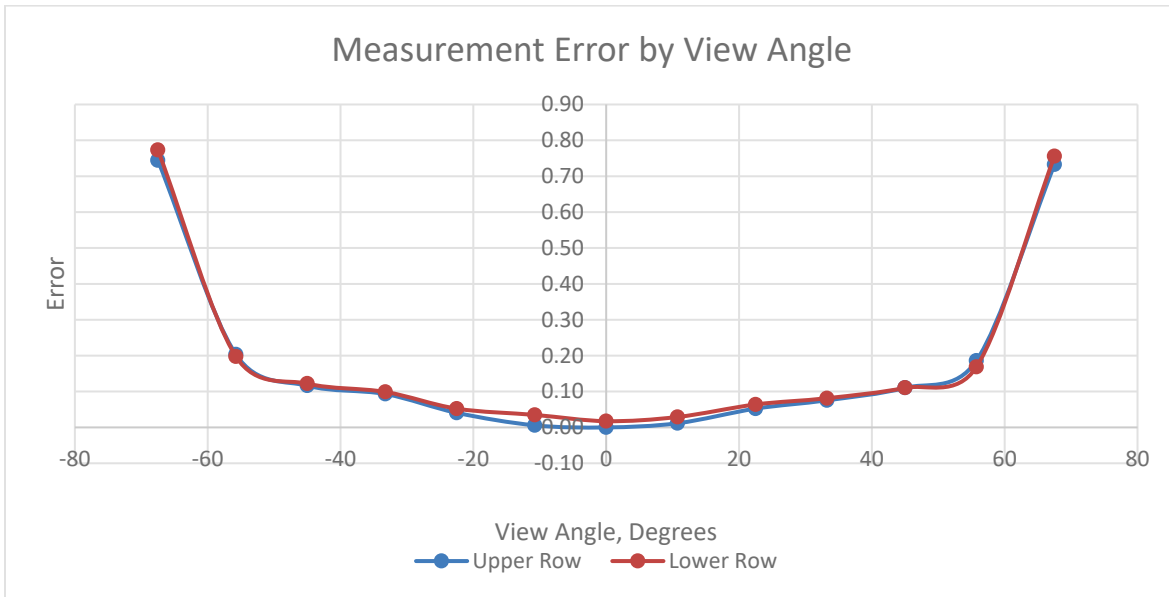
Figure 10. Measurement error by view angle.

The results indicate that small changes to the view angle will reduce the accuracy of the perceived temperature from thermal imaging, and the difference becomes significant at large angles. Due to the position of the concrete sample in the thermal chamber, the view angle was estimated to be in the 20-40-degree range. Per the study, this could cause the temperature to be underestimated by 2-3 °F. This is consistent with what is shown in Table 2, where the infrared measurement is typically approximately 3 °F less than the value measured by the contact thermistor.

The normalized equation described by Cheng et al. (2012) to capture the measurement error as a function of the view angle is provided in Equation 3. The apparent temperature measurements for each viewing angle, as determined from the thermal images, were applied to the equation, and the resulting errors are plotted by angle in Figure 10. The atmospheric temperature was determined to be 76 °F.
