NAVY DEPARTMENT
BUREAU OF ENGINEERING

FR-1283

Test of Propeller Shaft Revolution
Indicator System
Manufactured and Submitted by the
Electric Tachometer Corporation, Philadelphia, Pa.NAVAL RESEARCH LABORATORY
ANACOSTIA STATION
WASHINGTON D.C.

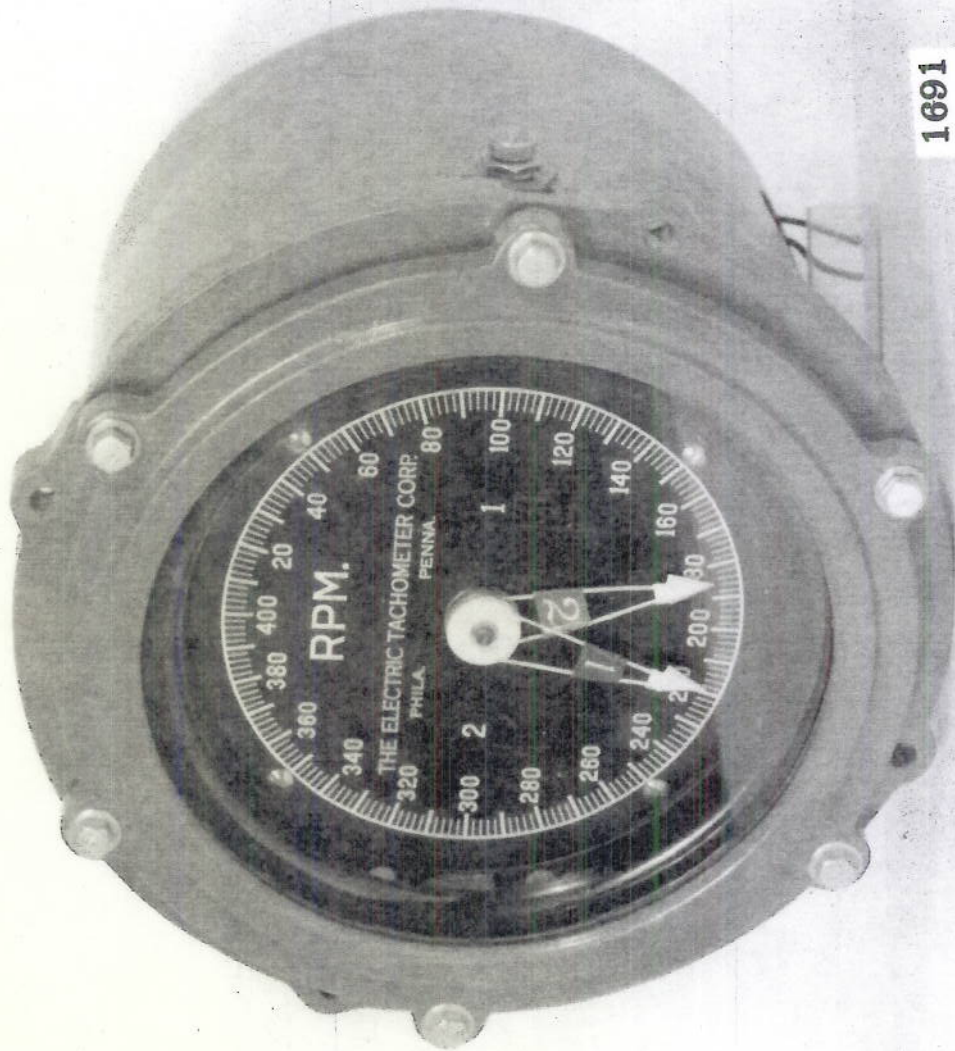
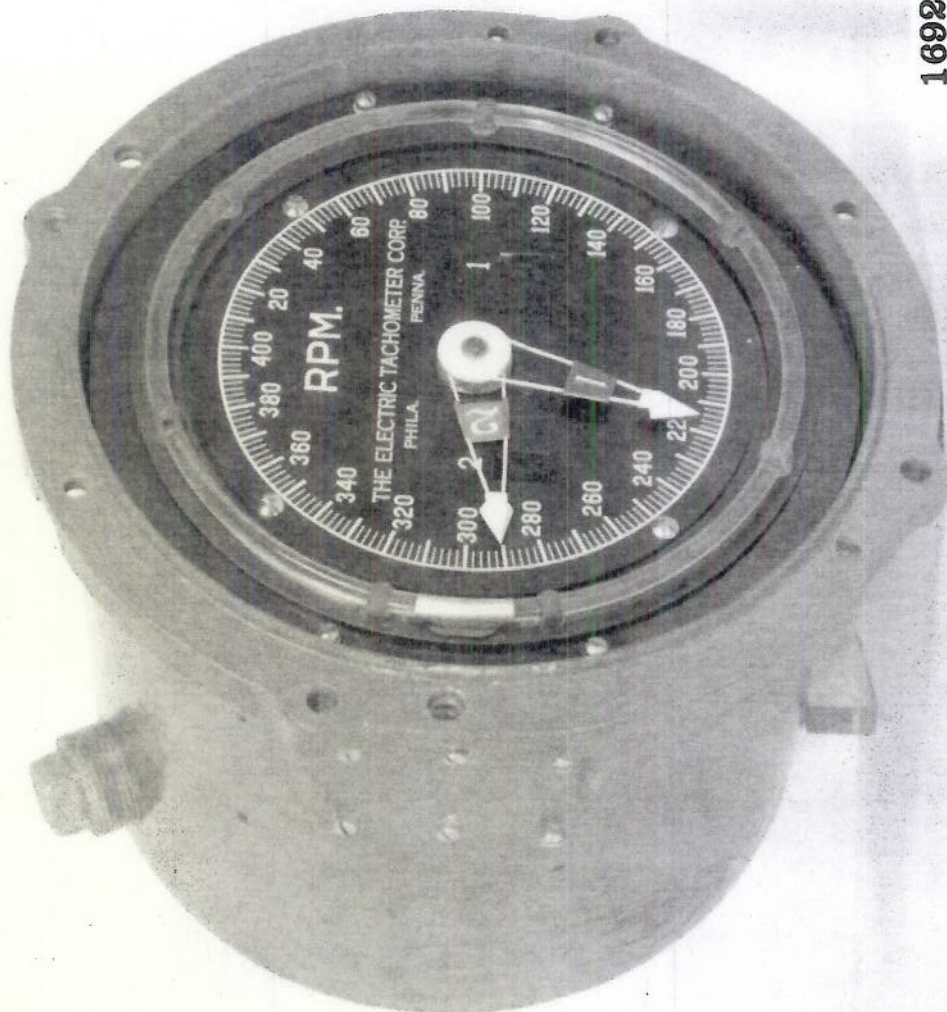
PLATE IO

50. The only instrument suitable for the watertight integrity test was the repeater indicator, shown by Plates 9 and 10. When submerged in water to a depth of 3 feet for a period of one hour, no leaks occurred.

56. Under inspection of materials, the following features on the repeater indicator, shown by Plates 9 and 10, were noted as being undesirable.

(a) Hand hole cover for dial lamps cannot be removed when the instrument is mounted on the gauge board.

(b) Under the same conditions, the rheostat handle will be inaccessible.

(c) Only three mounting lugs can be used for mounting the instrument due to location of the hand hole cover.

(d) The light shield for the lamps is too flimsy.

- (1) The pointers should be made of heavier material.
- (2) The spring for the operating lever of the zero cut-off switch should also be made of heavier material.
- (3) Correction of defects in the case design of the repeater indicator noted under "Conclusions", paragraph (d), should be made.
- (4) The resistance of the rheostat used for dimming the dial lamps should be decreased to a point where the potential at the lamps will be 3.5 volts, with full resistance in the circuit.
- (5) Master instruments should be furnished in watertight cases.
