| <b>1. REPORT DATE (DD-MM-YYYY)</b><br>05-12-2021 | | <b>2. REPORT TYPE</b><br>Project Final Report | | <b>3. DATES COVERED (From - To)</b><br>Jun 2019 to Dec 2021 | |
| <b>4. TITLE AND SUBTITLE</b><br>In-Process Control for L-PBF | | | | <b>5a. CONTRACT NUMBER</b><br>SP4701-19-C-0027 | |
| <b>7. PERFORMING ORGANIZATION NAME(S) AND ADDRESS(ES)</b><br>Flightware, Inc.<br>829 Podunk Road<br>Guilford, CT 06437 | | | | <b>8. PERFORMING ORGANIZATION REPORT NUMBER</b><br><br>TBD | |

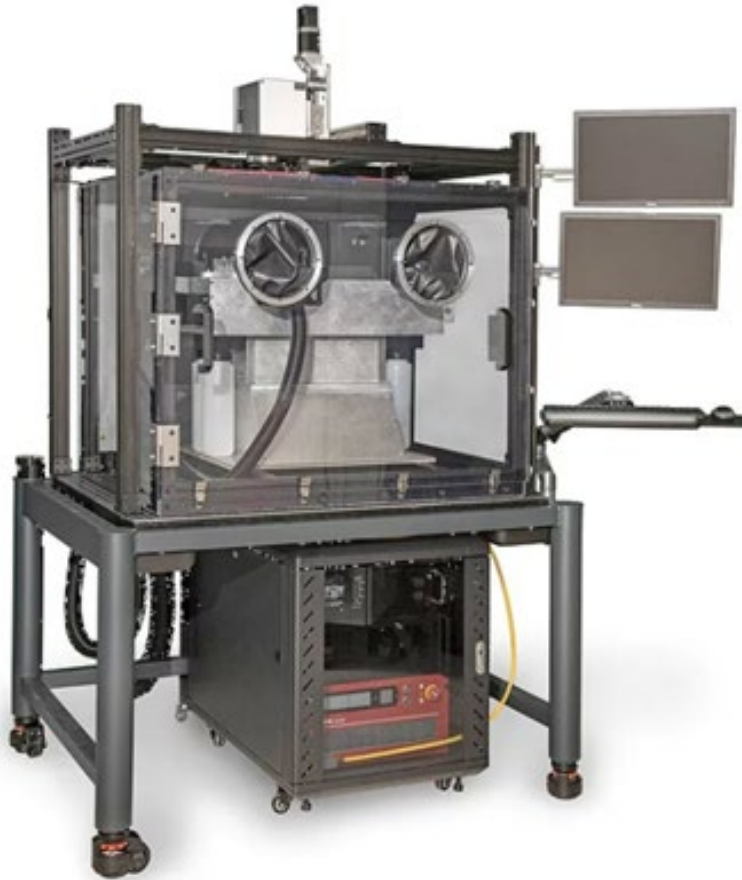
This is a research machine and progenitor of the PANDA® unit offered commercially by Open Additive. It features an open architecture that allows the User to access almost all the machine's operating parameters.

**Figure 1 - AM2 Metal AM Printer at Open Additive**
